**Failure Analysis, Fault Determination and Isolation  
of Laser-Damaged Interline Transfer CCDs**

**Submitted by  
6052 Failure and Materials Analysis Lab  
NSWC Crane  
November 30, 2006**

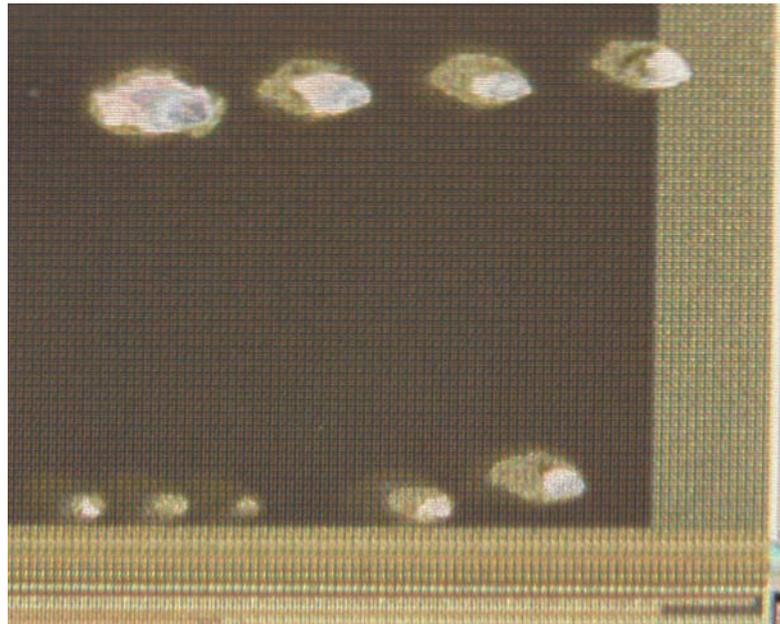
The initial CCD was received in a nonfunctional condition. The device was subjected to 10 laser shots of increasing energy, at an angle with respect to the surface of the array. The entire die was inspected optically and photographed to identify the array area, controlling poly silicon gates, parallel and serial shift registers as well as the clock, gate drive, and power circuitry. An electrical schematic was derived to help gain an understanding of the device's normal operation. This process also provides background information to assist in exploring how the laser shots created a particular level of damage, either causing local pixel malfunction, row or column problems, combined problems or total device failure.

*Image 1*  
*High magnification photograph of the laser damaged area.*

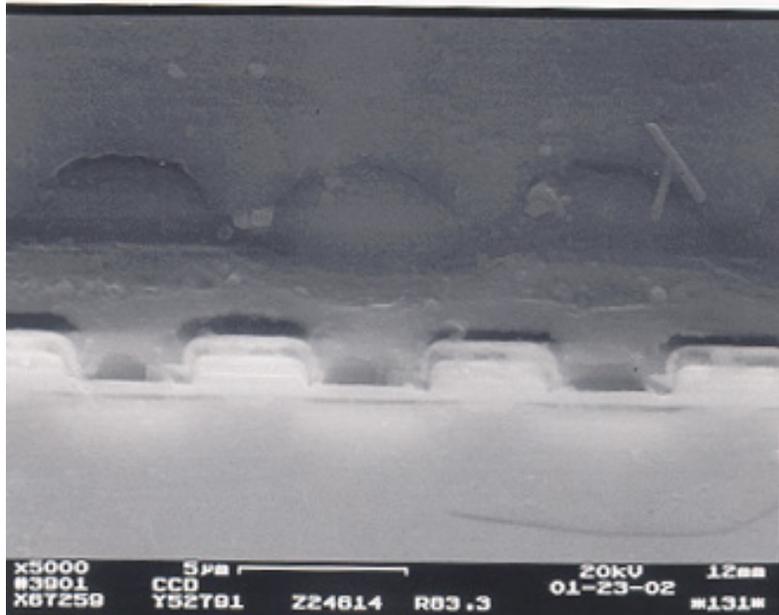
*Image 2*  
*Representative cross section of die structure*

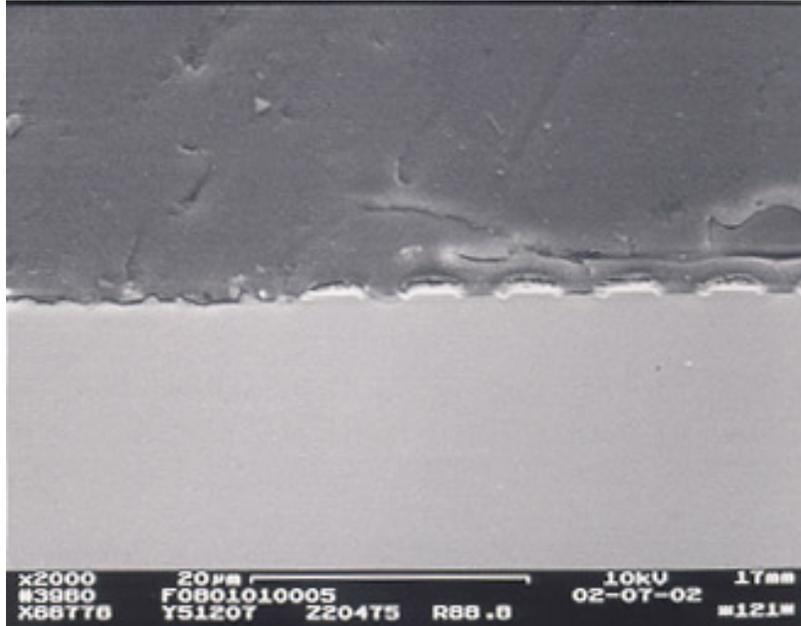
In the area of the 10<sup>th</sup> shot, the inspections confirmed that the clear coat, planarization layer, lenses, and cover coat had been vaporized. The inspections and analyses also clarified that the dual metal, aluminum over tungsten, light shield had been melted into the polysilicon gates and into the silicon surface shorting the channel stops to the pixels and possibly into the substrate beneath the epitaxial area. The melting of the metal light shield into the silicon is shown on the SEM photomicrographs and SEM-EDS and confirmed by the absence of metal above the polysilicon gates. Damage exhibited at the failure site is typical of the extent of damage that is sufficient to kill a semiconductor

FET. Although no isolation or probe station electrical measurements were made, the metal and polysilicon to substrate shorts were clearly adequate to prevent device operation.

*Image 3*  
*Cross section of laser damage*

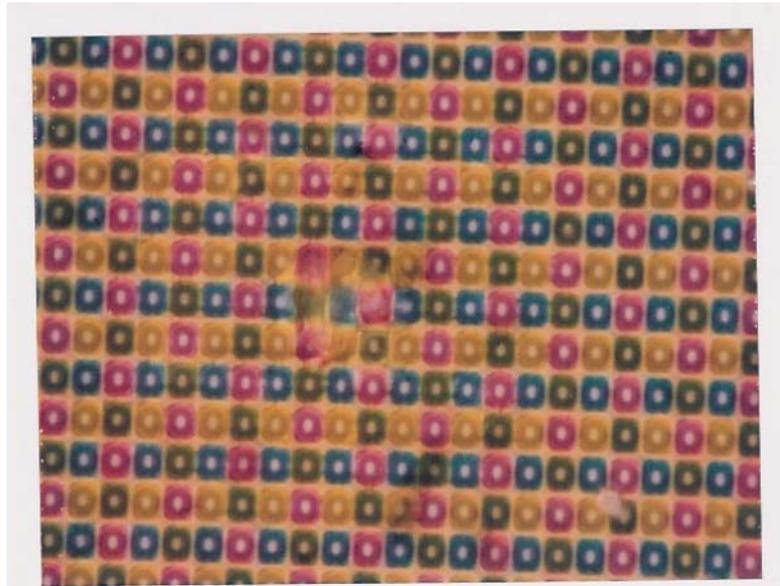
*Image 4*  
*Optical microphotograph of laser shot damage*

Inspection of the damaged spots using high magnification microscopes indicated that the laser had disturbed either the dye, planarization layer, or micro-lens depending on the shot energy of the damaged area inspected. With increasing energy, a corresponding increase in the depth and severity of the disturbance was observed in one or more of the layers. To observe the extent and location of damage it was necessary to continuously vary the focus and mentally reconstruct what was being seen into a three dimensional image. While small sections of metallization could be seen on selected spots, there did not appear to be any significant damage to the metallization.

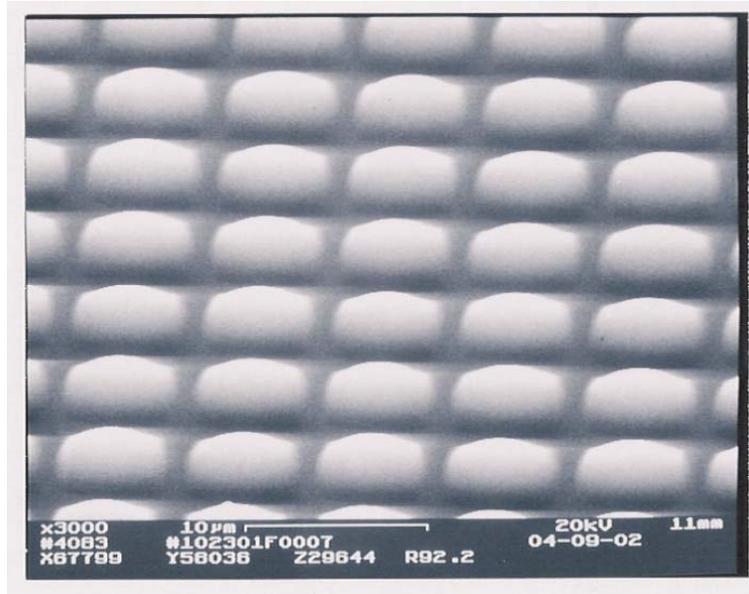
*Image 5*  
*SEM photo of laser damaged area*

Of interest at the laser damaged spots, visible by optical or functional malfunction, was that SEM secondary and backscatter electron images at various acceleration potentials and at various magnifications were unable to detect any difference in the cover coat or lens shape over the damaged spots compared to undamaged spots. This finding together with the observations made above, confirmed that the damage or disturbance was localized to the organics between the cover coat and the dielectric layer covering the light shielding metallization and silicon. Even the highest energy shot area was indistinguishable from fully functional pixel areas.

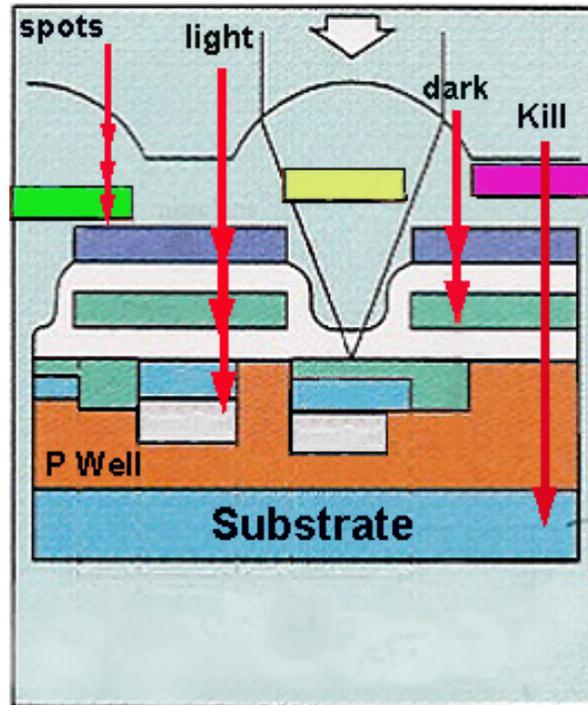
Figure 1 above highlights some of the locations/positions of the laser shot within a pixel (or group of pixels) and which layers/surfaces are damaged or shorted to the next underlying (or adjacent) layer cause the damage seen on the video output.
