## USS BOONE (FFG 28) Voyage Repairs Complete – Safely Resumes Deployment

9 May 2011

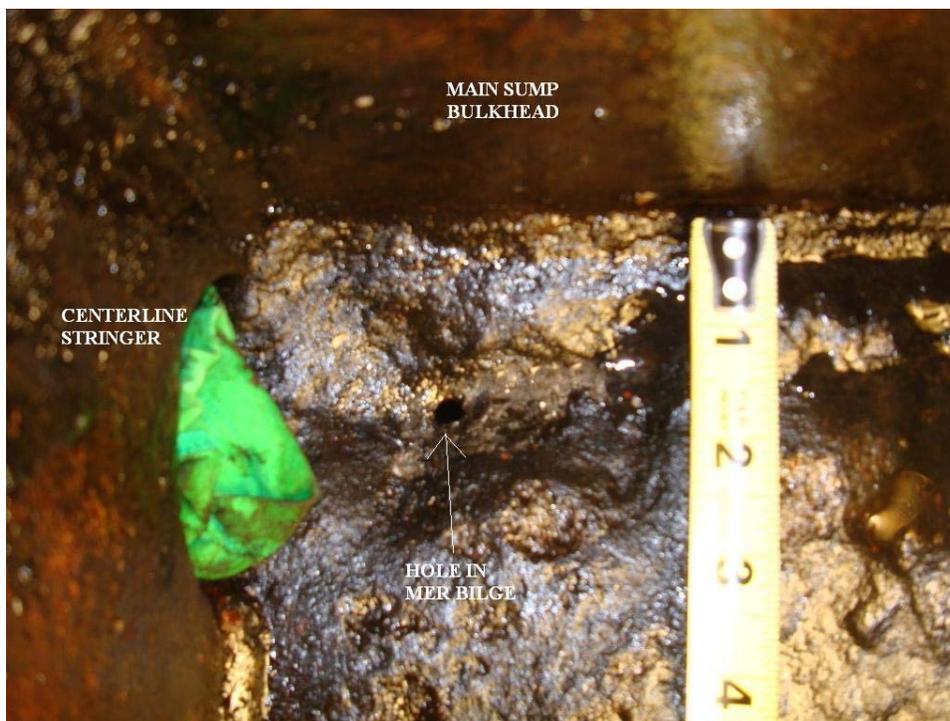
With the assistance of the U.S. Consulate the SUPSALV team obtained visas and arrived in country on 24 April. Working with a Brazilian subcontractor supplying the dive system, the team was able to assemble their dive station and conduct the first inspection dive Tuesday 26 April. This inspection dive looked for gross damage and examined known access plates and plugs for leaks. After dewatering the flooded portions of the skeg, a more thorough inspection and investigation was conducted to locate the source of the water ingress. Additionally, the team conducted an ultrasonic testing (UT) inspection of the area surrounding the hull breach to determine the degree to which corrosion had affected the hull plate thickness. Results from the inspection indicated water ingress was through a 3/8" hole in a recessed area less than two-inches aft of the Main Reduction Gear (MRG) lube oil sump. The proximity to the MRG sump (full of oil) was of concern for conducting a weld repair.

*Close up image of the hole in the MER bilge.*

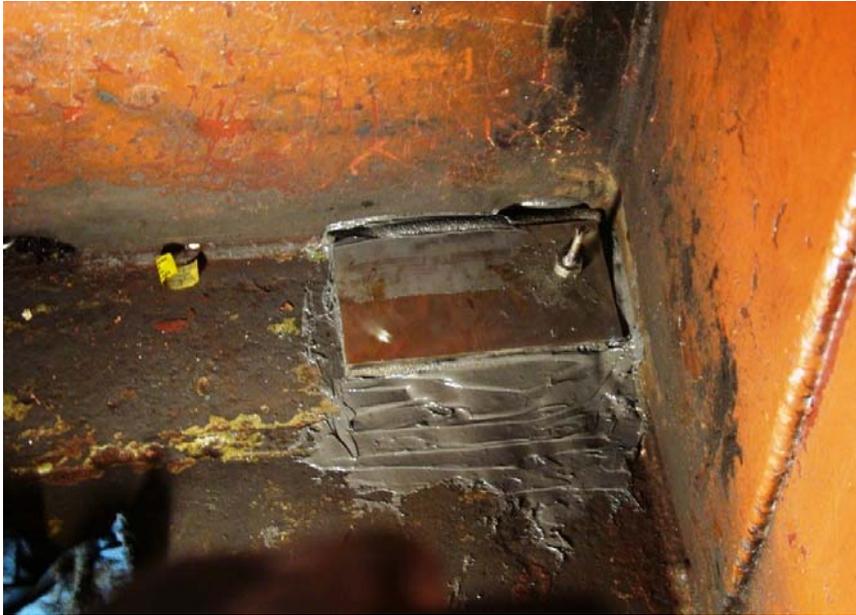
*J-Hook and steel patch set in epoxy in bilge of MER.*

After dewatering, the level of the remaining liquid in the skeg was measured and monitored through the night; there was no change. The final piece of testing was a pressure test with accompanying internal inspection by ship's force and external inspection of the skeg by the divers; there was no drop in pressure for a period that exceeded 20 minutes. After conducting a conference call with the SERMC engineers, NAVSEA technical authorities, and ship's force representatives and, based on the satisfactory results of the UT and pressure testing, the decision was made, and authorization granted, to drill out the hole to a slightly larger size (to stabilize the stresses) and patch the hole using a J-Hook-type mechanical patch.

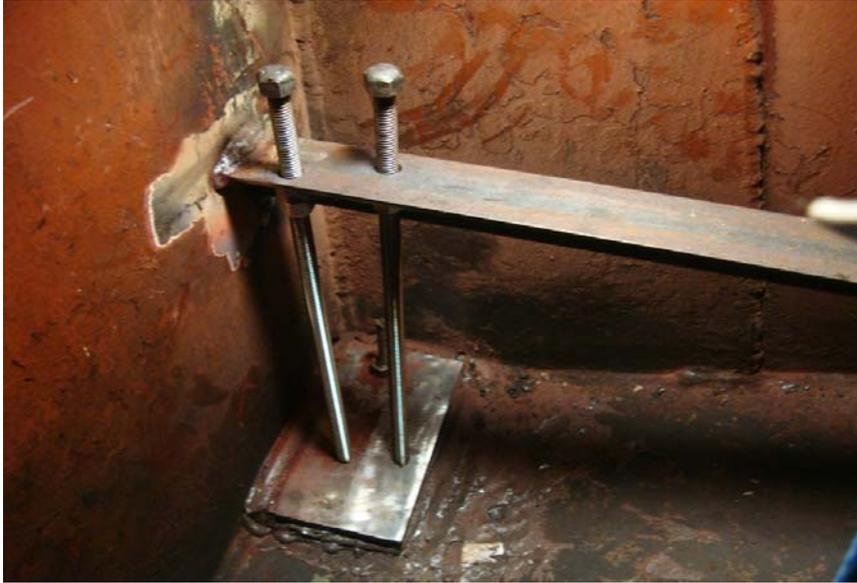
*Metal patch stabilized by welded brace.*

After drilling but before installation of the patch, a final magnetic particle testing (MT) inspection was performed in the vicinity of the hole. The J-Hook was installed and stabilized with external bracing and the ship's condition was documented. SUPSALV's Mr. William Reid, who supervised the repair said, "Our primary concern was to confirm the integrity of the skeg and hull to ensure there was no danger to the ship or crew. We were well satisfied with the skeg conditions as found. The hull, skeg and bilge tested satisfactory with the single discrepancy being an isolated case. The patch installation went smoothly. Though this was not a permanent repair, the mechanical patch achieved the objective of returning BOONE to her mission on schedule SAFELY."
