## **SUPSALV Teams with Commercial Diving and Equipment Contractors to Provide an Immediate Rudder Nut Inspection for USS NICHOLAS (FFG 47)**

10 September 2013

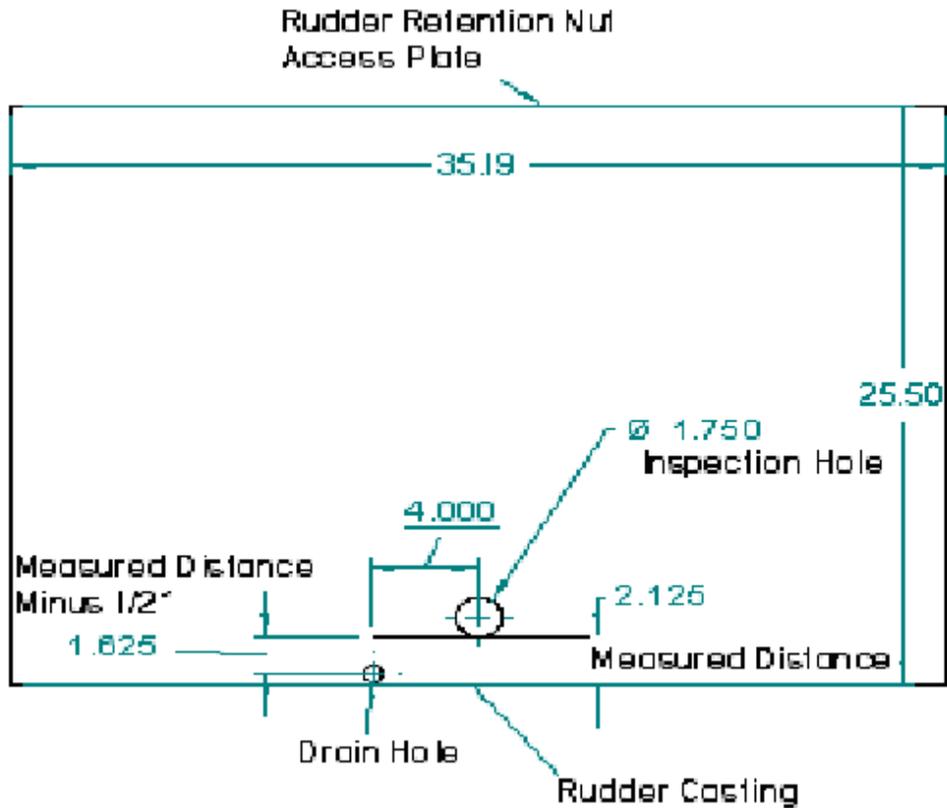
*Diagram of the Rudder Retention Nut Access Plate shows the location and specification for the access holes*

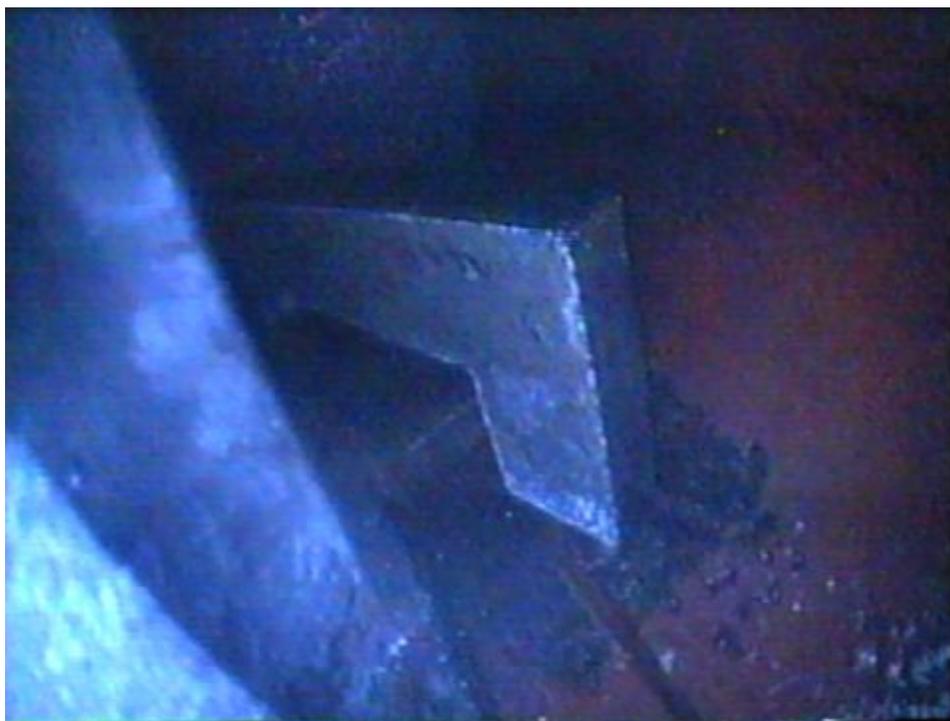
The MN-30 miniature video camera attached to a long rod was manipulated around the rudder nut void by the diver and produced a clear image of the nut, stopper plate and lug for NAVSEA OOC operations manager to monitor pier side. Video from Phoenix was interfaced via live web feed by Seaward to Washington, DC, where NAVSEA program manager could assess the current condition. Below pictures, provided justification that the rudder nut was not backing off nor was rudder dropping.

*Stopper plate and lug plate were intact*

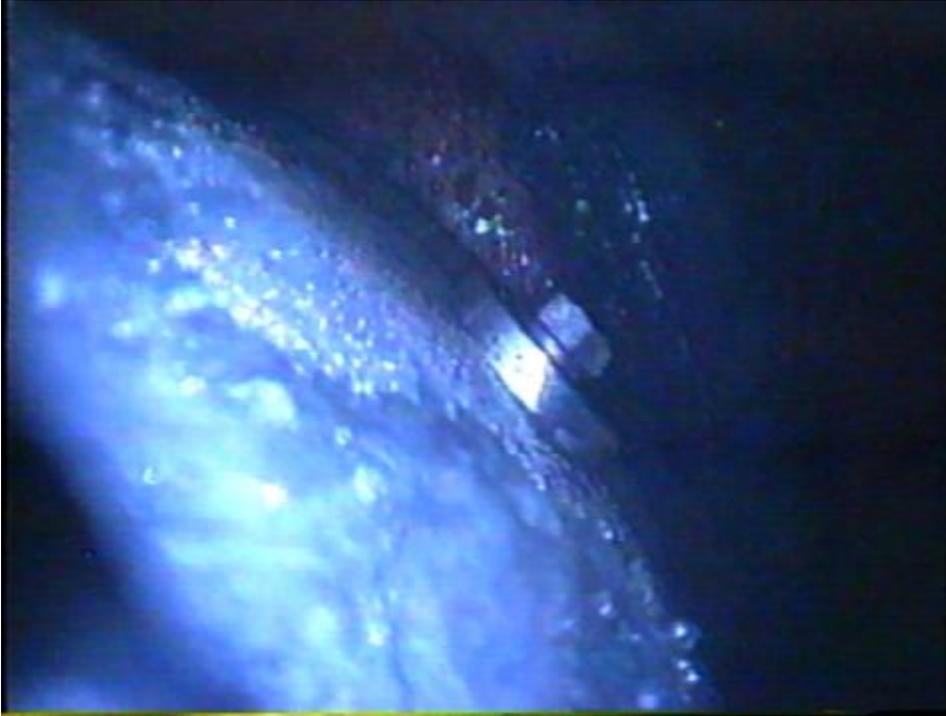
*3/8" bolt and cover plate securing tapered pin (previously installed though rudder nut and stock)*

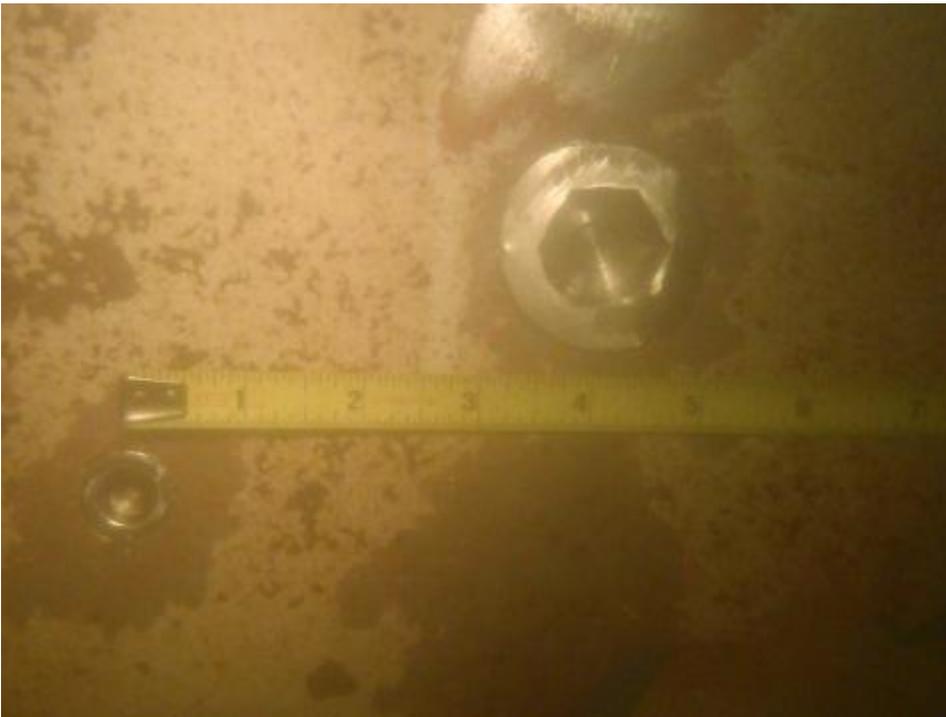
*New plugs installed sealed the rudder retention access plate*

Upon completion of inspection, both holes were tapped and a new plug was installed in the inspection hole. Nitrogen was purged into the rudder nut access void to dewater and preserve the space. Final plug was installed. Thanks to the successful combined efforts by NAVSEA 00C5, Phoenix, Seaward,
