SUPSLAV teams with NSSA to repair USS TAYLOR's (FFG 50) damaged propeller and hub.

11 April 2014

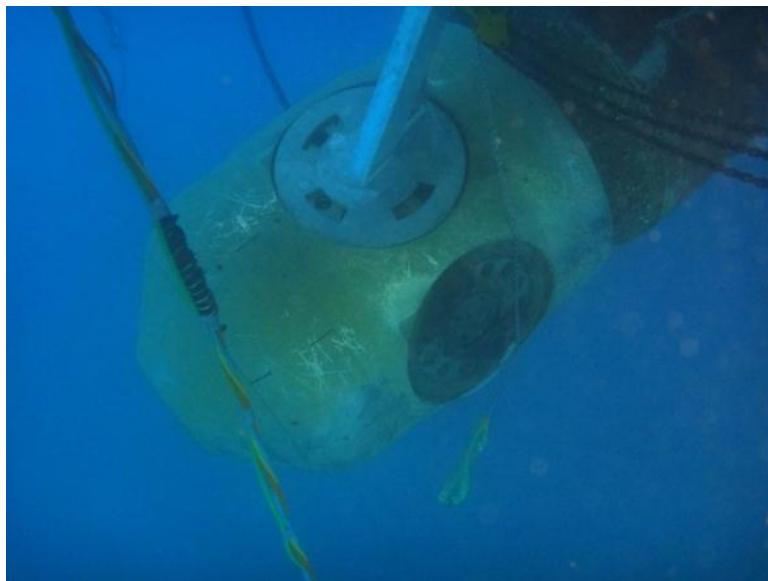
TAYLOR's old hub with blades removed and hub davit installed.

With two NSSA dive teams, one Phoenix dive team, and 3 SUPSLAV underwater repair specialists on site, 24 hours a day underwater operations were possible. One of the initial tasks was to install lifting beams, both port and starboard, under the hull to allow rigging material in place and removing interferences. Once that was done, a hub davit was installed in 1A blade port to support removal of the rope guard and installation of the bearing sealing plates.

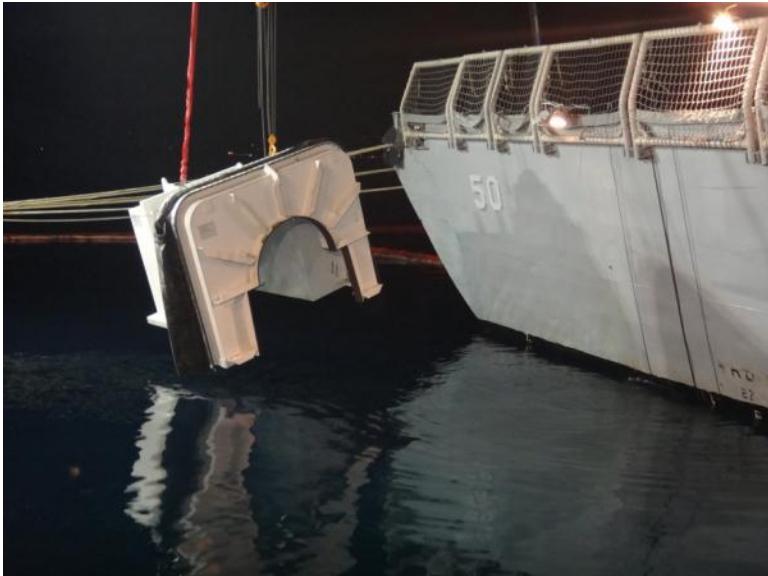
Hub cofferdam being lowered into the water for a test fit.

One of the challenges with this job was to prevent water intrusion into the hub and shaft when breaking the hub to shaft seal before removing the hub and again when installing the new hub. The solution to this challenge is to install a cofferdam which is rigged under the vessel and bolted to the shaft bearing flange.

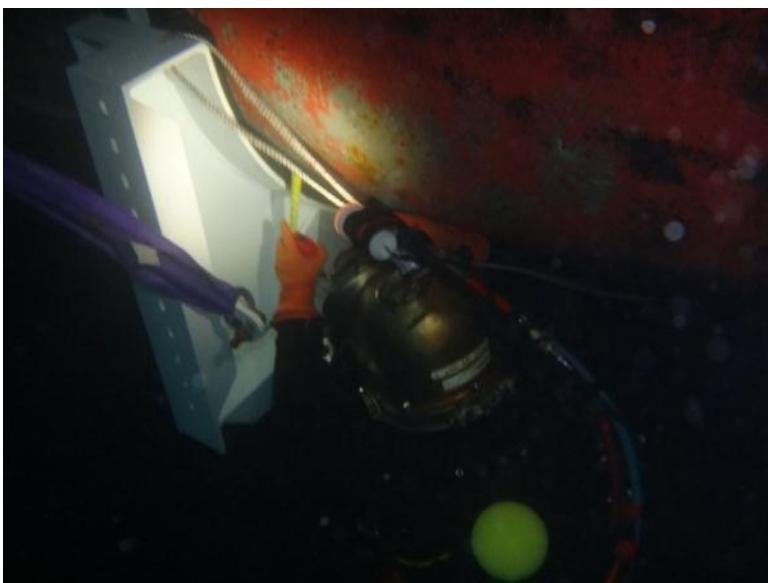
Here a diver is measuring the cofferdam lower door to see what additional gasket material is needed to provide a watertight seal for the hub removal.

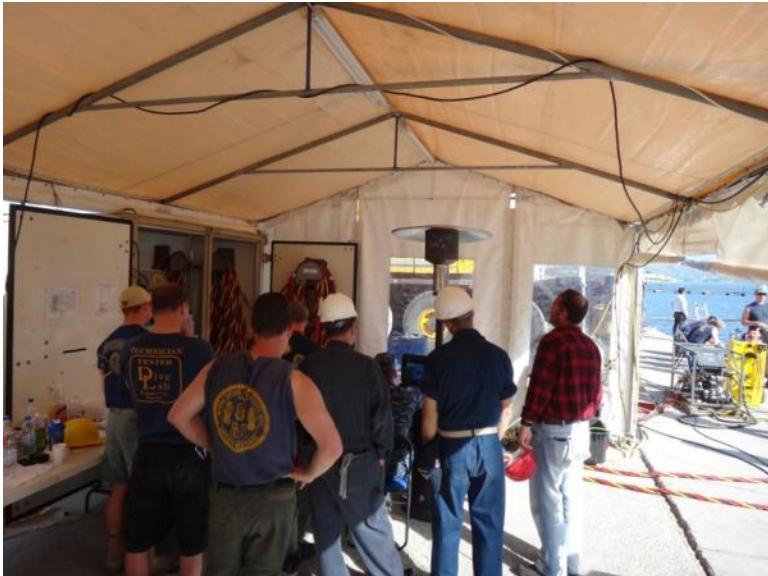
NSSA dive team observing operations using underwater video camera from the pier adjacent to USS TAYLOR.

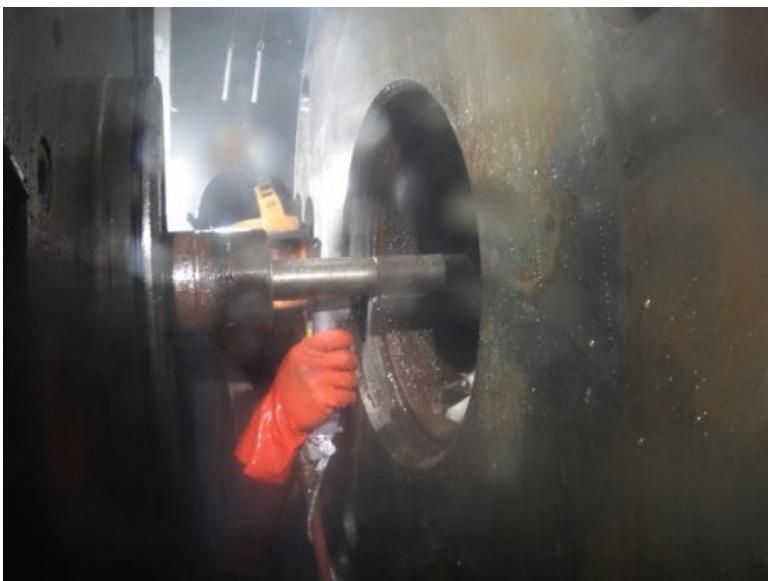
Underwater Repair Specialist completing the removal of the hub (on left) from the shaft.

On 27 March, the teams successfully removed the old hub from the shaft, yard-and-stayed it to the outboard side of the hull and recovered it to the pier. The cofferdam was removed from the hub and installed on the new ready for issue (RFI) hub which was then hoisted back into the water.

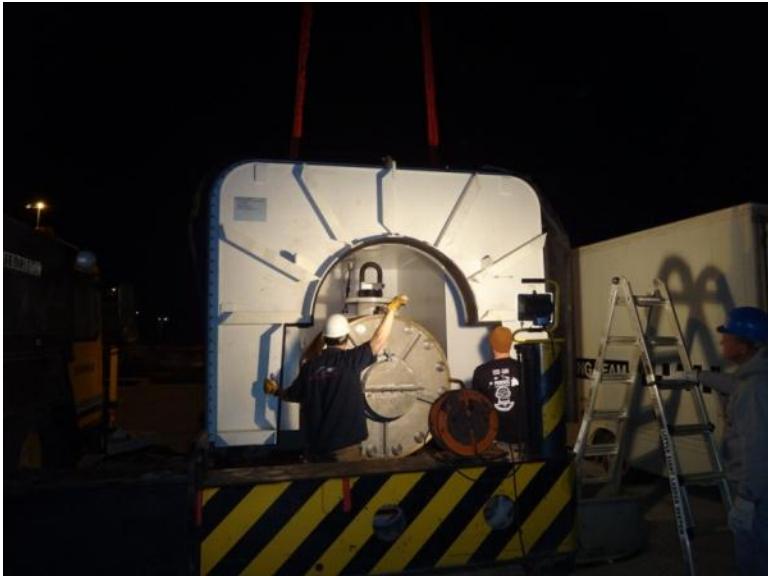
The cofferdam being lowered onto the ready-for-issue hub in preparation for reinstalling hub on the shaft.

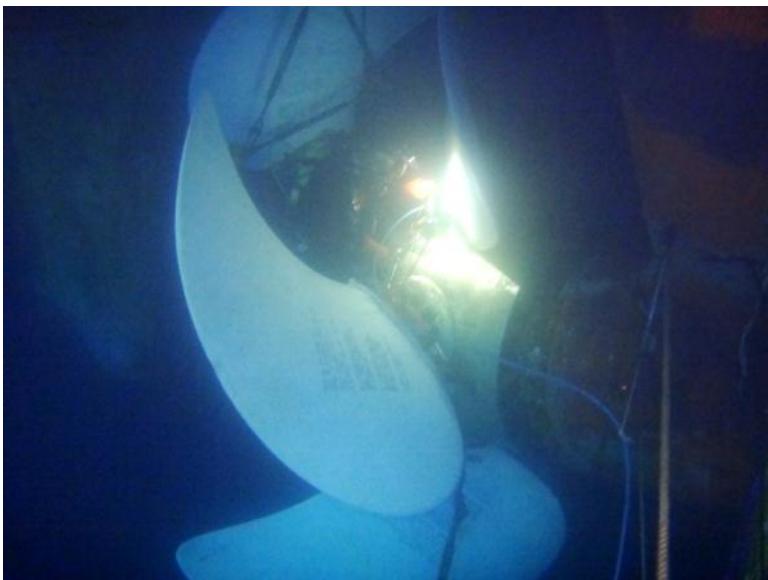
8 April 2014 image of new hub with the blade installation in progress.

Over the course of the following days, the hub was installed onto the shaft, filled with oil and verified to be functional. The cofferdam was removed and new blades were reinstalled. USS TAYLOR completed dockside testing on 10 April followed by sea trials on 11 April, returning her to service and allowing her to complete her deployment. The ability of SUPSALV's UWSH Division to develop the waterborne hub replacement procedures and NSSA and Phoenix divers to carry out the repairs in a remote port have saved the Navy time, money and restored a deployed resource to full operational capability.
