S0300-BE-MAN-010

**CASE STUDIES
OF SELECTED HARBOR
CLEARANCE OPERATIONS**

PUBLISHED BY DIRECTION OF COMMANDER, NAVAL SEA SYSTEMS COMMAND

1 JUNE 1989

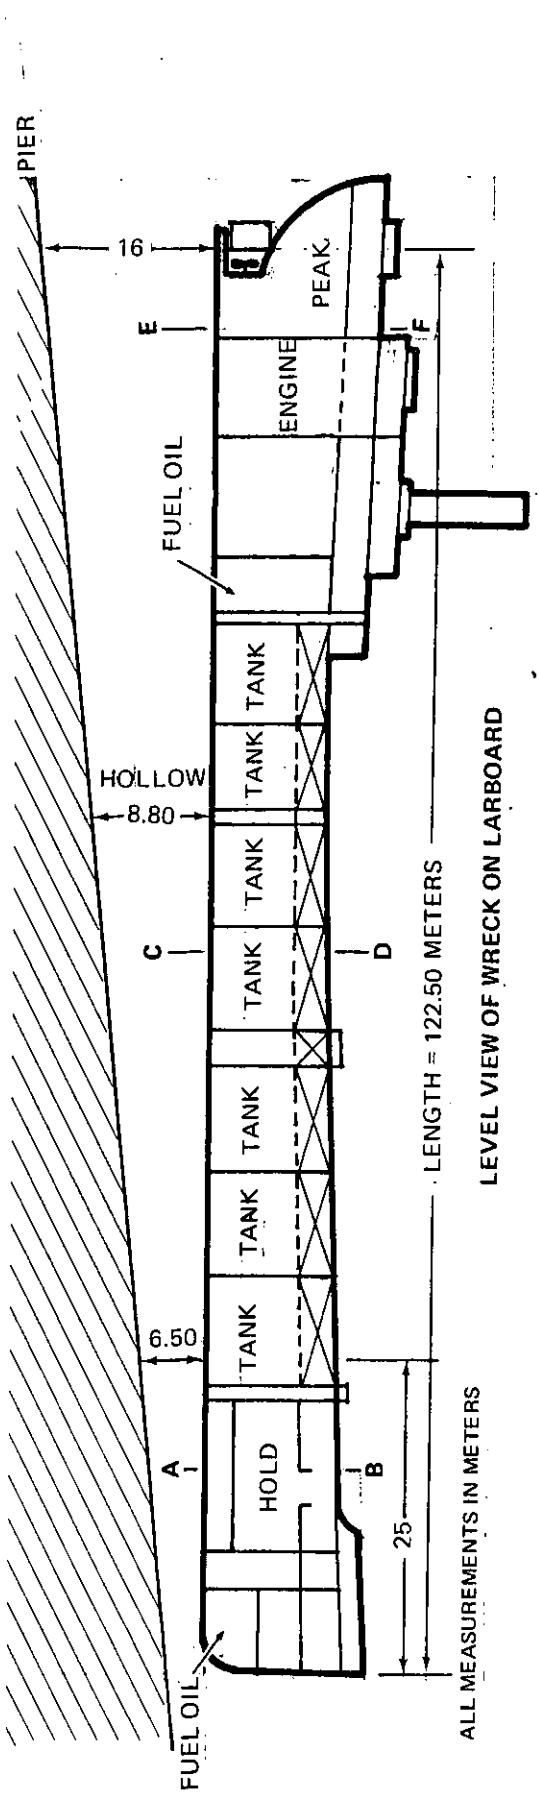
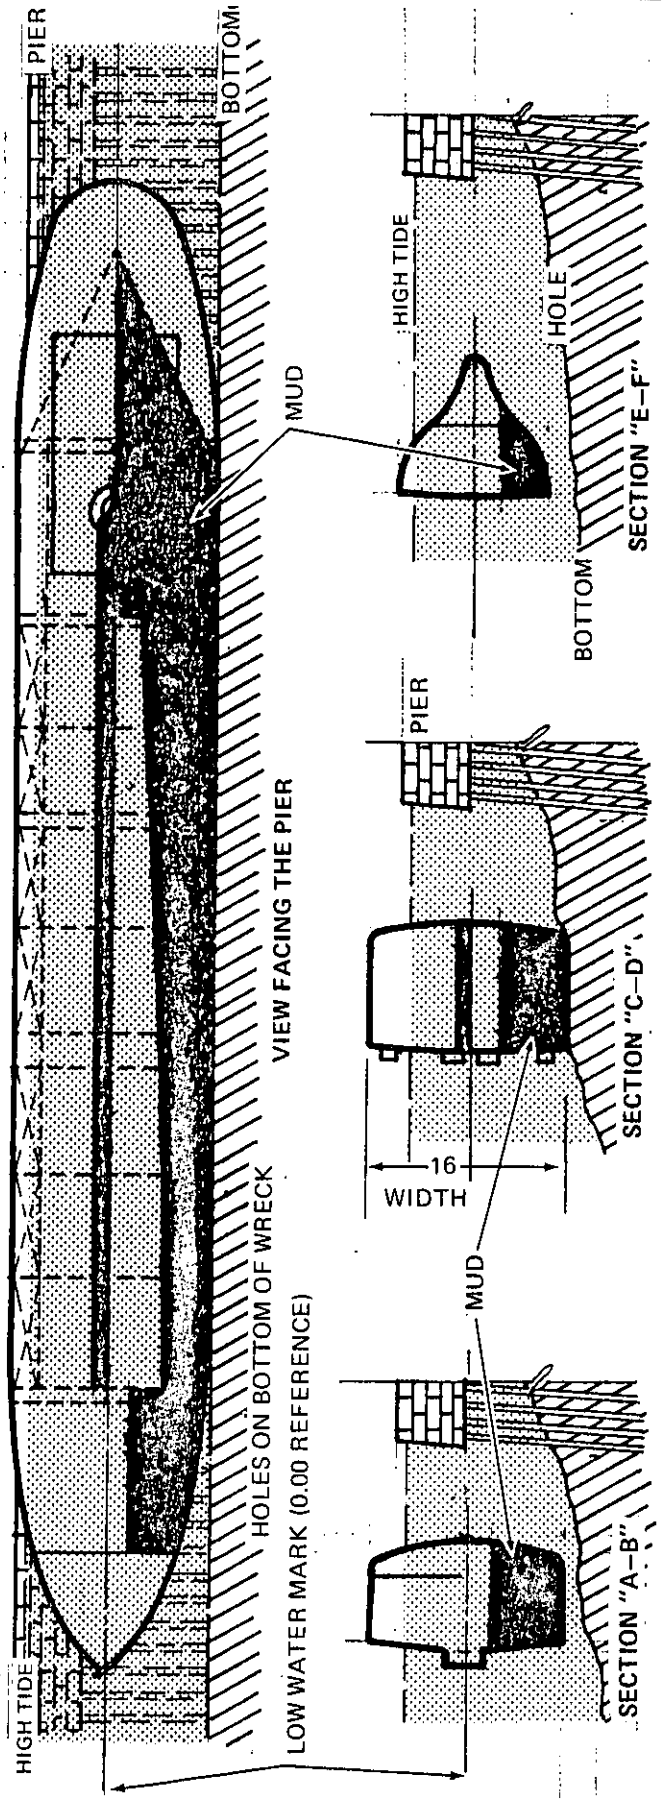
The ship had been scuttled by charges placed at the bottom of starboard tanks 4, 5, 6, and 7 and in the engineroom, as shown in Fig. 1, No. 1. The tank holes varied from one to two feet, although the engineroom fracture was larger.

THE TANKER "TODARO" SUNK ALONGSIDE THE PIER.
 FIG. 1 NO. 1

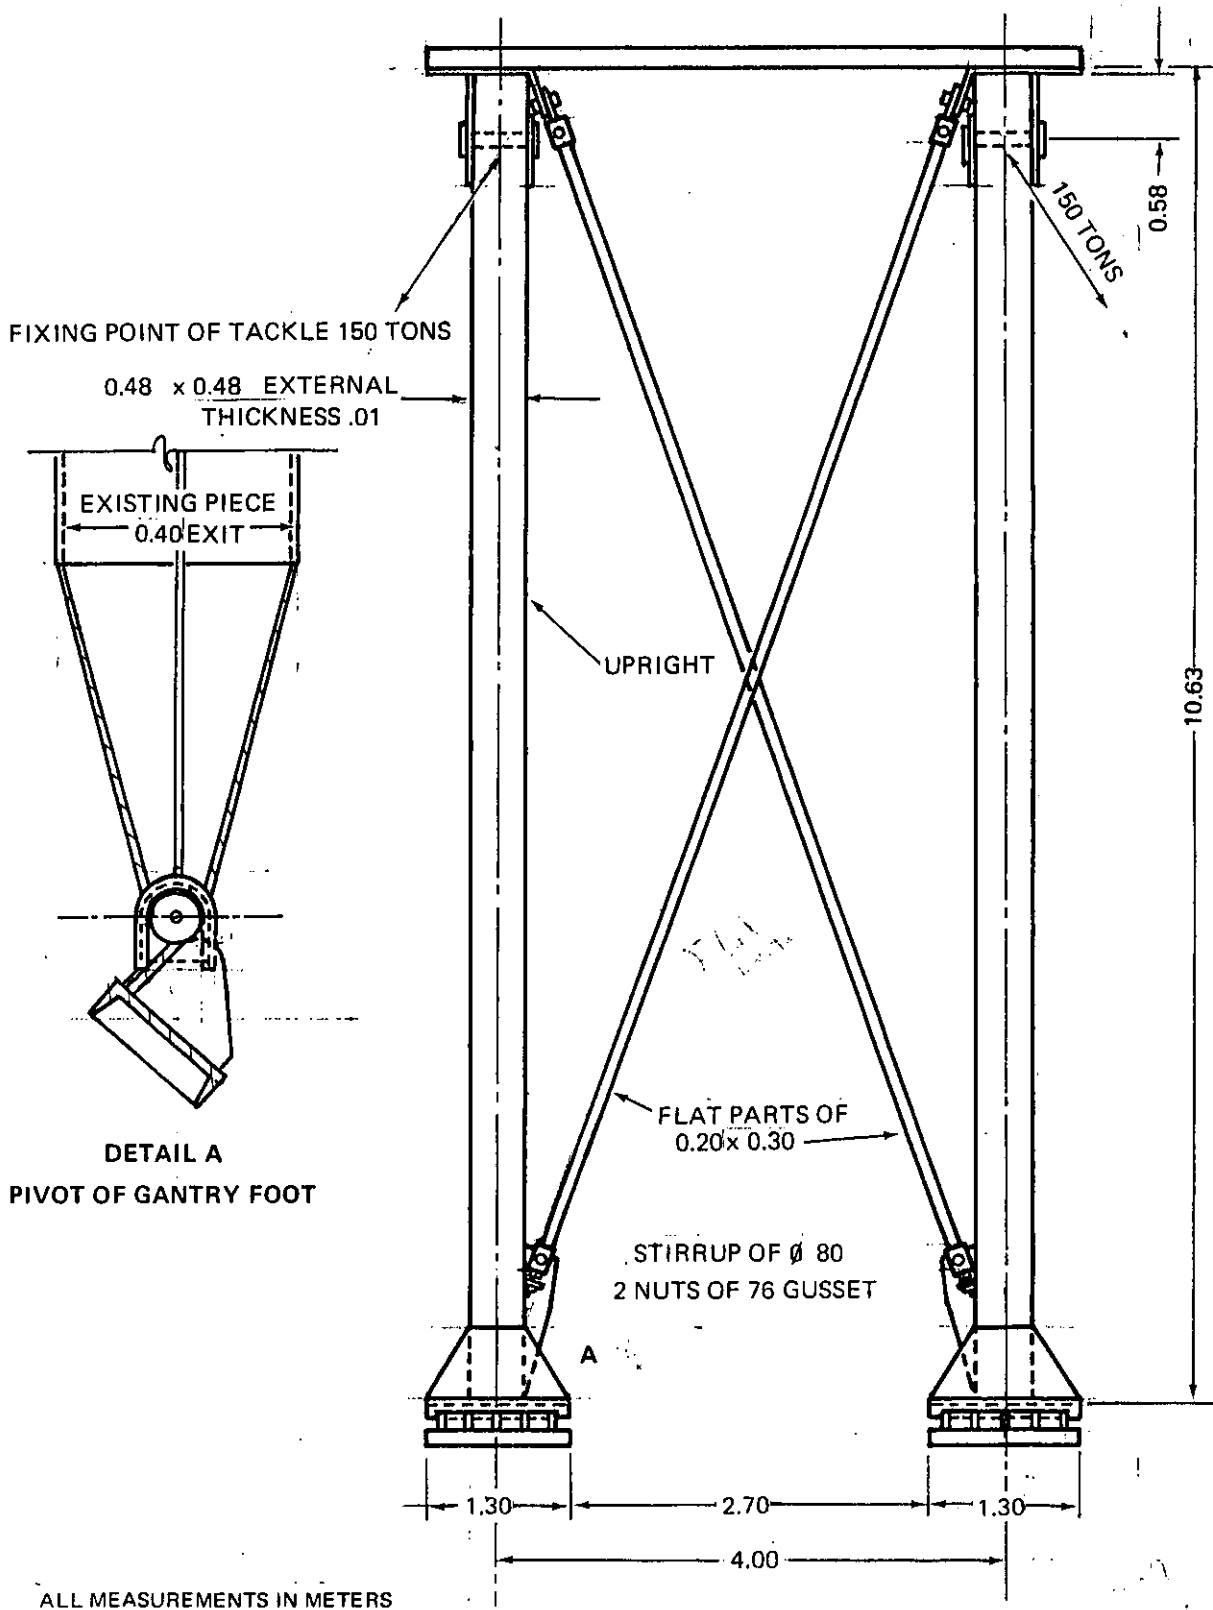
GANTRY DETAIL.
FIG. 1 NO. 2

The cranes were repaired and reinforced by external counterbraces while further silt was removed and the patches reinforced. A new portion of the castle was removed and on 27 July 1946 the second righting effort commenced. The righting was a success, with the sand box counterbalance being broken up as expected.

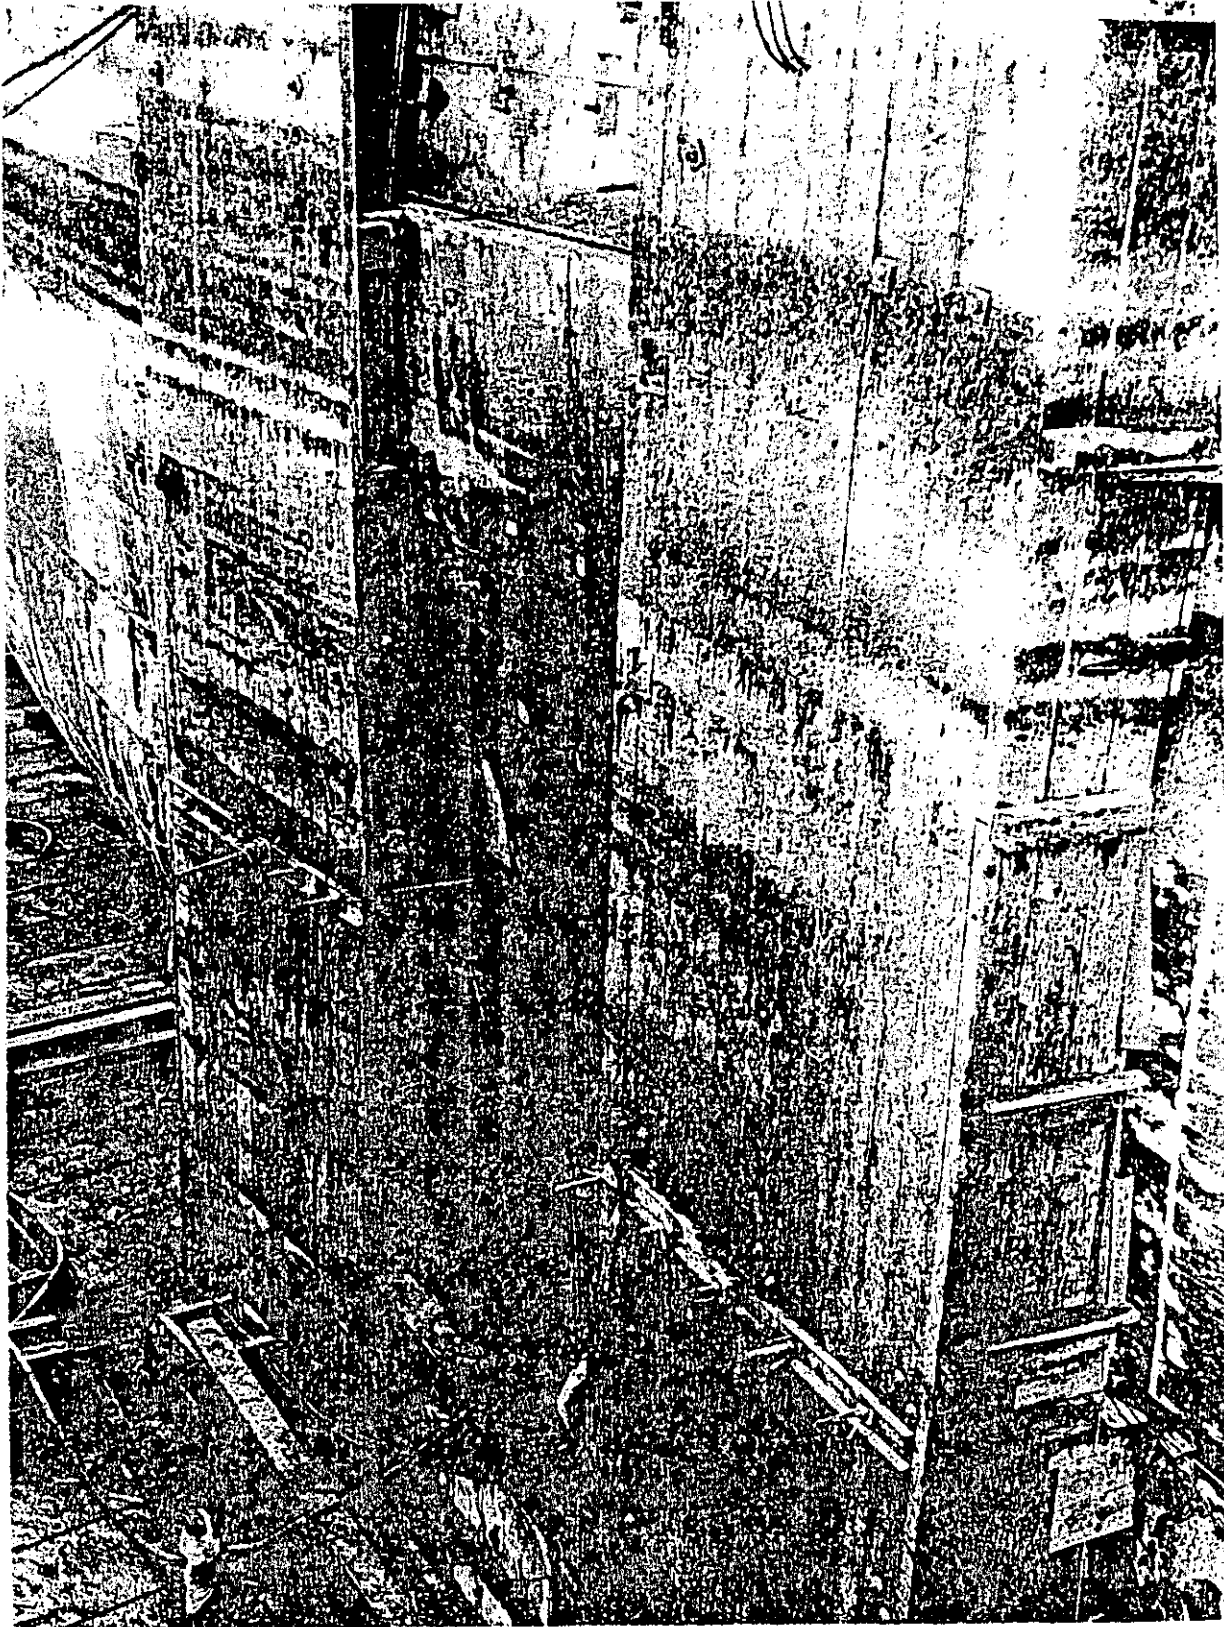
A view of the *WEST VIRGINIA* in drydock exposed the very great damage suffered by the ship, but on the other hand it also showed that a large proportion of the ship was still there. A great amount of manpower and material was necessary, of course, to bring back the ship as a fighting unit of the Fleet, however, aggressive action of the shore-based facilities accomplished this within a reasonable time.

USS WEST VIRGINIA IN DRYDOCK. REMOVAL OF ONE SECTION OF THE FORWARD SMALLER PATCH SHOWS SOME DETAILS OF CONSTRUCTION AND SECURING METHODS. FIG. 12 NO. 3

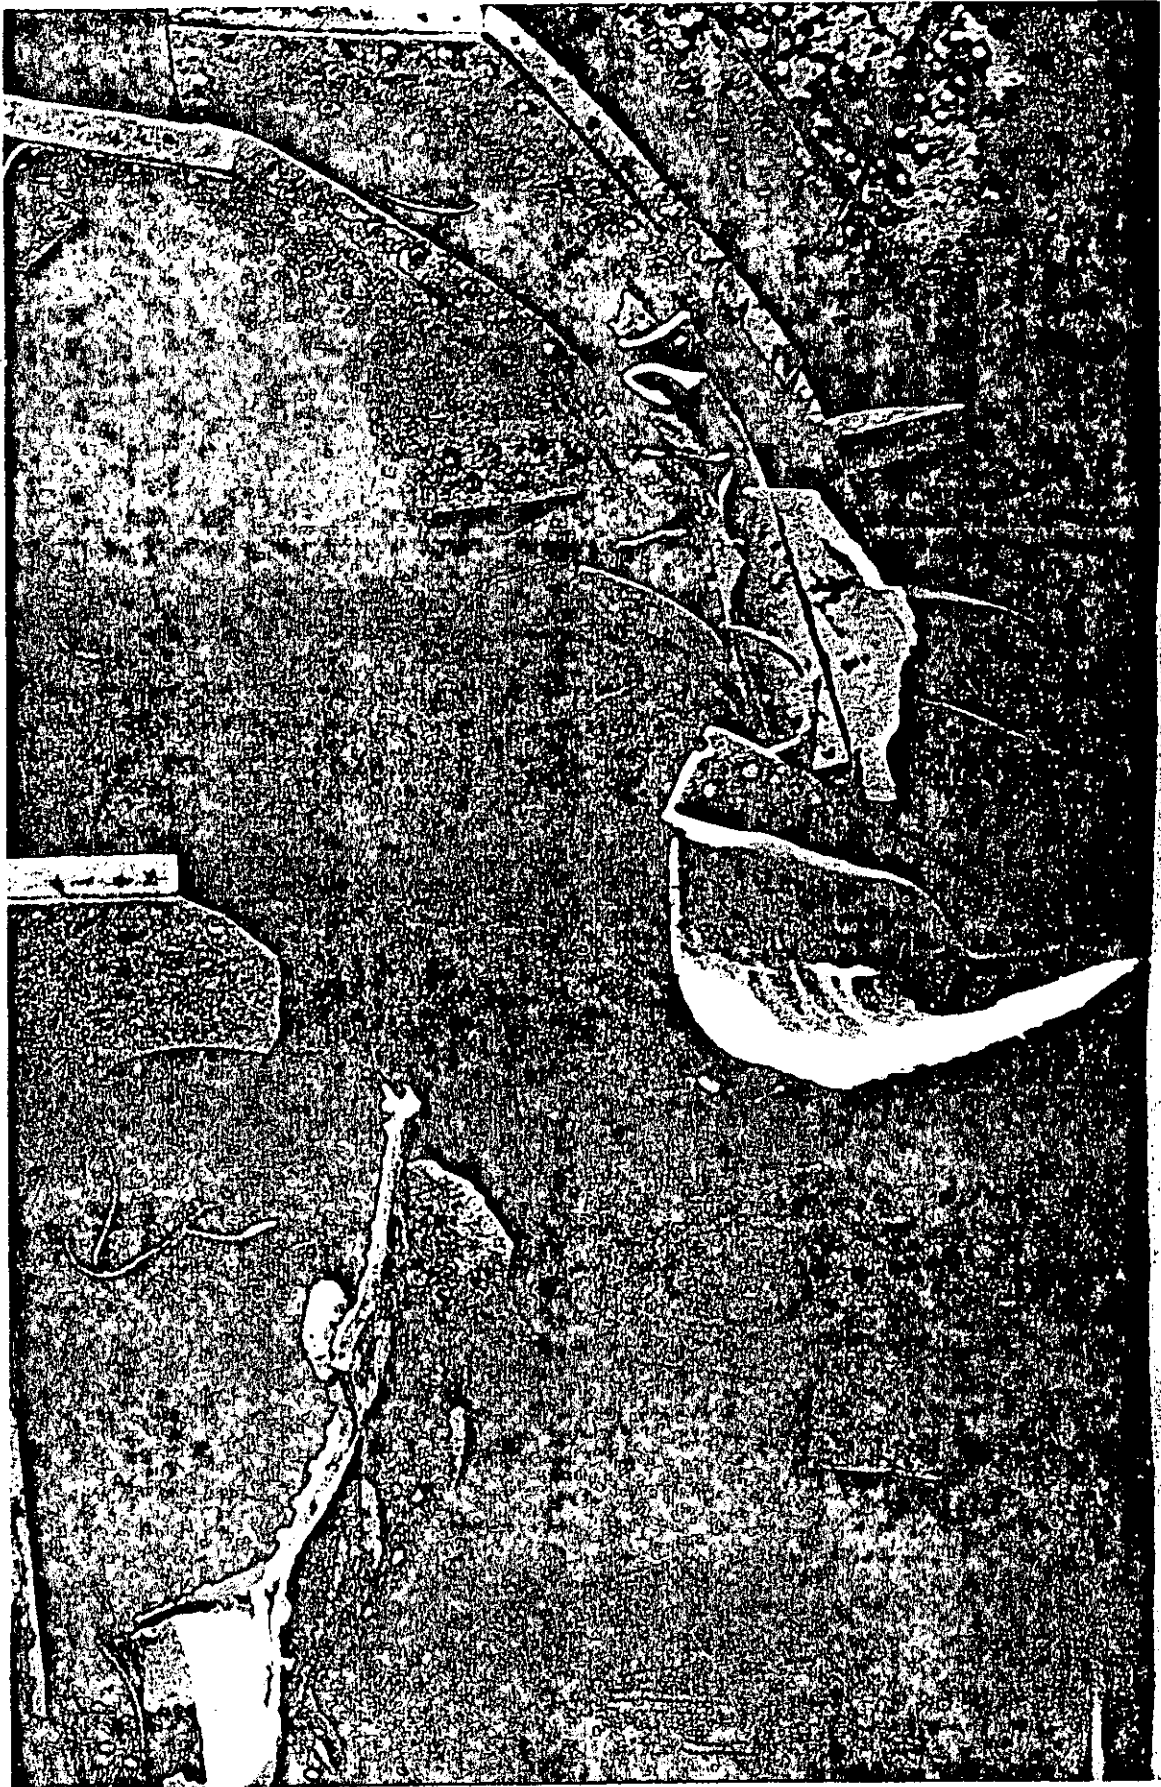
NEW JERSEY PORT SIDE EXPLOSION DAMAGE.
FIG. 14 NO. 21

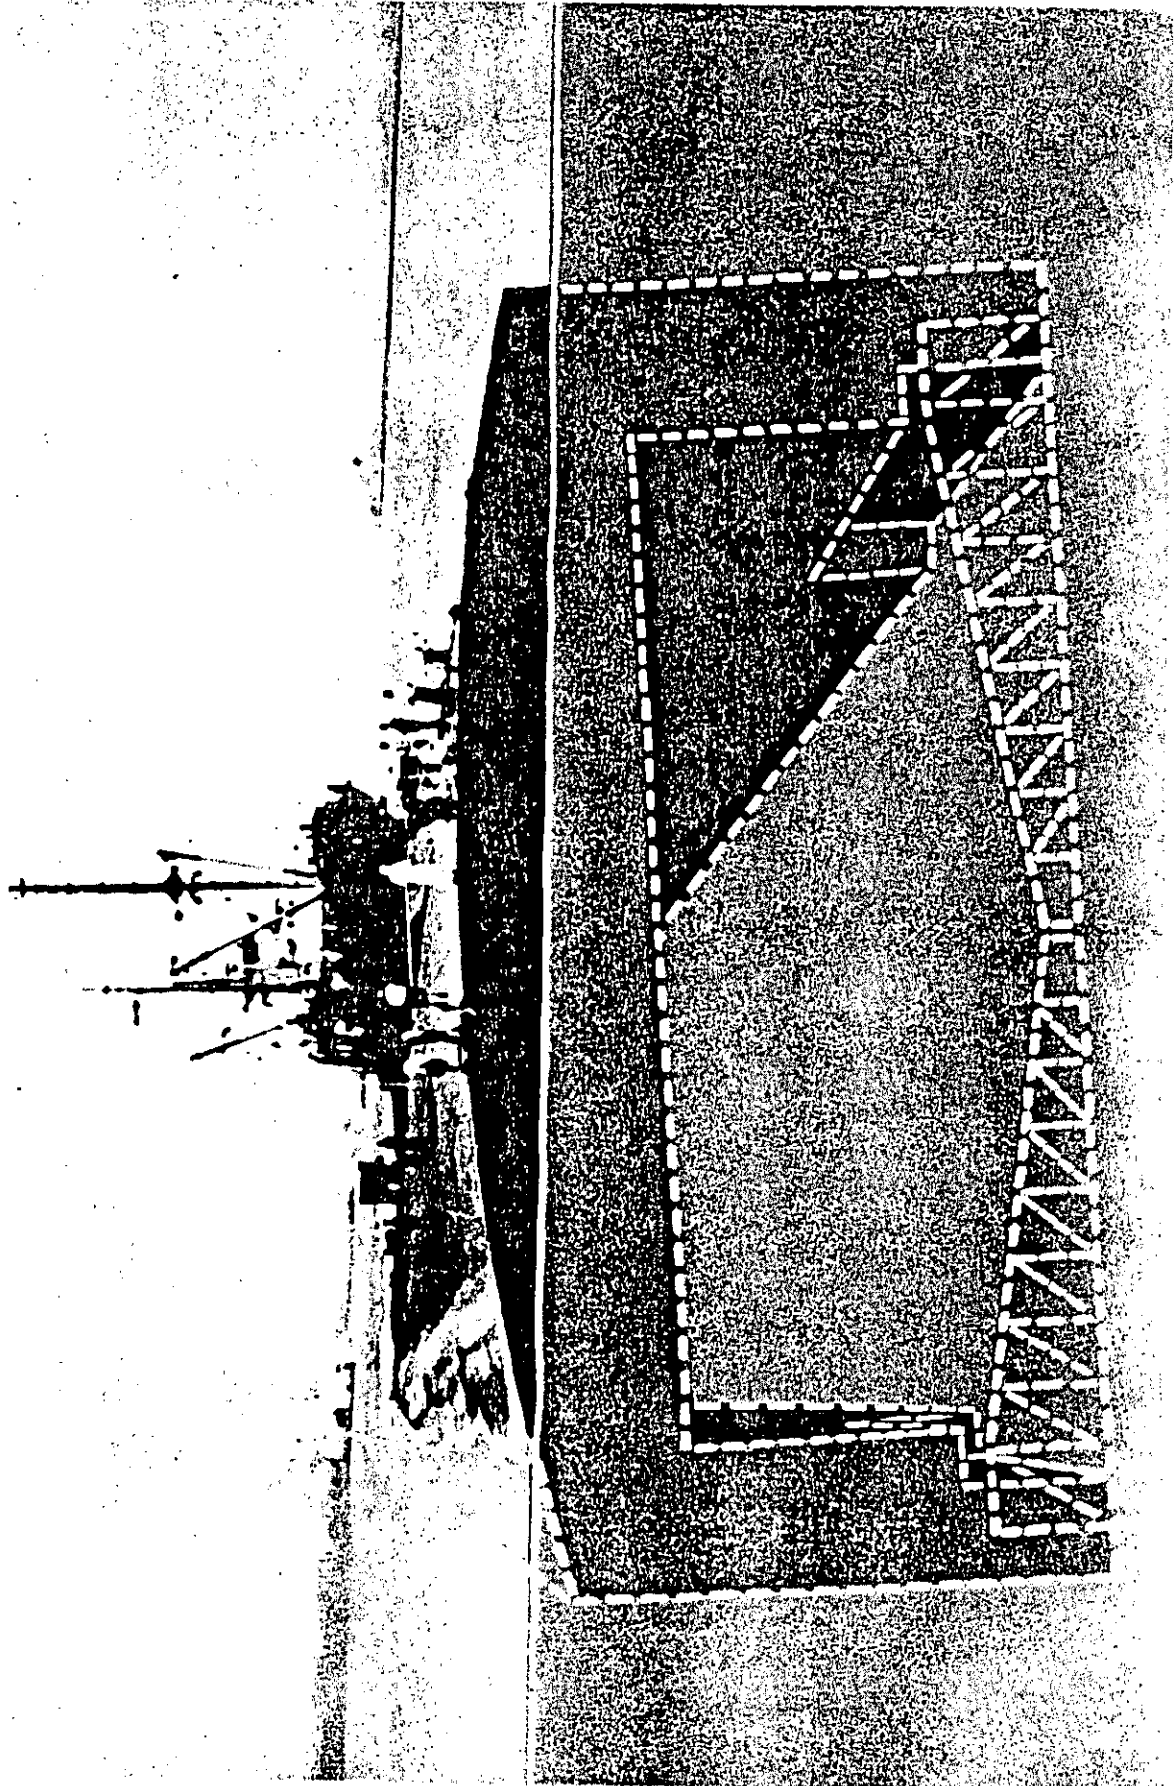
CAPSIZED AFMD-2.
FIG. 15.5 NO. 3

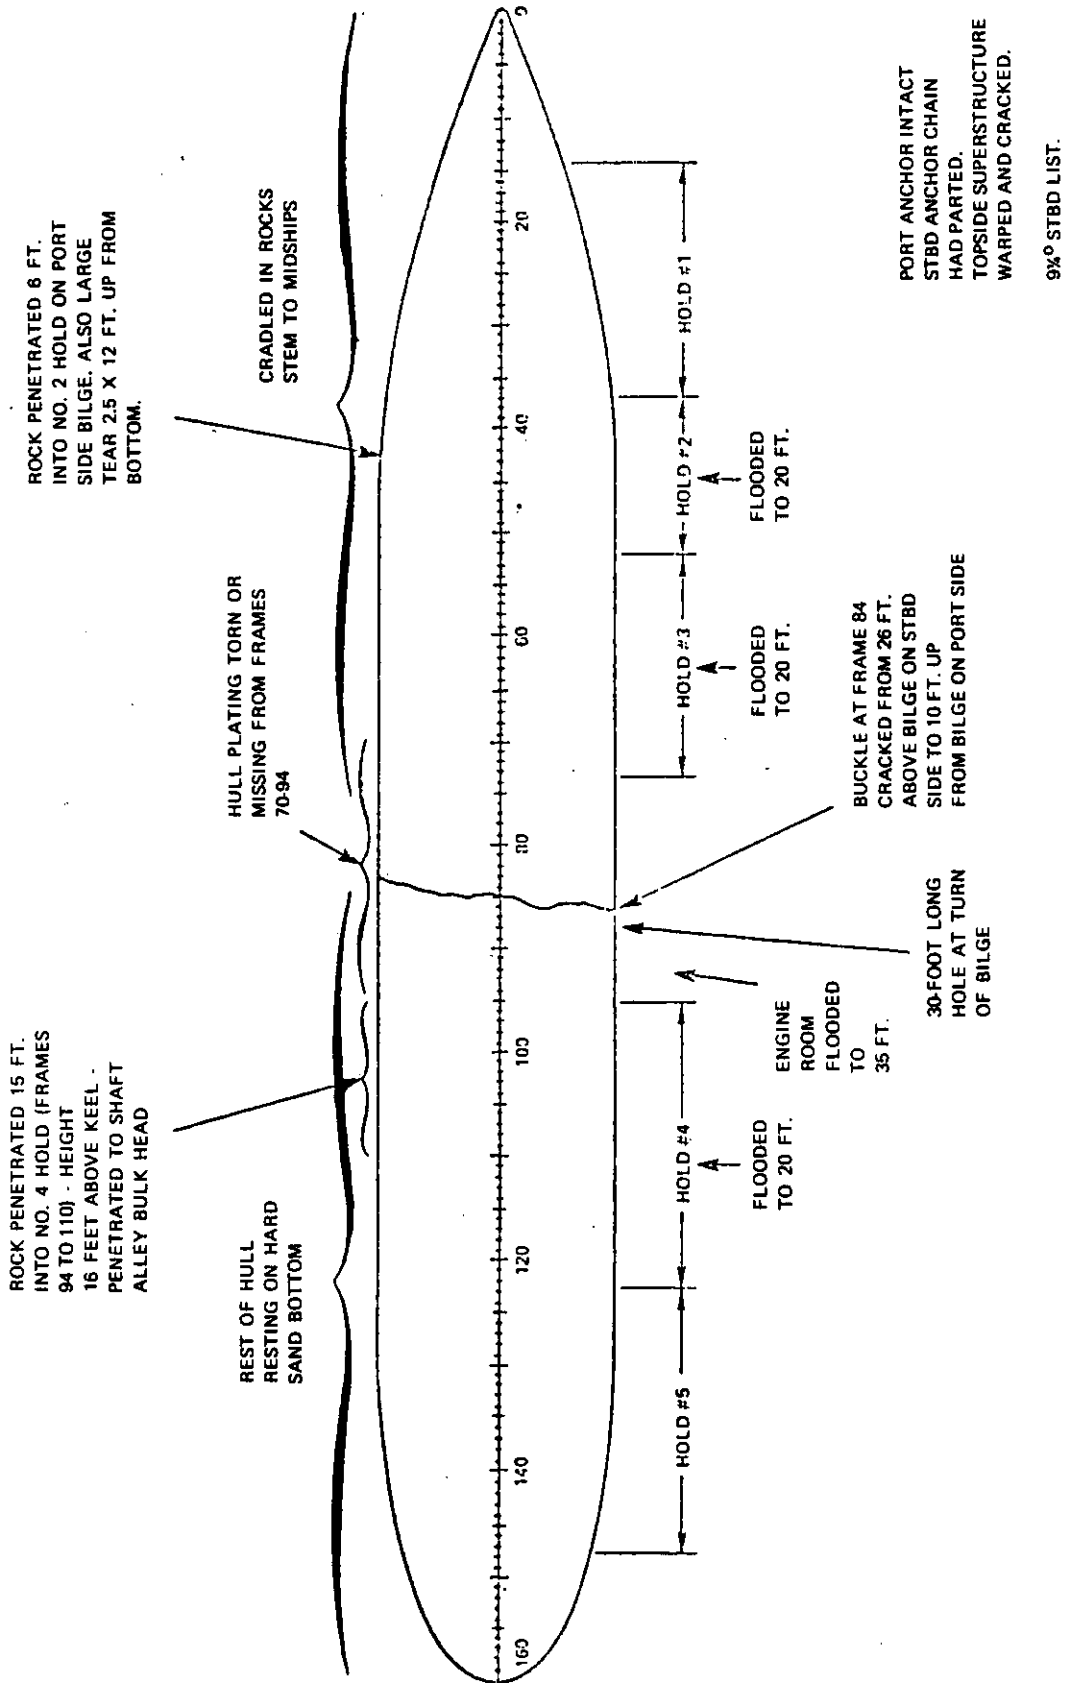
"USS REGULUS" UNDERWATER DAMAGE SURVEY RESULTS
 FIG. 15.9 NO. 2

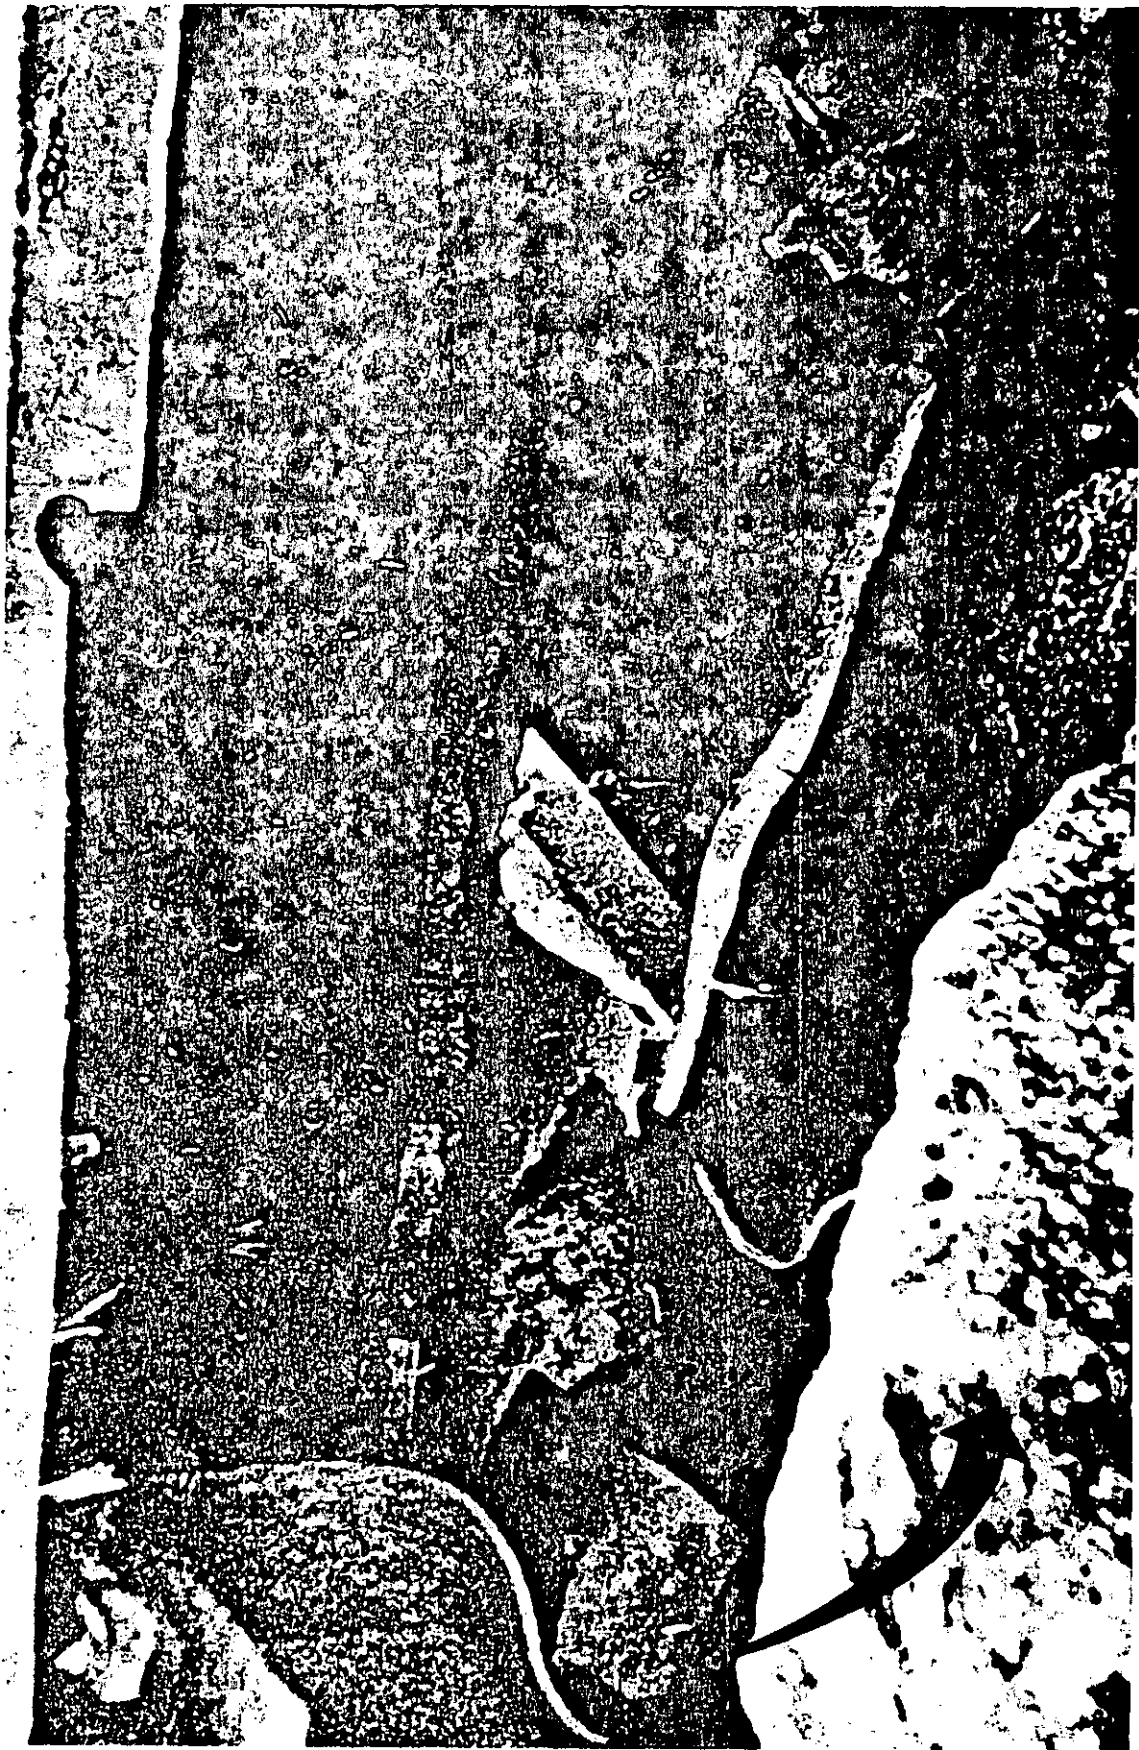
ROCK DAMAGE ON THE BILGE KEEL SECTION
OF THE SHIP.
FIG. 15.9 NO. 4

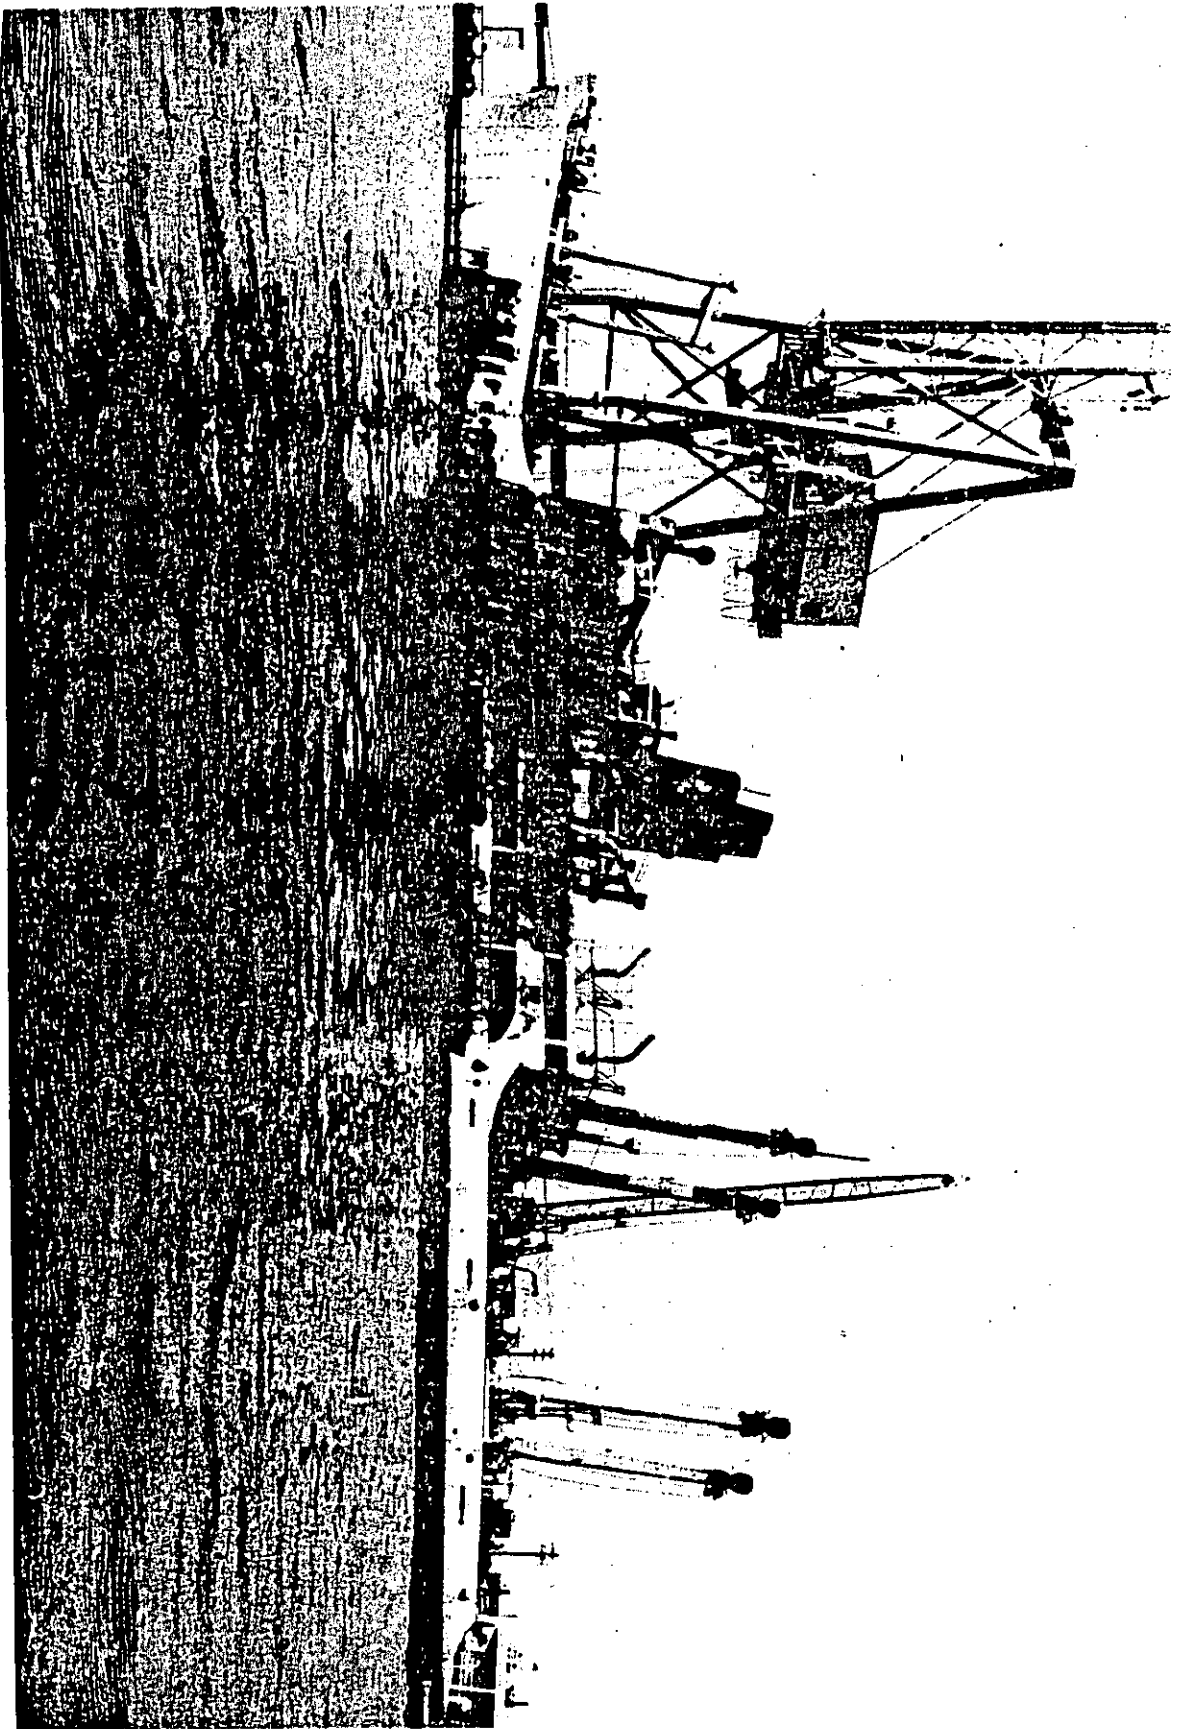
PORT RIVER VIEW OF THE "M/V ORIENTAL WARRIOR".
MIDSHIP DISCOLORATION FROM FIRE DAMAGE CAN BE SEEN
FIG. 15.10 NO. 1

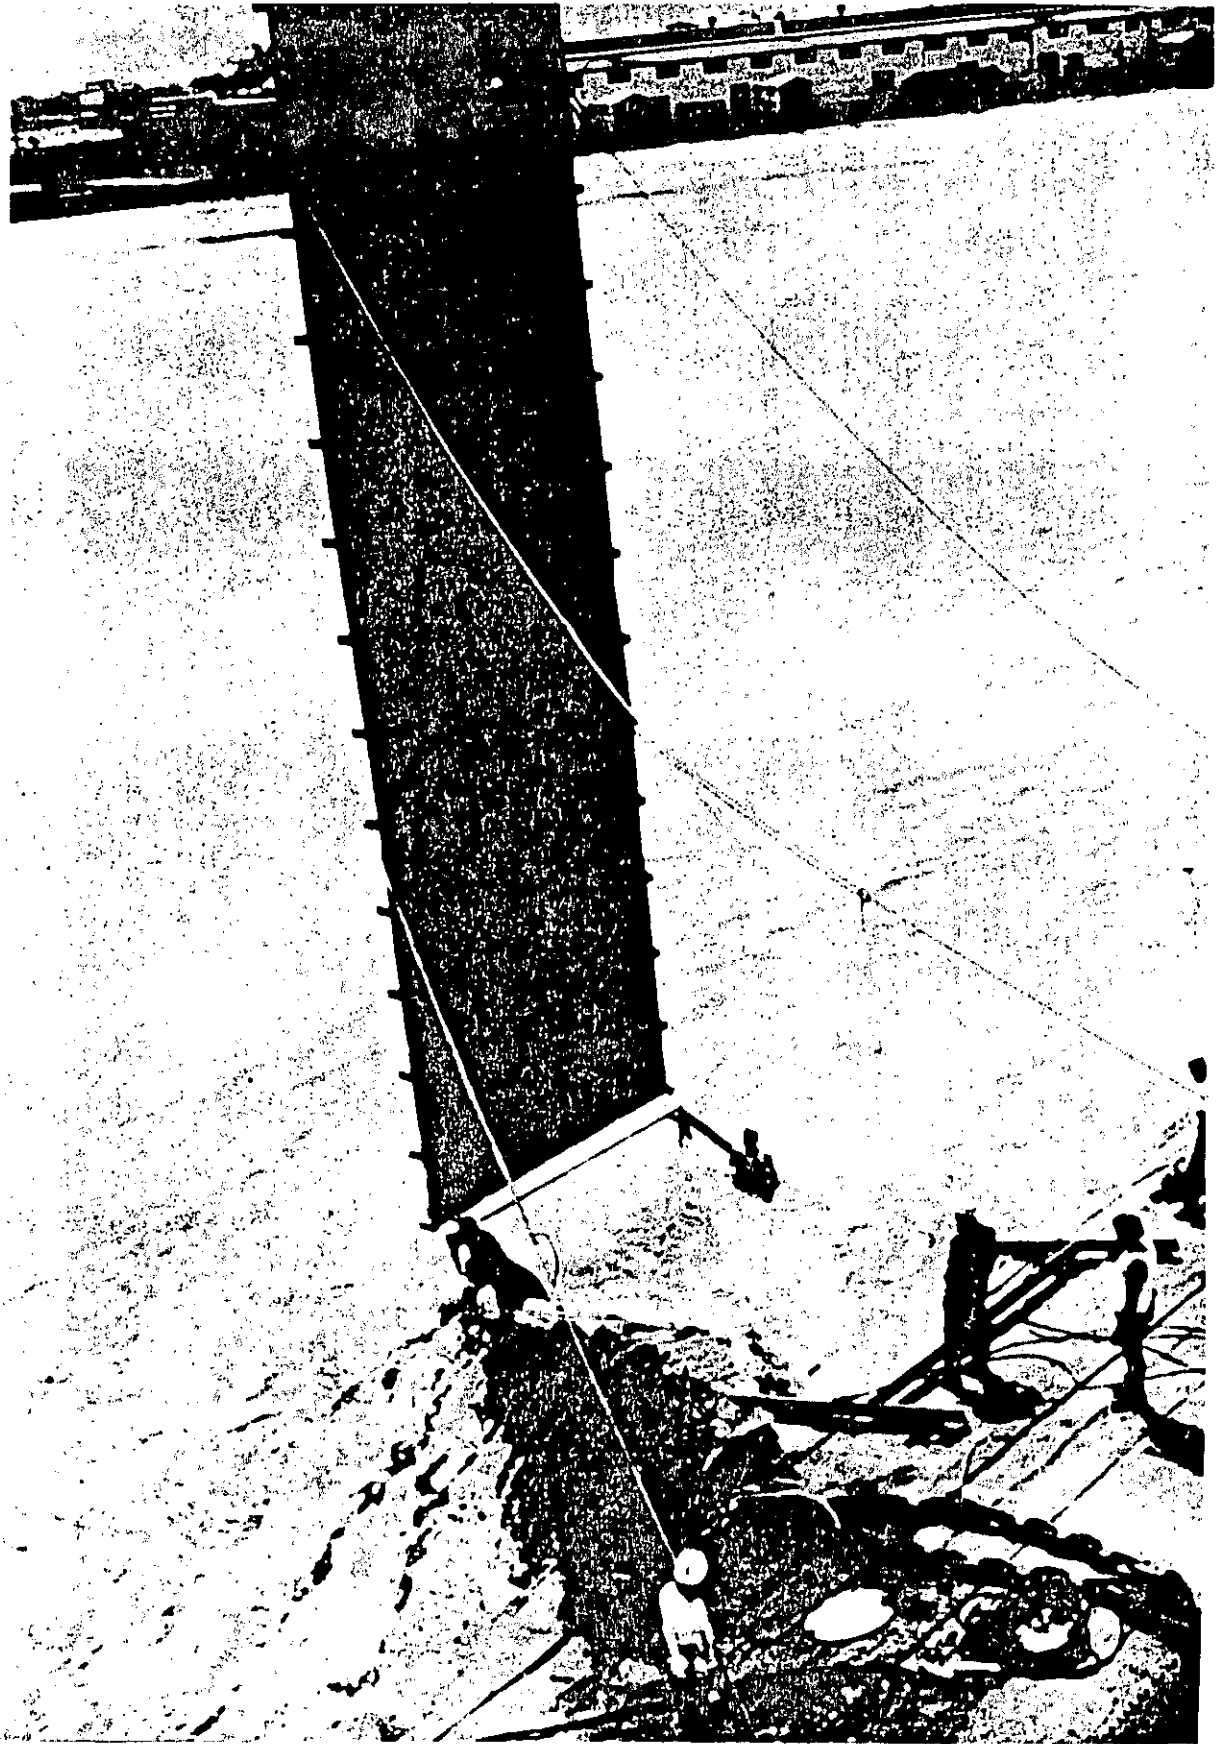
DECK PLATE PATCH BEING LOWERED INTO POSITION.
FIG 15.11 NO. 6
