## THE SALVAGE OF THE LITTON LAUNCHING PLATFORM

U.S. NAVY SUPERVISOR OF SALVAGE

NAVAL SEA SYSTEMS COMMAND

LCDR C.A. Bartholomew  
U.S. Navy Supervisor of Salvage

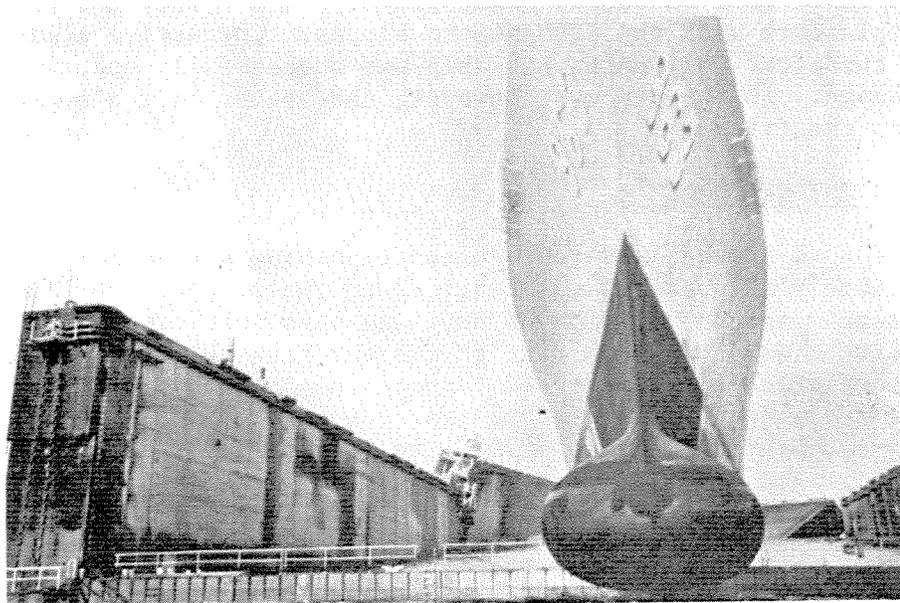
shearing loads broke the platform in two, and the forward half sank to the bottom in 72 feet of water. Photographs 3 and 4 show the breaking up of the platform with the SPRUANCE on blocks. Corrective action continued on the after half until the ship was successfully undocked with minimal damage. In the process, however, the second half also sank adjacent to the first.

*PHOTOGRAPH 3. Dock breaking up with USS SPRUANCE on blocks. Attempting to control list and trim.*

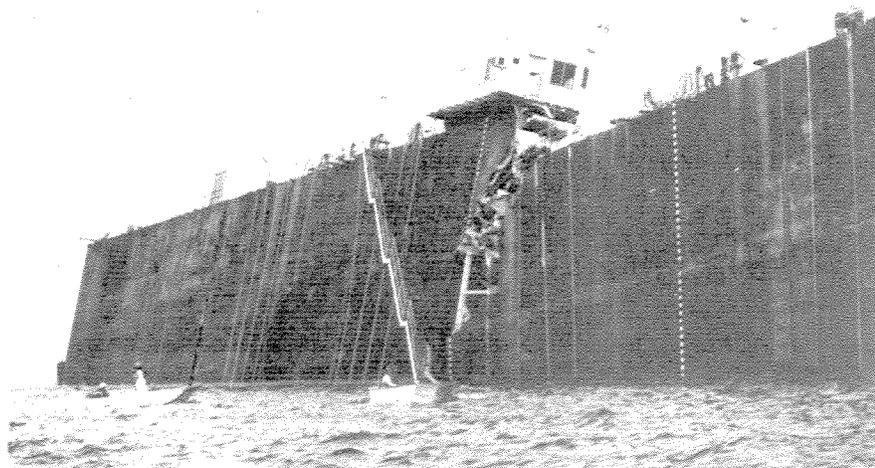
*PHOTOGRAPH 4. Launching platform failing amidships in combined shear and compressive buckling.*

The damage cited in (2) above to port and (3) and (4) above to starboard appeared to be caused by the compressive loads induced upon the upper portions of the wing walls as the pontoon deck sagged. Basic failure in compressive shear on the port side was clearly evidenced by the 45° axis of structural failure. On the starboard side, damage was less significant because the compressive load tore the portable wing walls loose from the pontoon deck and resulted only in minor structural damage to the wing wall above Tank 19. The four detached wing wall boxes were retrieved and set ashore for repairs within a few days. It may be further theorized that when the starboard portable wing walls broke loose and the platform completely fractured amidships, the forward half initially rotated and/or lifted a sufficient amount relative to the ship to strike the SPRUANCE propellers, causing the holes cited in (5) above.

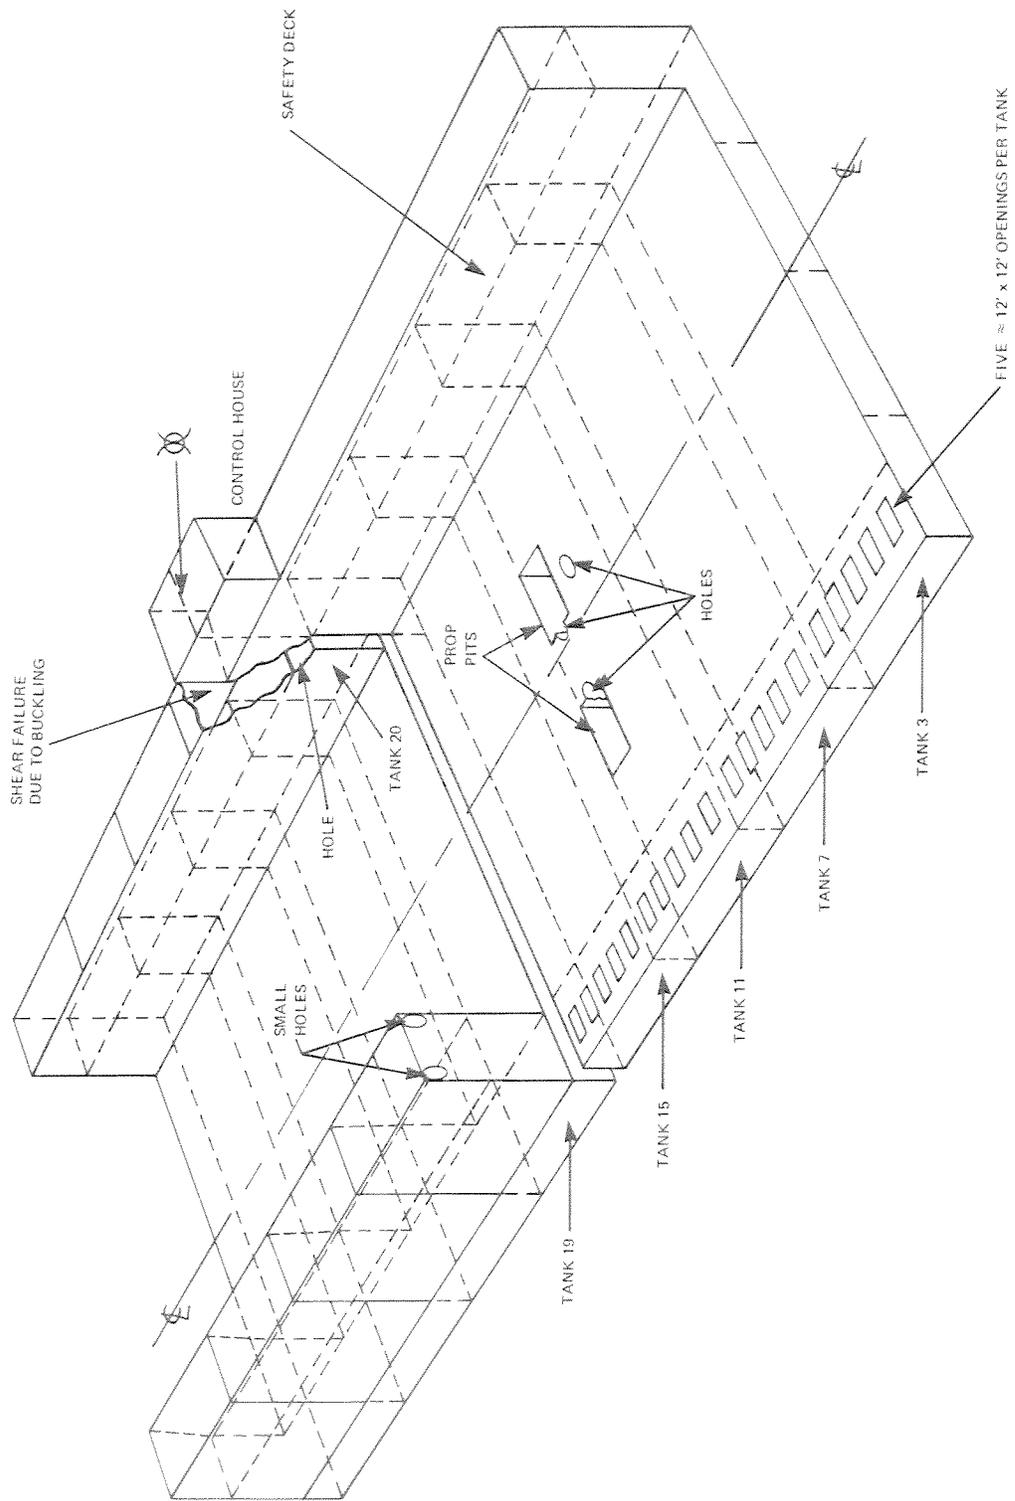
(2) Both machinery spaces above the safety deck and Tank 20\* were severely damaged and open to the sea (see Figure 6).

FIGURE 6. Schematic View of Underwater Damage.

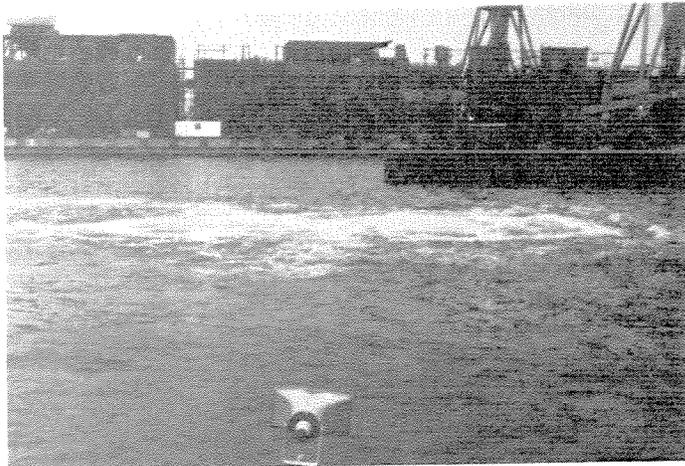
*PHOTOGRAPH 9. Air leakage from propeller pits.*

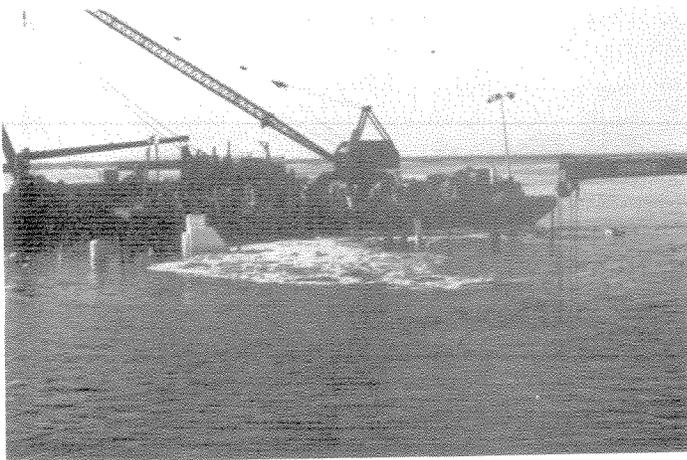
*PHOTOGRAPH 10. Air leakage from damaged plate on inboard wing wall.*

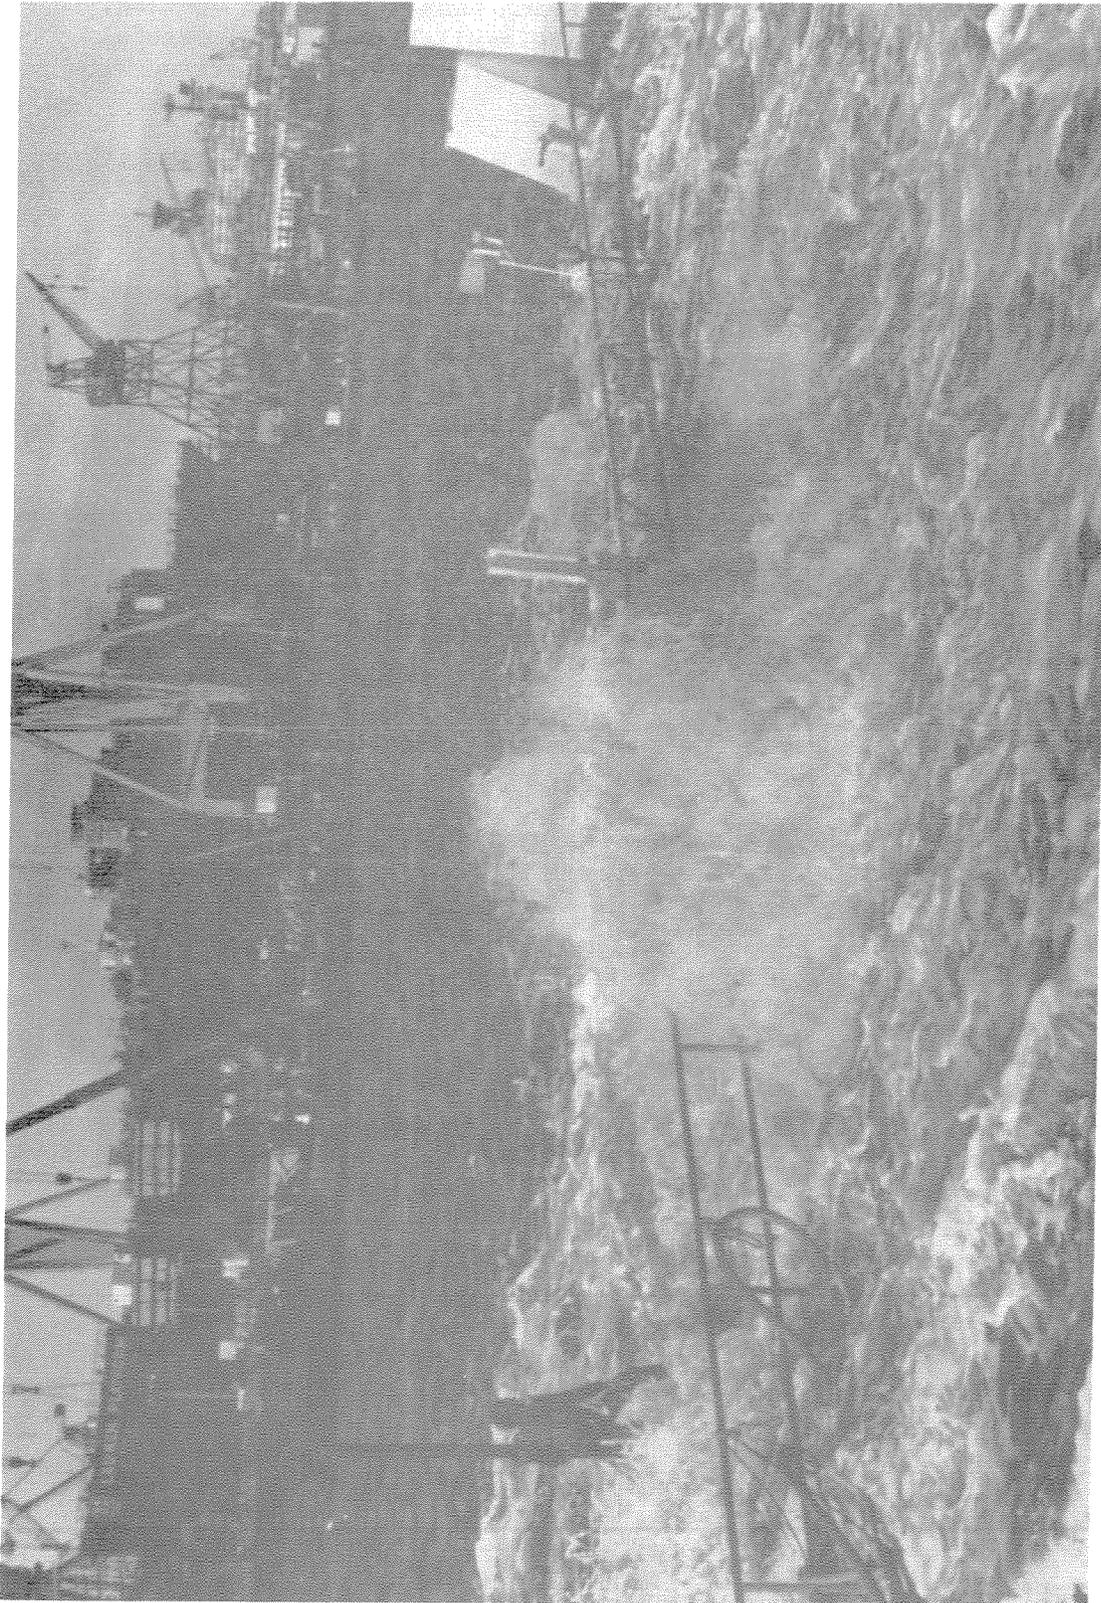
All preparations on the forward half of the launching platform were completed without major incident and blowing of Tanks 8 and 12 commenced on 23 March. Four 600 CFM and two 750 CFM compressors were available to feed the tanks via a gauged manifold through eight 2-inch hoses. The bubble was pushed 23 feet down the wing wall without incident, but as it spread beneath the Pontoon Deck, massive leakage developed from Tank 10 in the vicinity of the propeller pits. Blowing was secured; subsequent diver inspection revealed part of the concrete patch in the propeller pit had been blown/scoured away and an additional 18" x 6" hole approximately 12 feet forward of the pit had not been patched at all, the divers apparently having failed to locate same during the initial underwater survey. These holes were patched with external metal patches and concrete and on 25 March blowing was resumed. When the water had been blown down approximately 2 feet below the Pontoon Deck, a rupture occurred in the inboard side of the wing wall in Tank 12. Blowing was again secured; diver investigation revealed a small tear in the shell 7 feet below the safety deck where the plating had apparently been previously damaged. This tear was repaired with an external patch and internal application of "Splashzone" epoxy sealer. Blowing resumed on 26 March. By the time the water level had again been blown 2 feet below the Pontoon Deck, pierside transit readings disclosed that the wing wall had risen out of the mud over 2 feet forward and 6 inches aft. At that time, however, two ruptures occurred almost simultaneously on the outboard wing wall. Blowing was for a third time secured; diver inspection revealed a welded seam had sprung open at the corner of the wing wall in Tank 12 and a previously damaged

area had ruptured in Tank 8; a more thorough internal diver inspection subsequently revealed substantial separation of the shell panels from the vertical stiffeners. These findings resulted in a lack of confidence in the ability of the upper portions of the wing wall to sustain the required internal pressure differential. The salvage plan to blow the platform to the surface with compressed air was therefore abandoned by the salvors in favor of a more conservative approach using salvage pumps.

*PHOTOGRAPH 11. Major rupture on outboard wing wall which led to abortion of Phase One plan to blow with air.*

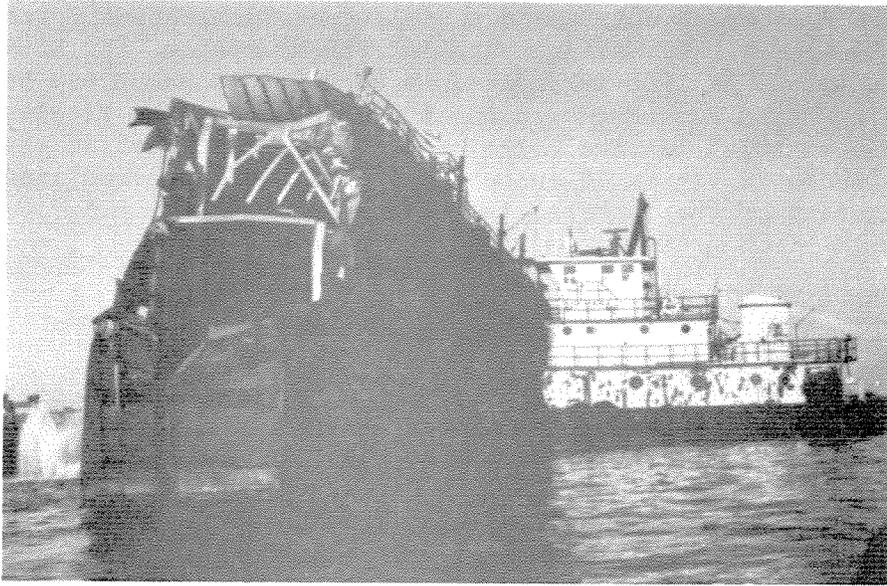
After intensive diver reinvestigation of the damage to the wing wall area of Tank 20 (see Photographs 26 and 27), the salvors begrudgingly agreed that the sustained structural damage rendered it incapable of withstanding the resulting hydrostatic forces if it were made watertight and pumped. Thus Tank 20 would remain open to the sea, as would Tanks 17 and 18, via the tank venting system. A second change to the salvage plan followed since the internal watertight bulkheads were not designed to withstand the required pressure differentials between the tanks being pumped (and vented to the atmosphere) and the ones now remaining open to the sea. As indicated previously, operational ballasting/deballasting discipline limited the pressure differential to 15 fsw, based upon a factor of safety of two on yield. As a minimum, a pressure differential of approximately 25 feet was calculated as required to float the starboard side and 48 feet to subsequently lift off the port side. The salvors therefore decided to pump compressed air into certain tanks to control the internal pressure and thus maintain the pressure differentials across any watertight bulkheads within acceptable limits. A simplified sketch depicting this principle is shown in Figure 10. As a bonus the air pressure would also reduce the apparent pump discharge pressure and thus increase pump flow rate. The use of air necessitated modifying the vent piping to provide for blanks with air connections as shown in Figure 11.

*PHOTOGRAPH 26. Damage to machinery throughway and Tank 20 (below safety deck) on aft section wing wall.*

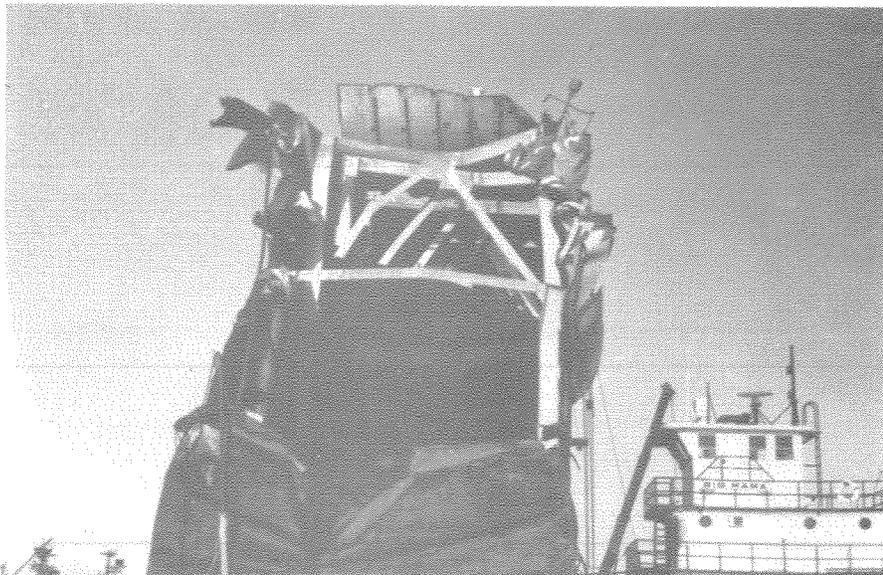
*PHOTOGRAPH 27. Closer view shows extensive damage which precluded patching and pumping of Tank 20.*
