NAVSHIPS 0900-004-8000  
(FORMERLY NAVSHIPS 250-694-3)

**REFLOATING**  
OF THE  
**U. S. S. MISSOURI**  
**(BB-63)**

NAVY DEPARTMENT  
BUREAU OF SHIPS  
WASHINGTON, D. C.

1 JUNE 1950.

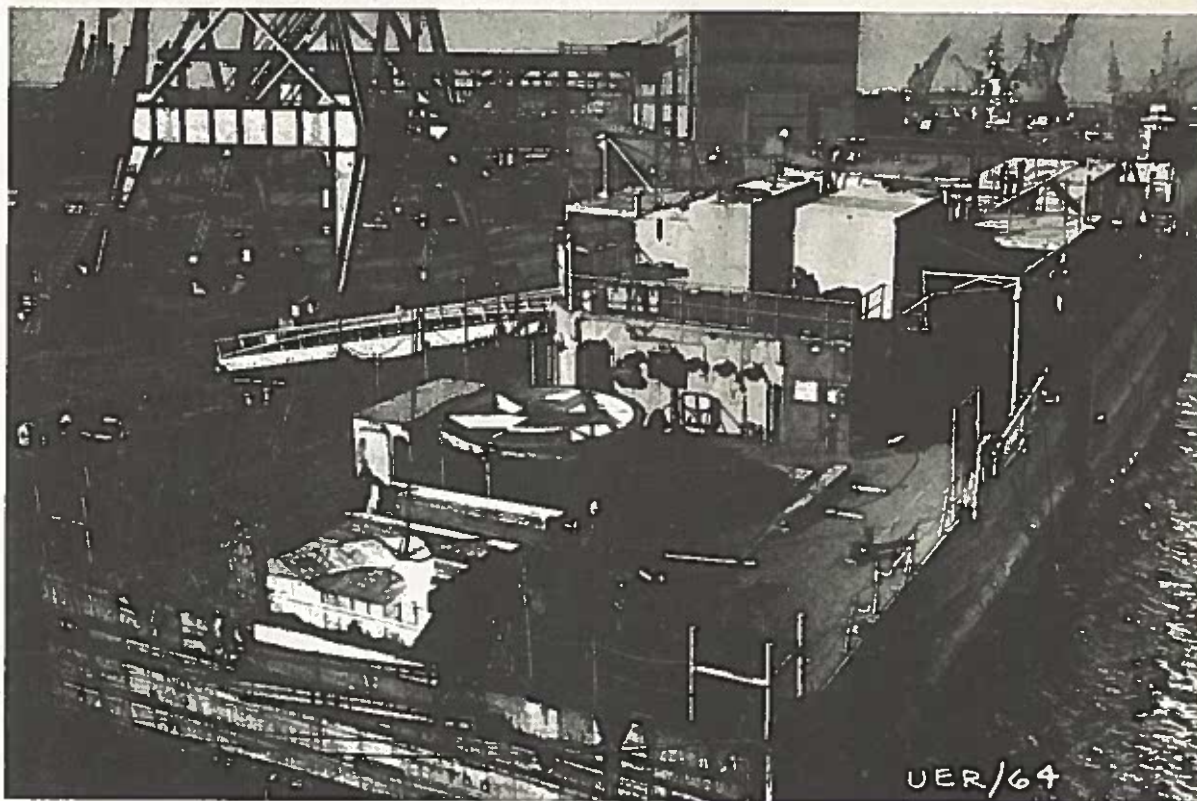
FIGURE 15.—Test barge adapted to lift stern of U. S. S. *Missouri*. Note cribbing on stern and pipe rails forward. Latter were to keep towing hawsers to tugs astern of *Missouri* clear of structure on barge. Though not used, this barge was on way to scene of stranding at time *Missouri* was refloat and would have been used had refloating proved unsuccessful on 1 February.

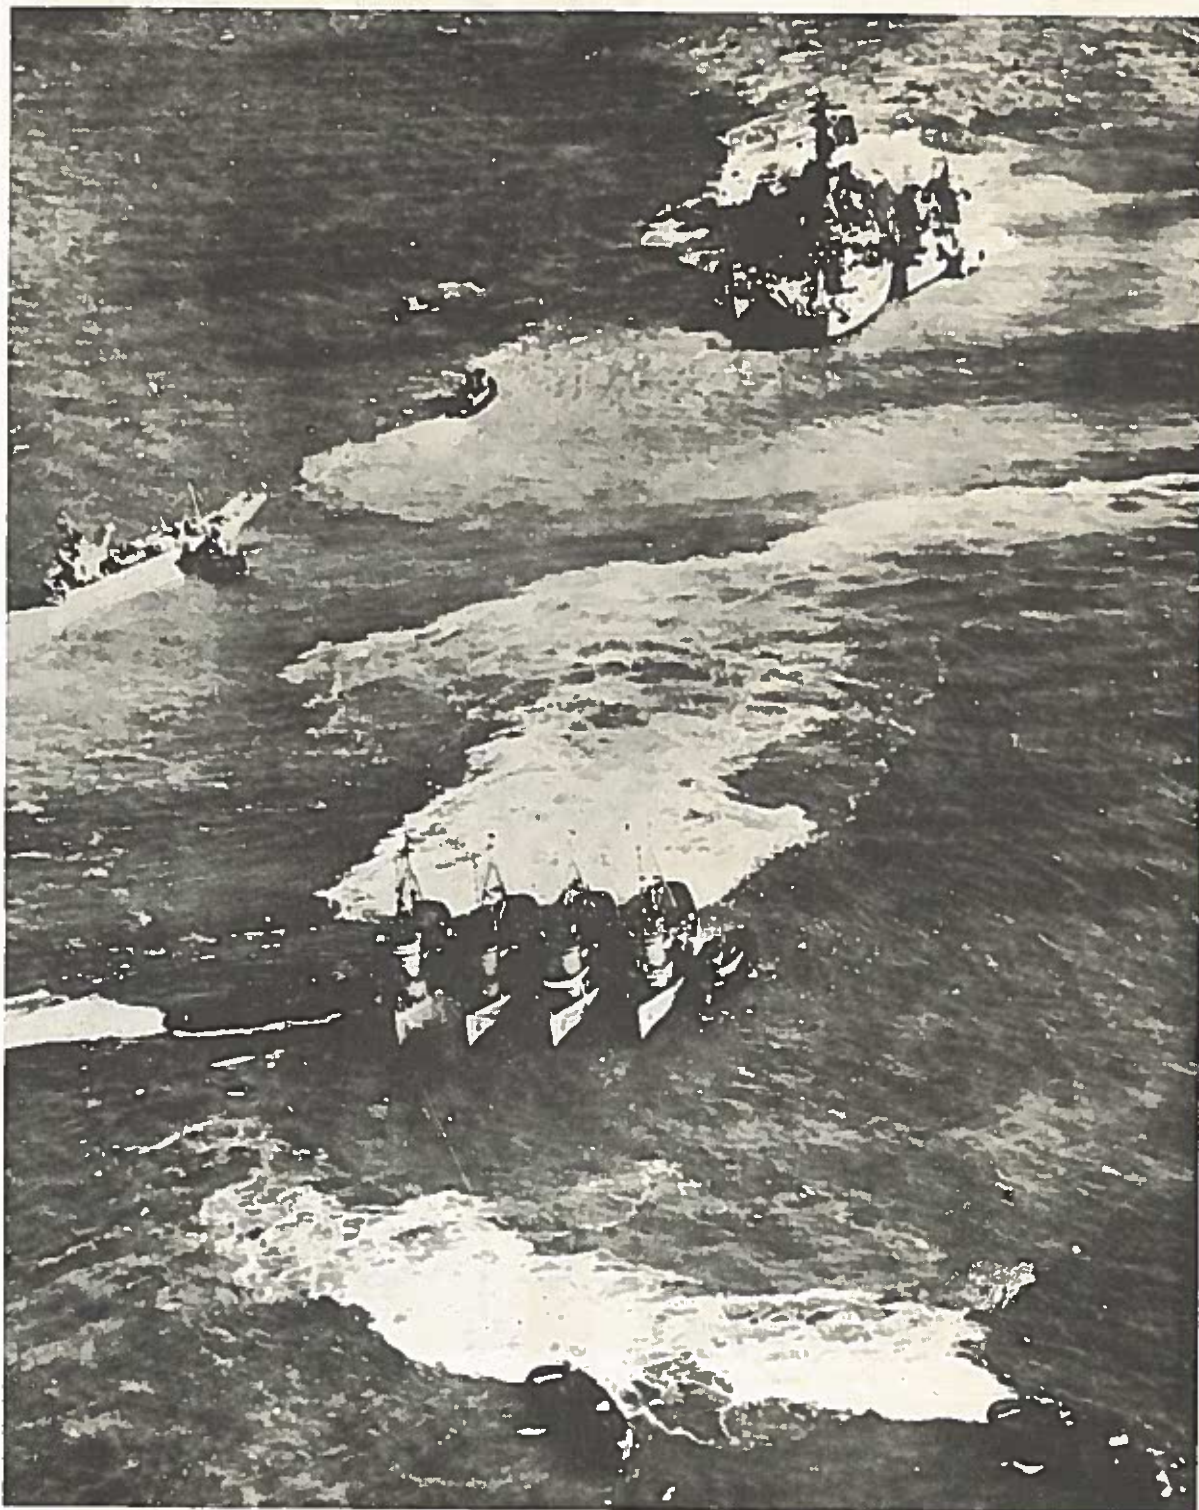
Water churned up by straining tugs during unsuccessful pull attempt on 20 January. Involved were 4 ATF's, 2 ASR's, 2 ARS's, 2 ATA's, and a number of small YTB type tugs. Approximately 8,000 tons, mostly fuel, had been removed from the *Missouri* and considerable dredging along each side had been accomplished.

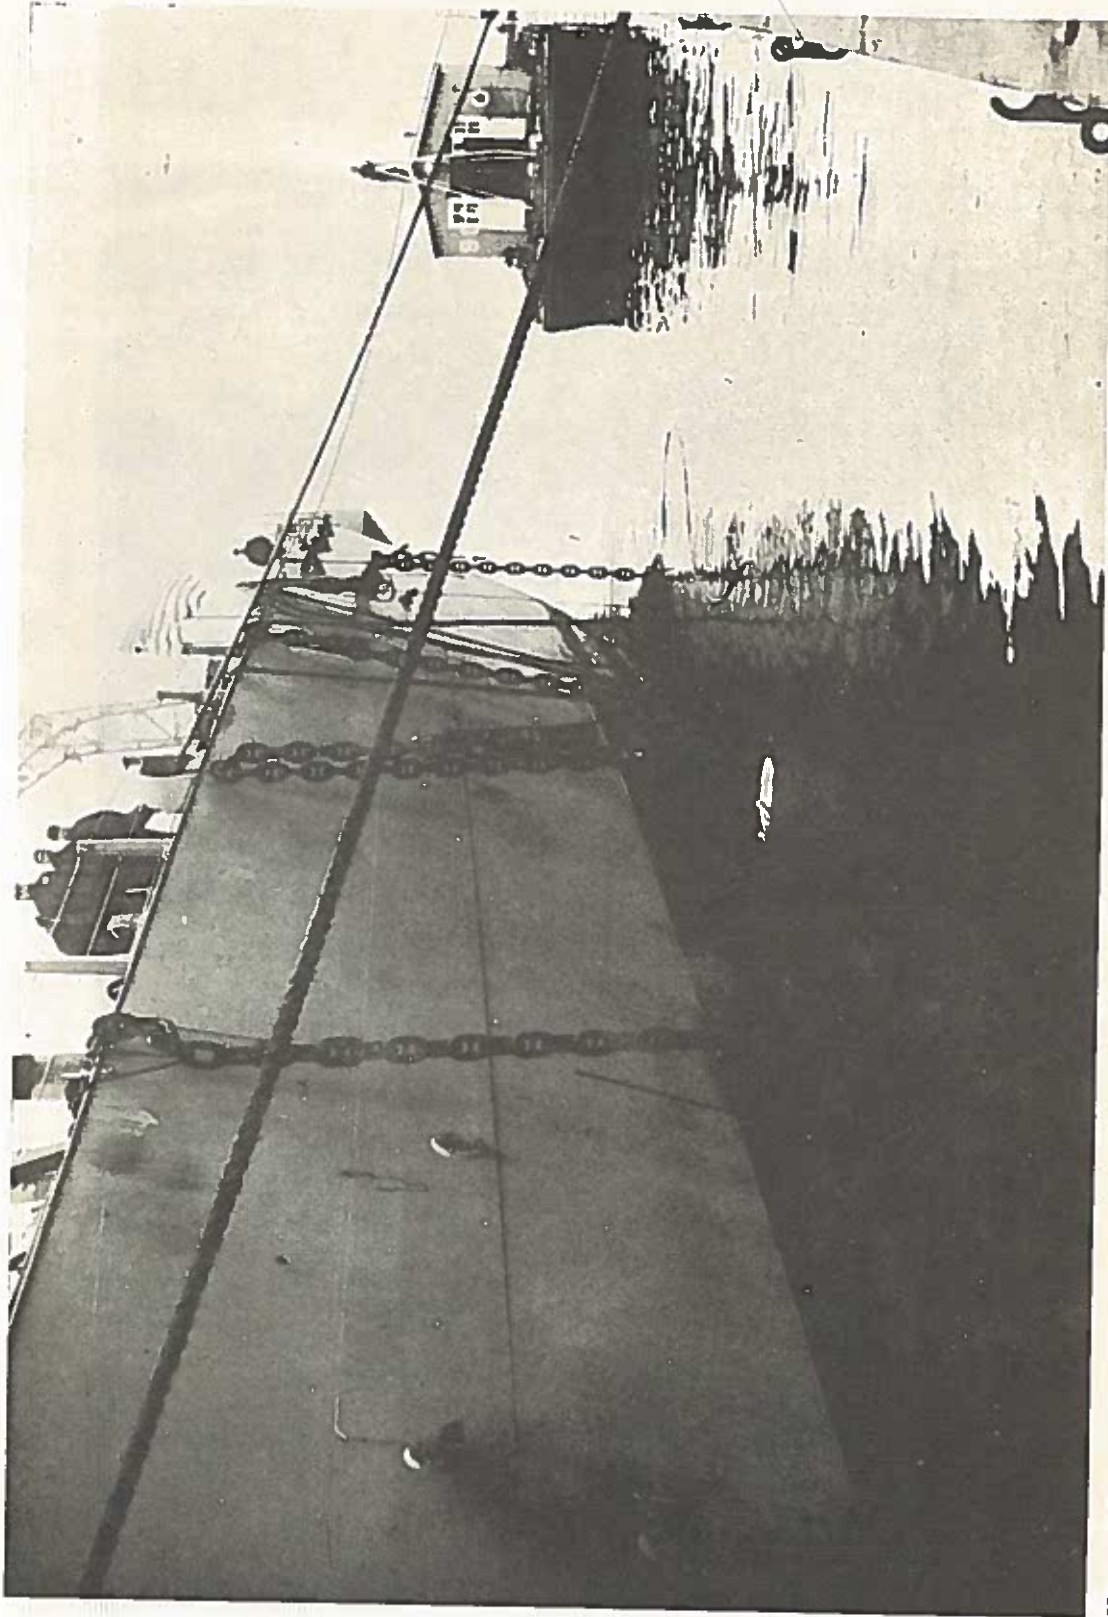
Heavy chains reeved under skegs at stern of ship to which pontoons were secured. Tip of one pontoon visible at water's edge. Pontoons used were sent by Boston Naval Shipyard where they are maintained for submarine salvage purposes. Each pontoon has a buoyancy of 80 tons. Six were installed at the stern of the *Missouri* and two at the bow.

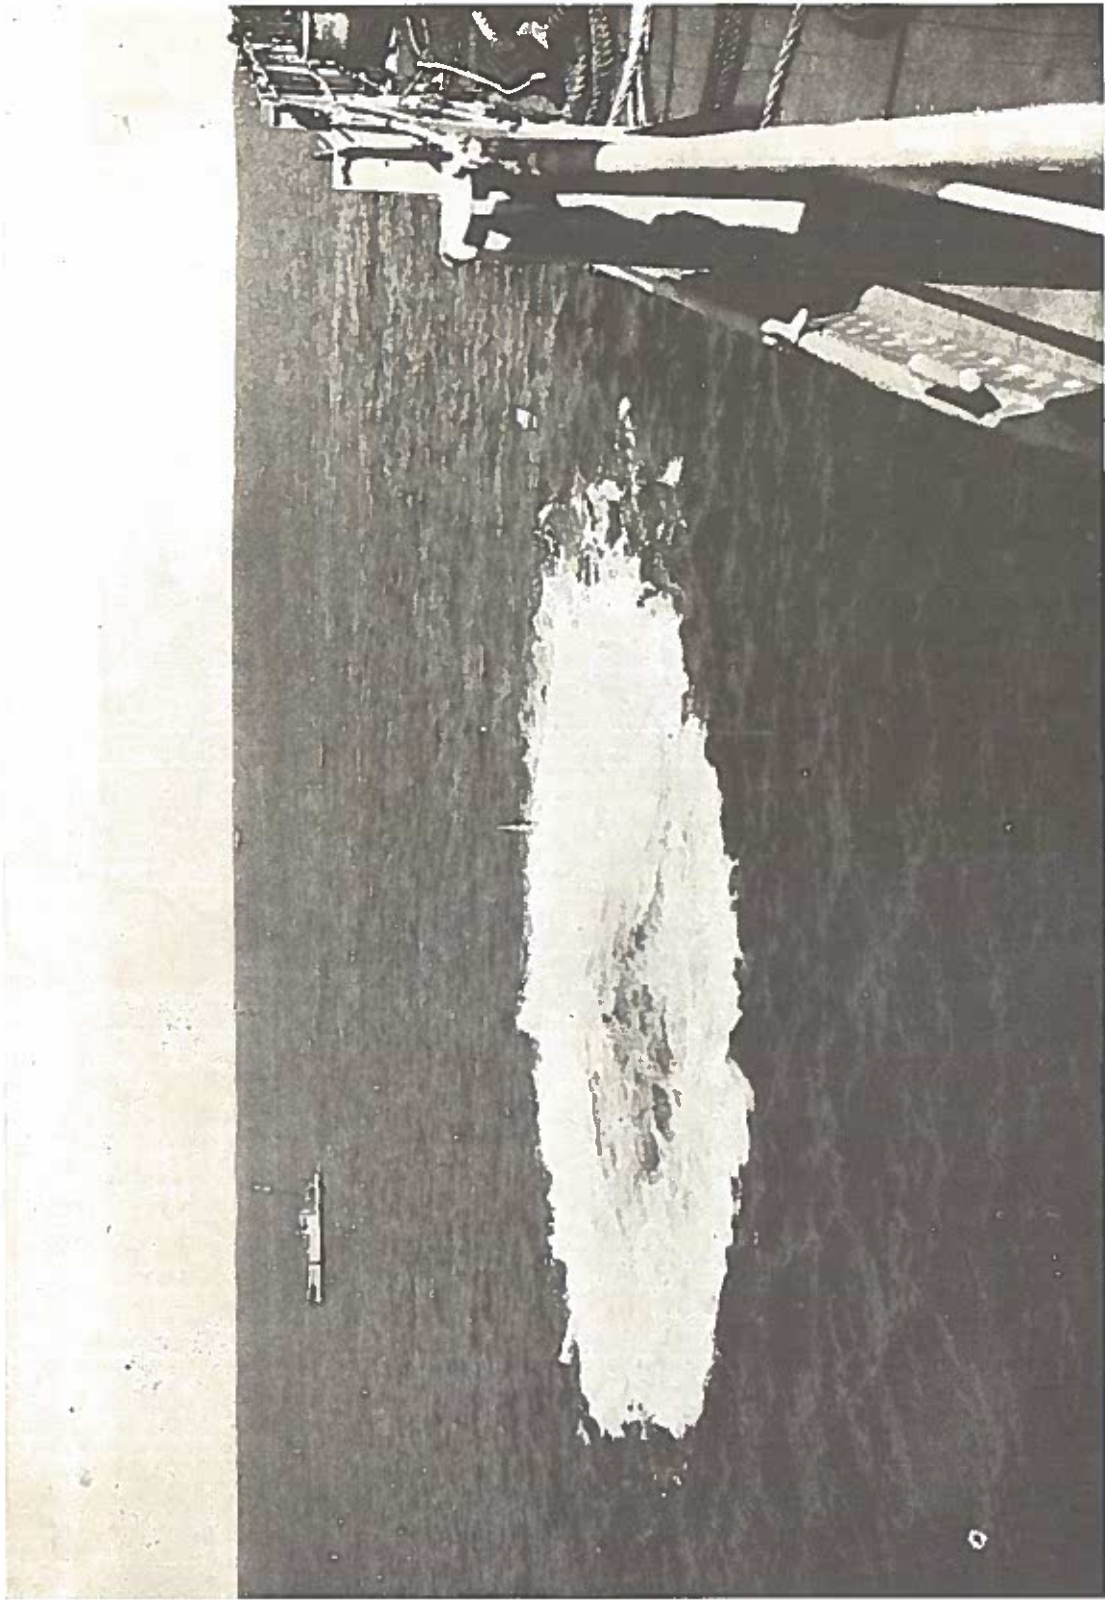
It was observed that each shot caused the stern of the *Missouri* to settle one-fourth inch. This confirmed previous beliefs that such a process would be slow and require more time than could be readily spared. Moreover, it is quite likely that succeeding shots would have resulted in successively smaller amounts of settling.

Explosion of 50-pound charge. Gas globule tended to remain underwater and resulted in two concussions that were felt on the stern of the *Missouri*.  
*Missouri* stern settled one-fourth inch.

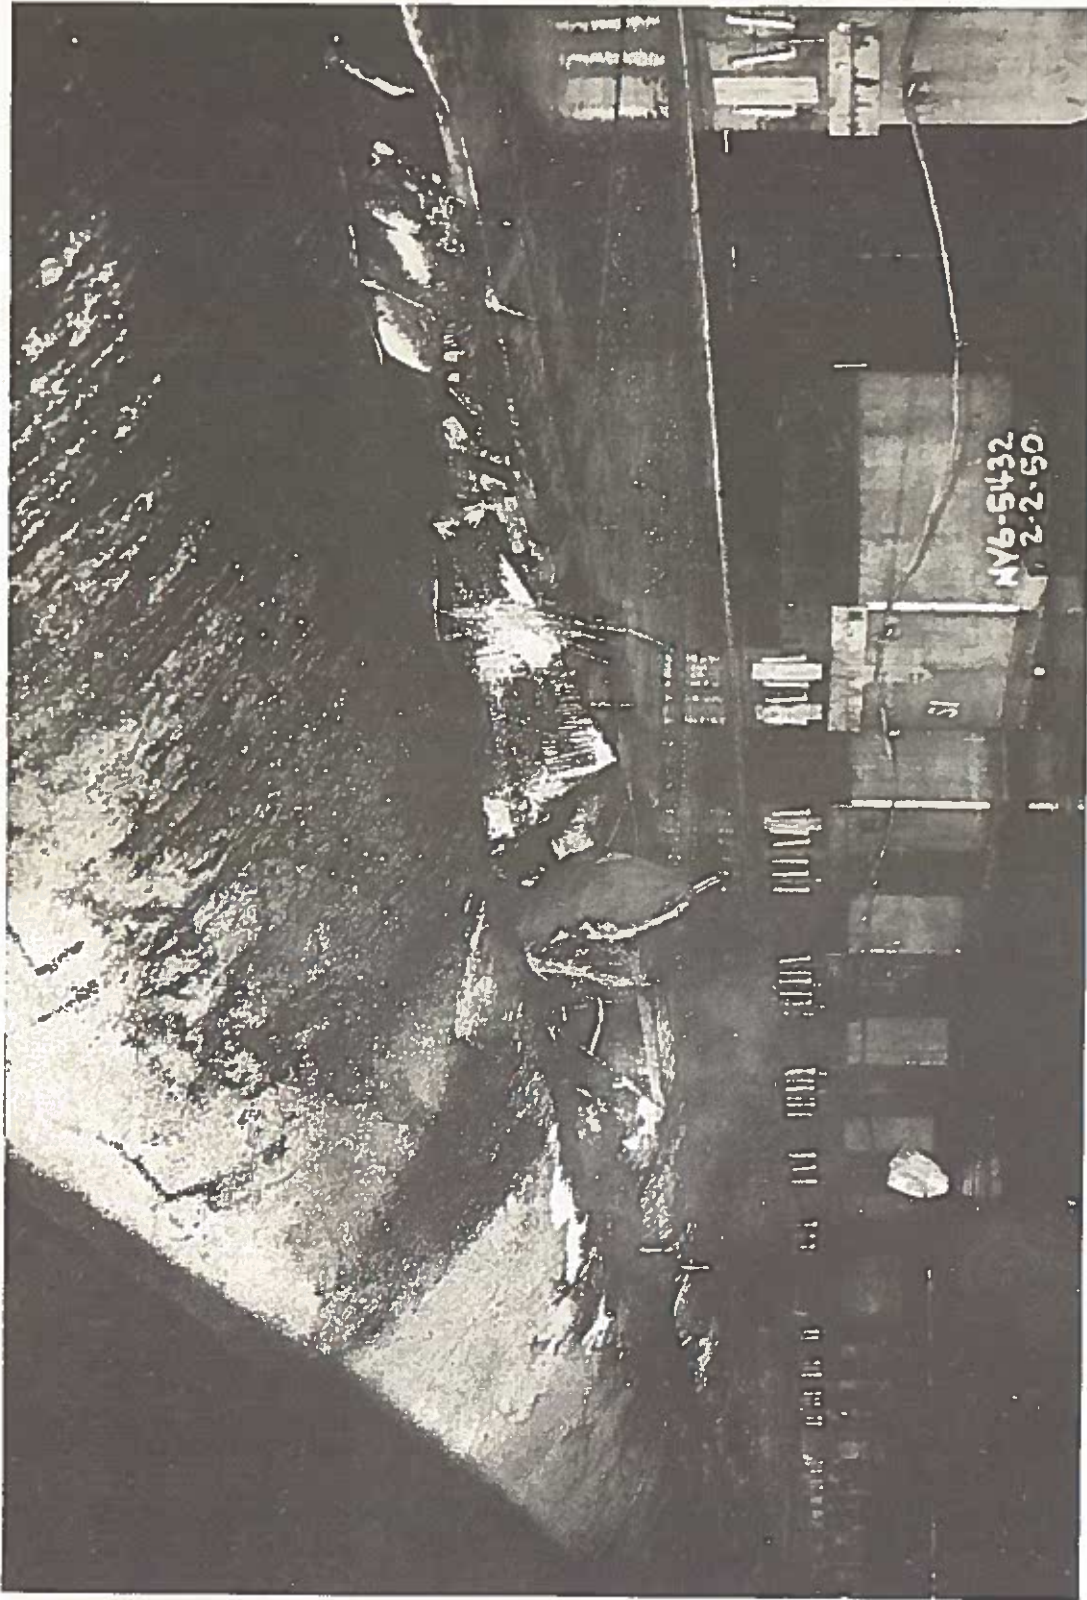
It was originally believed that some buried obstruction, such as had caused the rupture in

the bottom plating in the way of the three oil tanks, contributed to the resistance against the pull. There was very little confirmation of this, however, since the only pronounced dimples in the hull, as observed in drydock, were immediately forward and aft of the ruptured area. While there may have been some degree of added resistance as a result of the damage, the most likely explanation for not refloating was the failure to slew the bow from side to side and the failure to obtain maximum pulling effort from the means available.

Damaged plating in way of oil tanks B-29-F, B-37-F, B-48-F. Divers located the damaged area and described its extent after attempts to pump these tanks proved futile. Just prior to refloating, these tanks were dewatered with air pressure.

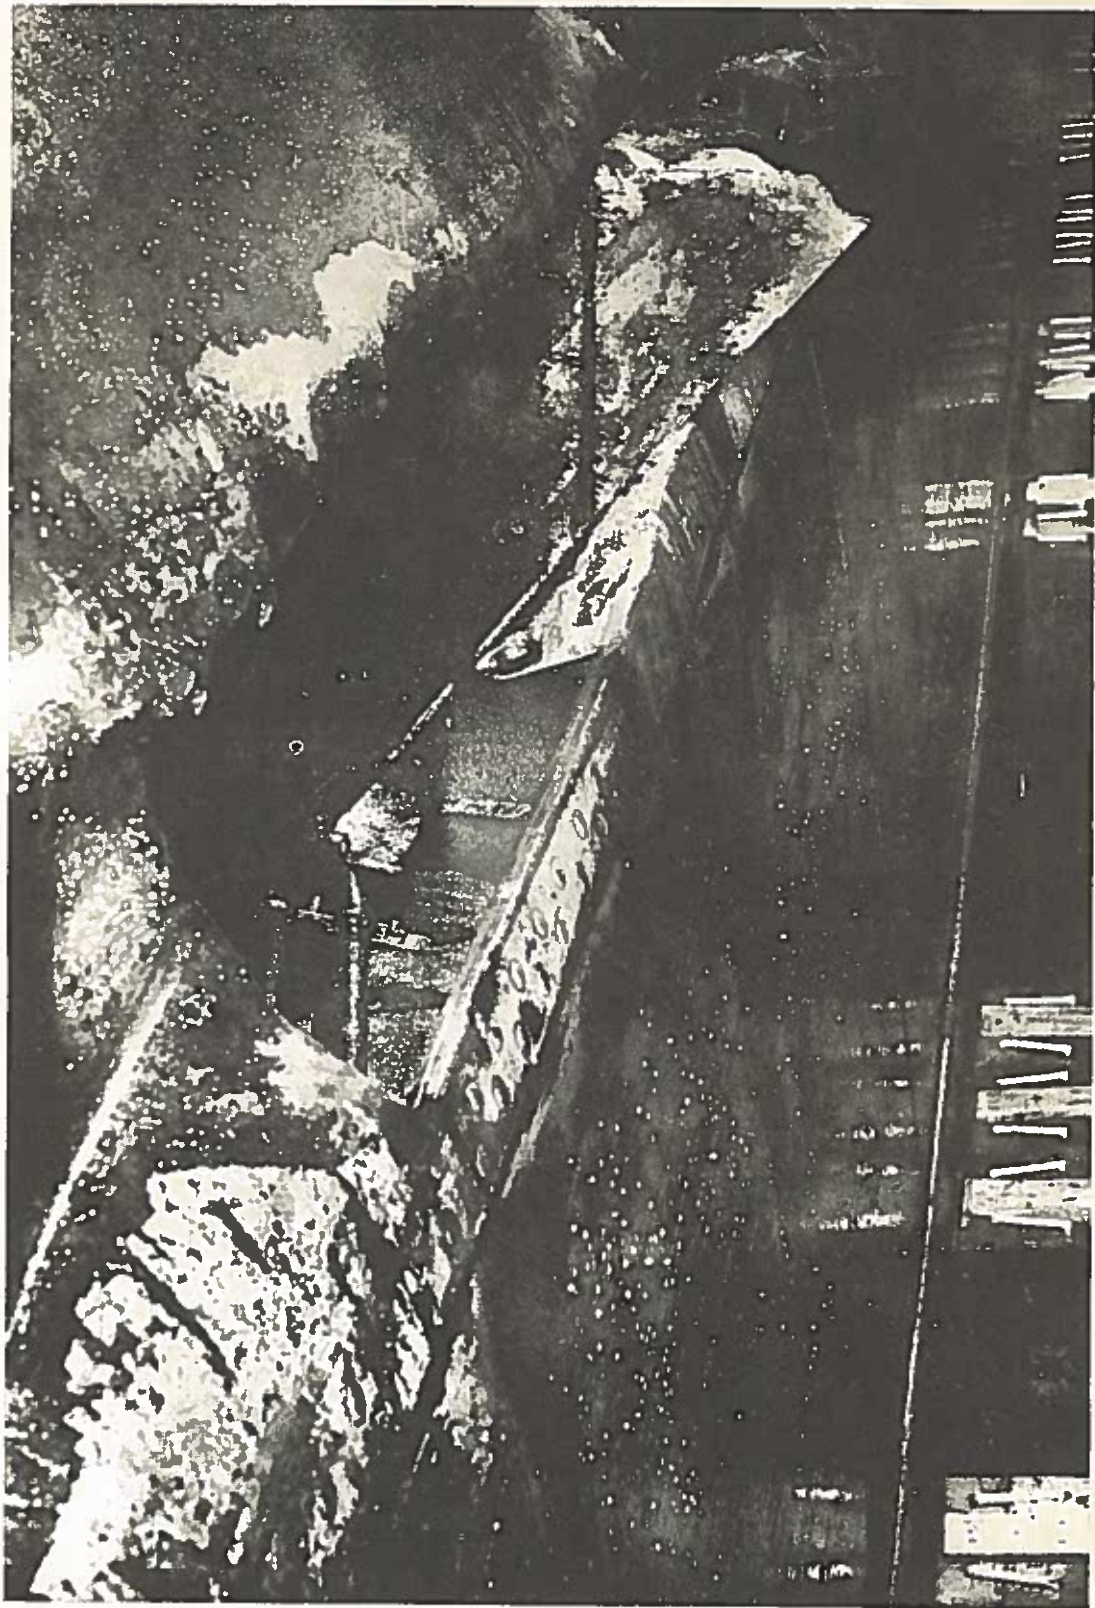
Damaged hull plating. The cause of the damage was unknown. Scraping marks extending forward and aft of the rupture indicated that the ship had passed over a heavy obstruction such as an old forgotten wreck or large boulder. Pieces of old metal were found protruding from the damaged hull by divers, giving some credence to old buried wreck belief.
