SALVOPS 73

A review of significant salvage operations
conducted by U.S. Navy salvage forces
and other salvage activities during 1973.

NAVSEA 0994-LP-012-6050

FOREWORD

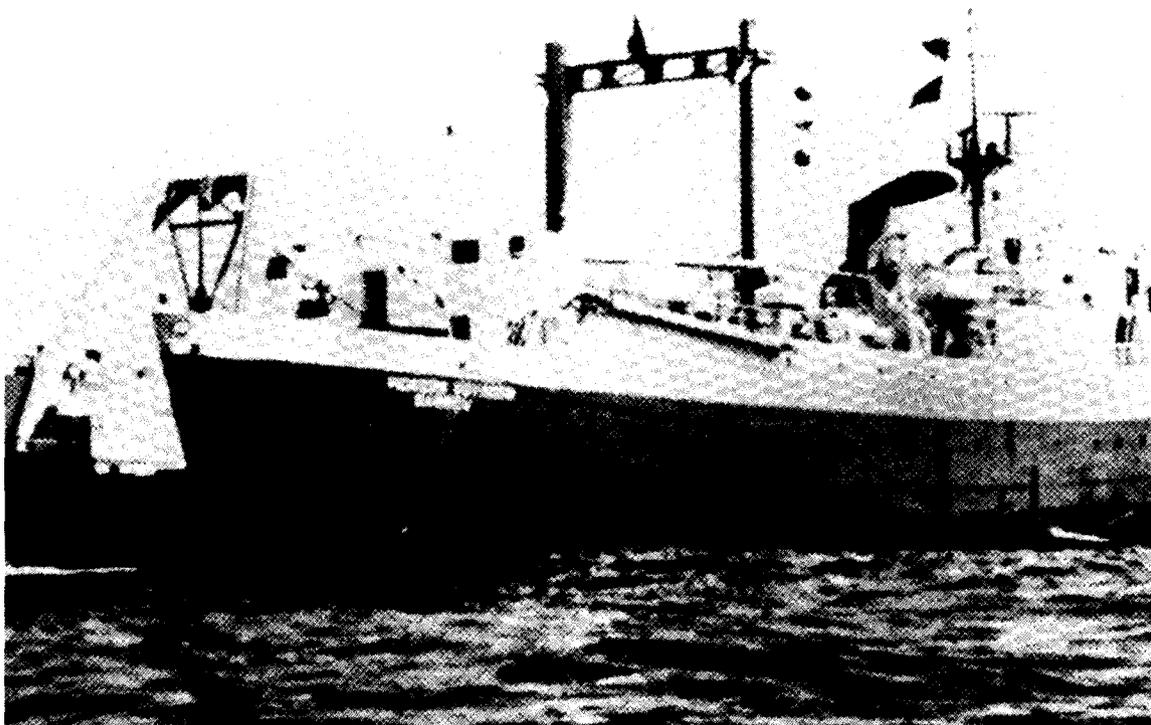
PISCES III was being hauled in, stern first, to VOYAGER's after-mounted A-frame recovery-lift, when its engineering sphere hatch was torn open.

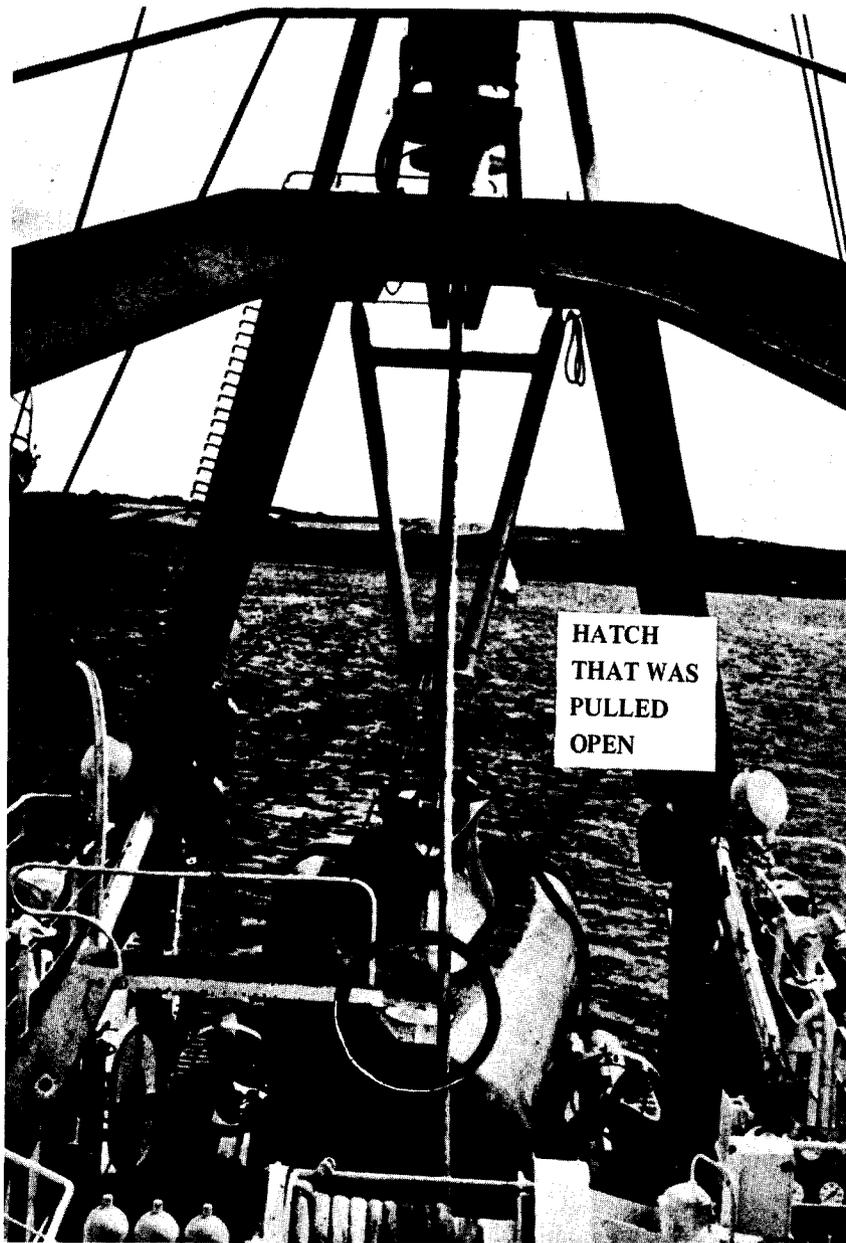
RECOVERY POSITION FOR PISCES III

PISCES III was still some distance from the recovery position, as shown above, when a surge in the sea painter caused a bight to foul the handle of the after hatch and pull it open, causing flooding of the after sphere.

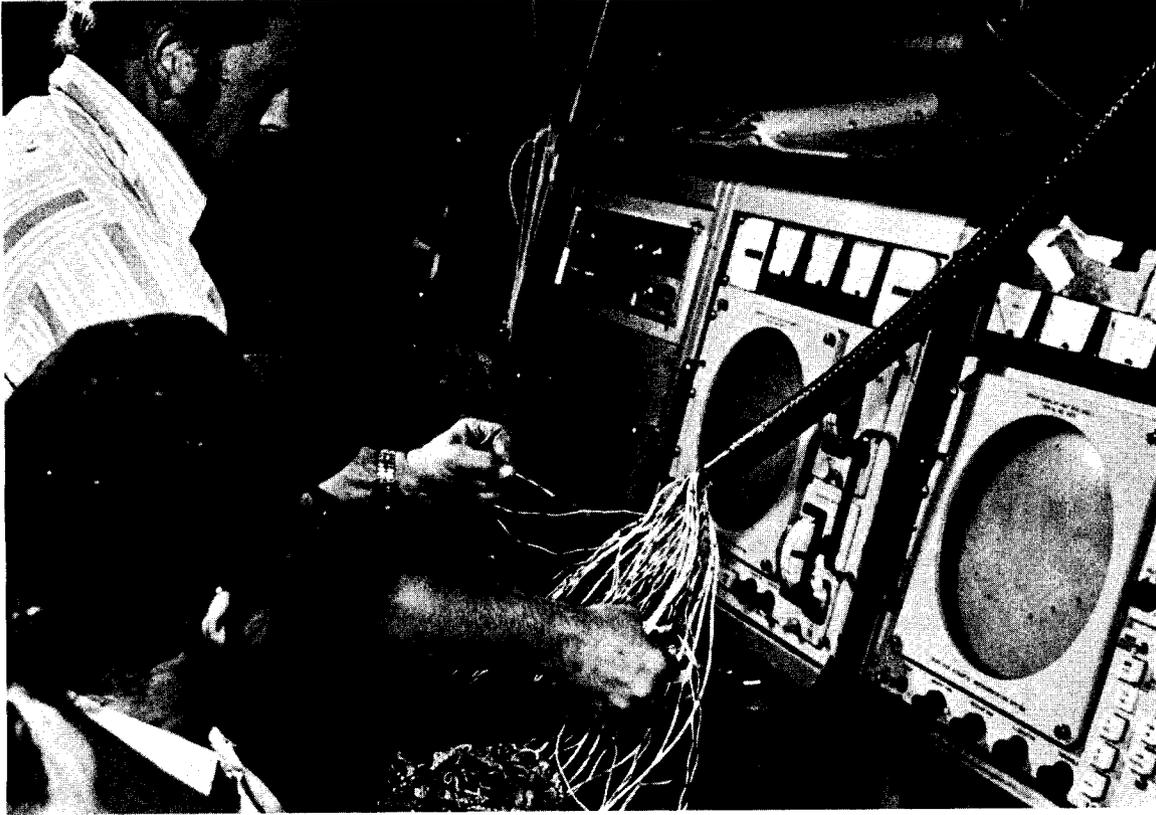
When green water came aboard CABOT and shorted-out CURV's primary 56-pin connector, repairs were pushed through in record time.

and control connector. Repairs were pushed through in record time. In addition, a gyro failure was imaginatively and effectively circumvented by the field expedient of strapping a diver's wrist compass onto CURV's carriage where it could be read by one of the TV cameras.

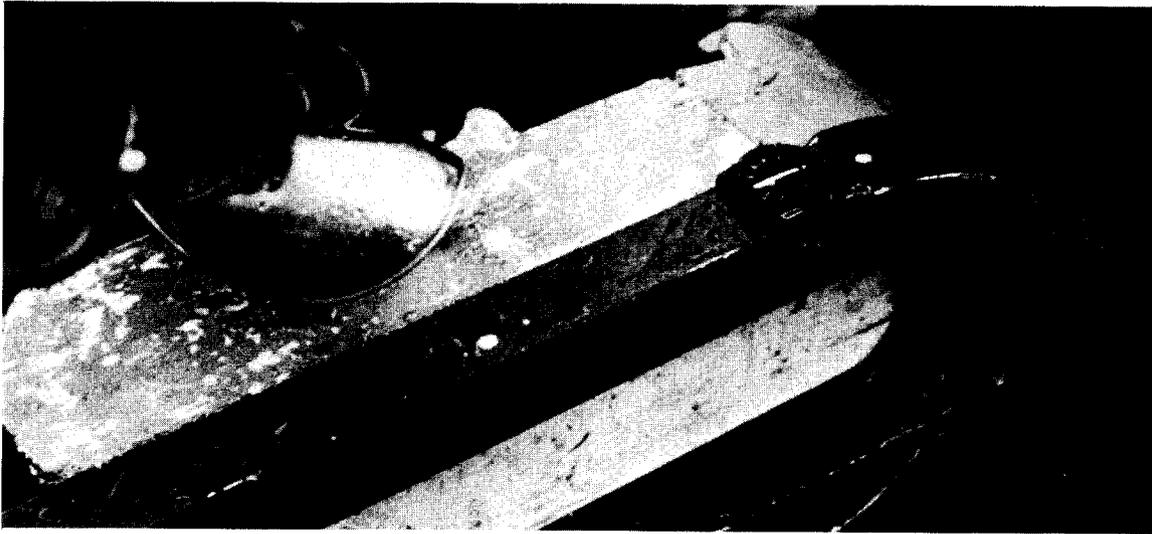
NAVIGATIONAL FIELD EXPEDIENT FOR CURV

A gyro failure was imaginatively and effectively circumvented by strapping a diver's wrist-compass onto CURV's carriage where it could be read on the closed-circuit TV cameras by operator.

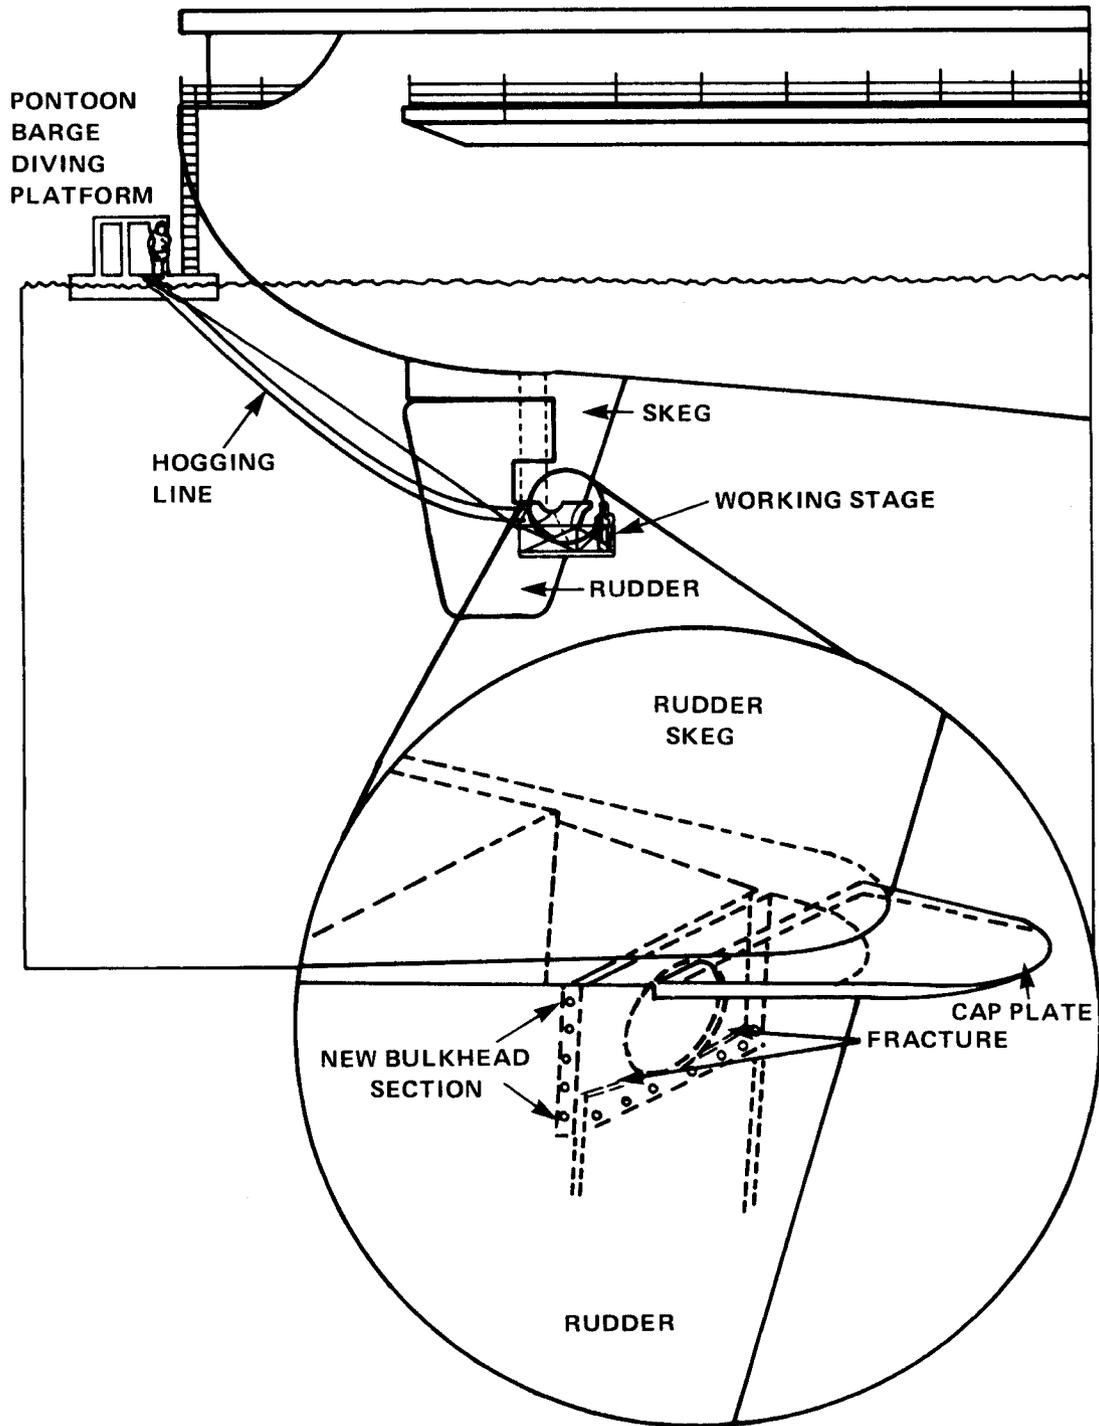
USS F.D. ROOSEVELT RUDDER REPAIRS

Diver's inspections, employing UDATS, the Underwater Damage Assessment TV System, revealed that welds at the top of the rudder had failed. Underwater inspections confirmed that a new transverse bulkhead and a flanged cap plate would first have to be fabricated for the rudder. They then could be installed underwater by divers. The new bulkhead was installed first and the replacement cap plate was then slid into the 2-inch clearance between the rudder skeg and the rudder and fitted into place. Divers had to then drill and tap 130 bolt holes in the rudder plate. When all the securing bolts were torqued down, an underwater epoxy was used to provide a watertight fairing of the cap plate to the rudder.

Diagram of underwater working setup for repairs to rudder of USS F.D. ROOSEVELT (CVA-42) and details of repaired section and repairs.

From inside the rudder, divers drilled and tapped holes on the inside of the rudder shell, to receive bolts that would secure the new bulkhead section. After the bulkhead was installed and repair engineers had inspected the installation, using UDATS operated by the divers, preparation was made for installing the 1,050-pound cap plate between the skeg and the rudder. The cap plate was installed using chain falls and wire, run beneath the ship between the rudder and the propellers. There was no way of attaching buoyancy to the cap plate to lighten it for handling by the divers, because of close quarters in the installation – the clearance between the top of the rudder and the rudder skeg above it was only 2 inches. The first attempt at installation revealed that the cap plate would have to be brought back to the surface for some changes. When installed the second time, a near perfect fit was achieved, with no more than .125 of an inch clearance at any one point.

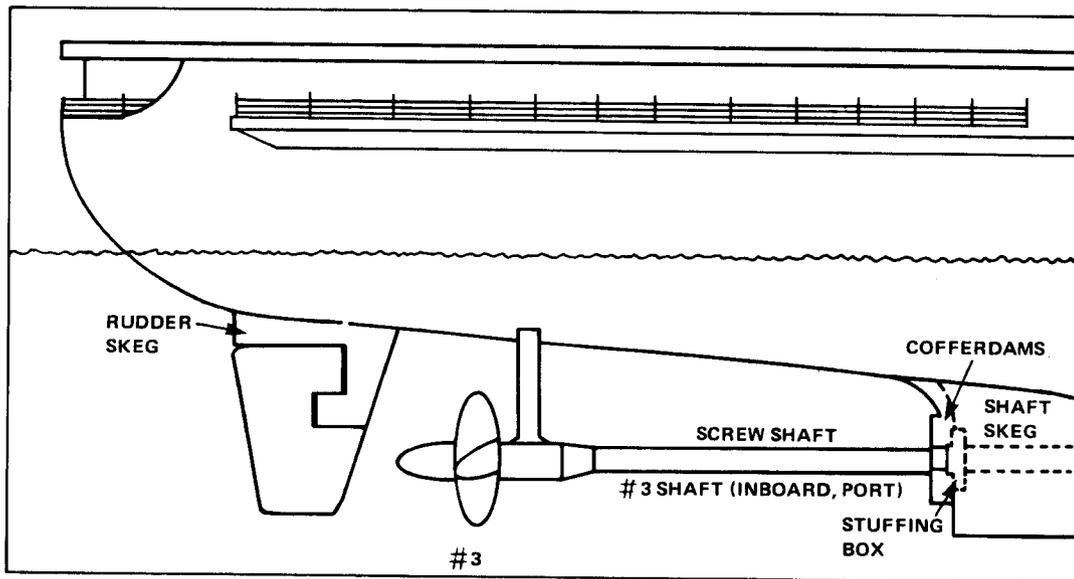
REPAIRS TO ROOSEVELT'S PROPELLER SHAFT

In May of 1973, it became necessary to undertake repairs to the ROOSEVELT's #3 (port inboard) propeller shaft. The work involved removing and replacing the packing of the stuffing-box gland, which keeps out the seawater where the propeller shaft pierces the rear of the shaft alley. Because flooding of the shaft alley is an immediate consequence of removal of the gland or its packing, this job is usually done in drydock. Again in this case, as with the repairs to the ROOSEVELT's rudder, it was deemed possible to circumvent the difficulties and expense of docking, by proper underwater repair techniques. The Supervisor

Diagram of cofferdam installation on #3 shaft of USS F.D. ROOSEVELT (CVA-42), showing location of cofferdams at the outboard face of the shaft skeg to hold out water from the stuffing box gland to permit replacement of packing.

The divers first emplaced a pair of patches over the bearing intake ports and formed a seal with rubber tape at the point that the propeller shaft emerged from the stern tube. Water, however, could not be drained from inside the stern tube so that the inside stuffing box could be opened. Deterioration in the skeg and the stern tube had created pinhole leaks that caused the stern tube to continue to flood. By installing two portable eductors, powered by firemain pressure on the bearing intake port patches, water flowing into the stern tube from the pinhole leaks could be diverted back to the sea. These arrangements kept the sea from flooding the shaft alley so that the inside packing gland could be dismantled and the packing rings replaced. The work proceeded satisfactorily and was completed in two days.

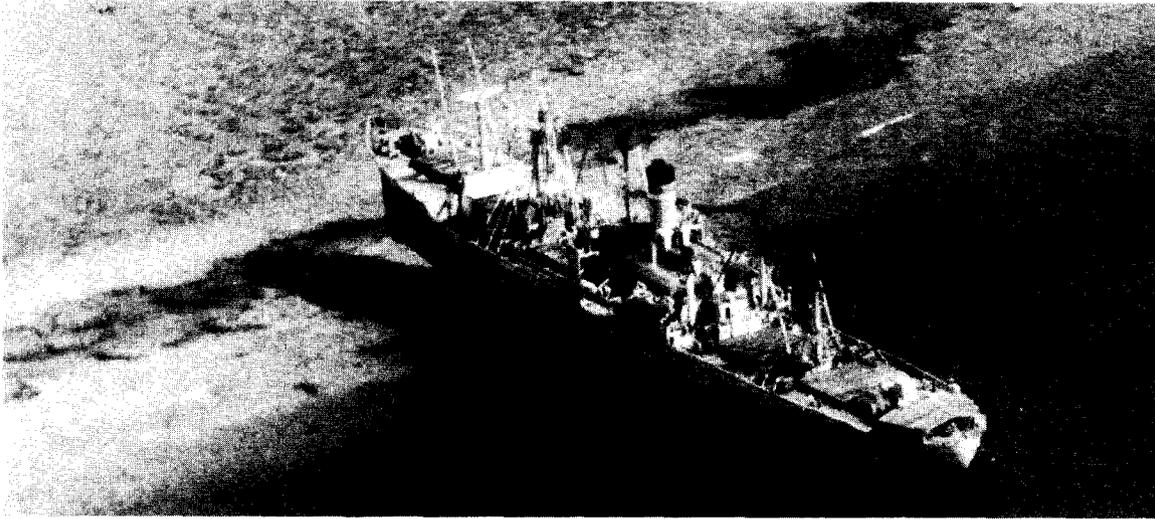
PENDLETON went aground on this coral reef in the Paracels, South China Sea. Although unholed and relatively undamaged, crucially heavy, unloadable cargo over the point of grounding defeated simple retraction operations.

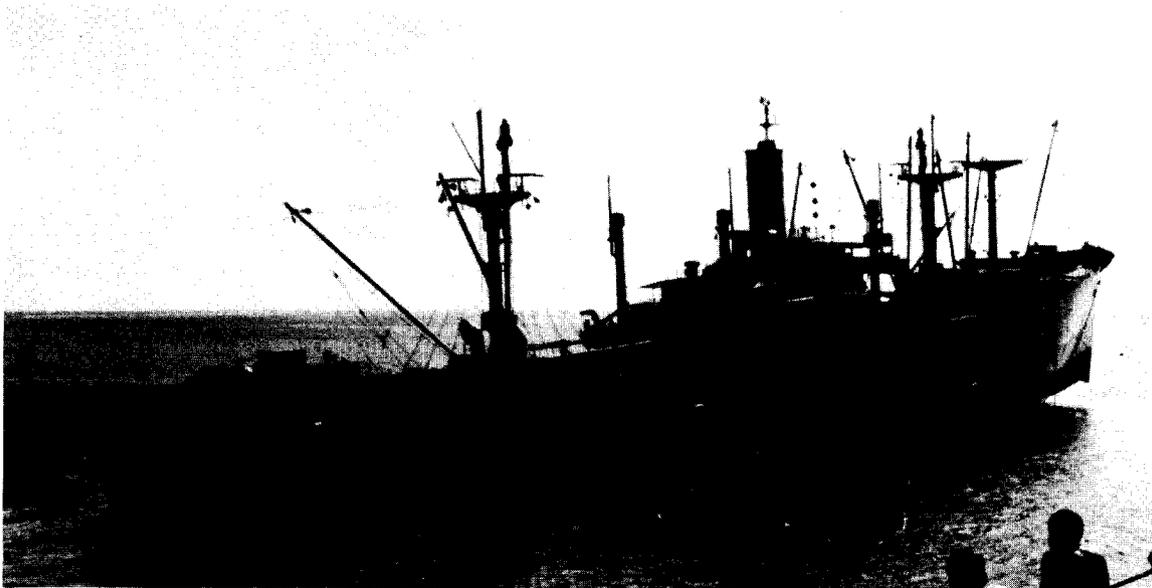
PENDLETON's condition at time of first unsuccessful retraction attempt by USS BEAUFORT (ATS-2). All saltwater ballast (1,523 tons) had been pumped overboard, and all 9,180 barrels of NSFO fuel oil (1,260 tons) had been consolidated in the after tanks.

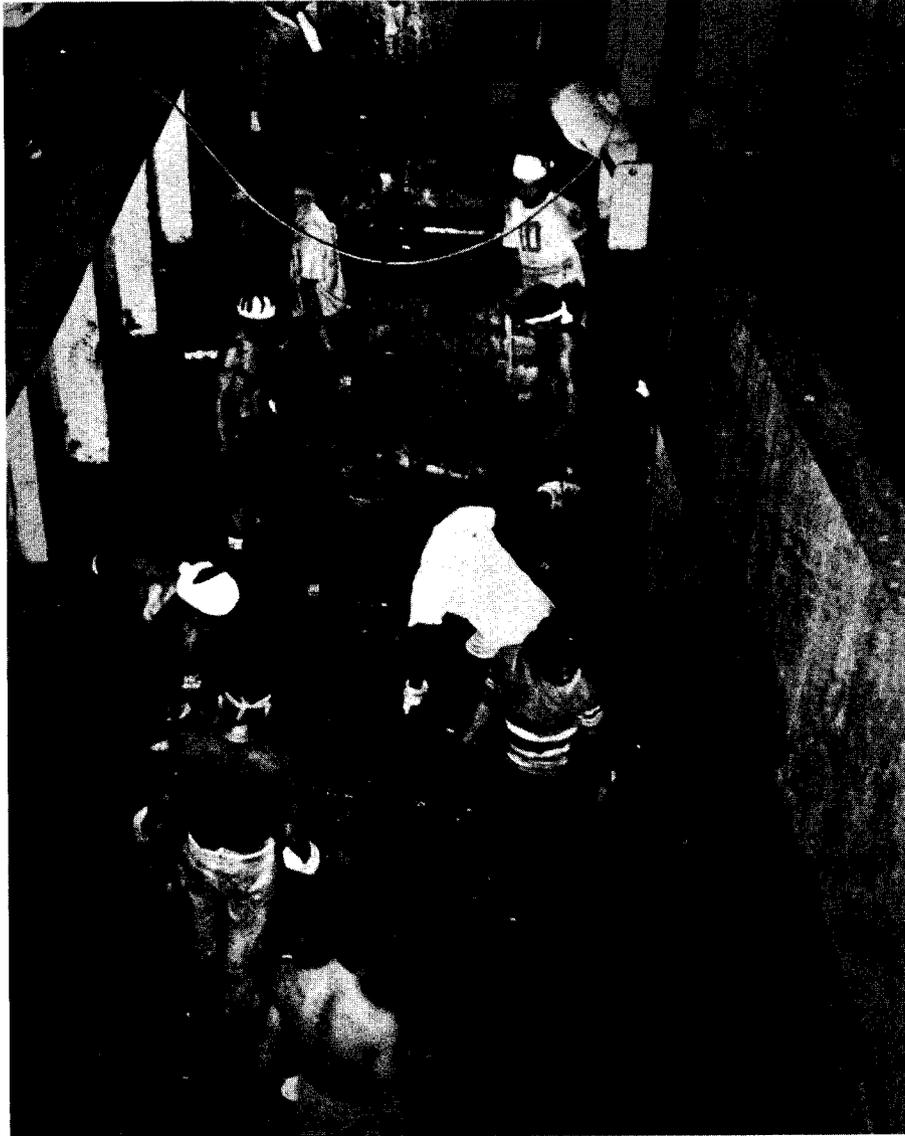
DAMAGE ABOARD PENDLETON AFTER TYPHOONS

LUSTEVECO stevedores are shown removing oil soaked pallets from the hold. The four successive typhoons had severely complicated the task of offloading. Ammunition pallets remaining in cargo holds were oil and water soaked, pallets broken, and contents scattered. High danger of fire existed aboard the wreck. Wiring on board was badly deteriorated and use of electric power would have been dangerous. Oil soaked dunnage and accumulation of other flammable debris enhanced this danger. With the ship's pump and main fire system inoperable, emergency fire fighting equipment had to be brought aboard.

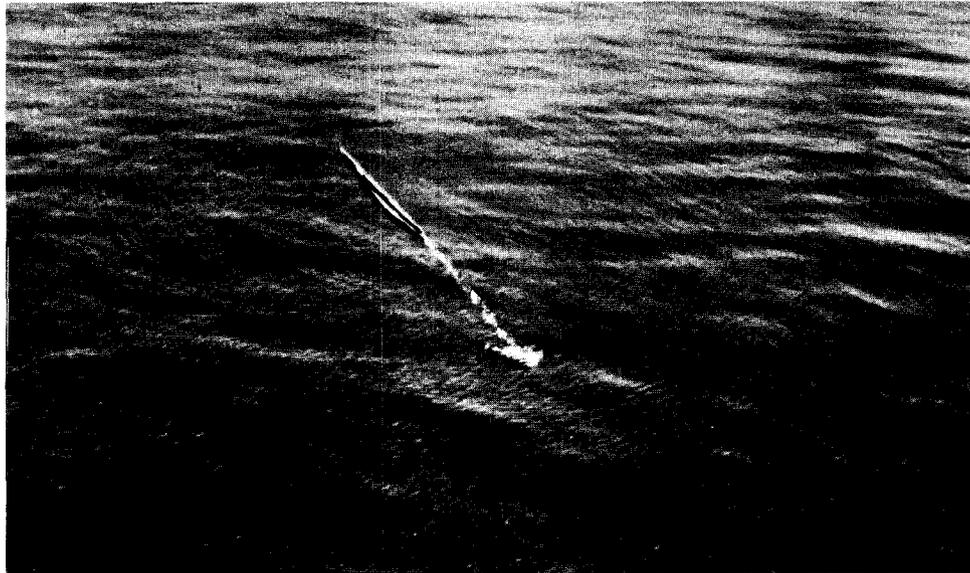
In shallow water off Vietnam, fish havens constituted a problem for sonar operation. These vertically anchored bamboo spars, on a number of occasions, became entangled with the towed sonar fish, parting the tow cable and damaging the fish.
