S.S. SIDNEY E. SMITH, JR. SALVAGE OPERATION

**Removal of the sunken coal freighter, SIDNEY E. SMITH
from the shipping channel of the St. Clair River**

**Port Huron, Michigan
June-November, 1972**

**Department of the Navy
Naval Sea Systems Command
Washington, D.C.**

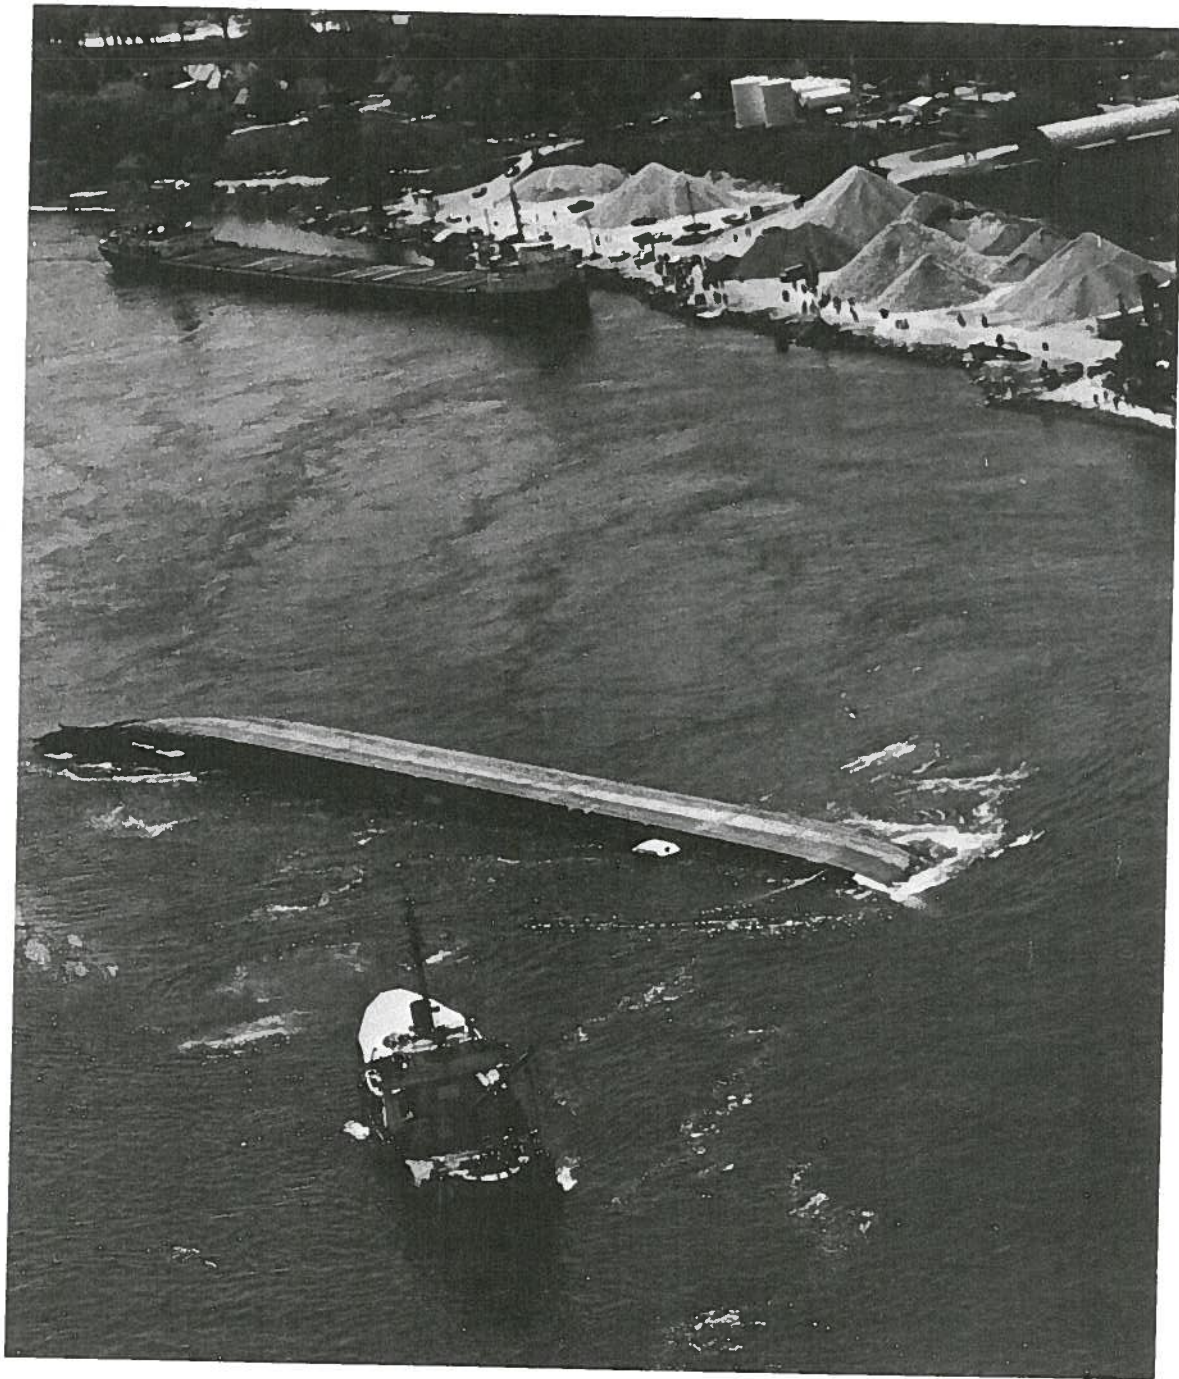
Overtuned SMITH lies bottomed on starboard side, morning after nighttime collision with PARKER EVANS (background). Hull, still intact, protrudes 250 feet into shipping channel. River current hammers at bow (upstream, right). SMITH broke up three days later.

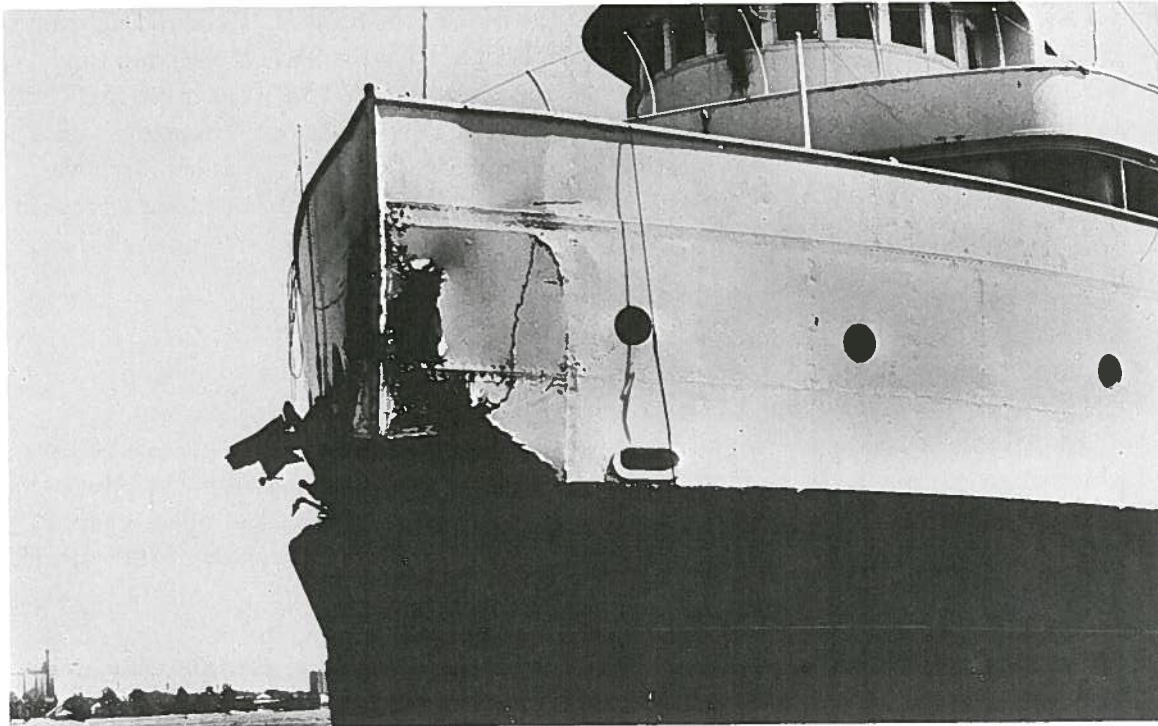
COLLISION WITH SMITH DAMAGES BOW OF PARKER EVANS

PARKER EVANS survived collision despite extensive bow damage. Freighter remained in Port Huron several days for temporary repairs, then proceeded downriver to permanent repair site.

The PARKER EVANS sustained serious bow damage. However, the freighter was securely moored shortly after the collision, under complete control and in no danger of sinking. Temporary repairs were made to the bow over the next several days. The PARKER EVANS then departed the Port Huron area, proceeding down river for permanent repairs. She played no role in the ensuing salvage operations.

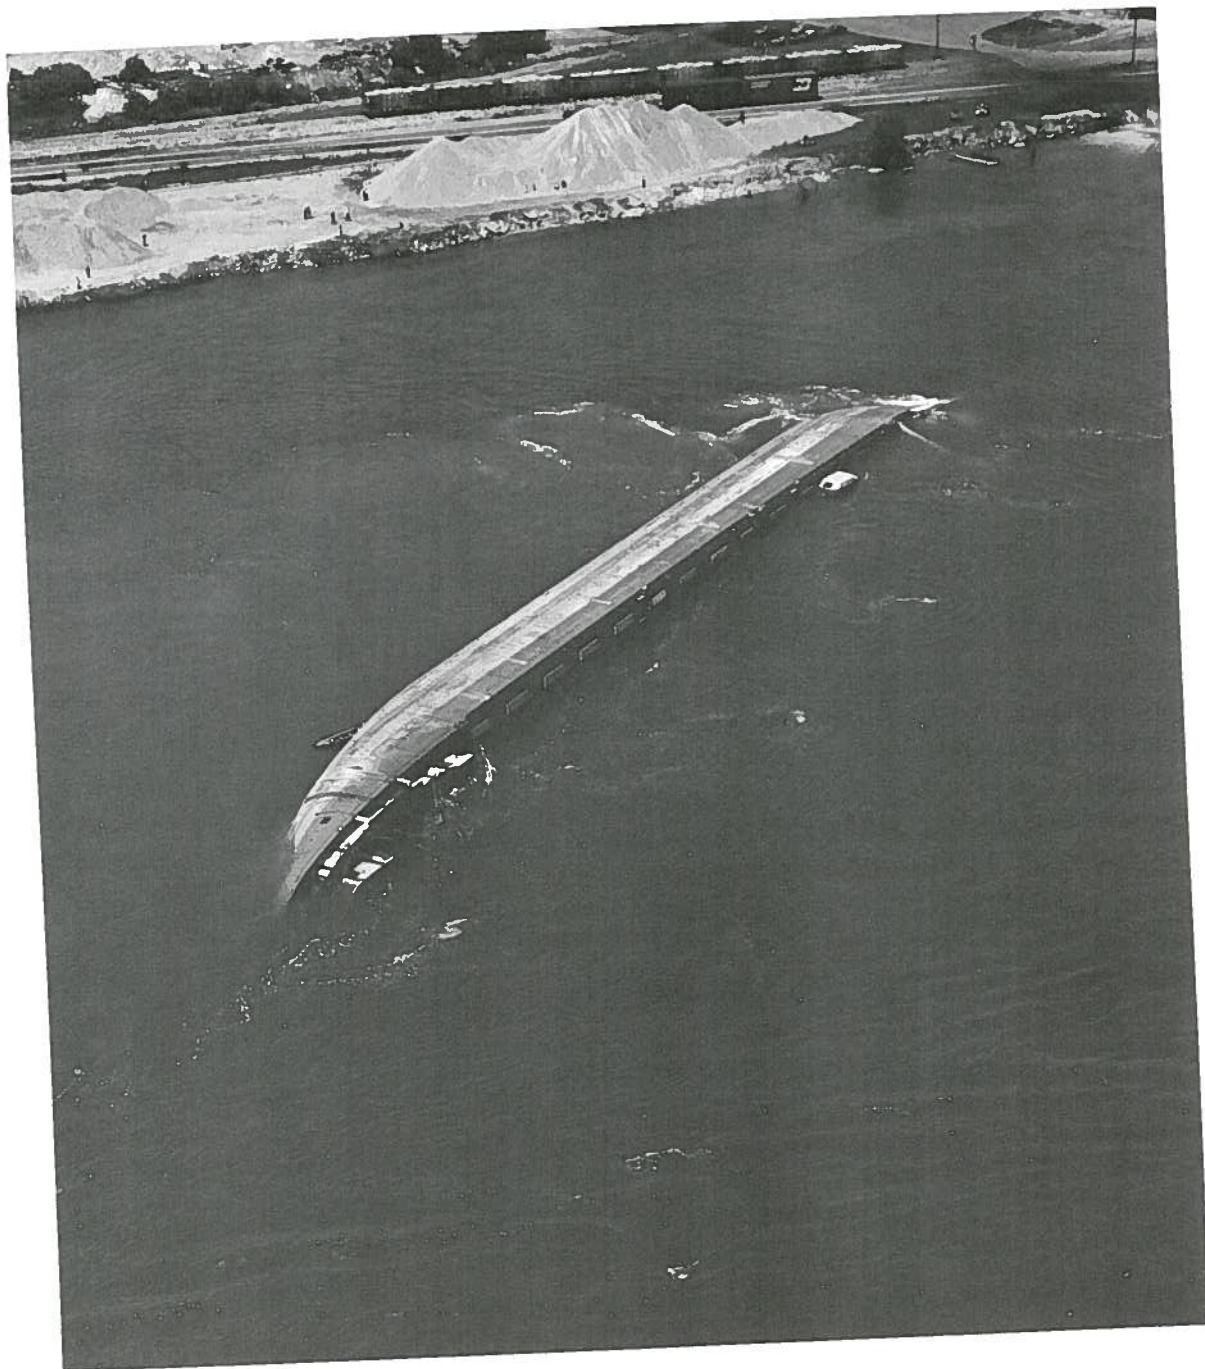
SMITH STILL INTACT BUT VULNERABLE TO FURTHER DAMAGE

The collision of the two large freighters had opened the SMITH's hull from the gunwale to beyond the turn of the bilge. Structural damage extended several frames forward and aft of the point of impact. Water immediately invaded the forward machinery space through the tear in the hull at frame 35 flooding this space. Unimpeded, the floodwater also proceeded aft through the conveyor tunnel into the cargo holds through the closed (but not watertight) hopper doors and from tank to tank along the starboard side where longitudinal piping penetrated the "watertight" bulkheads.

Flooding of the conveyor tunnel added a great volume of water to the vessel, decreasing its freeboard significantly and adding a substantial overturning moment. The second point of impact, which occurred about 25 feet aft of the initial gash, caused starboard side tank #2 outboard of hold #1 to flood and probably also caused flooding directly into hold #1 above the tank tops. In addition, the starboard side double bottom tank outboard of and beneath the forward machinery space flooded immediately, while the port side tanks remained dry. All this water pouring in on the starboard side resulted in a rapidly developing starboard list.

Morning after collision, wreck was already beginning to settle and break up. Water poured in through cargo hold hatches and at point of impact. Extensive flooding, plus rapid scouring of river bottom beneath bow region (right), created severe stresses on hull.

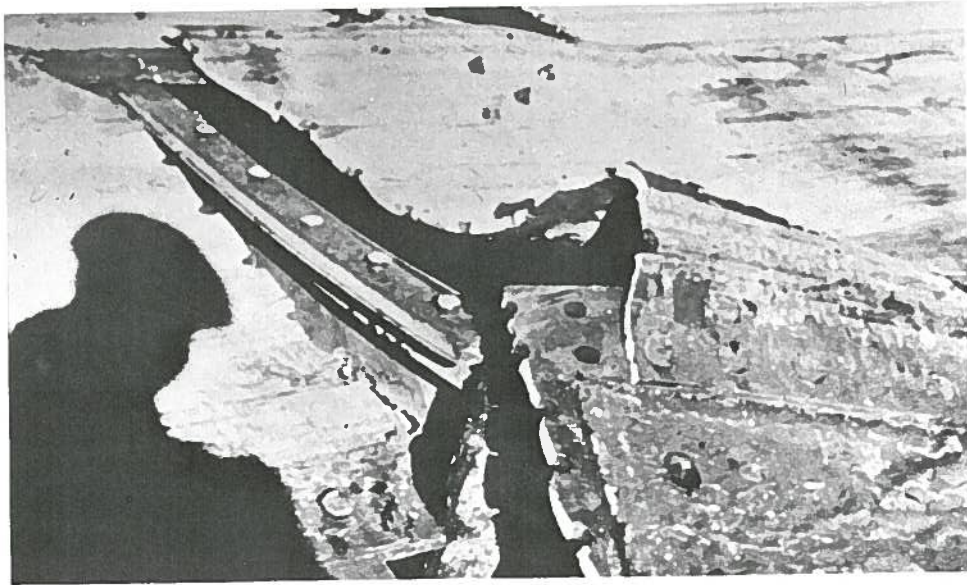
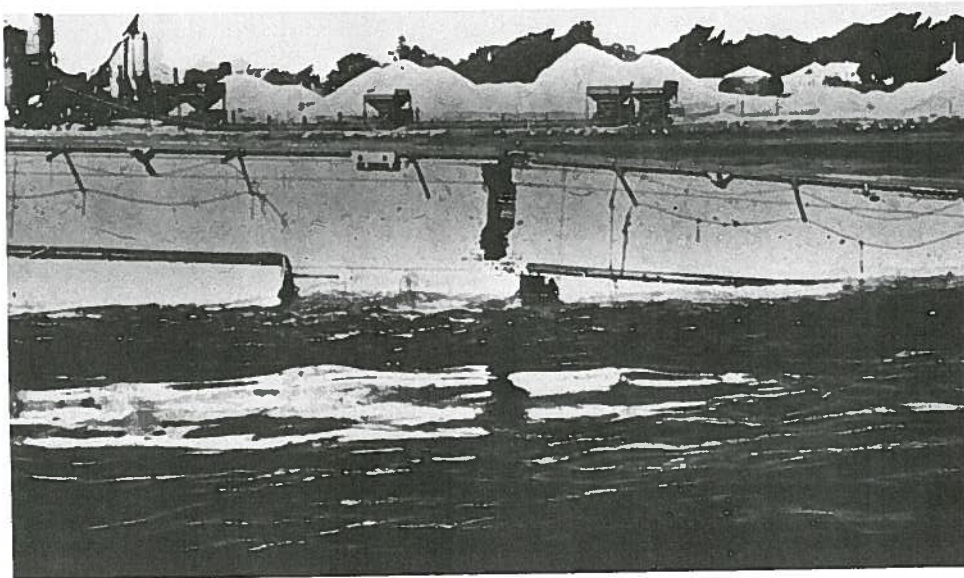
RIVER CURRENT SPLITS SMITH'S HULK IN TWO SECTIONS

The condition of the sunken hulk deteriorated rapidly under the ceaseless attacks of the powerful river current. The current, deflected by the hulk, swirled around and under the forward section, producing a massive scouring action which carried away more and more of the sandy bottom. This scouring reduced and finally eliminated the already tenuous support for the bow, suspended over the depression. With nothing to support its forward weight, the hulk split in two sections.

Bow began settling shortly after collision. Widening cracks marked progress of break-up over 3-day period. Bow section (bottom, right) slipped completely below surface by 8 June.

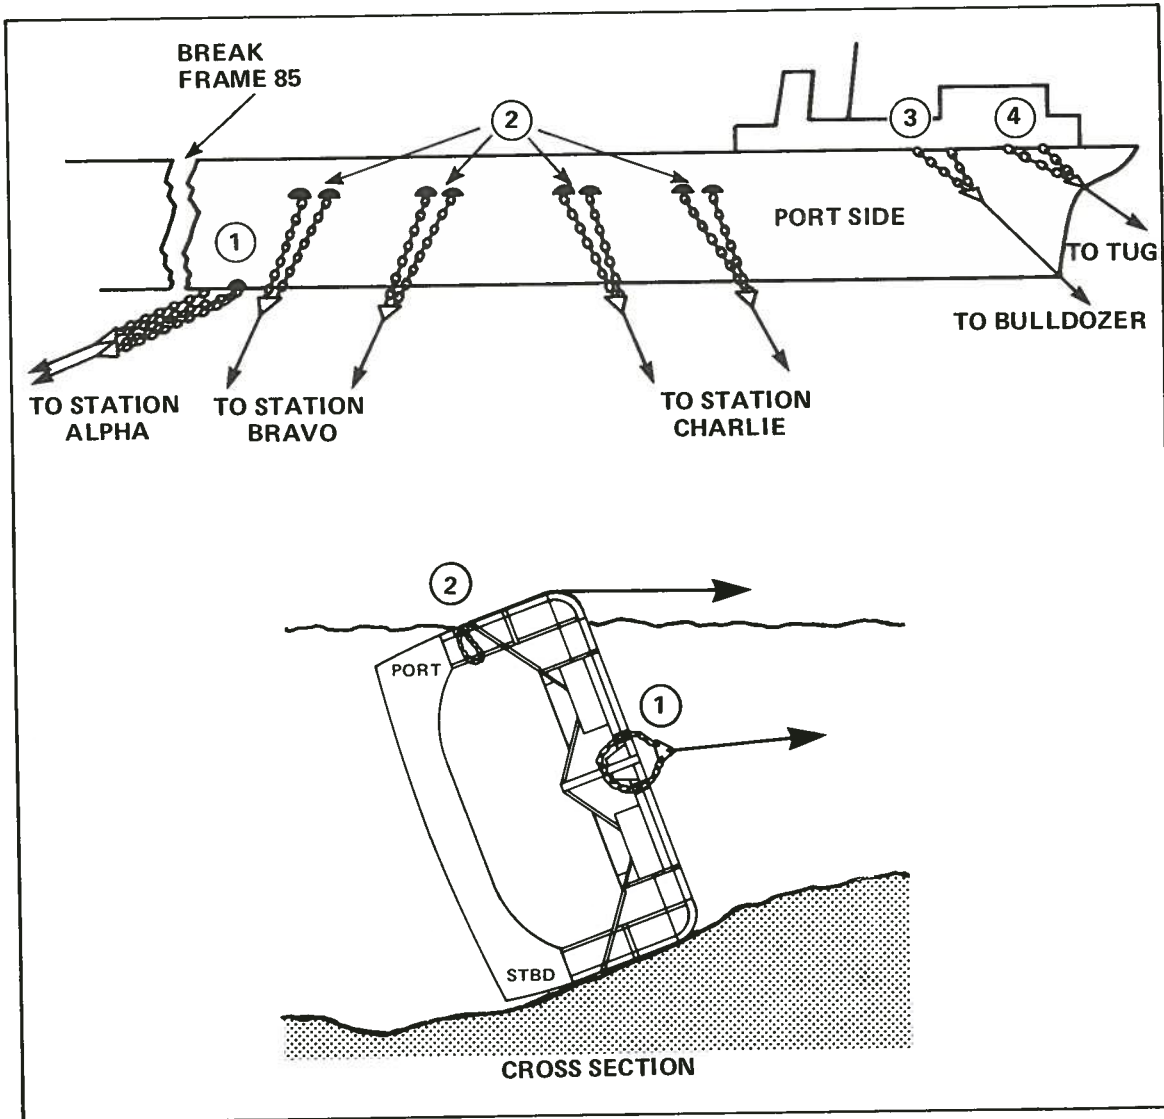
RIGGING OF PULL POINTS ON STERN SECTION

- ① To hold wreck against current, pulling wires were attached to 2¼" chains looped around keel at frame 94.
- ② For parbuckling and shoreward pull, four pull points were rigged high on port side. Flounder plates connected pulling wires to 2¼" chains attached to each of four strength members 24' apart in cargo holds 5 and 6.
- ③ For additional 27-ton shoreward pulling force from bulldozer, pull point aft on port side was rigged.
- ④ Tow wire from tug to stern of wreck was rigged in attempt to separate stern from bow section.

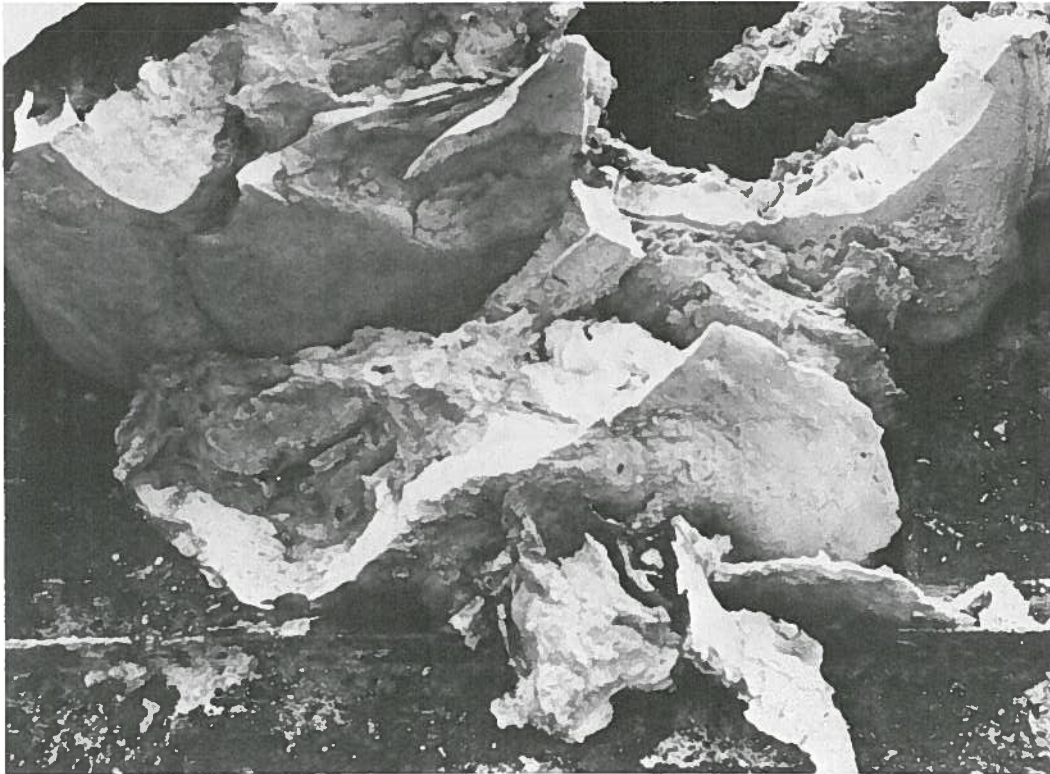
Testing of foam samples confirmed salvors' belief that foam quality was poor. Causes proved difficult to pinpoint.

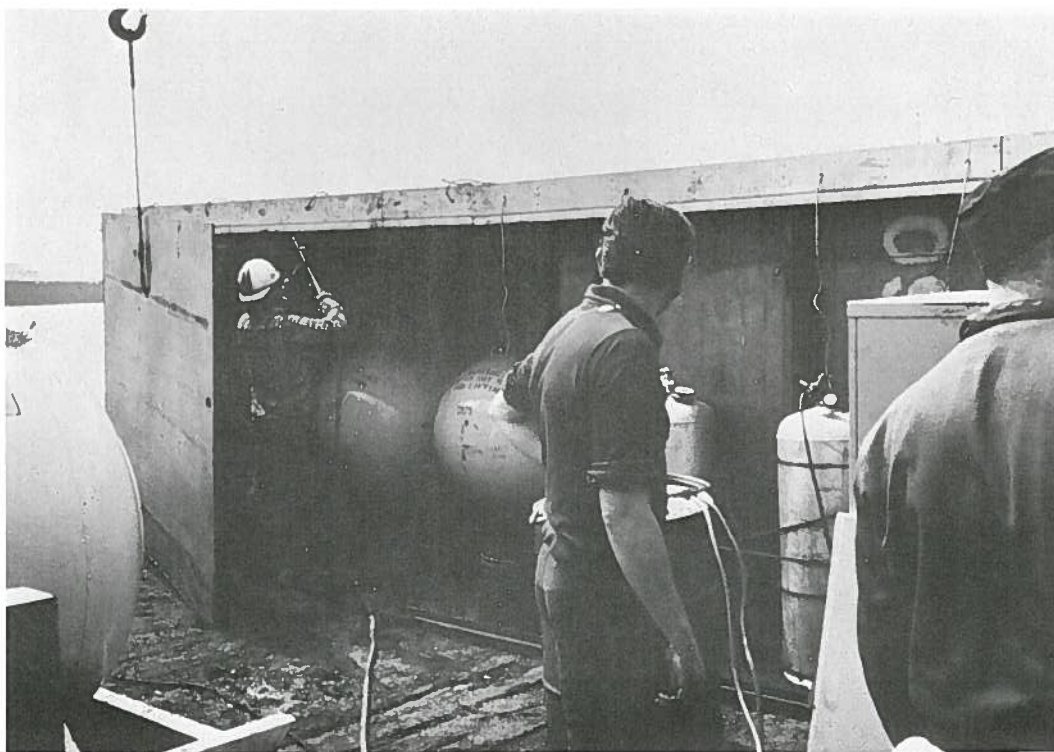
Tanks were heated externally with space heaters in this improvised shelter in an effort to improve foam quality. Low pressure in aerosol delivery system precludes in-line heating of chemicals.

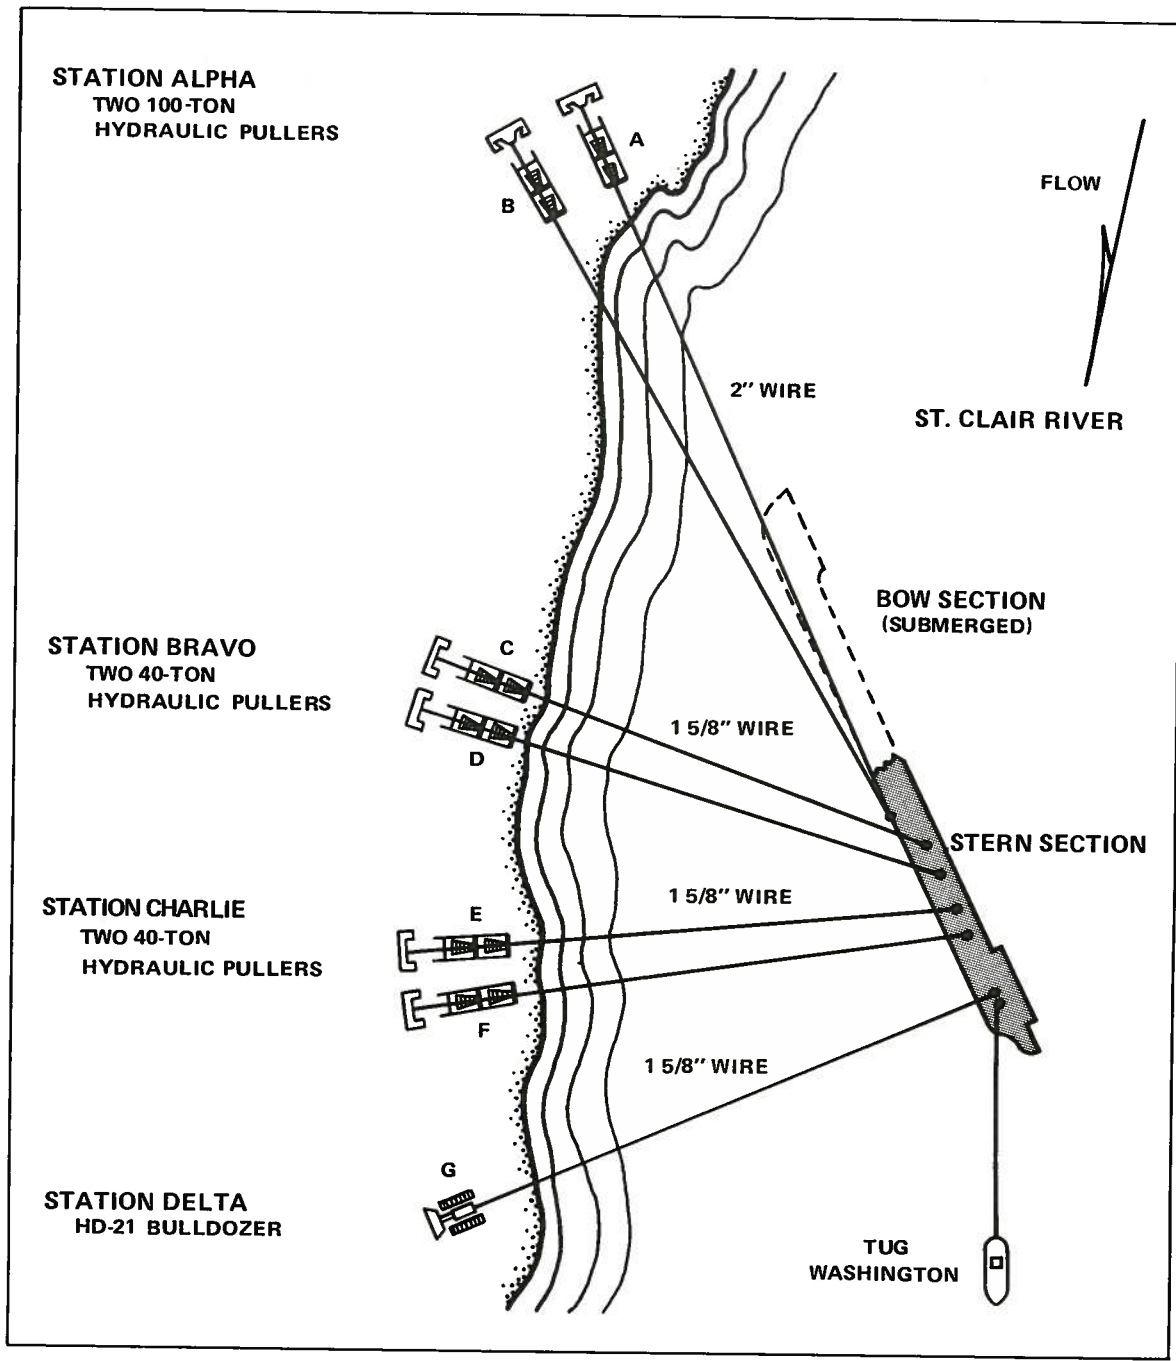
Maximum pulling force from all four shore stations, plus later help from tug downstream, failed to dislodge stubborn stern section from mid-channel. After 3-day effort, wreck was partially righted but shoreward movement remained minimal.

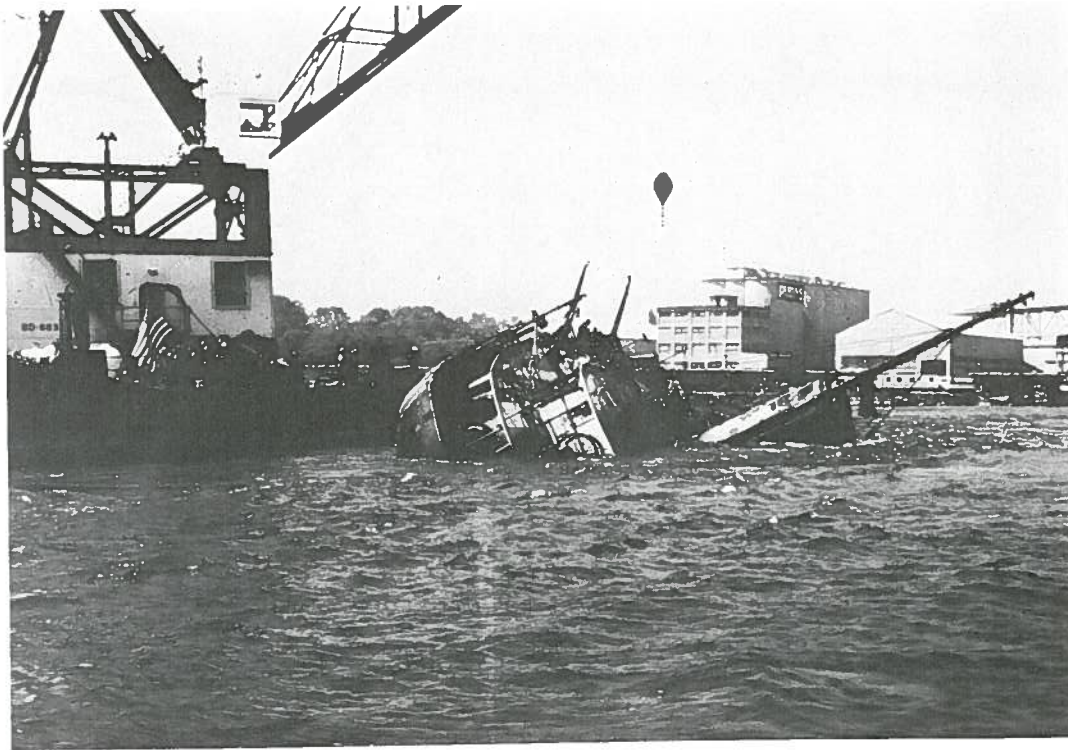
Initial pulling efforts failed to budge the hulk. Salvors then decided to install additional foam. Hatch covers were also reinforced at this stage before renewing pulling attempts.

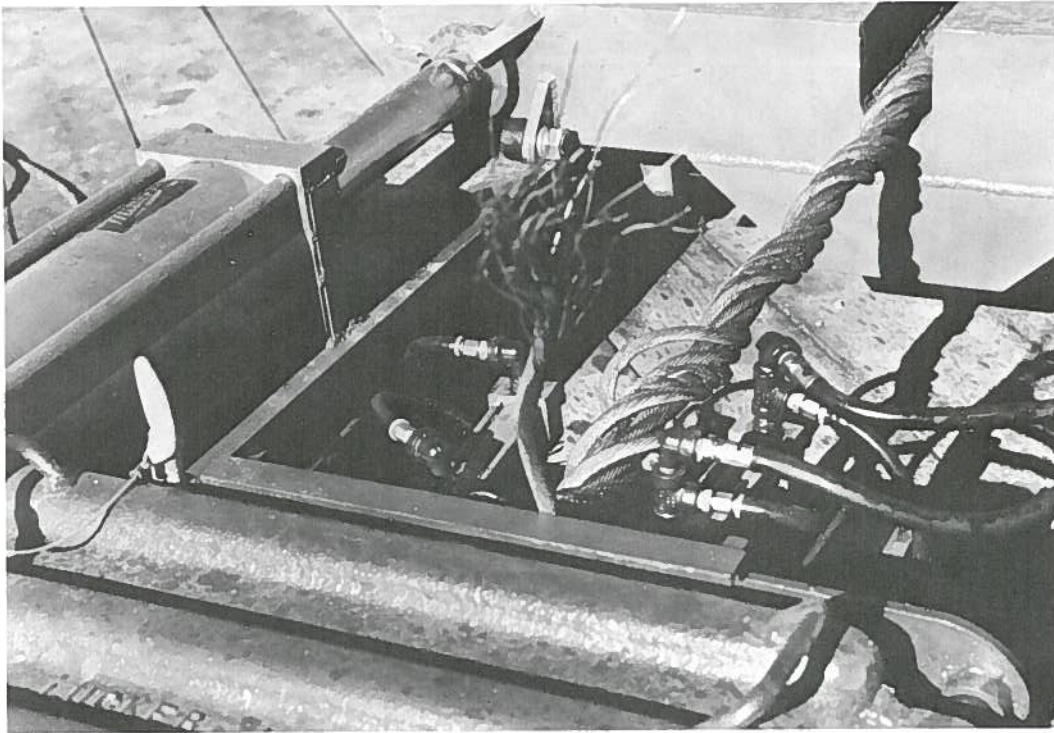
Three strands of the 2" pulling wire parted on 3 August. Repairs were made quickly. Photo shows puller's stationary grip. Grips on 100-ton puller are hydraulically activated (small hose connections).

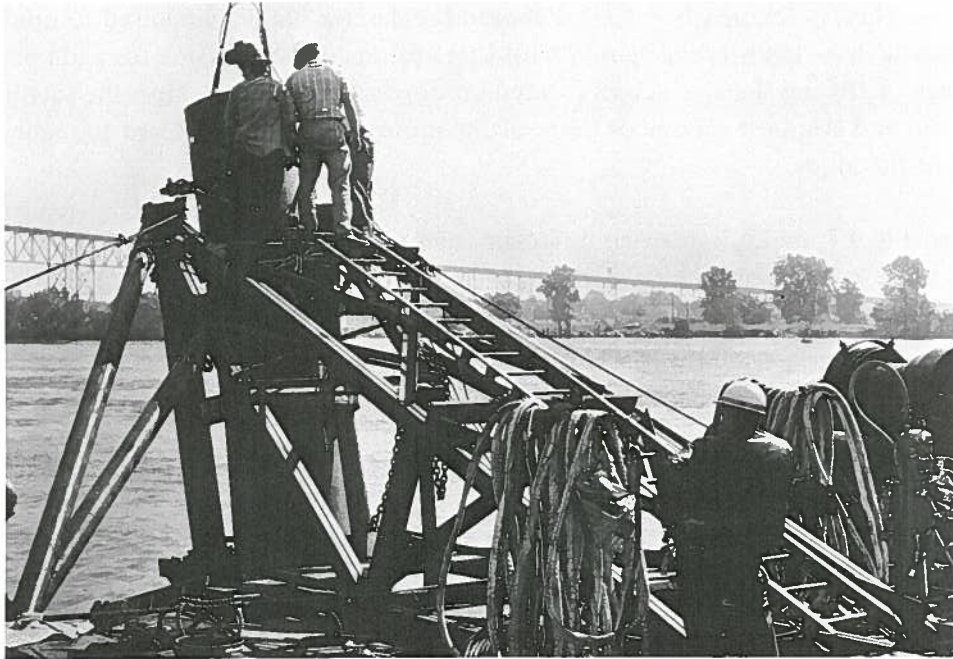
Cofferdam didn't seat properly against bow bottom. Screw-type jack carried away and both cofferdam and A-frame were damaged. Salvors here are extricating cofferdam following the failure.
