ex-USS TORTUGA (LSD 26) SALVAGE REPORT

T9597-AB-RPT-010/SUPSALV

14 SEPTEMBER 1989

**SUPERVISOR OF SALVAGE
U.S. NAVY**

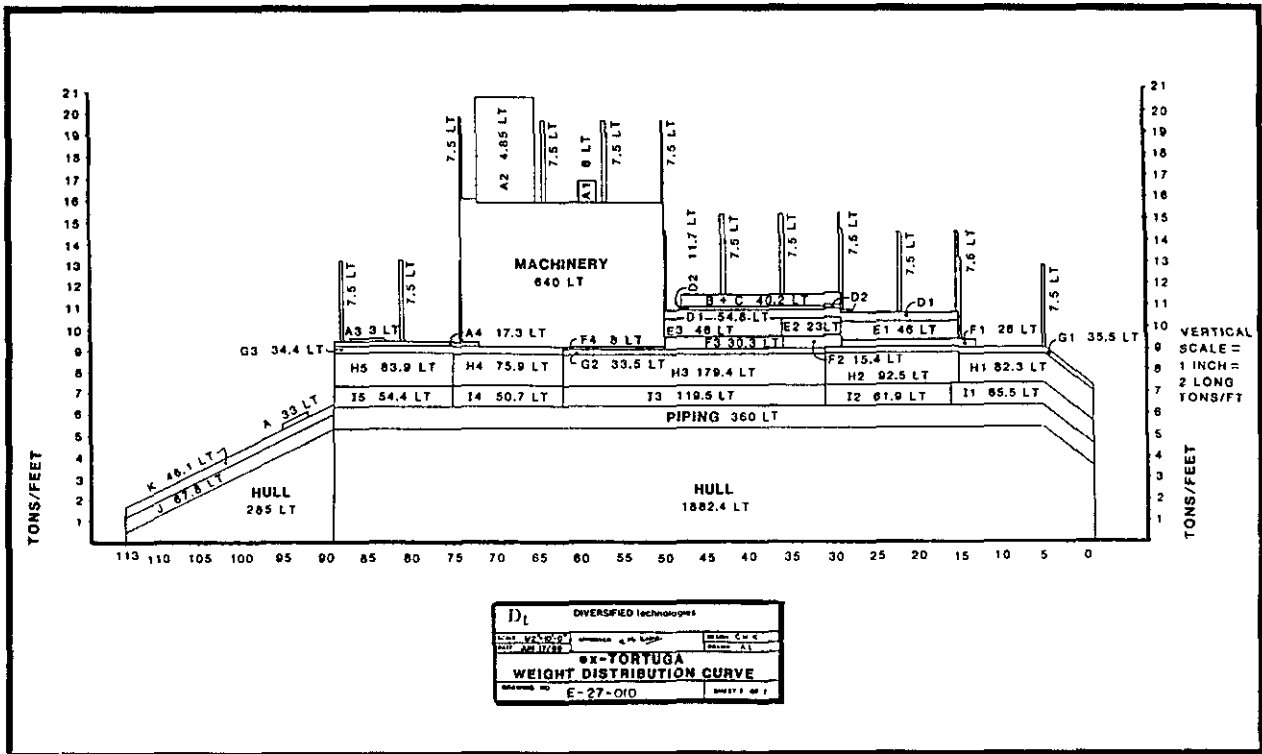
FIGURE 4-4. Weight Distribution Curve (Before Weight Removal).

Due to extensive damage, it was suspected that the strength of the hull had been significantly reduced. Maximum stresses were computed to compare with the yield stress of the remaining structure. Figures 4-4 and 4-5 show the weight distribution for the entire fore section before and after the topside weight removal phase. The weight distribution of Figure 4-5 was used to generate the weight curve in Figure 4-6 which, when combined with the buoyancy curve generated from Bonjean areas, yielded the load curve. Second integration of this load curve, in turn, yielded the bending moments (M) which were computed for eleven evenly-distributed stations 35.2 feet apart. Figure 4-7 shows the summary of moments for both a stillwater condition and worst-case conditions of hog and sag. The worst-case scenarios are based upon a standard L/20 wave, where it is assumed that the fore section is supported amidships or at both ends on the crests of a 352-foot long, 17.6-foot high wave. As can be seen in Figure 4-7, the maximum bending moment predictably occurs in the midships area.

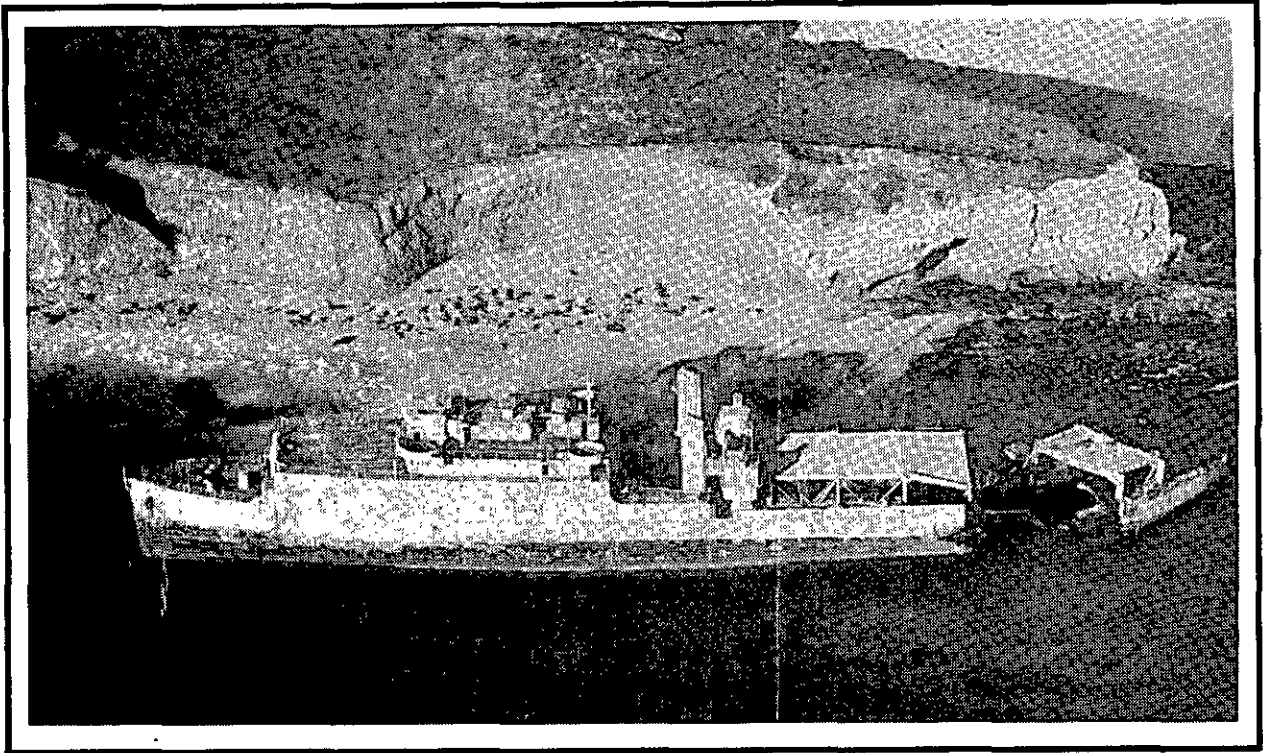
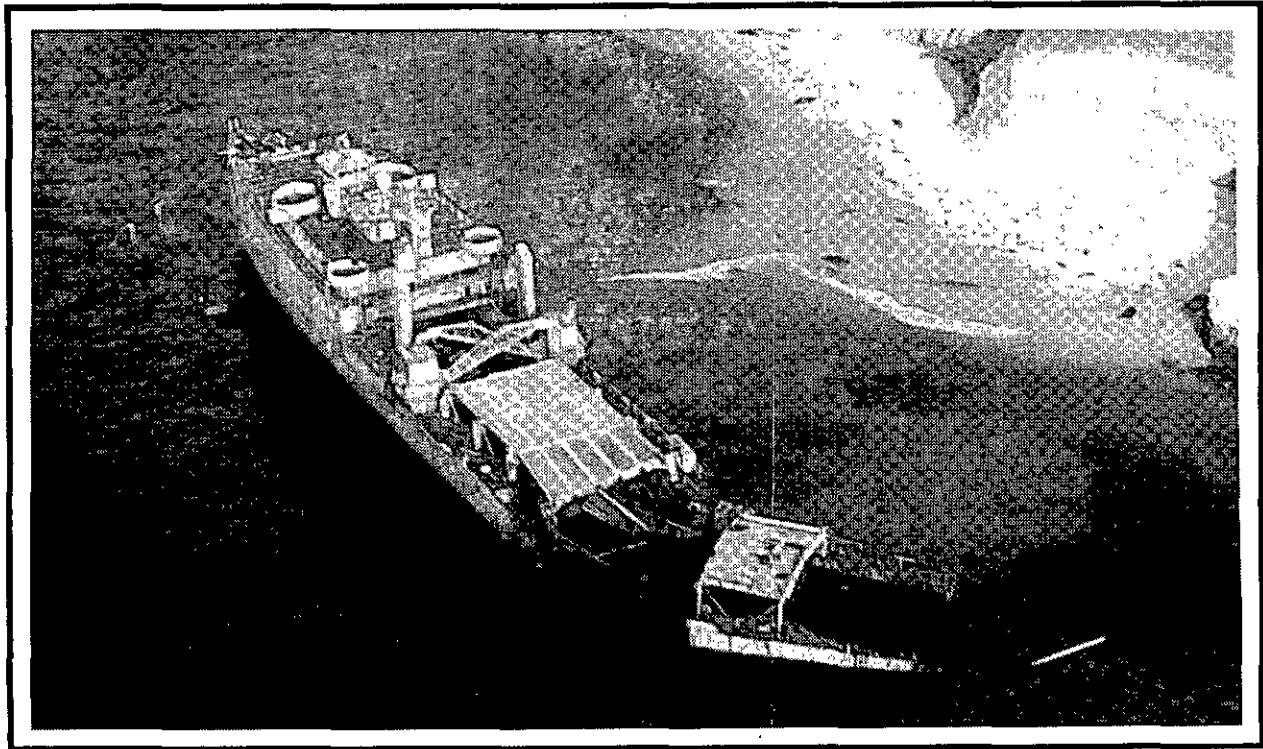
FIGURE 5-1. Two Views of TORTUGA as Originally Stranded on San Miguel Island.

Actual Condition of TORTUGA. At the conclusion of the survey, it was believed that TORTUGA was impaled in several places on a jagged rock bottom; however, once the operation got underway, the vessel was discovered to be significantly impaled only by one large boulder in the starboard auxiliary machinery room, and was otherwise resting on a sand-covered rock ledge. The numerous holes in the bottom shell plating may have been caused for the most part by this single boulder. Survey results had also suggested that the hull plating was cracked extensively around Frame 41, but no evidence of actual hull cracking that would have threatened the structural integrity of the hull girder was found during the removal effort; i.e., all hull damage was local in nature. Figures 5-1 through 5-5 show actual conditions of the stranded TORTUGA.

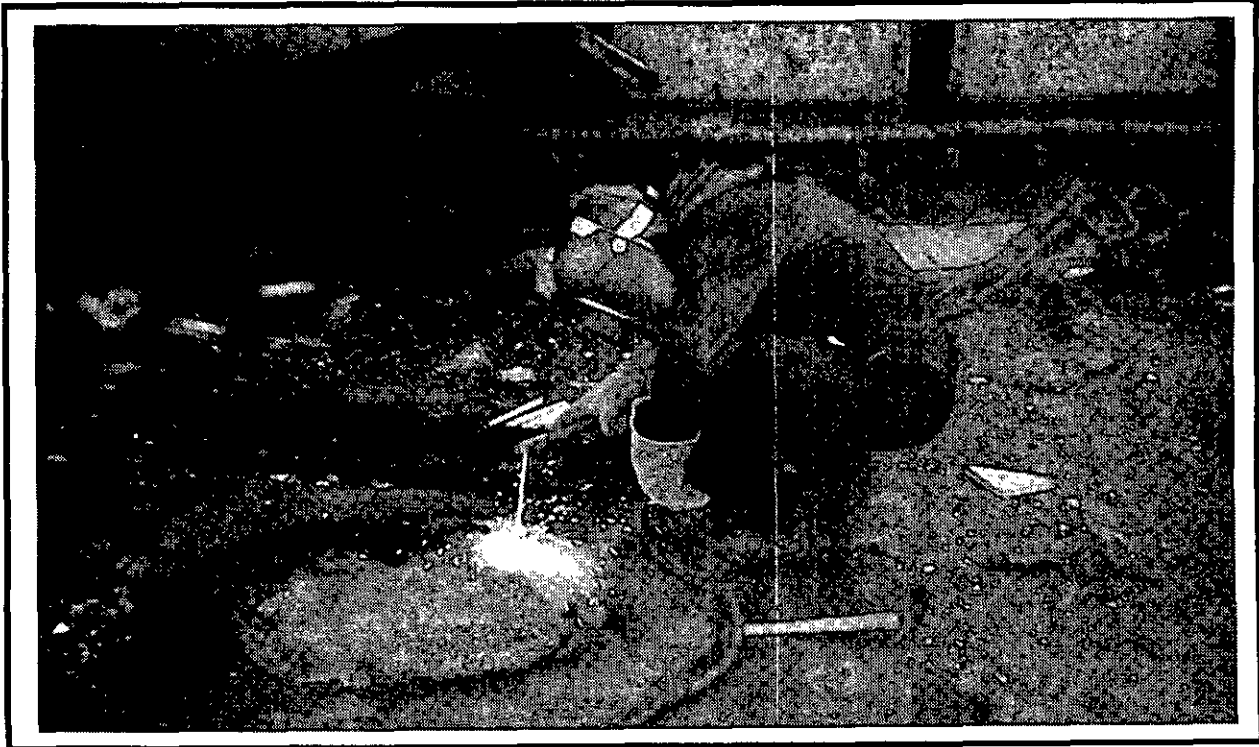
FIGURE 5-17. Welding Close Tank Tops.

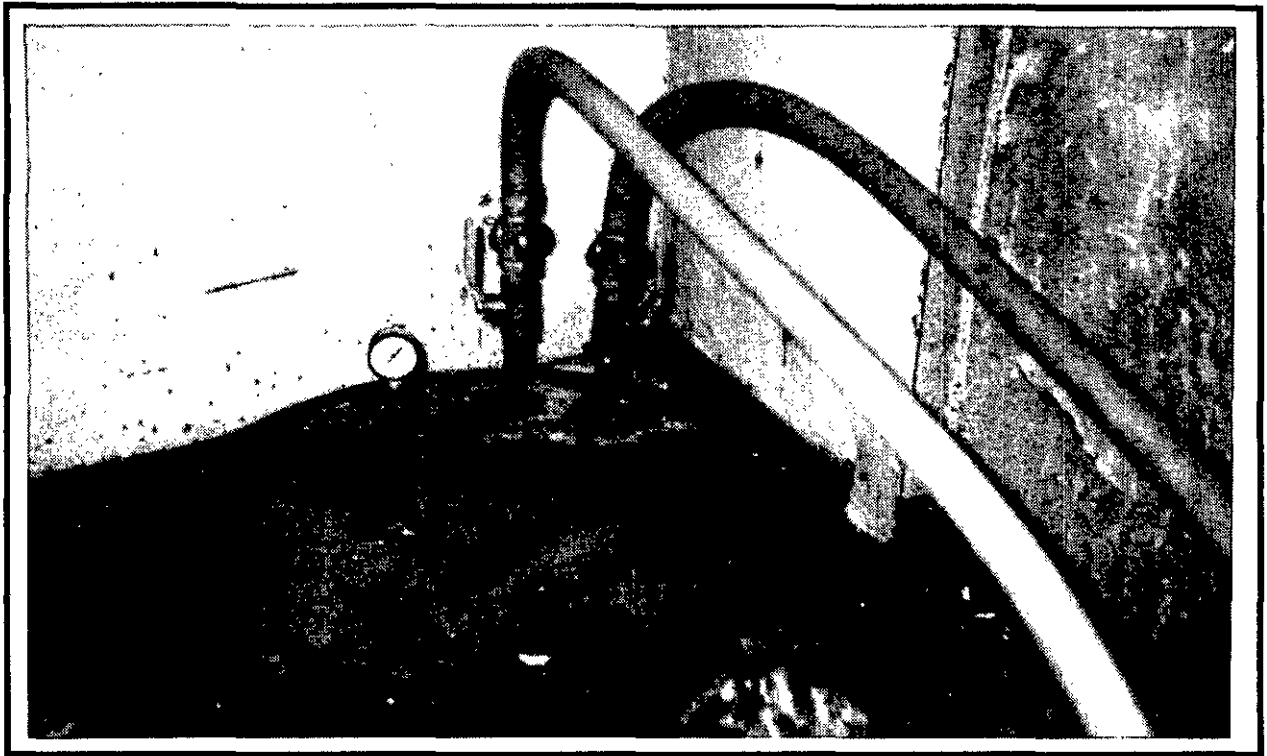
FIGURE 5-18. Tank Top Sealed with Hose Connections to the Manifold.

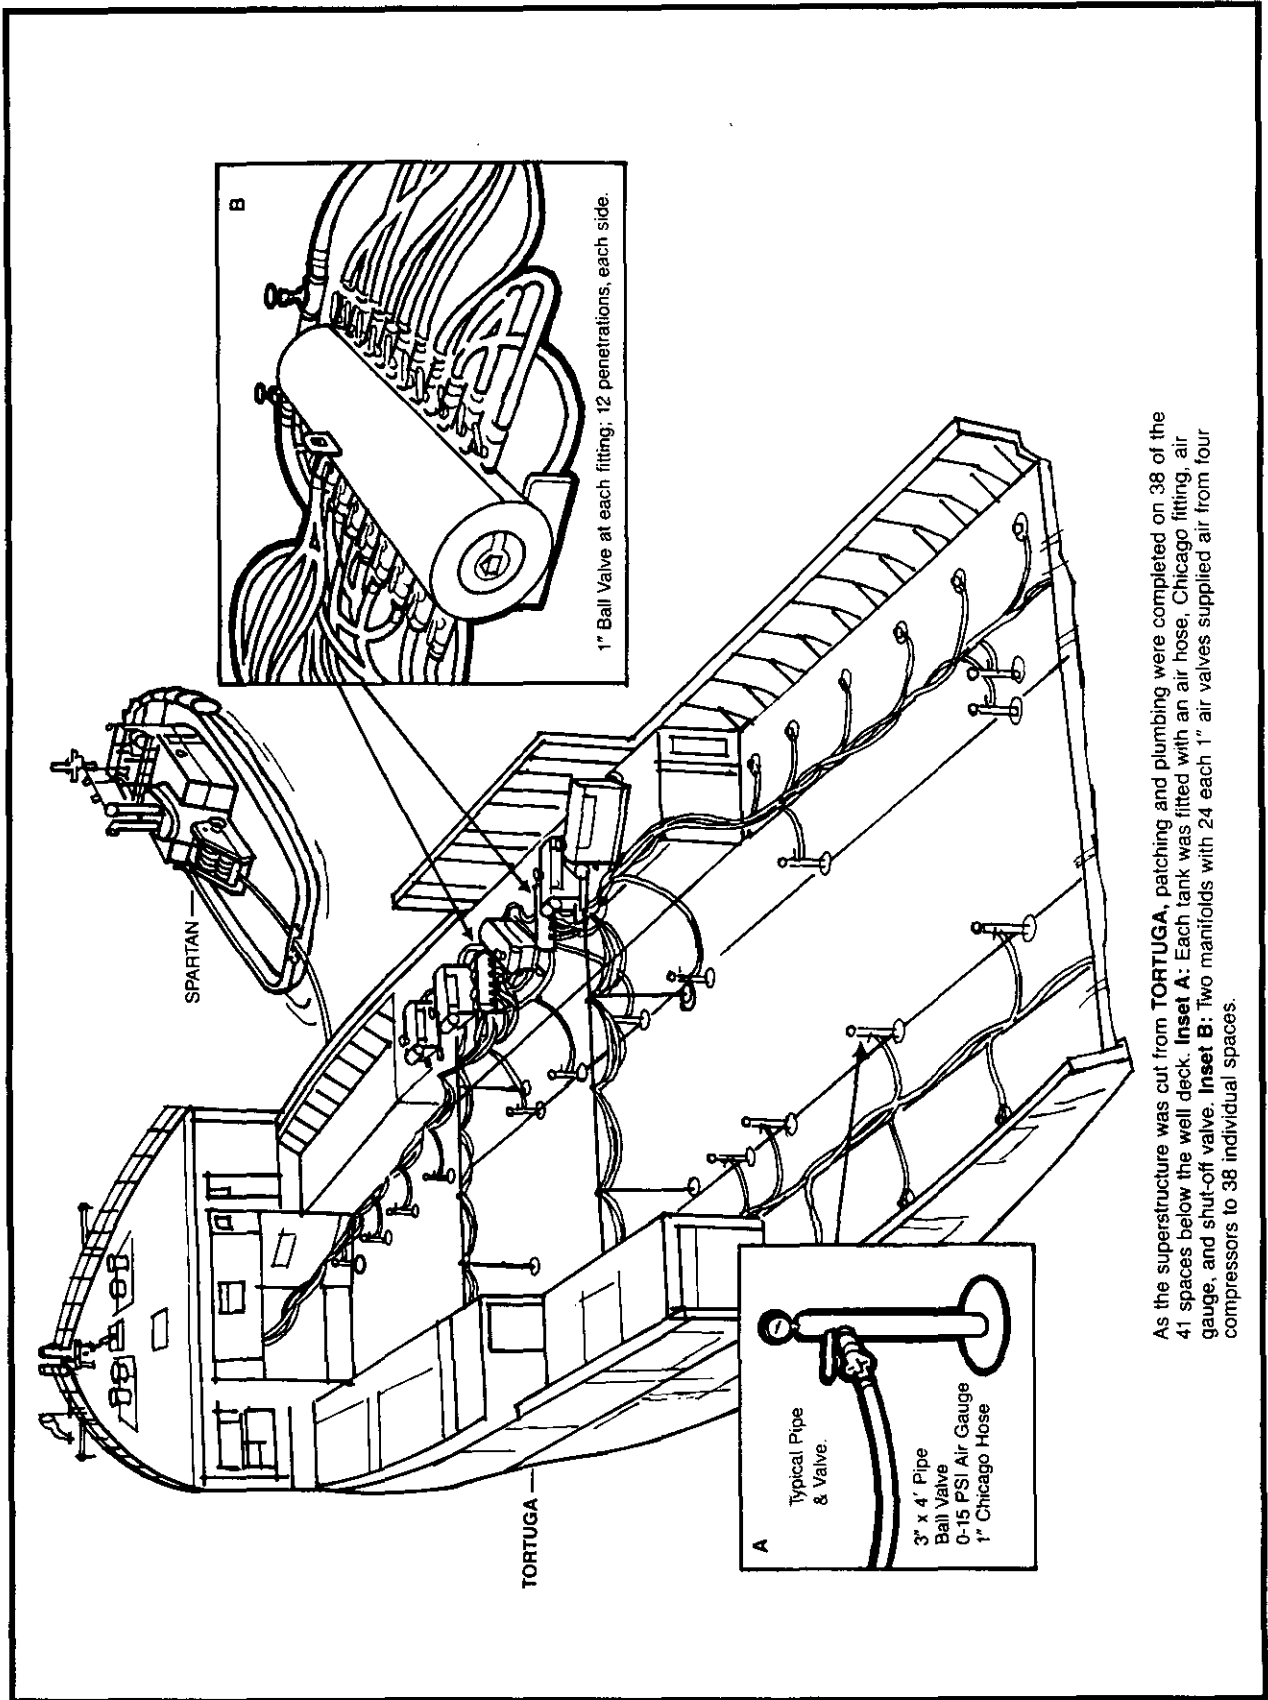
FIGURE 5-20. Plumbing of Spaces Below the Well Deck.

As the superstructure was cut from **TORTUGA**, patching and plumbing were completed on 38 of the 41 spaces below the well deck. **Inset A:** Each tank was fitted with an air hose, Chicago fitting, air gauge, and shut-off valve. **Inset B:** Two manifolds with 24 each 1" air valves supplied air from four compressors to 38 individual spaces.
