FORREST SHERMAN

DD 931

MAY 17, 2010

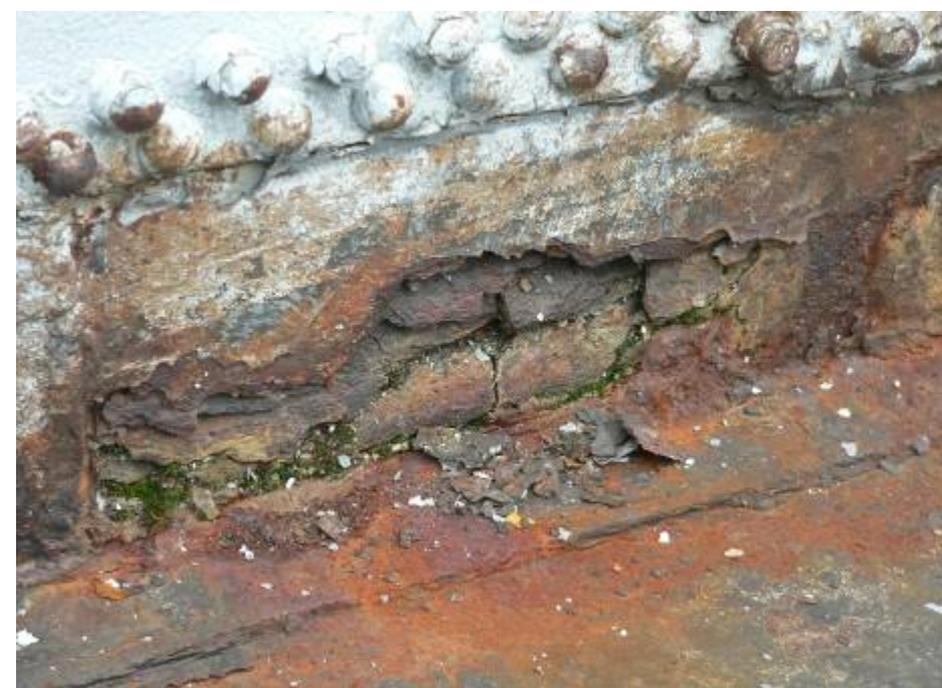
base of superstructure corrosion

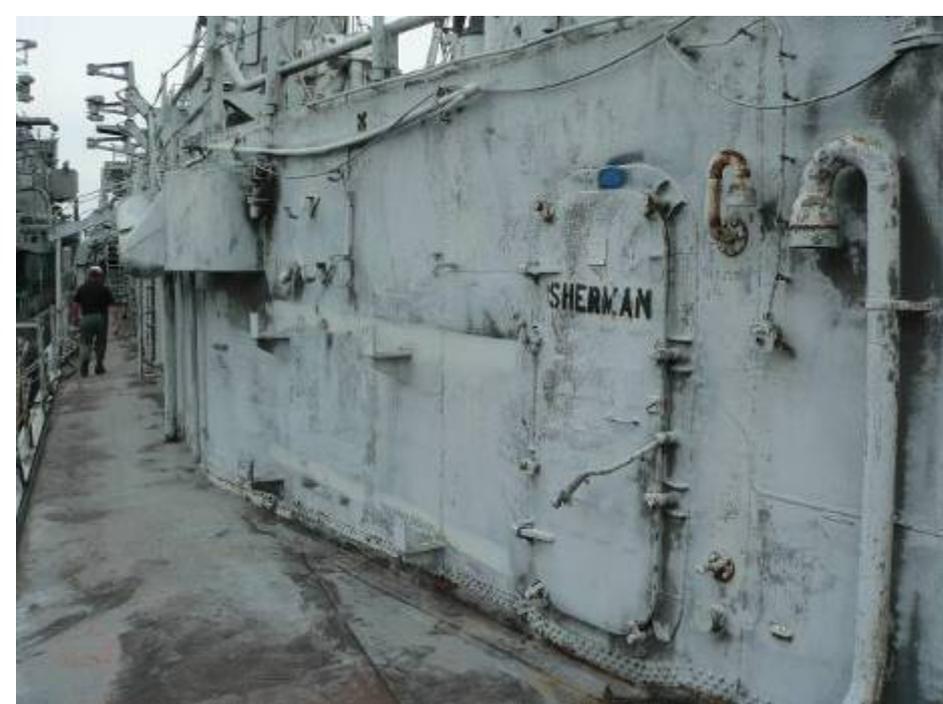
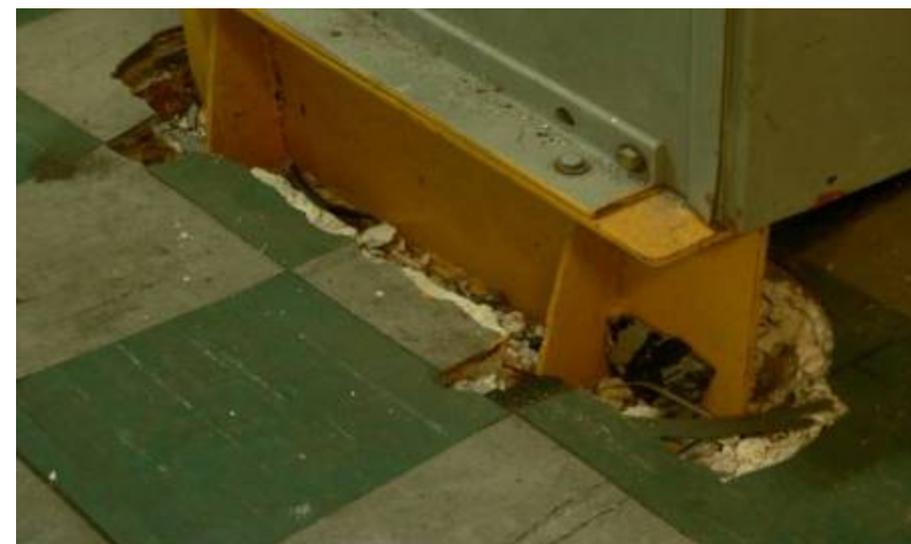
admin space deck damage

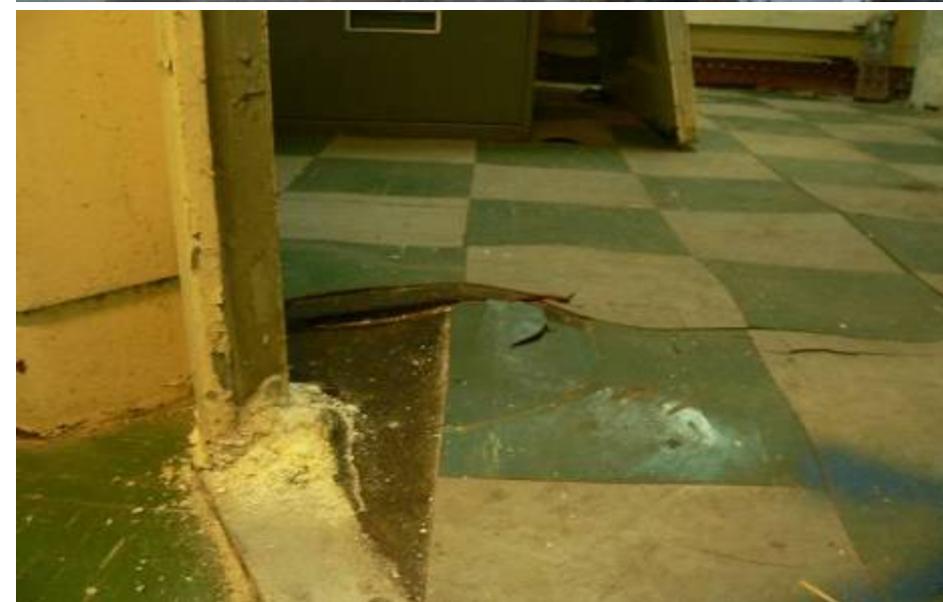
admin space deck buckling

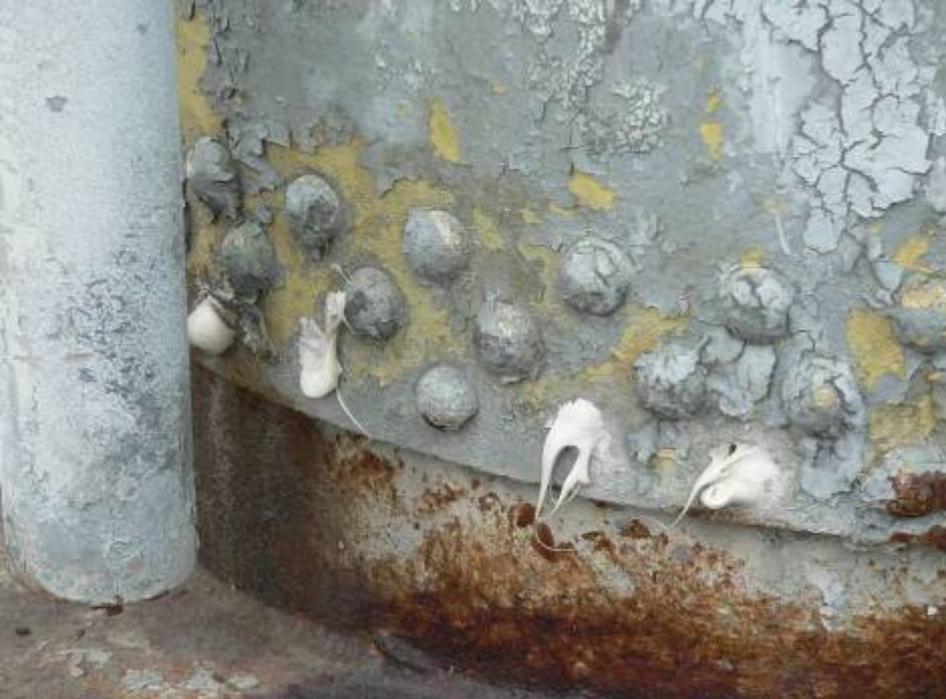
base of superstructure starboard side

base of superstructure missing rivet heads

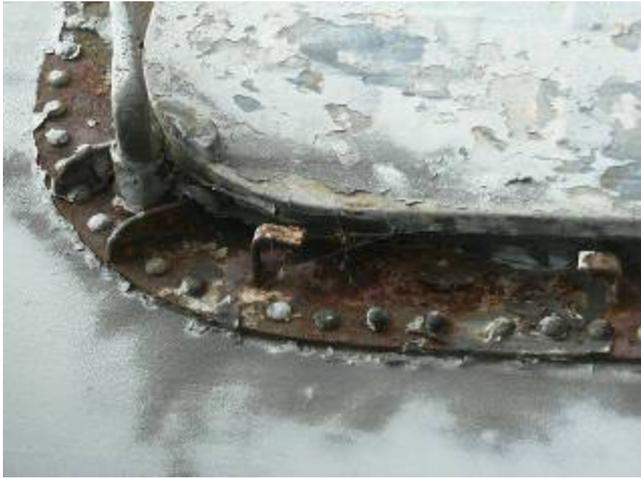
close up watertight door
corrosion

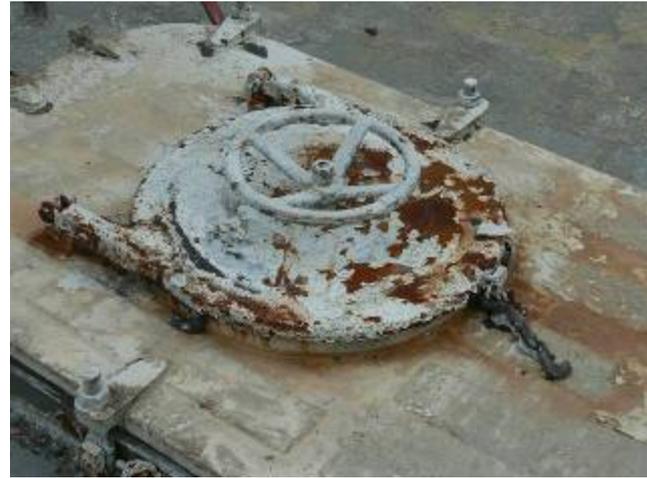
corroded hatch aft deck by
stern

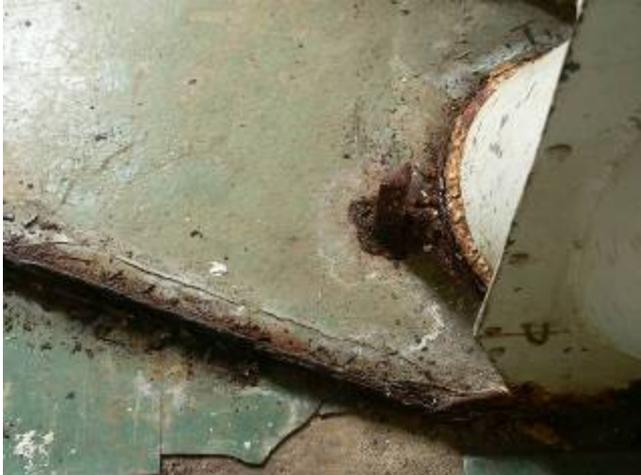
corrosion

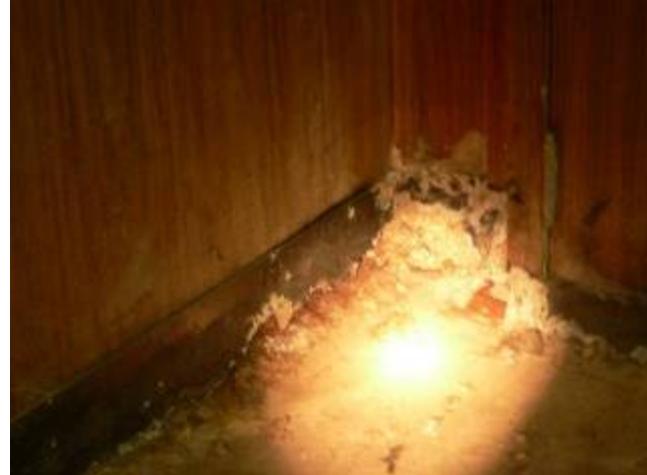
corrosion

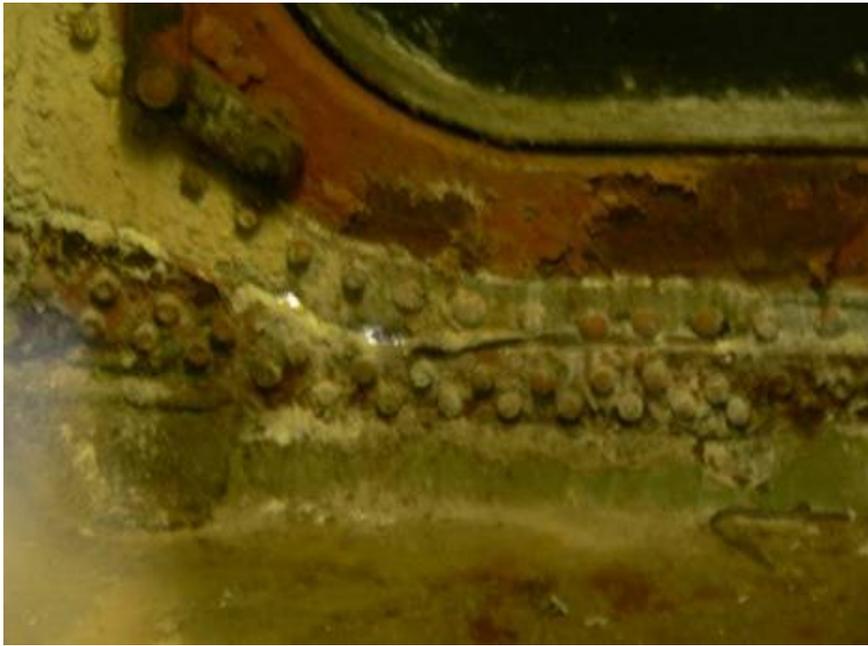
corrosion around watertight door

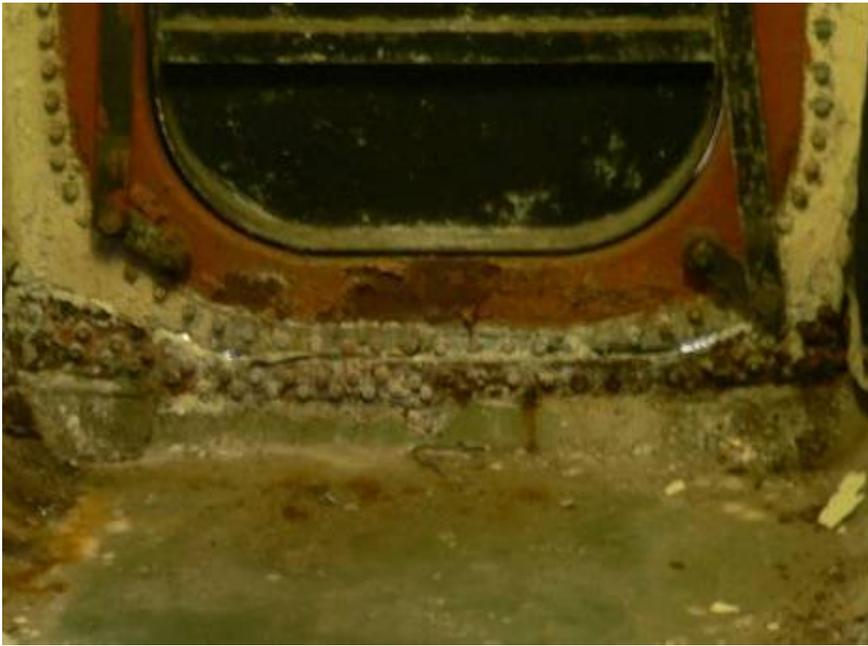
corrosion around watertight door

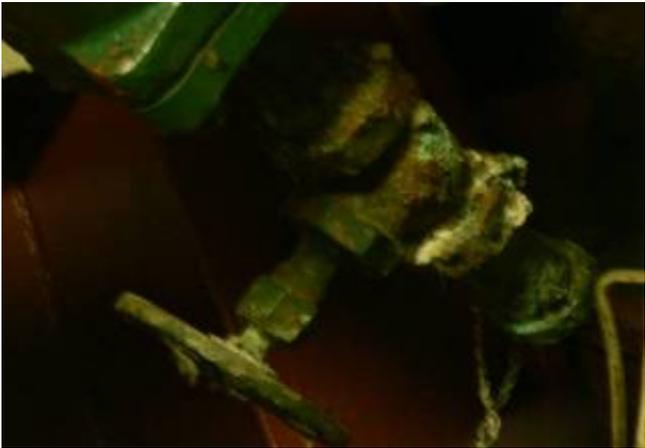
corrosion on cooling system piping

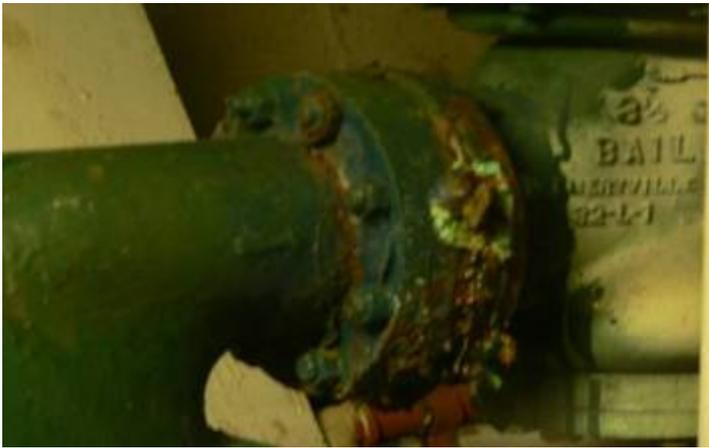
corrosion on cooling system piping

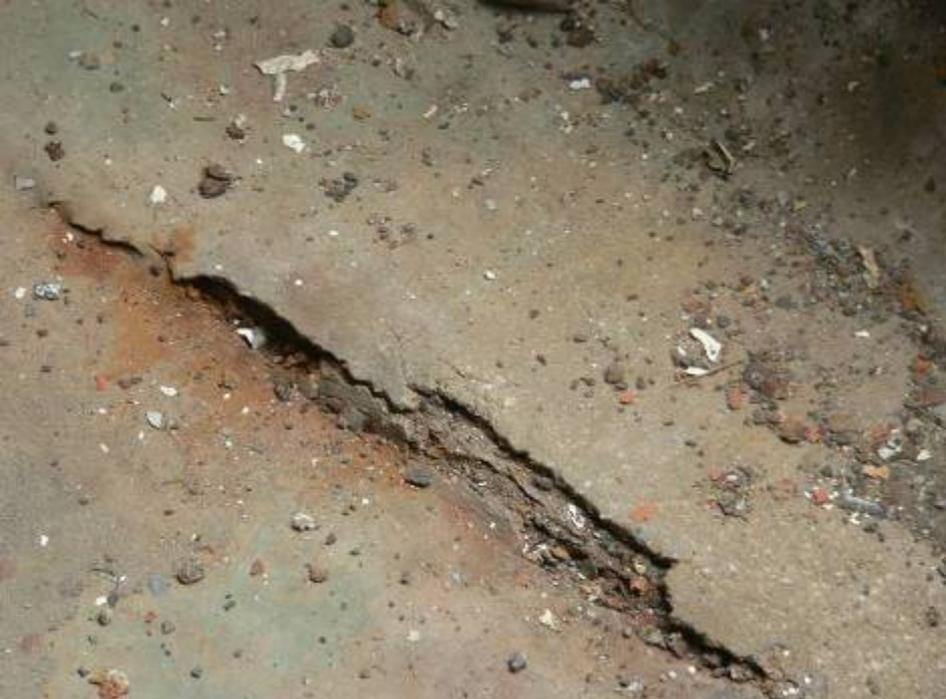
deck corrosion

deck lifting

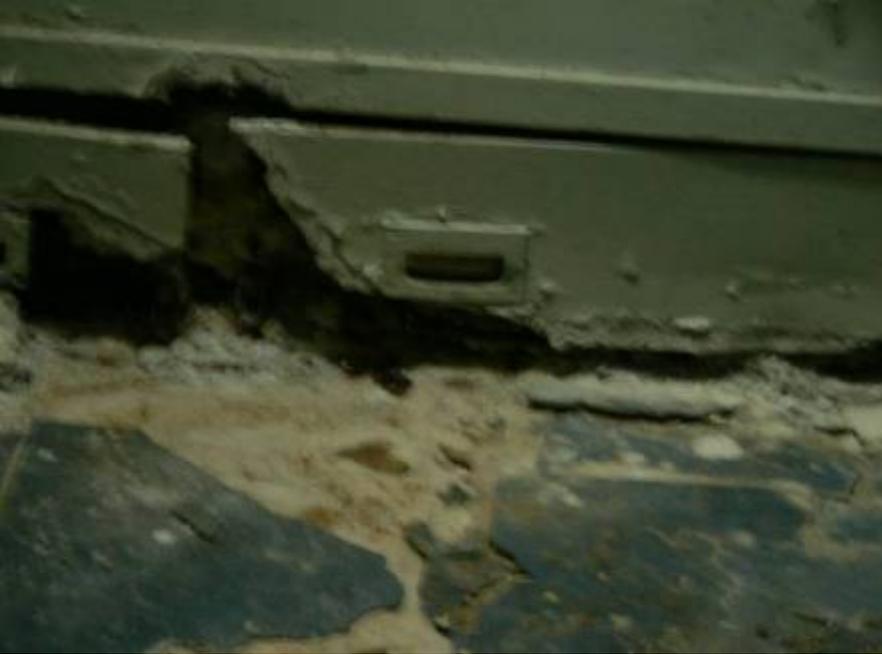
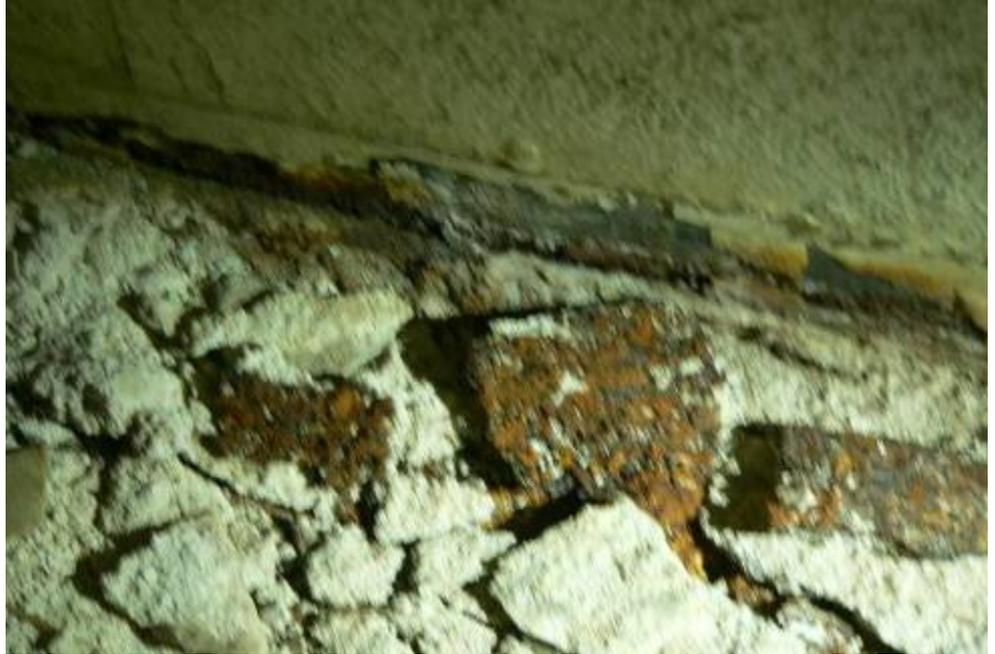
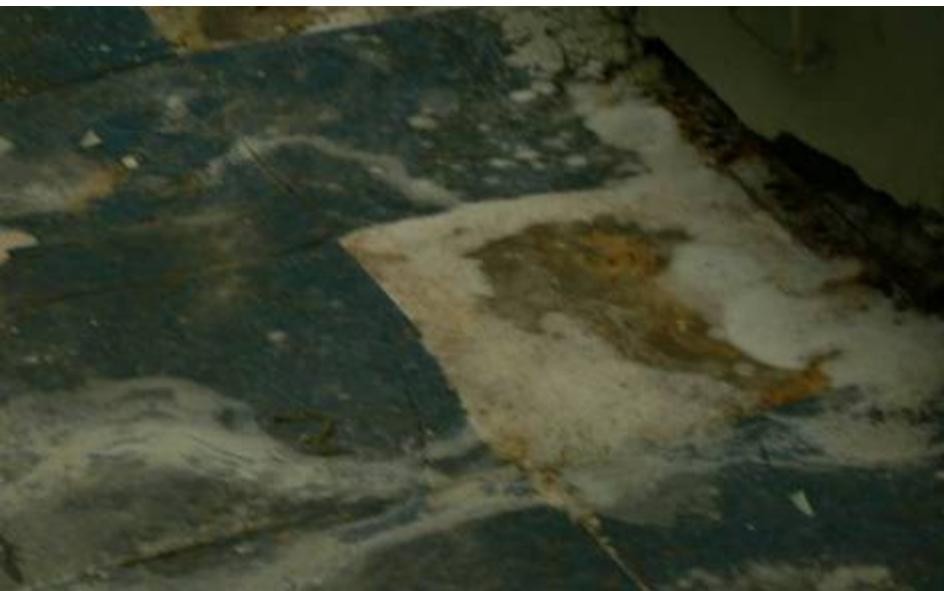
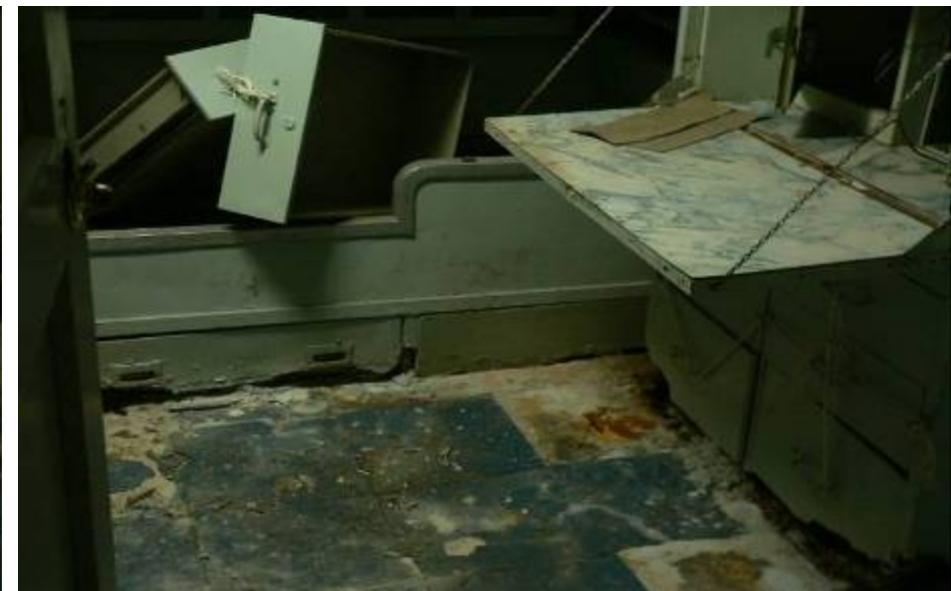
dissimilar metal corrosion stateroom

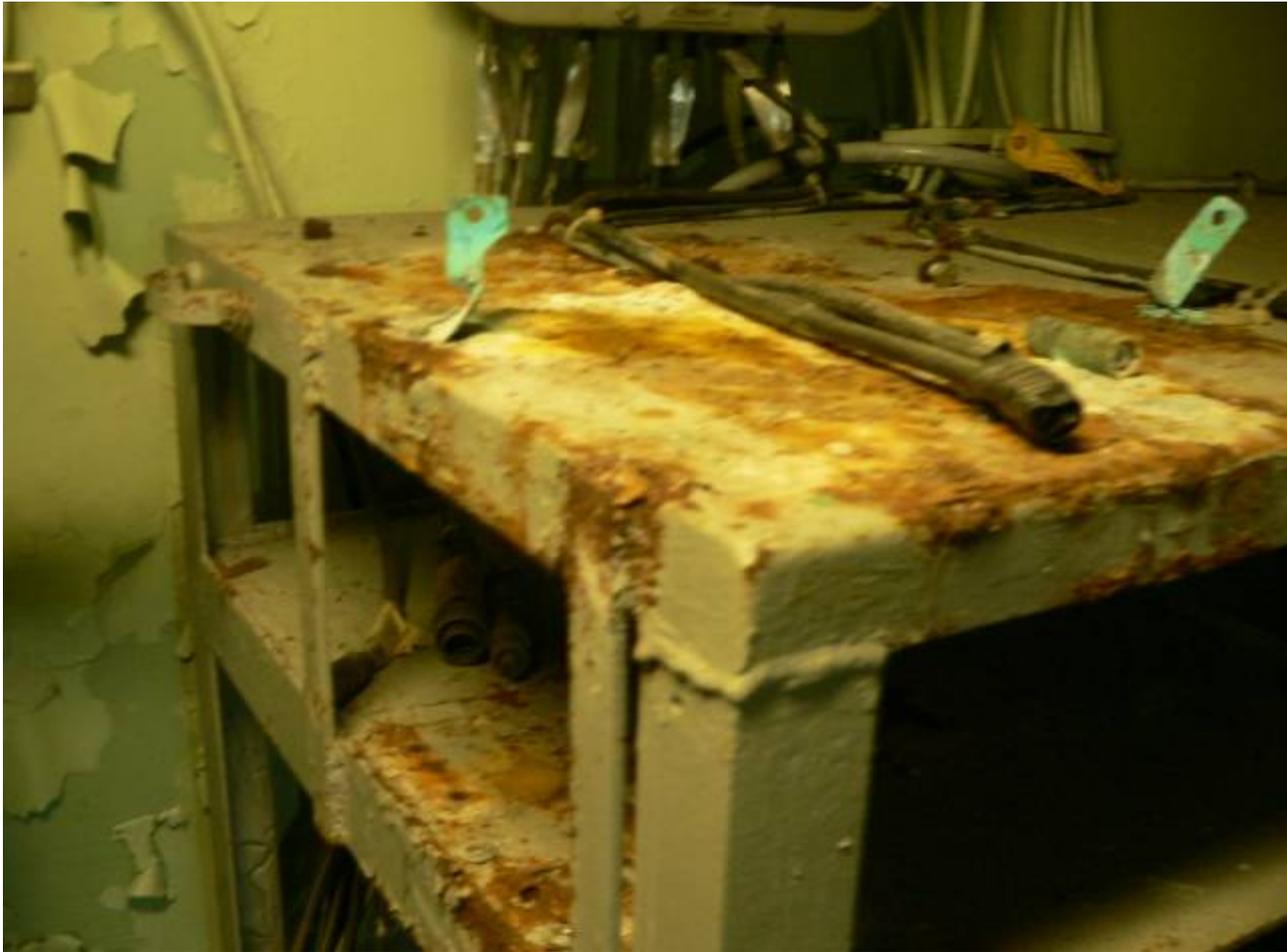
metal corrosion

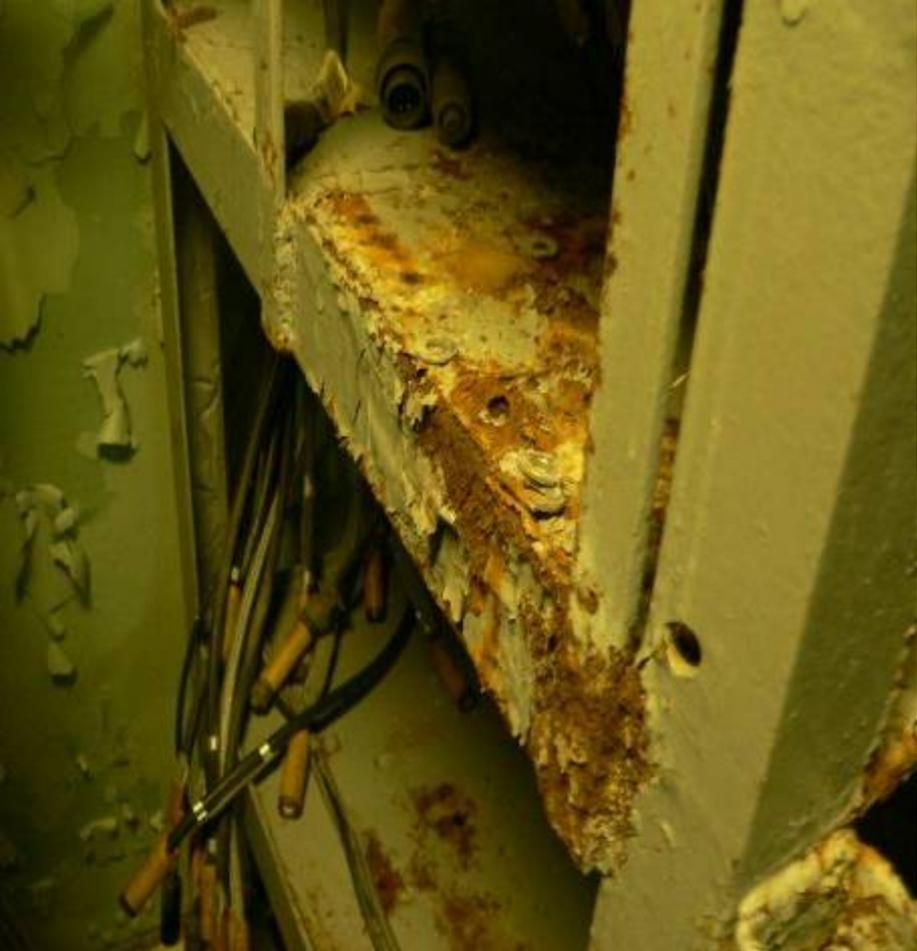
metal corrosion

oil leak overhead on mess deck

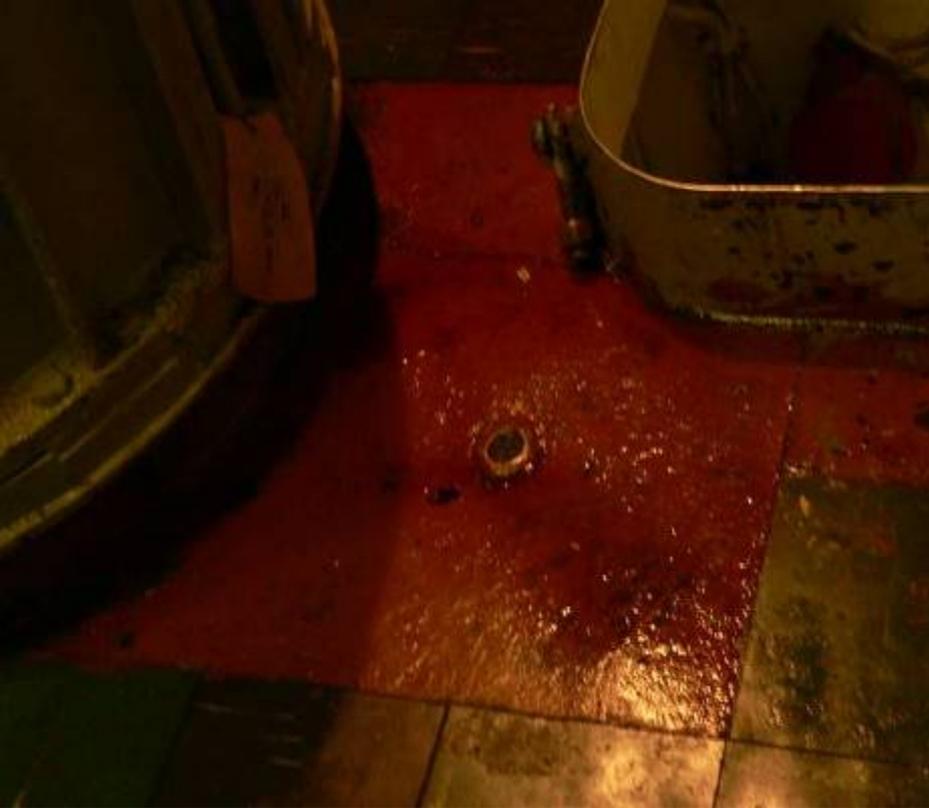
oil on deck leaking from anchor
windlass

oil on deck from anchor windlass

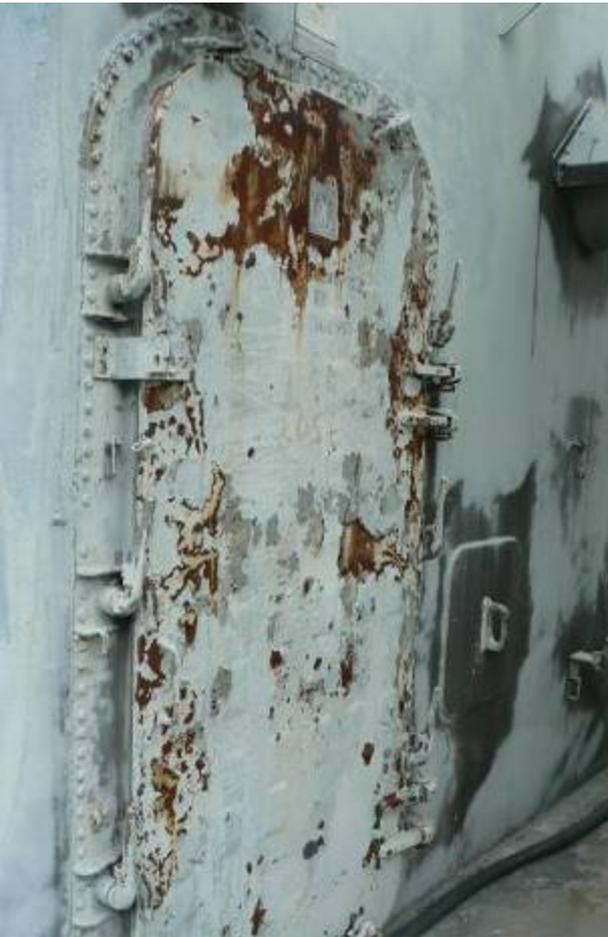
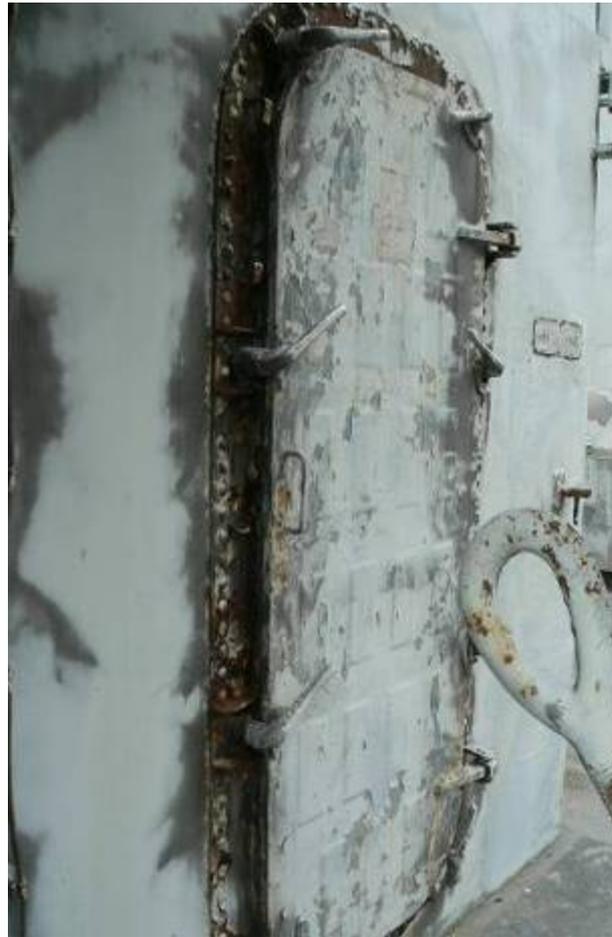
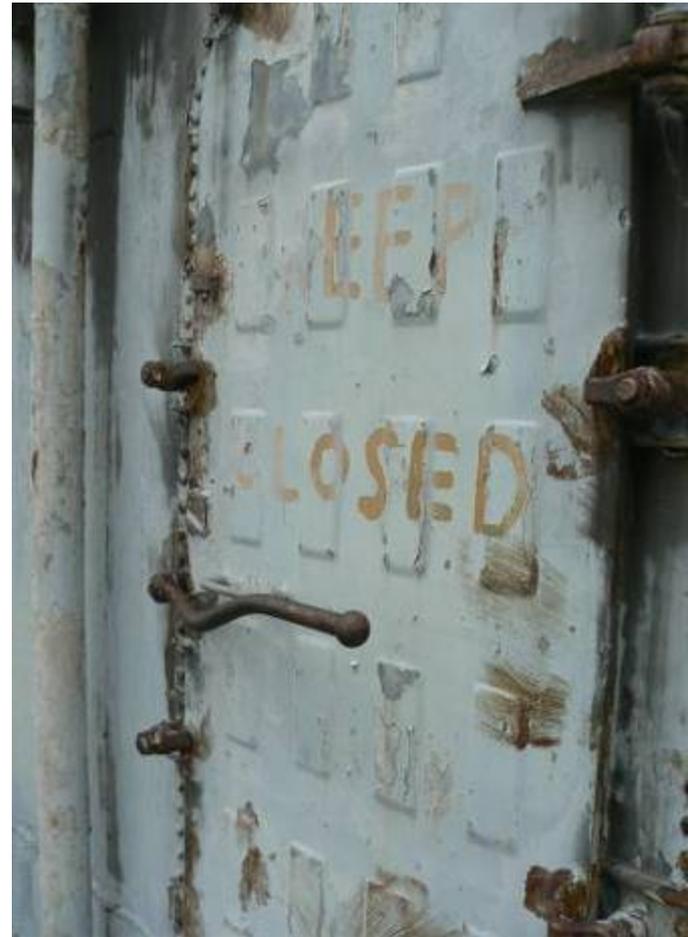
water tight door corrosion

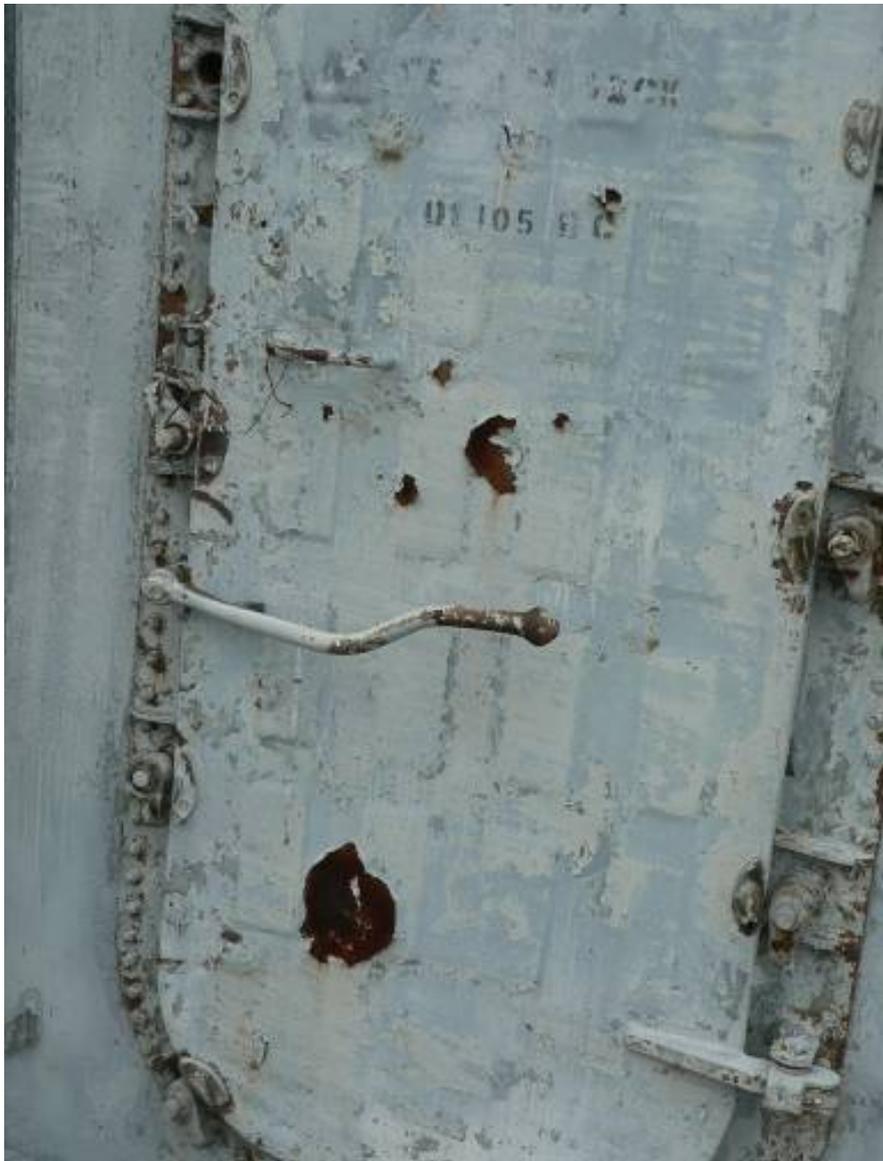
watertight hatch missing dogs

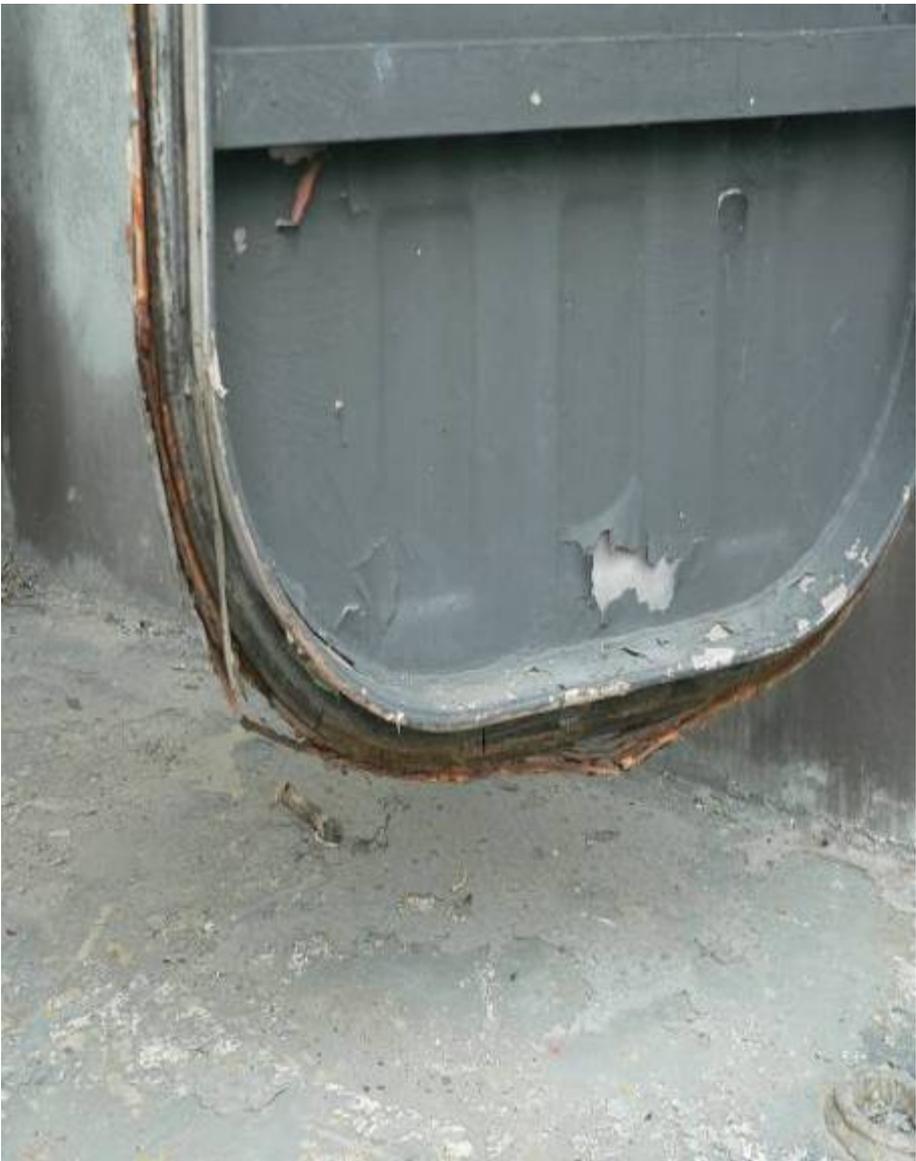
watertight hatch corrosion
