CAD/PAD International Logistics Meeting (ILM)

USN and USMC CAD/PAD MIST/EI/CODR

- 11 June 2019 -

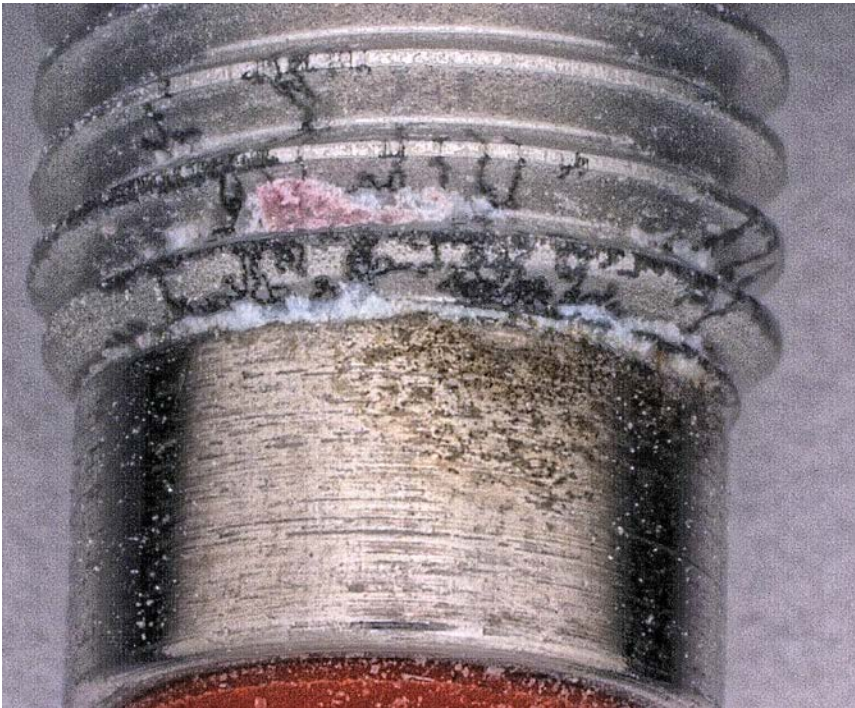
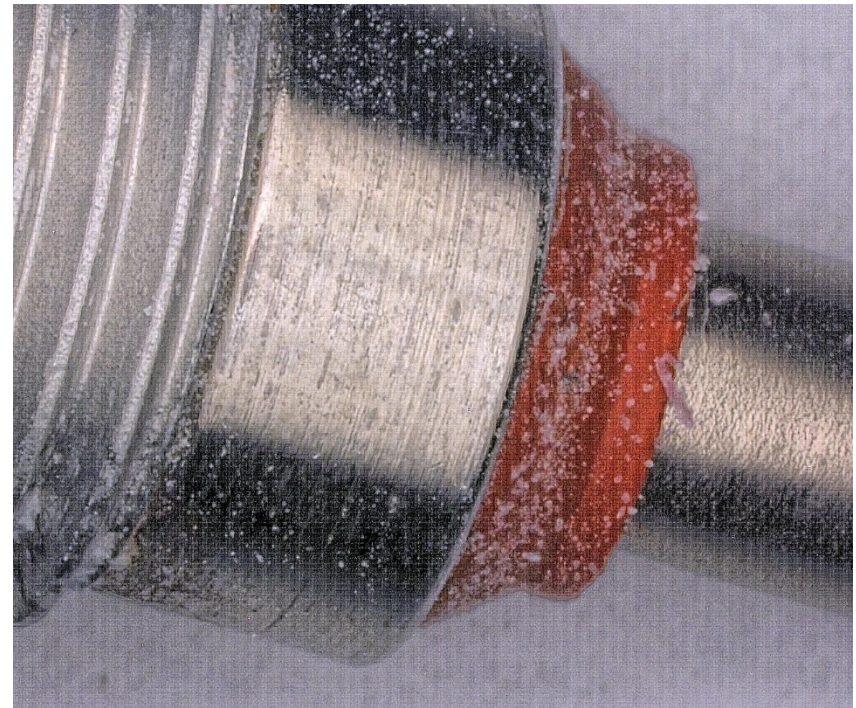
- Open:
 - T-6 SMDC: Corrosion, Seized JL50 to acceptor. At the lab having the corrosion analyzed

- Open:
 - T-6 SMDC: Corrosion, Seized JL50 to acceptor continued
 - Lab Analysis:
 - Clear, crystalline-like particles
 - Elements detected from the particles are aluminum and chlorine, silicon, carbon and oxygen
 - Near the thread, grease like material was found
 - More testing of the elements found needed

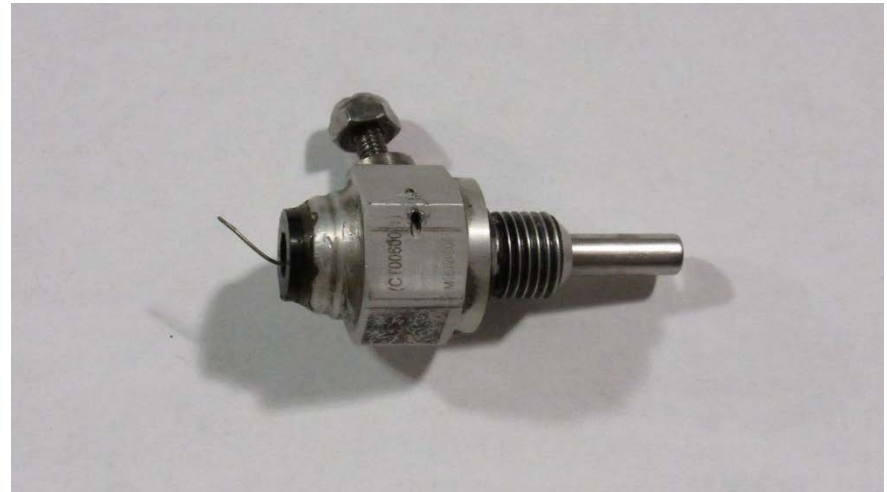
- Open:
 - WB53 H-60 Fire Extinguisher Cartridge x 2: Broken electrical connector. Item has been shipped to Naval Surface Warfare Center Indian Head Explosive Ordnance Disposal Technology Division (NSWC IHEODTD)
 - WB53 H-60 Fire Extinguisher Cartridge: Broken electrical connector. Received with no post/connecting point

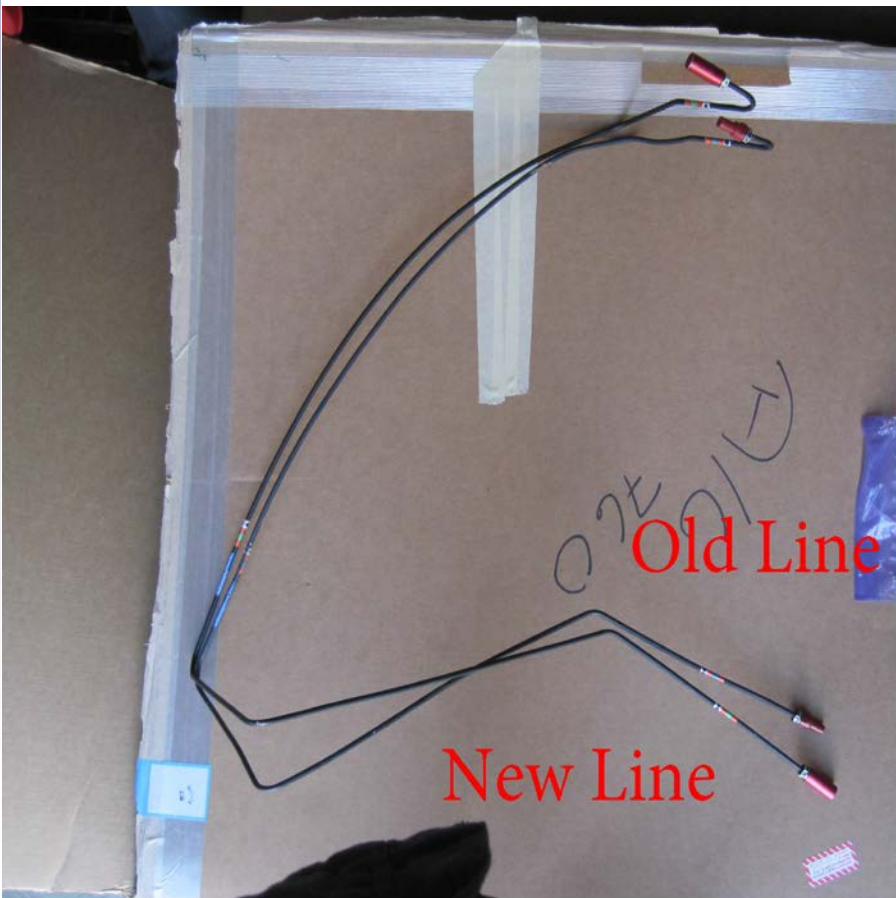
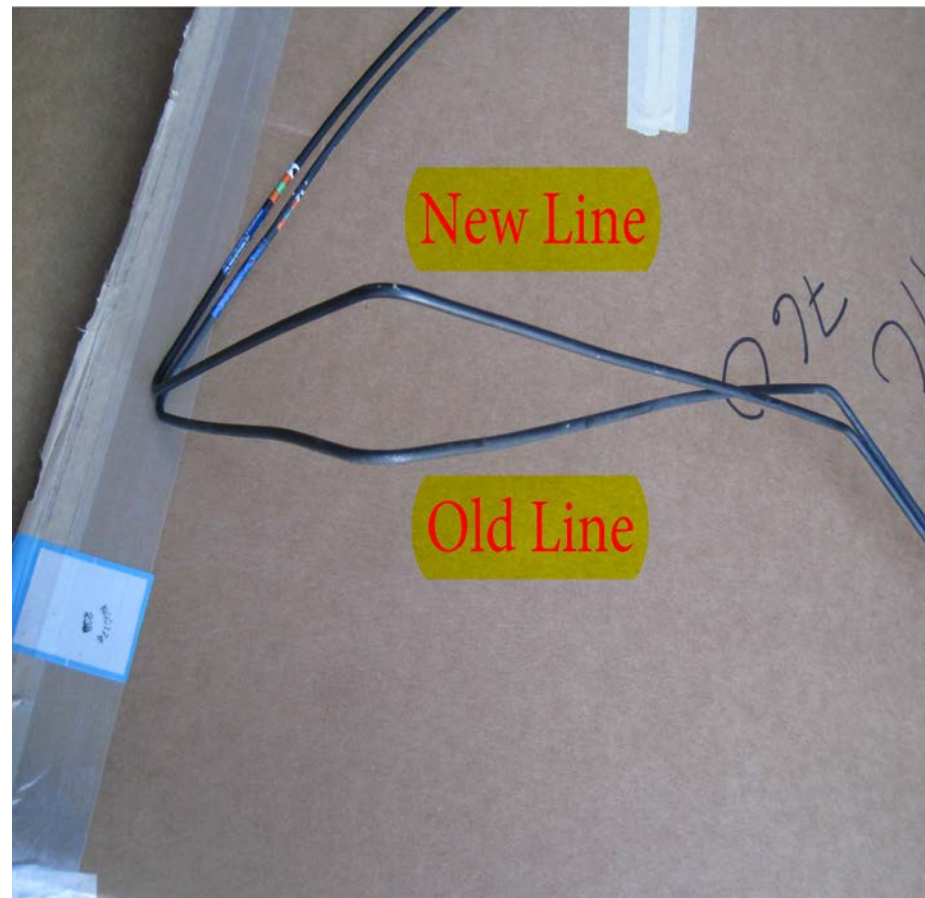
AH-1Z bent SMDC lines

- Open (con't):
 - AH-1Z SMDC x4: Bent SMDC line from manufacturer. On-site engineering investigation conducted
 - Four different SMDC lines from the same command all had incorrect bends upon initial install
 - All four devices shipped to NSWC IHEODTD for additional investigation
 - JL50 T-6 SMDC: Bent SMDC line from manufacturer. Received, looking through stock for matching bends
 - JM61 CH-53 Fire Extinguisher Cartridge: Broken Electrical Connector. Newly designed cartridge broken on initial install. Awaiting shipment of device

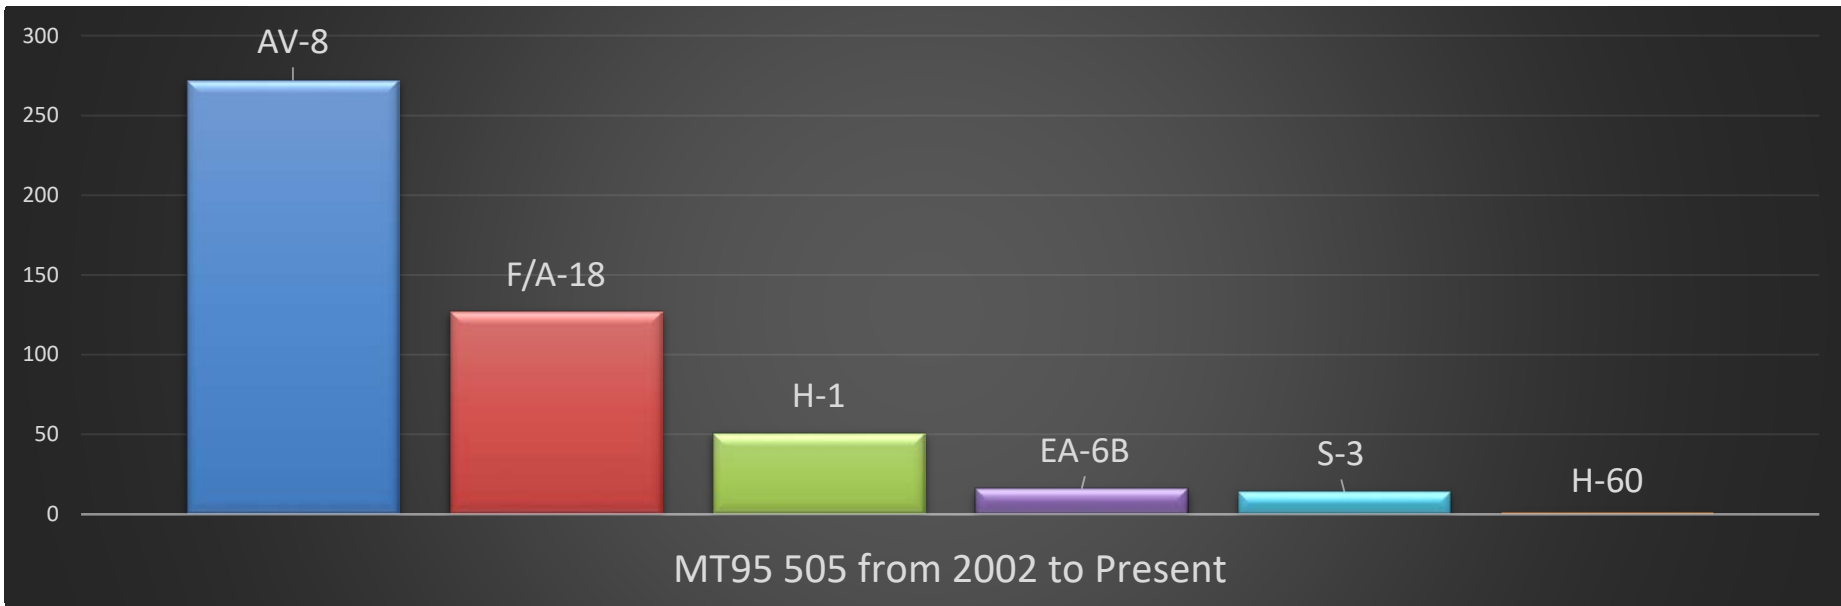
- Open (con't):
 - As seen in the graph, the AV-8 makes up 54% of the total CODRs for the MT95 with 272 dating back to 2002. The F/A-18 comes in second with 127 MT95 CODRs. Since January of 2016, there were 150 MT95 CODRs with 131 of them, 87% originating from the AV-8 platform. Out of those CODRs, 102 or 78% were associated with the BRU-70 or Digital Improved Triple Ejector Rack system

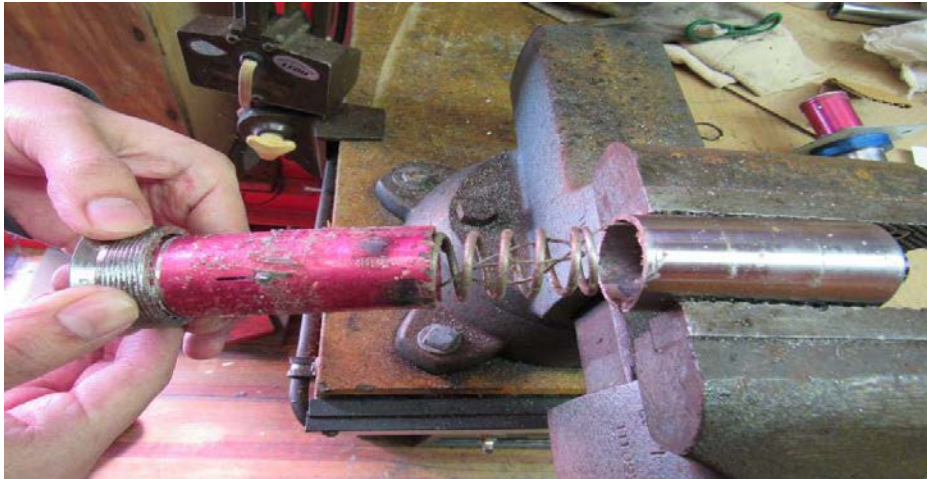
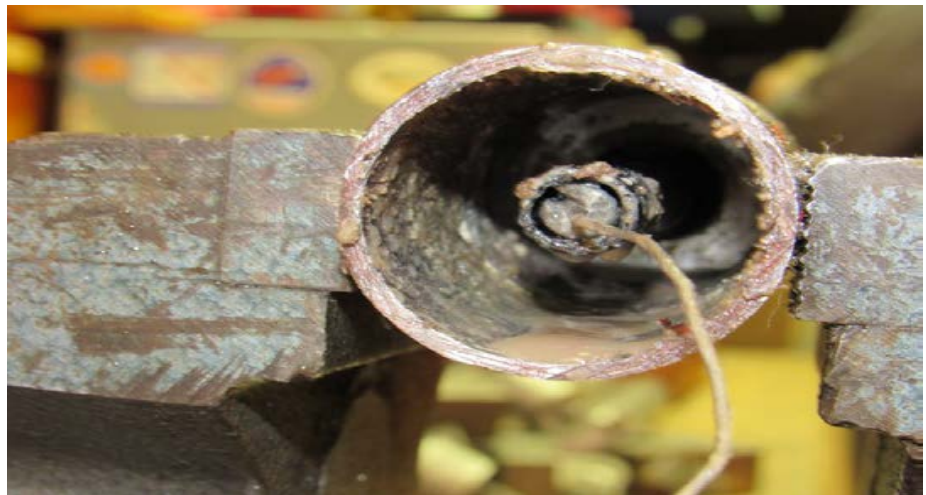
- Testing:
 - The center housing was cut off of the seized initiator to find root cause
 - After the handle was easily extracted, we observed:
 - Moisture intrusion
 - Over greasing
 - Dirt
 - Severe corrosion
 - Swollen O-rings

- External Initiator Opened:

- External Initiator Test:
 - Pull test was conducted
 - One initiator was recorded at 37 in-lb, and the other at 34 in-lb
 - Inspection of the lanyards and firing pins showed that no moisture was getting into the firing pin assembly and the lanyard was not damaged
- External Initiator Solution:
 - Travel to Tooele Army Munitions Depot to conduct inspection of stock
 - Return initiators to NSWC IHEODTD after passing preliminary inspection

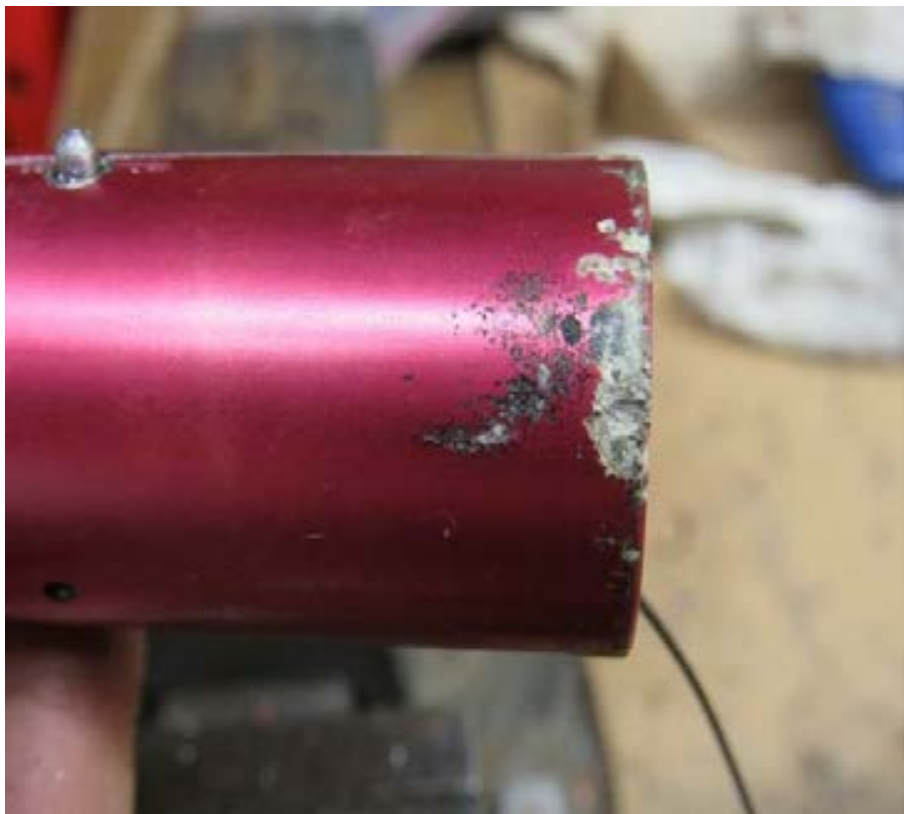
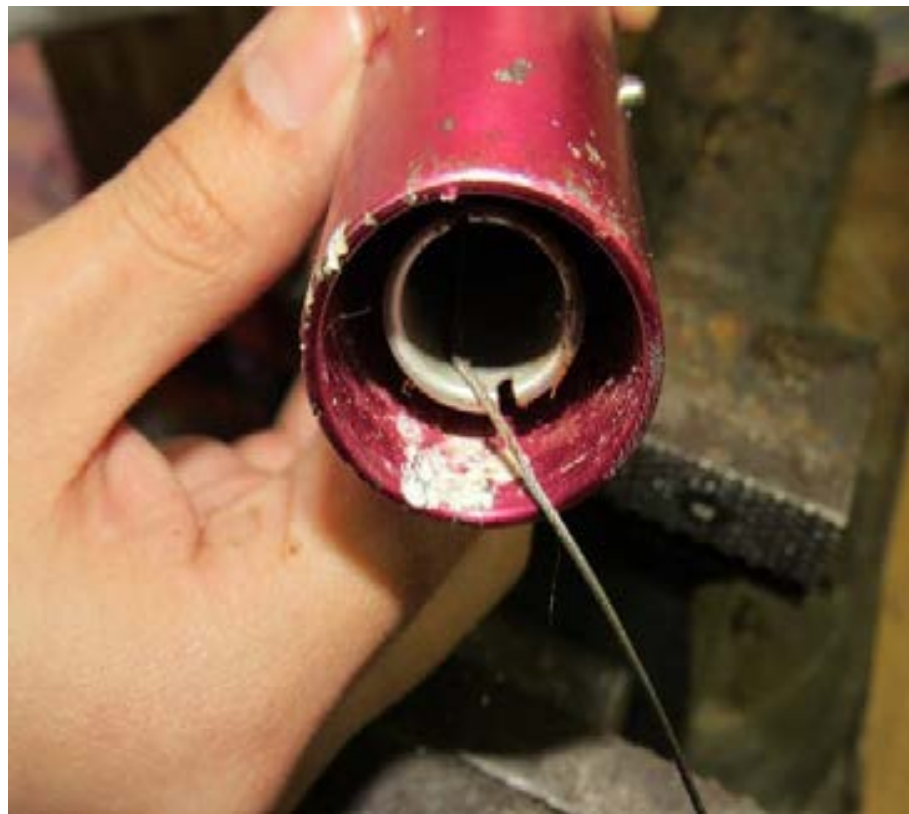
- External Initiator Opened:
 - After cleaning, the corrosion was much more prominent
