INDIAN HEAD EXPLOSIVE ORDNANCE DISPOSAL TECHNOLOGY DIVISION

**Expired PDRM/WB15s left out in fleet;
incident and preventive measures**

06/27/2018

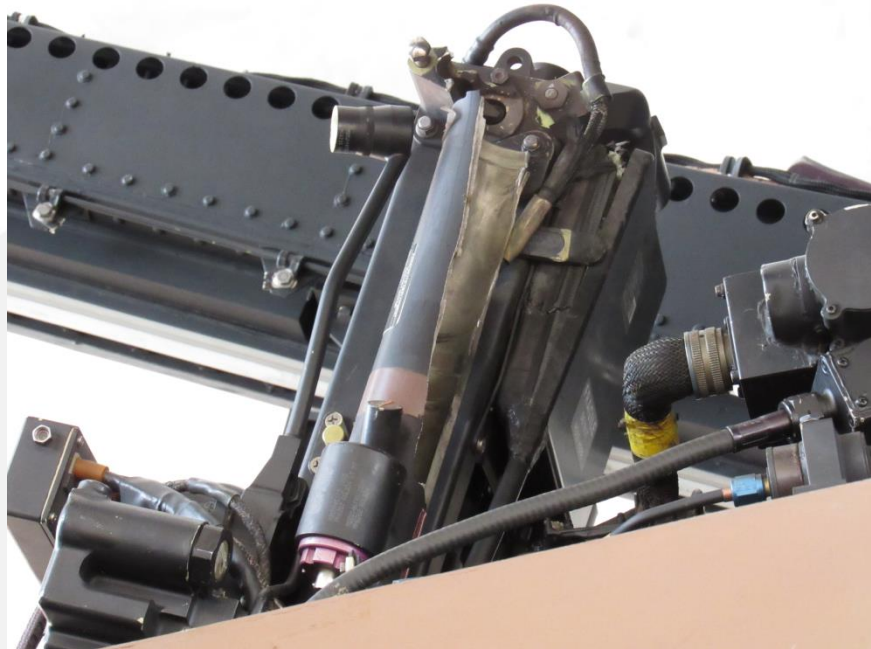
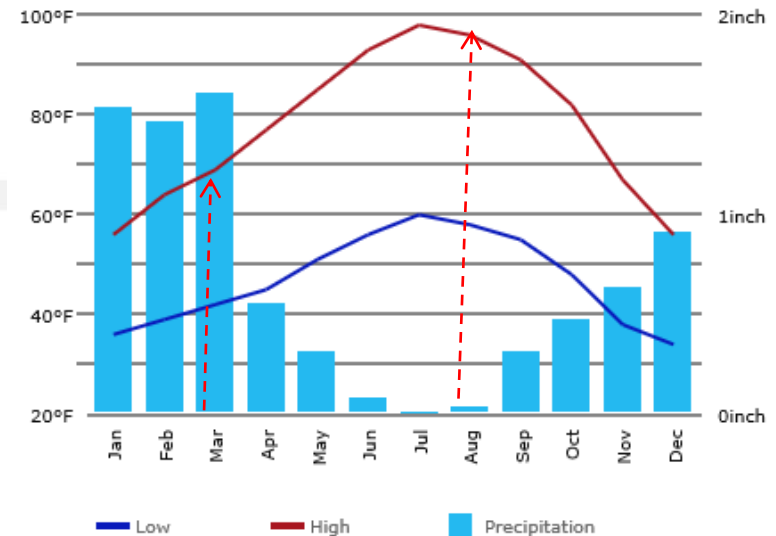
An F/A-18F Rear Seat PDRM self-initiated while parked on ramp at NAS Lemoore, CA

- Occurred 1 August 2017
- Ambient temperature was ~95°F at the time of incident

- Climate Data
 - Significant increase in temperature from end of install life till incident occurred

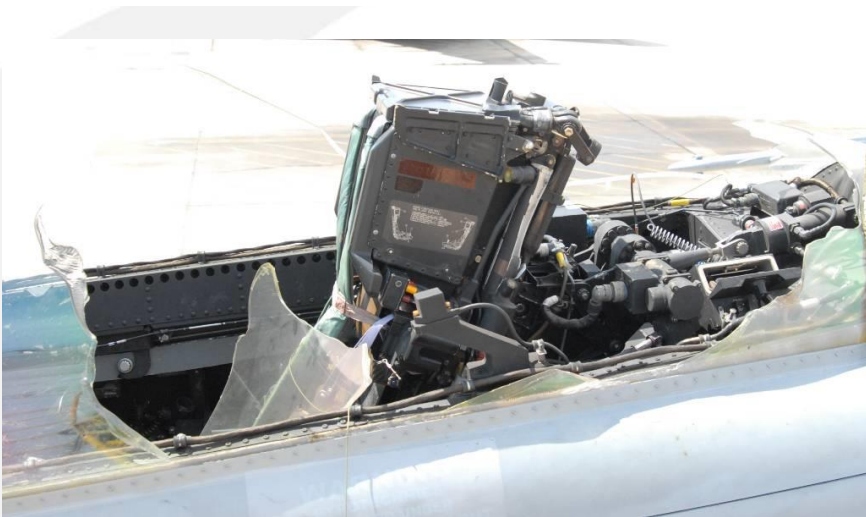
China Lake Airfield 7-5-2007

An F/A-18D Rear Seat PDRM self-initiated while parked on ramp at China Lake, CA

- Occurred 5 July 2007, 1630PST
- Aircraft Parked, tied-down with canopy closed, for approx. 4 hours
- Ambient temperature was 112°F at 1630
- Peak Temperature was 116°F earlier that day

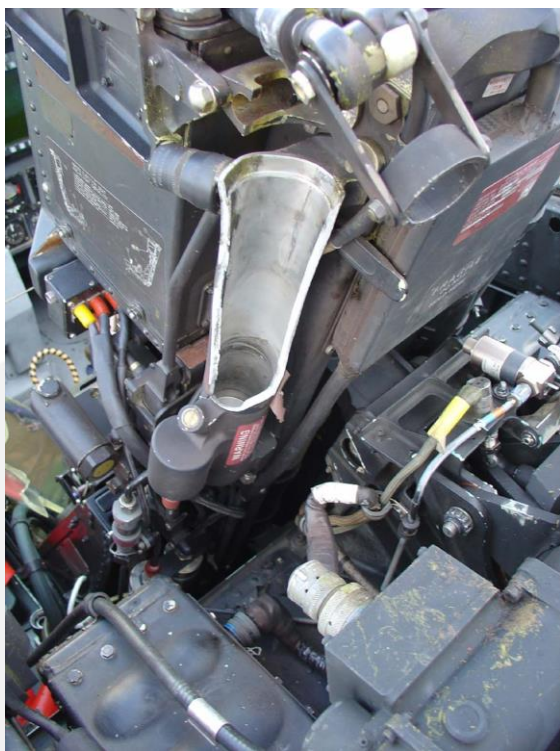
- Aluminum outer body ruptured, section separated
- Steel rocket motor case ruptured from over-pressurization
- Nozzle top cap and upper motor tube section ejected from cockpit
- Residual propellant (green) spattered onto cockpit surfaces

Ruptured PDRM Body on Ejection Seat

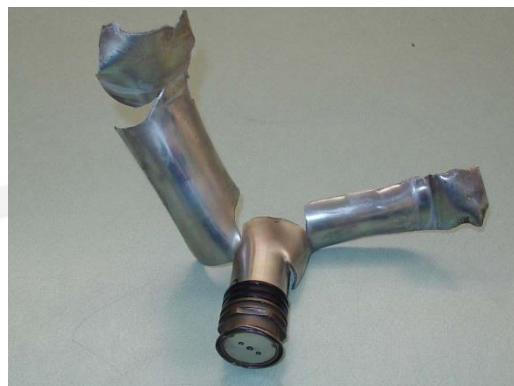
Ruptured Motor Case

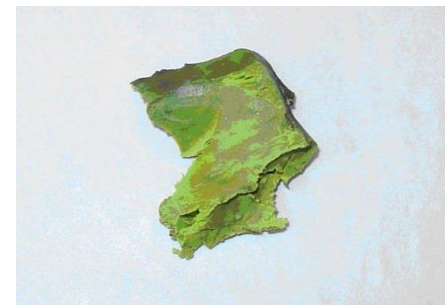
Recovered Propellant Fragment

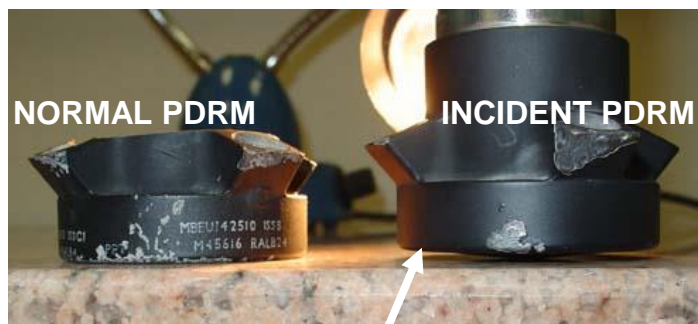
Nozzle Cap distorted .070 in. "domed"
