INDIAN HEAD EXPLOSIVE ORDNANCE DISPOSAL TECHNOLOGY DIVISION

USAF F-15/F-16/ACES II

26-27 June 2018

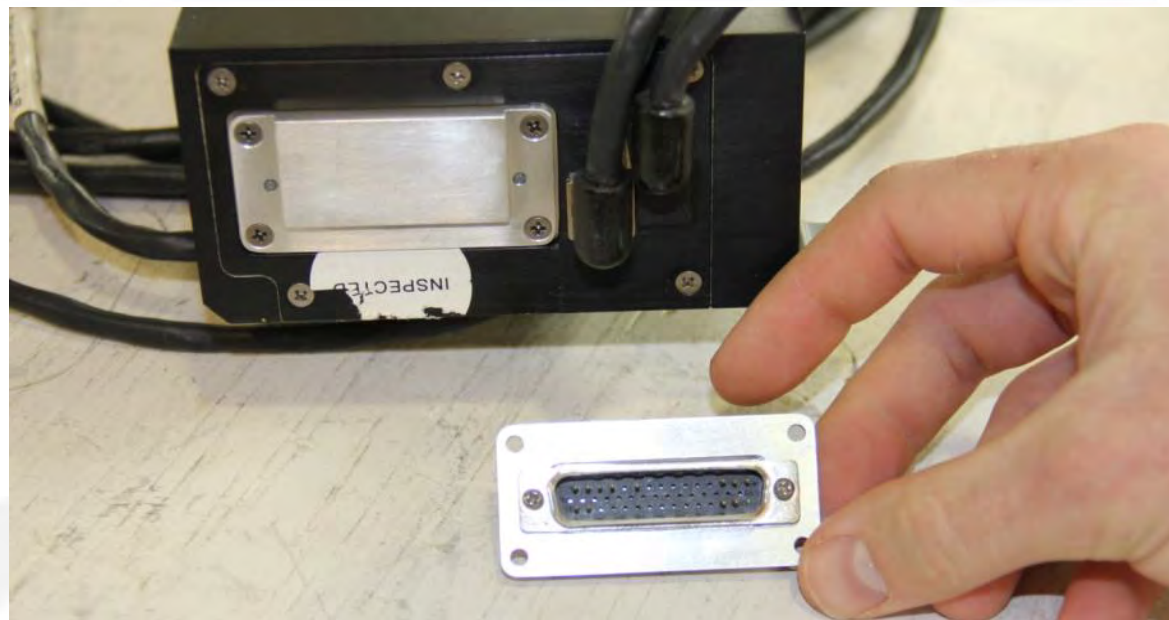
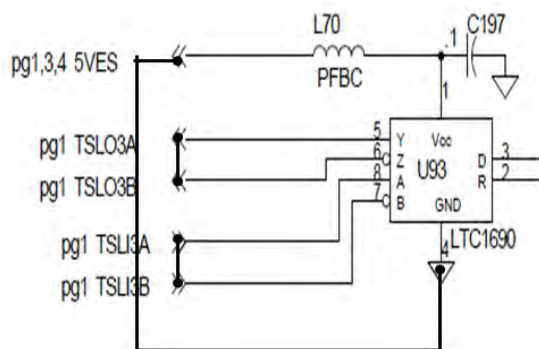
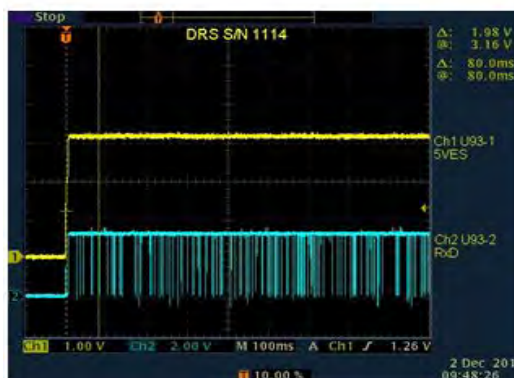
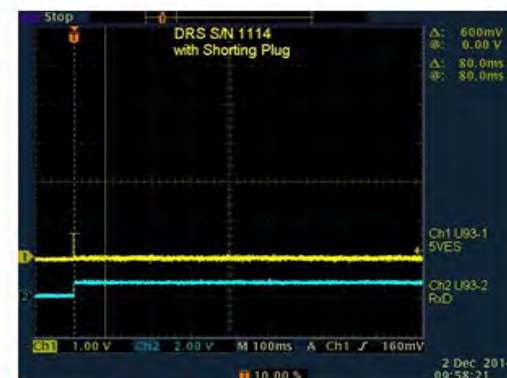
ACES II Digital Recovery Sequencer (DRS) Shorting Plug TCTO

- **Issue:**
 - Pilot ejected and DRS failed to perform automatic operations (2014)
 - Pilot pulled emergency manual parachute deployment handle for seat-man separation and parachute deployment

- **Cause:**
 - Channel 1 circuit failed due to defective Power-On Reset (POR) chip
 - Channel 3 circuit failed due to firmware bug and noise
- **Impact:**

- All DRS units affected by firmware and hardware issues that directly contributed to this failure
~8,000 aircraft
 - DRS system reliability requirement is 0.999, 90% confidence; currently 0.056% observed failure rate

- Fighter Bomber Program Office Hazard Risk Assessment (Medium Risk), dated 19 Dec 2014
- **Get Well:**
 - ✓ Production records reviewed and three DRS units recalled with bad POR chips – Feb 2015

- ✓ Test port shorting plug qualified to mitigate failures – Jul 2015
 - ✓ Time Compliance Technical Order (TCTO) published January 2016
 - Requires TCTO compliance at 36-month seat inspection by Jan 2020

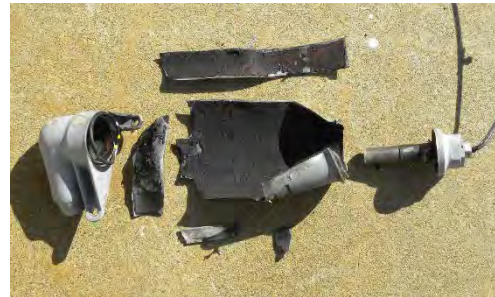
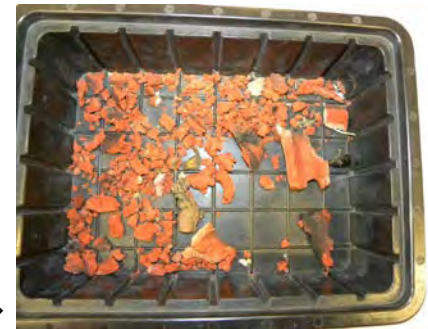
160 of 290 grams recovered →

- Three ruptured motor failures since 2010 at Manufacturer
 - Lot Acceptance Test (LAT) failure 9 Aug 2010
 - Cold unit (-65°F) experienced rapid overpressure (exploded)
 - Batch check unit failure 9 Mar 2012
 - Hot unit (+200°F) experienced rapid overpressure (exploded)
 - LAT failure 28 Oct 2013
 - Hot unit (+200°F) experienced rapid overpressure (exploded)

- Manufacturer A - Insufficient bond strength between propellant, liner, and motor tube case leading to excessive surface area burning and unit overpressure
- Manufacturer B - Propellant grains (PN 55012) cast from TAL-1526 B161 propellant exhibited soft propellant at the machined ends of the grain
 - Exhibited inadequate material strength and was deformable with light hand pressure

- ✓ FY09 Contract; 172ea L/H and 134ea R/H (Warranty Returns)
 - ✓ 134ea R/H delivery complete – Sep 2017
 - ✓ 172ea L/H delivery complete – Mar 2018
- ✓ FY15 Contract; 155ea L/H and 154ea R/H
 - ✓ Original scheduled delivery Dec 2016; Shipped complete Dec 2017
- ✓ FY16 Contract; 88ea L/H and 70ea R/H
 - ✓ Original scheduled delivery May 2017; Shipped complete Dec 2017
- FY17 Contract; 158ea L/H and 253ea R/H – Delivery due by Sep 2018
- FY18 PR; 136ea L/H and 199ea R/H – Anticipate contract award by Sep 2018

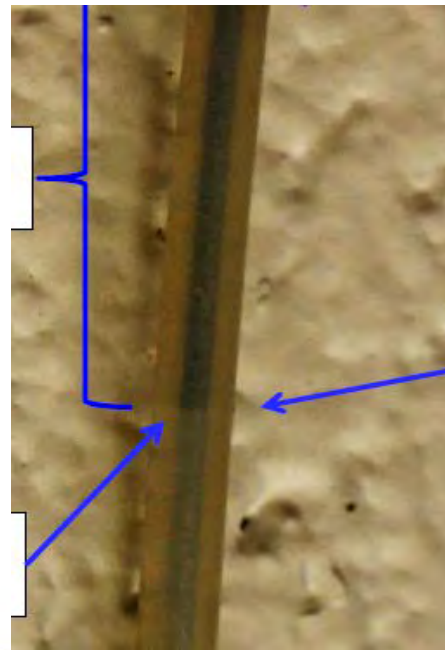
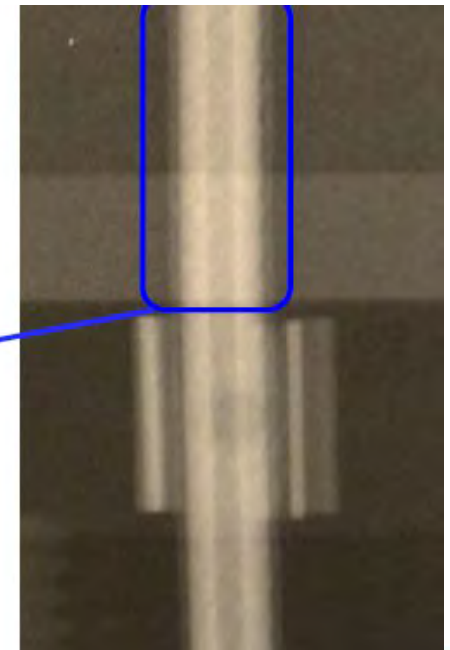
— Product Recall/Suspension #1 – February 2015

- Three production shifts implemented to fill backlog once GFM braided cord was available (~1,000 lines/month)
- Production engineer identified new operator did not cut sufficient material from rejected sections & splices
 - Automated inspection equipment sprays red mark on areas with high or low explosive core load; 80" sections to be removed
 - Affected lines produced/delivered in 2014 are restricted from issue and currently pending warranty replacements
 - User to dispose locally

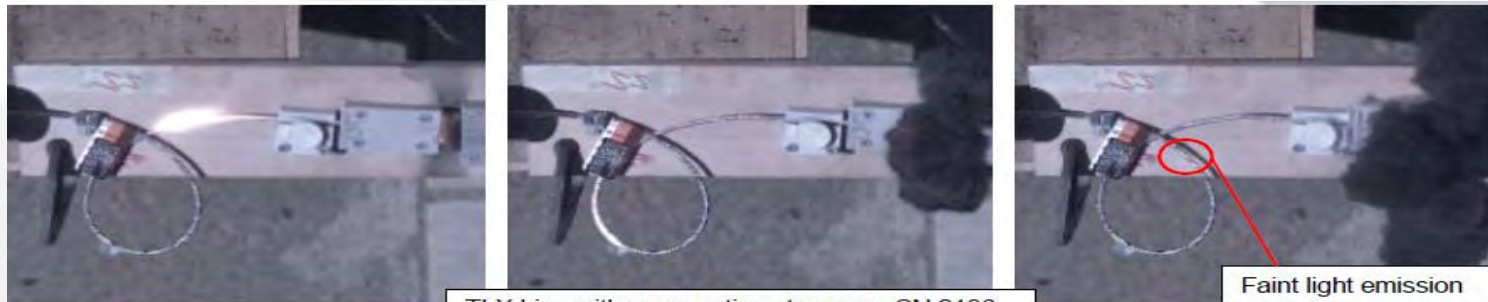
- Lot Acceptance Test (LAT) Failure – December 2014
 - During routine LAT a single line failed to propagate
 - Initial investigation looked at many possible factors but pointed to test fixture causing line kinking
 - Fixture modified with new “Z” bend fitting and double sampling added; additional failures occurred
 - Extensive explosive core load measurements revealed some lines were very low & some high
- Product Recall/Suspension #2 – June 2016
 - Investigation identified all 2014 and 2015 produced TLX lines as suspect and recall issued
 - Suspension from issue released for affected lines
 - Low/high core loads due to improper laser core load sensing system calibration (**Root Cause**)

TLX Line with propagation stoppage, SN 2186

<u>Baseline</u>	<u>Current</u>
✓ Core load failure investigation/improved inspection & process procedures	Oct 2016	
✓ Trial process runs to validate updated procedures	Nov 2016	
✓ First Article Test (FAT) – Several lines vented/one severed	Mar 2017	
✓ Coordinate w/ B-2, F-16, B-1 SPO for concurrence/risk acceptability	Mar 2017	
✓ Return to production at initial rate of ~1,000/month	Mar 2017	
• ~18,000+ TLX lines on backlog (USAF/FMS, Navy, Commercial)		
☐ FY12 Contract	Mar 2013	
✓ Deliver -721 & -723 lines		Mar 2018
☐ Deliver remaining P/N lines		Jul 2018
☐ FY13 Contract (DO 1) Delivery	Apr 2014	Nov 2018
☐ FY14 Contract (DO 2) Delivery	Nov 2016	Nov 2018
✓ Award 5-Year IDIQ Contract	Feb 2017	Mar 2018
☐ FY15/FY16/FY17 Contract (DO 1) Delivery; 5,172ea	Sep 2019	
☐ FY18 Contract (DO 2) Award	Jun 2018	
☐ FY19 Contract (DO 3) Award	Jan 2019

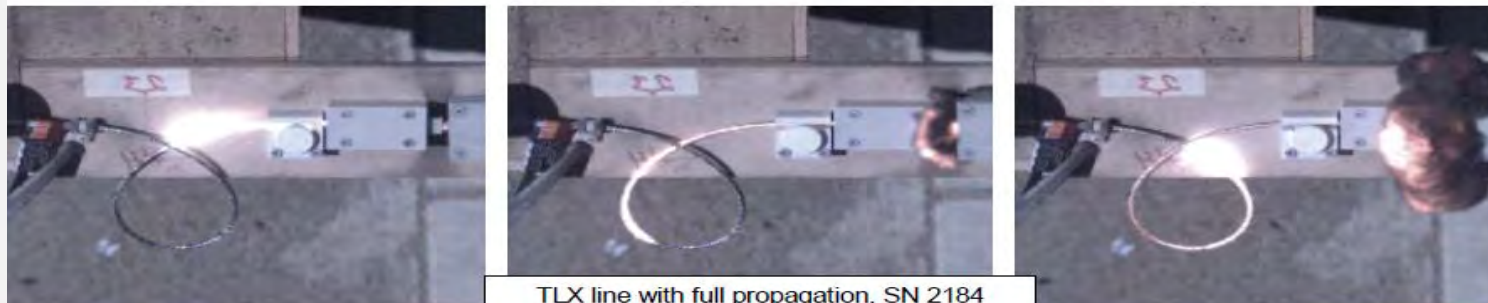
TLX line with full propagation, SN 2184
