INDIAN HEAD EXPLOSIVE ORDNANCE DISPOSAL TECHNOLOGY DIVISION

CAD/PAD MIST CODR & EI

06/26/2018

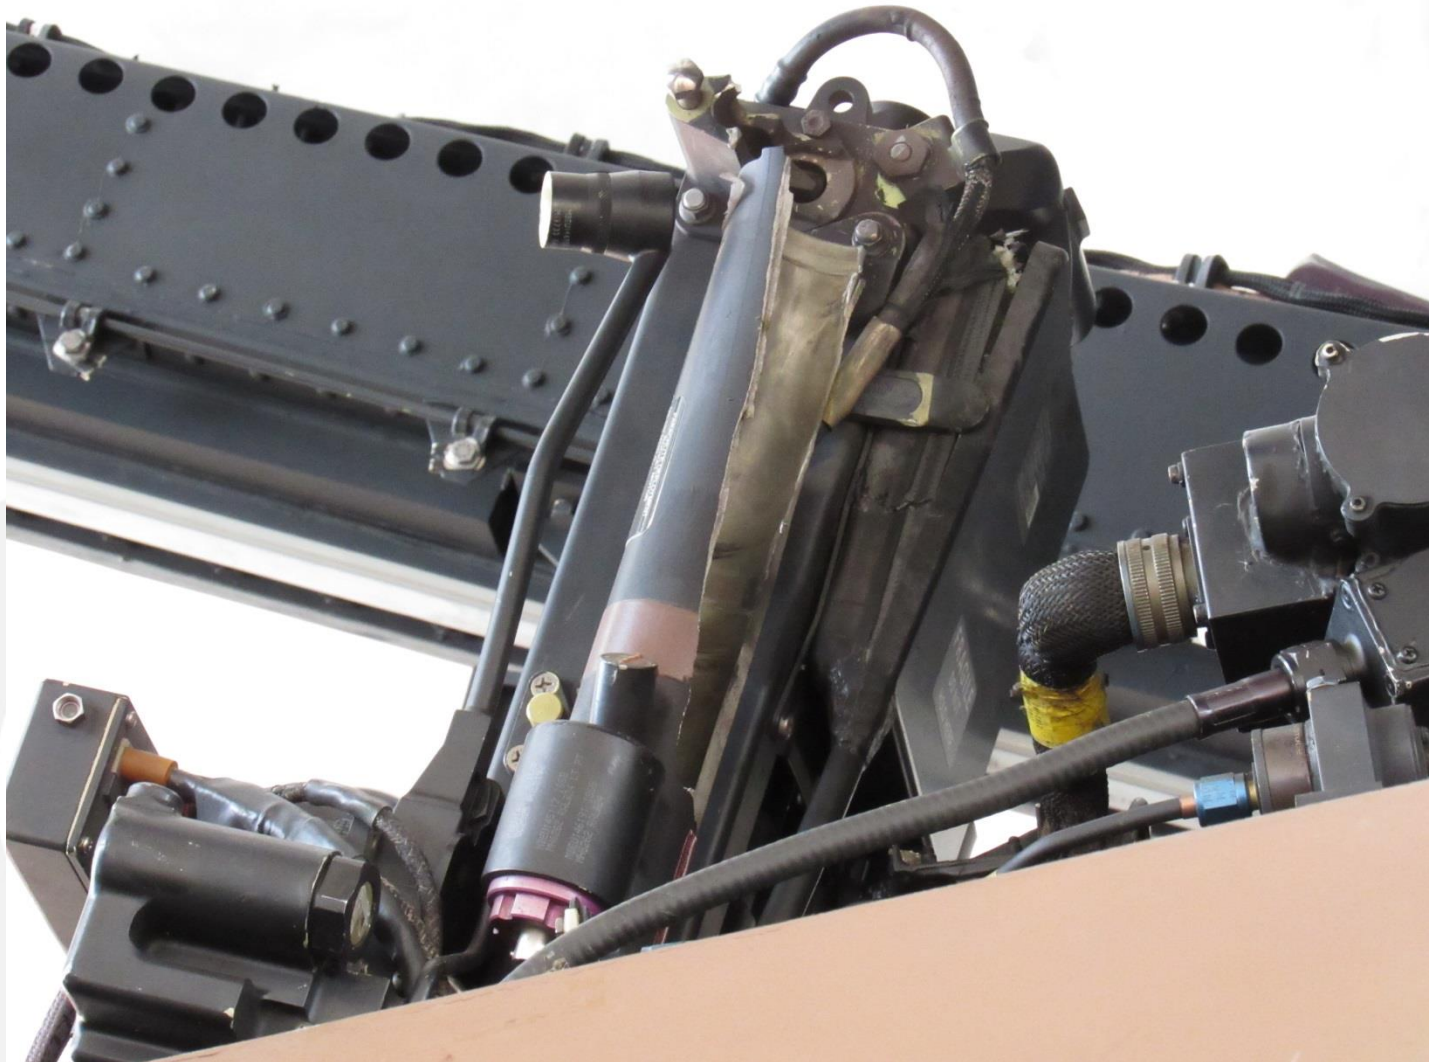
Lemoore PDRM Mishap

- 01 Aug 2017 an F/A-18F aft seat PDRM auto ignited. MIST was activated and with the help of EOD, both PDRM's were removed and detonated on site. The main cause of this mishap was incorrect maintenance, storage, handling and disposal of the device. The stabilizer depleted resulting in autocatalytic ignition because of these four factors.
- Aircrew Bulletin (ACB) 1307 and 1308 were initiated, giving instructions for the fleet to remove all affected PDRM's and WB15's.

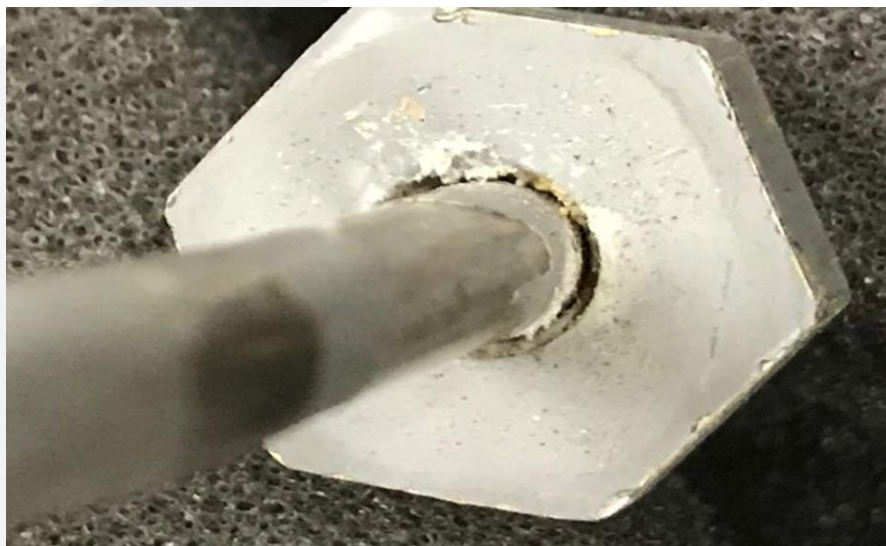
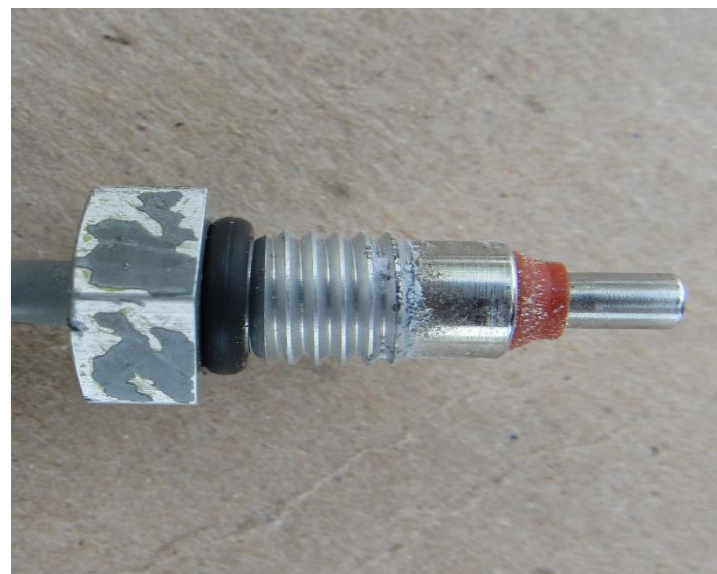
JL50 SMDC Corrosion

- JL50 Shielded Mild Detonating Cord: During de-arming, Collateral Duty Quality Assurance Representative noted threaded fitting was difficult to turn. Upon closer inspection we noticed the threaded fitting was deteriorating from the inside. Holding at Squadron.
- The JL50 has seen 22 reports for corrosion since April 2017 and all of the reports have been from one command and averages to 1.7 reports a month for corrosion. Since this is only happening in one location, we think that this is either a corrosion issue, maintenance issue, or a publications deficiency.

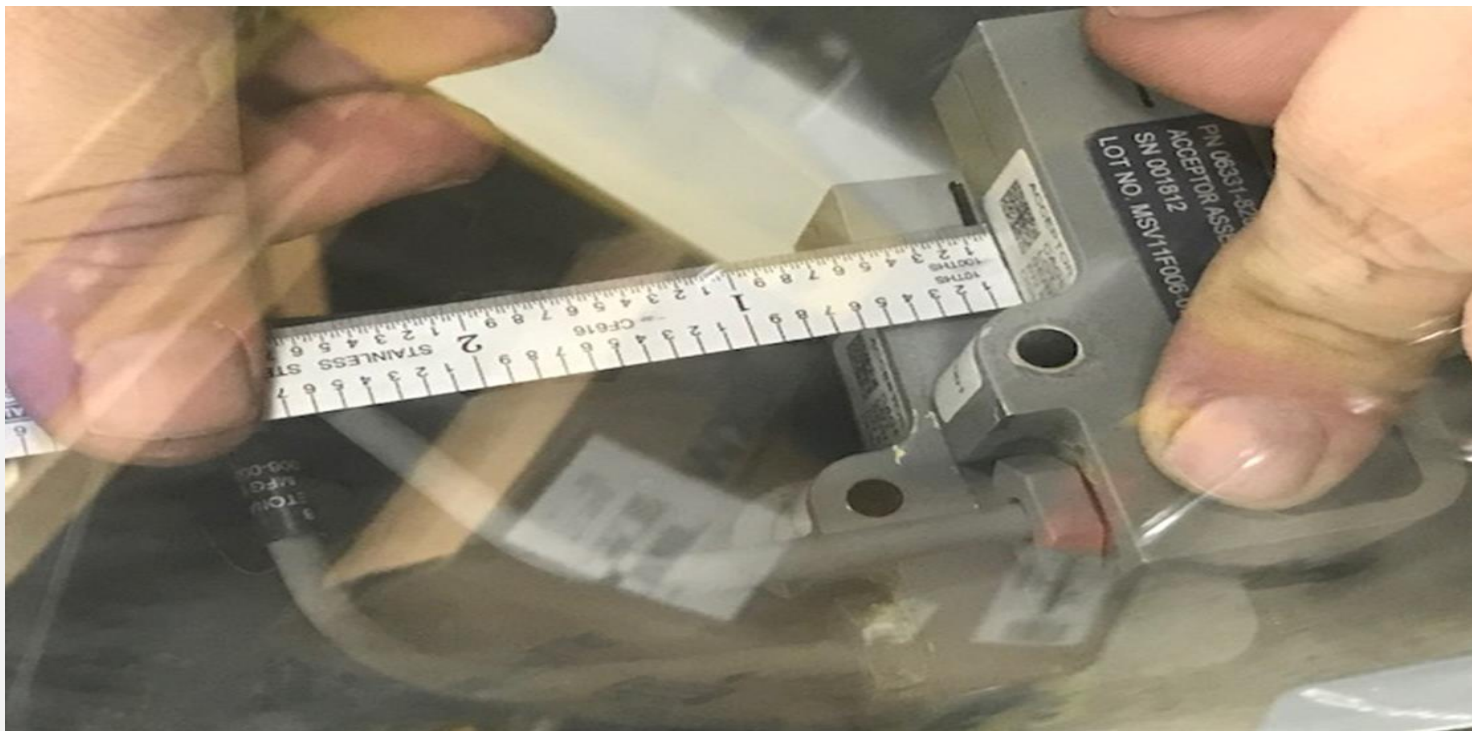
JL50 SMDC Bent

- JL50 Shielded Mild Detonating Cord : While installing JL50 on aft canopy bow, the manufactured bends made it impossible to line up the acceptor without putting bends in the device. Device recalled for further examination.

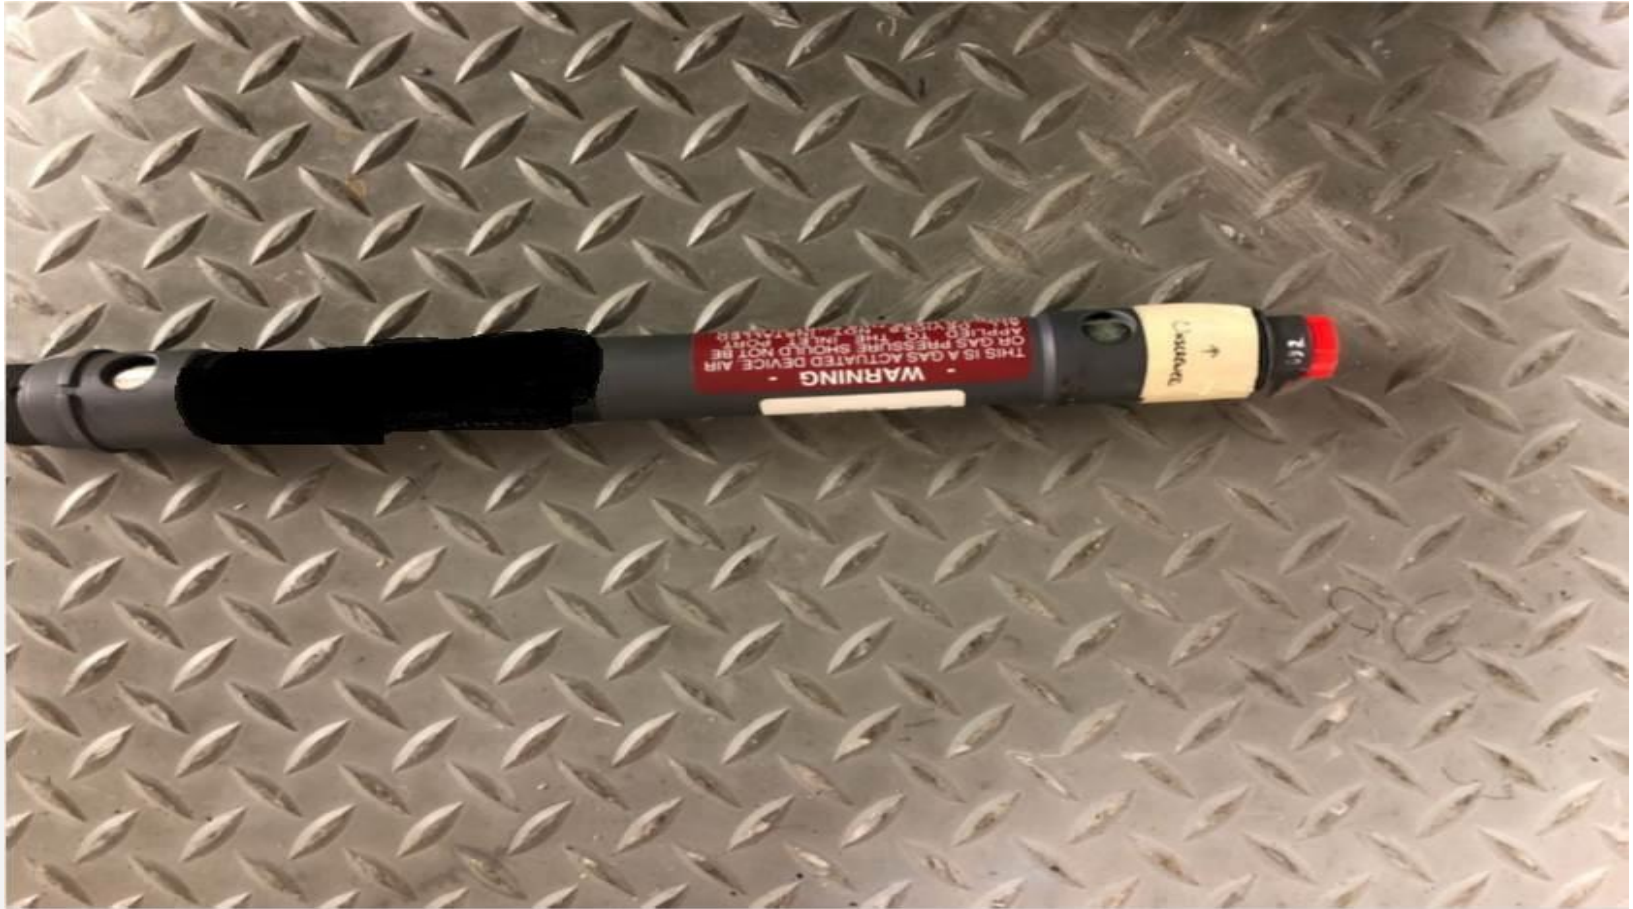
XW36 Loose Rocket Motor Igniter

- XW36 Rocket Motor Initiator: After removing XW36, it was discovered that the left hand end cap was spinning freely. Device has not arrived yet.

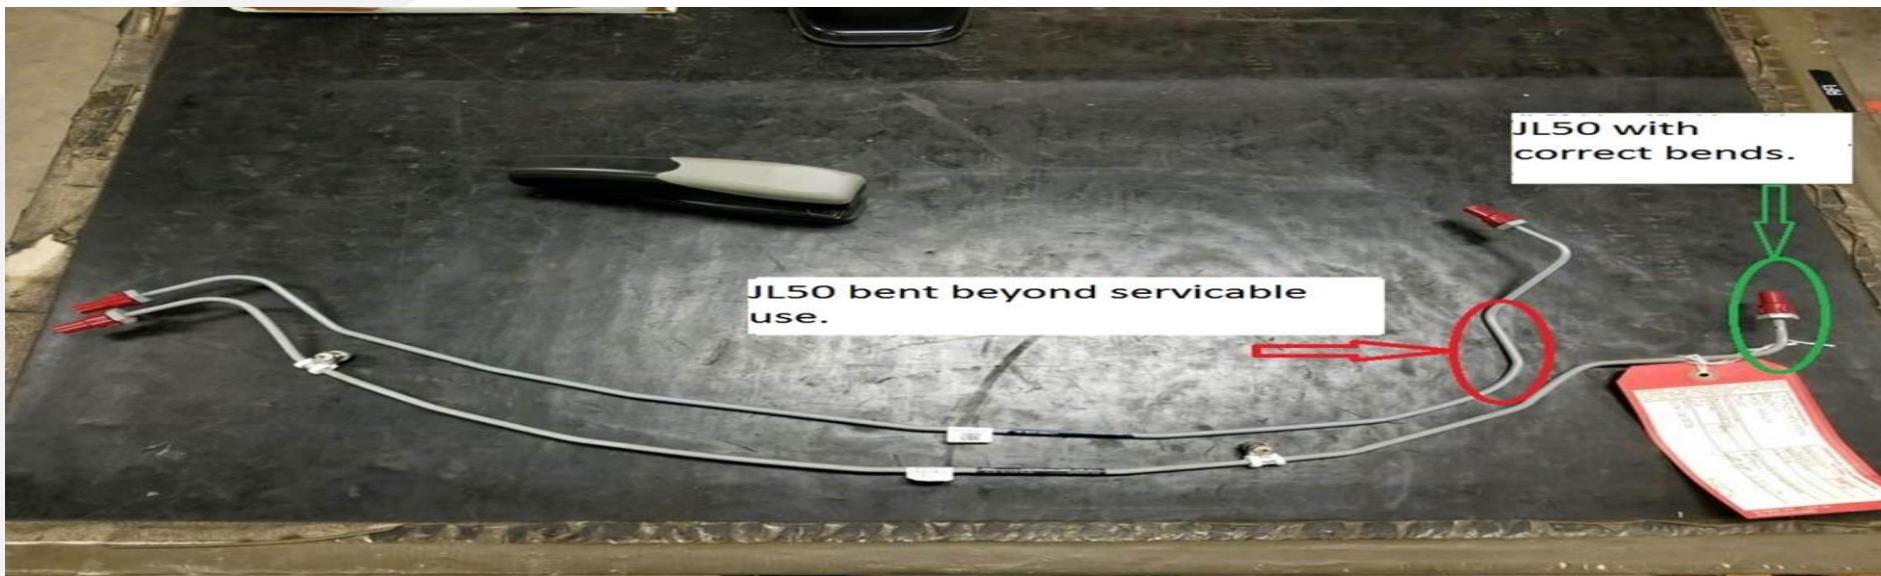
JL50 Bent

- Received bad from supply. Upon inspection prior to installation, noted the JL50 to be bent beyond serviceable limitations. In addition to the bending, exterior of JL50 exhibits scratching or scoring in the vicinity of the bent area. Cause of bending and exterior markings unknown.
- Final Disposition: Det cord was inspected and noted that the length of the JL50 was correct but was bent beyond design limitations. The shipping box did have significant damage. After inspecting packaging material, gray paint flakes were found in the barrier bag. Findings indicate that the JL50 was damaged during shipping and/or storage.

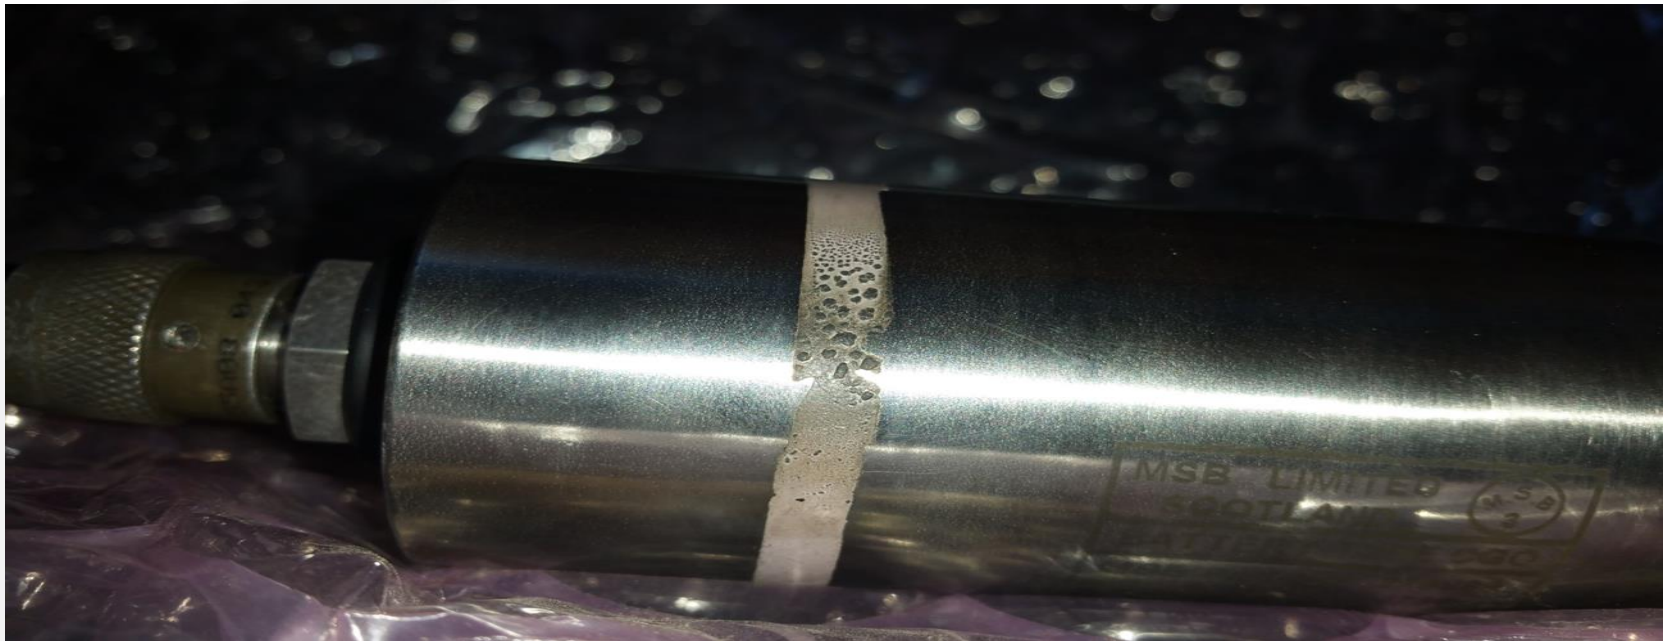
Thermal Battery Chemical Strip

- CWDR Thermal Battery:
 - Plane captains were holding training on proper daily inspections. During the cockpit portion, they checked to make sure the seat was safe. During inspection, the plane captains noticed the sequencer expended unit indicator (doll's eye) was white and the thermal battery strip was blacken and charred.
 - CWDR Final Disposition: A radiographic inspection was conducted on the thermal battery and showed no evidence of the firing pins moving or any evidence of the cell stack activating at all. Thermal battery received an outside heat source and damaged the temperature sensitive indicator.

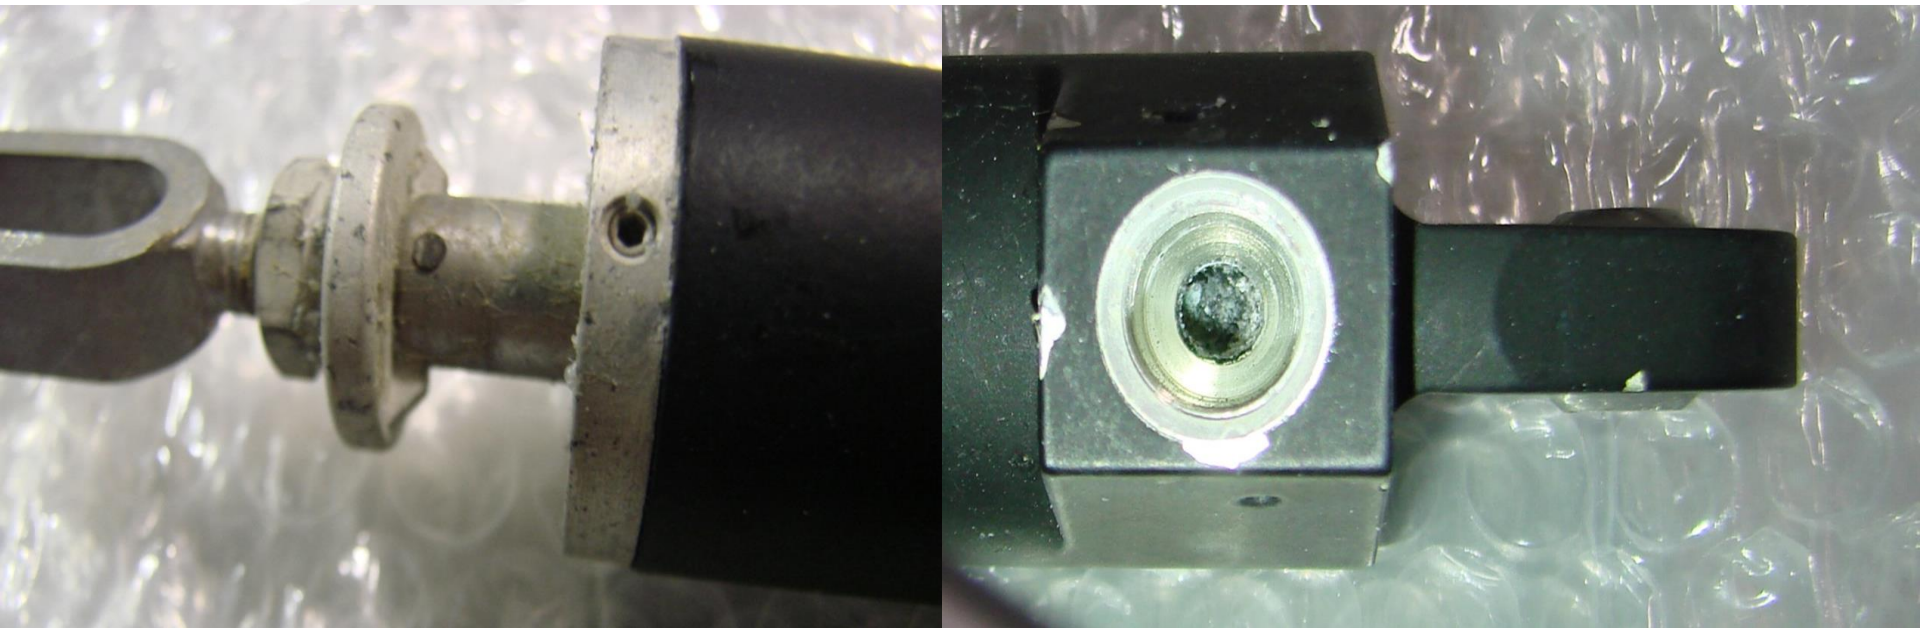
JL02 Failed to Fire

- JL02 Seat Initiator Cartridge:
 - Class “A” mishap involving an MV-22 Osprey off of the east coast of Australia. JL02 seat thruster cartridge did not actuate during mishap. CODR/EI requested by Aircraft Mishap Board.
 - JL02 Final Disposition: Thruster piston was fully extended and properly aligned. Thruster shear pin was sheared and explosive residue can be seen inside the TLX port. This evidence shows that the thruster worked as designed.

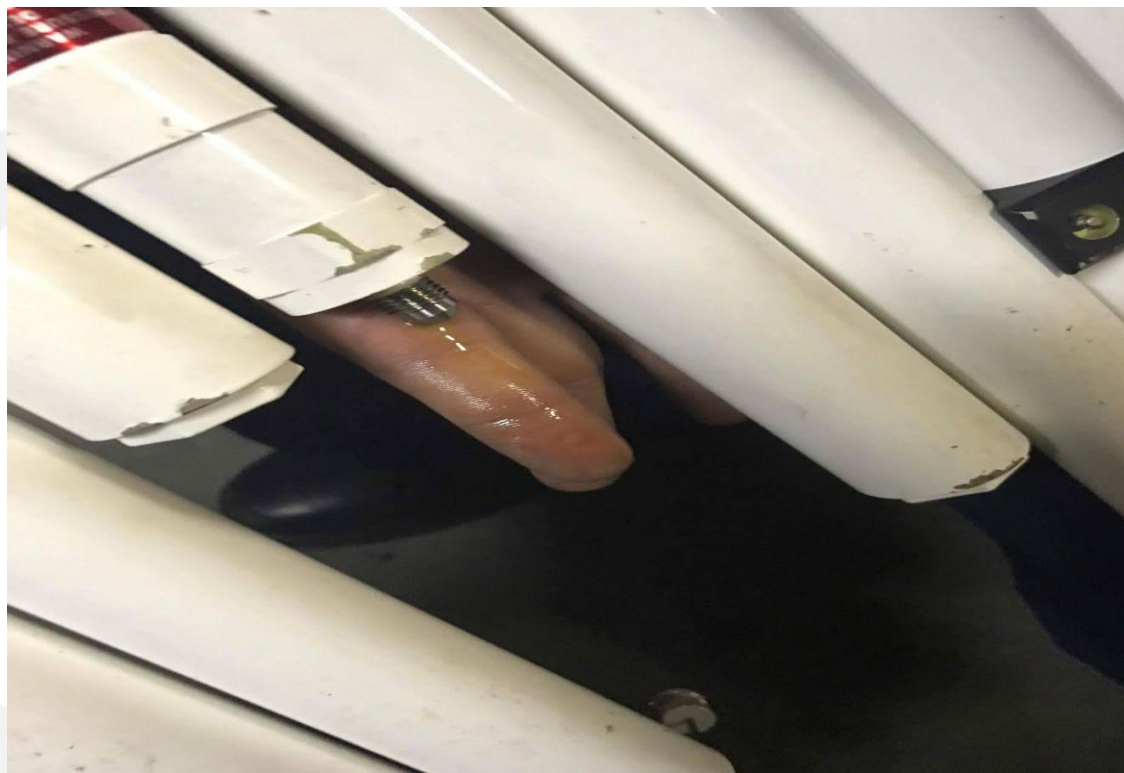
MT30 & MT31 Oil Intrusion

- MT30 and MT31 Underseat Rocket Motor (USRM)
 - Pac Fleet found oil in several USRM's and ballistic gas lines during a 728 day inspection.

- Indian Head E25 In Service Engineering Branch developed an emergency test plan and approved for use in four days. Testing provided insight on clogging, blockage and pressure loss.
- A decision was made by NAVAIR based on the results from testing to move forward with operations and be advised of a ACB to address the issue
- ACB 1290
 - To be completed on the next 84 day inspection.
 - Inspect for oil intrusion in/on the gas lines, USRM, Breech Assembly, and MT91 Initiator Cartridges. Clean if discovered.
