# **Microcircuit Failure Mechanisms and Anomalies**

This section describes failure mechanisms and anomalies of microcircuits. Use this section as a guide to design and select microcircuits.

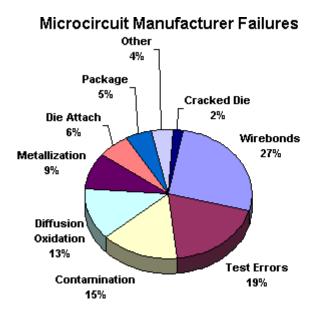
Figure 2. PEM Assessment Results Source: NSWC-Crane Division

The Naval Surface Warfare Center, Crane Division has been periodically assessing PEMs for over 25 years. For an example, they recently assessed over 3,000 PEMs for Trident Fire Control, Trident Navigation, CEC, Army Tank Command (TACOM), and the NAVSEA Parts Reliability and Derating Manual Programs from 1997 through 1999. Figure 2 shows the number of failed, marginal, and passing PEMs during this assessment period. The more common failures and anomalies found during this assessment are (1) improper moisturesensitivity-level of package, (2) contamination, (3) poor die-paddle construction, (4) poor wire-bonds, (5) voiding, and (6) delaminations. Having 30% of the total microcircuits either failing or being marginal enforces the obvious need for PEM assessments and monitoring.

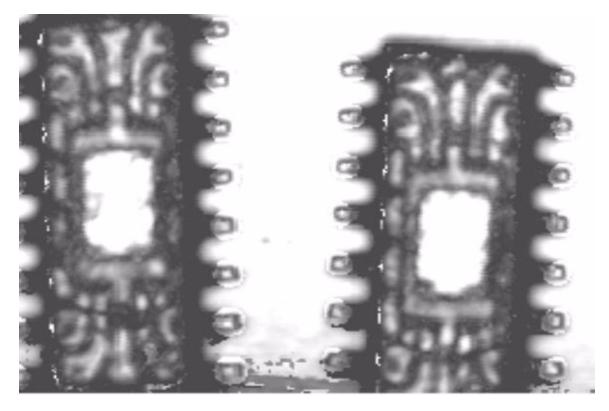
**Figure 3** C-SAM image of PEM with die-attach delaminations (white area) and poor material porosity causing fuzzy image.

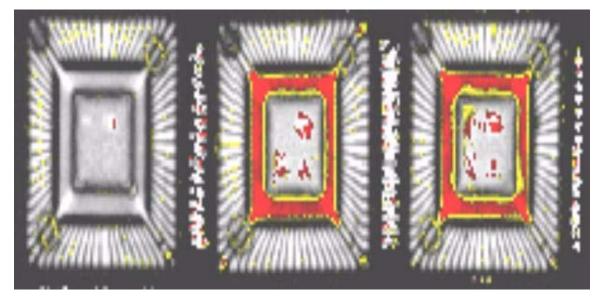
**Figure 4** C-SAM images of PEM with delaminations (Red area)

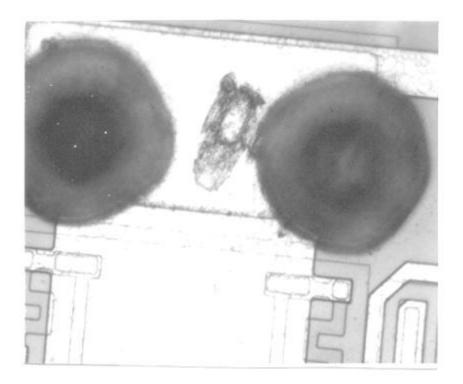
**Figure 8** Construction analysis photo of PEM. Wire-bond displacement weakening bond causing latent dis-bond failure.

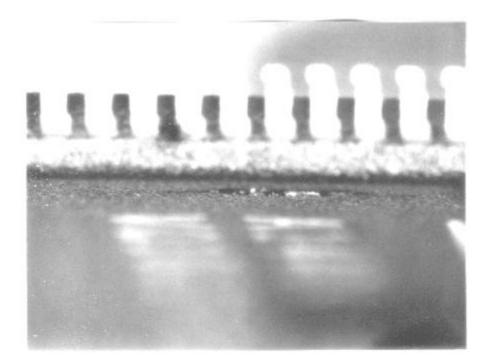
# **Figure 10** Construction analysis Photo of PEM. "Pop-Corning" effect caused crack in plastic from vapor phase solder re-flow overheating.

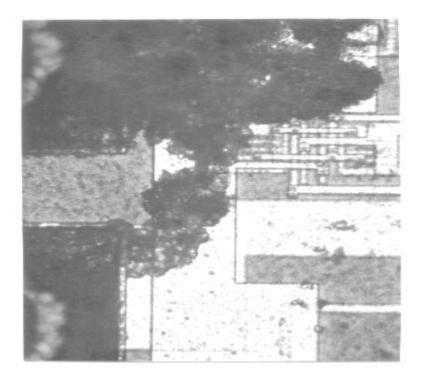
# Figure 11

SEM photo of PEM. Contamination - Residue from halogen presence in package. Cause latent defect by accelerating corrosion and weakening bond.

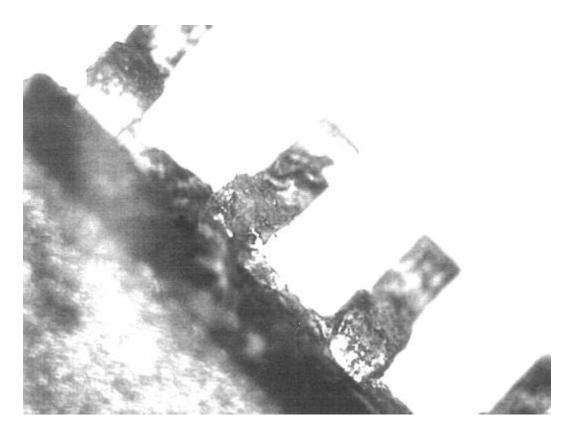
Figure 12 Photo of PEM following Salt Spray test. Failures from excessive lead damage. Caused by Salt Spray.

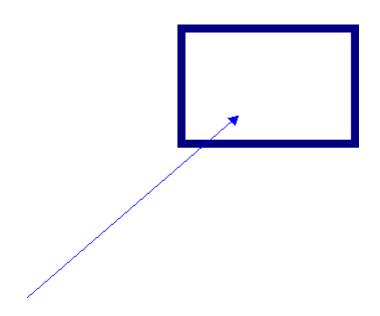
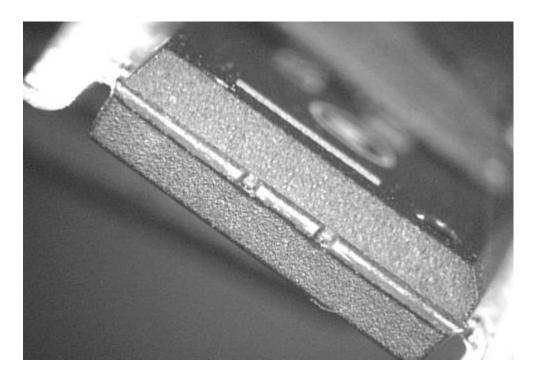
**Figure 13** Photo of PEM. Loss of seal integrity at leadframe tabs of PEM. Allowed moisture/salt ingression during salt spray Test. Accelerated corrosion latent defect.

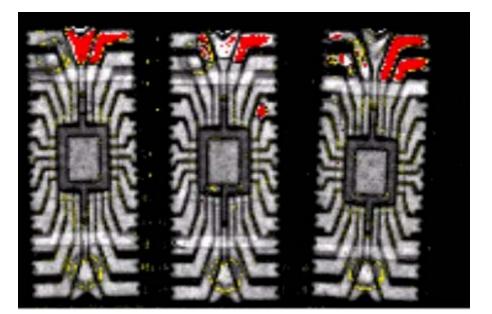
**Figure 14** C-SAM image of PEMs. Salt ingression into PEM following Salt Spray test. Cause latent corrosion defect. Same PEM as Figure 11.

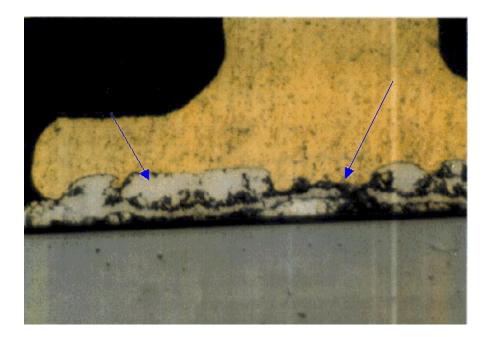
**Figure 15** SEM photo of PEM with Kirkendall Voiding (Purple Plague)

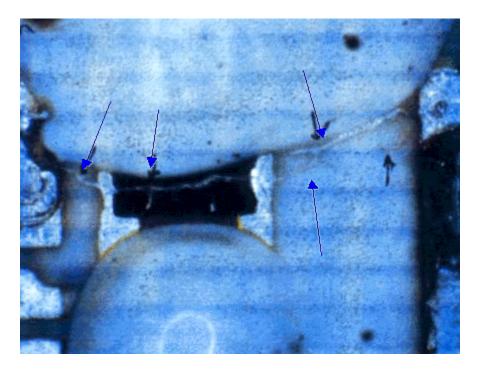
**Figure 16** SEM photo of PEM with internal dendritic growth

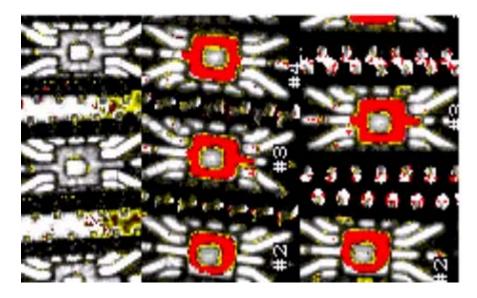
**Figure 17** C-SAM images of PEMs with poor die-paddle attachment. Left images are initial scans. Center images are following pre-conditioning. Right images are following 50 hours of HAST.

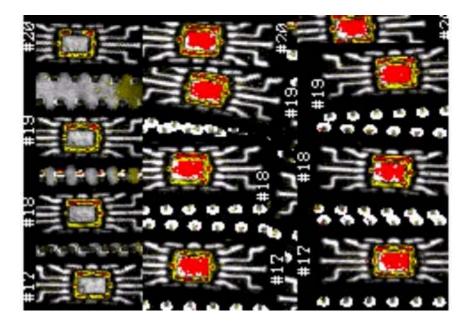
Figure 18 C-SAM images of PEMs with poor Die-Attach. Left images are initial scans. Center images are following pre-conditioning. Right images are following 50 hours of HAST.
