Navy and Marine Corps CAD/PAD Mishap Investigation Support Team Engineering Investigations and Mishaps

14th Cartridge Actuated Devices/Propellant Actuated Devices
(CAD/PAD) Technical Exchange Workshop

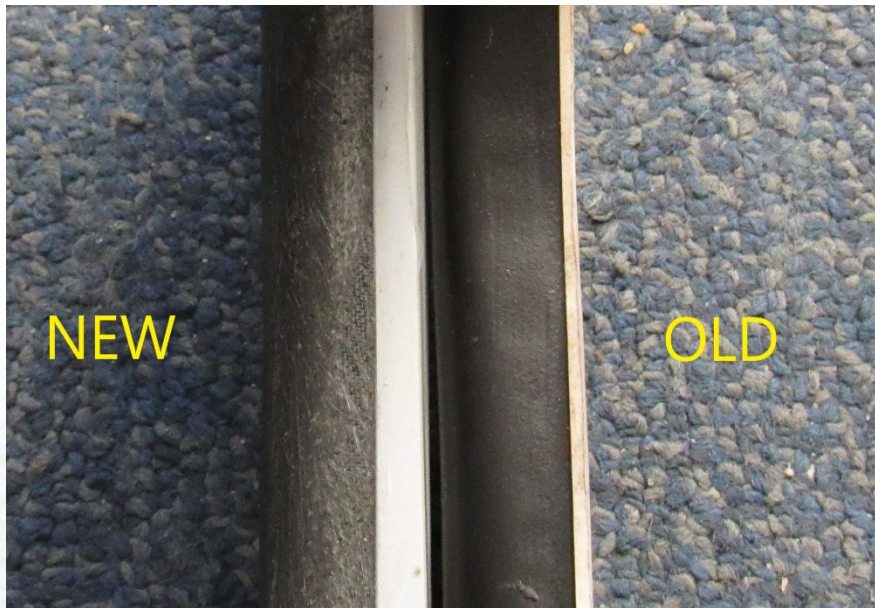
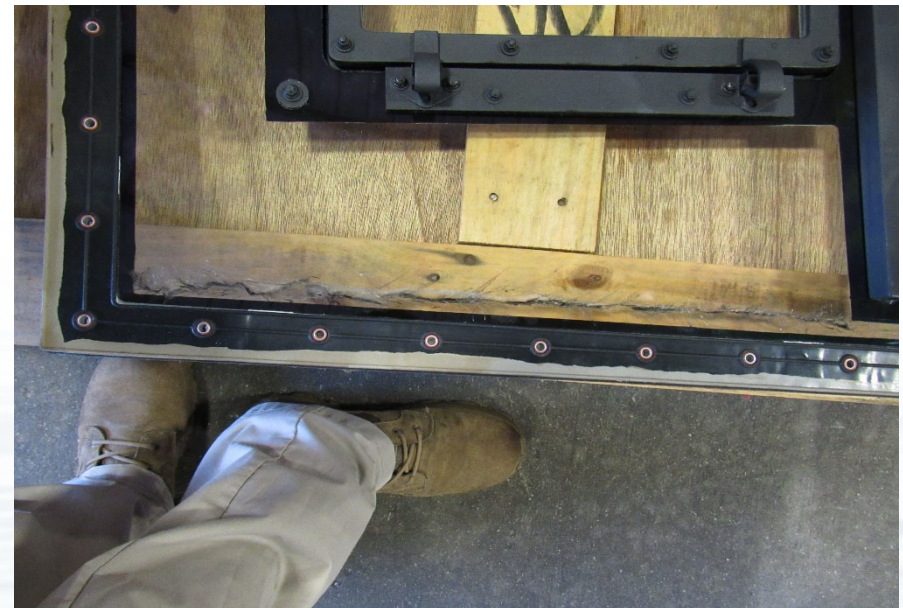
WB34 On-Site EI

- V-22 Window Cutter Assembly (WCA) cracking windows.
 - New WCA has a visibly thicker charge than the old.
 - Cracked three windows before the WCA was suspect and we completed our on-site assessment.
 - Currently working with the ISE and contractor, looking at drawings/requirements.

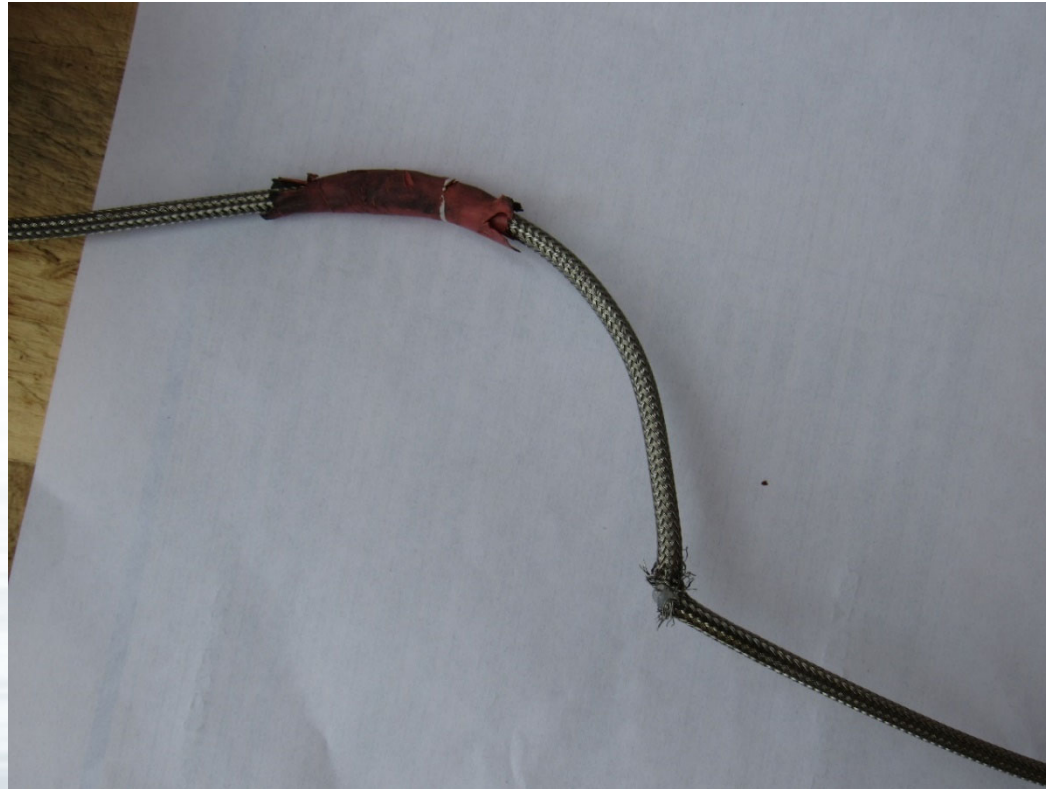
T-6 JN45 EI

- USAF T-6 SMD Det. Cord found damaged during daily inspection.
- E23 Hill Air Force Base and E25 Indian Head CAD/PAD worked together on this EI.
 - This happened six times in 1.5 years depleting stock on CFIS B kits.

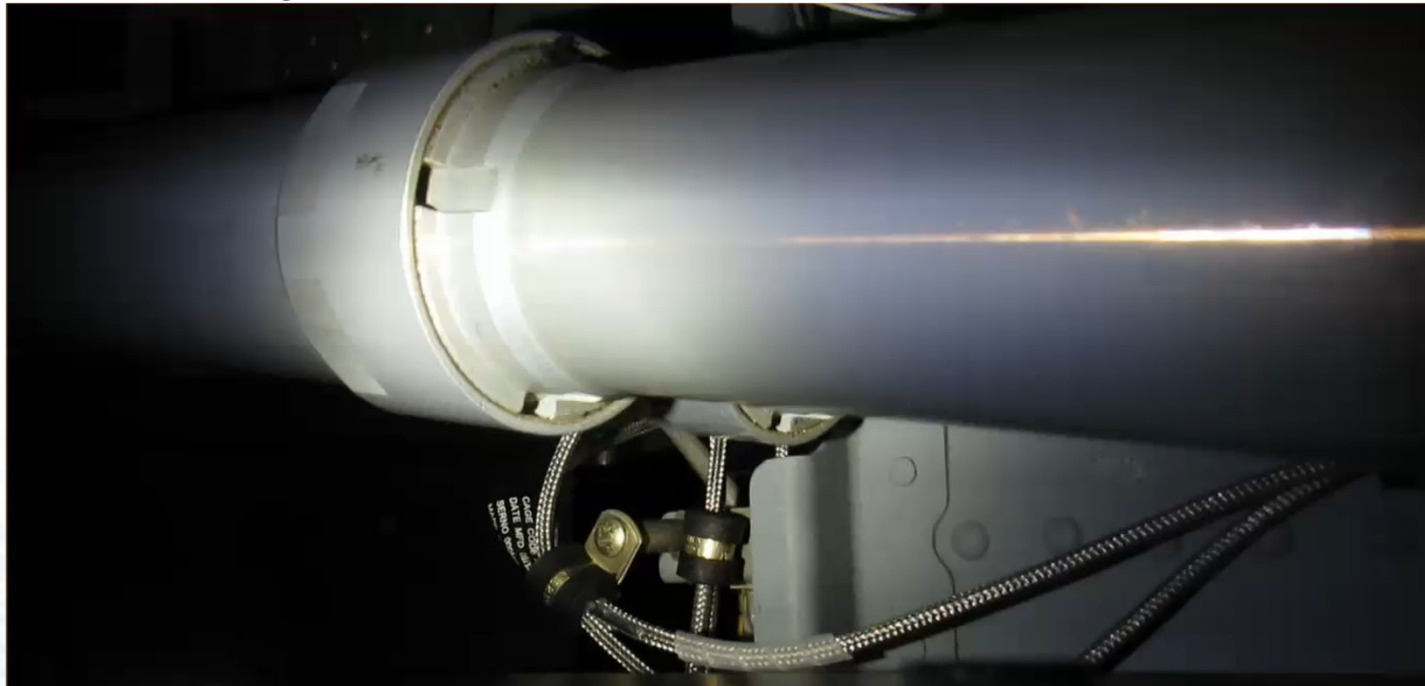
T-6 JN45 EI

- Inspected Navy installed assets at Naval Air Station (NAS) Patuxent River, NAS Pensacola and Edwards Air Force Base.
 - Inspections revealed the canopy strut is coming in contact during opening and closing.

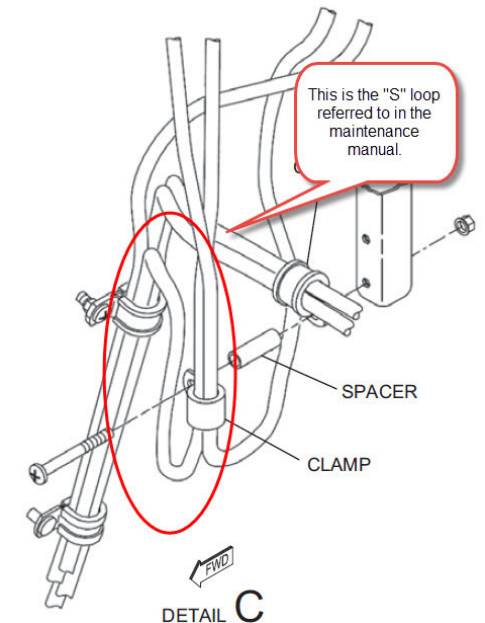
T-6 JN45 EI

The maintenance publications state to make sure there is an “S” loop in the line.

- A spot check inspection revealed that a small number of lines did not have the “S” loop installed correctly.
- Instruction found to be confusing.

- TCTO issued to inspect on next seat maintenance cycle.
- Replace if needed
- Re-route Det. Cord.

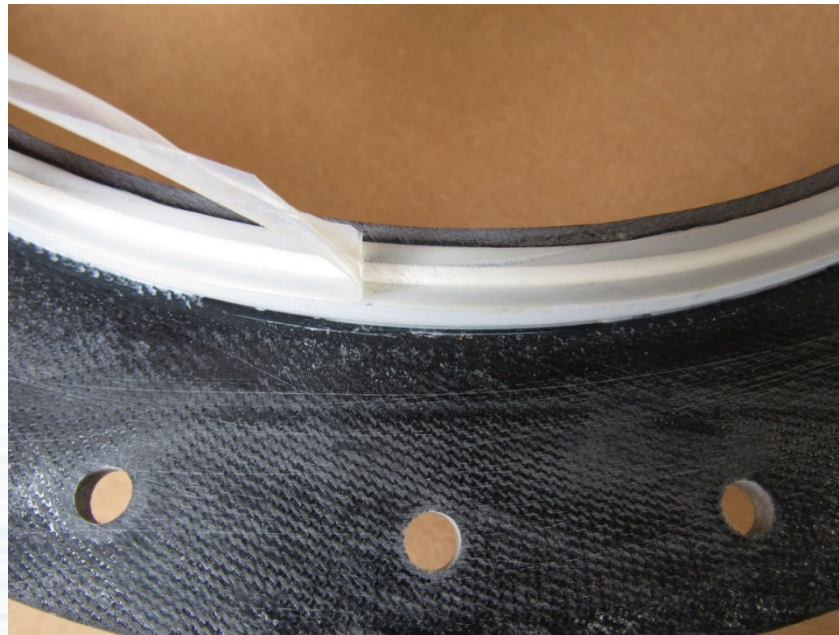
V-22 WB36 WCA

- CODR reported white environmental tape on two new WB36s is falling off.
 - Both devices recalled for an EI, only one was returned.
 - Initial inspections revealed significant degradation of the adhesive that holds the environmental tape to the charge.
 - Contractor confirms error during build process while applying tape.

- Continue to let the fleet report through the CODR process.
- Issued a “CAUTION” in the NA 11-100-1.1 CAD/PAD Technical Manual stating the issue and report if it fails inspection.
- Contractor will repair what is in stock at Indian Head in phases.
- Contractor changed build procedure to mitigate future risk.
