# Lessons Learned About Pyrotechnic Delays

Frank J. Valenta

Exodynamics Technology, Incorporated

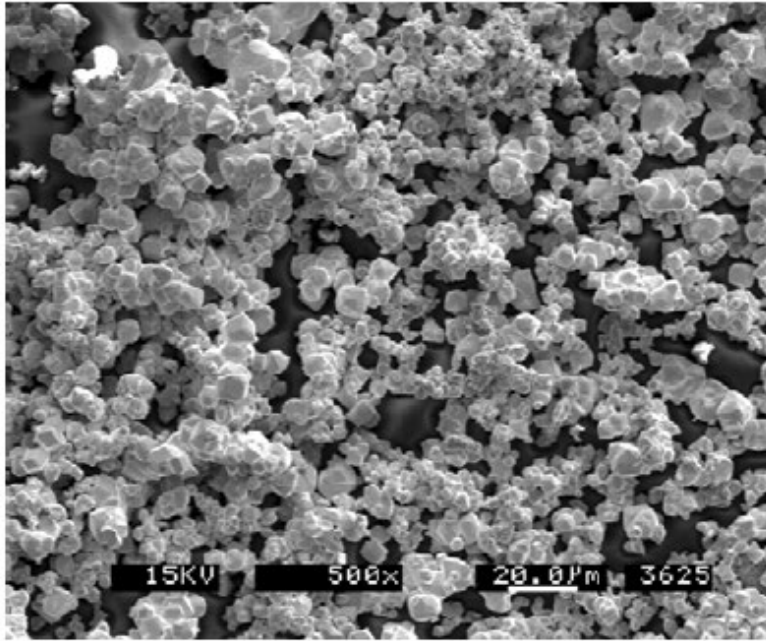
Figure 1(a) - Morphology of as-received tungsten powder observed by SEM, revealing the agglomerate structure.

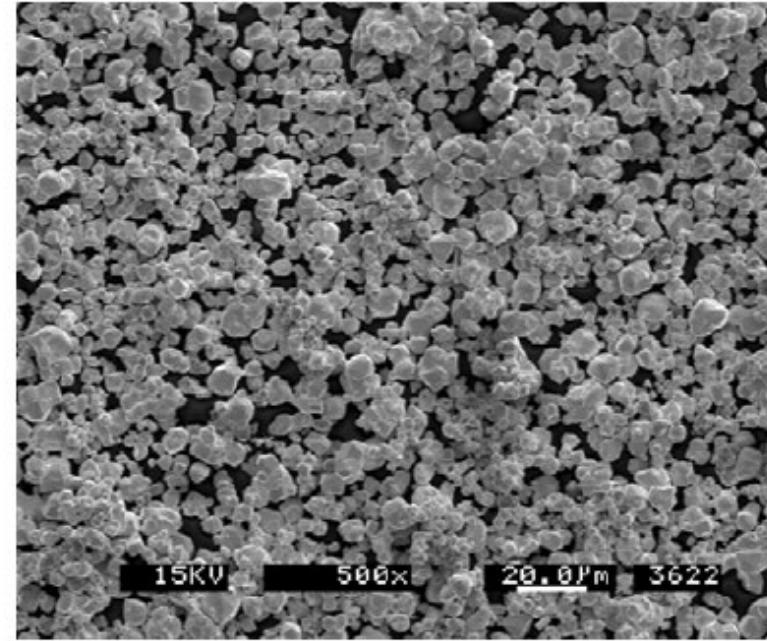
Figure 1(b) - Morphology of rod-milled tungsten powder observed by SEM, revealing the presence of a deagglomerated powder.

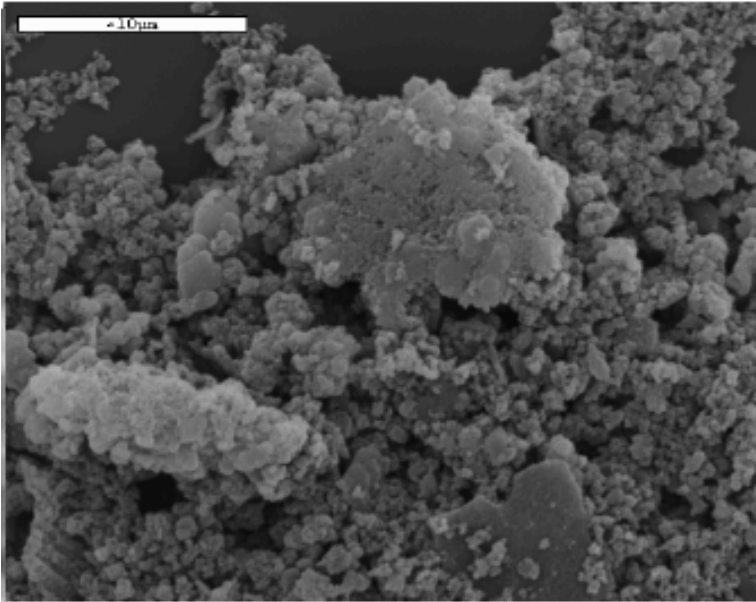
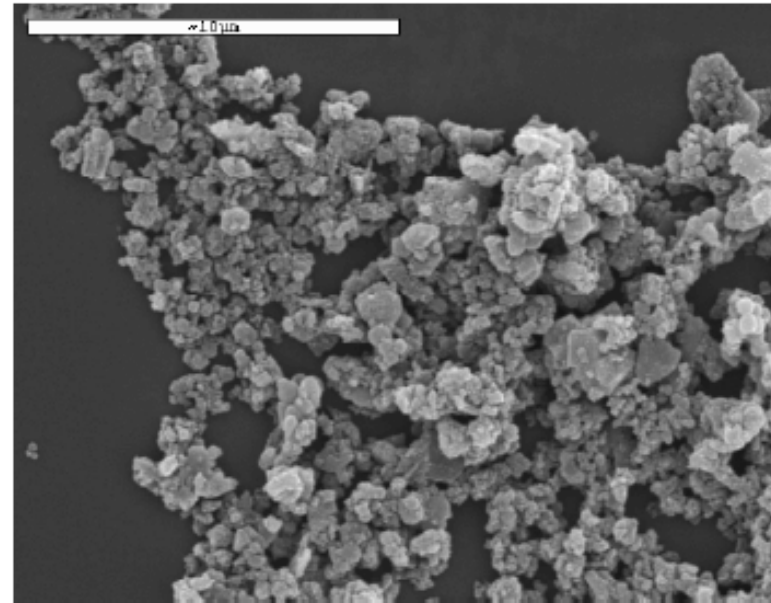
Oxygen analyses indicates clearly the presence of oxygen containing compounds ( $H_xB_yO_z$ ) on the surface of boron. Boron powder when exposed to moisture tends to hydrolyze forming boric acids and/or oxides. This oxygen containing compounds can be easily removed by dissolution in methanol.

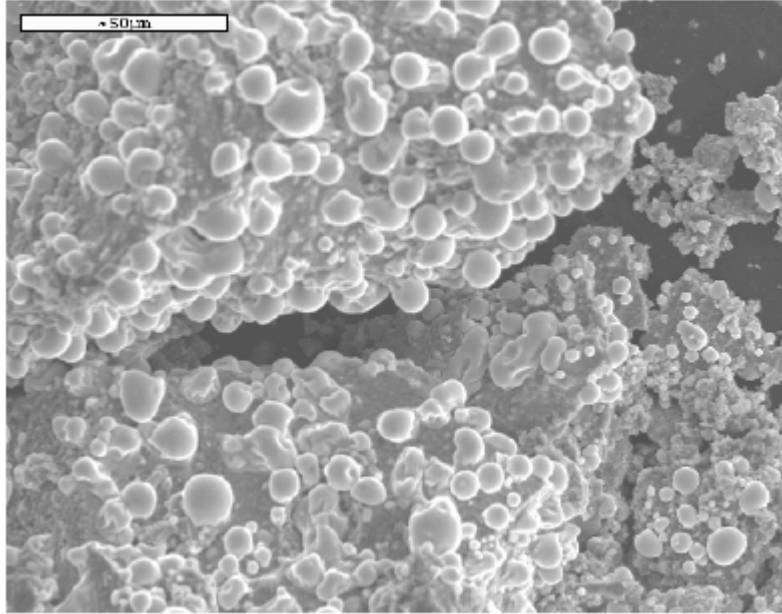
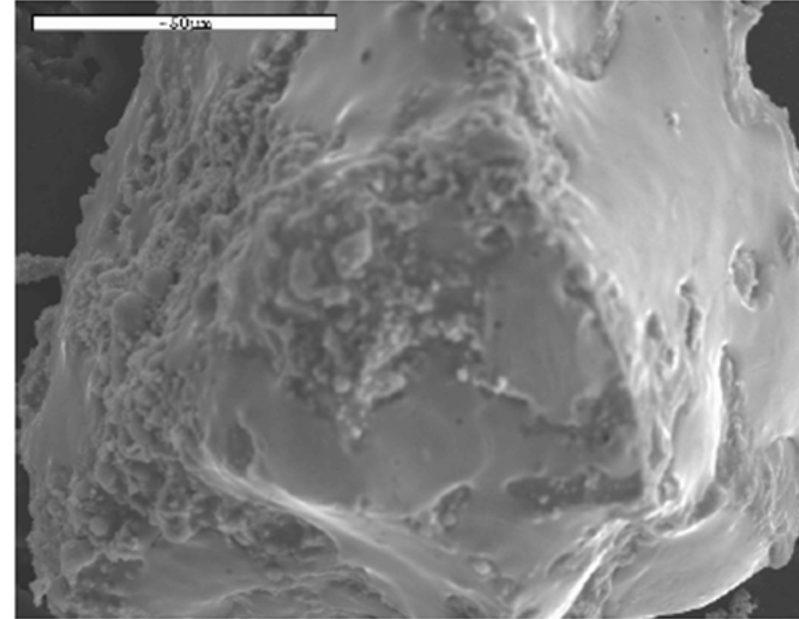
**“Bad”**

**“Good”**

BaCrO<sub>4</sub> lots (used in a 4.5% boron mix). “Bad” barium chromate did not load well while the “good” barium chromate did. Both lots (from different suppliers) met the barium chromate spec.

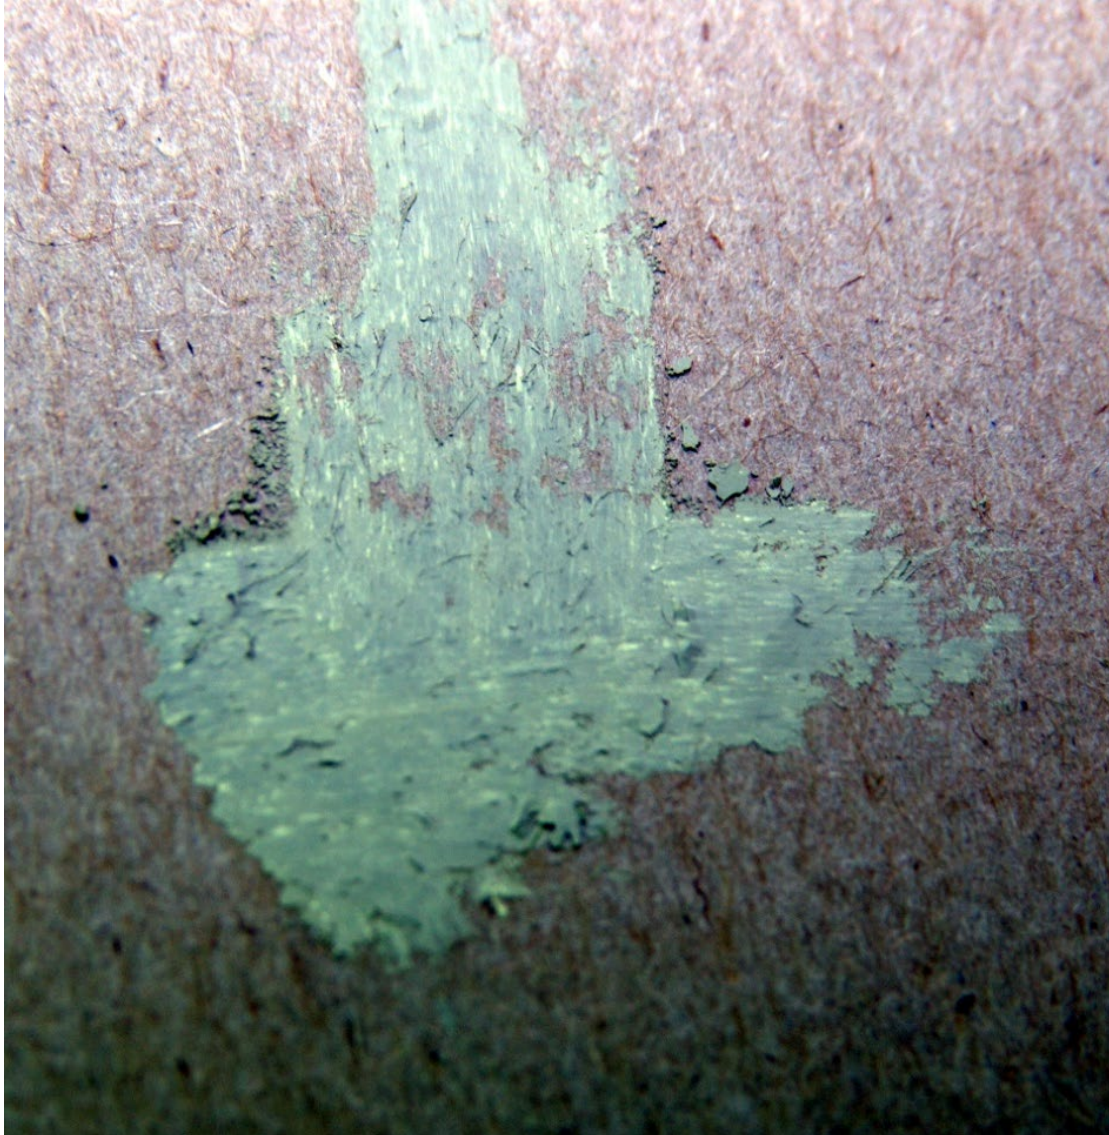
Shown is a B-BaCrO<sub>4</sub> delay composition mix (with 3.5% B). Yellow streaks show the presence of larger agglomerates of BaCrO<sub>4</sub>

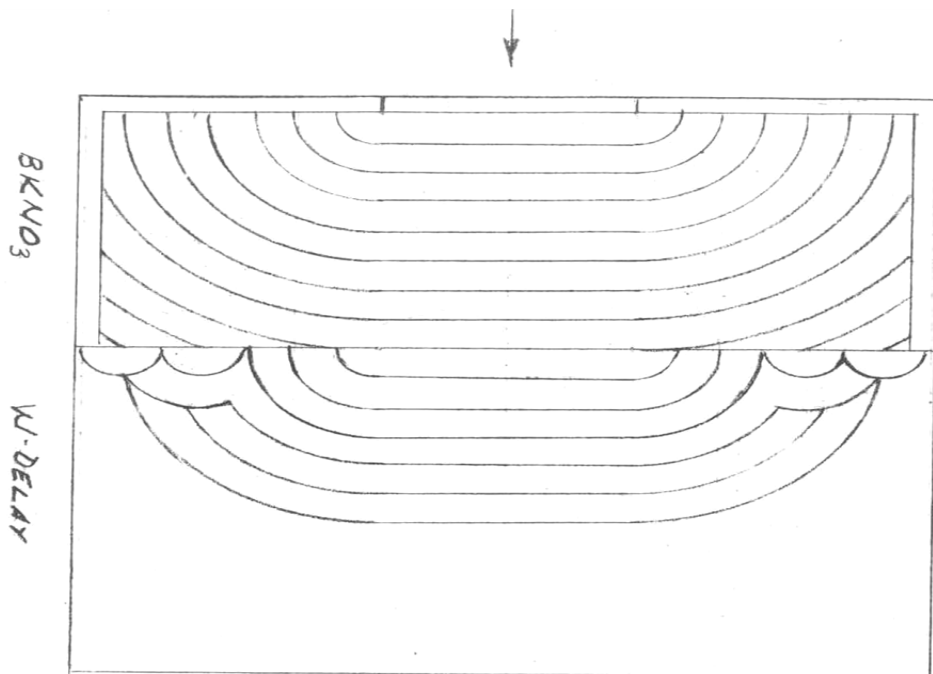
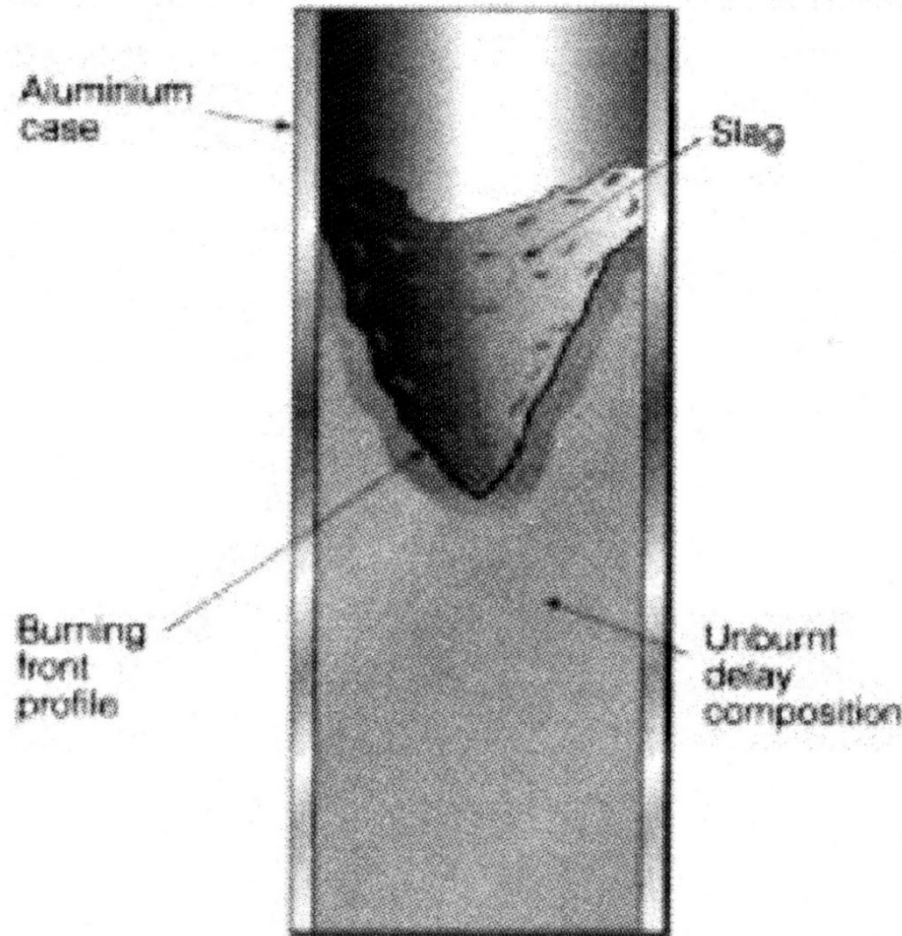
*Figure 4. A delay column that has failed due to heat losses.*

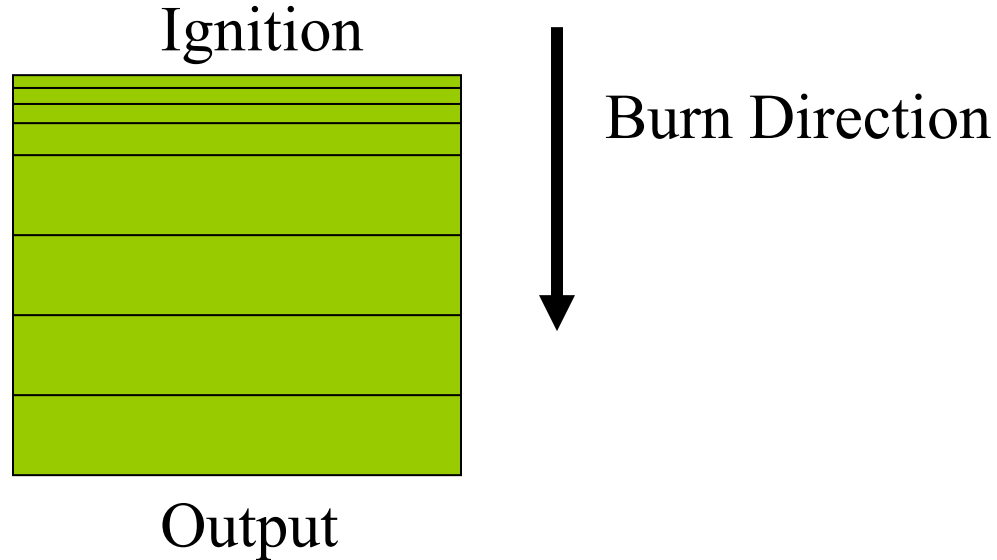
Assigned Cause: Thin initial thin increment likely broke up and did not maintain sufficient contact with next increment to assure propagation.

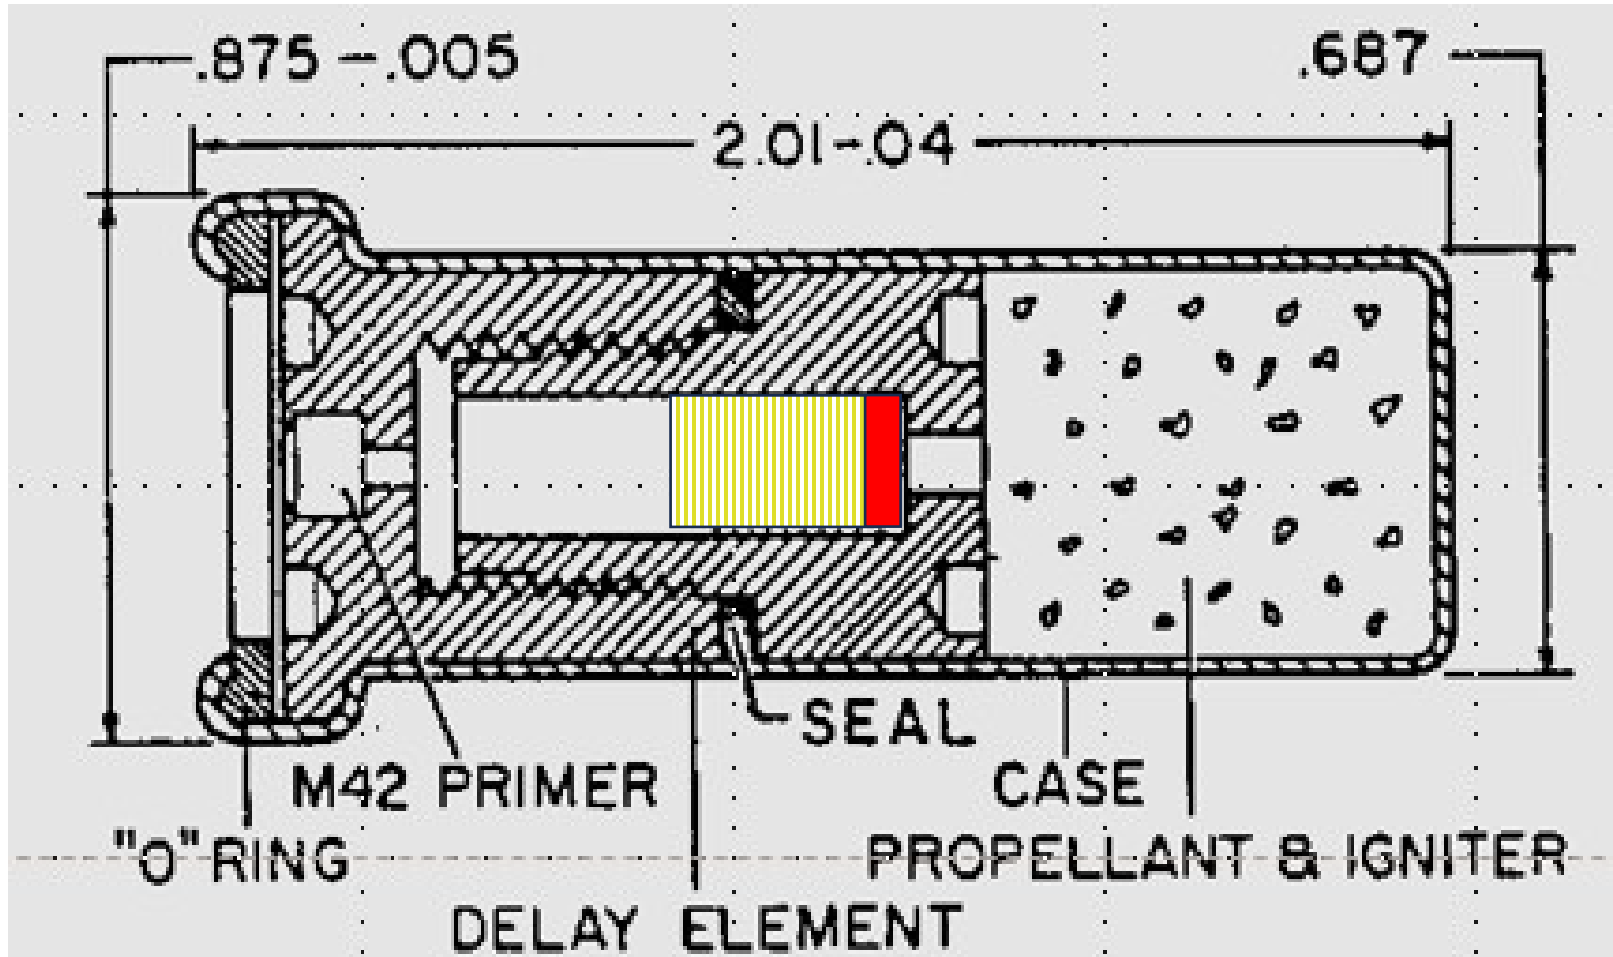
# Zr-Ni Comp Delay Failure (Dud)

- Insufficient thermal output, of primer or delay increment
- Too high density at increment interface, affecting ignitibility and gas flow
- Contamination of sidewall with output charge during loading
- Expansion/contraction causing movement of displaced increment during burn
- Too high loading pressure (glazed increment) – too hard to ignite
- Too low loading pressure (reacted increment) – too soft to retain position
- List could go on and on...
