USN & USMC CAD/PAD Mishaps and Engineering Investigations

Technical Exchange Workshop 2025

MD65 Failed to Fire EI

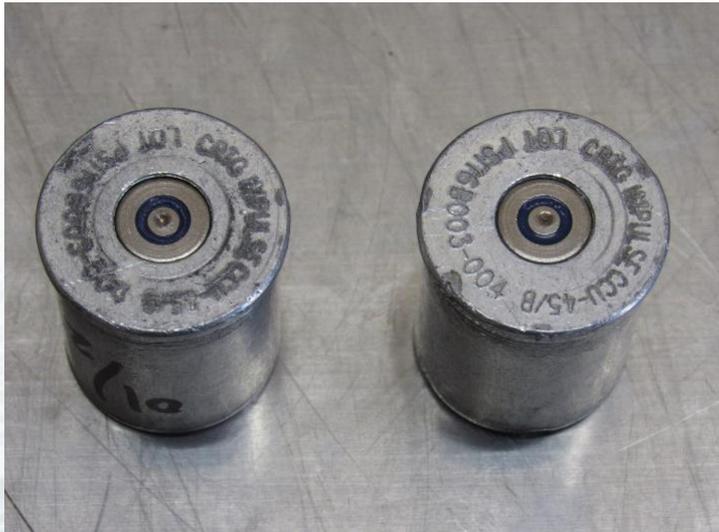
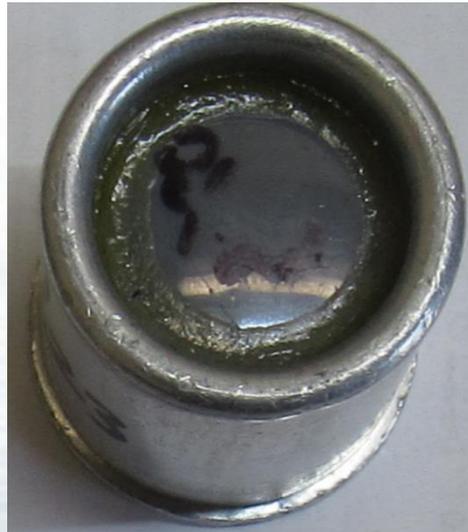
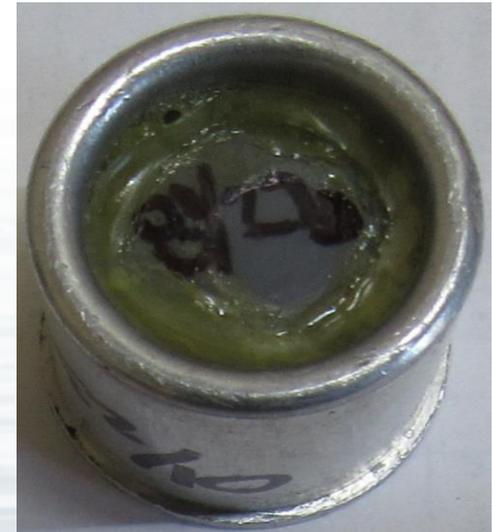
MD65 Fail to Fire Lot: PSI16B003-004

- Initial visual inspection:
 - Both CADs displayed evidence of mishandling, corrosion and mislabeling. The cup closure assemblies appeared discolored with broken epoxy sealant and an appearance that additional epoxy had been applied.
 - Container open and expiration dates on both CADs were labeled with incorrect expiration dates on them. Inspection of the rest of the MD65s from this lot at station weapons revealed numerous labeling/marketing discrepancies as well as mishandling.

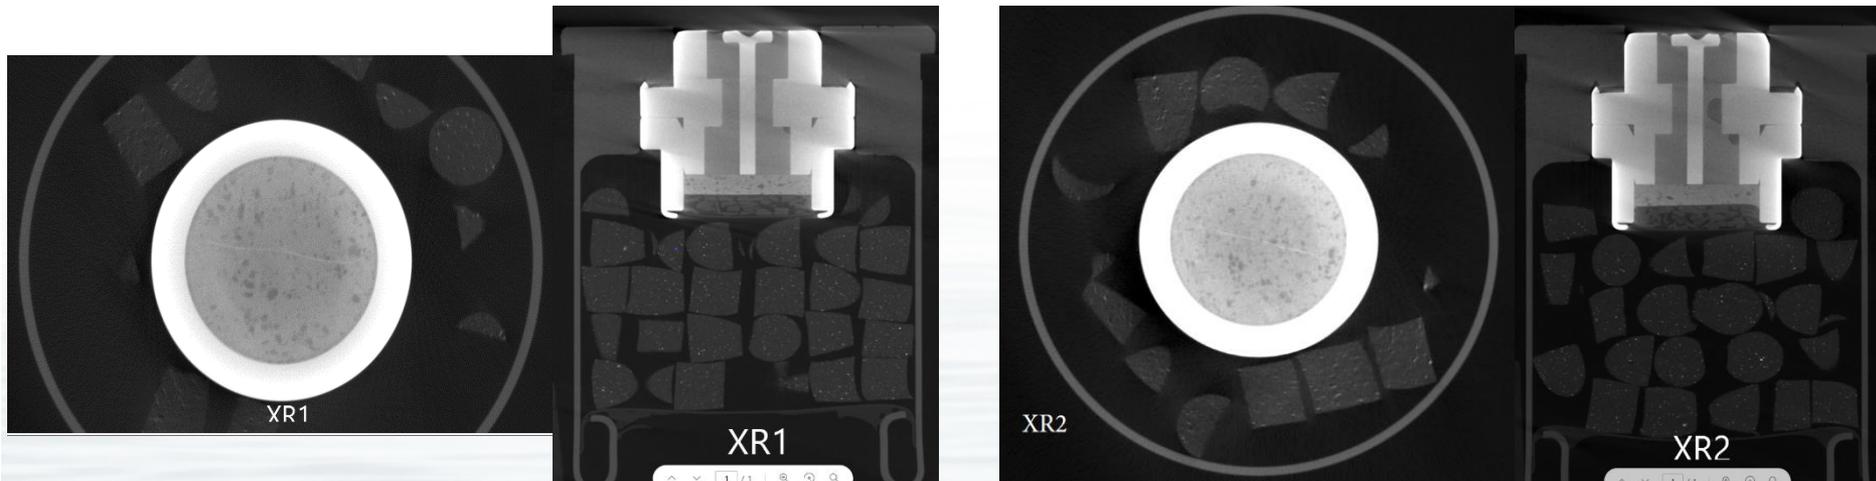
Bridge Wire and NDT

- Computed tomography scan displays both ignition elements and bridge wires intact.
- Igniter circuit test indicate circuits are within acceptable specification range of 1.1 +/- 0.15 ohm.
 - XR1: 1.19Ω
 - XR2: 1.17Ω

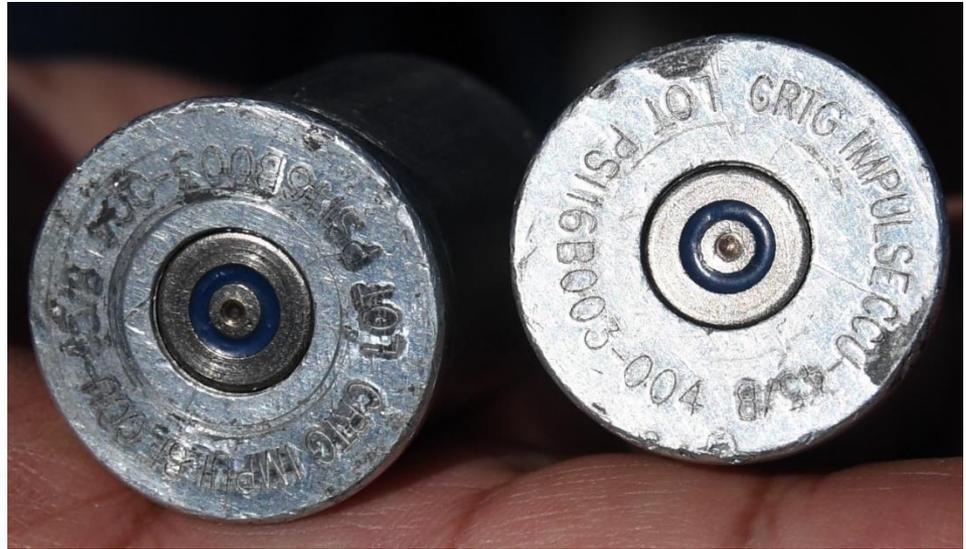
Ignition Element Depth Insp.

- LAU-116 firing pin length tolerance is .026 - .067.
- The results for the measuring of firing pin indents on the cartridges are as follows:
 - XR1: .029"
 - XR2: .041"

- Results for the firing pin electrode lengths of subject LAU-116 are as follows:
 - Forward measured between 0.023 and 0.044
 - Aft measured between 0.024 and 0.033

- Both suspect CAD's (XR1 and XR2) passed all NDT analysis.
- Comparison measurements of the indents on both CAD ignition elements and the firing pin electrodes of the LAU-116 indicate a deficit between contact of the firing pin electrode and the CAD ignition element.

- XR1 ballistically functioned when commanded during testing.
- NSWC IHD E25 In-Service Engineering believes that if the LAU-116 firing pins were long enough to fill the void of the dimples in the XR1 and XR2 then they would have ballistically functioned during flight.

- PMA-201 AAE, FSAT and NSWC CAD/PAD are developing a test to measure variances between different racks and launchers that would measure dimple depths, widths and current on stores cartridges.
