SUPSALV completes repairs to USS KEARSARGE (LHD 3) fuel oil tanks.

23 April 2014

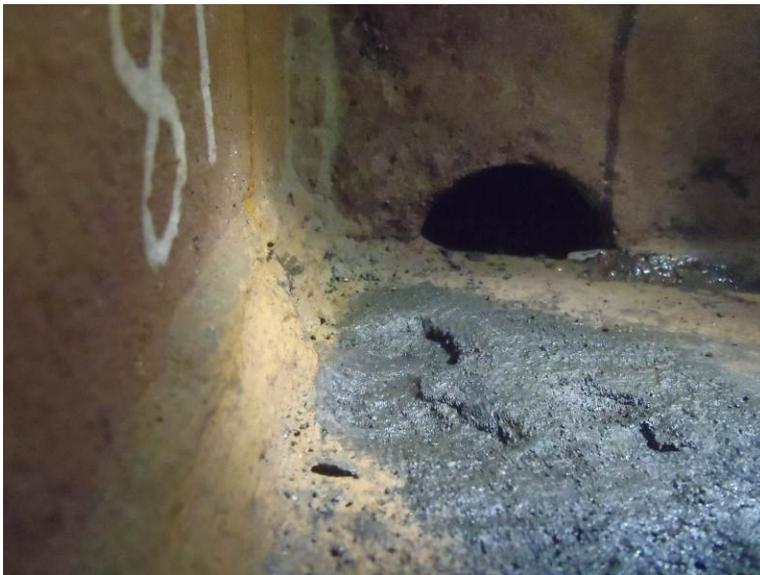
Example of corrosion found in a tank which needed to be cut out and patched.

To repair a deficiency, the team would place an external patch over of the section which needed repair. Then they would cut out the damaged steel and weld a plate in place from the inside. Then an open cofferdam would be installed on the outside of the ship which allows diver access and the plate would be prepped, welded and painted from within the cofferdam.

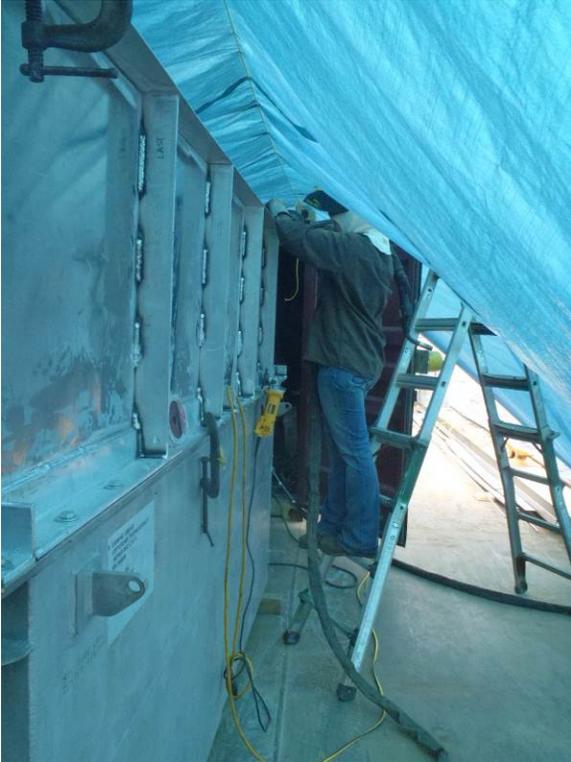
A team of divers, working under a cover on the dive barge, are welding the top hat of the open cofferdam. This configuration ensured the seal was effective and would allow in-water welding on the outside of the hull.

The cofferdam would need to be templated for each section of the hull that it was to be used to ensure a good seal was present when placed against the hull. This was done on the dive barge and it involved fabricating a "top hat"

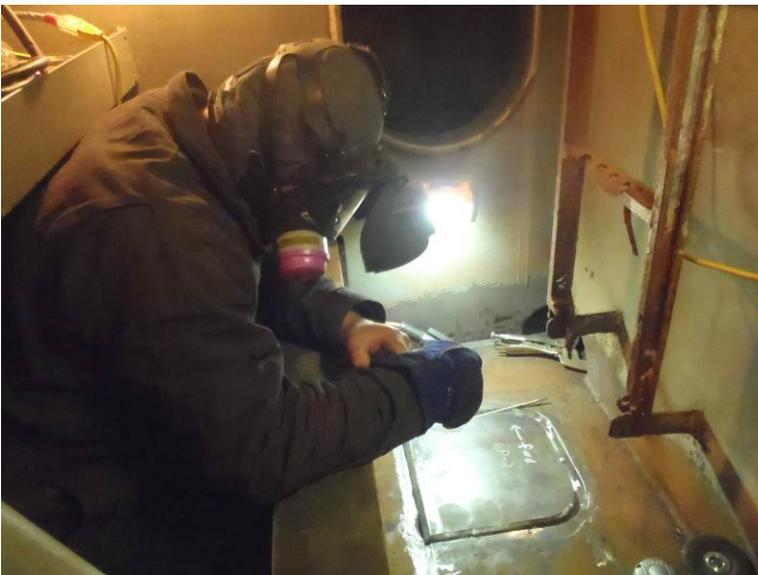
This picture shows a welder working inside the ship, beginning the weld repair with a root weld.

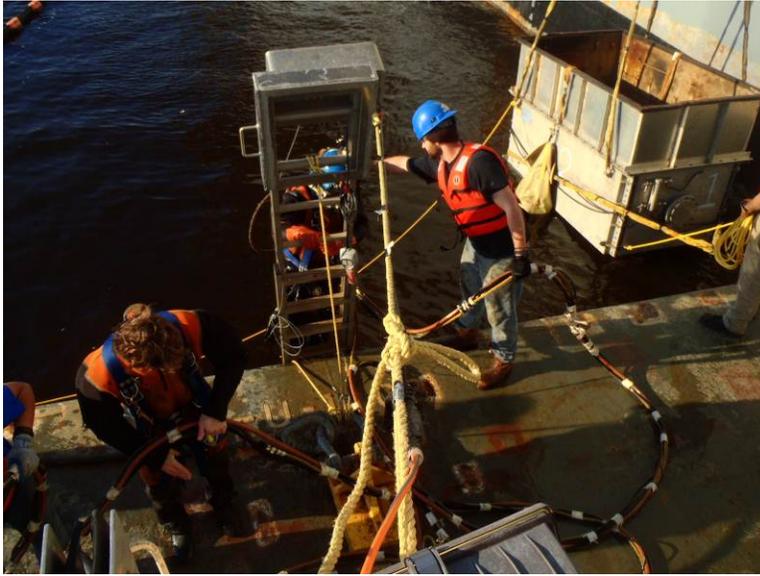
A diver exiting the water (on the ladder) and the cofferdam on the right is suspended by a crane above the water's surface after completing a weld repair.
