SUPSALV Completes Timely Repairs to Three Norfolk Based DDG Class Ships

7 December 2012

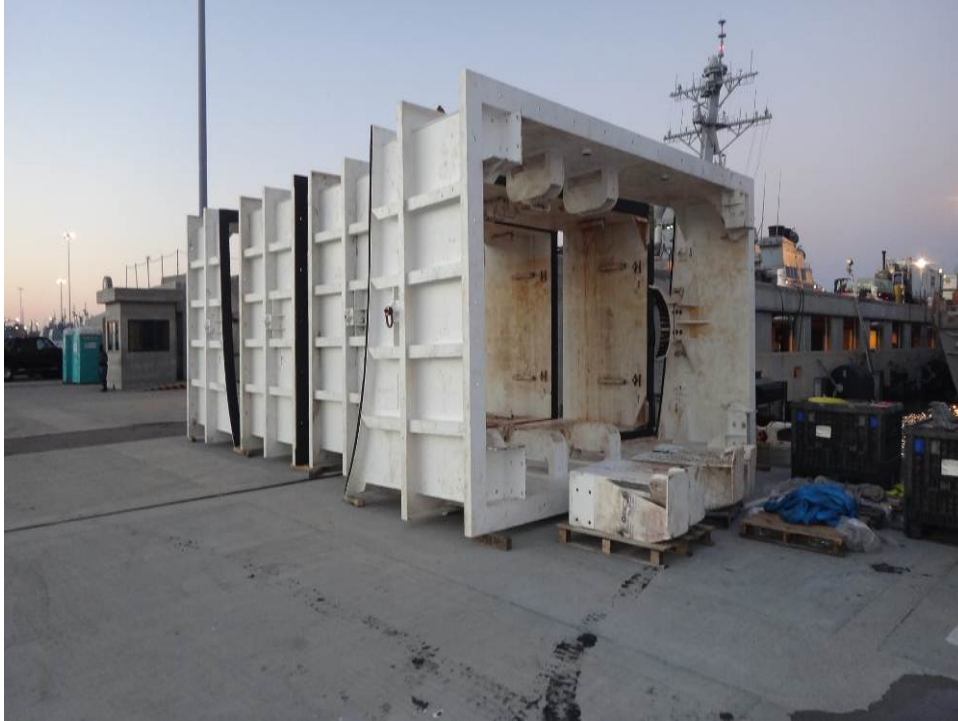
The three sections of the full cofferdam are shown on Pier 6 in Norfolk Naval Station.

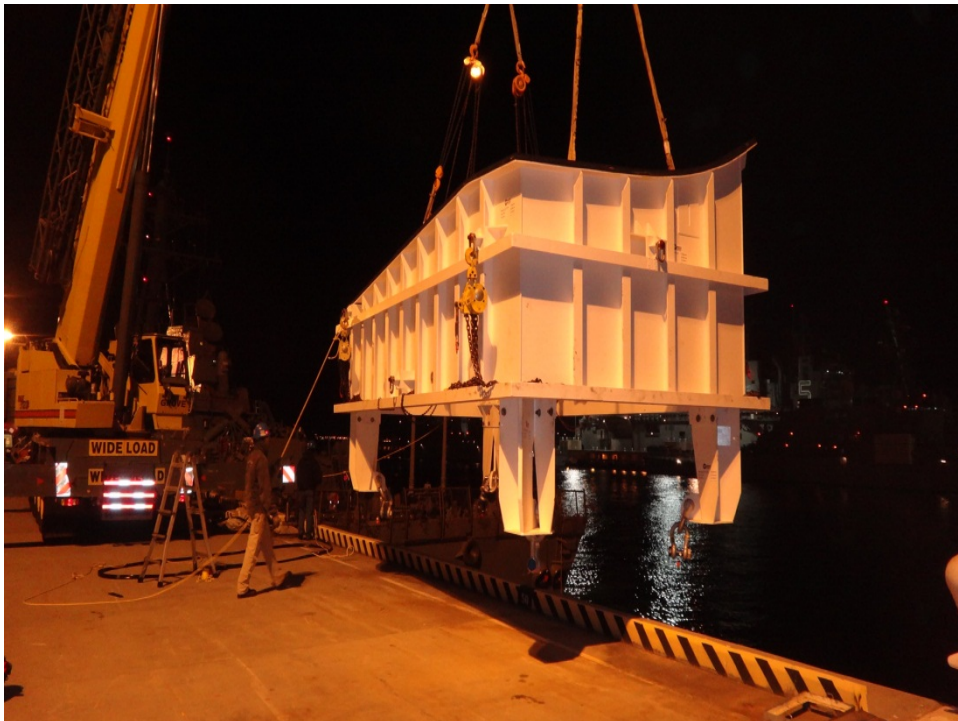
One section of the new three-piece rudder cofferdam being moved from the pier to the water for fitting onto USS MAHAN (DDG 72).

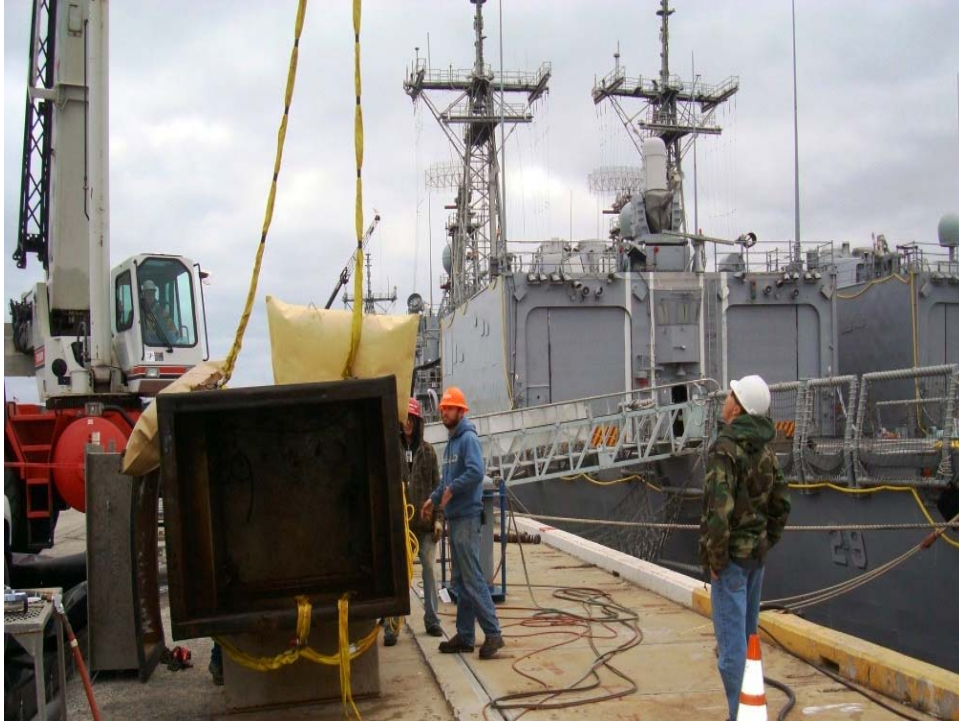
An image of the traditional 4' x 4' dry habitat being rigged for use.

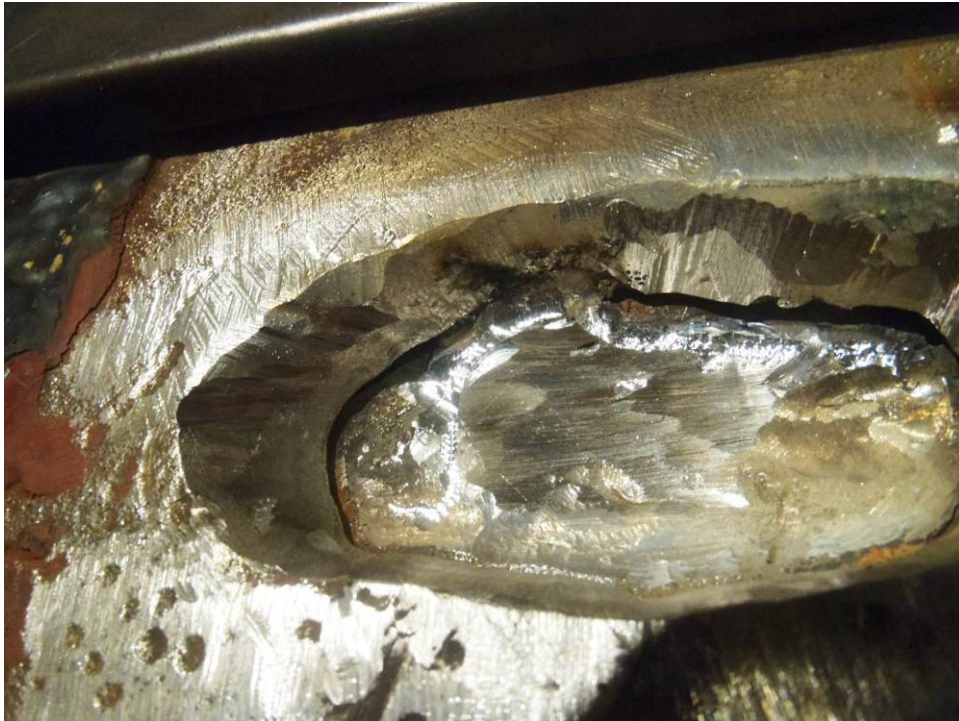
As is typical, the size and number of indications on a rudder found during the repair process is often greater than originally reported. The newly discovered indications, the term used to describe the visual portion of a suspected crack needing repair, require additional effort to accomplish and often the fault (crack) will run sub-surface making the repair area larger than the visual presentation. Once an indication is confirmed to be a crack in the rudder, repairs require: excavation of crack to soundsteel, verification/fitting of backing plate, welding and grinding flush, conducting VT (Visual Inspection), MT (Magnetic Particle Inspection), and pressure testing prior to acceptance and then application of anti-corrosive coating.

An example of a crack that has been ground out and the backing plate before welding commences.
