■ technical report on SALVAGING OF AFDM-2

PUBLISHED BY DIRECTION OF COMMANDER, NAVAL SEA SYSTEMS COMMAND

THE AFTERMATH OF HURRICANE BETSY

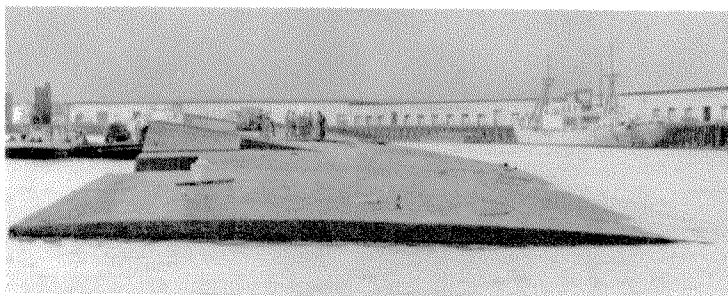
CAPSIZED DRYDOCK'S bottom pontoon sections were not seriously damaged, but more than 100 breaks were found in the wingwalls.

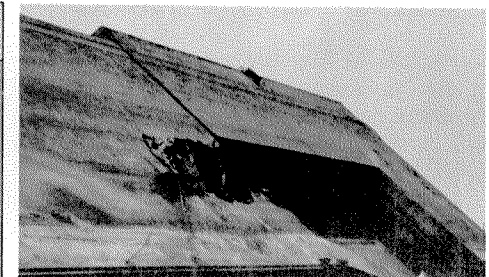
Reports from the divers indicated that damage to the exterior hull plating was not as extensive as had been expected. There were more than 100 holes in the hull structure, but only one major break was considered serious. This was an oval-shaped gash, 20 feet by 15 feet, at one end of the center section, about midway between the upper deck and the chine line, on the outside shell plating. In all probability, this hole shipped most of the water that capsized the drydock on her erratic journey during the hurricane.

BIGGEST BREAK was an oval-shaped gash, 20 feet by 15 feet, at the end of the center section.

It was decided that only one wall—the one that would be under water during the parbuckling operation—need be watertight. The more seriously damaged wall—with the large oval-shaped break—would be placed offshore during the salvage operation and consequently most of this wall area would be above water for the duration of the parbuckling. Some repairs near and below the water-line would be necessary. Major repairs could be deferred until the drydock was righted and towed to a shipyard. Thus, the salvage contractor could concentrate his repair efforts on the wall that would be underwater during the parbuckling operation.

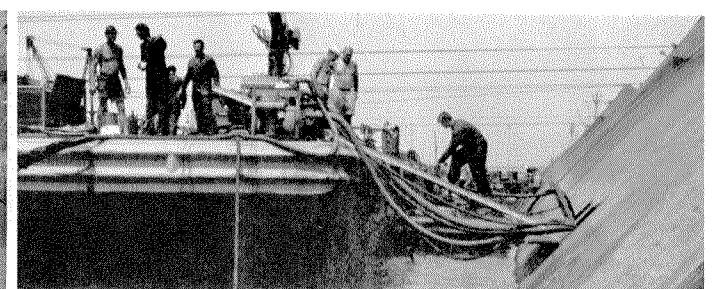
Once again the Mississippi's tightly compacted mud proved to be the culprit. The divers' assessment that only a negligible amount of mud remained in the hull had been made under highly adverse conditions. As a matter of fact, mud was clinging to horizontal stiffeners in both the pontoon and A wall machinery space areas to a thickness of about one foot. The weight and location of this mud was the upsetting factor.

BALLAST was added to inshore compartments of center section. Before drydock would assume Stage I position, 2,000 tons of mud and water had to be removed.

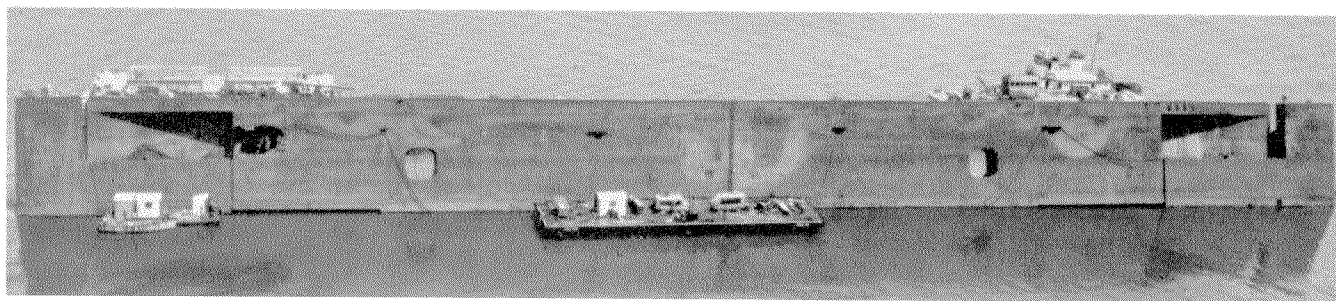
MOST SERIOUSLY DAMAGED WINGWALL, with oval-shaped hole (left), is shown at Stage XI. Salvage plan called for this wall to be placed offshore during the parabuckling operation so that the hole would be above water while the drydock was being rolled.

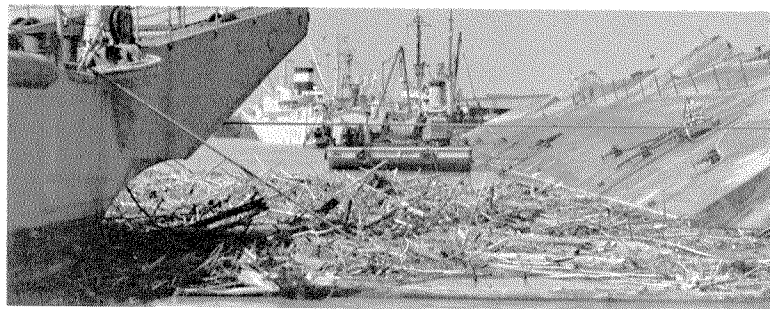
TONS OF DEBRIS, carried by high velocity flood waters, apparently snapped anchor cable of lift ship holding AFDM-2. Drydock was swept to opposite bank of Mississippi River.
