U. S. NAVY SALVAGE REPORT

USS FITZGERALD (DDG 62) AND USS JOHN S MCCAIN (DDG 56) SALVAGE RESPONSE AND HEAVY LIFT OPERATIONS

Published by Direction of Commander, Naval Sea Systems Command

1 MAY 2019

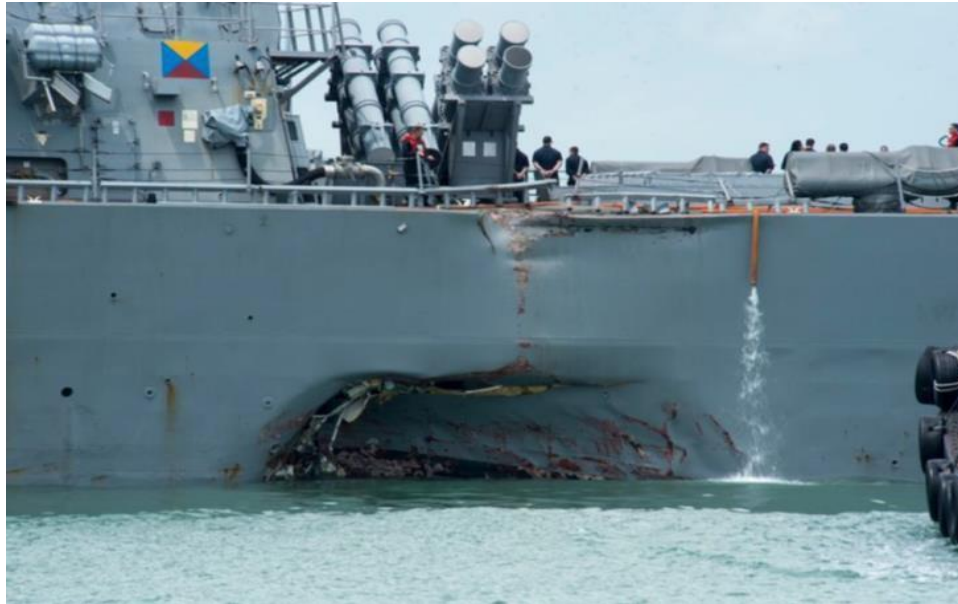
The bulbous bow of ALNIC MC struck USS John S McCain's port quarter creating a large indentation on the hull spanning approximately from frames 308 to 340 from approximately 7 feet above the keel to 31 feet above the keel. At the center of this indentation was a 4 – 7 ft wide split in the hull plating. The immediately affected compartments were Berthings 3 and 5, and Fuel Oil (FO) Service Tank 5-300-4-F. The indentation from the collision extended approximately 10 ft into all three of these spaces. Figure 1-4 show an image of the damaged hull and figure 1-5 shows a plan view of the damaged decks and spaces.

In addition to the side hull, the bilge keel suffered deformation from frame 330, where the bilge keel ends, to approximately 15 feet forward of the impact site. At the impact site, 95% of the bilge keel had peeled away, and the aft weld seam on the bilge keel had sheared off approximately 6 inches on top, and 1 foot on the bottom.

Figure 1-4. Photograph of the damage to the port side of John S McCain extending from frame 308 to frame 342.

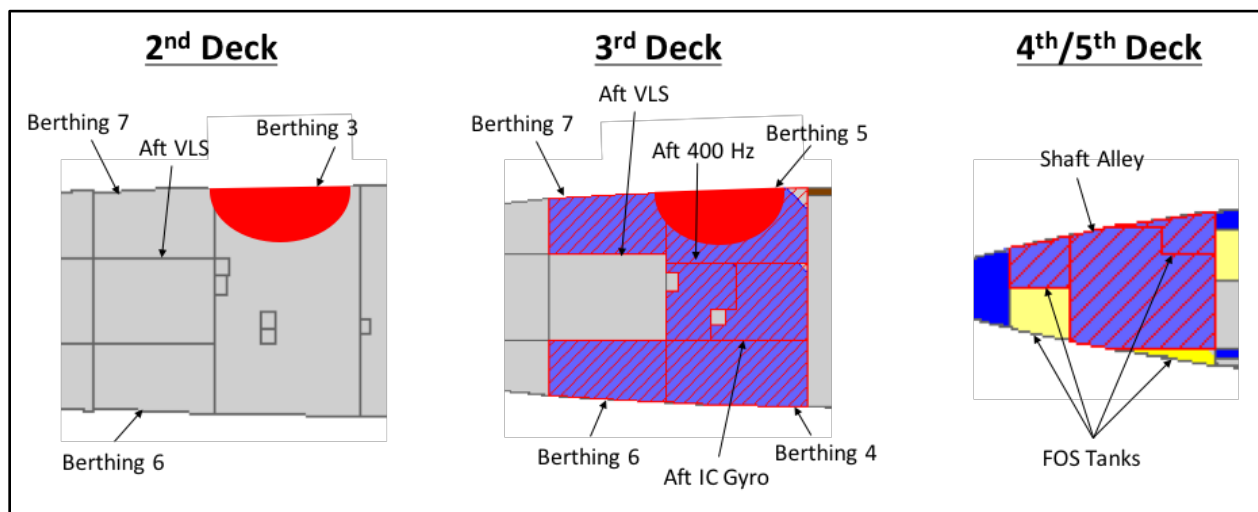
Figure 1-5. A plan view of damage to John S McCain. The red indentation represents collision damage. Red hashed spaces represent areas affected by flooding. Yellow spaces indicate the presence of fuel.

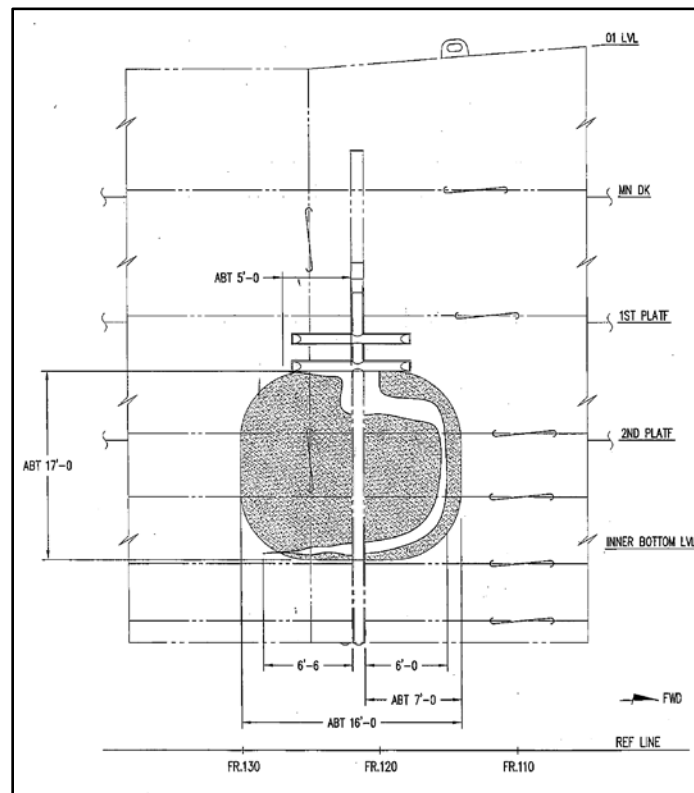
Figure 2-1. Early drawing of the damage based off the diver's description and sketch. The horizontal and vertical "tubes" that run down the middle of the hole are masker air belts.

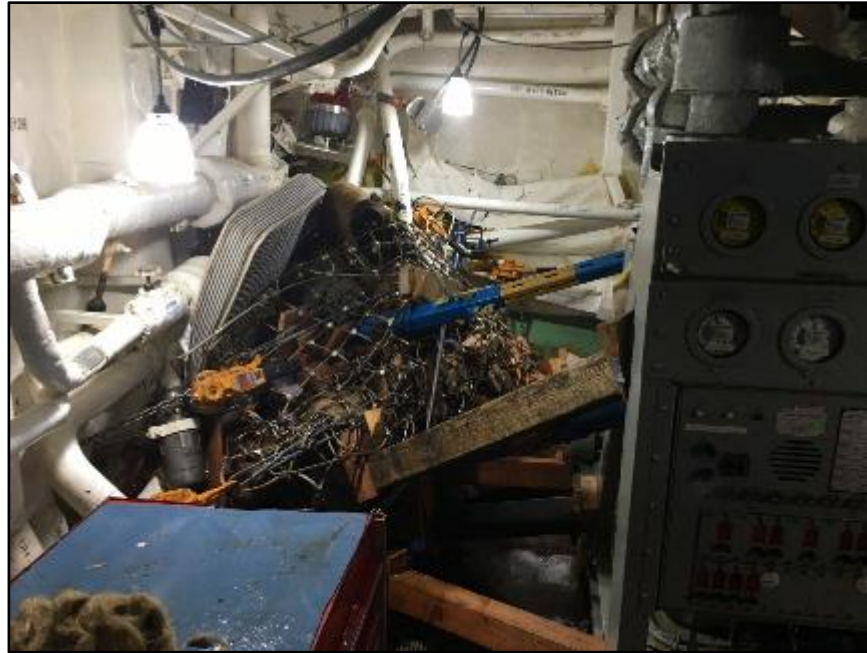
Analysis of flooded spaces determined that dewatering AMR 1 would improve the ship's damaged stability as it contained over 750 LT of seawater and was also contributing significantly to the 5-degree list of the ship. The salvage team tried multiple pumping configurations but were unable to outpace the leak rate beyond pumping a few feet below the ship's waterline. Ultimately they configured two 6-in hydraulic pumps rated at 2200 gallons per minute (GPM) in the AMR 1 escape trunk to dewater the space. By the end of the day, the space went from fully flooded to 5 feet of water on the upper level (the pumps had removed approximately 230 LT of seawater at that point). At this point, MDSU and SRF divers were able to access the space and identify a leak coming from the frame 126 transverse bulkhead between AMR 1 and Berthing 2. After divers patched the leak, the water level decreased to just below the lower level deck plates. MDSU and SRF divers were able to plug the hole with wooden wedges, mattresses, and other items all held in place with flight deck nets and chain hoists.

Figure 2-2. Auxiliary Machinery Room 1 salvage patch

This salvage patch slowed the rate of leaking into AMR 1 and greatly aided the ship's draft and trim. Over the next few days, the patch was improved and the wooden wedges swelled, further decreasing the leak rate. After 5 days, the leak rate was minor enough to be handled by the ship's installed main drainage system. Cement was later added around the patch, further strengthening it and filling gaps.

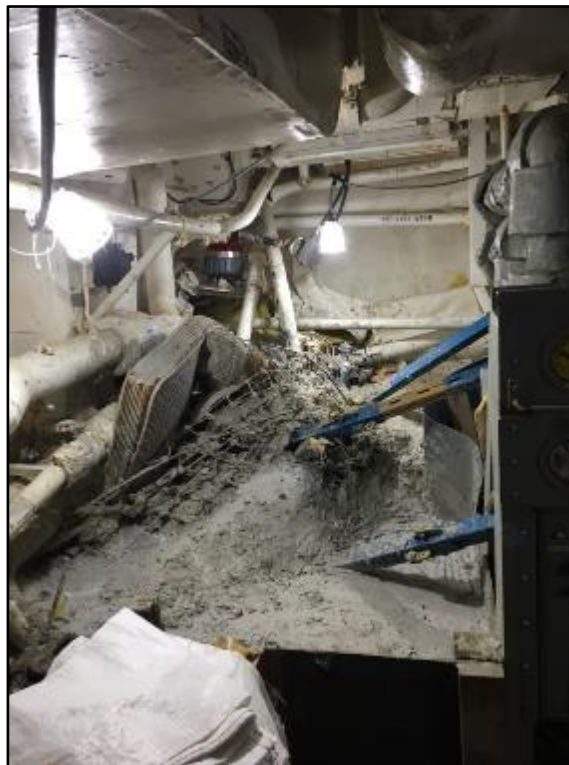
Figure 2-3. Auxiliary Machinery Room 1 salvage patch after application of cement

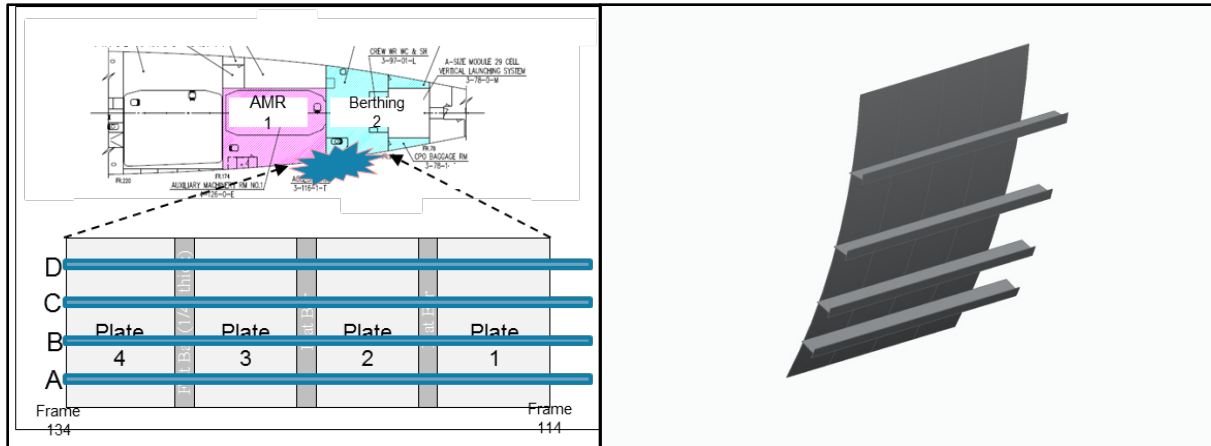
Figure 2-4. Fitzgerald Patch Design.

There were concerns about the ability of the unstiffened patch design to withstand the hydrostatic pressure. SUPSALV recommended that additional horizontal T-stiffeners be added to the design to ensure the patch did not buckle and fail under the expected stress levels. The patch was redesigned to have four horizontal T-stiffeners installed over the patch panels and flat bars. The stiffeners would have an 8 in flange and 13 in web, with a length of 24 ft, extending past the patch by 4 ft to join undamaged frames forward and aft of the affected area. Design calculations for stiffeners can be found in Appendix C. Welding requirements called for 1/4-inch root welds filled in to a 5/16-inch weld. However, since the majority of the stiffener welding was onto the DH-36 steel patch panels, the Phoenix International team used carbon steel welding rods saving time and money. SRF provided chemical lab analysis of the steel patch panels to verify and validate the use of the carbon steel welding rods.

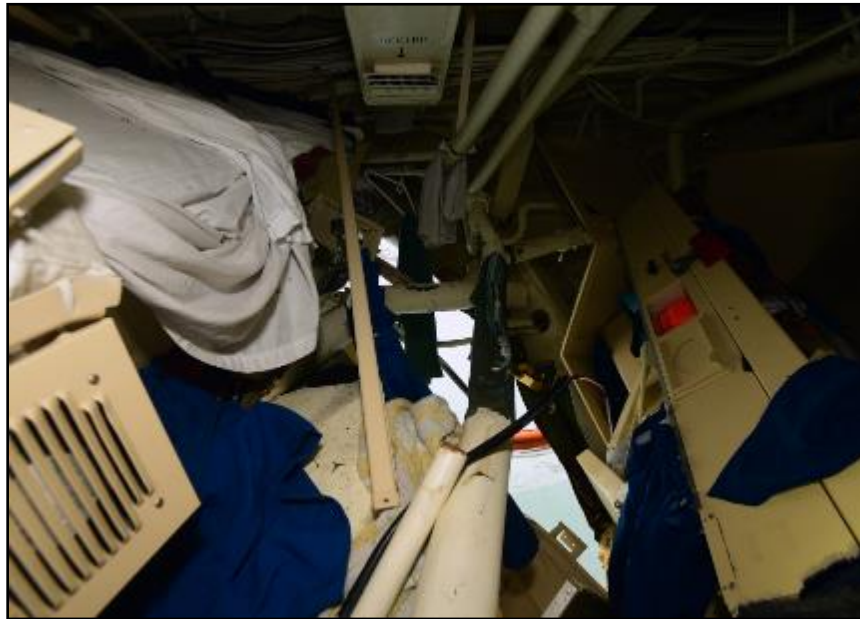
This work proceeded slowly – the underwater environment was packed with debris. Figure 3-1 shows the damage that occurred in Berthing 3 (directly above Berthing 5), and illustrates the difficulties the divers faced underwater. Space to maneuver/work was extremely confined. The first remains were recovered 23 August. All remains were recovered by 27 August 2017, 6 days after the initial collision.

Figure 3-1. Berthing 3 damage similar to that seen underwater in Berthing 5.

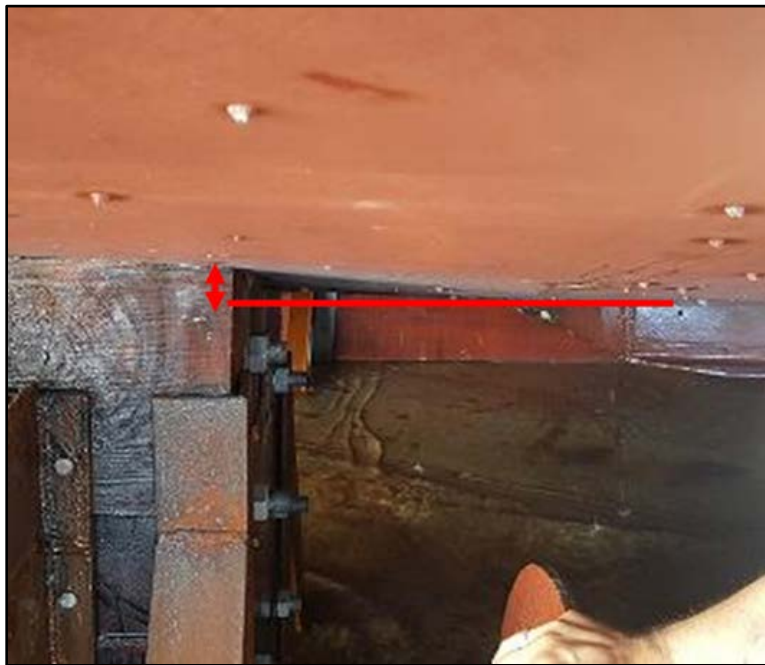
Figure 4-11. Hull deflection of approximately 15 mm at block interface

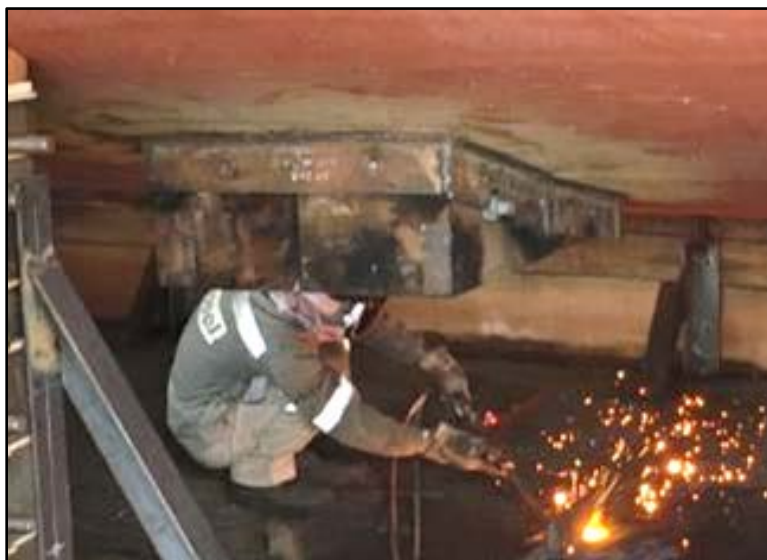
To prevent further leaks from the cracked compensated fuel tanks and fathometer trunk, Keppel manufactured and installed box patches. For the fuel tanks, the soft caps of the blocks acted as damage control plugs, and minimal leakage was observed while in Subic Bay. The blocks were loaded, and the team discussed how the leak rate would be affected by removing the blocks to install the patches. Another concern was how best to execute the removal of loaded side blocks. The team developed a method to keep the soft caps in place, while removing the lower portion of the blocks. Small metal frames were welded to the hull of USS John S McCain around the soft caps, and lag bolts were installed through the frames into the cap, (Figure 4-20). Once the soft caps were secured, hydraulic jacks and sledgehammers were used to remove the loaded blocks.

Figure 4-20. Soft cap "DC plugs" under box patches

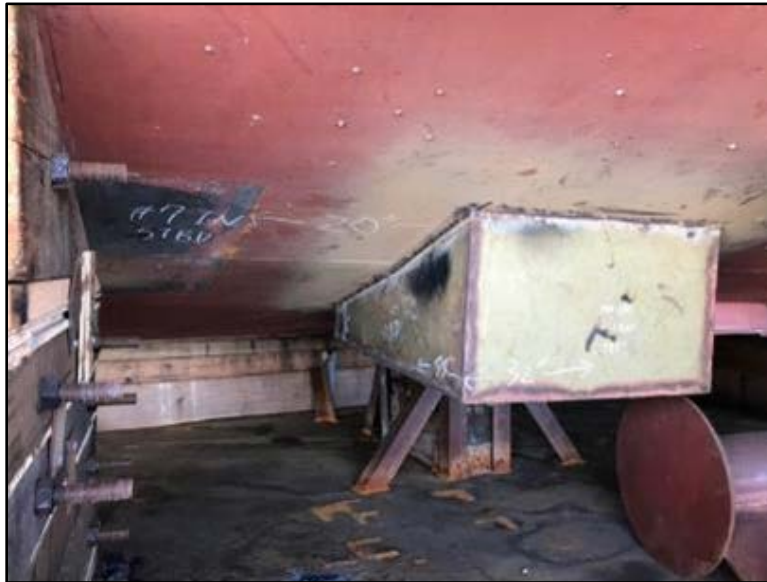
The box patches were welded to the hull and fitted to the frames that held the soft caps. The leak rate of the cracks did increase slightly when the loaded blocks were removed. The patches were fitted with a drain pipe and valve to allow for drainage during the welding process (Figure 4-21).

Figure 4-21. Completed box patch

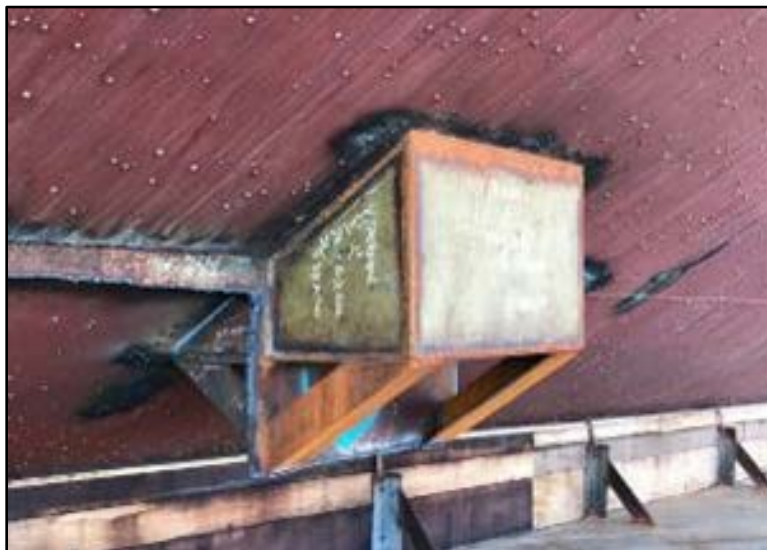
A leak in the fathometer trunk was determined to be caused by weld burn-through while securing a strong box during sea fastening in Singapore. Before departure, the leak was sealed with epoxy. When USS John S McCain arrived in Subic Bay, the epoxy seal was leaking. The trunk contained castor oil which Keppel indicated was a safety issue for welding on the tank. The solution was to assemble a larger box patch that could be welded outside the boundaries of the fathometer trunk and concrete was used to fill the box to form a seal (Figure 4-22).

Figure 4-22. Concrete filled box patch around Fathometer Trunk

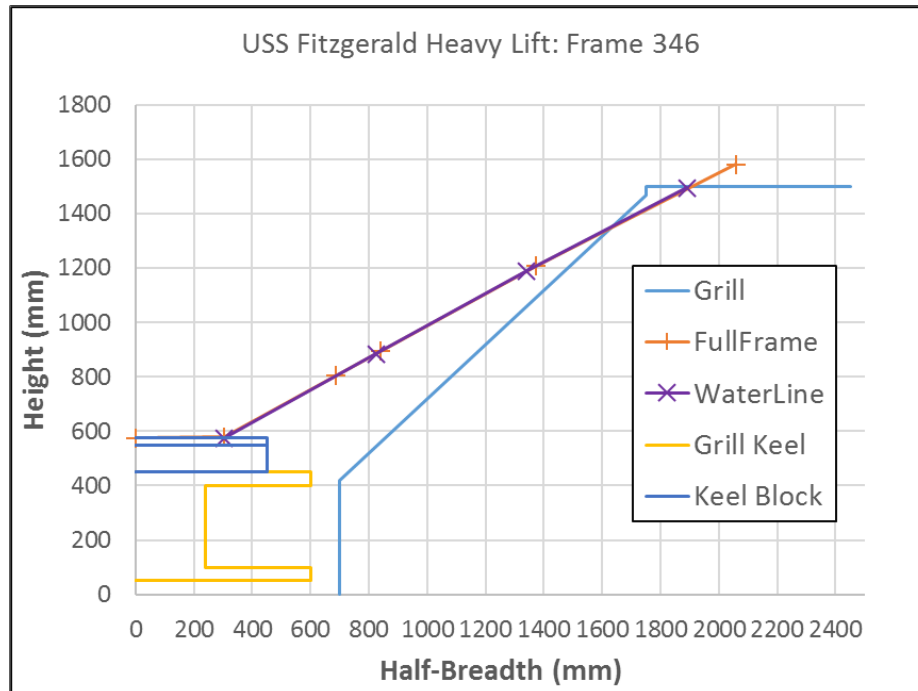
Figure 5-15. Starboard grillage and hull interference

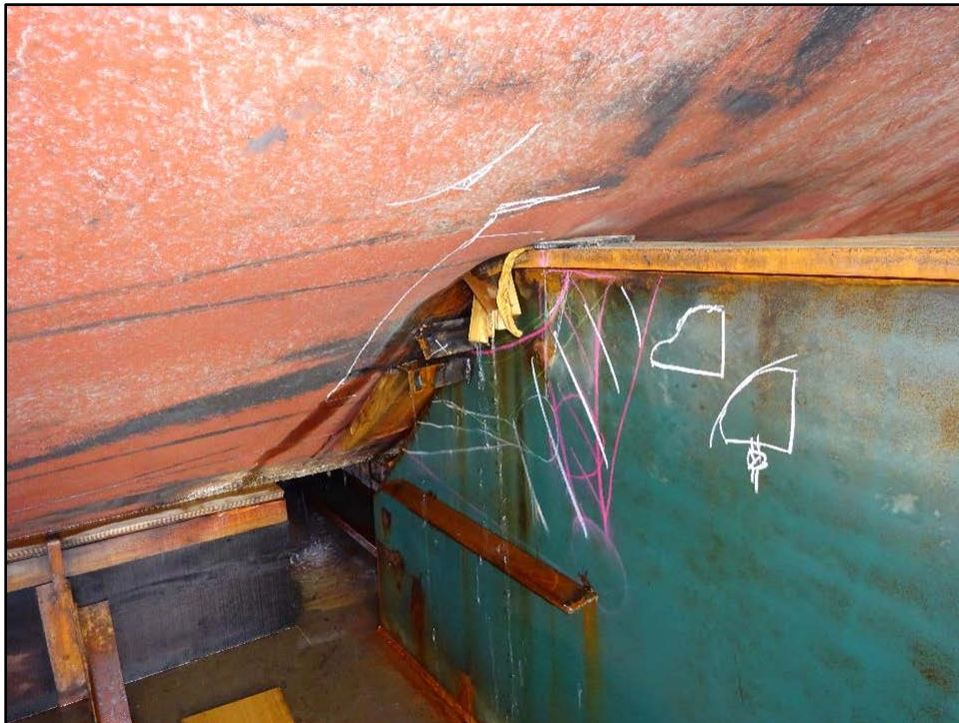
Figure 5-16. Port side damage due to interference with grillage, also found on starboard side

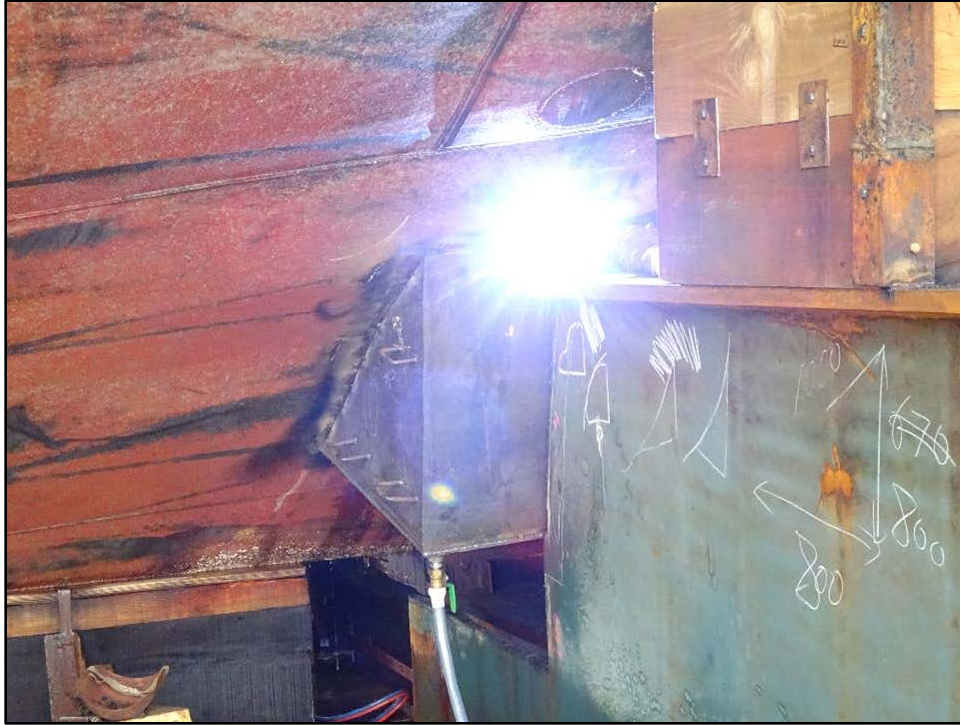
Figure 5-17. Portside box patch being welded to USS Fitzgerald hull

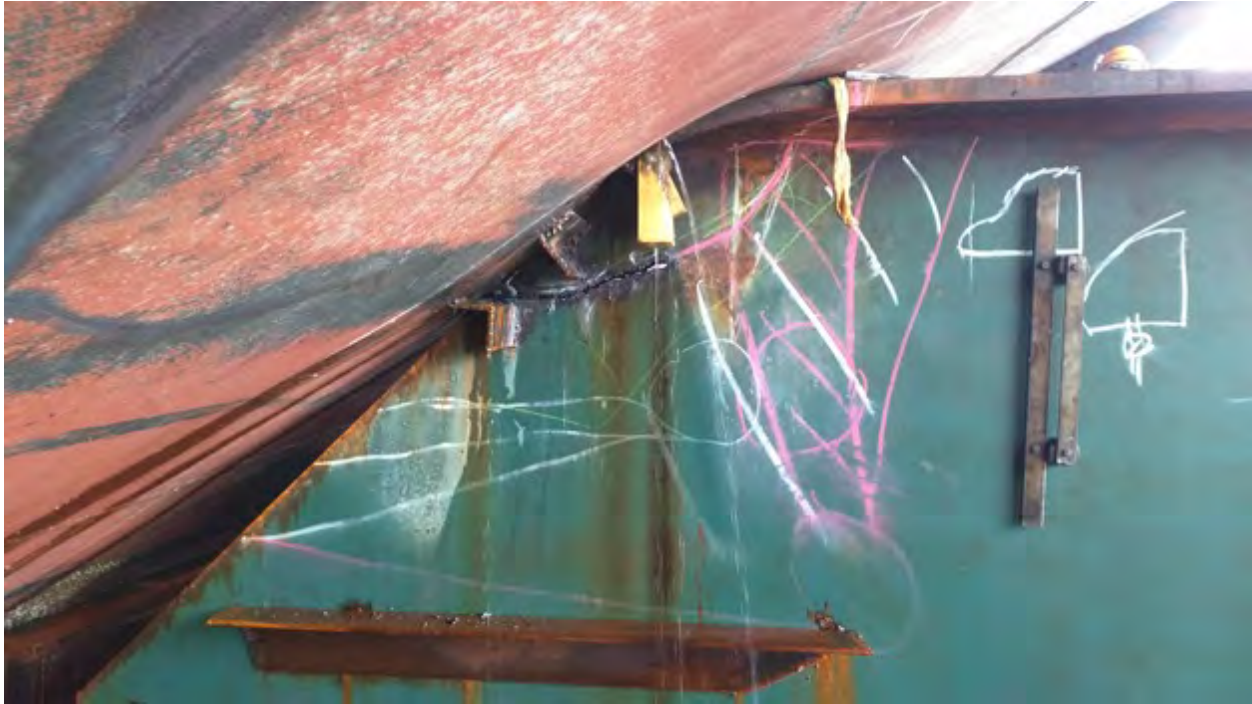
Fig 7. Cargo port side hull puncture resulting from contact with grillage at HTV frame 88.

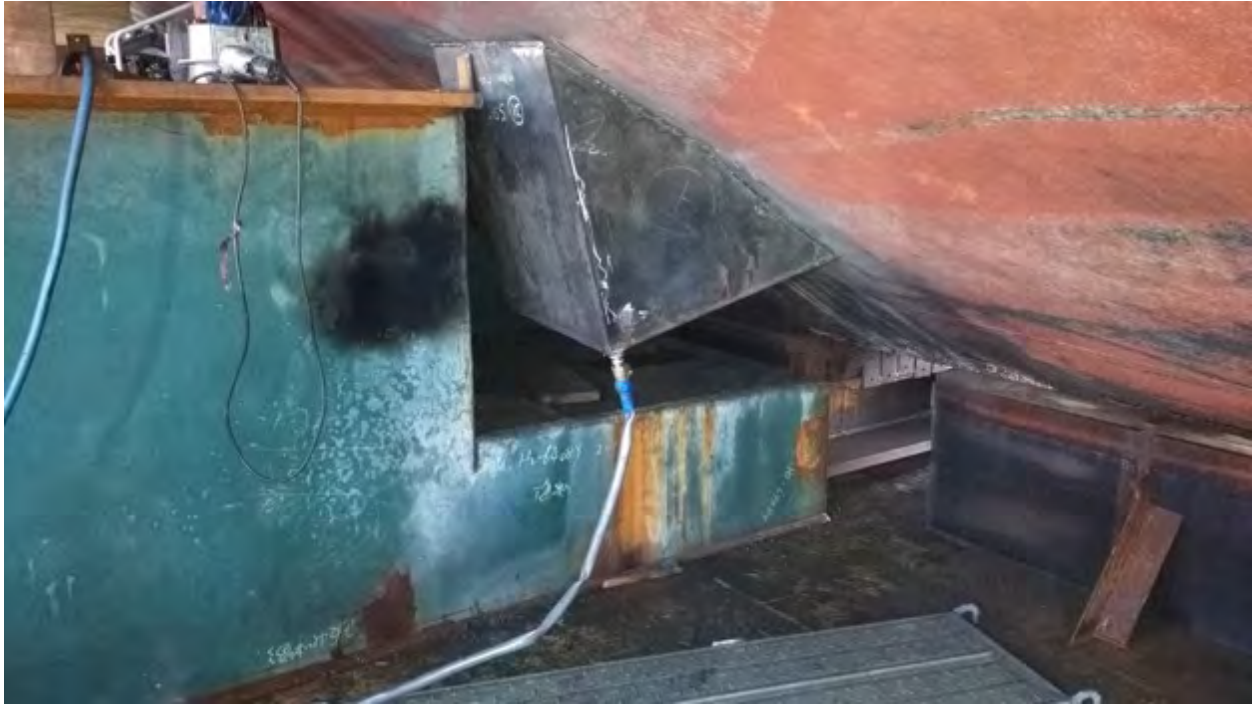
Fig 8. Cargo starboard side hull puncture box patch.

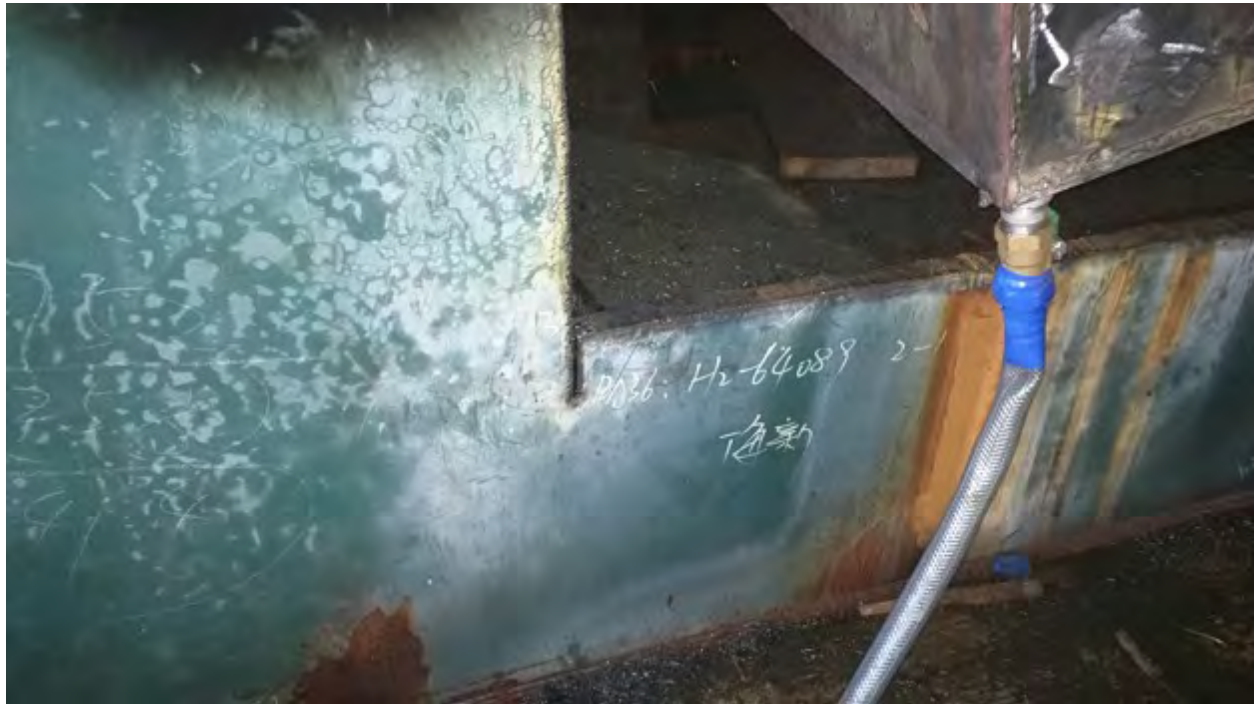
Fig 10. Overcut of the beam under the cargo starboard side box patch.

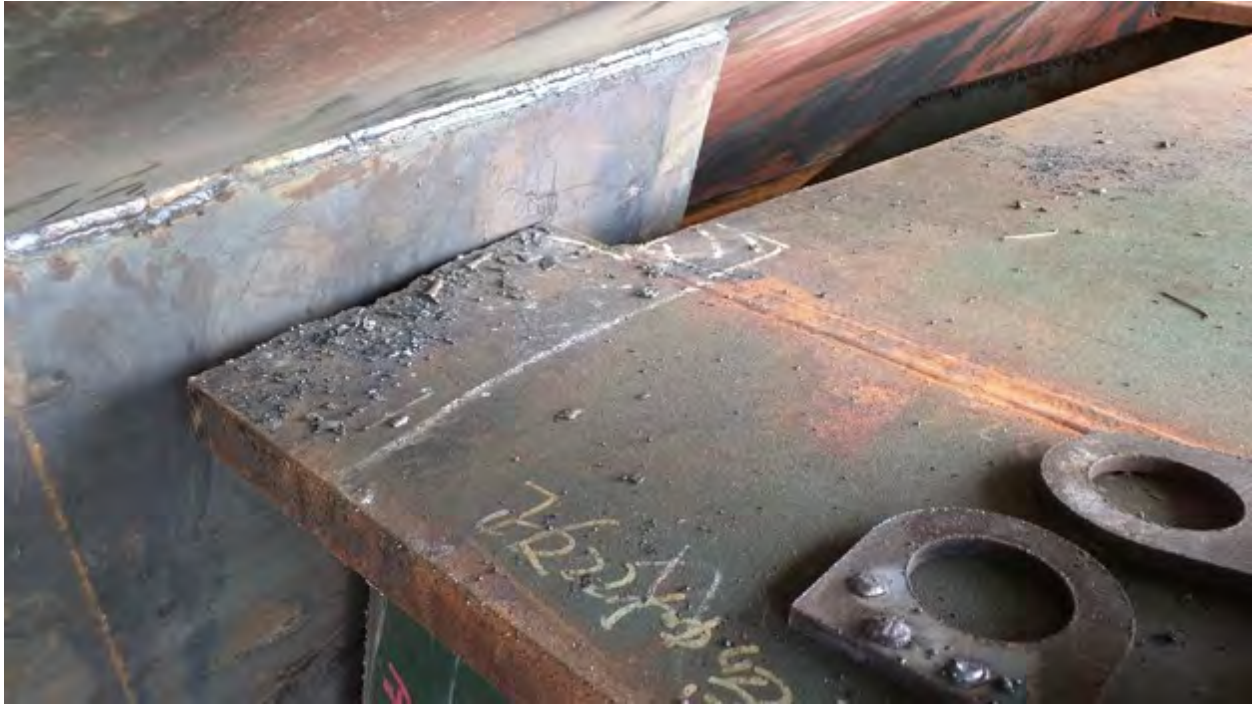
Fig 11. Grillage beam in contact with the box patch on the cargo hull's port side.

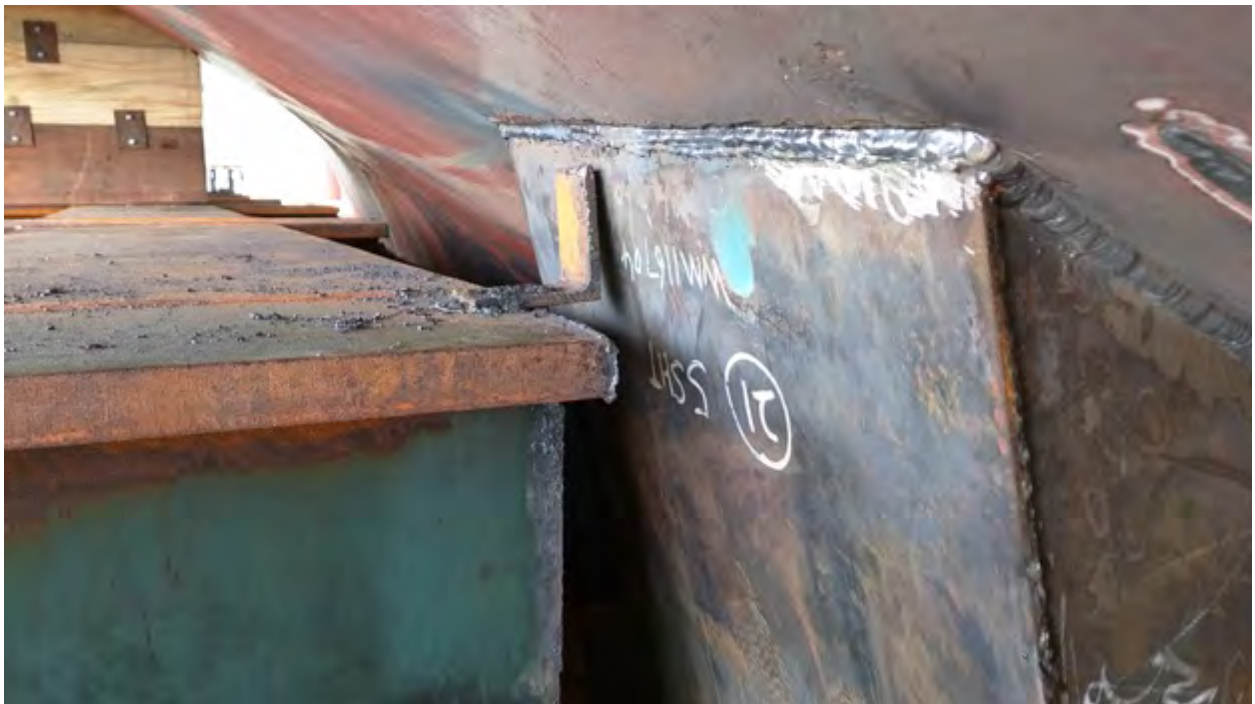
Fig 12. Grillage beam in contact with the box patch on the cargo hull's starboard side.

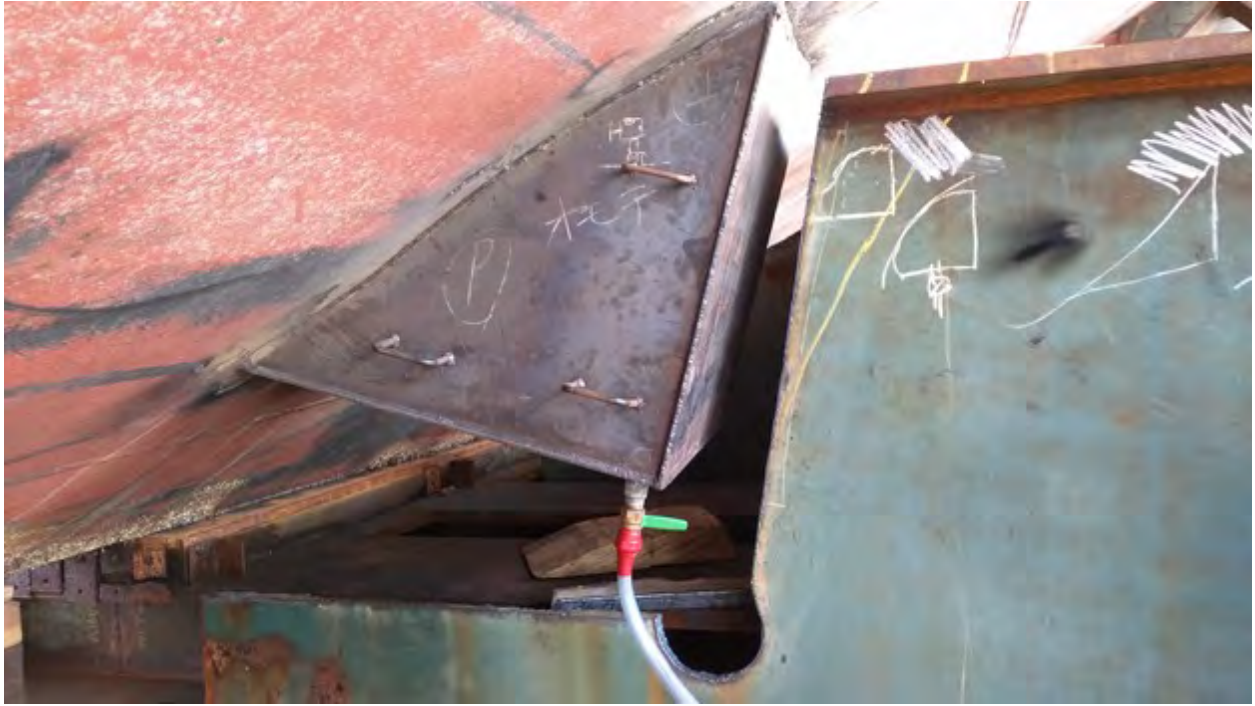
Fig 13. Revised grillage cut on the cargo hull's port side.

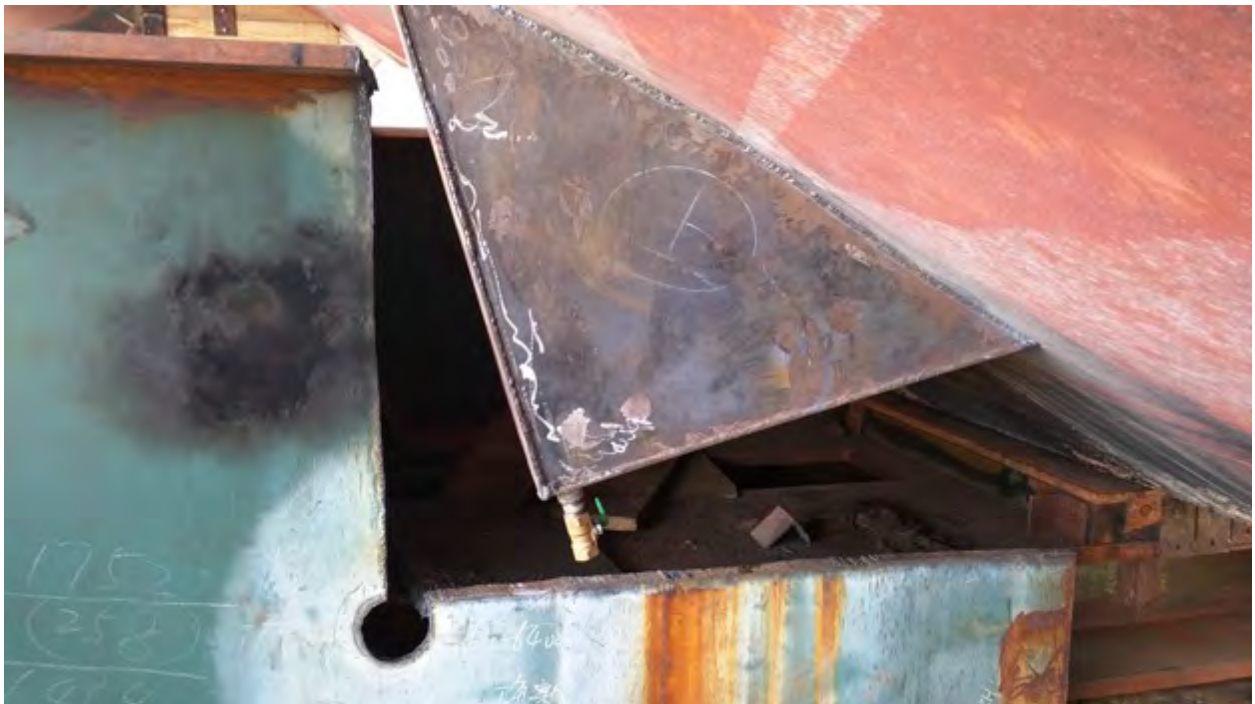
Fig 14. Revised grillage cut on the cargo hull's starboard side.
