THE SALVAGE OF THE LITTON LAUNCHING PLATFORM

U.S. NAVY SUPERVISOR OF SALVAGE

NAVSEA 0994-LP-017-5010

LCDR C.A. Bartholomew USN
Office of the U.S. Navy Supervisor of Salvage

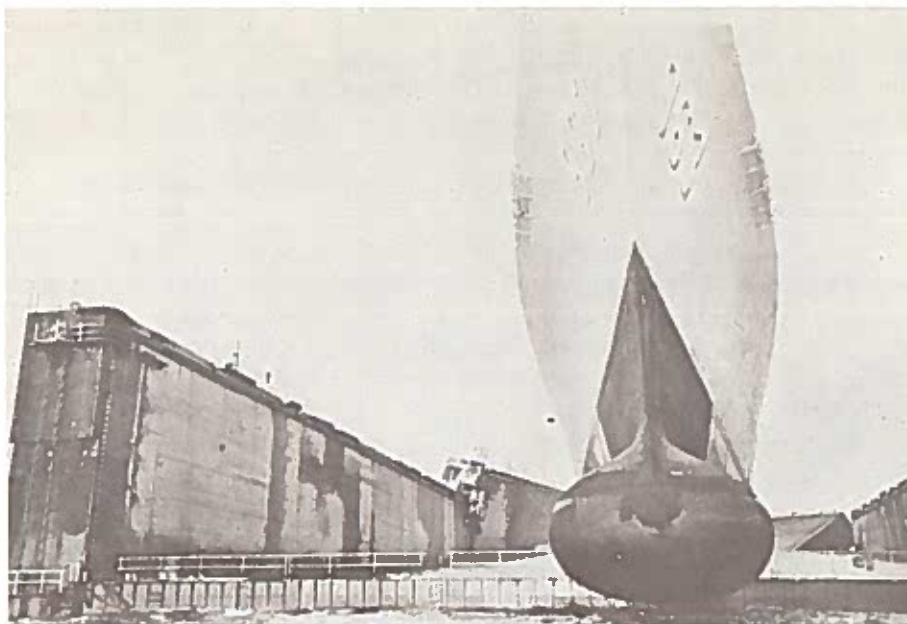
PHOTOGRAPH 3. Dock breaking up with USS SPRUANCE on blocks. Attempting to control list and trim.

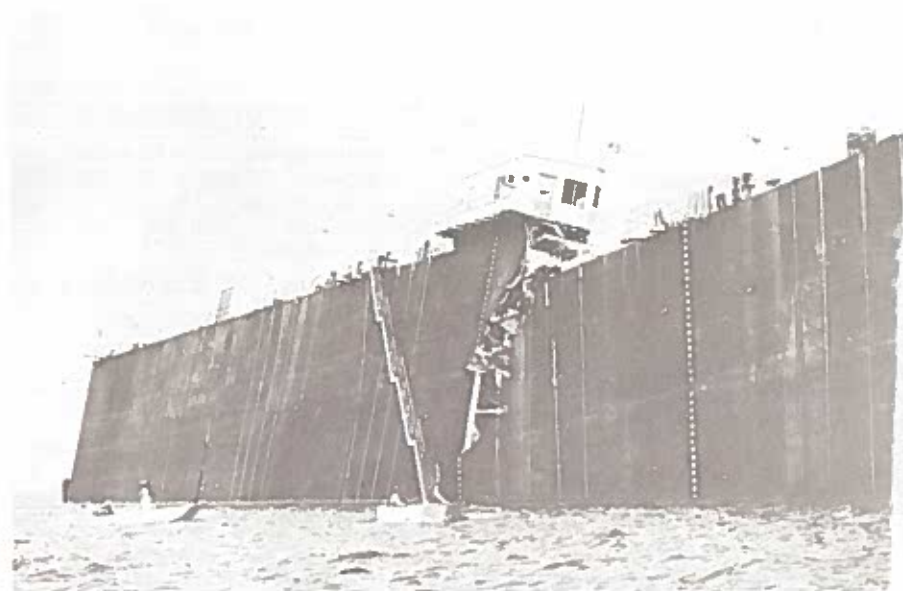
PHOTOGRAPH 4. Launching platform failing amidships in combined shear and compressive buckling.

The damage cited in (2) above to port and (3) and (4) above to starboard appeared to be caused by the compressive loads induced upon the upper portions of the wing walls as the pontoon deck sagged. Basic failure in compressive shear on the port side was clearly evidenced by the 45° axis of structural failure. On the starboard side, damage was less significant because the compressive load tore the portable wing walls loose from the pontoon deck and resulted only in minor structural damage to the wing wall above Tank 19. The four detached wing wall boxes were retrieved and set ashore for repairs within a few days. It may be further theorized that when the starboard portable wing walls broke loose and the platform completely fractured amidships, the forward half initially rotated and/or lifted a sufficient amount relative to the ship to strike the SPRUANCE propellers, causing the holes cited in (5) above.

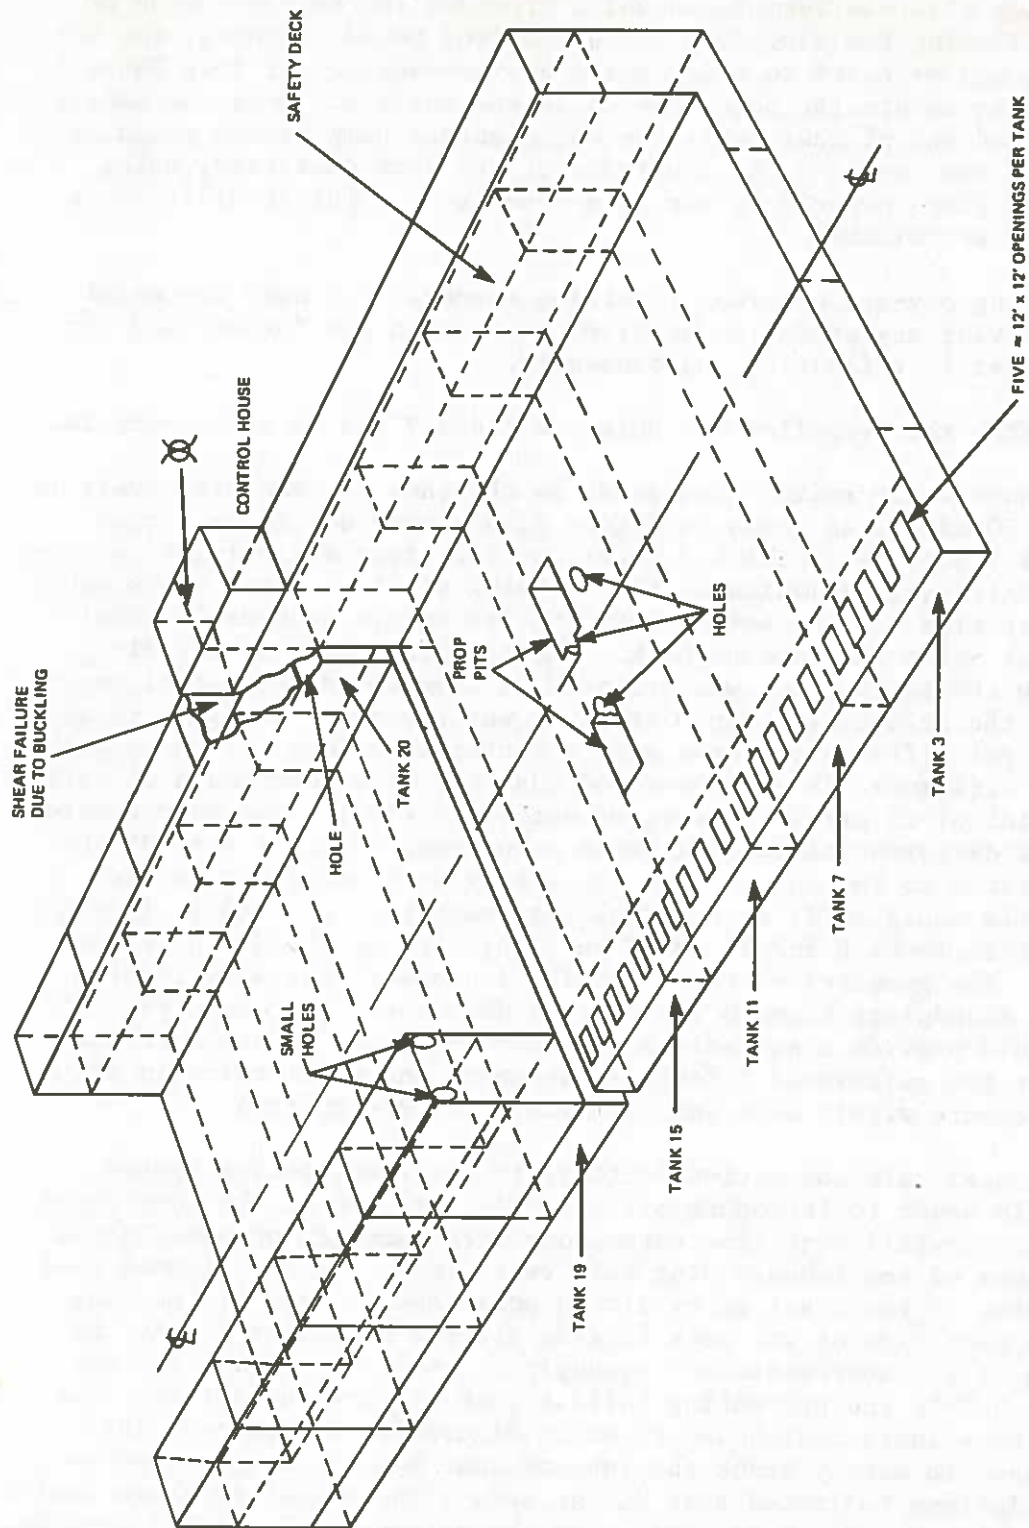
FIGURE 6. Schematic View of Underwater Damage.

(2) Both machinery spaces above the safety deck and Tank 20* were severely damaged and open to the sea (see Figure 6).

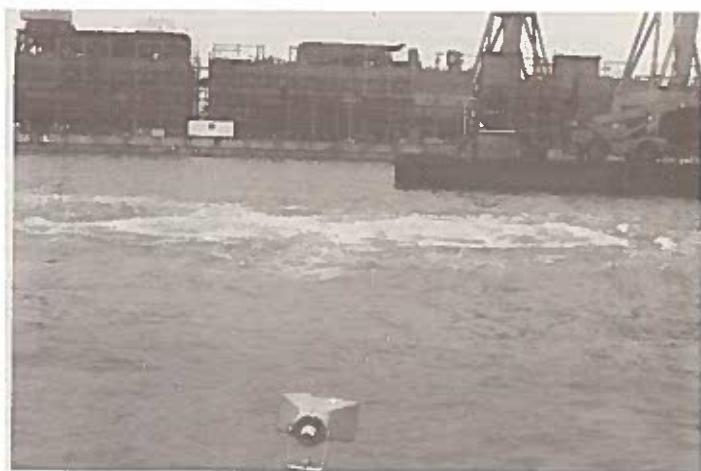
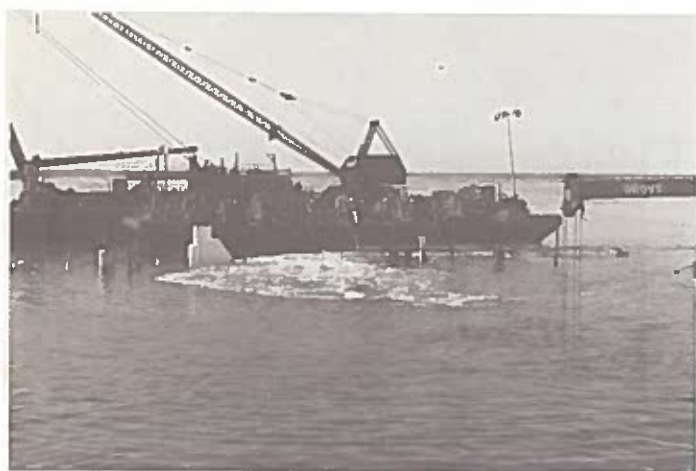
PHOTOGRAPH 9. Air leakage from propeller pits.

PHOTOGRAPH 10. Air leakage from damaged plate on inboard wing wall.

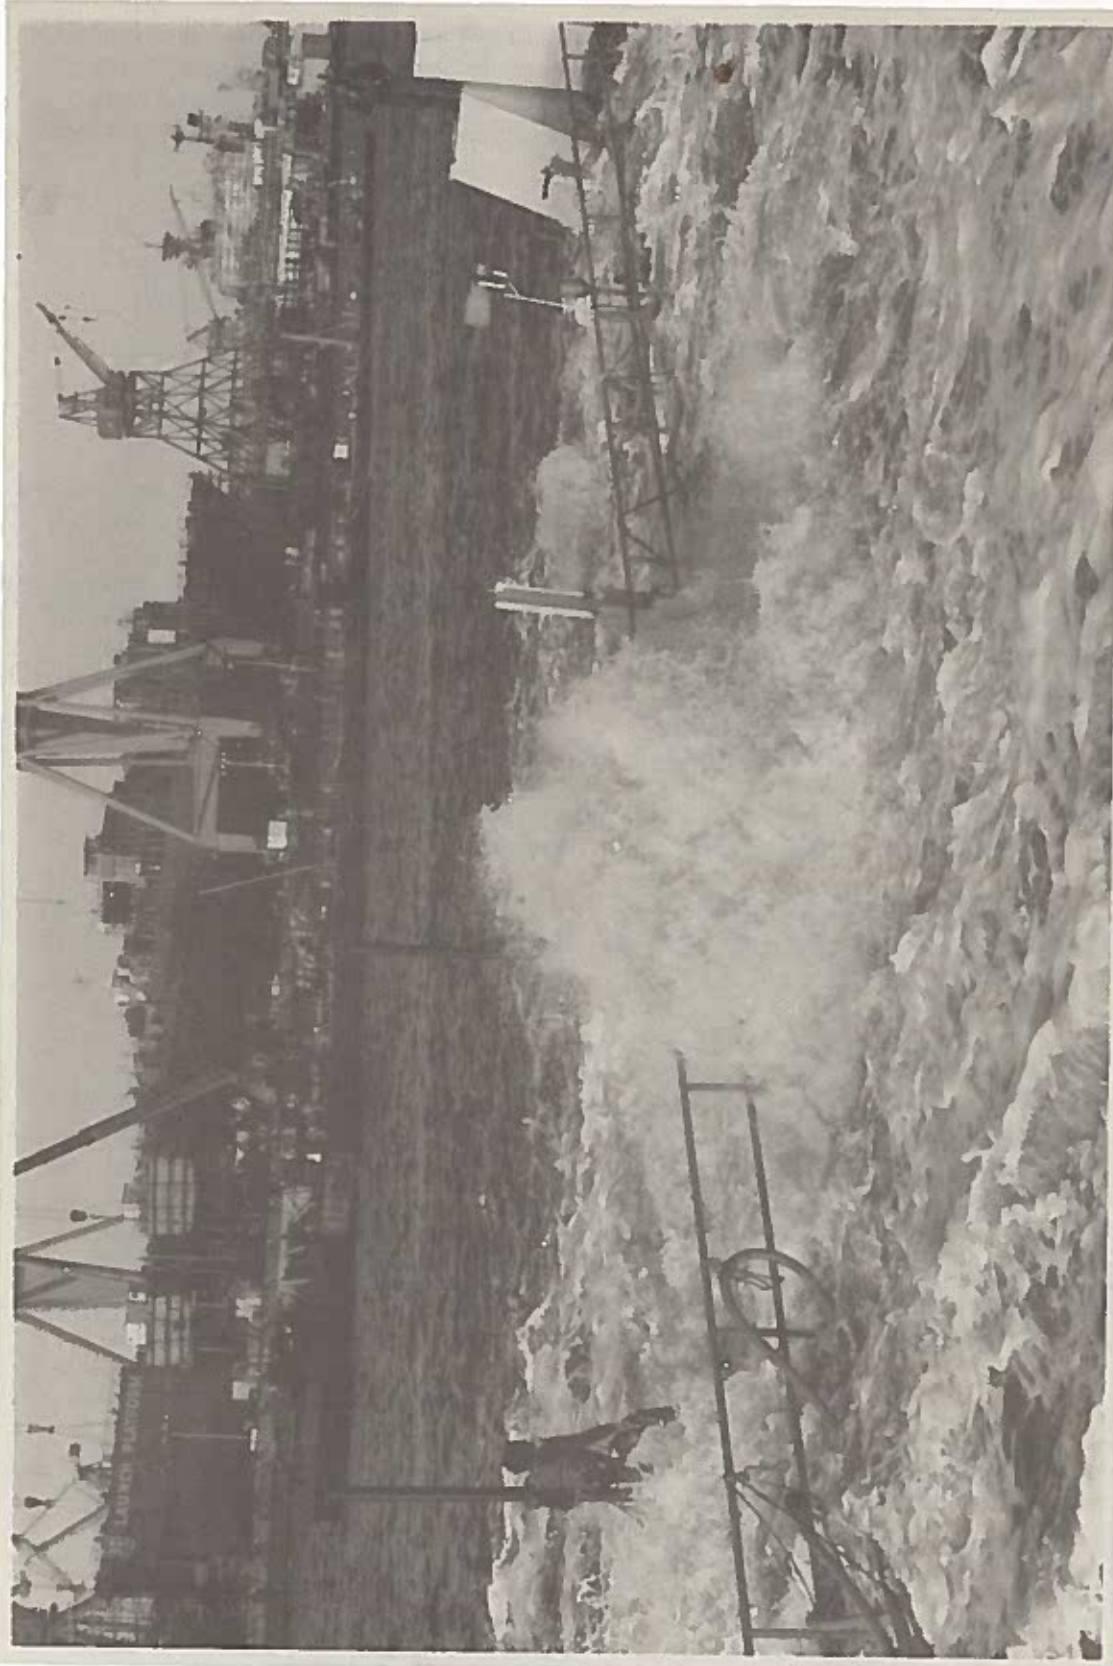
All preparations on the forward half of the launching platform were completed without major incident and blowing of Tanks 8 and 12 commenced on 23 March. Four 600 CFM and two 750 CFM compressors were available to feed the tanks via a gauged manifold through eight 2-inch hoses. The bubble was pushed 23 feet down the wing wall without incident, but as it spread beneath the Pontoon Deck, massive leakage developed from Tank 10 in the vicinity of the propeller pits. Blowing was secured; subsequent diver inspection revealed part of the concrete patch in the propeller pit had been blown/scoured away and an additional 18" x 6" hole approximately 12 feet forward of the pit had not been patched at all, the divers apparently having failed to locate same during the initial underwater survey. These holes were patched with external metal patches and concrete and on 25 March blowing was resumed. When the water had been blown down approximately 2 feet below the Pontoon Deck, a rupture occurred in the inboard side of the wing wall in Tank 12. Blowing was again secured; diver investigation revealed a small tear in the shell 7 feet below the safety deck where the plating had apparently been previously damaged. This tear was repaired with an external patch and internal application of "Splashzone" epoxy sealer. Blowing resumed on 26 March. By the time the water level had again been blown 2 feet below the Pontoon Deck, pierside transit readings disclosed that the wing wall had risen out of the mud over 2 feet forward and 6 inches aft. At that time, however, two ruptures occurred almost simultaneously on the outboard wing wall. Blowing was for a third time secured; diver inspection revealed a welded seam had sprung open at the corner of the wing wall in Tank 12 and a previously damaged

area had ruptured in Tank 8; a more thorough internal diver inspection subsequently revealed substantial separation of the shell panels from the vertical stiffeners. These findings resulted in a lack of confidence in the ability of the upper portions of the wing wall to sustain the required internal pressure differential. The salvage plan to blow the platform to the surface with compressed air was therefore abandoned by the salvors in favor of a more conservative approach using salvage pumps.

PHOTOGRAPH 11. Rupture on outboard wing wall which led to abortion of Phase One plan to blow with air. (Estimating the size of a leak by the size of the bubble is difficult. This spectacular boil was caused by an 8"x1" (max.) tear in a corner weld. The differential pressure across the rupture was only 15 FSW; it leaked at the rate of 1200-1800 SCFM. The air of course expanded rapidly during its free rise of 33 ft to the surface.)

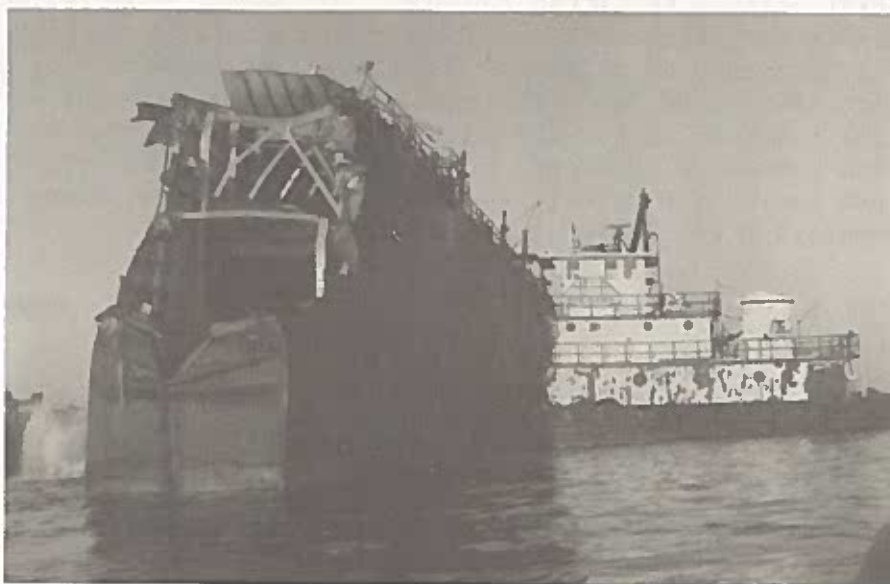
After intensive diver reinvestigation of the damage to the wing wall area of Tank 20 (see Photographs 26 and 27), the salvors begrudgingly agreed that the sustained structural damage rendered it incapable of withstanding the resulting hydrostatic forces if it were made watertight and pumped. Thus Tank 20 would remain open to the sea, as would Tanks 17 and 18, via the tank venting system. A second change to the salvage plan followed since the internal watertight bulkheads were not designed to withstand the required pressure differentials between the tanks being pumped (and vented to the atmosphere) and the ones now remaining open to the sea. As indicated previously, operational ballasting/deballasting discipline limited the pressure differential to 15 fsw, based upon a factor of safety of two on yield. As a minimum, a pressure differential of approximately 25 feet was calculated as required to float the starboard side and 48 feet to subsequently lift off the port side. The salvors therefore decided to pump compressed air into certain tanks to control the internal pressure and thus maintain the pressure differentials across any watertight bulkheads within acceptable limits. A simplified sketch depicting this principle is shown in Figure 10. Actual selection of the air pressure to be used was a compromise since the air pressure needed on the bottom became a potential hazard after the section rose and the counter hydrostatic pressure was removed. As a bonus the air pressure would also reduce the apparent pump discharge pressure and thus increase pump flow rate. The use of air necessitated modifying the vent piping to provide for blanks with air connections as shown in Figure 11.

PHOTOGRAPH 26. Damage to machinery throughway and Tank 20 (below safety deck) on aft section wing wall.

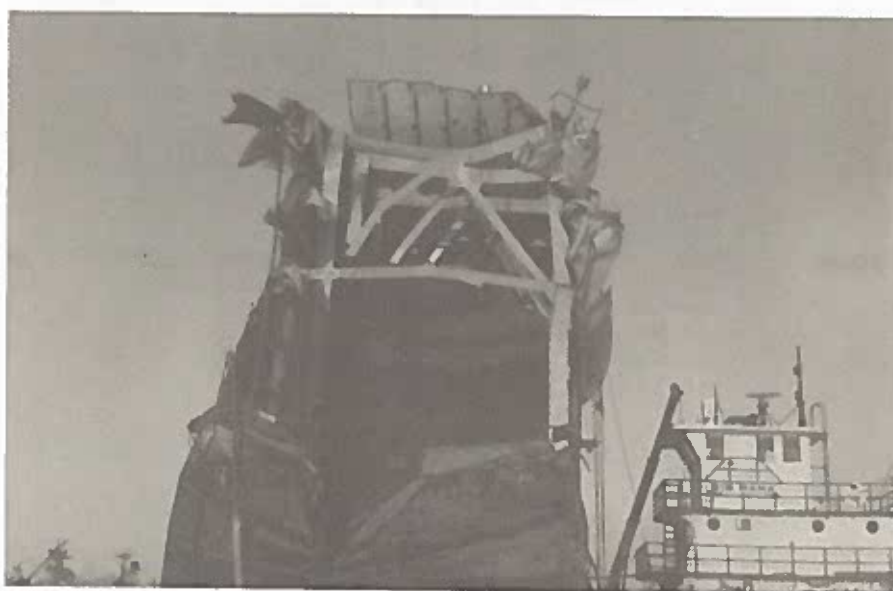
PHOTOGRAPH 27. Closer view shows extensive damage which precluded patching and pumping of Tank 20.

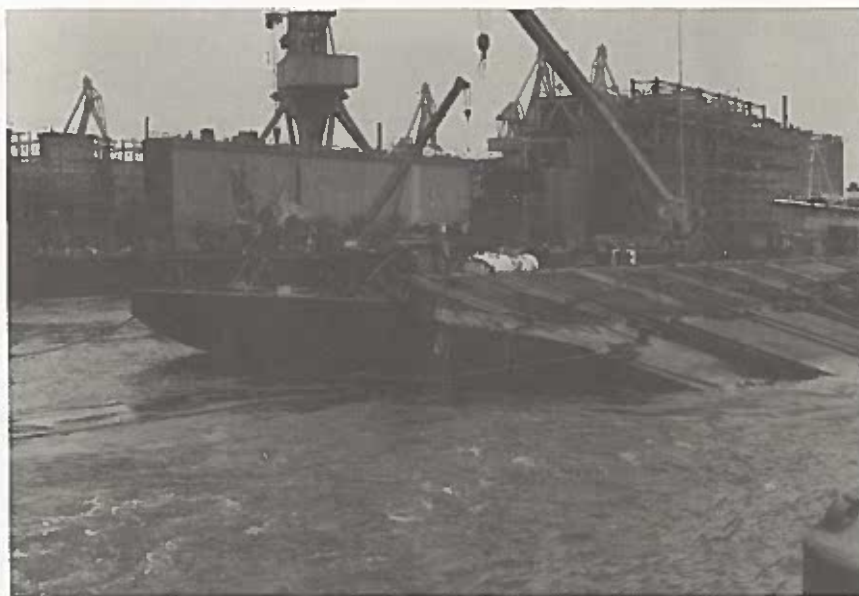
PHOTOGRAPH 44. Repairs in progress to the after section during Phase Three.
