RESURRECTION OF THE SURVEYING SHIP USS KELLAR (TAGS 25)

MR. STEWART B. NELSON,
Ship Design Coordinator, Naval Oceanographic Office
(Formerly of the Mine Service and Patrol Craft Branch
Naval Ship Systems Command)

4TH ANNUAL TECHNICAL SYMPOSIUM

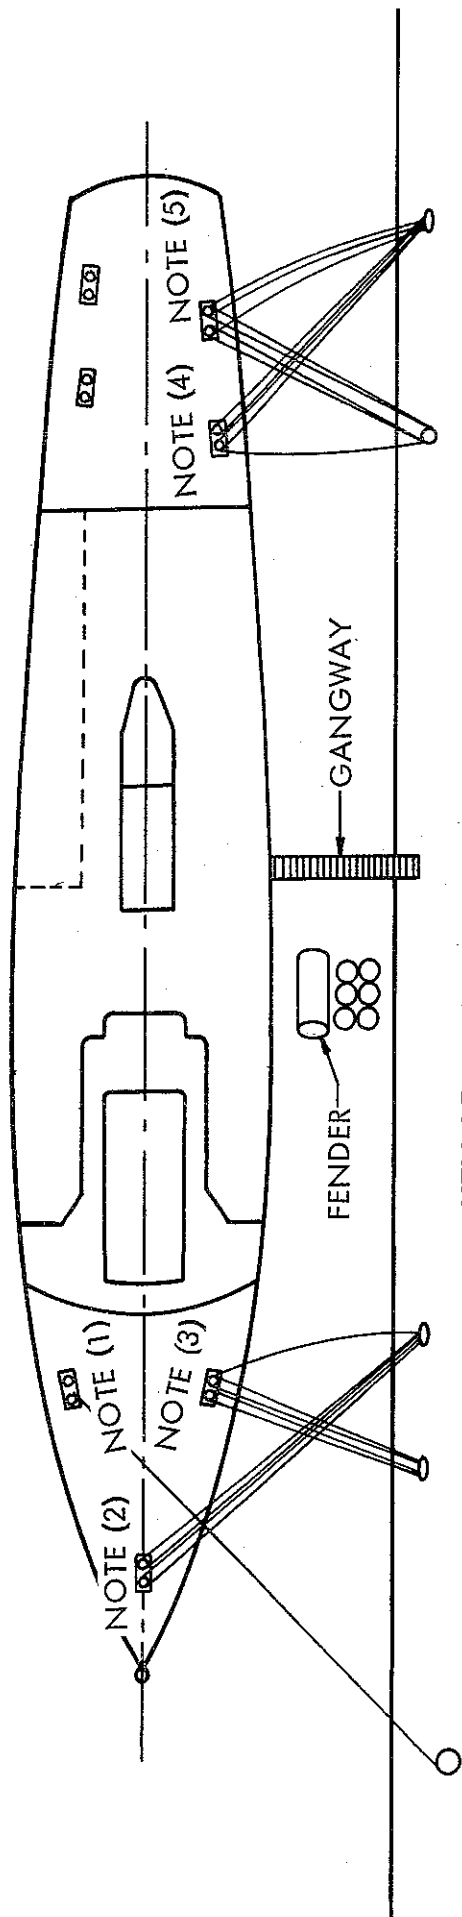
FIGURE 5

10:30 p.m. The USS HYMAN (DD-732), moored about 150 yards astern of the KELLAR, hit by an adrift merchantman and crane barge which then passed forward of the HYMAN and into the berths occupied by the KELLAR.

(2) She was rammed, holed, and torn loose from her moorings by a crane barge and one or more merchantmen during the height of Hurricane "Betsy."

KELLAR MOORING DIAGRAM

(AT TIME OF HURRICANE)
