# **SALVOPS 69**

**A review of significant salvage operations  
conducted by U.S. Navy salvage forces  
and other salvage activities during 1969**

**Department of the Navy  
Naval Ship Systems Command  
Washington, D.C.**

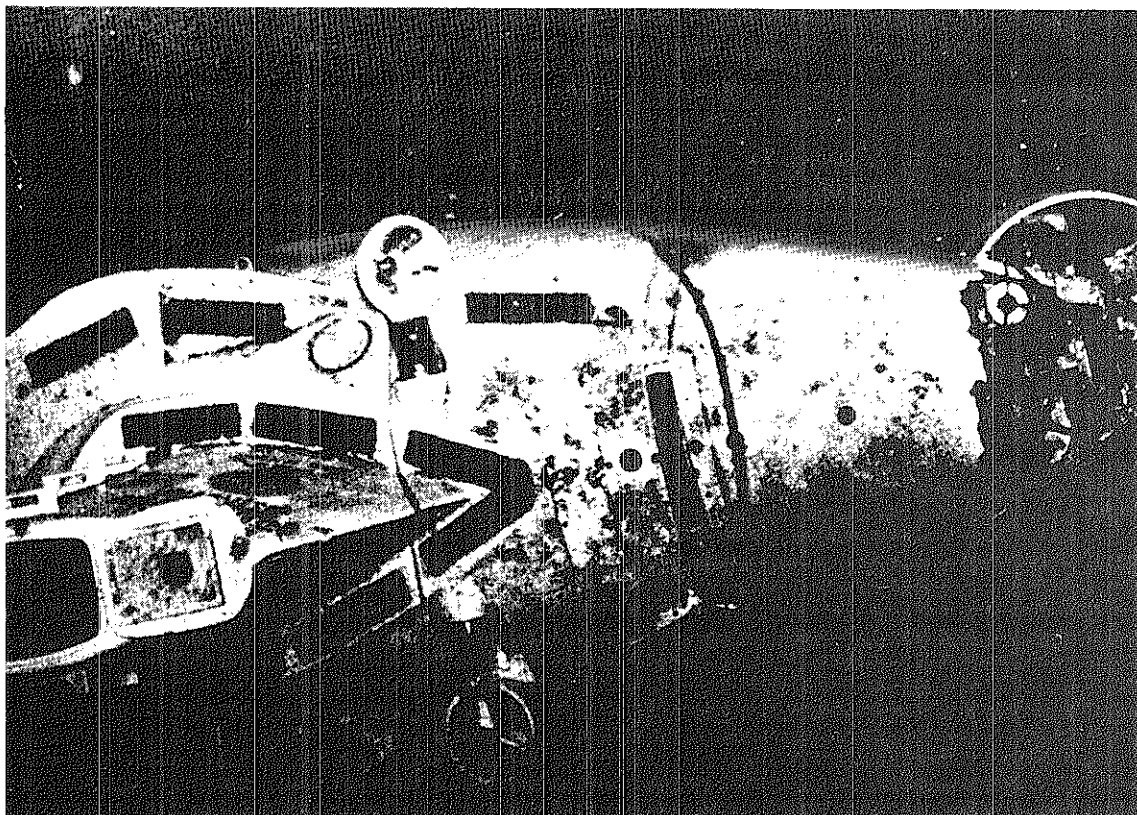
It was not possible to make a detailed estimate of possible damage to ALVIN at this time. LULU's crew members had observed, however, that the initial impact of plunging into the water had knocked off ALVIN's stern propeller. It was also surmised that she sustained other damage in the stern area, possibly to facilities such as the trim tanks, the buoyancy control mechanism and the steering propulsion mechanism. Salt water damage to instrumentation in the pressure sphere was expected to be extensive. Damage from impact on the bottom was also a possibility. The consensus was that she had dropped at a speed of approximately 10 knots, at a 45° to 60° nose-down angle, and with hatch open. The bottom was thought to be firm clay covered by silt.

*This photograph revealed that ALVIN was readily accessible to salvage attempts, being basically in an upright position. Confirmation that her sail hatch was still open was also important in salvage planning. Status of the pressure sphere hatch remained unknown, however.*

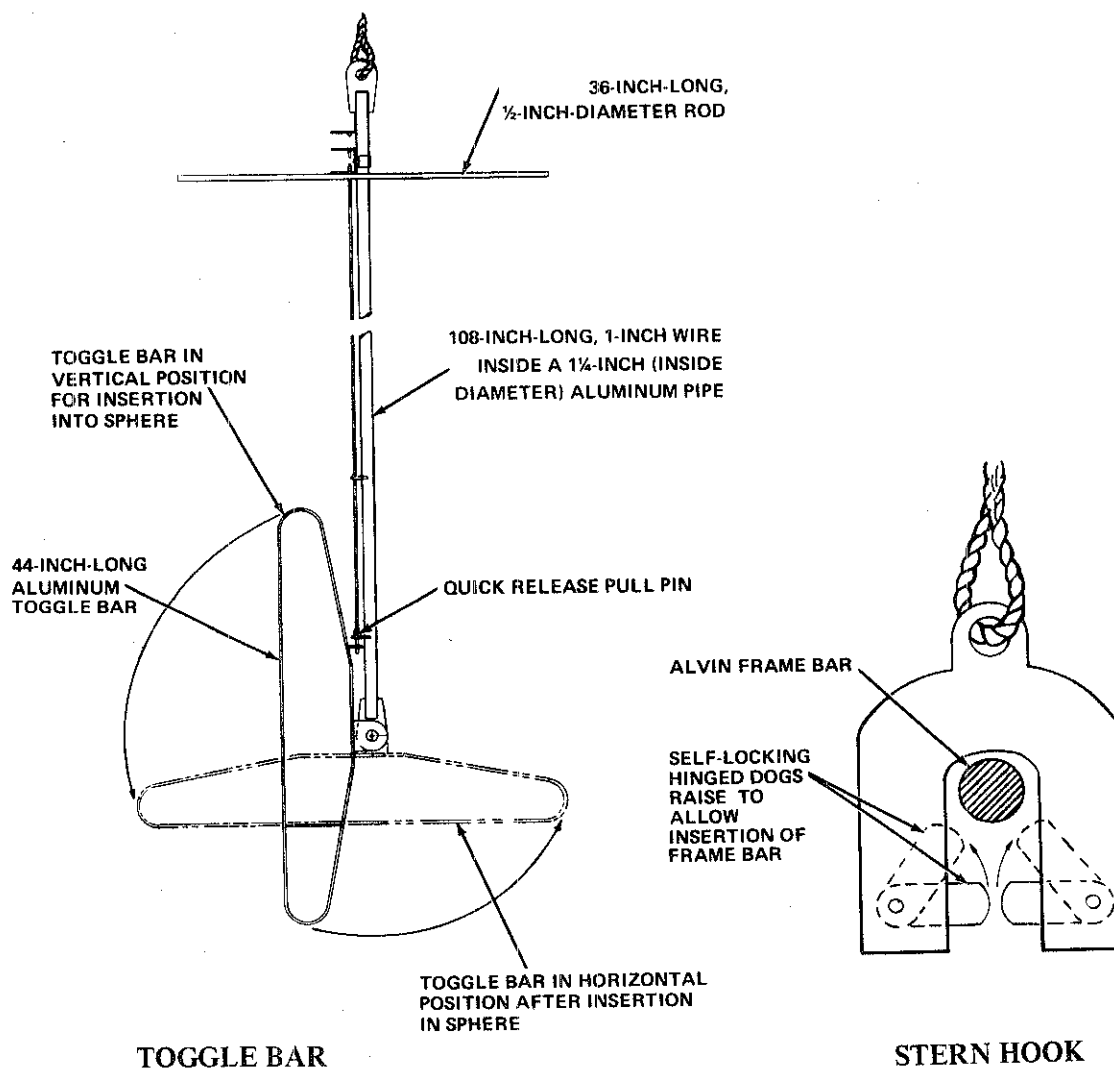
*Salvors originally planned to make a two-point lift using these two devices. They redesigned the toggle bar after the initial unsuccessful lift attempt and switched to a one-point lift, eliminating use of the stern hook.*

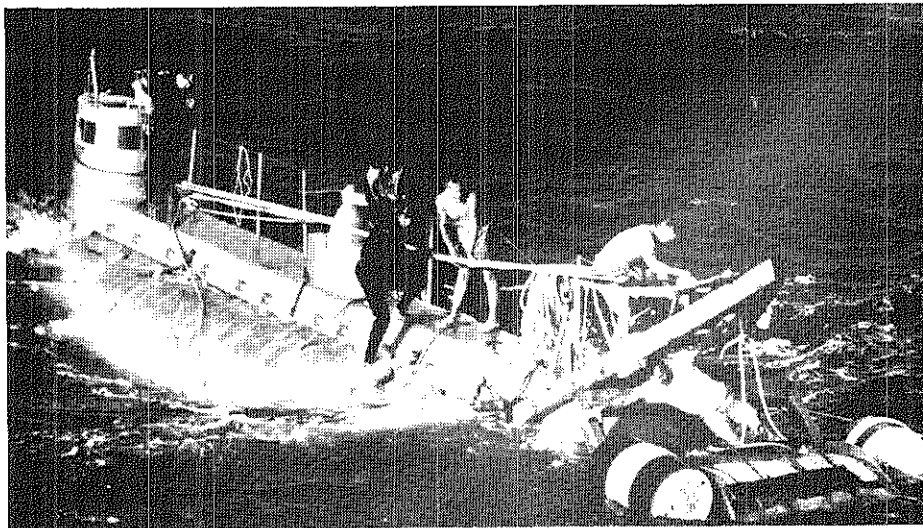
*Rehearsals showed this method of carrying the lift line to be unsound. An alternate plan was implemented in which the lift line was suspended from the surface; ALUMINAUT then secured it to the lifting device on ALVIN.*

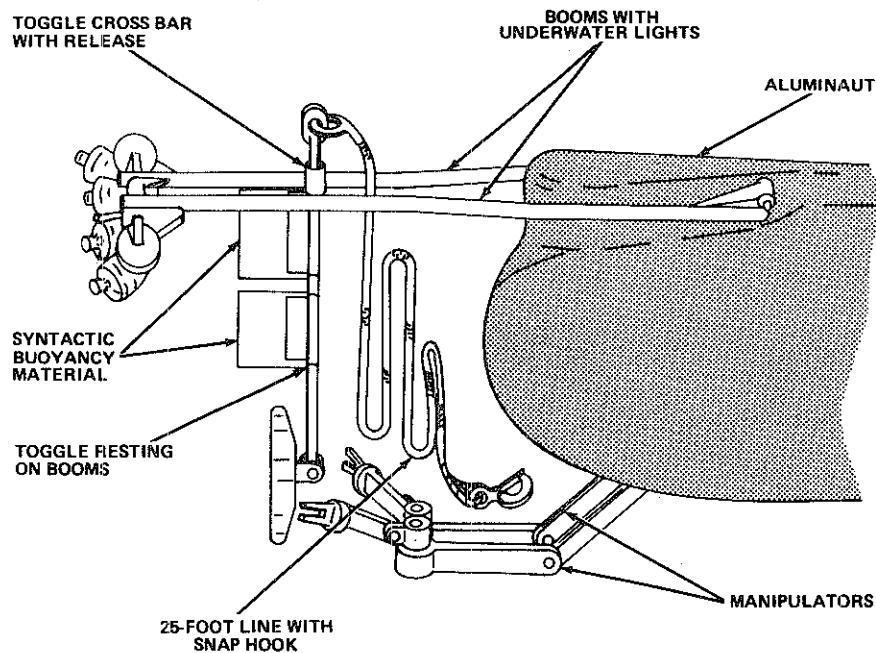
*After the initial unsuccessful lift attempt salvors redesigned the toggle and devised this scheme for carrying it aboard ALUMINAUT. ALUMINAUT could use one manipulator to hold onto ALVIN and the other to maneuver the toggle into ALVIN's pressure sphere.*

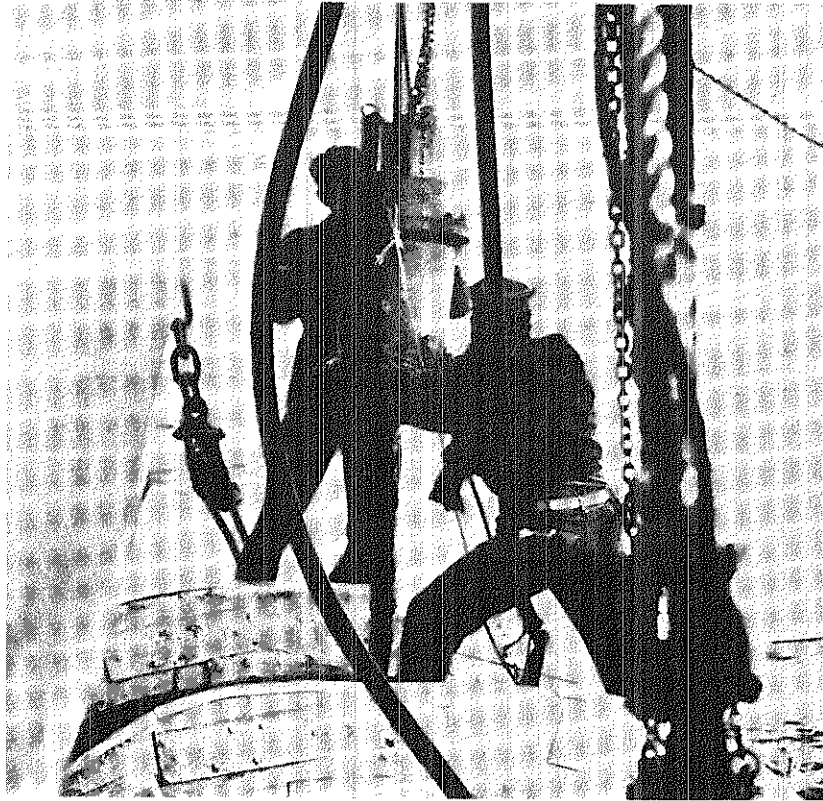
*Short 1-inch wire rope tail tapers spliced to 2-1/4-inch lifting wires made it difficult to position control pontoons.*

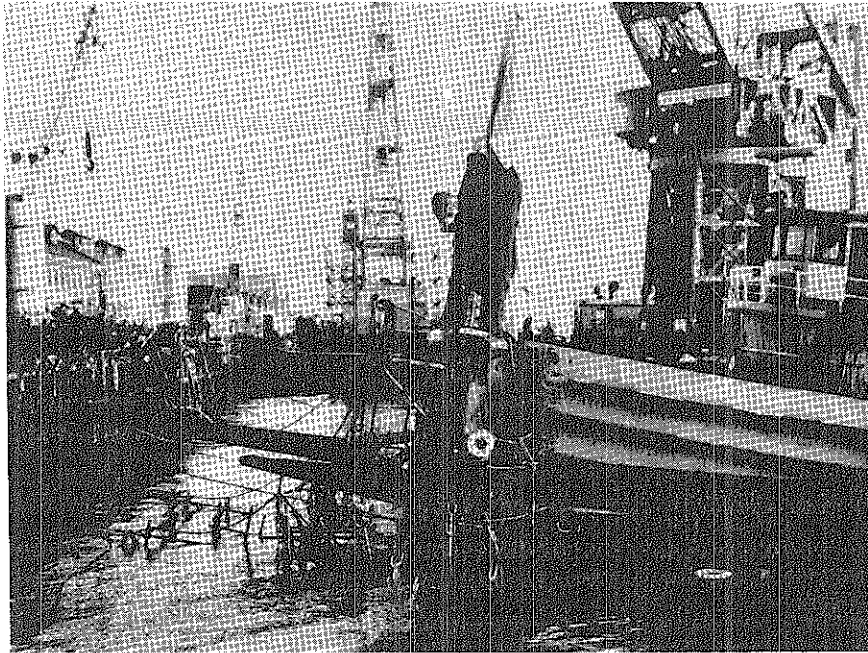
*The USS GUITARRO, partially submerged and in final stages of construction at the San Francisco Bay Naval Shipyard, sank in 30 feet of water to an almost totally submerged condition as a result of unexplained sudden flooding in the bow section. Water rapidly spread from this point to other bottom areas which caused the submarine to settle quickly on the bottom at a six-degree port list.*

*The submarine came to rest at about a six-degree list. Fairwater above the sail planes and conning tower access trunk remained above water.*

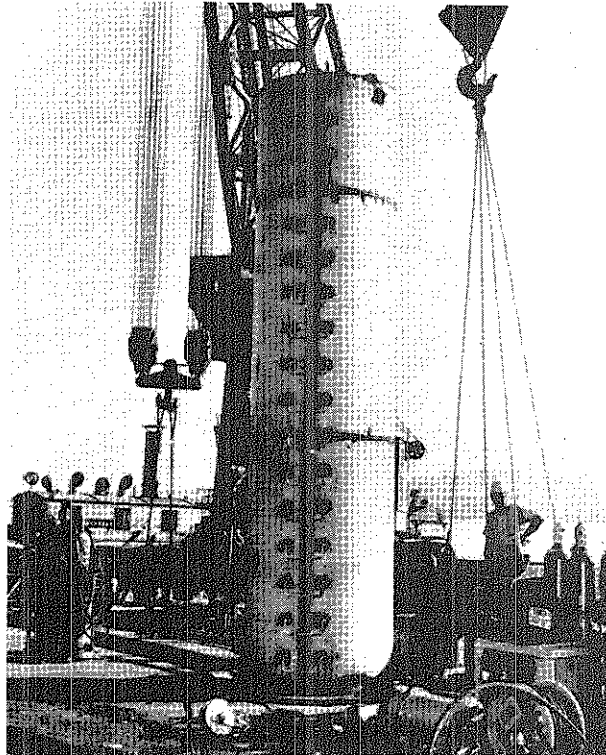
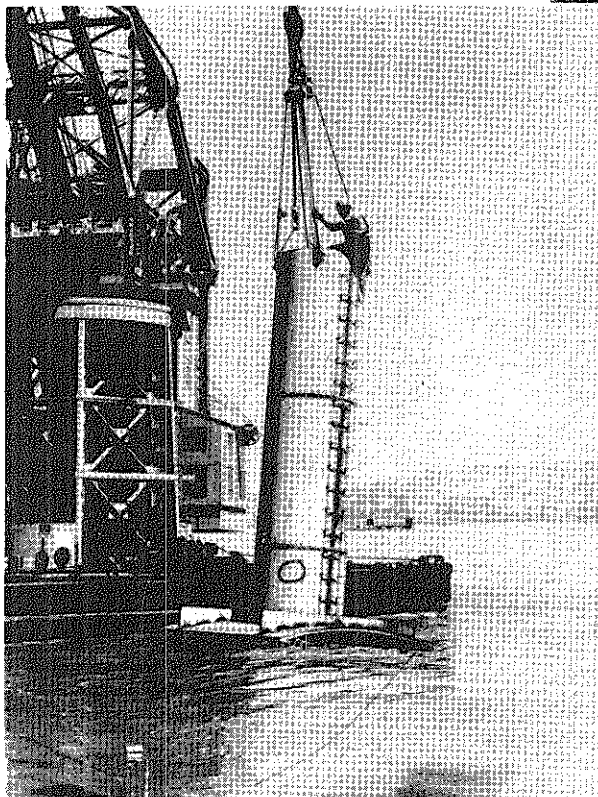
*The submersible pump/cofferdam approach to dewatering proved highly effective during the operations. Employment of this method, combined with air blowout and use of a floating crane, brought about successful refloating of the submarine.*

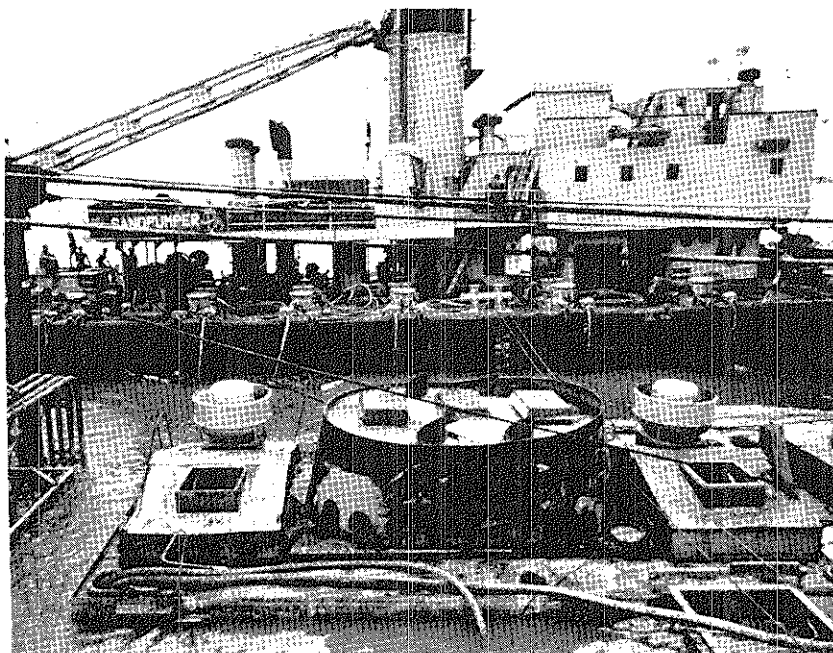
#### VIEW OF SANDPUMPER IN SUBMERGED CONDITION

*SANDPUMPER, in foreground, was flooded throughout bottom areas and rested 80 percent submerged at high tide. Heavy lift craft is in background.*

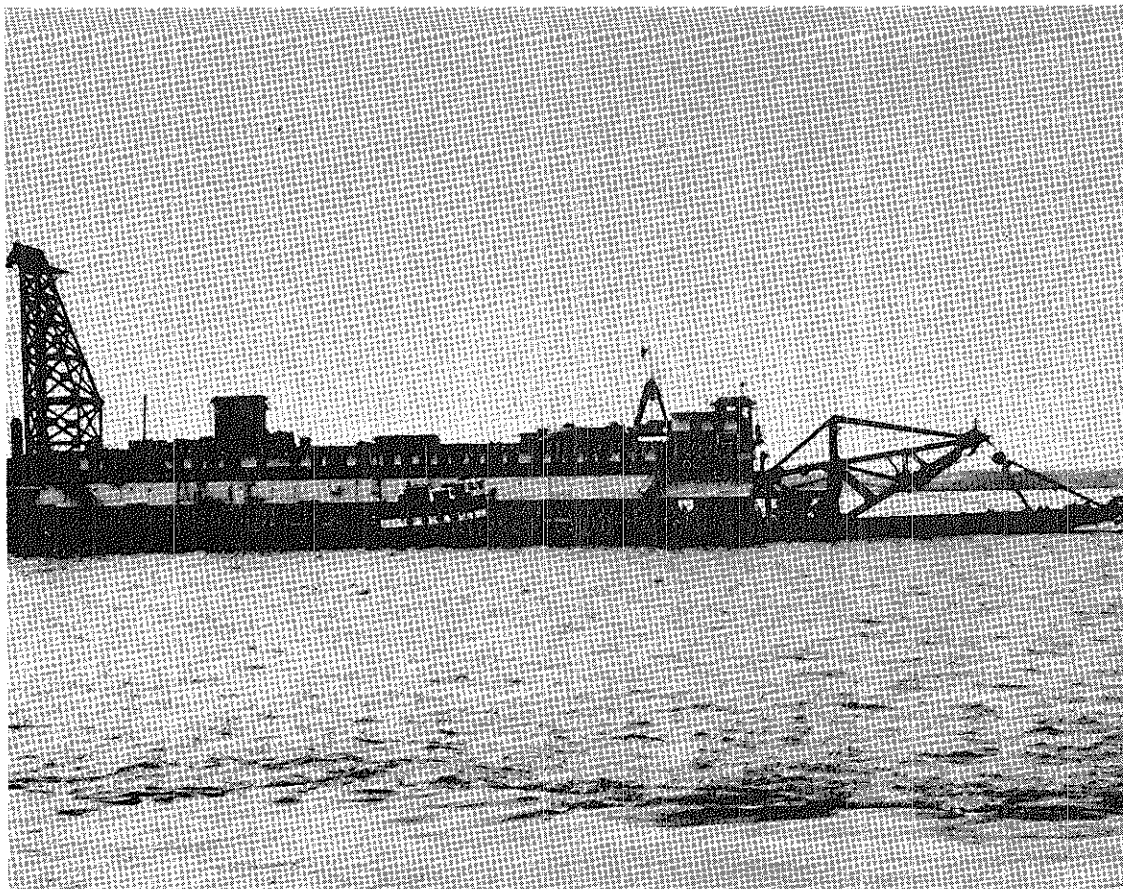
*NEW JERSEY, a 30-inch pipeline dredge, was successfully refloated after a mine explosion sank her in the My Tho River, South Viet Nam.*

Bilges and tanks within the defined flooding boundaries were pumped dry to gain greater freeboard clearance, and damaged areas were reinforced by concrete patches.

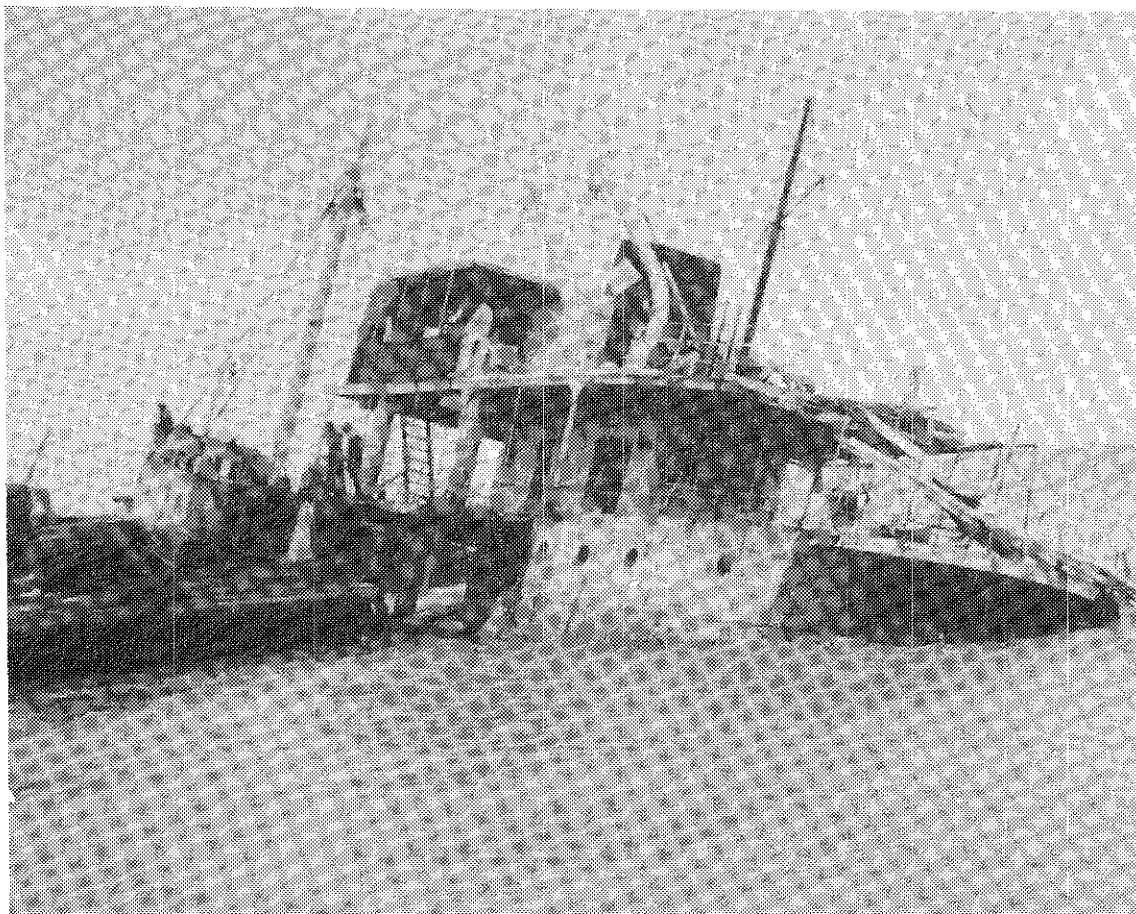
*POWIS sank in relatively shallow water off the coast of Guyana after striking a sunken barge. The Supervisor of Salvage provided technical advice and assistance in the salvage operations.*

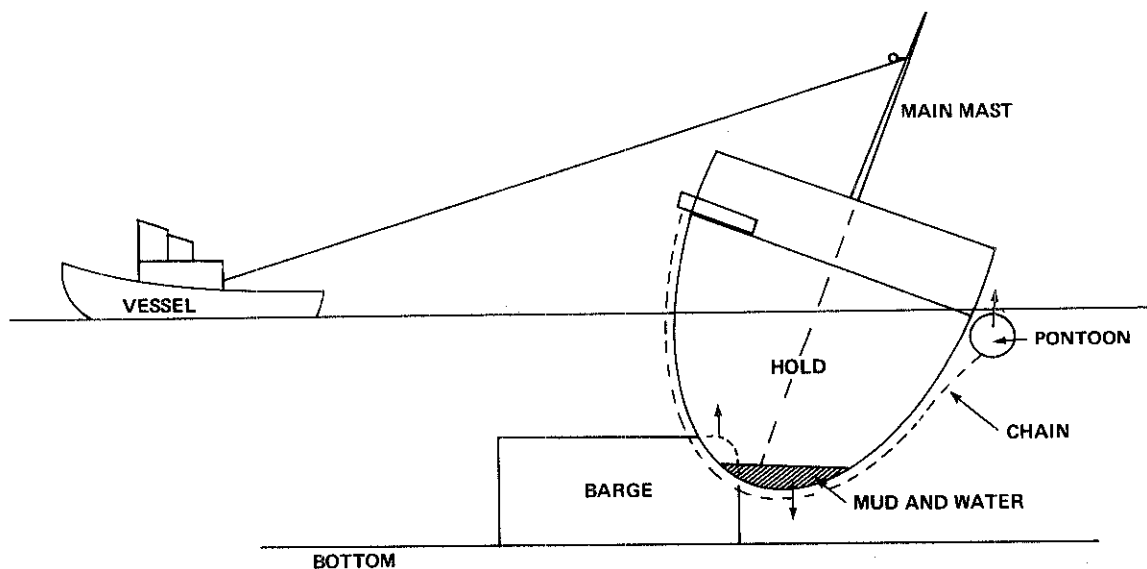
*To overcome upsetting moments, two lift pontoons (converted oil tanks) were to be placed on starboard side of the POWIS. Surface vessel would attach line to mast of POWIS to reinforce control of list.*

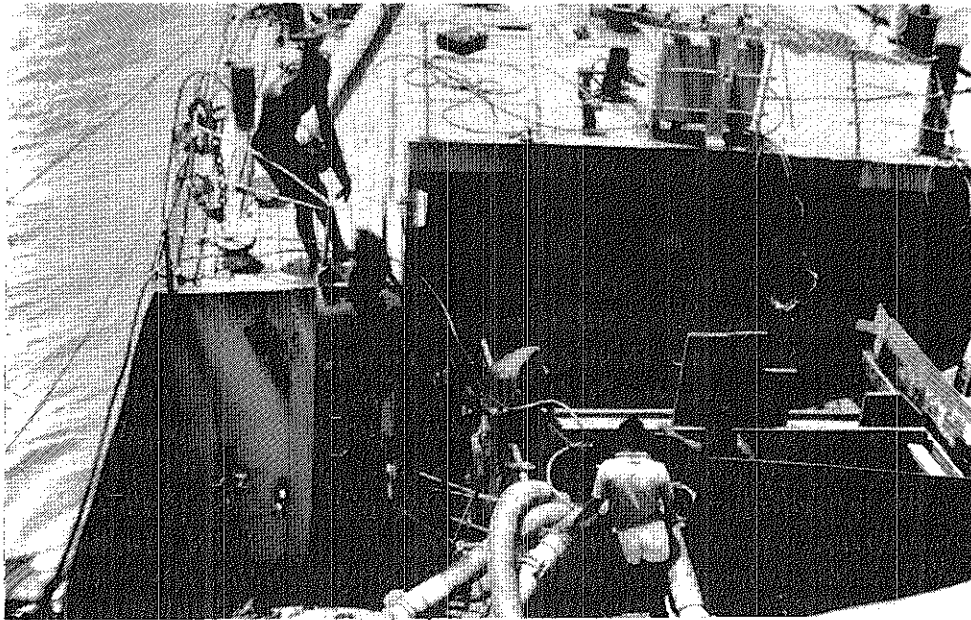
*Two pumping stations were established on the POWIS, one at the forward hold and the other at the aft engine room. Pumping at forward hold was abandoned principally because calculations indicated that vessel could be refloated even though the forward hold was flooded.*

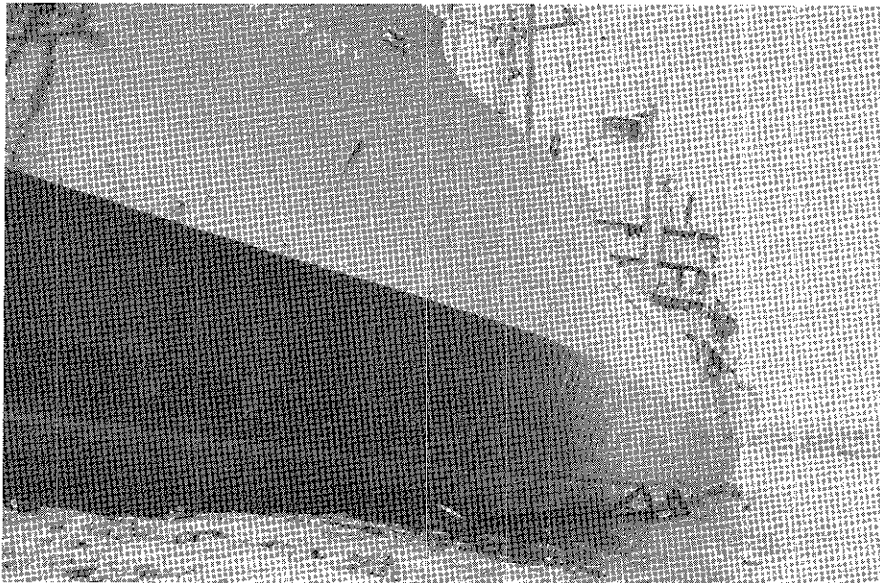
*ALAMO VICTORY was forced aground atop broken sections of concrete pilings and other debris. Fortunately, no major damage was sustained by the hull.*

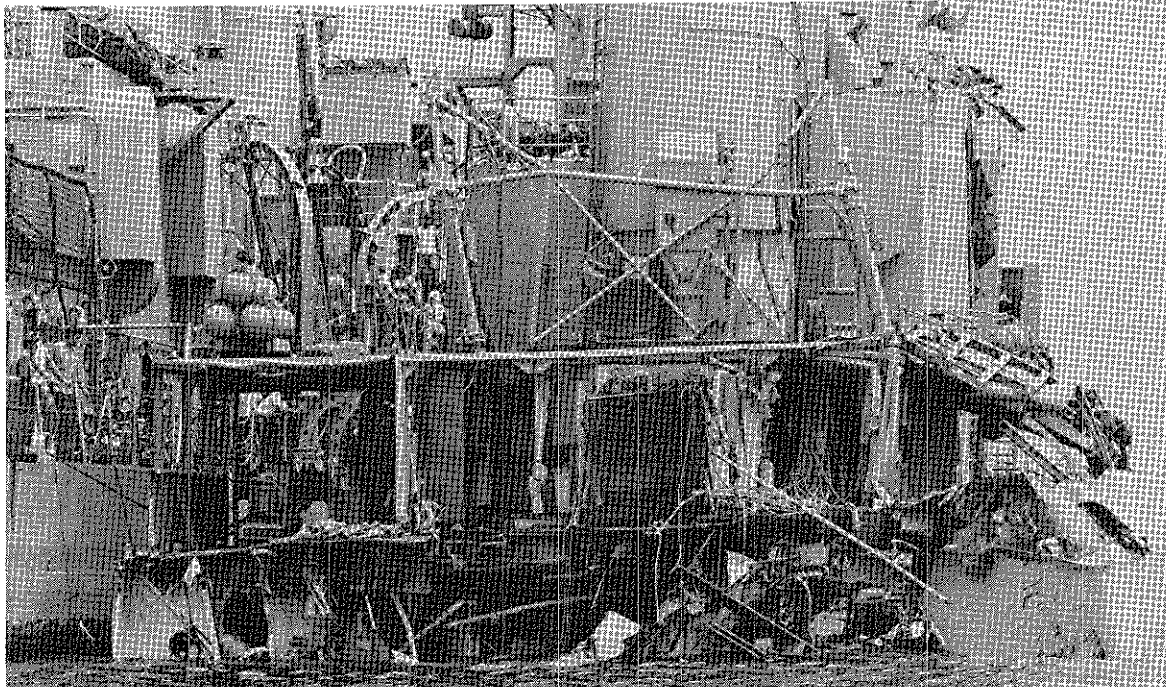
*Damage extended no further than two frames from the stern's severance point and hull deformation was confined mainly to the area of impact.*
