# **SALVOPS 71**

**A review of significant salvage operations  
conducted by U.S. Navy salvage forces  
and other salvage activities during 1971.**

**Department of the Navy  
Naval Sea Systems Command  
Washington, D.C.**

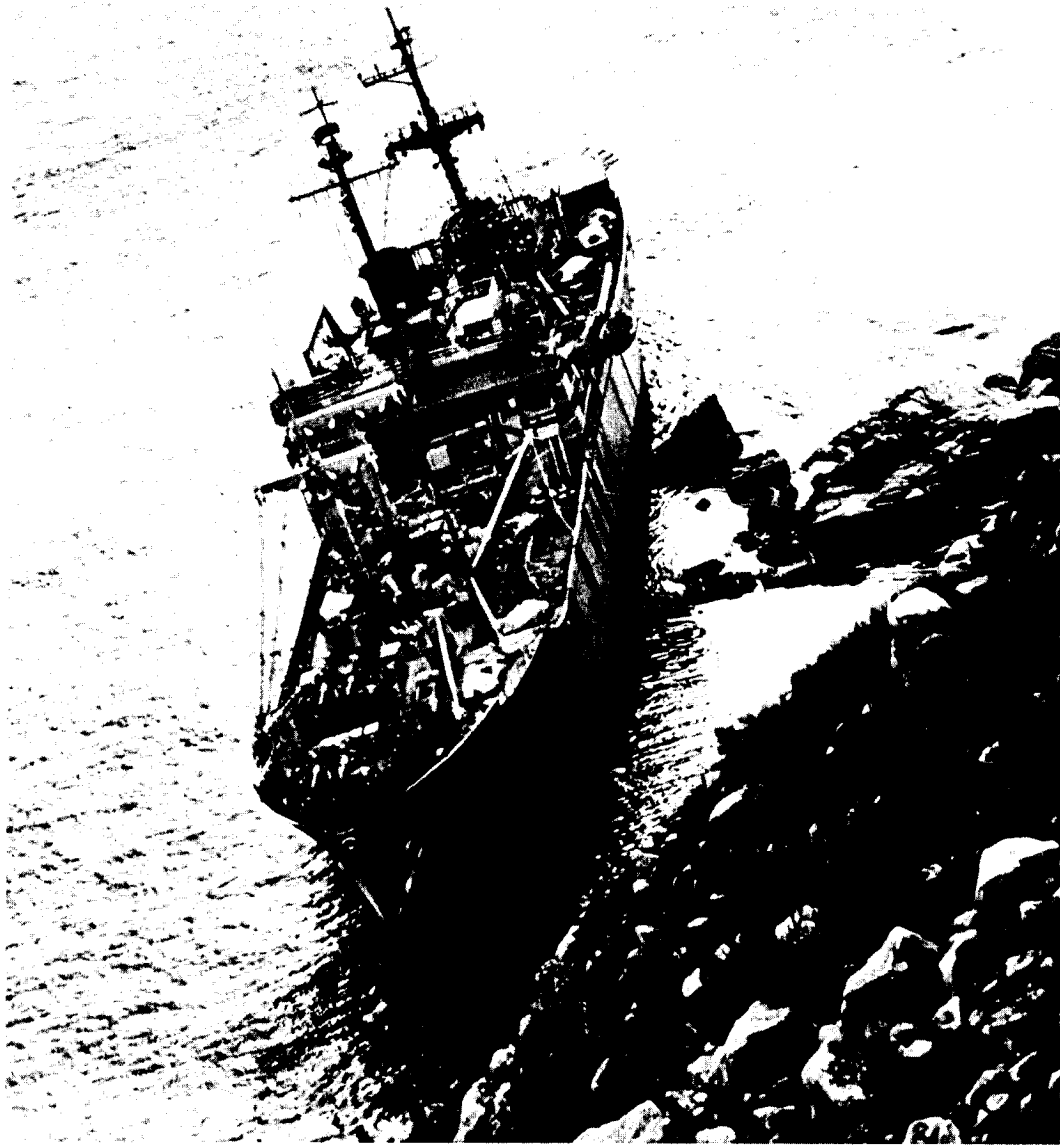
*Force of Typhoon Rose drove ship aground on rocky shore of Kau Yi Chau Island off Hong Kong Harbor in August 1971. Damage was too severe to permit retraction and salvage. After decommissioning, Supervisor of Salvage arranged for contractor salvors to dispose of hulk.*

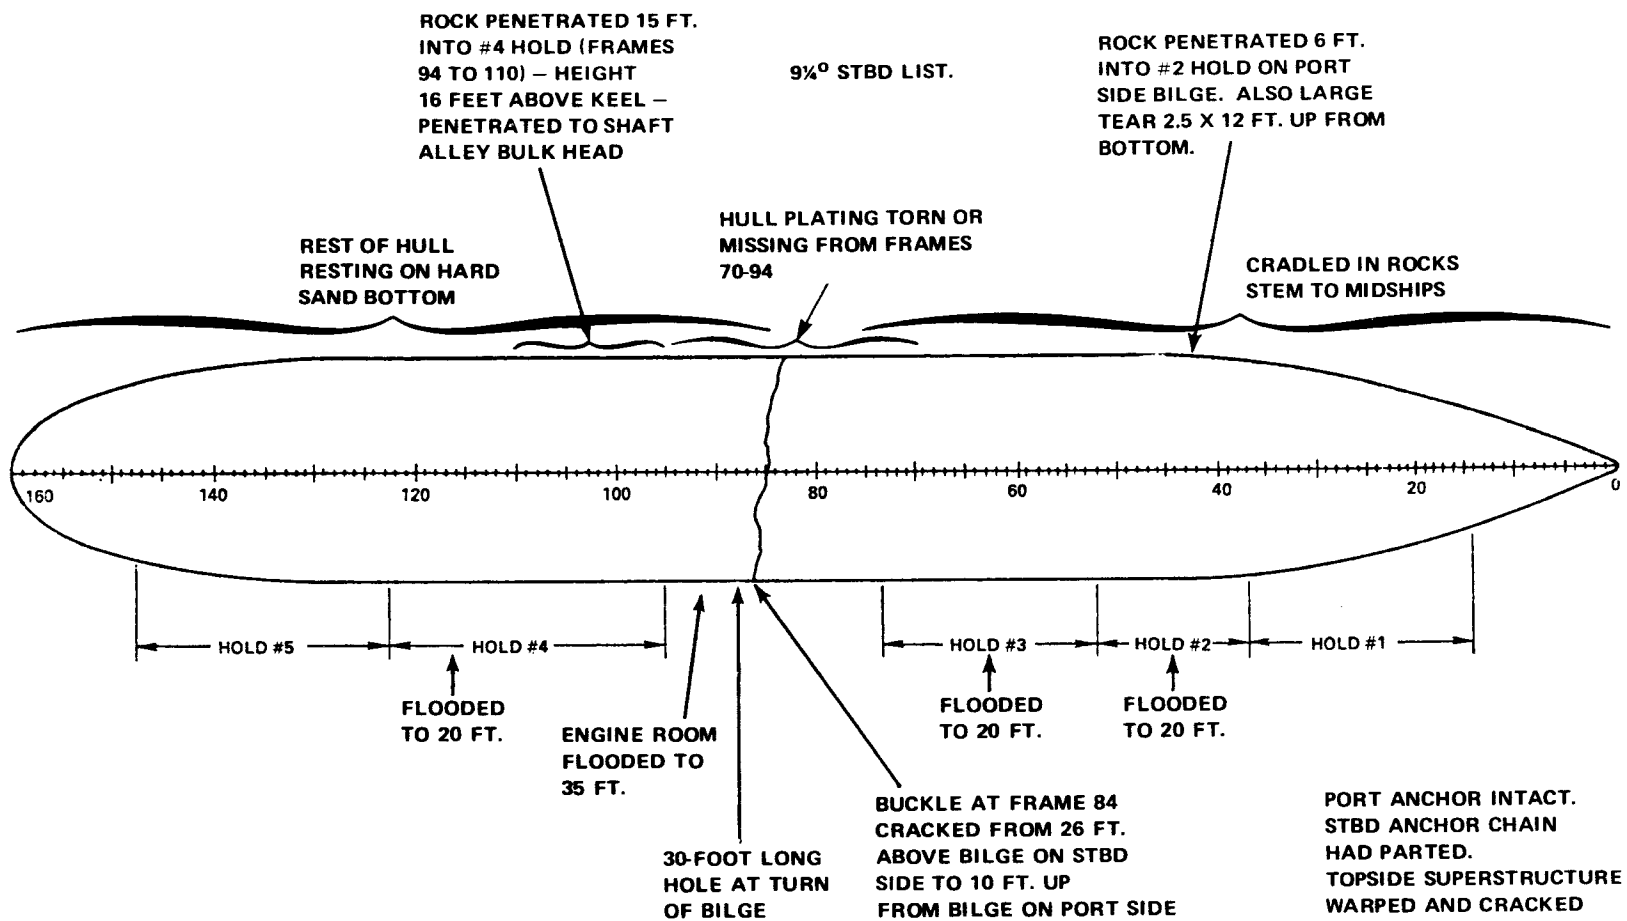
Surveys of damage were made almost daily and these surveys progressively revealed the extensive nature of the damage. By 21 August it was determined that the ship was cradled in rocks from stem to midships with the remainder of the hull resting on hard sand bottom. It was aground its full length at high tide and approximately 4000 tons aground at the highest tide of 8 feet. The buckle at frame 84 was cracked from approximately 26 feet above the bilge on the starboard side around to 10 feet up from the bilge on the port side. Although the bottom could not be seen, the crack appeared to go completely across. There was a hole 30 feet long in the port side of the ship at the turn of the bilge.

*Daily diver surveys conducted during the salvage phase revealed extensive damage to the ship and led to the decision to sell the hull on an "as is, where is" basis.*

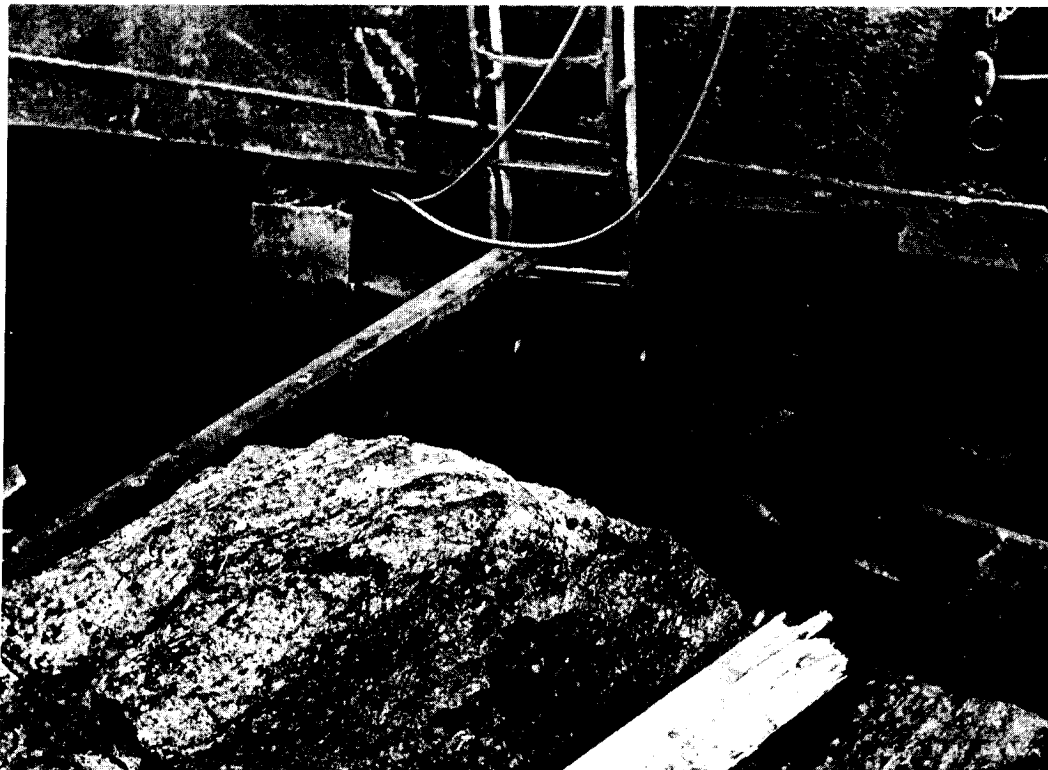
the rock penetrated inboard to the shaft alley bulkhead; however, additional investigations on 26 August showed that, although the shaft alley was flooded, the flooding had not been caused by the rock in number four hold since the common bulkhead was intact. In addition, all fuel oil tanks except 6-122-1 and 6-122-2 and the settling tanks were found either to be holed or suspect.

*At number four hold a rock 32 feet wide had penetrated through the bottom and side of the vessel from frames 95 through 105. It extended 24 feet into the hold to the shaft alley bulkhead and stood 18 feet above the base line.*

On 23 August it was determined that it was not feasible to extract the ship intact in its present condition at this time due to the size of the rock in number four hold and the extent of the tear at frame 84. Investigations at local shipyards into strengthening the hull showed that it would cost \$100,000 for hull strengthening material and take about 50 days to install, if strengthening members could be moved into place, which was doubtful. Alternatives to the retraction of the REGULUS being considered at this point were to sever the hull at frame 84 and refloat the two sections separately or to sell the hull to a commercial salvage company for scrap with guaranteed immediate removal. The former alternative was chosen and cutting operations were planned to begin early on 25 August.

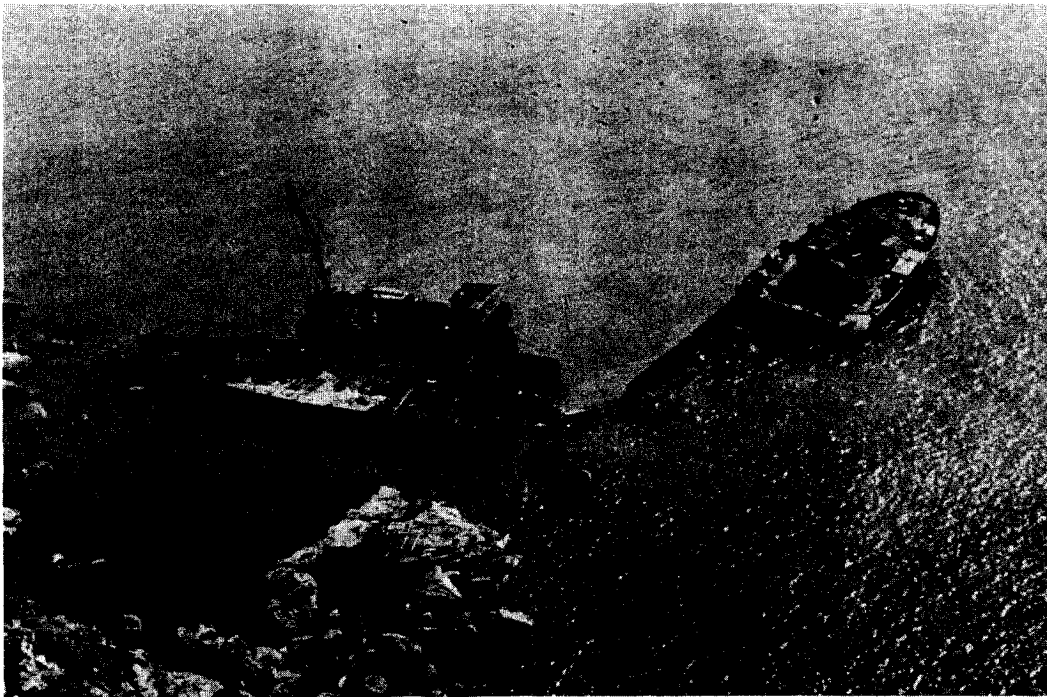
*The ex-REGULUS, stripped of all its superstructure and topside weight, lies in two sections. The bow section was finally pulled free from the rocks on 24 January and the stern section on 3 February.*

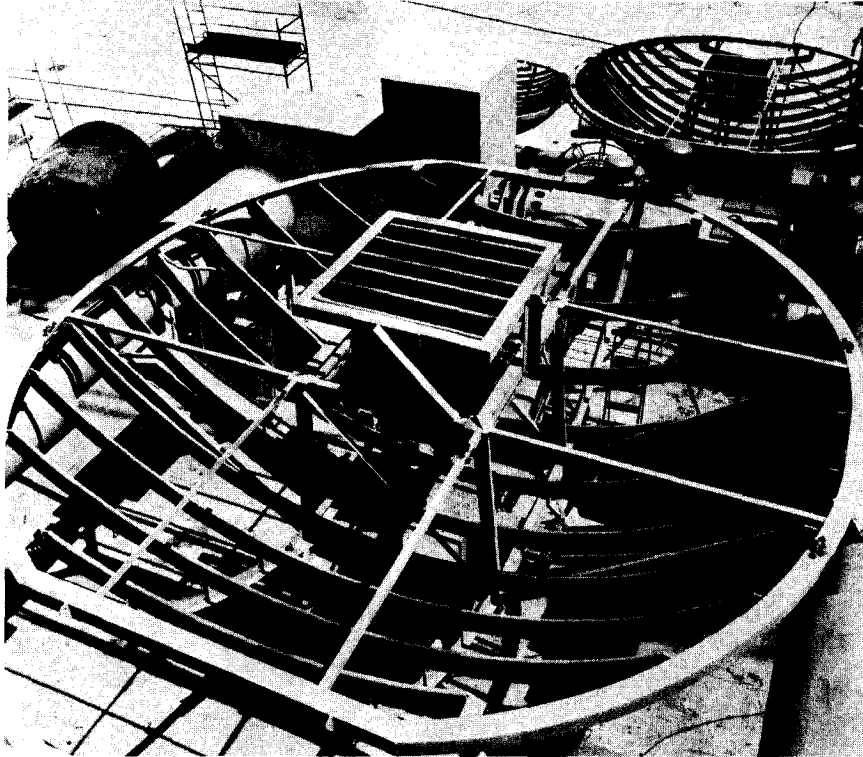
*This close-up was taken at Ponta Delgada while ECHO tower was being repaired during the summer of 1971 prior to final implantment.*

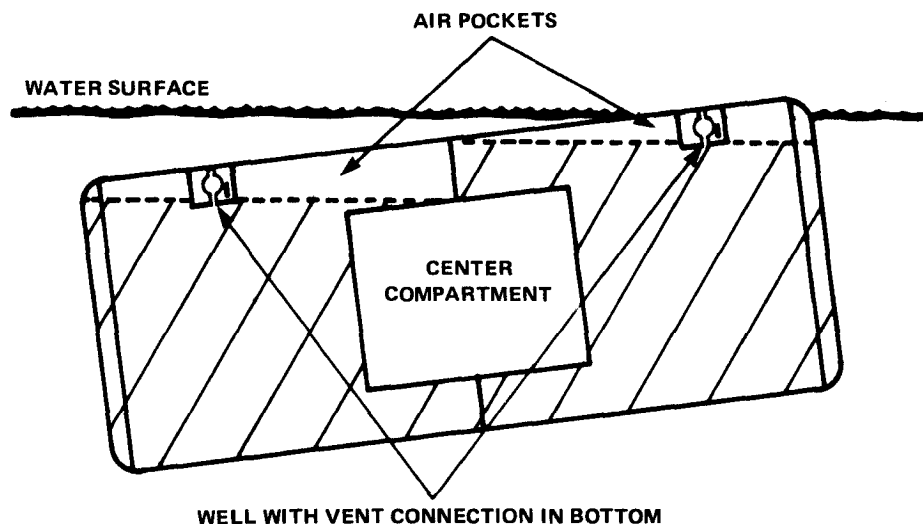
*Trouble was encountered in lowering the stern lift pontoon, YSP-62. Because the vent valves were installed low in the pontoon, air pockets formed; there was not enough venting to sink the pontoon. The pontoon finally submerged after the center compartment was flooded with 5 tons of water.*

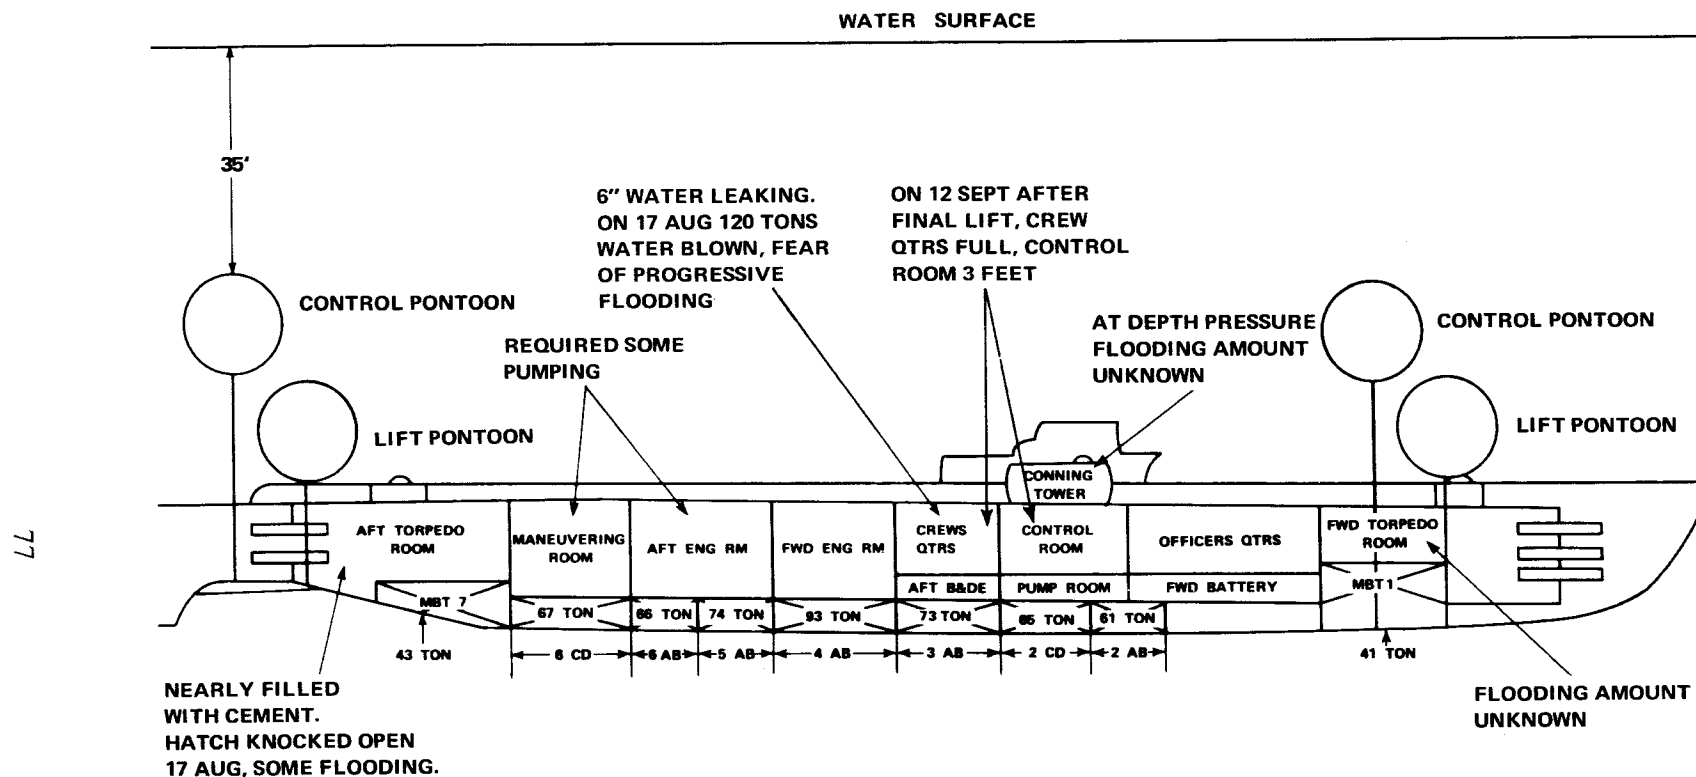
*Flooding of several compartments complicated the salvors' problems. Decision was made on 18 August to blow ballast tanks dry to compensate for flooding, rather than dewater compartments.*

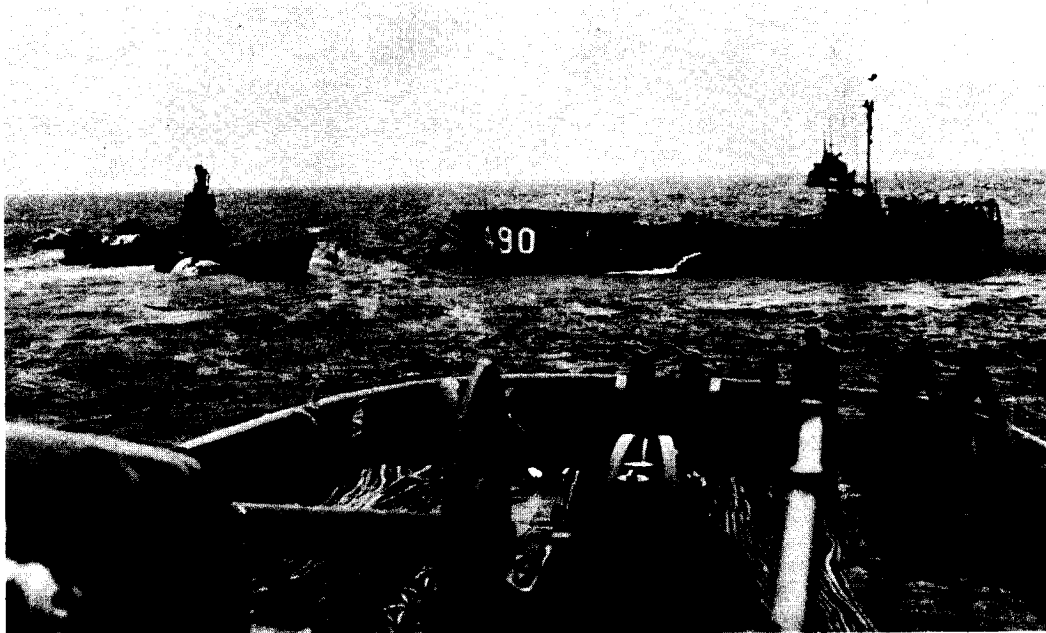
*During the surface lift on 12 September, LCU 1490 was swung away from the ex-HAKE by tidal currents causing the air hoses to the pontoons and ballast tanks to part.*
