SALVOPS 72

A review of significant salvage operations
conducted by U.S. Navy salvage forces
and other salvage activities during 1972

NAVSEA 0994-LP-012-6040

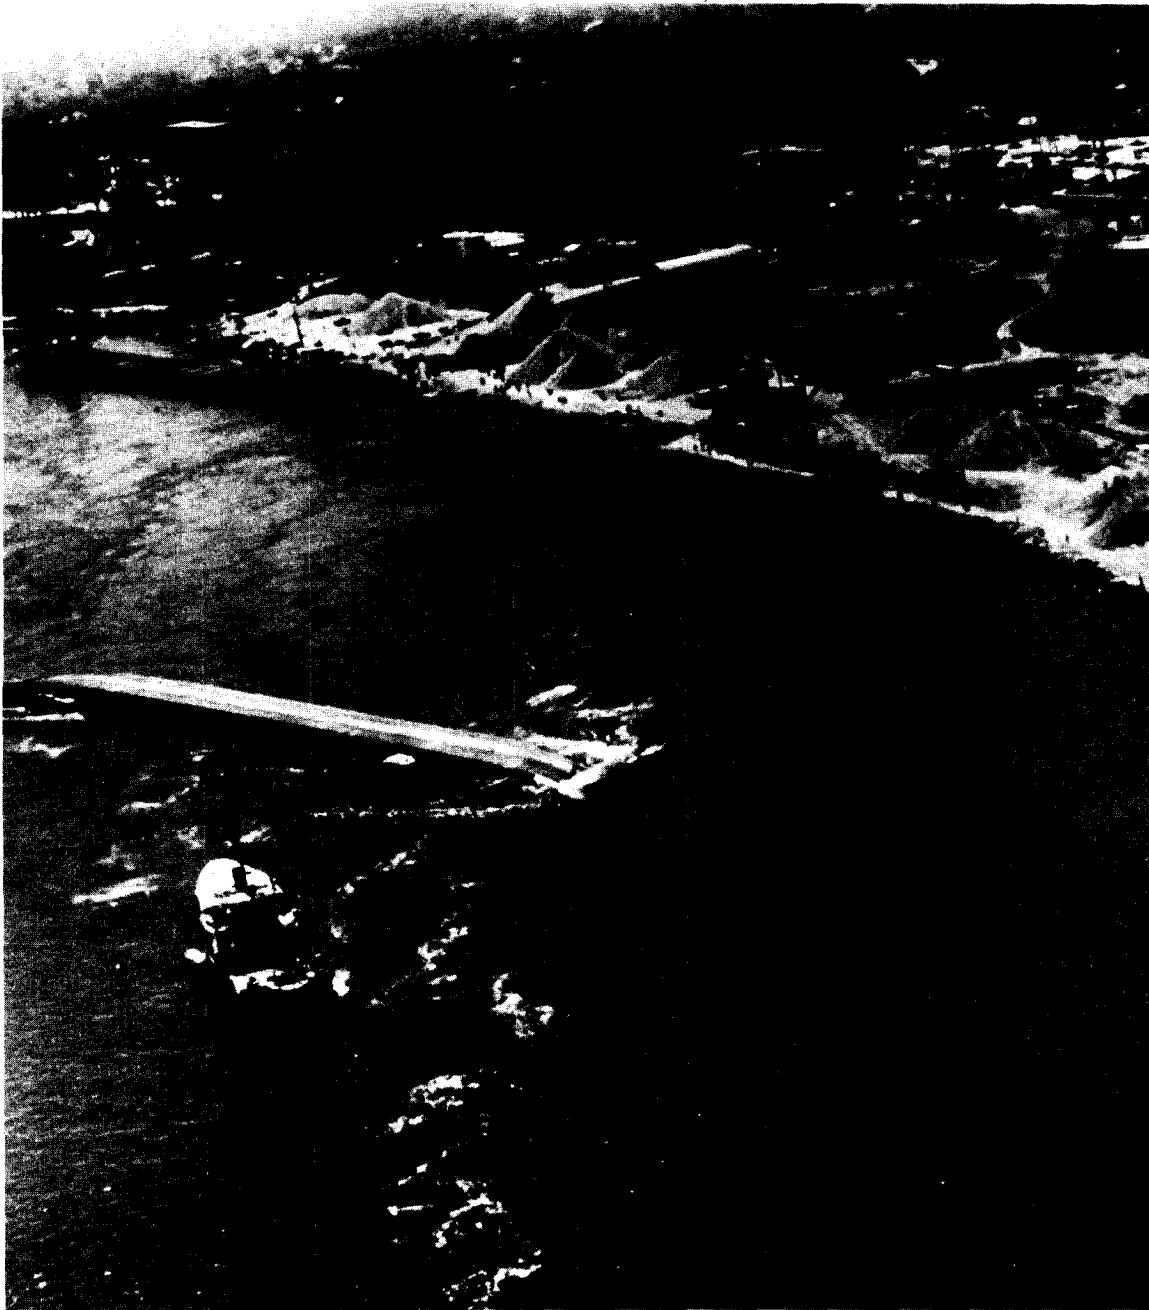
CAPSIZED SIDNEY E. SMITH OBSTRUCTS RIVER CHANNEL

Overturned SMITH lies bottomed on starboard side, morning after night-time collision with PARKER EVANS (background). Hull, still intact, protrudes 250 feet into shipping channel. River current hammers at bow (upstream, right). SMITH broke up three days later.

Although the EVANS suffered only minor damage, and no crewmen on either ship were injured, the SMITH's starboard bow region was punctured. The 66-year-old ship had only minimal watertight integrity, and flooded immediately. Before any damage control measures could be taken, the vessel rolled on her starboard side and sank, straddling the downbound lane of one of the busiest and narrowest passages of the Great Lakes waterway.

Because of the swift current, the condition of the wreck steadily deteriorated. Turbulent water surrounded it, scouring away the river bottom, especially beneath the ship's forward area. Within a day the bow's support was eroded and the wreck began to break in half.

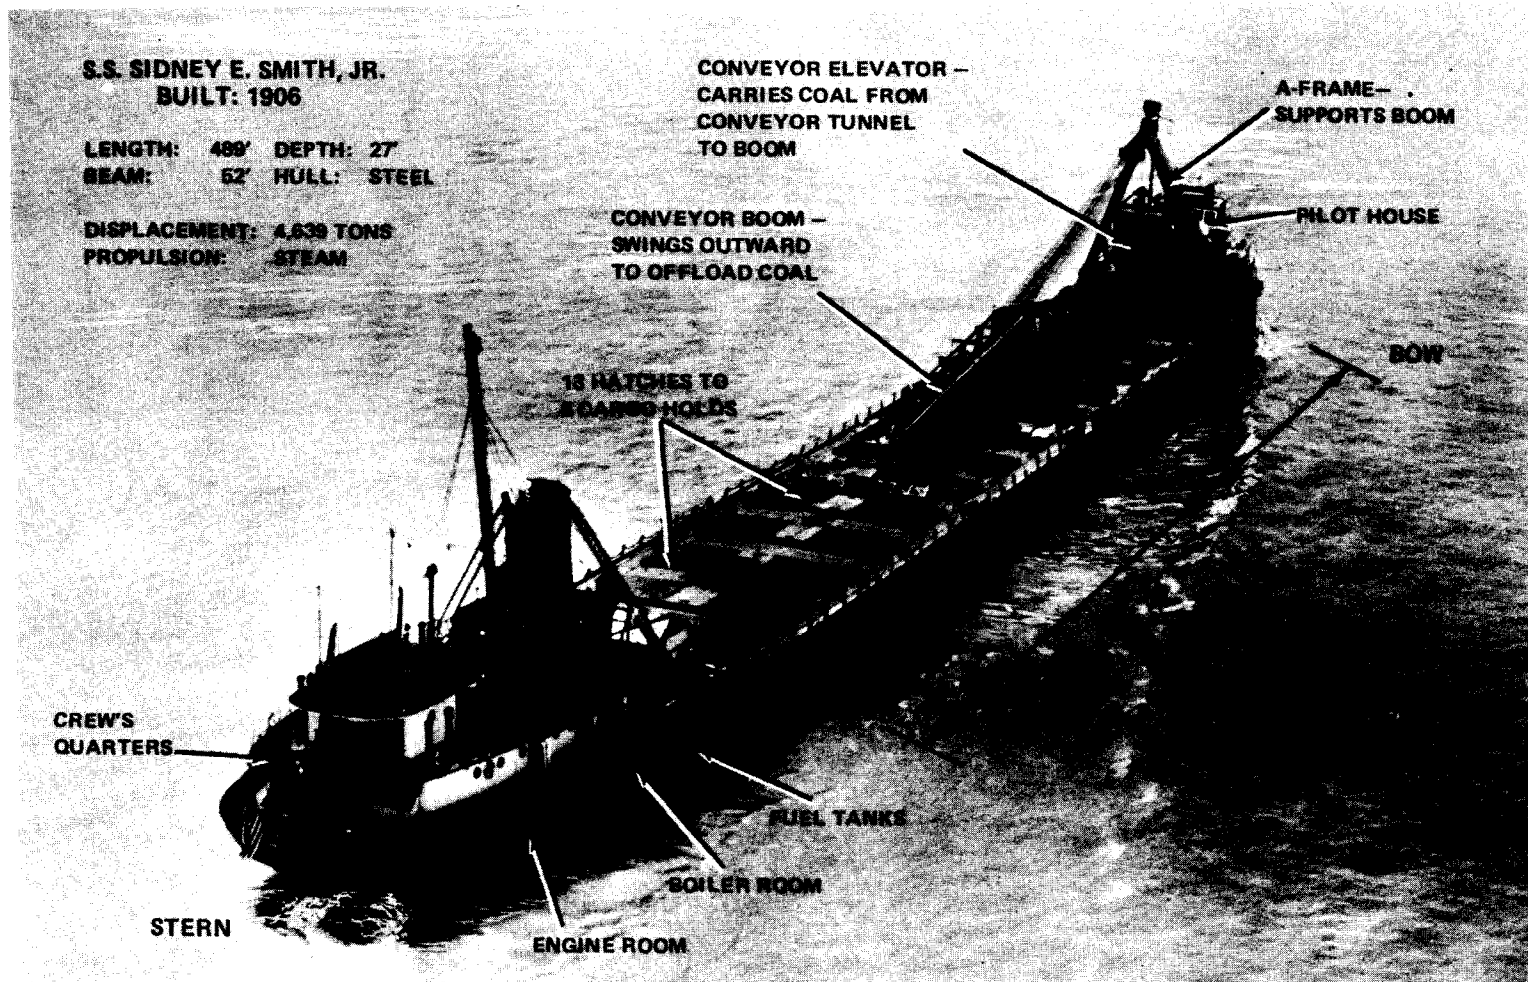
Flooding was also extensive. The SMITH was old and, as a self-unloading coal carrier, had spacious, open cargo holds and a conveyor tunnel that ran almost the entire length of the ship. Water first entered at the point of impact and then through the loosely fitting hatches after the heavy listing to starboard. Unchecked, it spread quickly throughout the vessel.

Machinery for offloading coal dominates forward superstructure. Cargo holds, tanks and other interior spaces form vast underwater compartment with minimal watertight integrity. Freighter's design and construction make it exceptionally difficult to salvage.

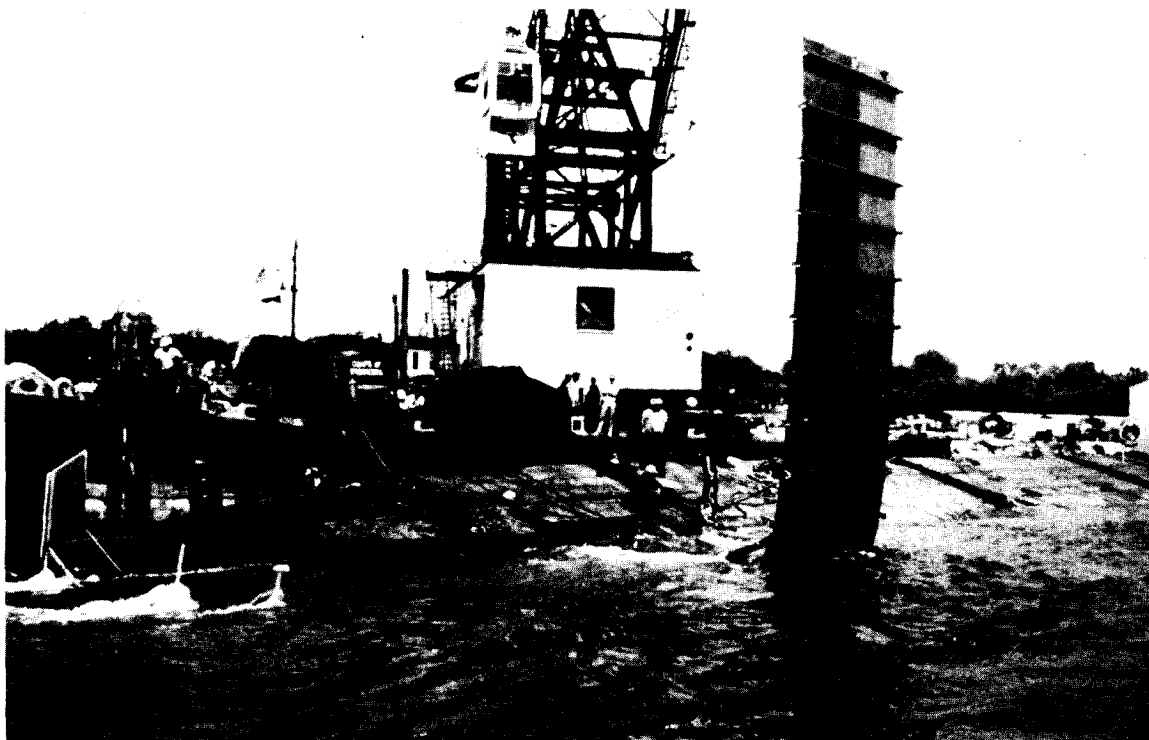
HATCH COVERS SEAL CARGO HOLDS FOR FOAMING

Hatch covers were emplaced in succession over hatches 13, 12, 10 and 11, sealing cargo holds 5 and 6. Installation was accomplished in 3-day period despite difficulties in handling and securing the heavy, cumbersome steel covers.

One minor setback to the foaming operations occurred on 13 July when a hatch cover above hold 5 began to break loose from the hatch coaming under the pressure of the installed foam. Although a large amount of foam escaped, much of it was trapped by a metal screen which salvors had placed downstream as a precaution against such accidents. Before installing new foam to replace what had been lost, the salvors installed turnbuckle jigs to secure the hatch covers more tightly against the coamings.

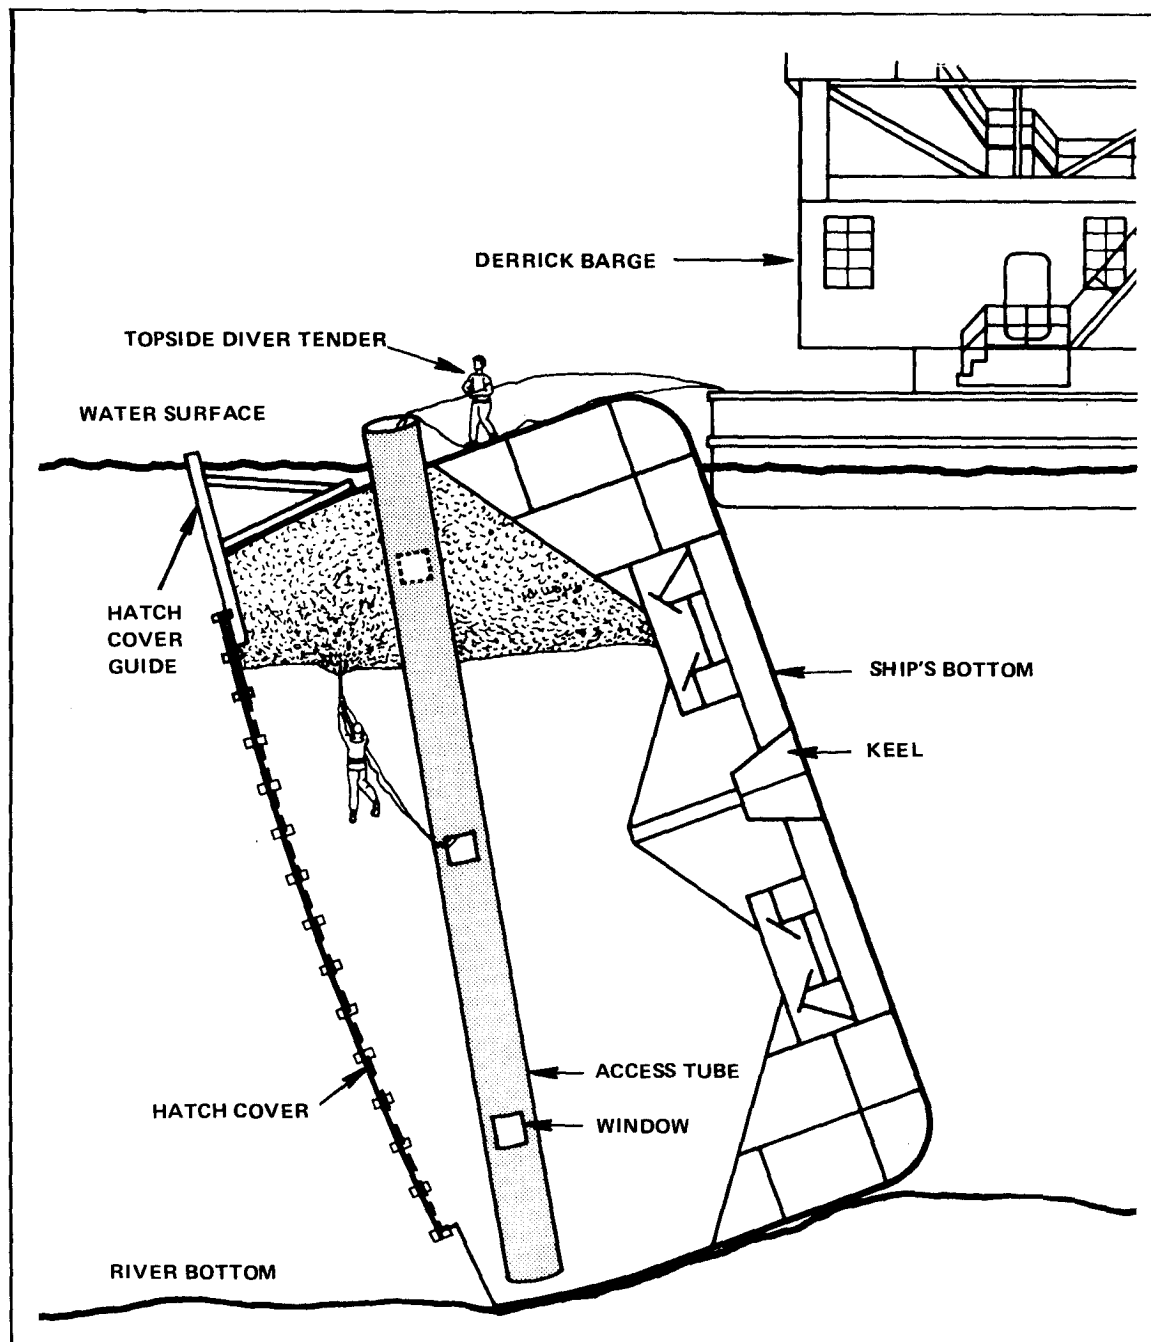
Diver foams cargo hold from top down, using each window in succession as foaming progresses to lower levels. Here, diver is tended from topside. Second diver went down to tend foaming diver when working in restricted spaces.

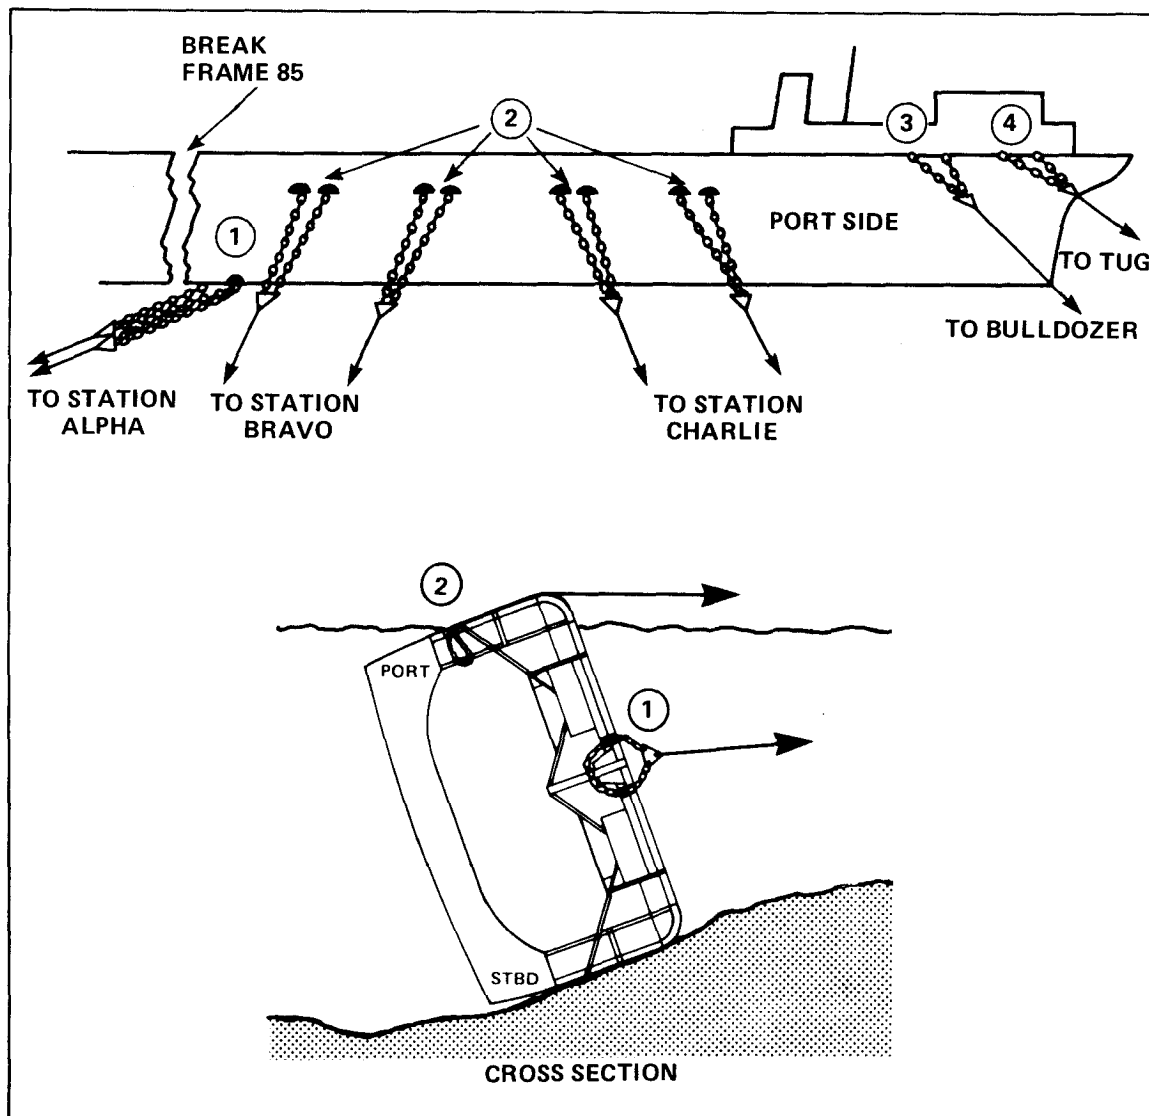
For holding the wreck against the 9-knot river current during the shoreward pull, divers looped two lengths of heavy 2 1/4-inch anchor chain around the keel at frame 94, 30 feet aft of the break. The 2-inch pulling wire from each of the two 100-ton pullers at Station ALPHA was then attached to the bitter ends of each chain with a flounder plate. To install the chain, a diver entered the conveyor tunnel beneath the hold and burned a hole on either side of the keel for passing through the ends of the chain.

- ① To hold wreck against current, pulling wires were attached to 2¼" chains looped around keel at frame 94.
- ② For parbuckling and shoreward pull, four pull points were rigged high on port side. Flounder plates connected pulling wires to 2¼" chains attached to each of four strength members 24' apart in cargo holds 5 and 6.
- ③ For additional 27-ton shoreward pulling force from bulldozer, pull point aft on port side was rigged.
- ④ Tow wire from tug to stern of wreck was rigged in attempt to separate stern from bow section.

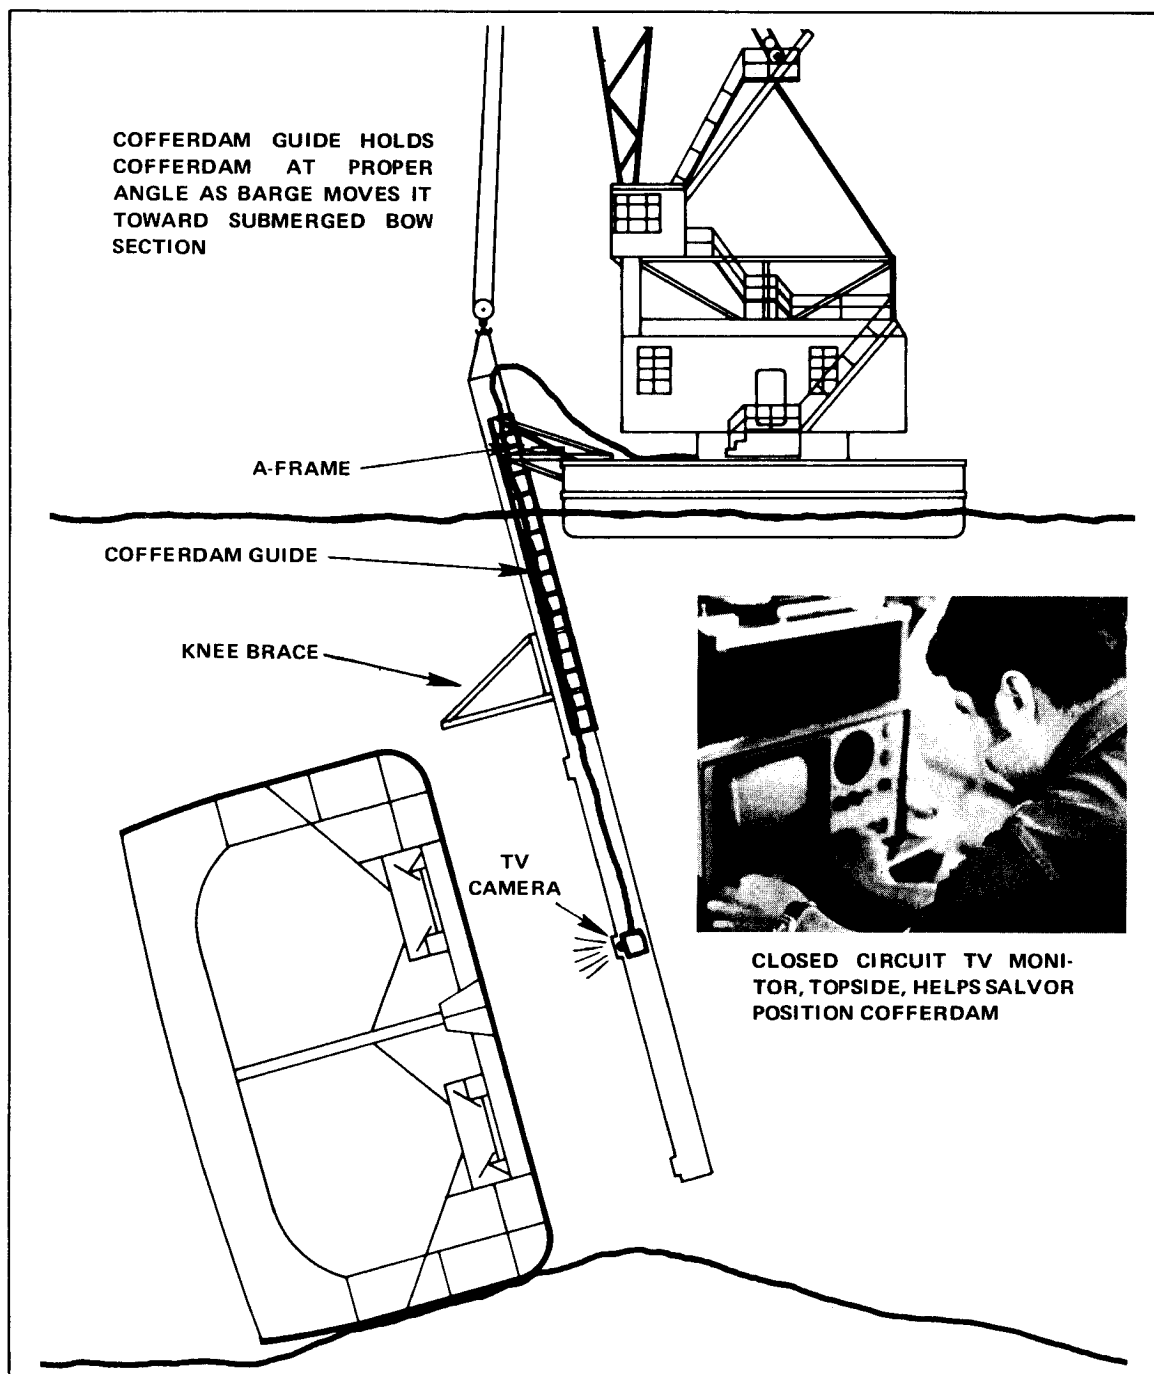
Barge moves cofferdam into place alongside wreck with aid of closed circuit TV camera. Jack on A-frame makes precise adjustments to cofferdam to insure flush contact with bottom of wreck.

Following the incident, a number of repairs were made. The A-frame and guide were equipped with strength members of increased size and number; the cofferdams were strengthened with lateral and longitudinal stiffeners (4-inch I-beams) and deep-welded at all joints. Finally, the screw-type jack on the A-frame was replaced with a pair of hydraulic cylinders.

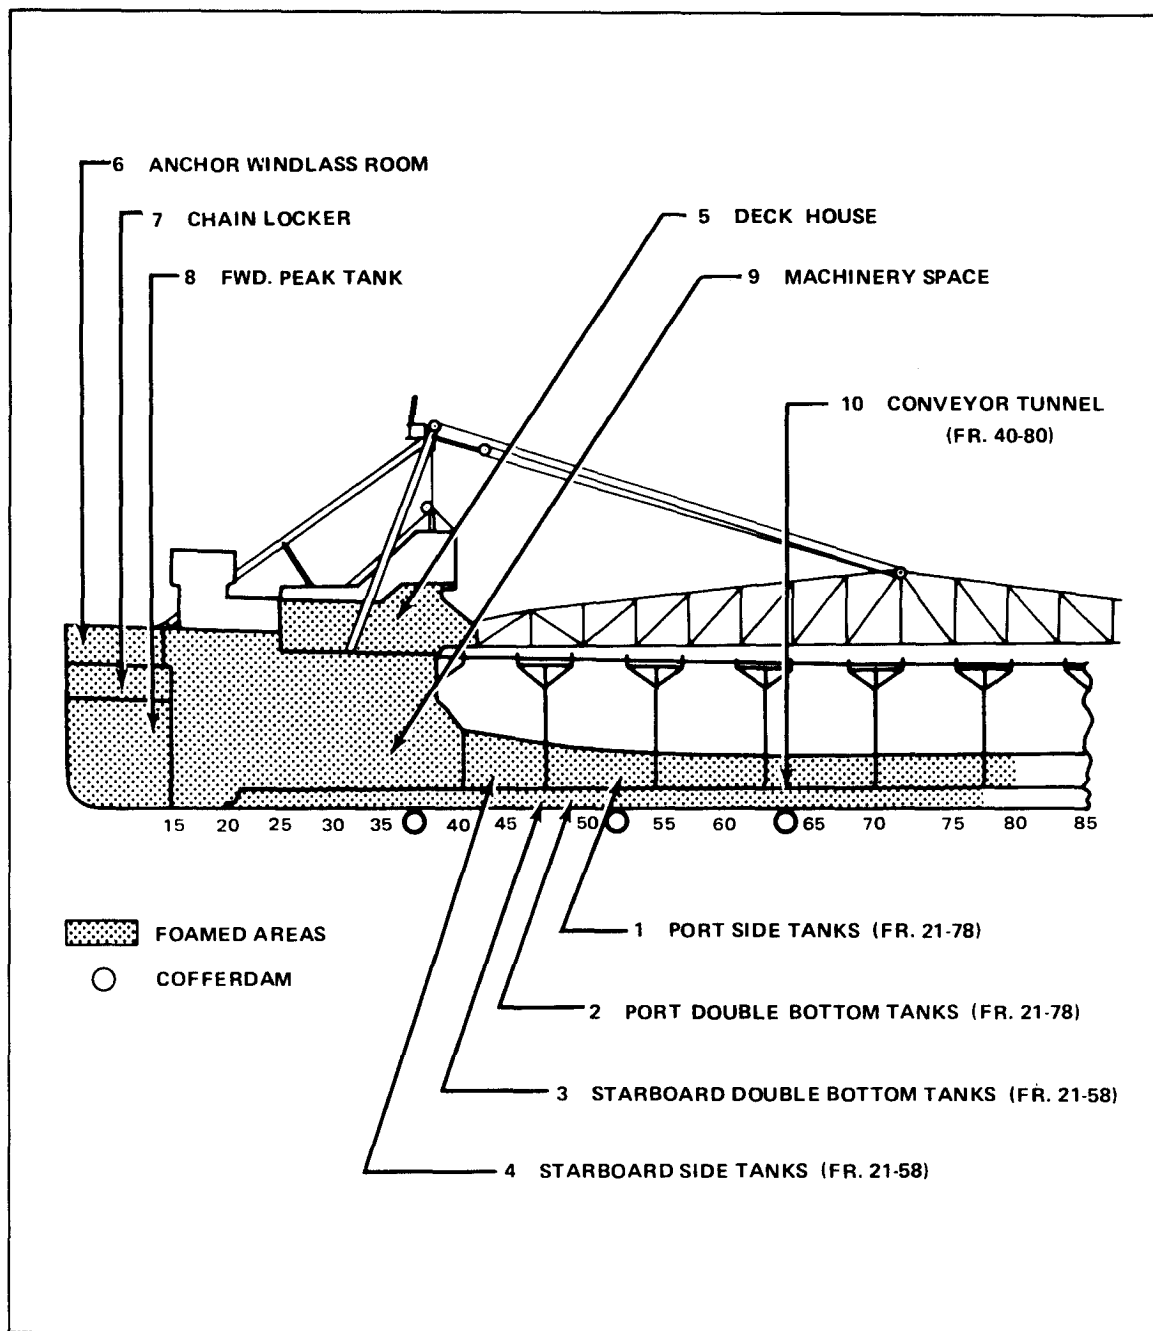
From 16 to 21 September, divers installed more than 1700 tons of foam buoyancy in bow section's three structurally distinct areas: stem to frame 15; frame 15 to 40; and frame 40 to break. Numbers indicate sequence of tanks and spaces foamed.

Inspection of the wreck revealed no major structural damage, although considerable sand and gravel had been washed into the coal conveyor tunnel. In preparation for foaming, all spaces were cleared of debris and sediment, holes were patched, and canvas bulkheads installed in the long, open conveyor tunnel. These bulkheads would enhance foam quality by controlling lateral flow of the unhardened foam.

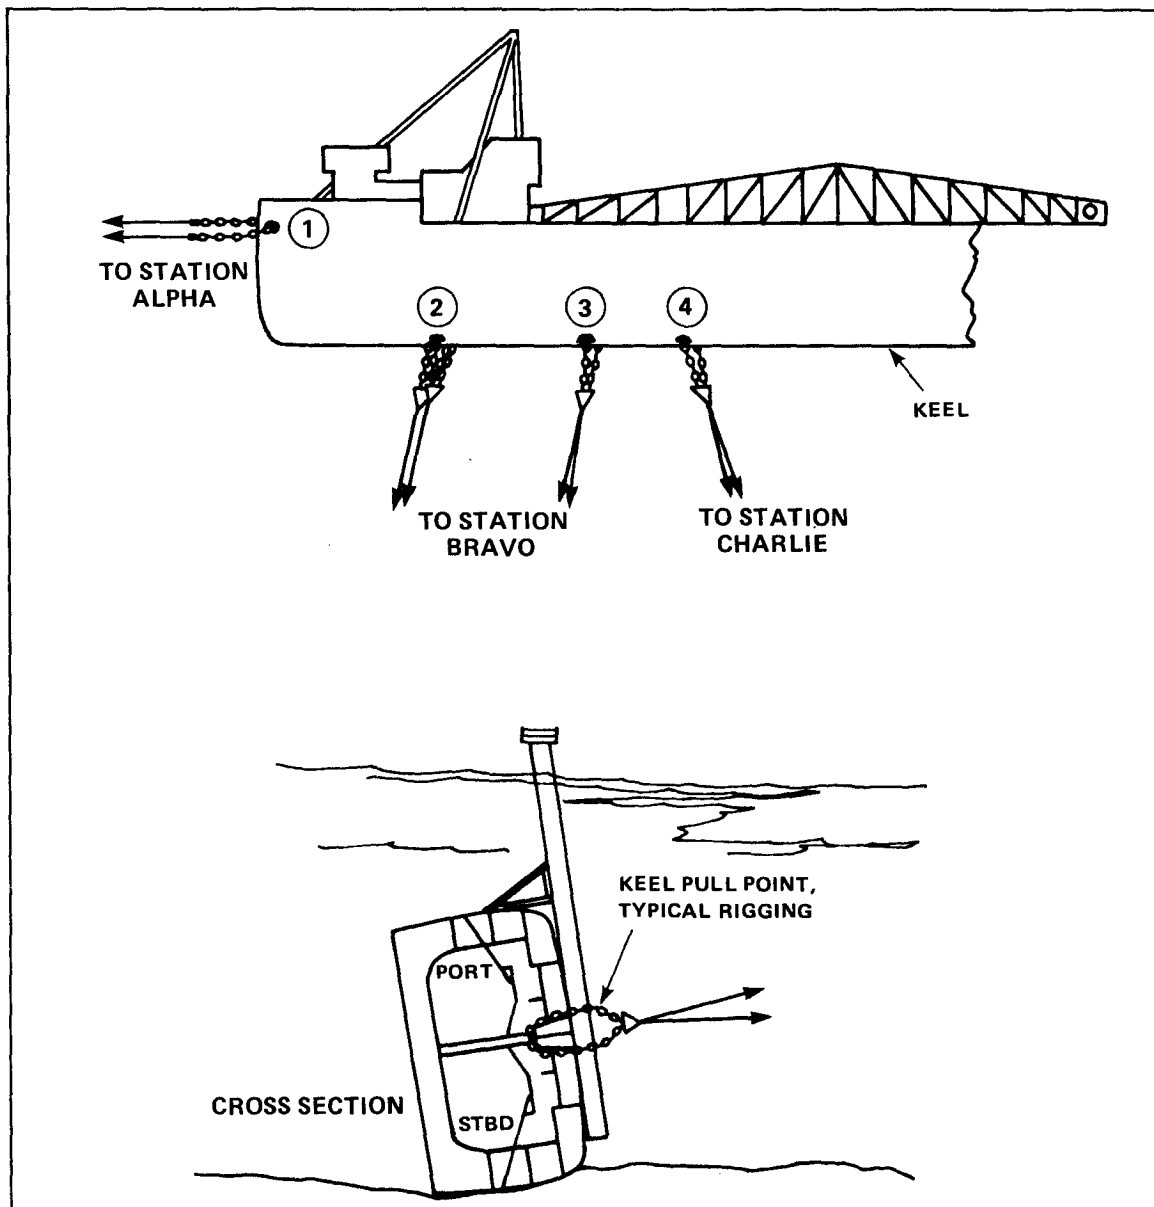
- ① Anchor chain extending from hawse pipes for pulling wires to 40-ton hydraulic pullers.
- ② Double loop of 2" chain around keel at frame 31 for pulling wires to 200-ton Skagit winch.
- ③ Single loop of 2½" chain around keel at frame 46 for pulling wires to 300-ton Skagit winch.
- ④ Single loop of 2½" chain around keel at frame 56 for pulling wires to 100-ton hydraulic pullers.

the wreck to move downstream, were now tensioned. A chain stopper aboard the wreck gave way, releasing the port anchor chain. The two holding wires connected to the anchor chain went slack as the chain began paying out. One of the other pair of holding wires parted as the load at Station ALPHA shifted completely to the remaining set of pullers. The bow section grounded at this time, pivoting on its broken after end, with the forward end swinging in toward shore. One of the anchor blocks at Station BRAVO was also damaged during this unsuccessful pulling attempt.

The salvors worked through the night to repair the damage at Stations ALPHA and BRAVO. As dawn approached on 22 September, pulling resumed. Within an hour, the hull of the vessel surfaced approximately 100 feet from shore, becoming visible for the first time in more than three months. The wreck was finally grounded 70 feet from shore, well clear of the shipping channel, bringing to a close Phase II of the SMITH salvage operation.

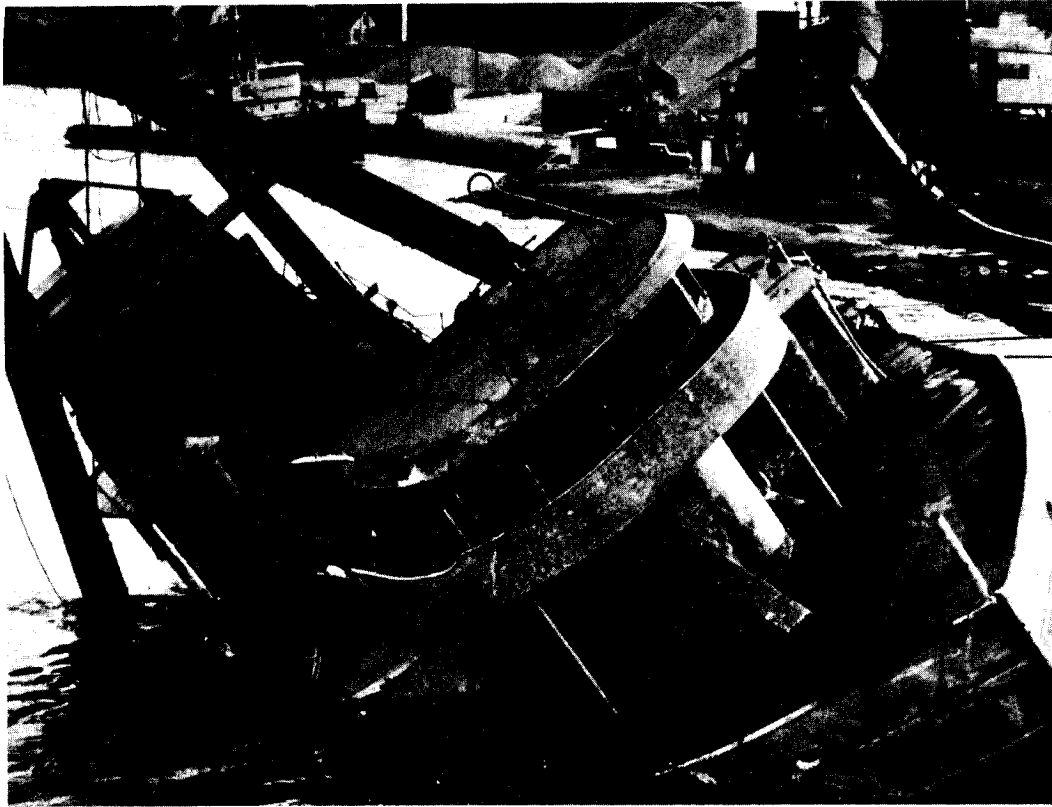
With pull points on wreck rerigged, bow section was brought to within 40 feet of shore and parbuckled to 40° starboard list. Further parbuckling reduced list to 22°, but efforts were hampered by presence of submerged pier pilings beneath wreck.

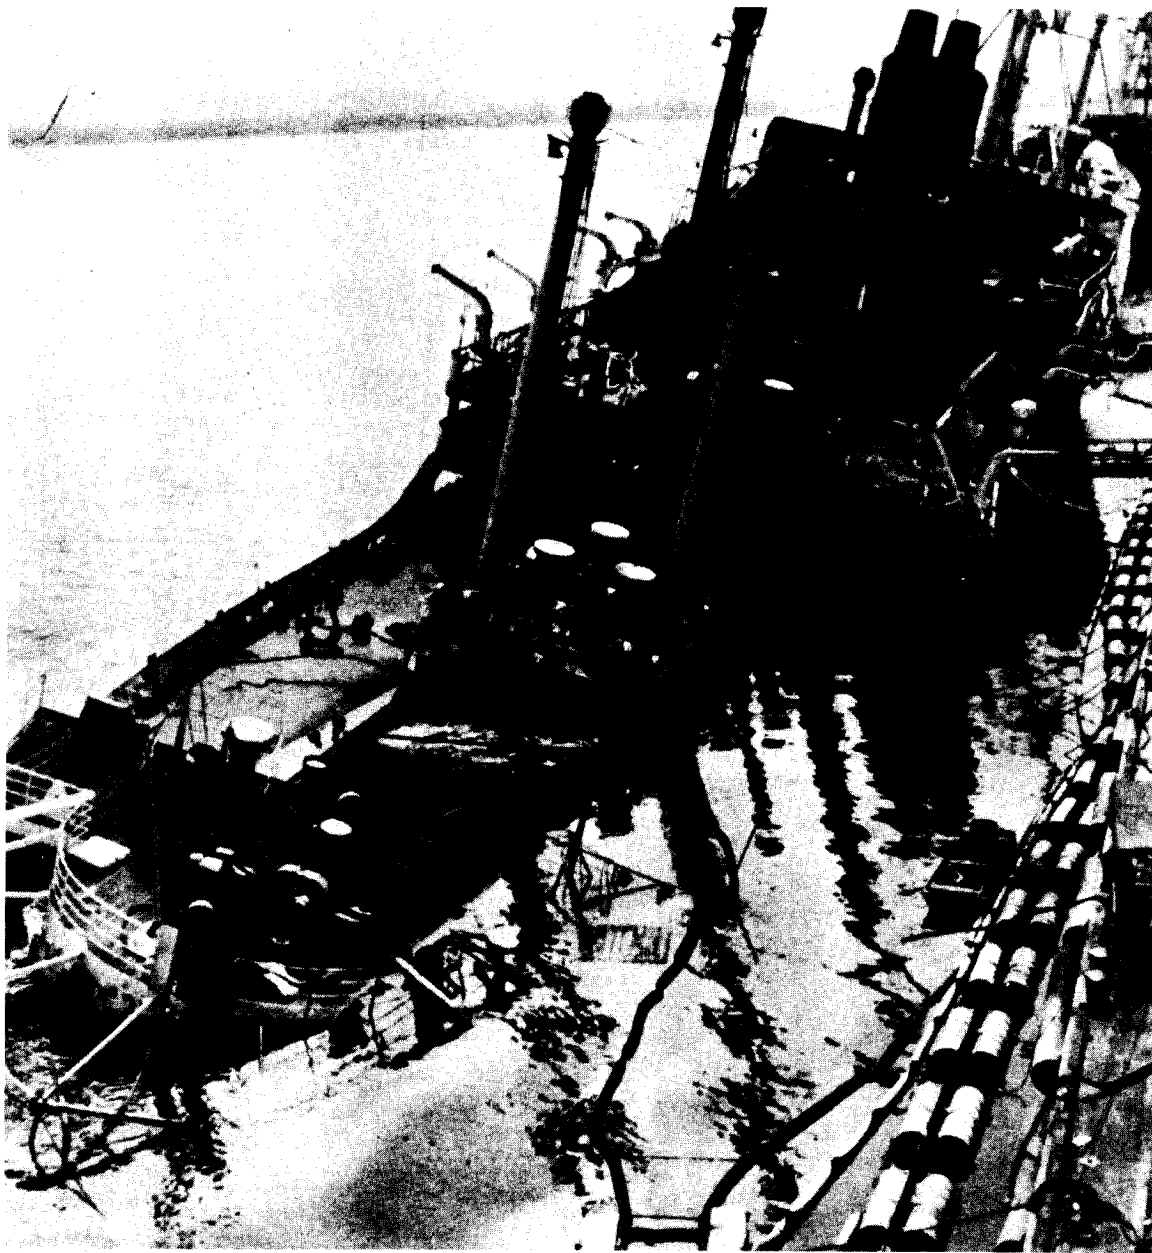
MV ORIENTAL WARRIOR began leaking oil into St. Johns River at Jacksonville, Florida, as a result of fire and subsequent sinking. Carrying nearly 300,000 gallons of oil, vessel presented serious pollution threat to surrounding waters.

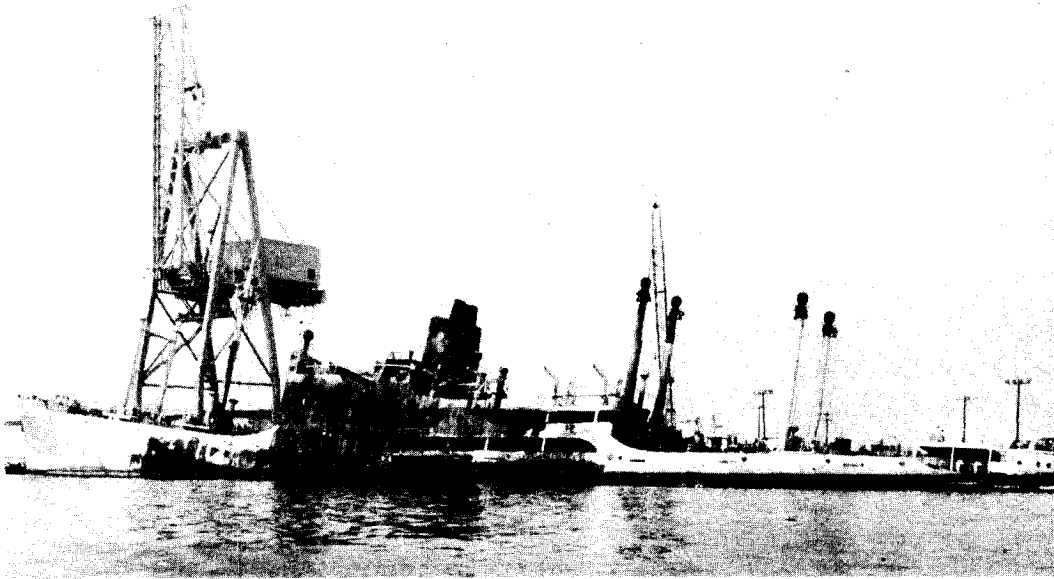
Fire-scarred WARRIOR lies bottomed at stern and listing 17 degrees to starboard. Salvors established 10 pulling stations on pier and reeved pulling wires beneath hull to prevent wreck from capsizing during refloating operations.

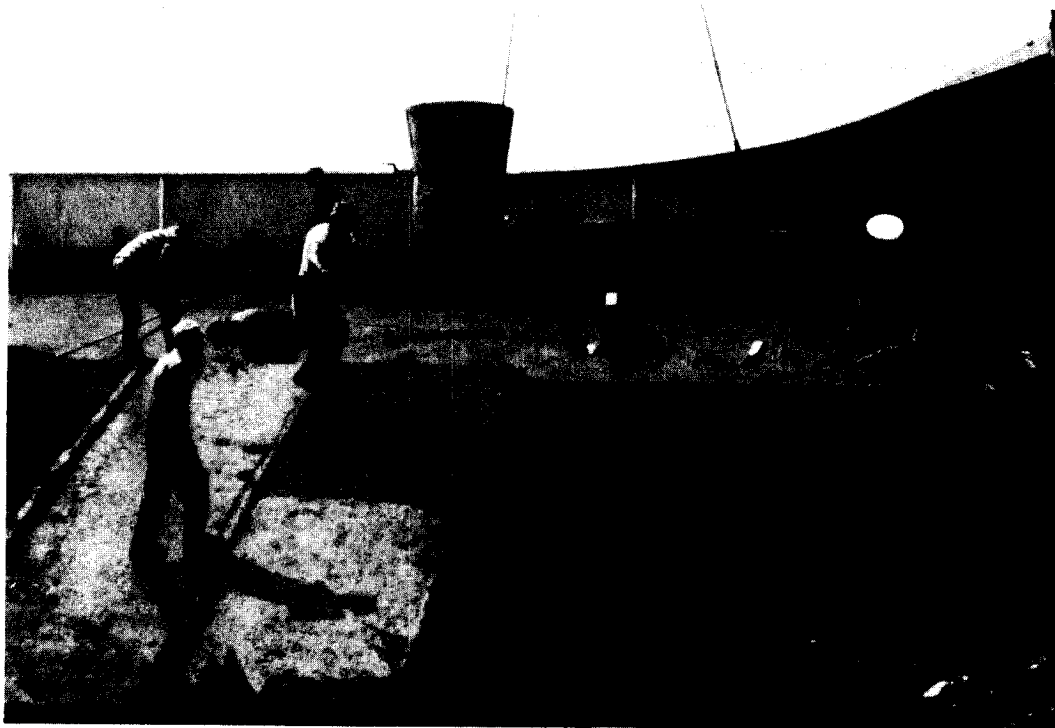
Steber Co. wreckers modified ship's steel hatch covers, then welded them to coamings to insure watertight fit over aft cargo holds 4, 5 and 6.

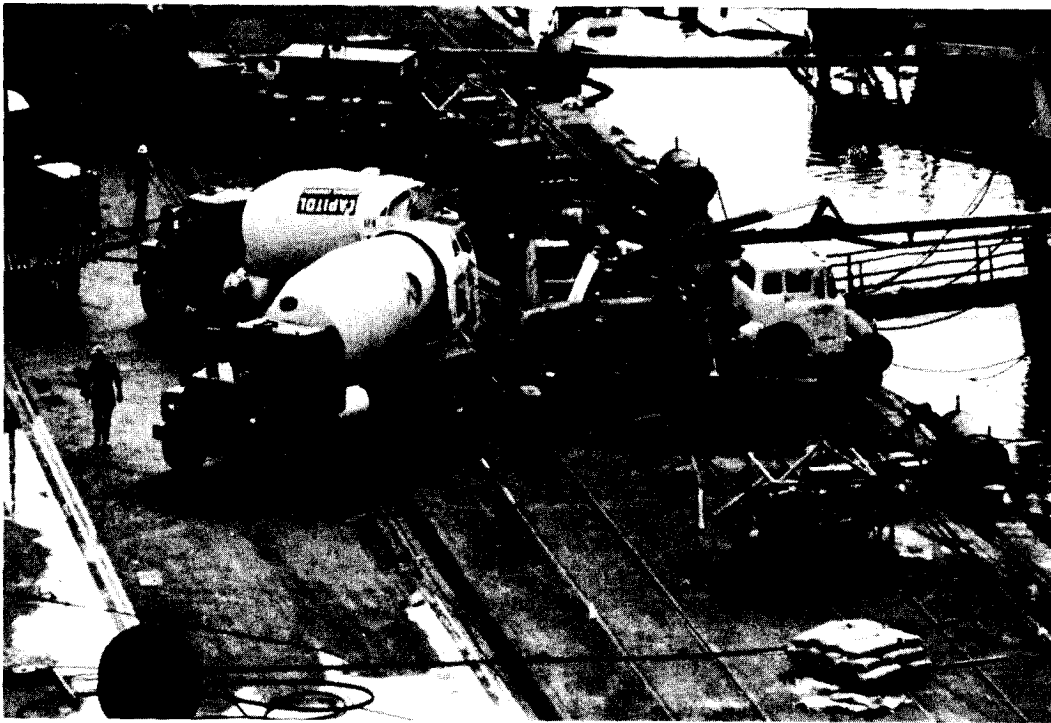
Salvors worked 20 consecutive hours pouring 400 yards of concrete to seal shaft alley and provide ballast for aft end of ship. Concrete was pumped to shaft alley through 3-inch and 4-inch hoses. Divers inside wreck positioned hoses to insure even distribution of concrete.

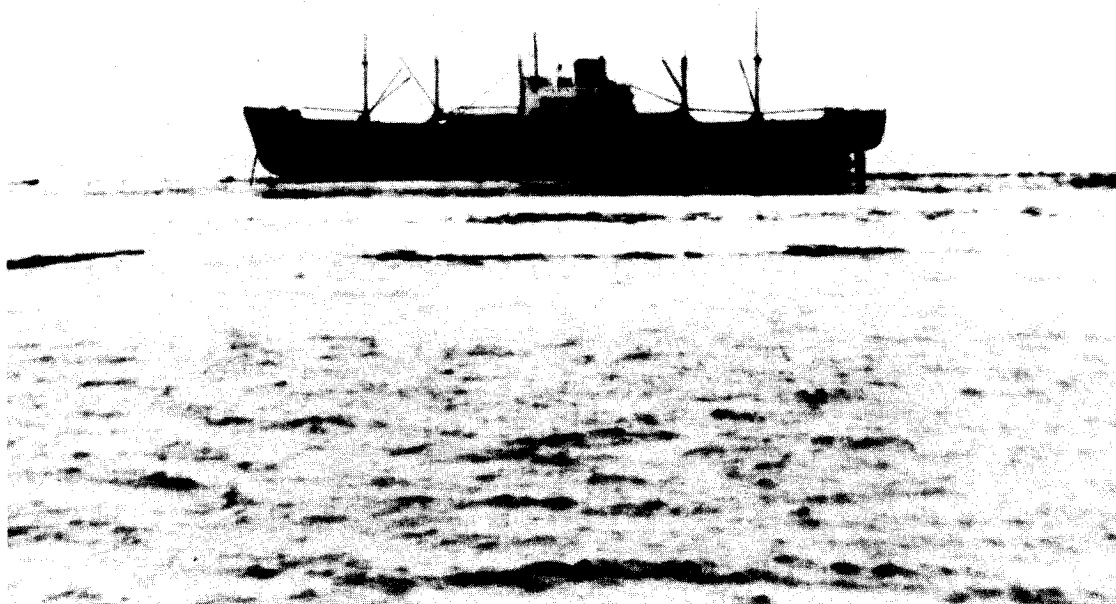
Vessel rested on coral reef at approximately even keel, leaking oil at rate of 20 gallons per day. Danger of serious spill increased with passage of several typhoons which caused 20-foot surf to pound against vessel's torn starboard side.

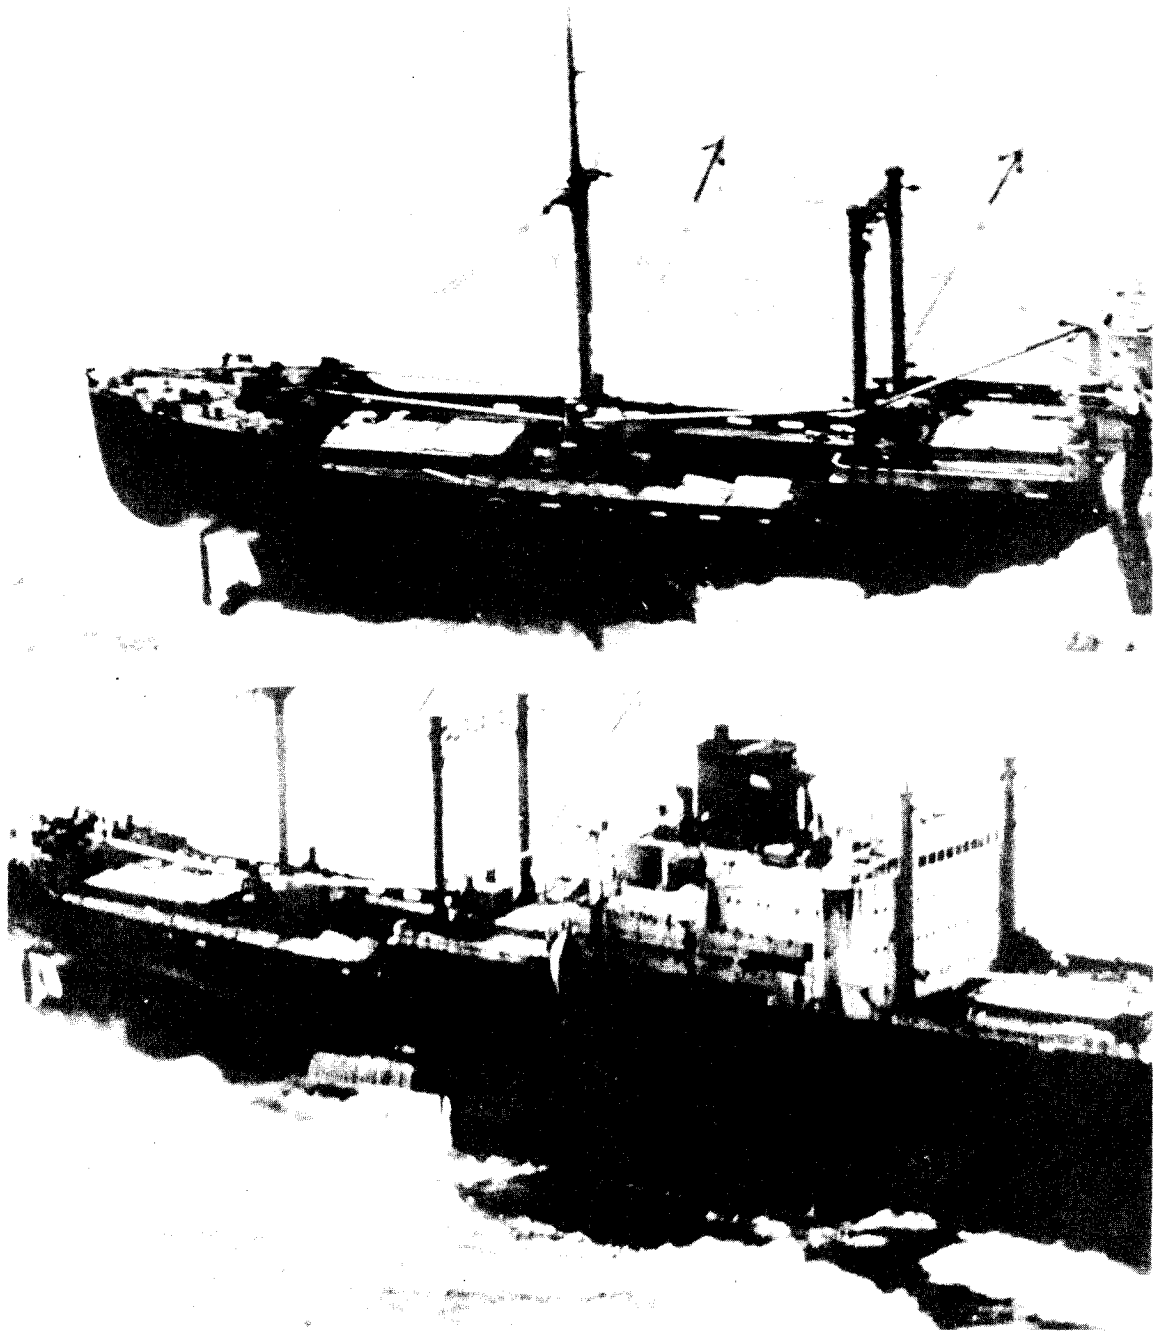
Invasion of sea water into aft cargo holds through gashes in starboard shell plating made access to aft double bottom tanks difficult and increased danger of oil spillage during recovery efforts.

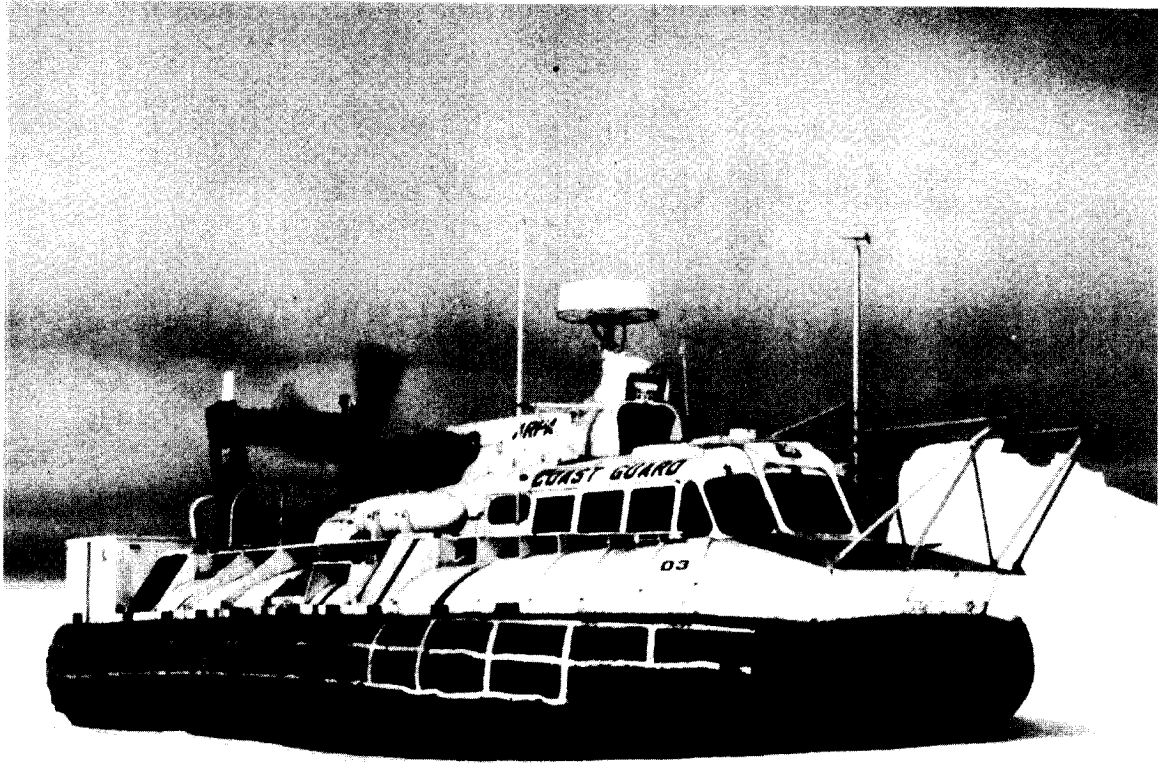
ACV-3 sank in northern Lake Huron after wave broke over its bow and knocked out windshield. Craft, shown here during earlier assignment in Arctic, was participating in study to extend shipping season on Great Lakes when accident occurred.

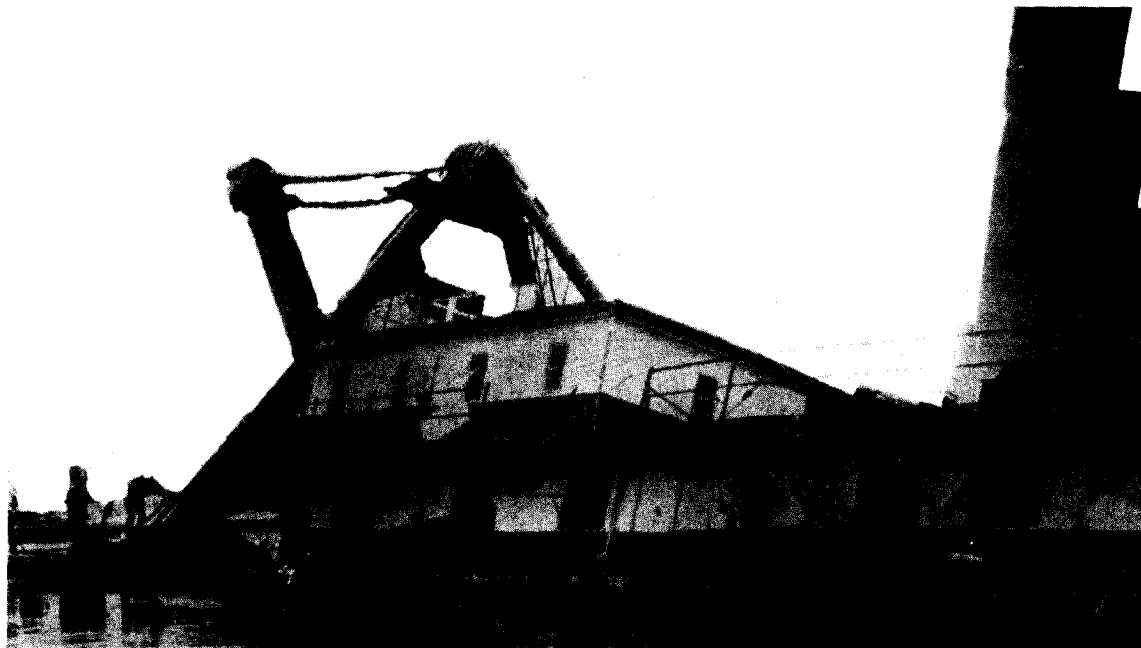
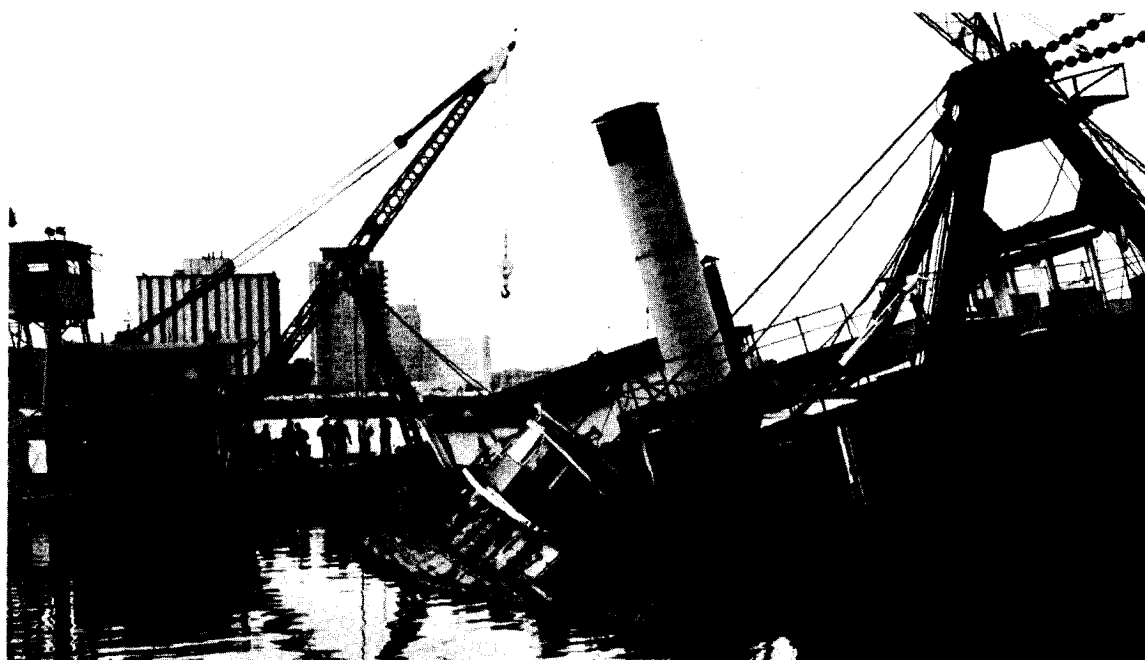
Oily water surrounds Dredge ATLANTIC and tug as salvors inspect casualty site aboard derrick barge YD-53. Top photo shows port side of dredge at high tide, looking forward; bottom photo is of starboard side at low tide, looking aft.
