# SALVOPS 74

**A review of significant salvage operations  
conducted by U.S. Navy salvage forces  
and other salvage activities during 1974.**

**SUPERVISOR OF SALVAGE, U.S. NAVY  
NAVAL SEA SYSTEMS COMMAND  
WASHINGTON, D.C.**

**NAVSEA 0994-LP-012-6060**

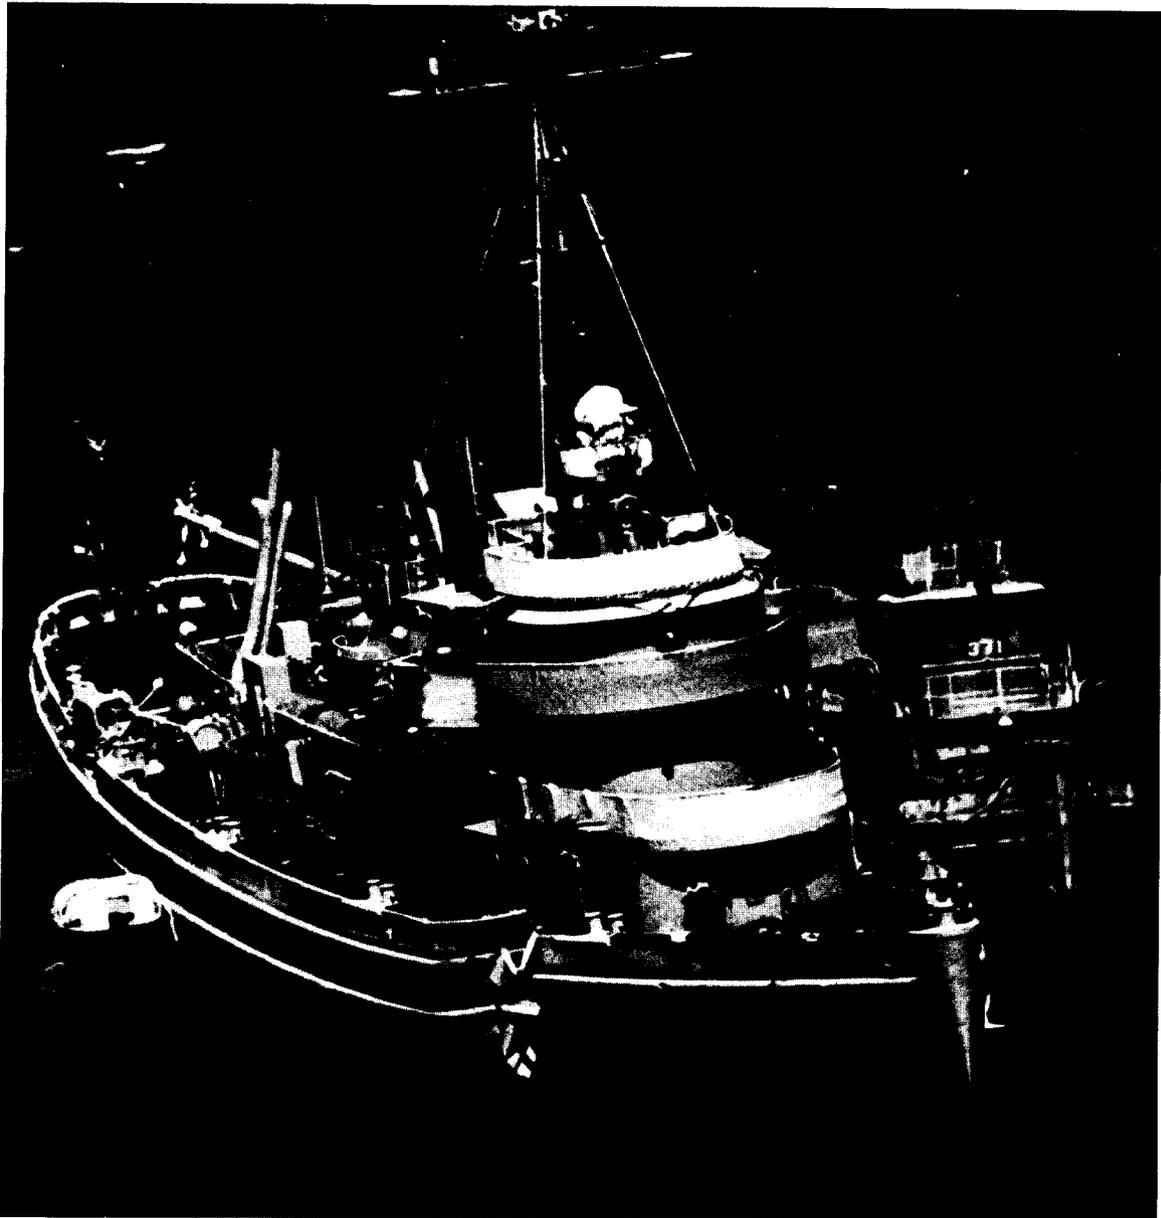
**WHILE TOWING A TUG, LIPAN COLLIDED WITH A TANKER**

*USNS LIPAN (T-ATF-58) was damaged in a collision with the tanker ATLANTIC PRESTIGE while towing the fleet harbor tug YTM-371 through the Strait of Juan de Fuca.*

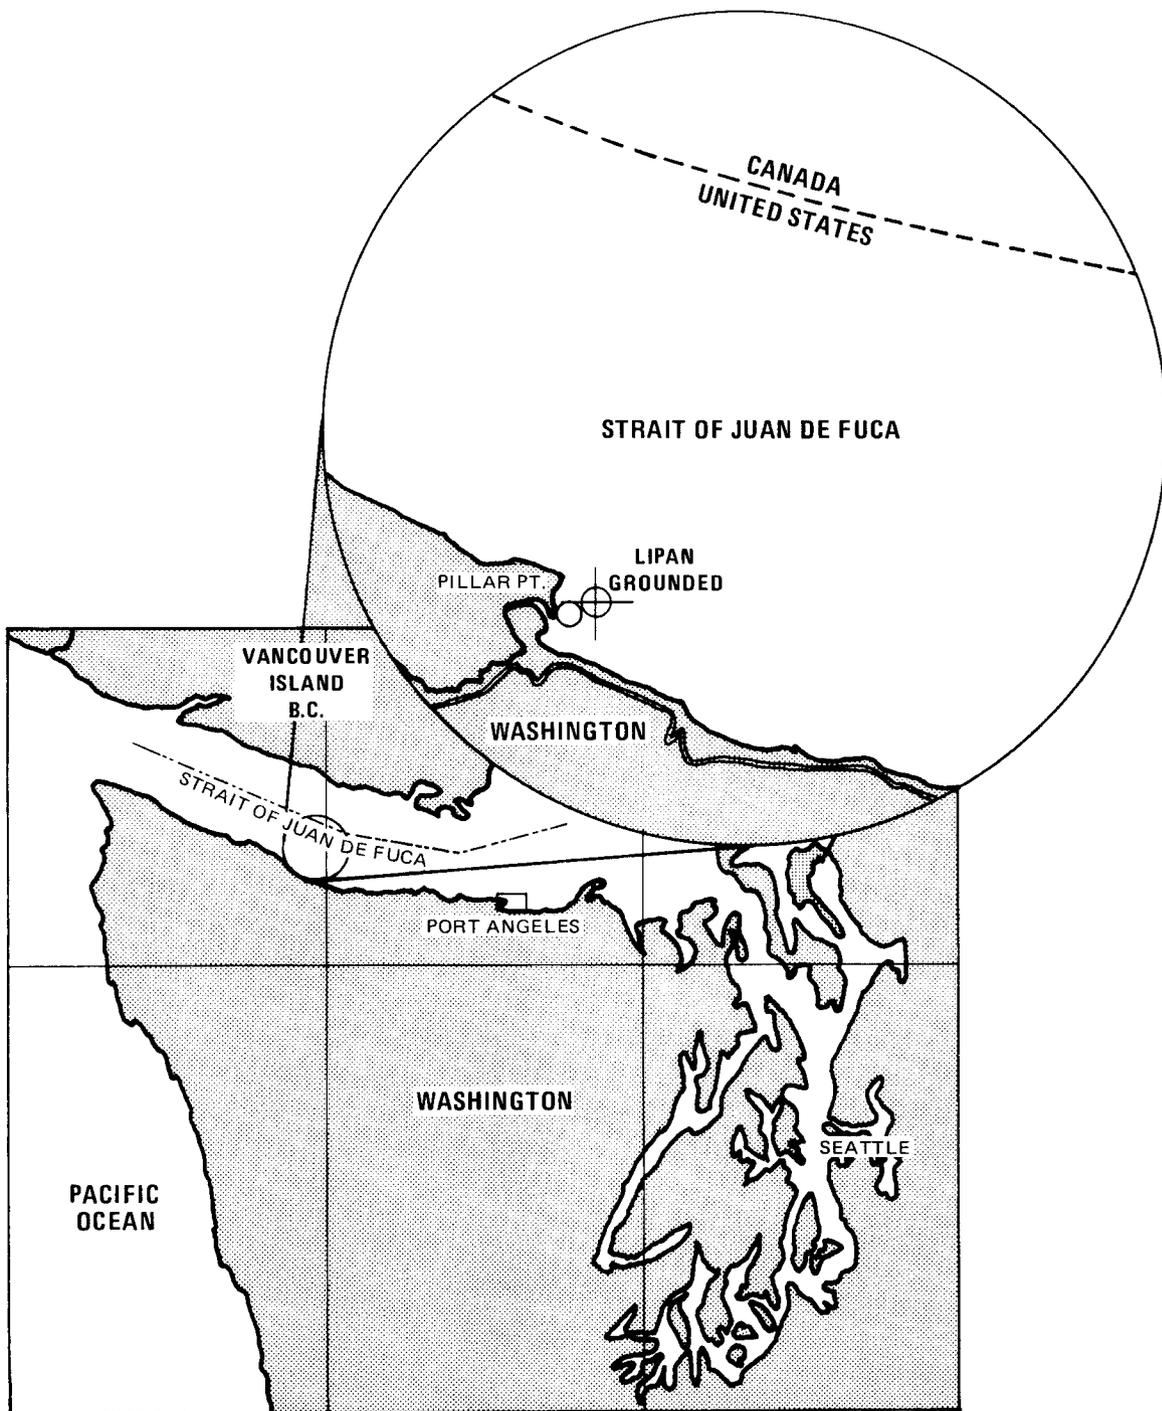
**LIPAN'S COLLISION LED TO GROUNDING OFF PILLAR POINT**

*After collision with a tanker in the Strait of Juan de Fuca, severe damage to USNS LIPAN (T-ATF-58) led to grounding at Pillar Point, off Pysht, Washington, to prevent loss from sinking.*

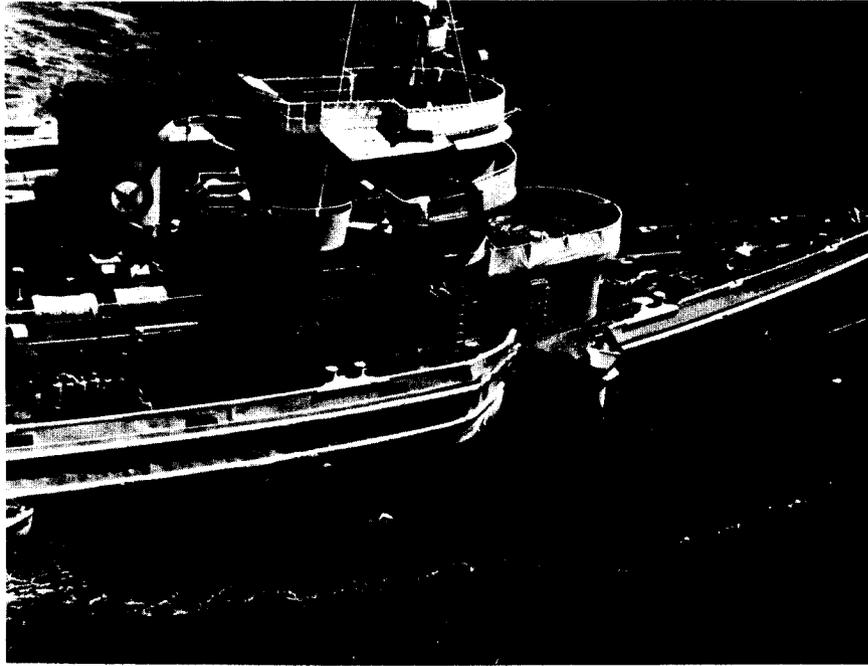
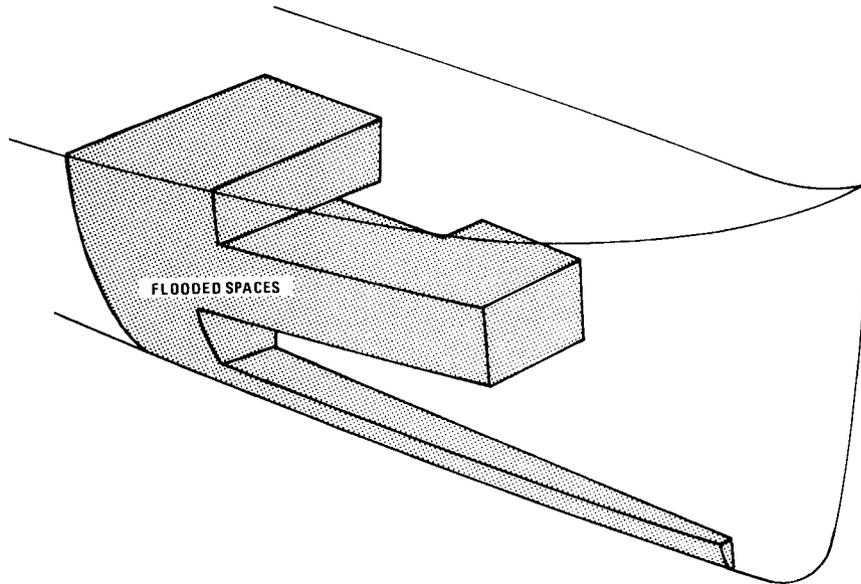
**THE TUG LIPAN SUFFERED SEVERE DAMAGE TO STARBOARD**

*Lipan was penetrated at two levels, which caused extensive flooding in forward spaces.*

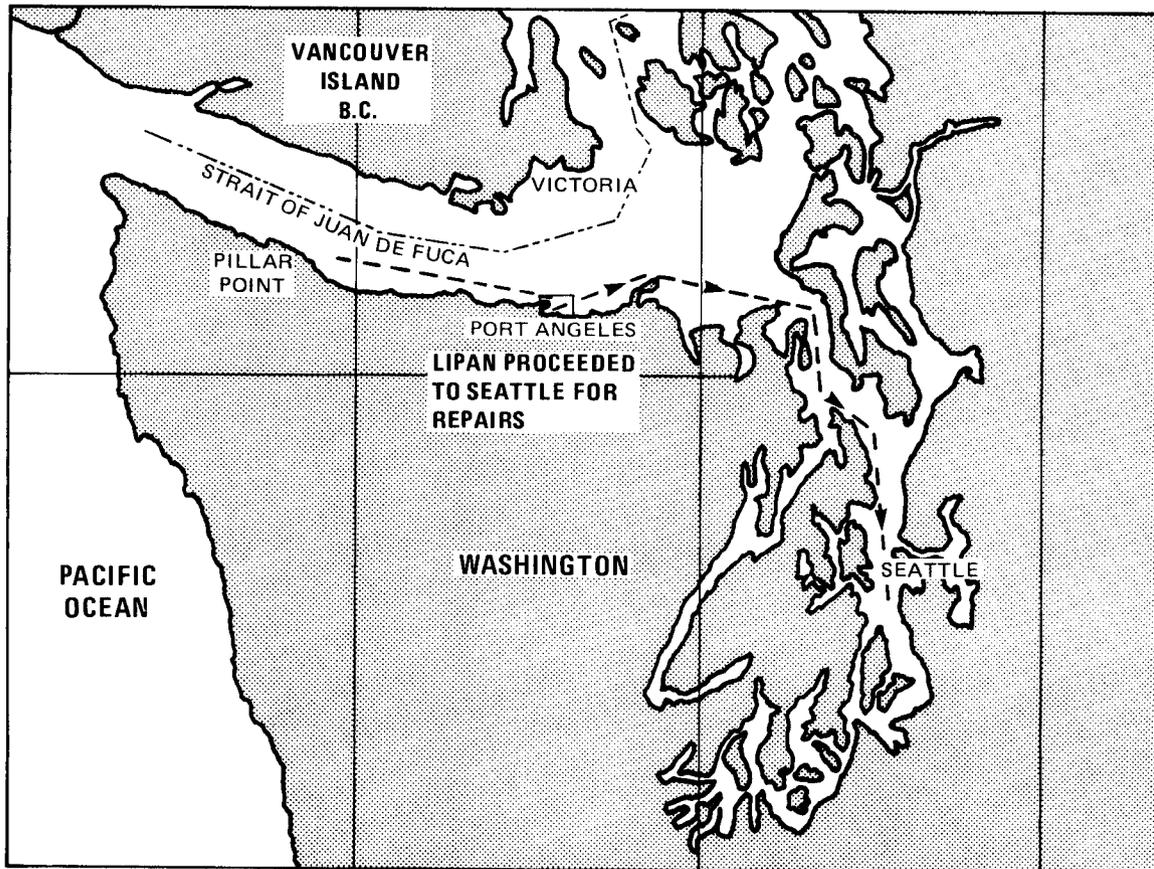
**UPON COMPLETION OF TEMPORARY REPAIRS AND DEWATERING,  
LIPAN GOT UNDER WAY FOR A SEATTLE YARD**

*Initially under tow, LIPAN proved unmanageable due to hull damage distortion. She then was escorted under her own power, first to Port Angeles for a pilot, and then to Seattle for repairs.*

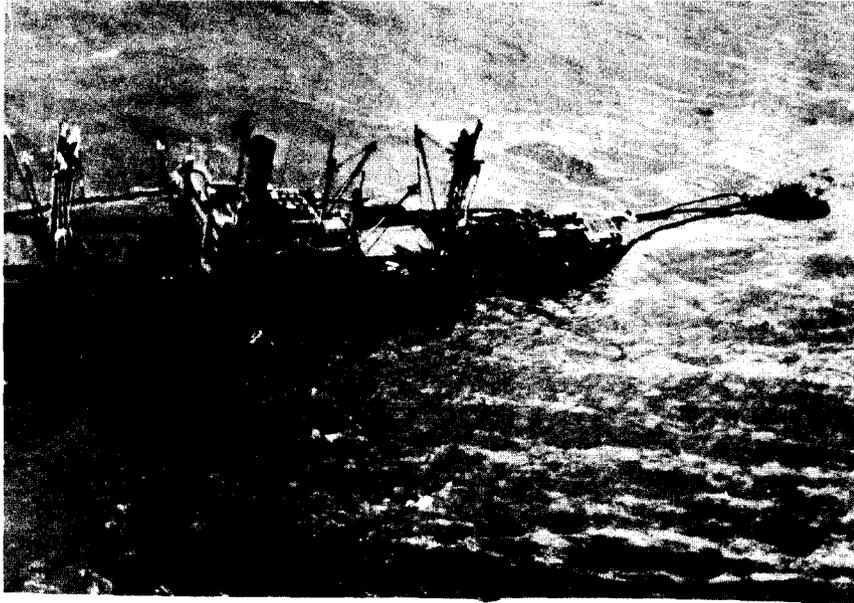
**MERRELL WAS LEFT DEAD IN THE WATER**

*The bow of the PEARL VENTURE penetrated MERRELL, port side aft, into holds 4 and 5.*

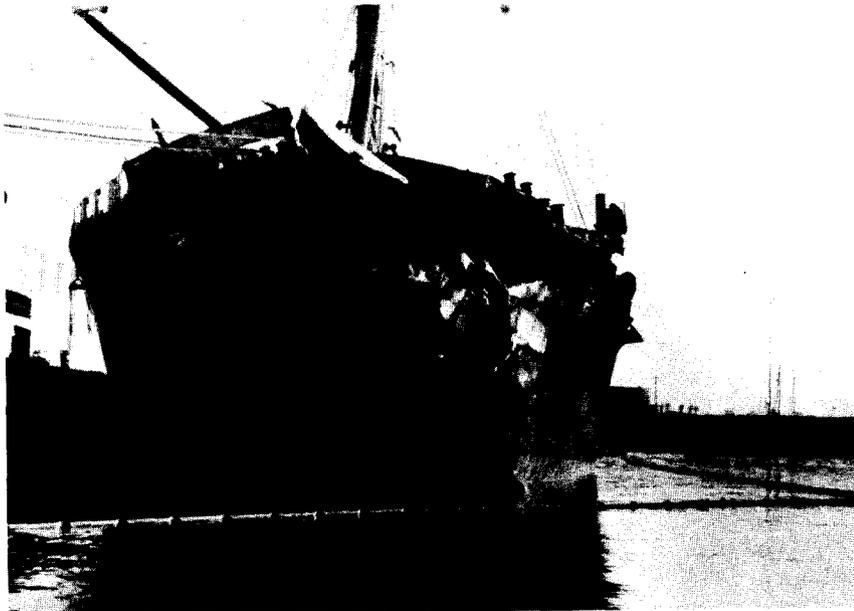
**PEARL VENTURE, ALSO DAMAGED, MADE PORT UNDER HER OWN POWER**

*The Liberian bulk carrier suffered heavy bow damage but was able to proceed to Los Angeles for repairs.*

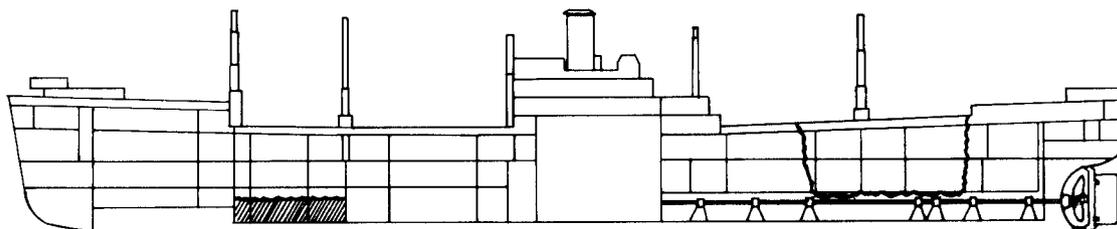
#### **DIAGRAM OF MERRELL'S DAMAGE**

*In addition to the 65-foot hole cut into holds 4 and 5 port side aft, divers reported a hull crease to starboard extending to the keel, a four-inch crack on the flat keel, and the propeller knocked out of alignment. While MERRELL had enough structural strength for the tow to Port Hueneme, 1,000 tons of sand was placed in number 2 hold to increase the metacentric height and relieve strain on strength members in the damaged areas.*

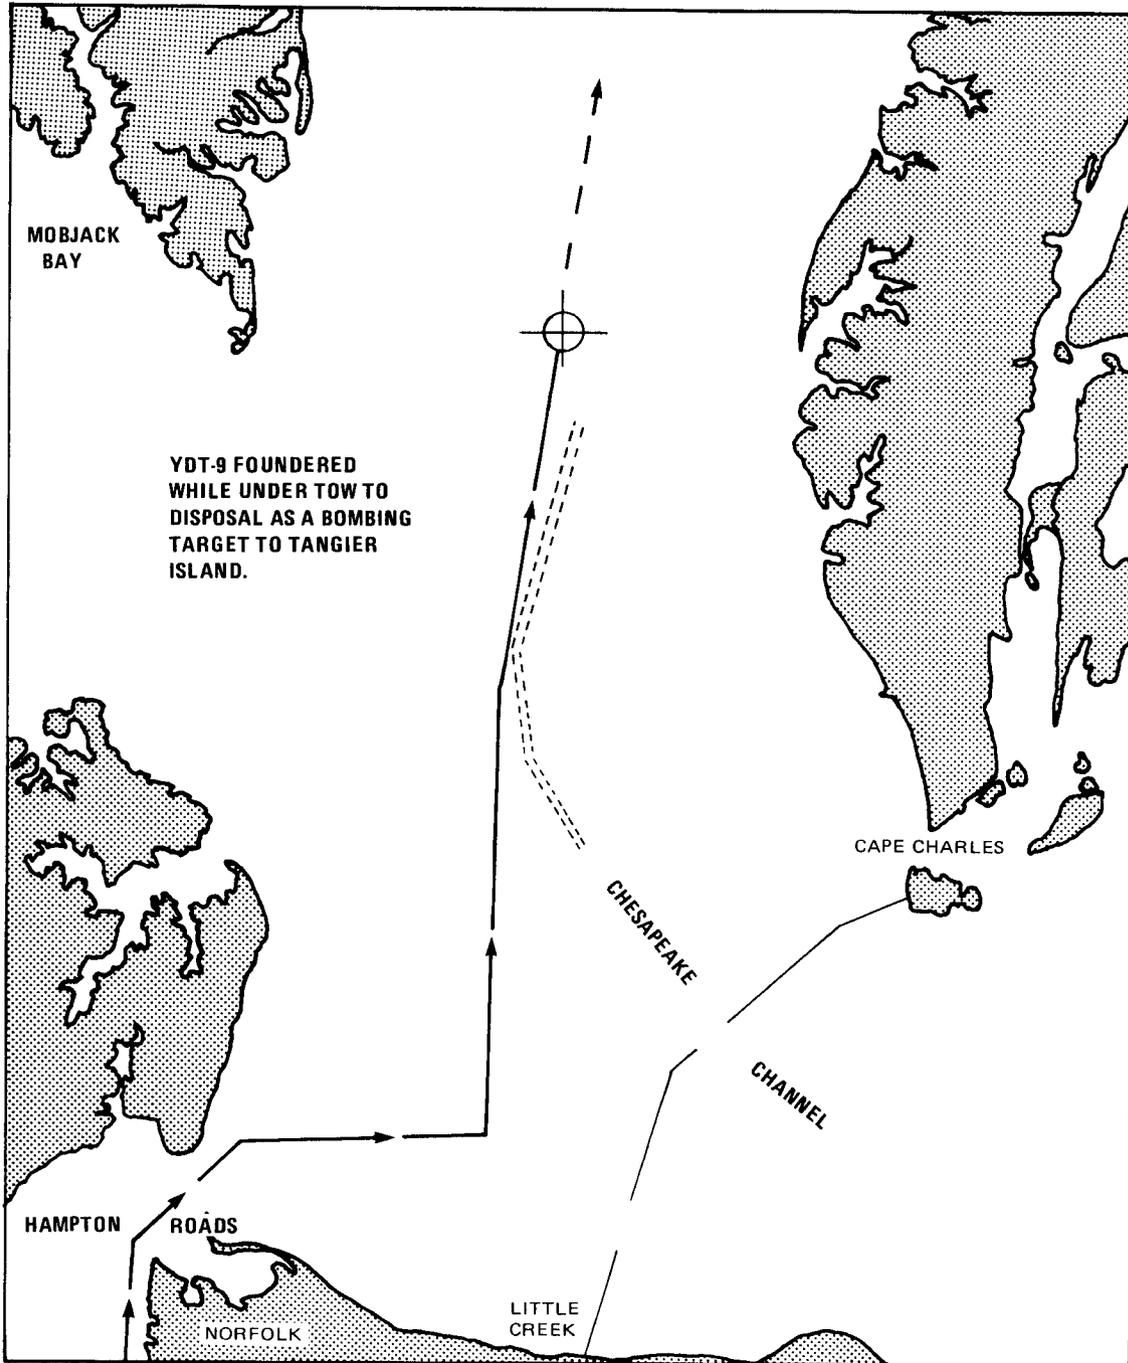
**YDT-9 WAS LOST WHILE IN TOW TO DISPOSAL**

*The 30-year-old ex-LCU/LCT foundered just north of the busy York Spit Channel and constituted a hazard to navigation requiring removal.*

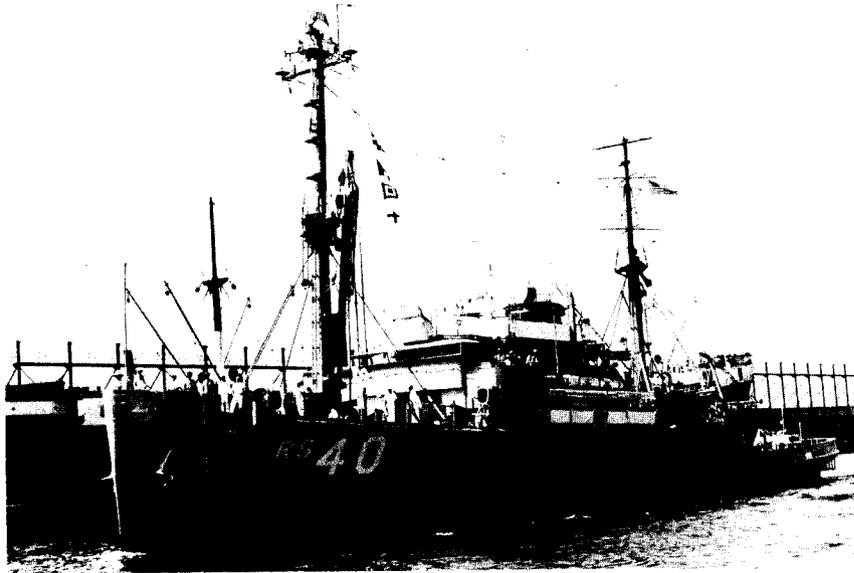
### HOIST DIVERS SURVEYED THE LOST YDT-9 AND STARTED LIFT PREPARATIONS

*Divers from the USS HOIST (ARS-40) found the elderly (1944) ex-landing craft to be badly worn and corroded from years of hard use. This condition had led to YDT-9's sinking, and plagued HOIST's efforts to remove her.*

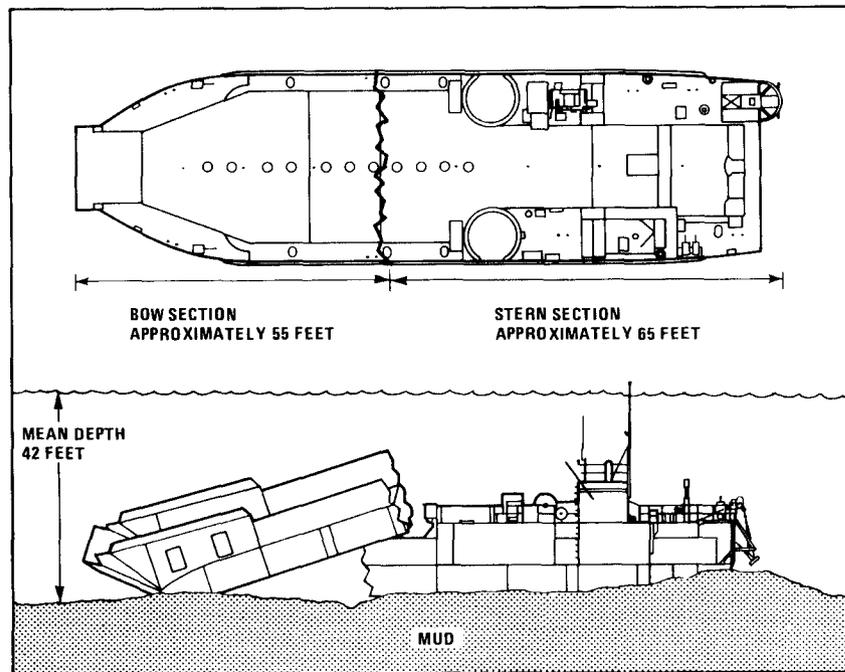
### YDT-9'S RUSTED HULL BROKE IN HALF

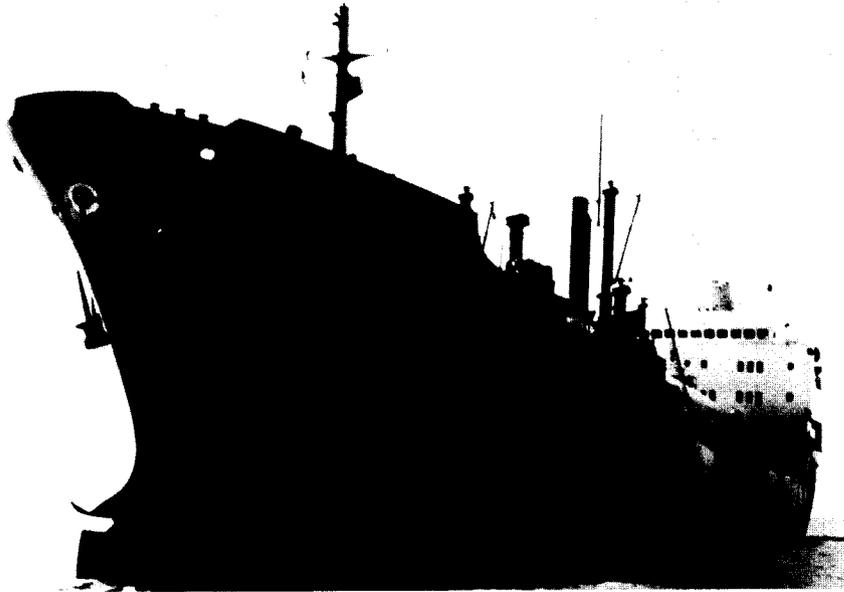
**THE BOW ELM SANK THE DREDGE MACKENZIE**

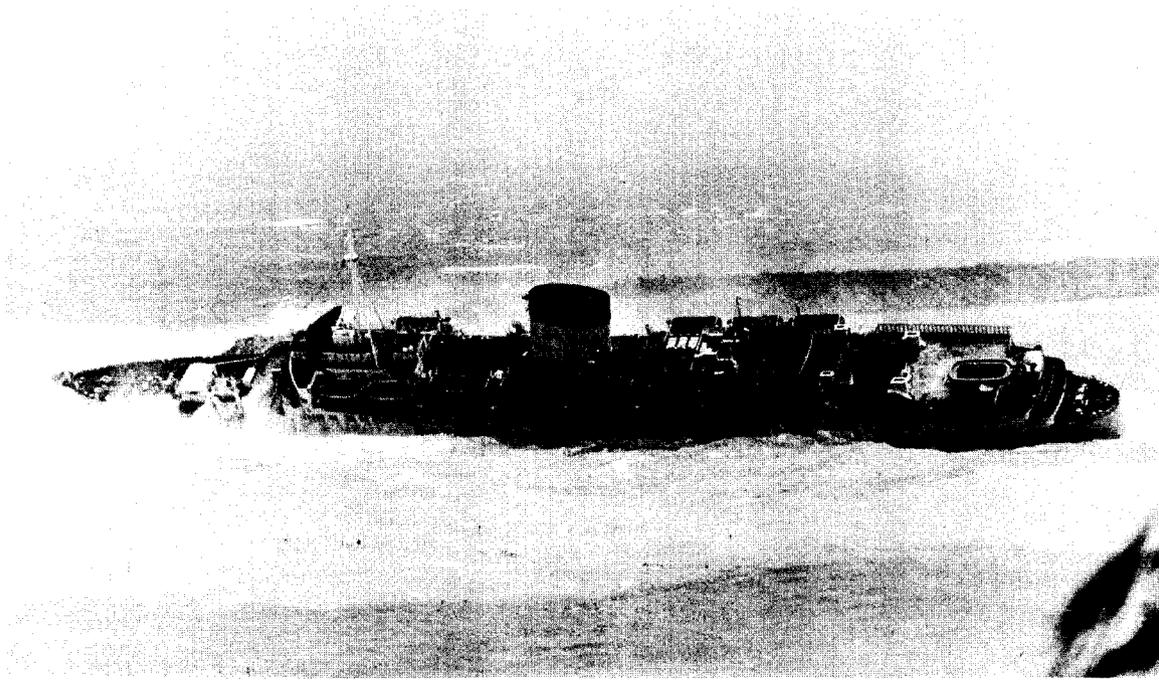
#### **CARIBIA IS DRIVEN AGAINST THE END OF GLASS BREAKWATER, GUAM**
