SL740-AC-RPT-010/SUPPSALV

USCGC MESQUITE SALVAGE OPERATION DEC. '89 - JULY '90 KEWEENAW PENINSULA, MICHIGAN

19 JULY 1991

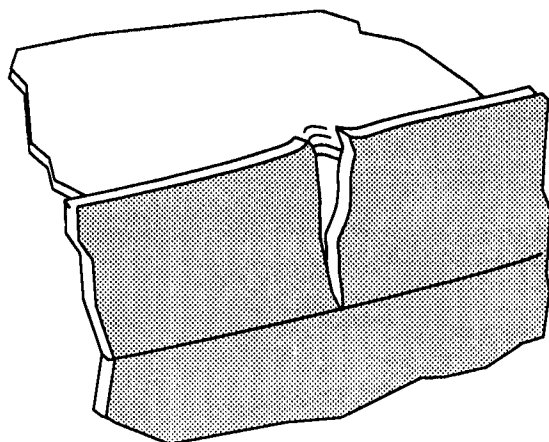
**CRACK LEFT IN DECK
EDGE AFTER REMOVAL
OF PARBUCKLING WIRES**

**PLATE OF 1" STEEL IS CUT
AND FITTED BEHIND SHEER
STRAKE AND WELDED TO
STRAKE - CRACK WAS FILLED**
