USNS Chauvenet (T-AGS 29) Stranding Salvage Operations

82-01 SUPSALV REPORT

USNS CHAUVENET (T-AGS 29)
SALVAGE OPERATIONS

by
Capt. C.A. Bartholomew, USN

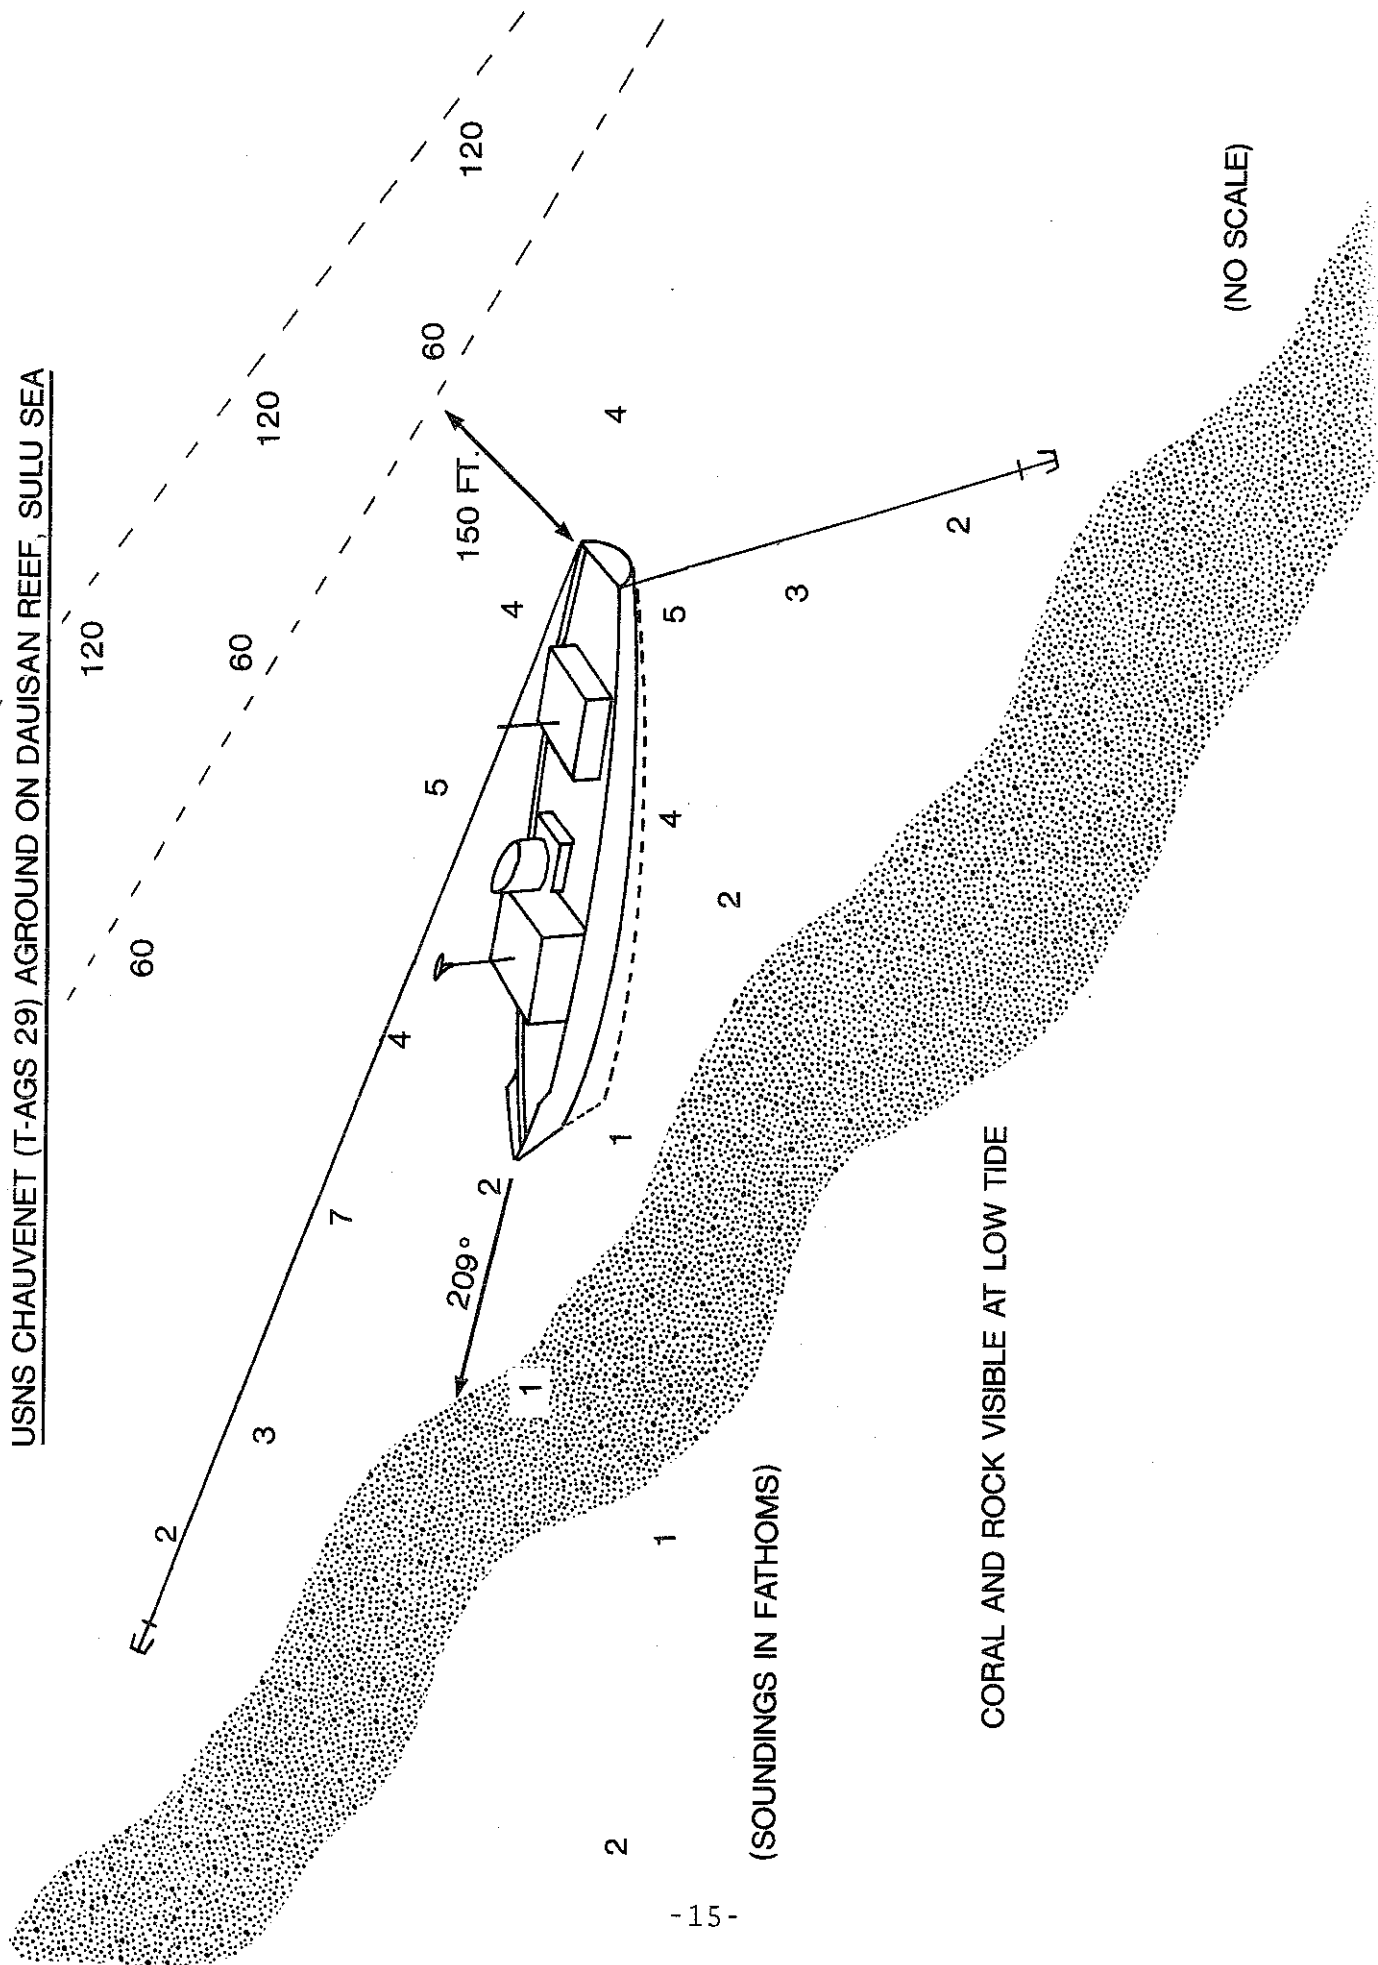
FIGURE 7

USNS CHAUVENET (T-AGS 29) AGROUND ON DAUISAN REEF, SULU SEA

During periods of high tides and wind and swell conditions, salvors noted a certain liveliness in the grounded hull. CHAUVENET would pitch and yaw against the reef. Such movement was considered undesirable in the interests of preserving casualty status quo and preventing progressive hull damage while patching operations were underway. Two Eell's anchors were deployed to hold CHAUVENET on the reef and avoid premature refloating in the event of high off-reef winds; review Figure 7.

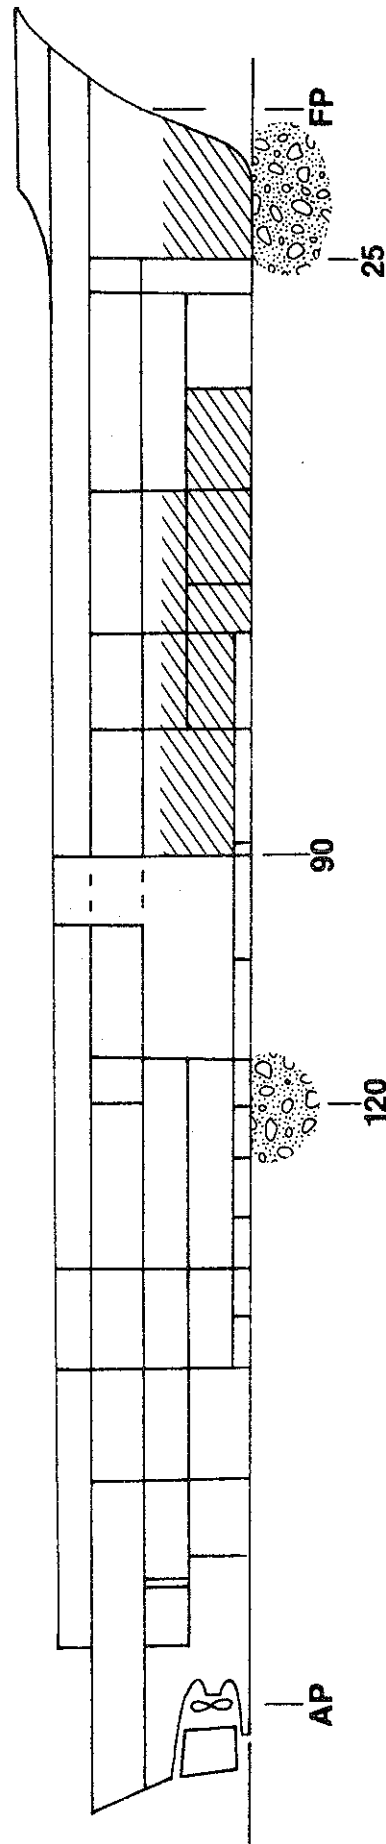
FIGURE 8

Hull rupture from the impact on the coral reef had resulted in the flooding of the forepeak tank, the diesel oil deep tanks on the port side, the sewage tank between frames 62 and 66, the dry stores reefer compartment between frames 66

Flooding and Ground Contact - High Tide - May 10th Condition Bravo

Flood water - all spaces tidal

and 77, and the auxiliary machinery room between frames 77 and 90 (Ref. Figures 4,5,6,8,9). Additionally, the spaces on the first platform over those compartments were also found to be tidal. All other spaces appeared to be watertight. The casualty lay approximately portside to the reef with a heading of 209 degrees True. At high tide an 8 degree port list was reported which decreased to 4 degrees to port at low tide. During the early phases of the salvops the list was somewhat variable and could actually be controlled by raising/lowering the ship's 10-ton survey boats in their davits, a clear indication of the instability of the casualty.

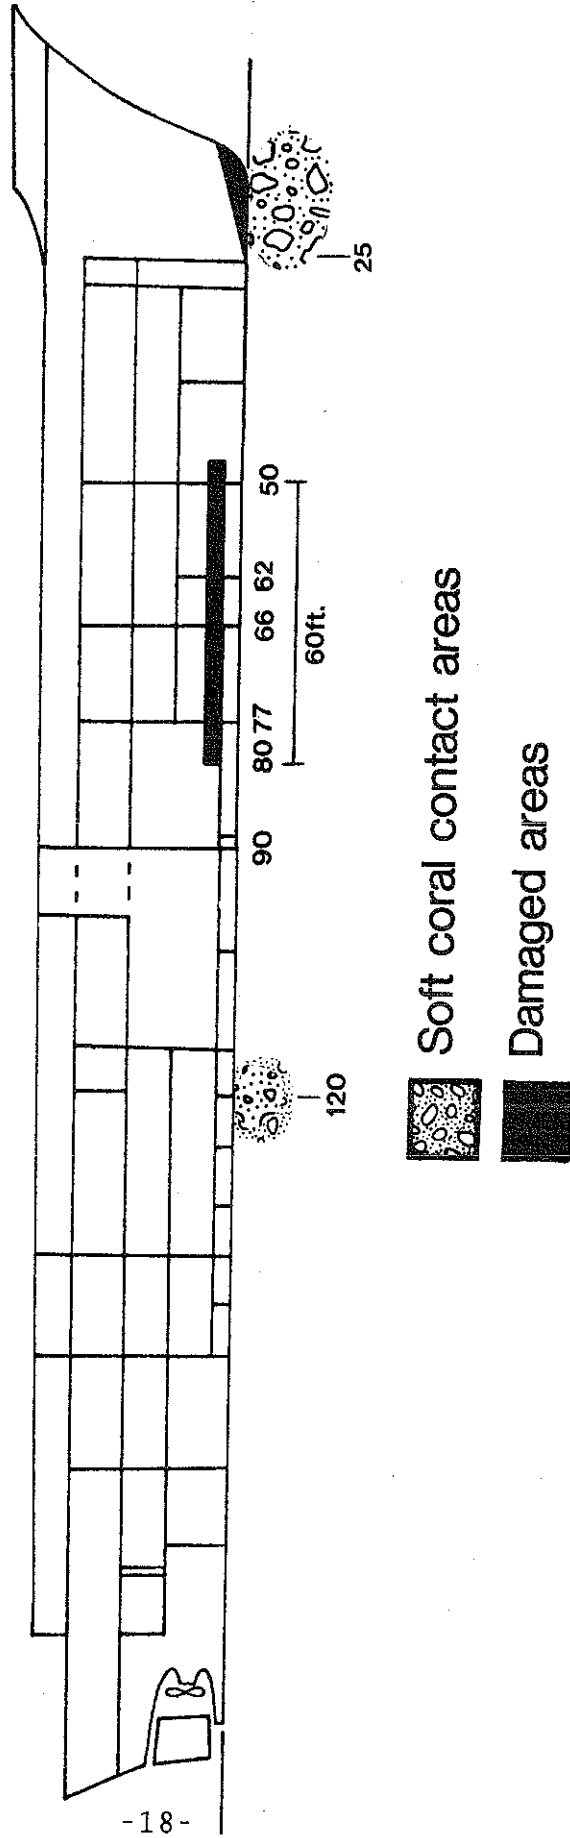
FIGURE 9
 Damaged Areas

Damage observed was most noticeable by way of the forepeak tank where the forefoot was buckled, Figure 9, with some holing noted in the shellplate. A 60 foot gash was found in the hull inside and parallel to the port bilge strake extending from frame 50 to frame 80. This tear varied in width from 1 inch to a maximum of 18 inches and the contiguous shellplate was buckled and rolled inboard. The forward sonar dome was sheared off although no holing was found in that location.

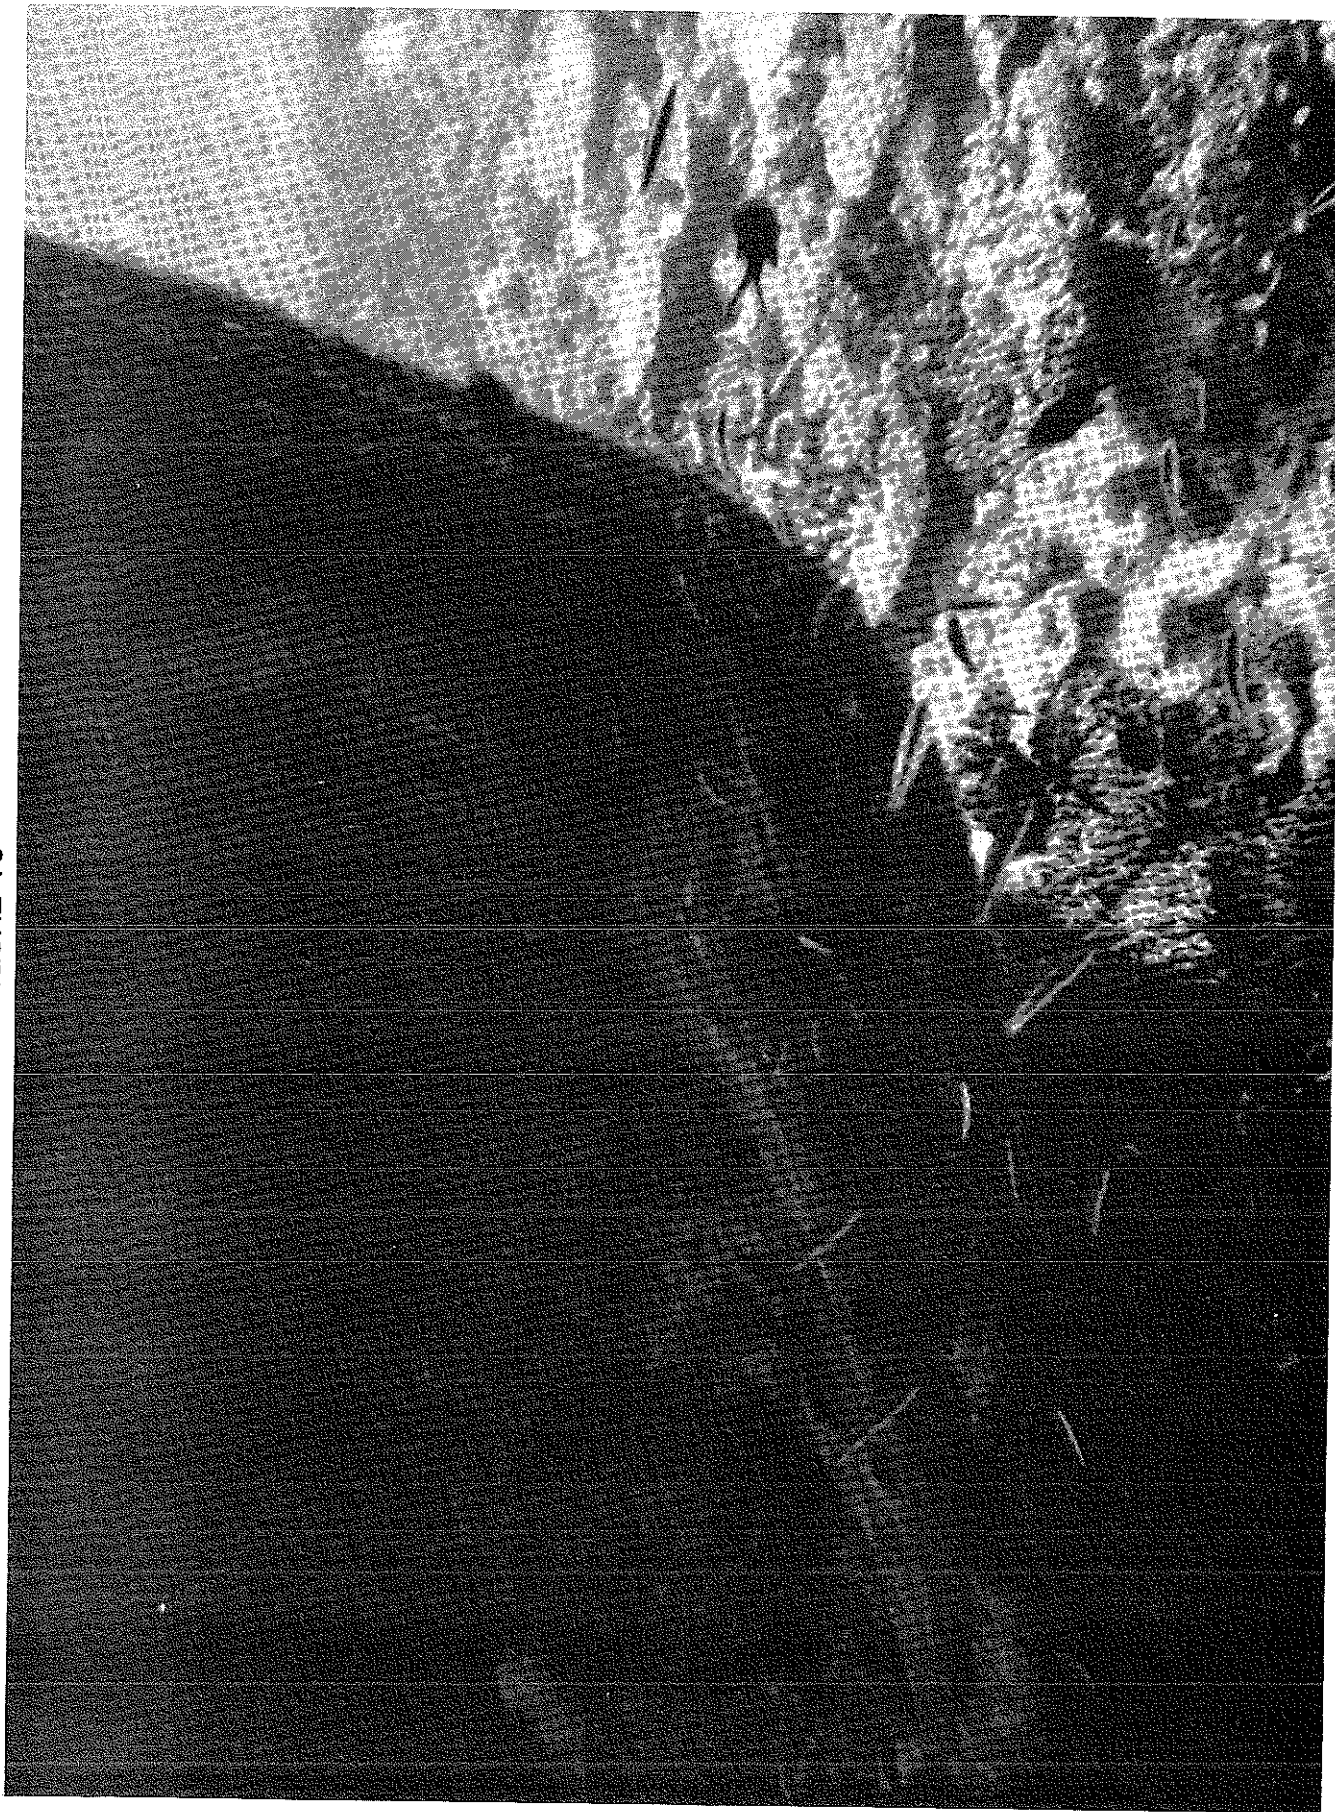
FIGURE 10

Initial Bow Damage

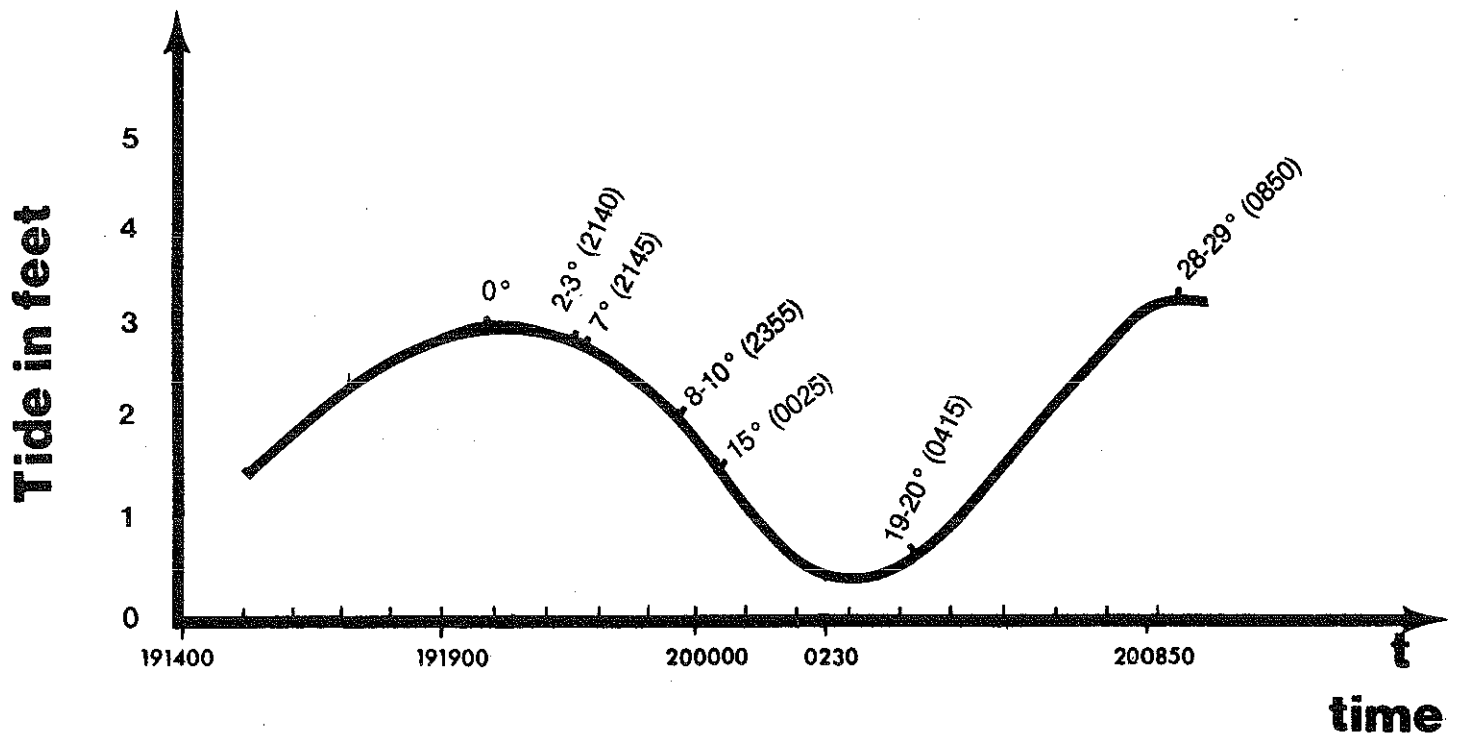
FIGURE 15

Eventually these last personnel were evacuated and by 0850, high tide, the list had increased to 29 degrees, Figure 15. Although winds of moderate force, 10-15 knots with gusts to 30 knots, and seas to 3 feet existed in the area at the time, these were not seen to be sufficient to increase the list so dramatically and sustain it. Although the situation was not clear, the salvors soon reboarded the ship and commenced shifting loose gear to port and removing topside weight starboard side until the list was reduced to about 20 degrees maximum.

STARBOARD LIST CONDITIONS MAY 19 - 20

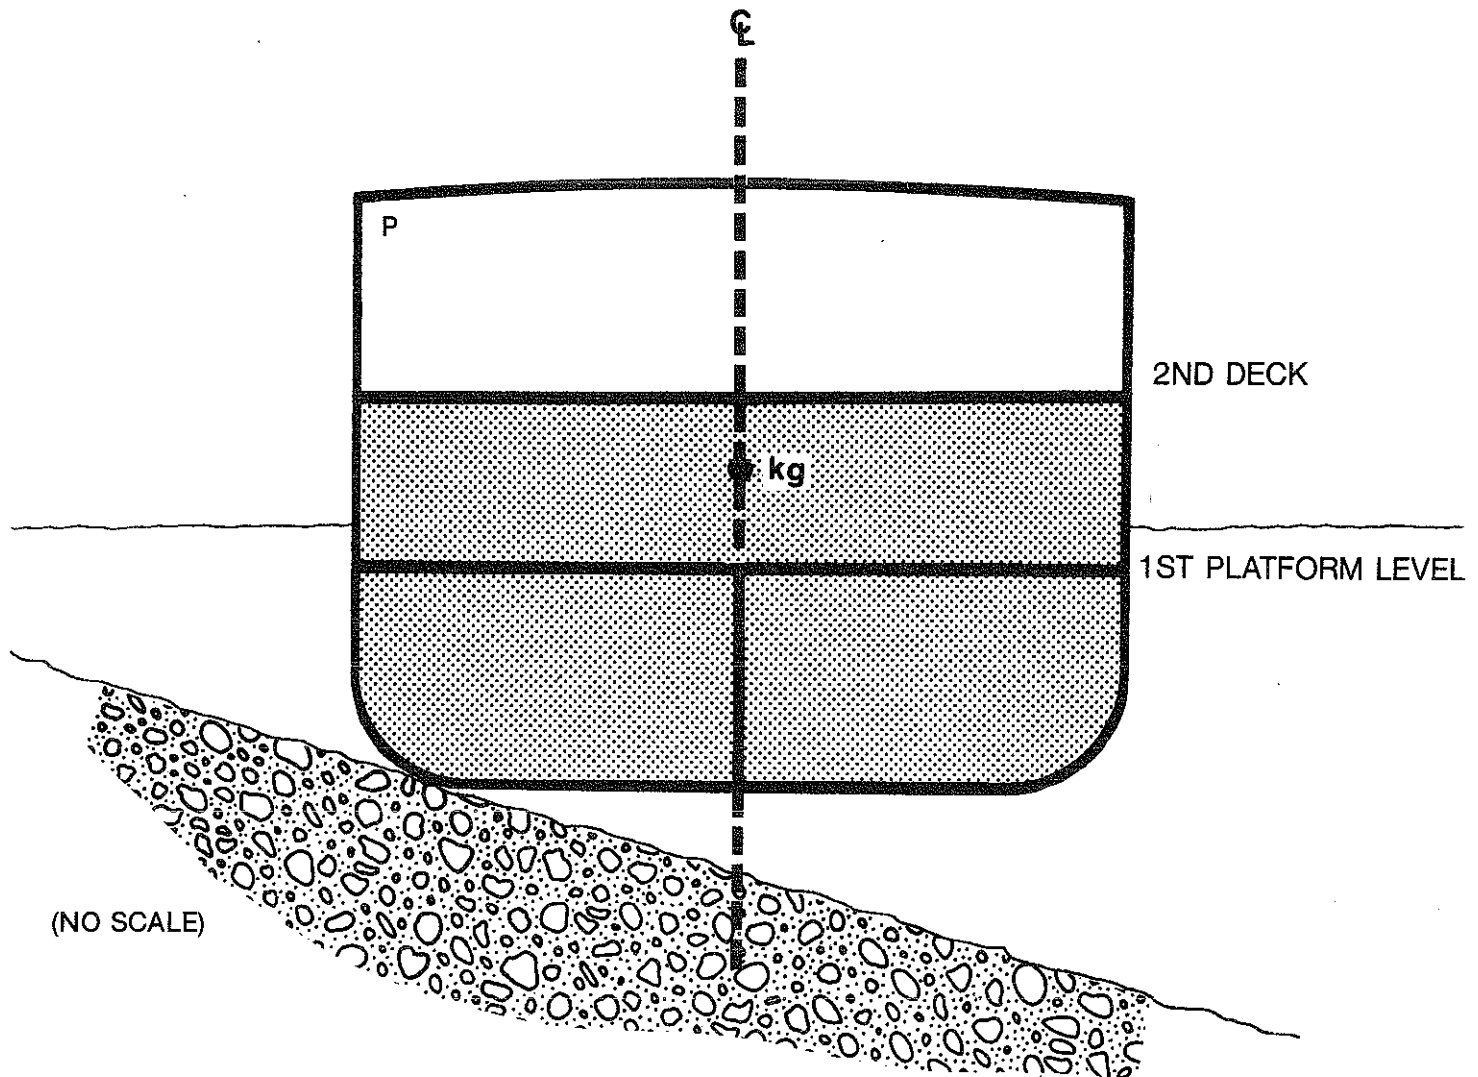
FIGURE 16
SCHEMATIC DIAGRAM OF CHAUVENET SECTION

- FLOOD WATER TO SECOND DECK BETWEEN FRAME 30 AND FRAME 90
- MID TIDE
- GROUND REACTION ON PORT SIDE OF KEEL

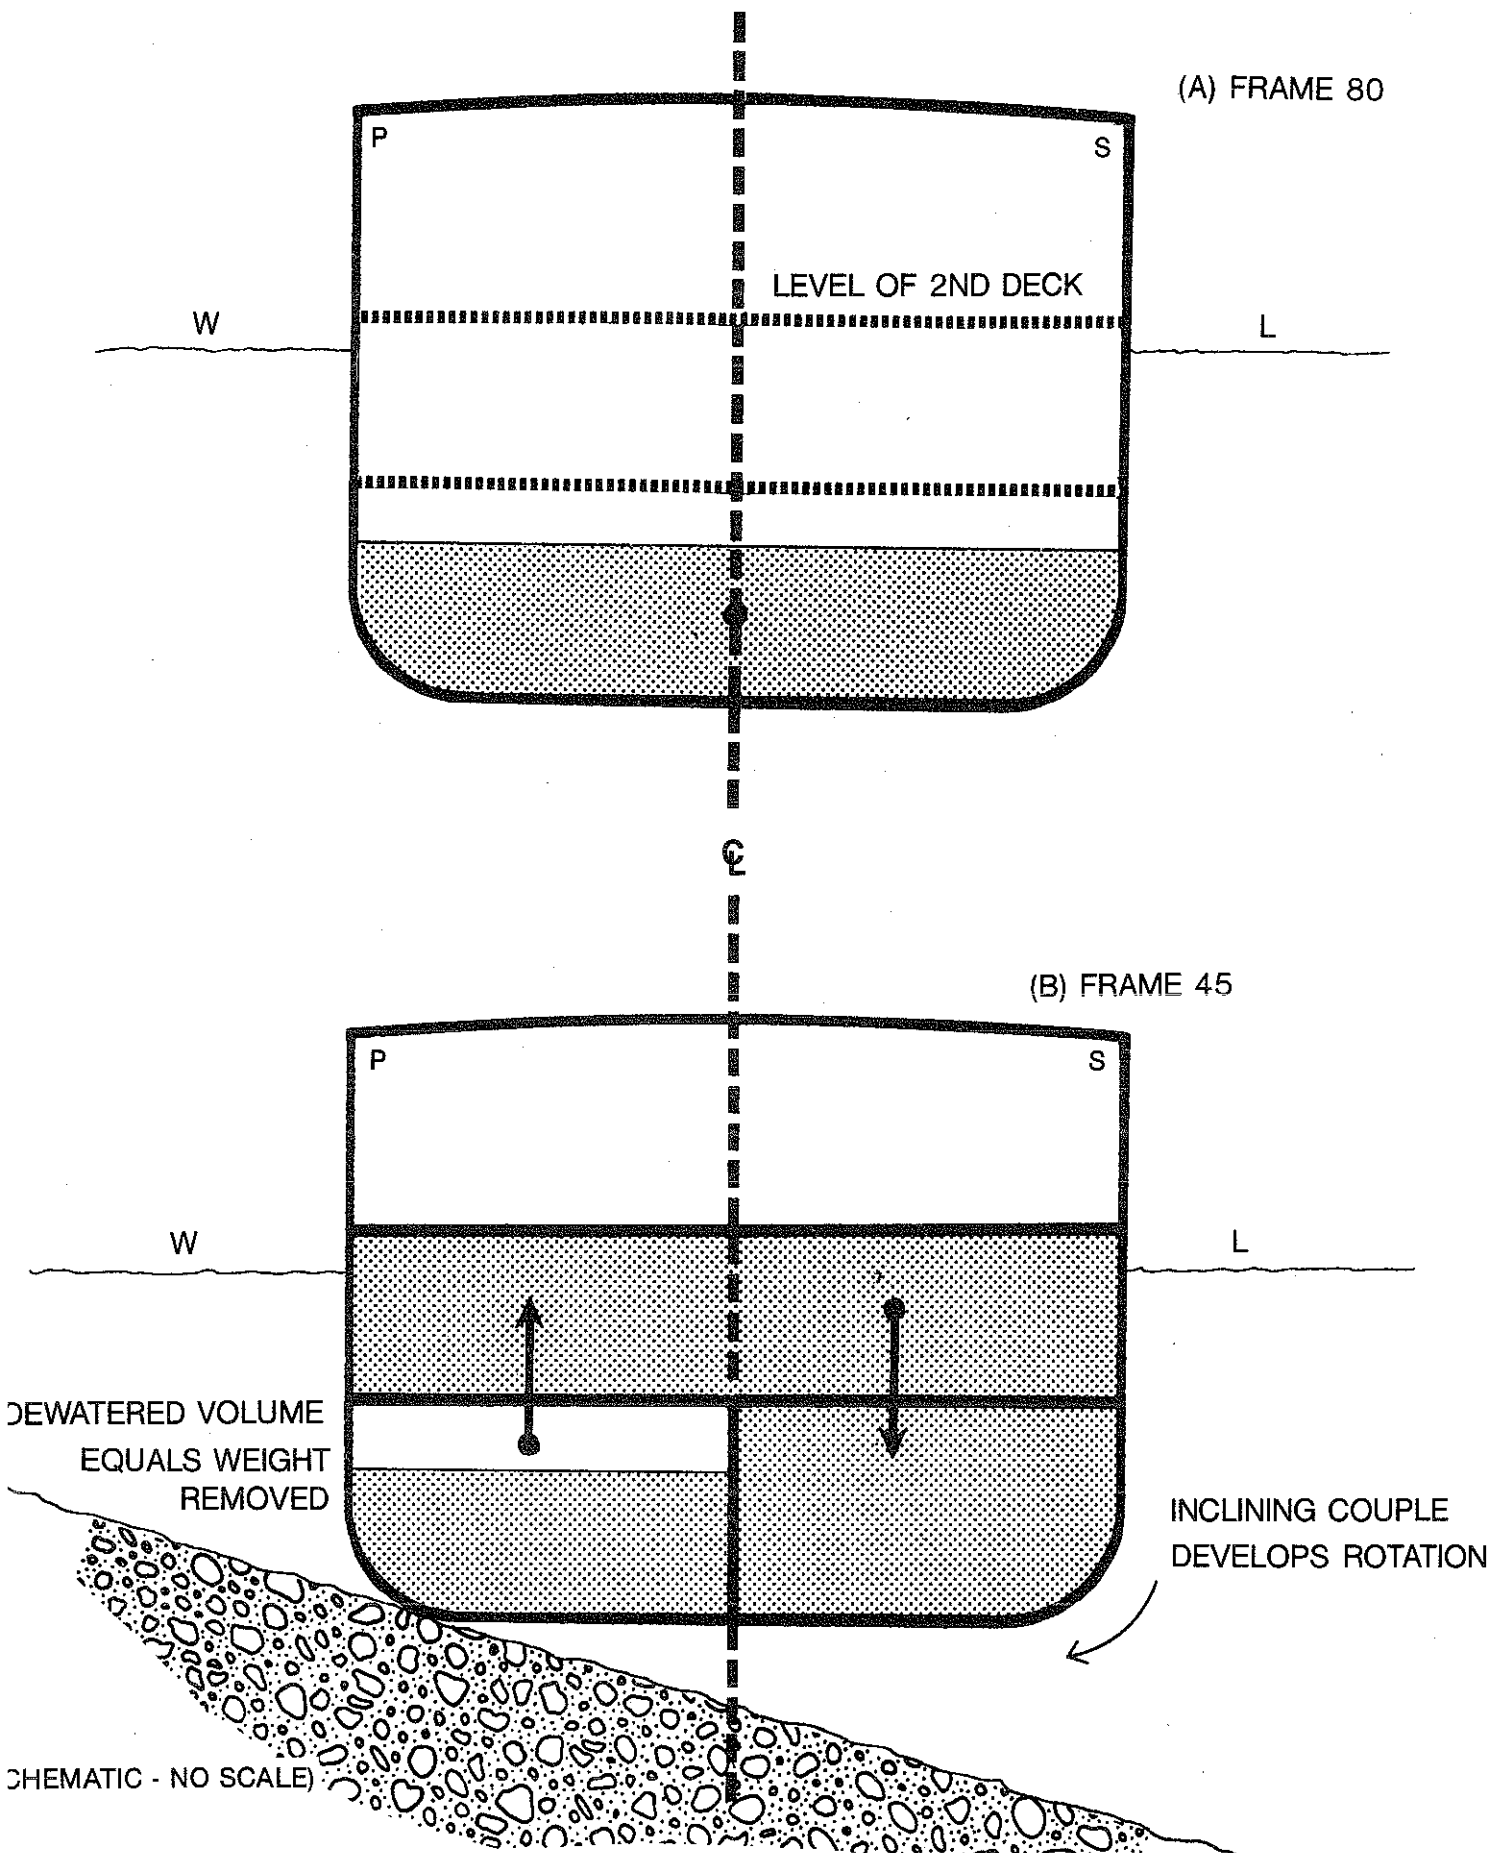
FIGURE 17

As the tide fell on the evening of 19 May, GM decreased. As AMR dewatering progressed below the first deck level, damage to transverse watertight bulkheads forward at frames 77, 66, 62, and 51 port side permitted fuel-contaminated flood water to flow aft. This resulted in the partial

AMR DEWATERED TO SIX FEET OVER THE TANK TOPS AT HIGH TIDE

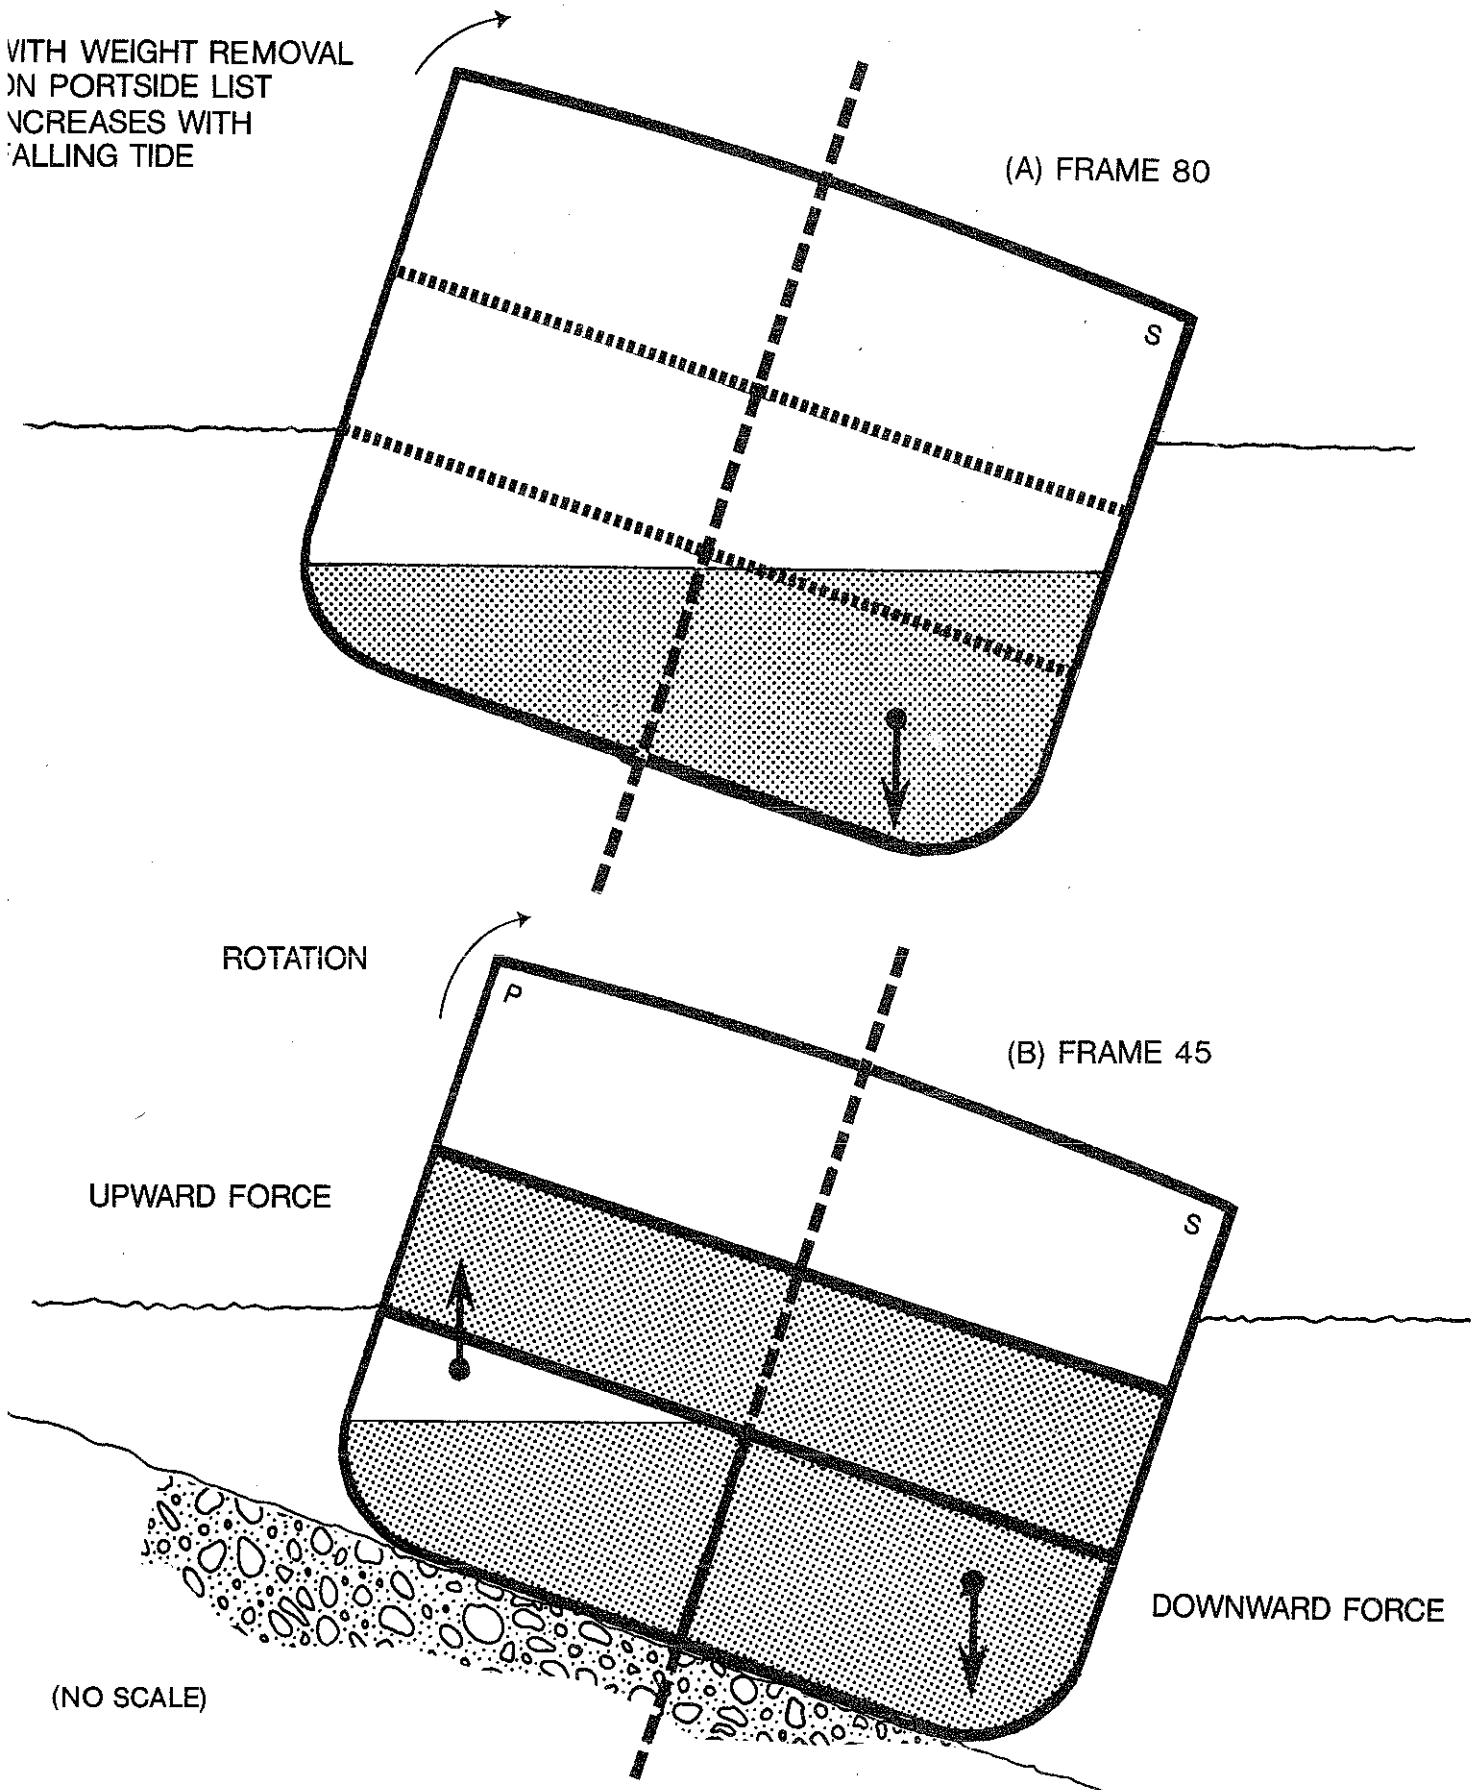
FIGURE 18

As the ebb continued, list increased and more flood water shifted to starboard. At low tide, the center of gravity of the flood water was substantially to starboard of the centerline. At this stage list stabilized, possibly because the hull at the starboard bilge keel was resting on the reef. With the flood tide, list continued to increase as the rising water increased displacement. During this sequence ground reaction had shifted from port toward the starboard side. Figures 15 thru 19 graphically display these events. Flooding in the athwartship spaces and significant loose gear below decks had shifted off-center to starboard. The list, though mitigated by the salvors' subsequent actions and the settling of the ship into the soft coral bottom, remained until the actual refloating on 29 May.

15° LIST CONDITIONS AT LOW TIDE

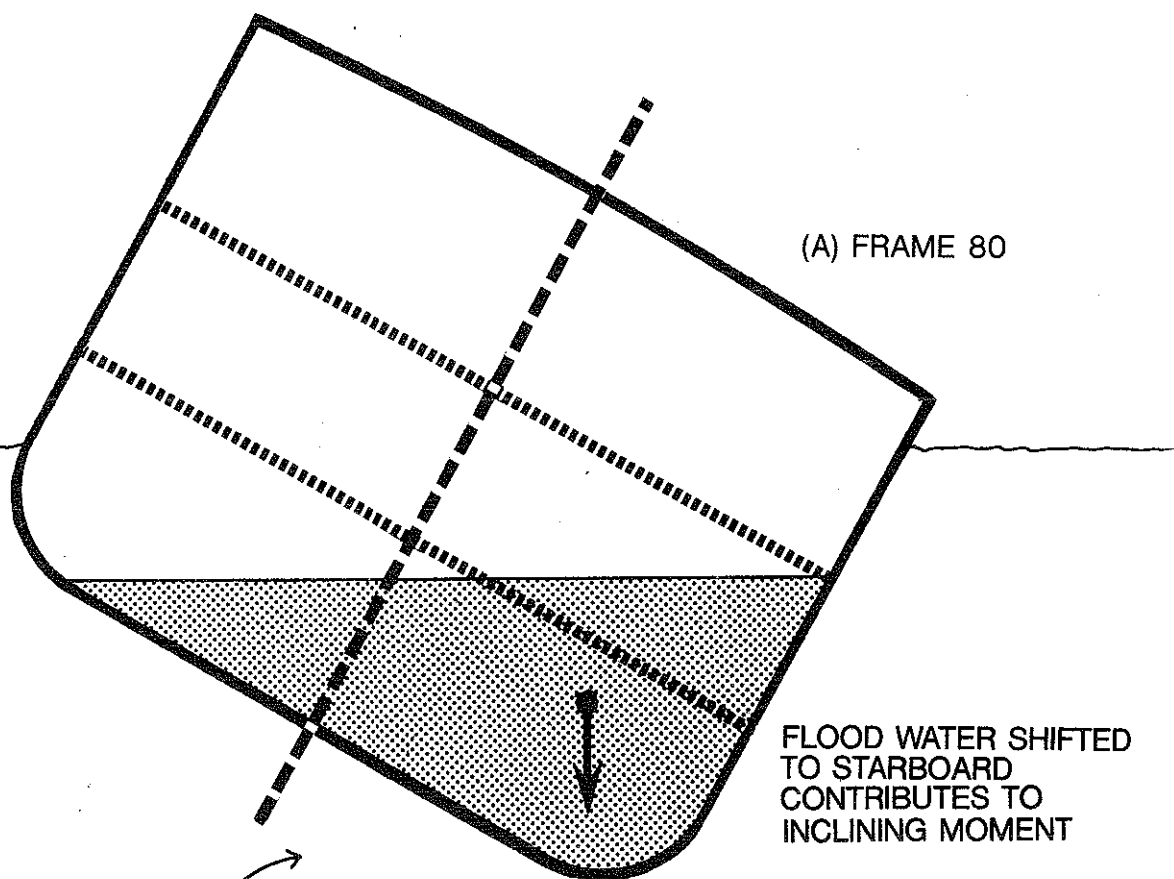
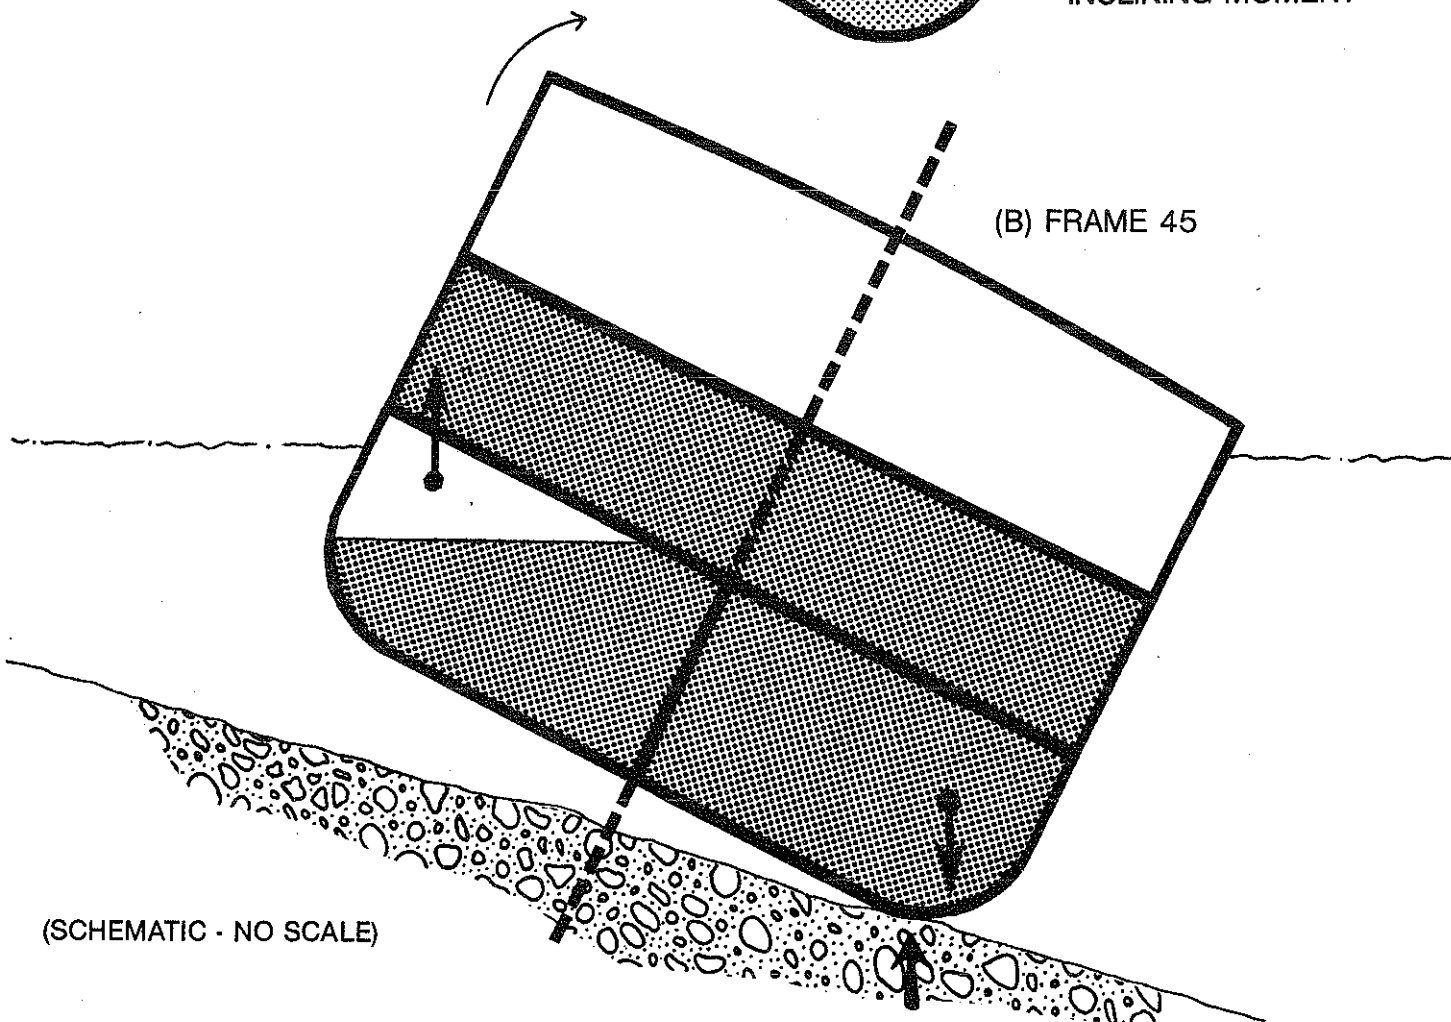
FIGURE 19

28° - 29° STARBOARD LIST AT HIGH TIDE (200850 LOCAL)

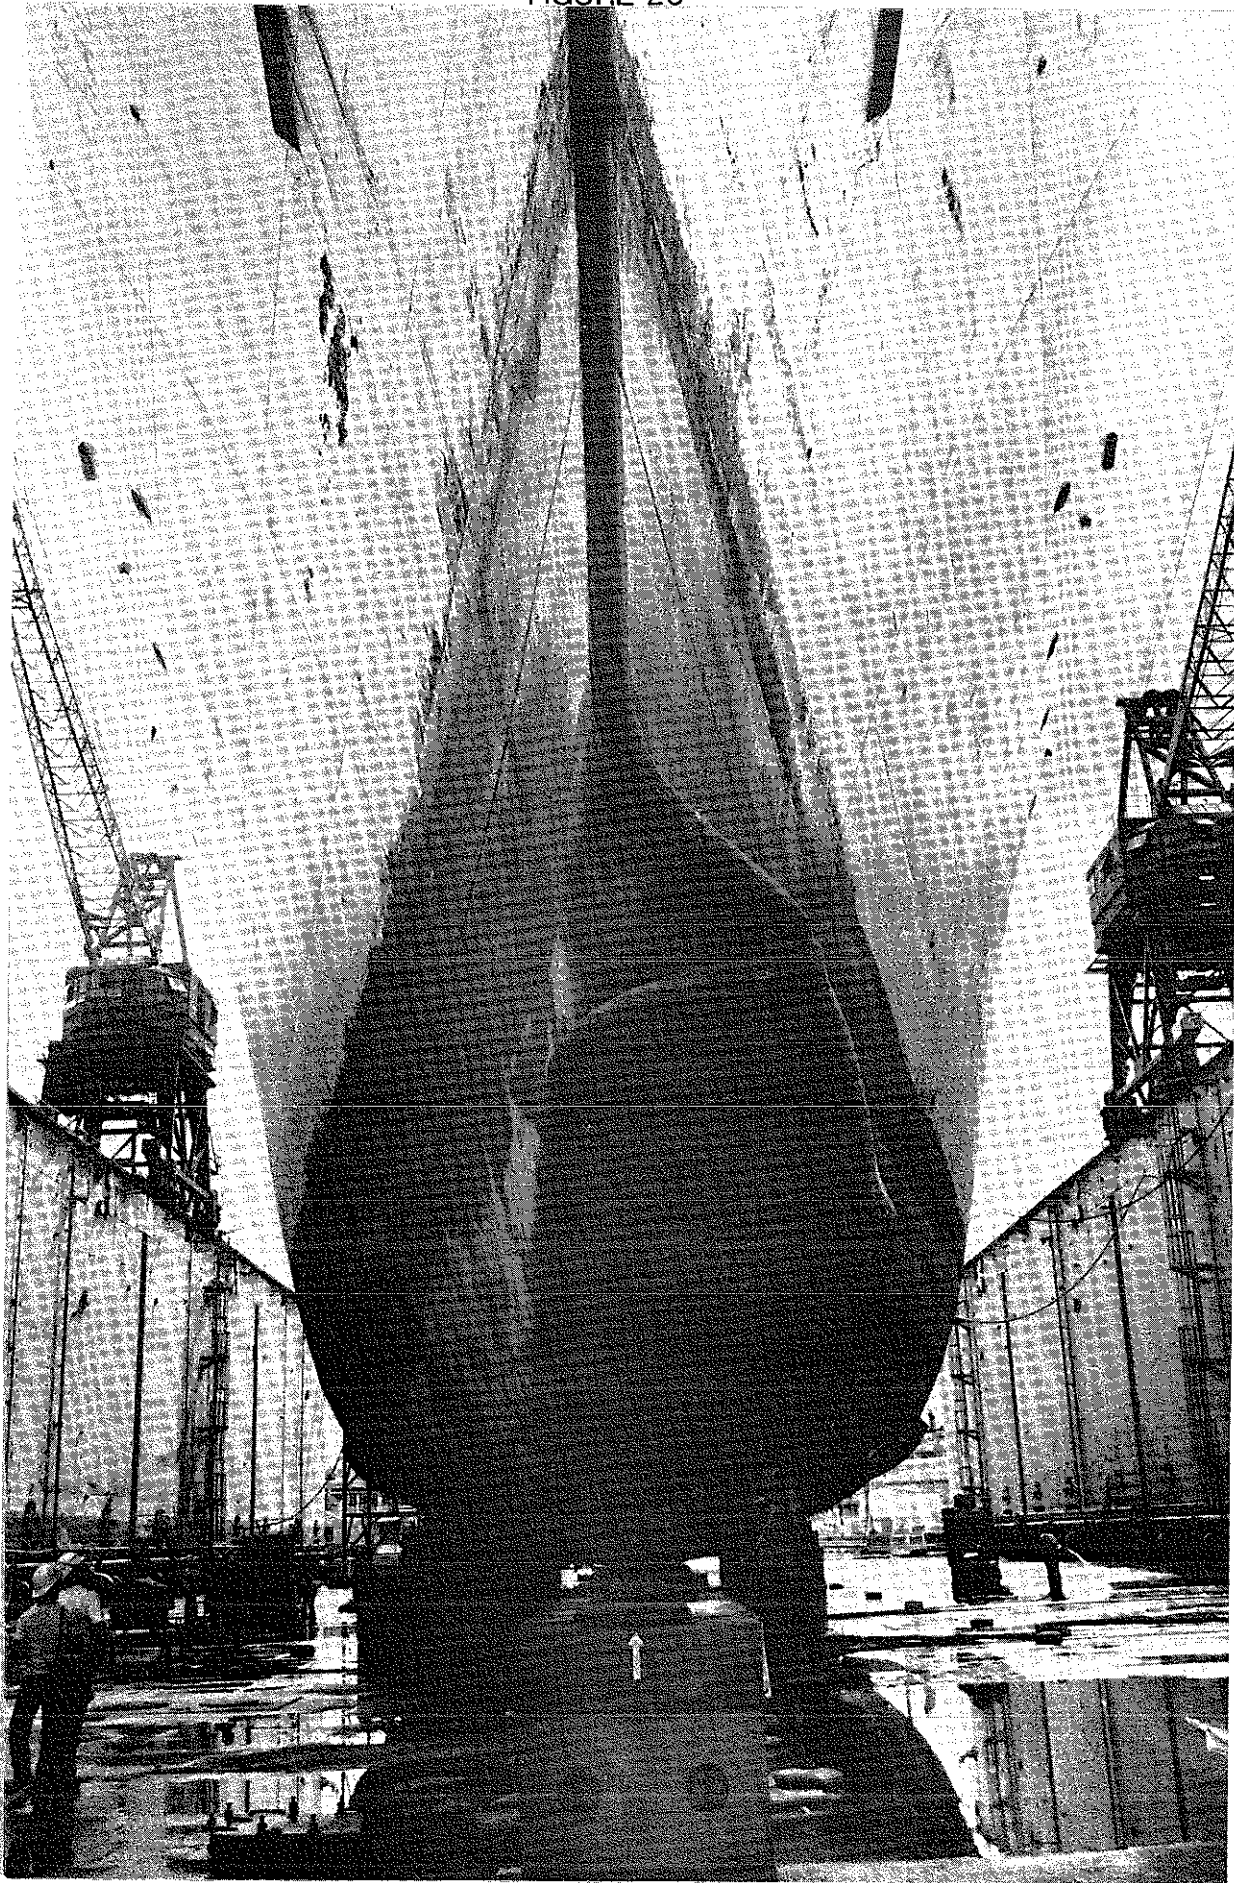
FIGURE 20

Bow Damage

the development of the list crushed the ship's bow and buried it into the soft coral reef. This resulted in a significant alteration in the hull to bottom interface and, consequently, a change in ground resistance to inclination. Figures 20-23 document the significant damage to the CHAUVENET's bow forward of frame 25.
