USNS Chauvenet (T-AGS 29) Stranding Salvage Operations

82-01 SUPSALV REPORT

USNS CHAUVENET (T-AGS 29)
SALVAGE OPERATIONS

by
Capt. C.A. Bartholomew, USN

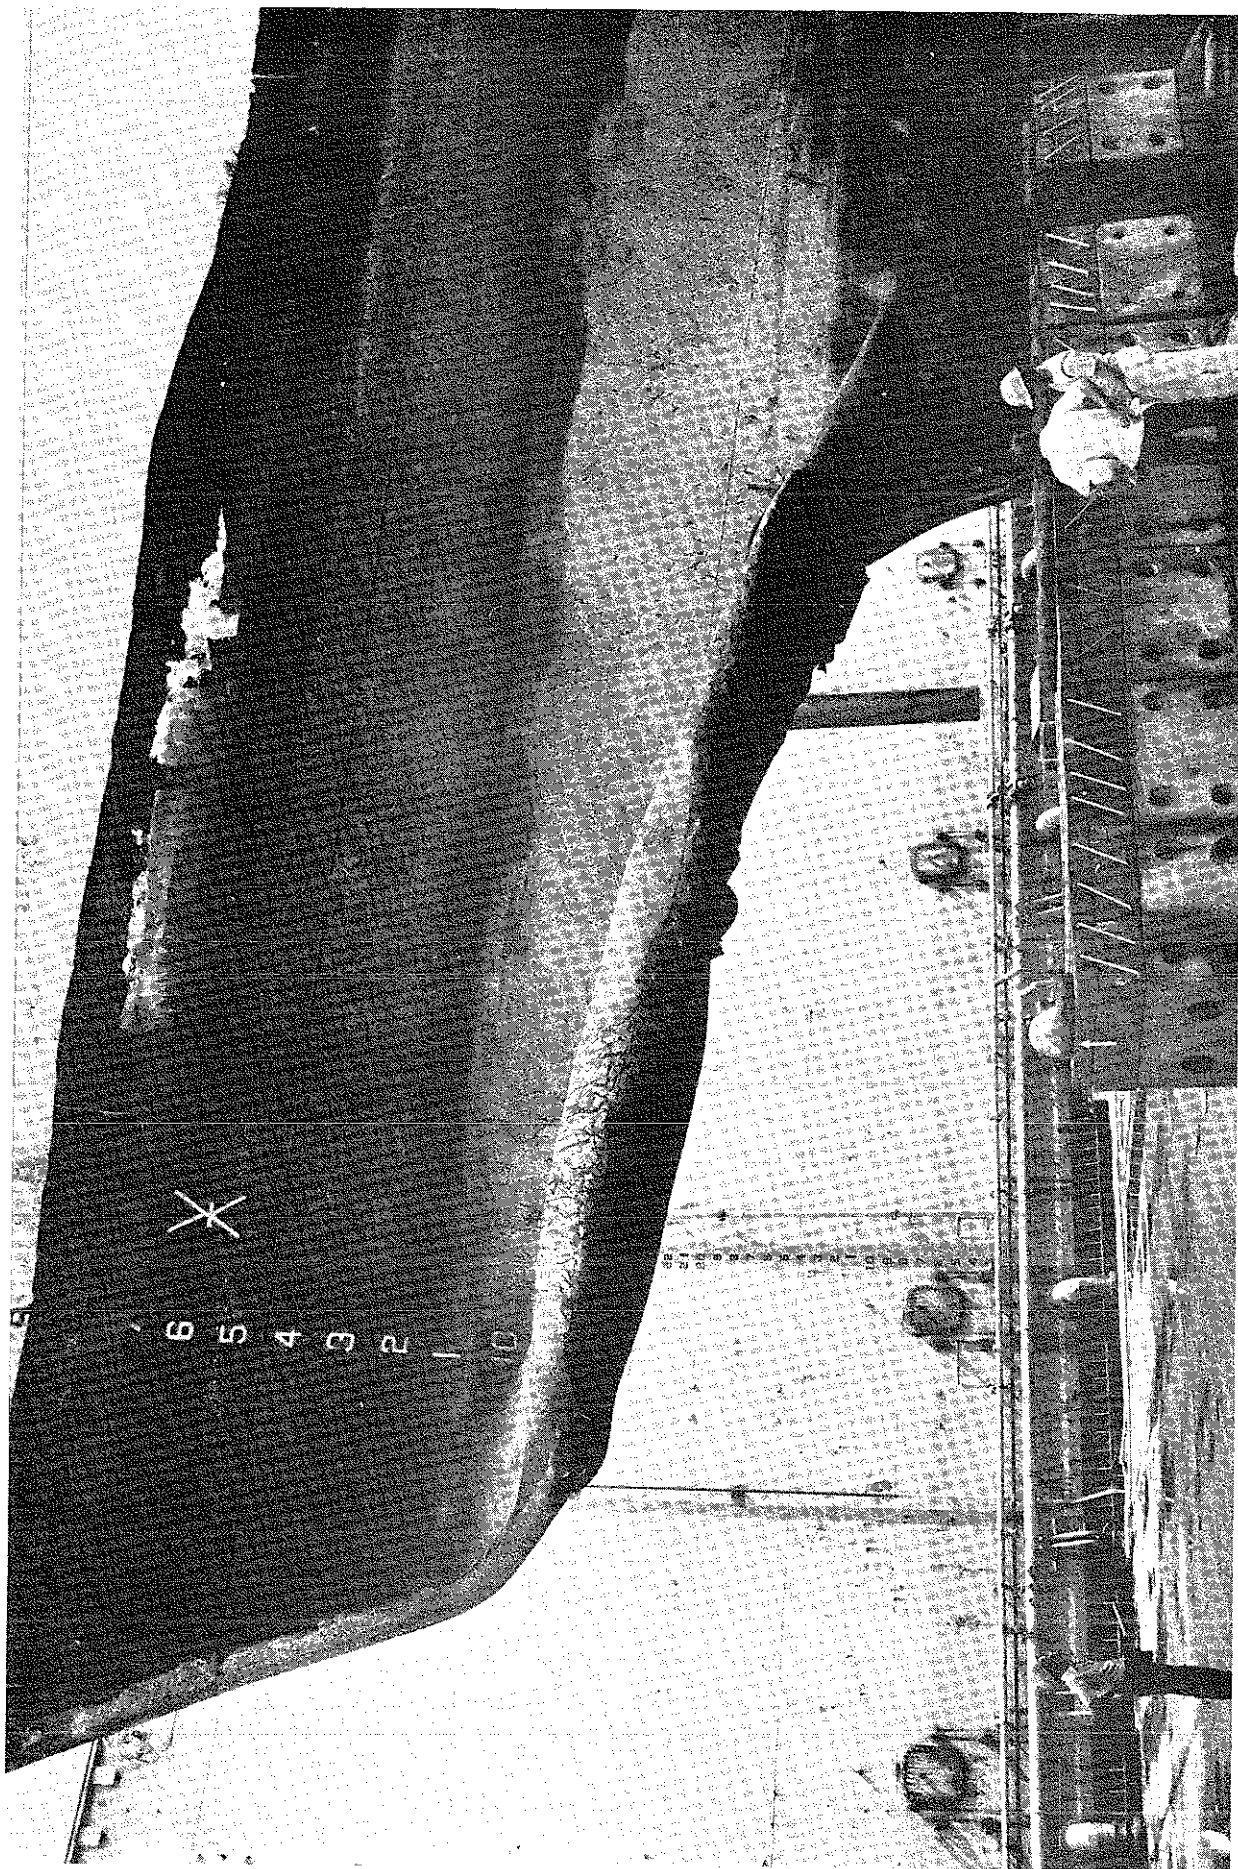
FIGURE 21

Bow Damage - Port Side

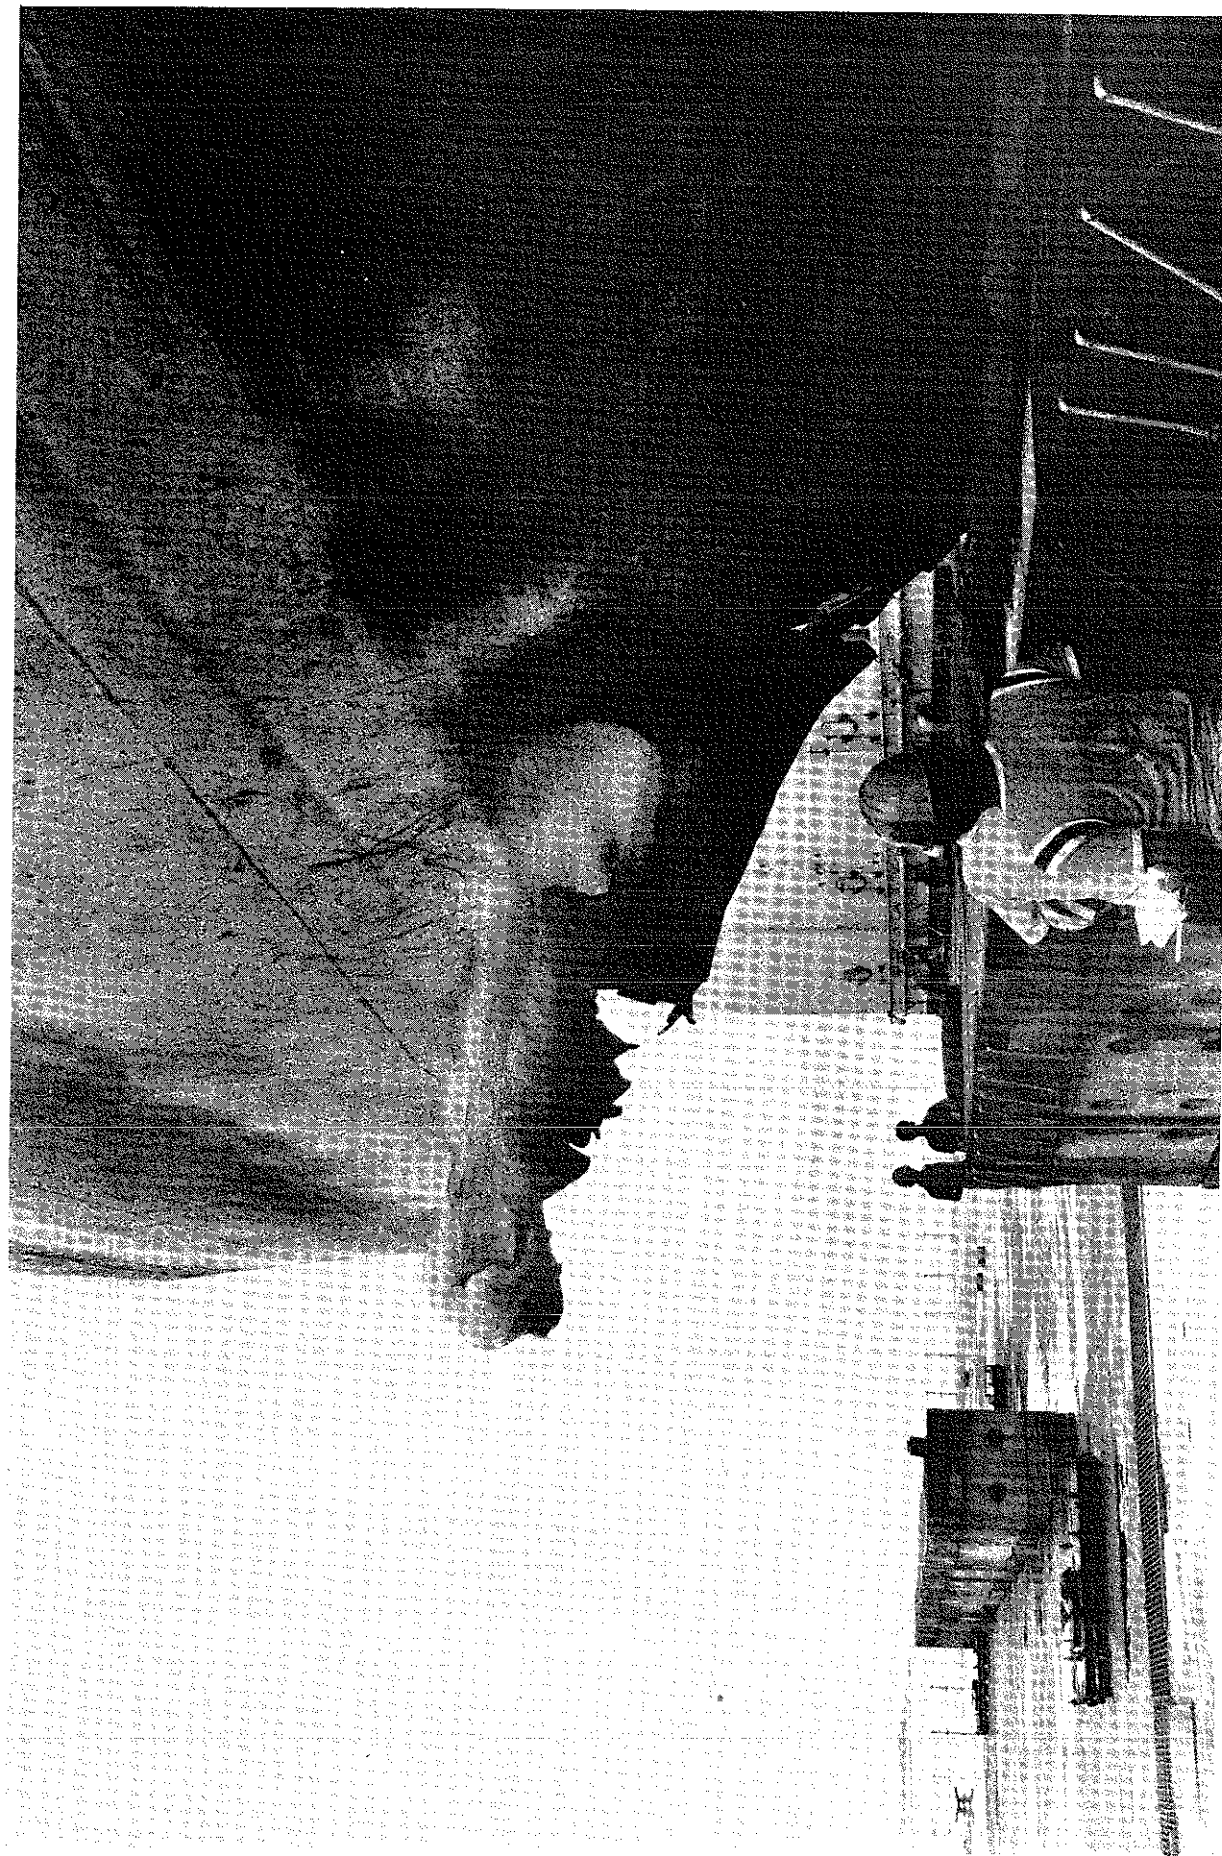
FIGURE 22

Bow Damage - Port Side Looking Forward

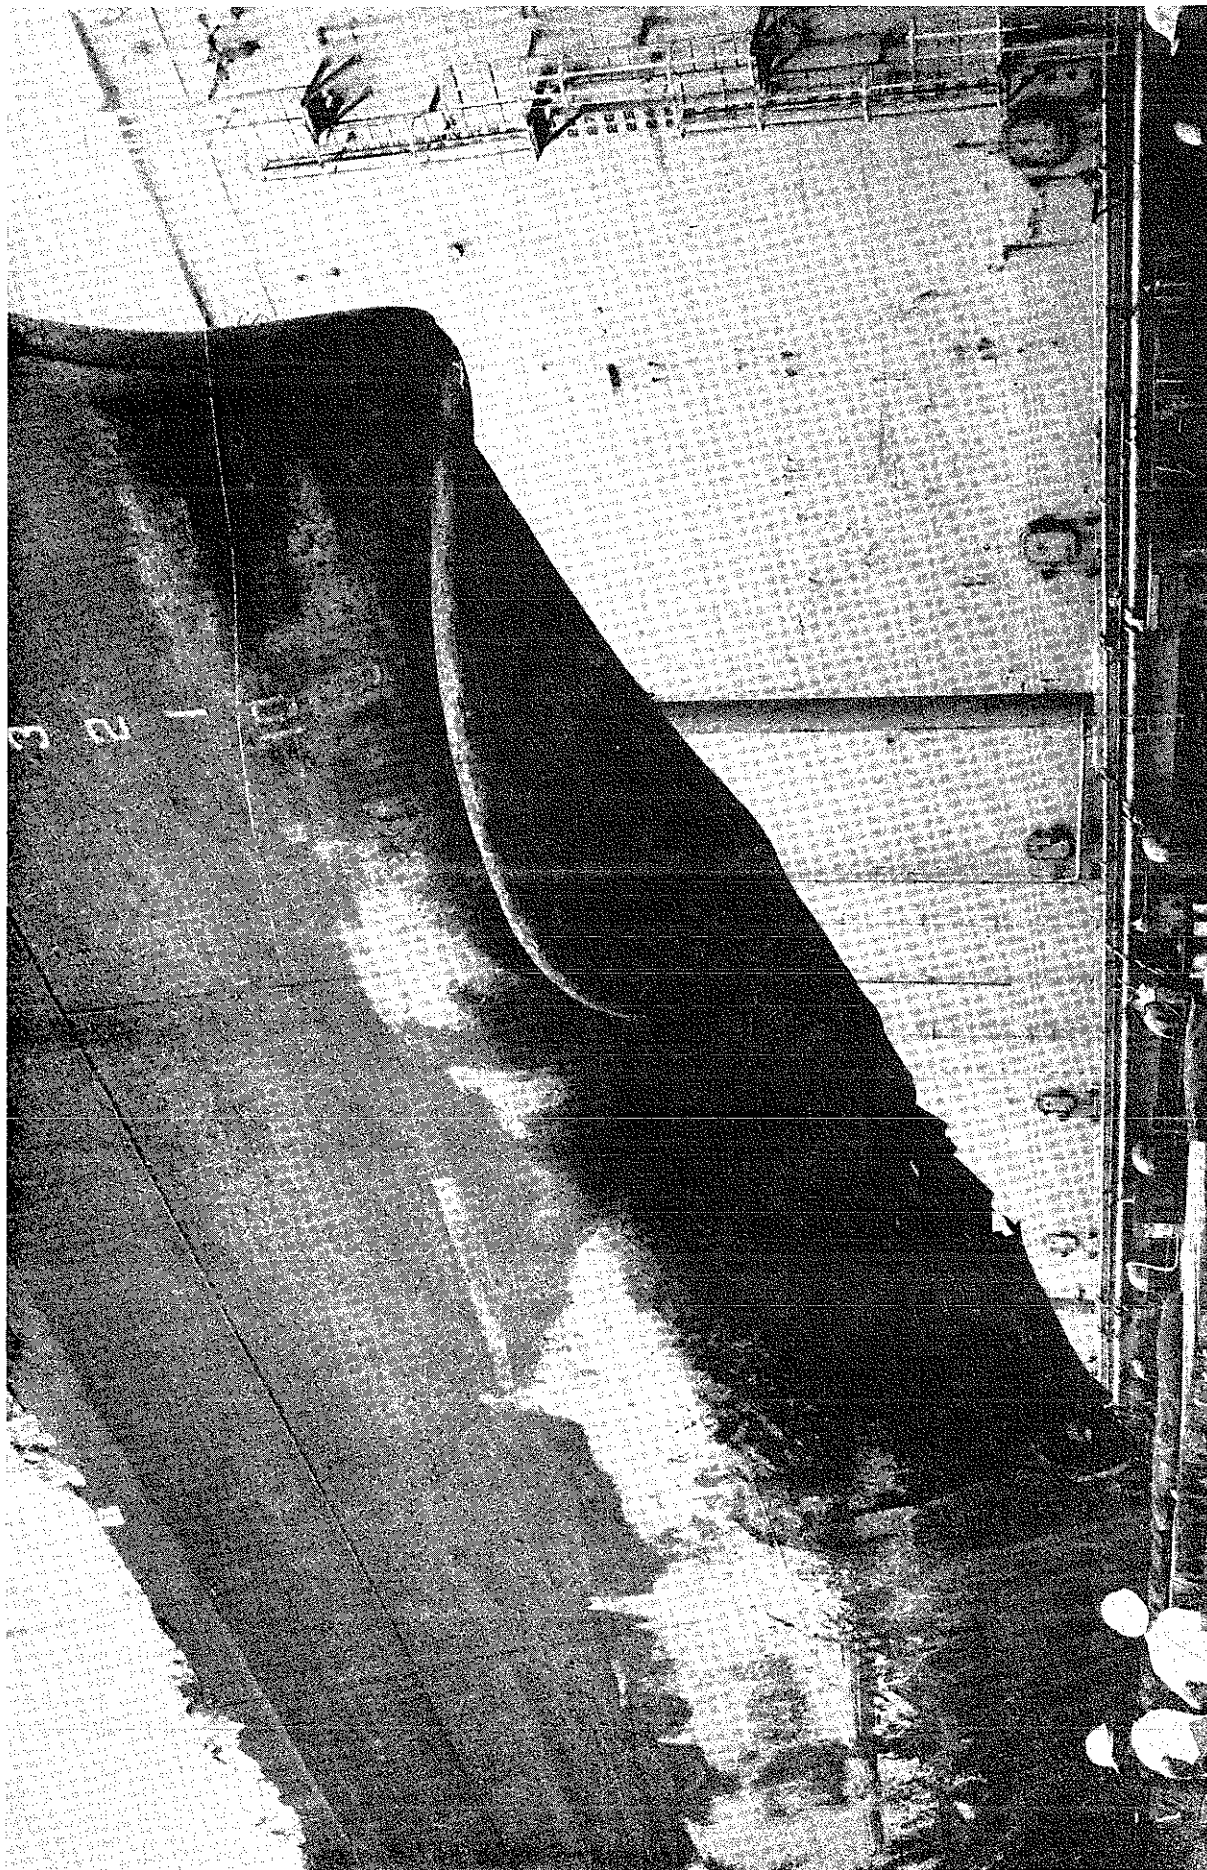
FIGURE 23

Bow Damage - Starboard Side

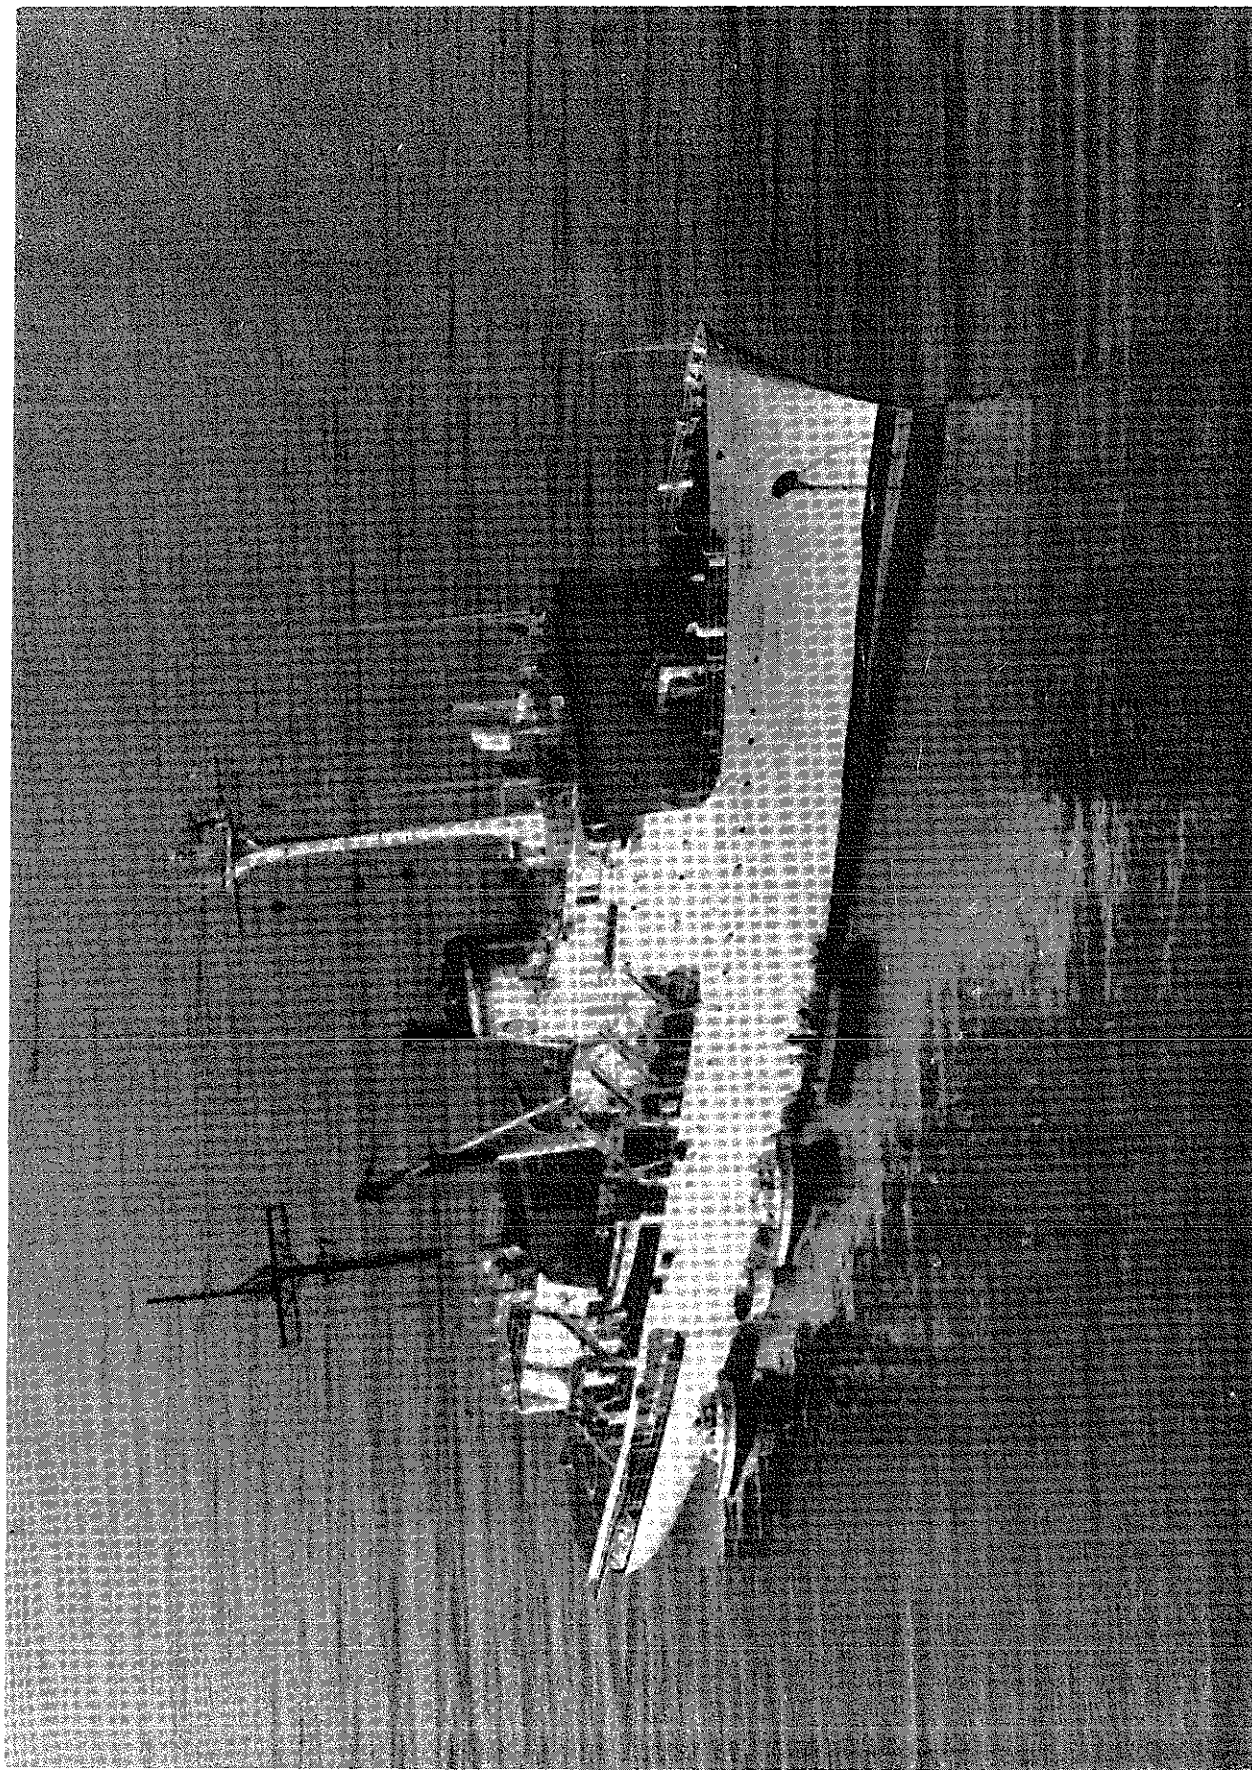
FIGURE 24

Initial Casualty Condition

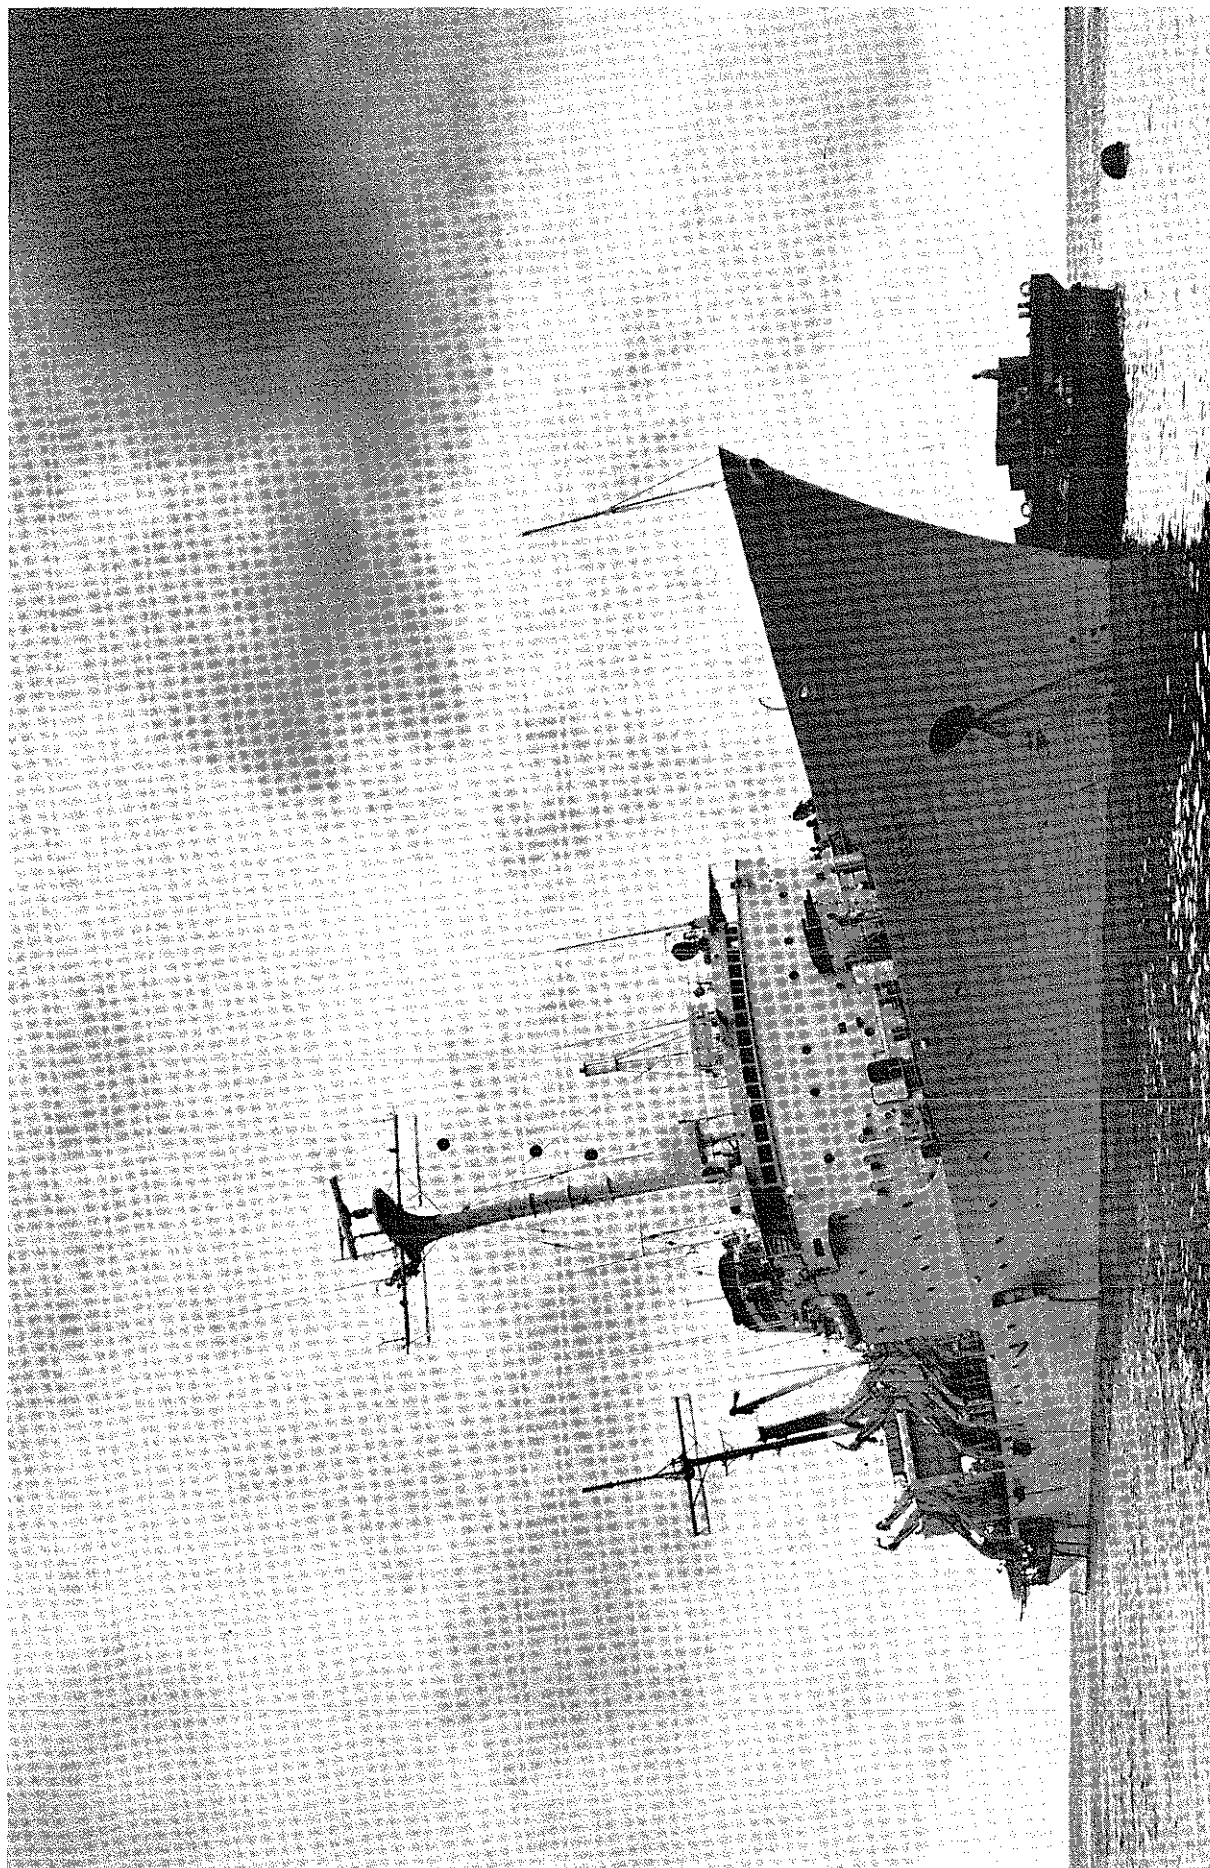
FIGURE 25

Casualty - Condition Delta

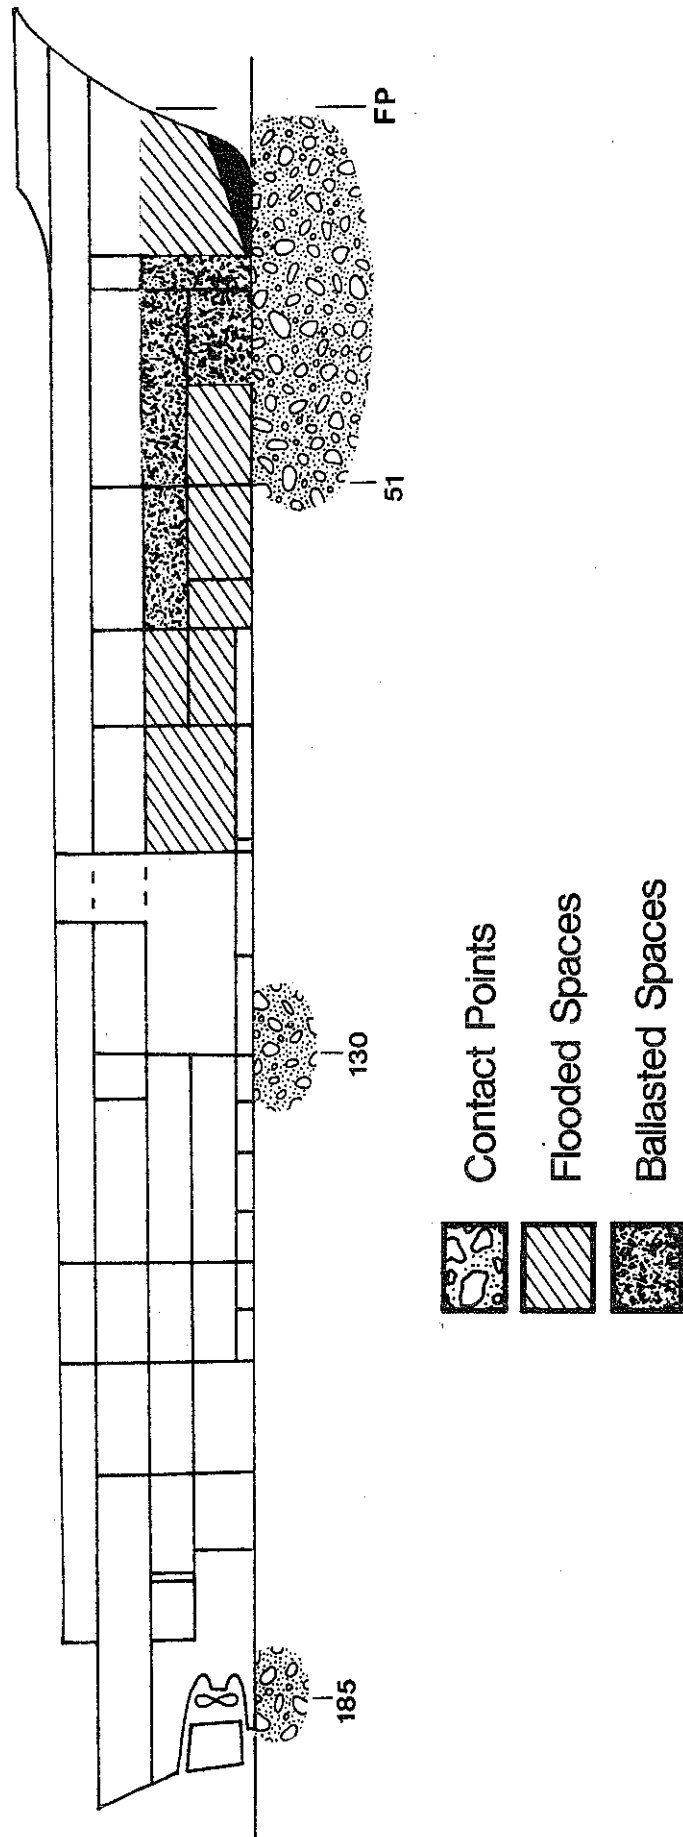
FIGURE 26

The failure of CHAUVENET's bow during the fall of the tide, May 19 - 20 time frame, caused a radical change in the trim conditions of the grounded ship. Whereas prior to this event the trim had averaged 6 feet by the stern, it shifted to average 1 to 2 feet by the bow. The before and after trim of the ship can be seen from Figures 24 and 25. This increased draft forward raised the water level in the AMR and chilled stores space to within one foot of the second deck level. Thus, in essence, CHAUVENET became fully flooded below the second deck from the forepeak to the forward bulkhead of the main engine room at frame 90, Figure 26.

Casualty Conditions During Condition Delta

The fore and aft free communication between frames 40 and 90 along the port side prevented space by space dewatering below the first platform deck and necessarily had to be considered in the formulation of a modified salvage plan to effect refloating. On 25 May, the revised salvage plan was, in concept, established. This plan, as subsequently refined prior to refloating, is outlined below.

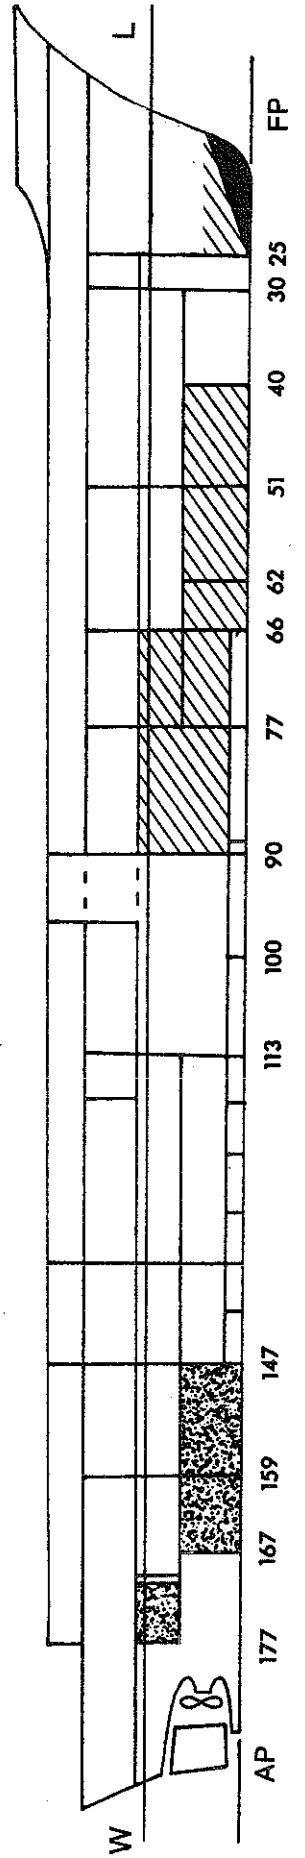
FIGURE 29

Ballast Condition upon Refloating Condition Echo

-   Flood water - all spaces except FPT pressed up
-   Pressed up with ballast water by salvors

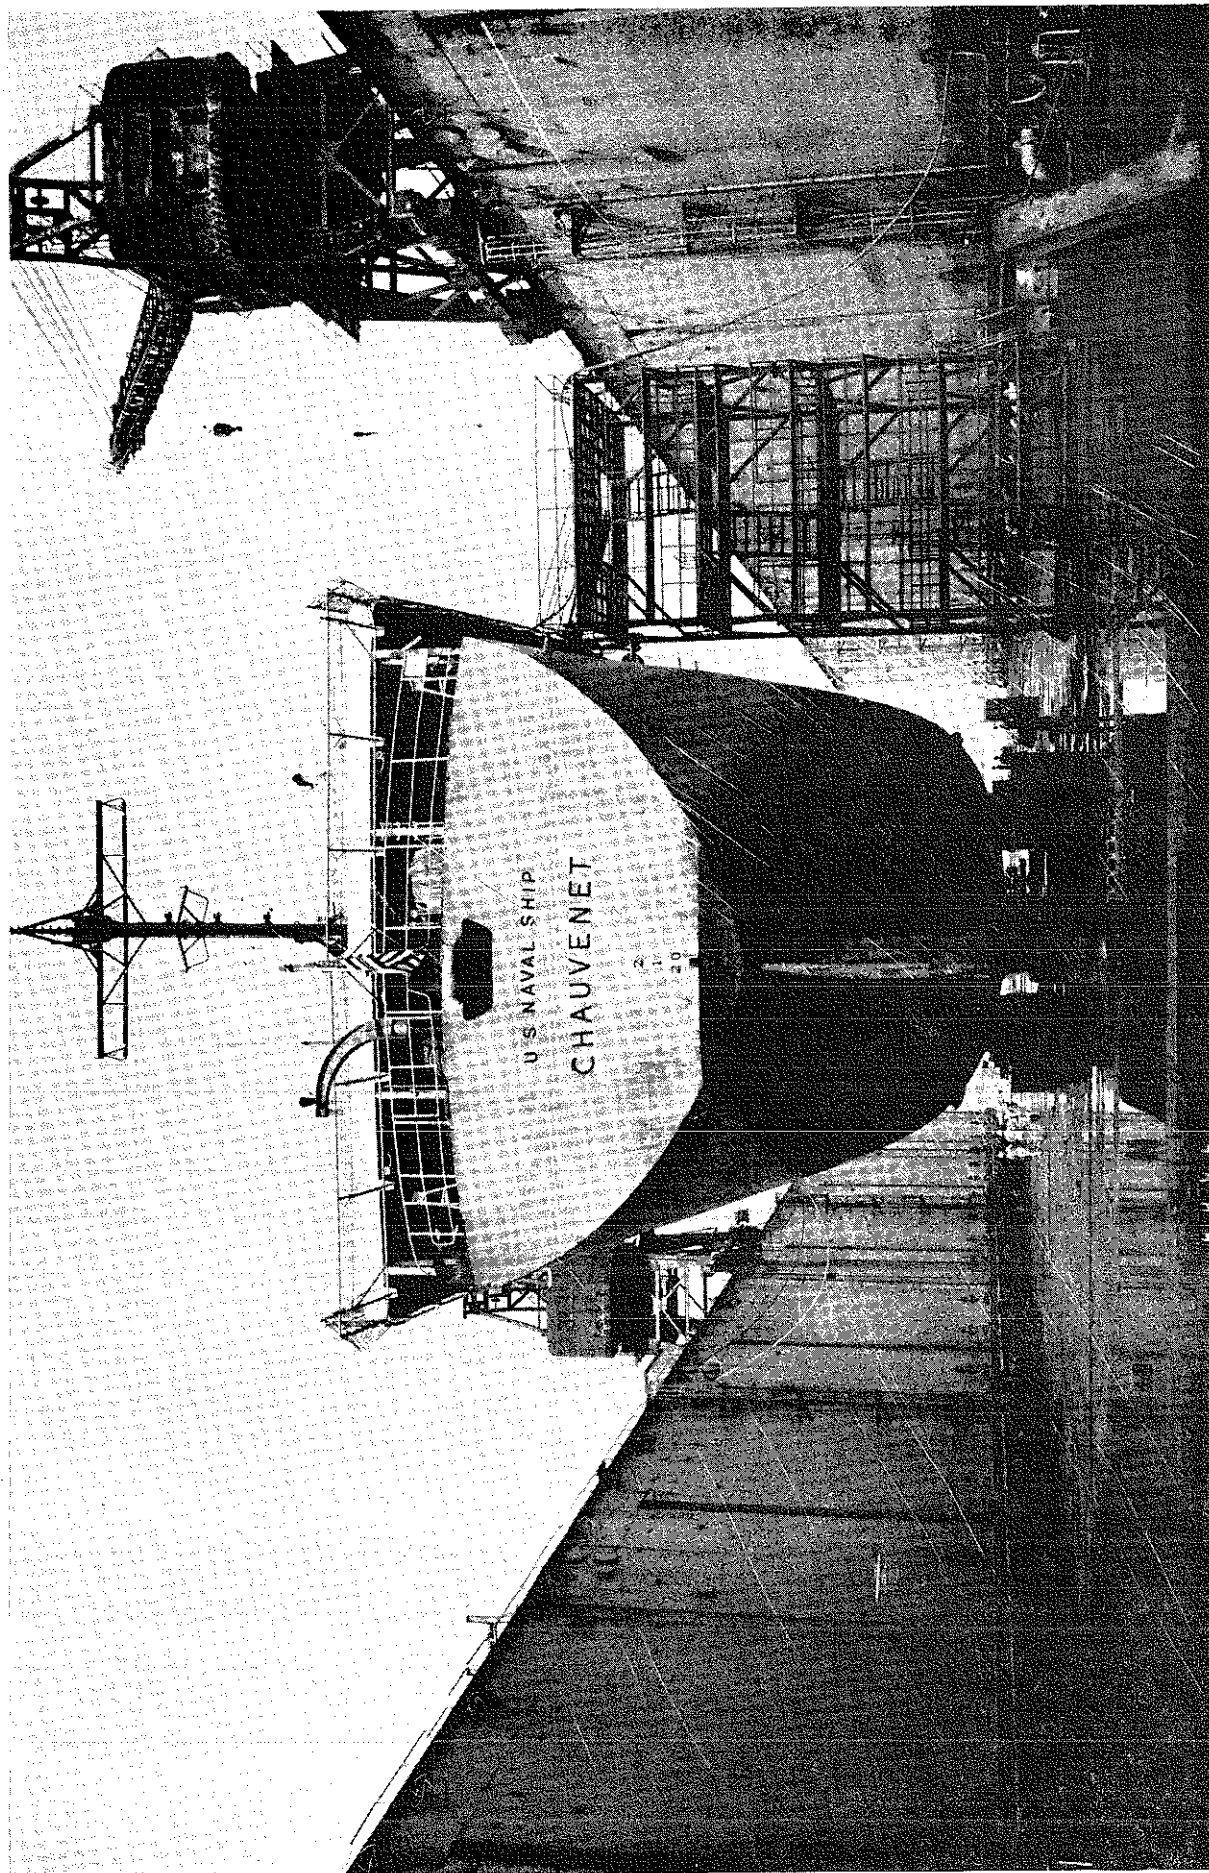
FIGURE 30

USNS Chauvenet on Dock, SRF Subic Bay
