# U.S. NAVY SALVAGE REPORT USNS SGT MATEJ KOCAK (T-AK 3005) SALVAGE AND TEMPORARY REPAIRS

This salvage report documents the recovery and temporary repairs conducted by NAVSEA 00C, Supervisor of Salvage and Diving, for the Military Sealift Command. The operations took place off the east coast of Okinawa from 22 January 2015, the date of the grounding, to 20 February 2015, when the temporary repairs were completed. Details of the efforts and accomplishments are provided in this report.

## USNS KOCAK (T-AK 3005) Refloating and Temporary Repairs

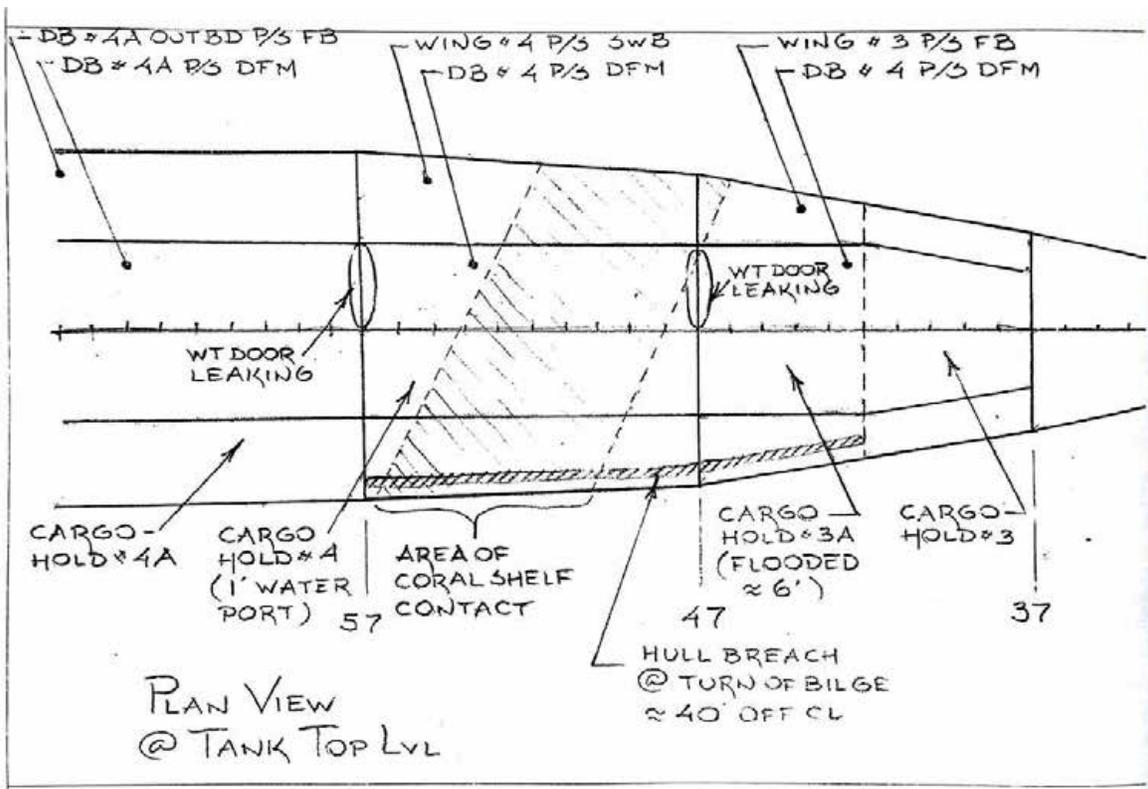
**Figure 3-1: Damage and Grounding Location based on initial dive survey and early damage investigation.**

*“External damage identified consists solely of a longitudinal breach of the hull plating running from the forward of Frame 57 to aft of Frame 42. Hull damage runs below the bilge keel and penetrates ballast tanks 4S Outboard and 3S Outboard (see Figure 3-2). No fuel tanks have been breached.”*

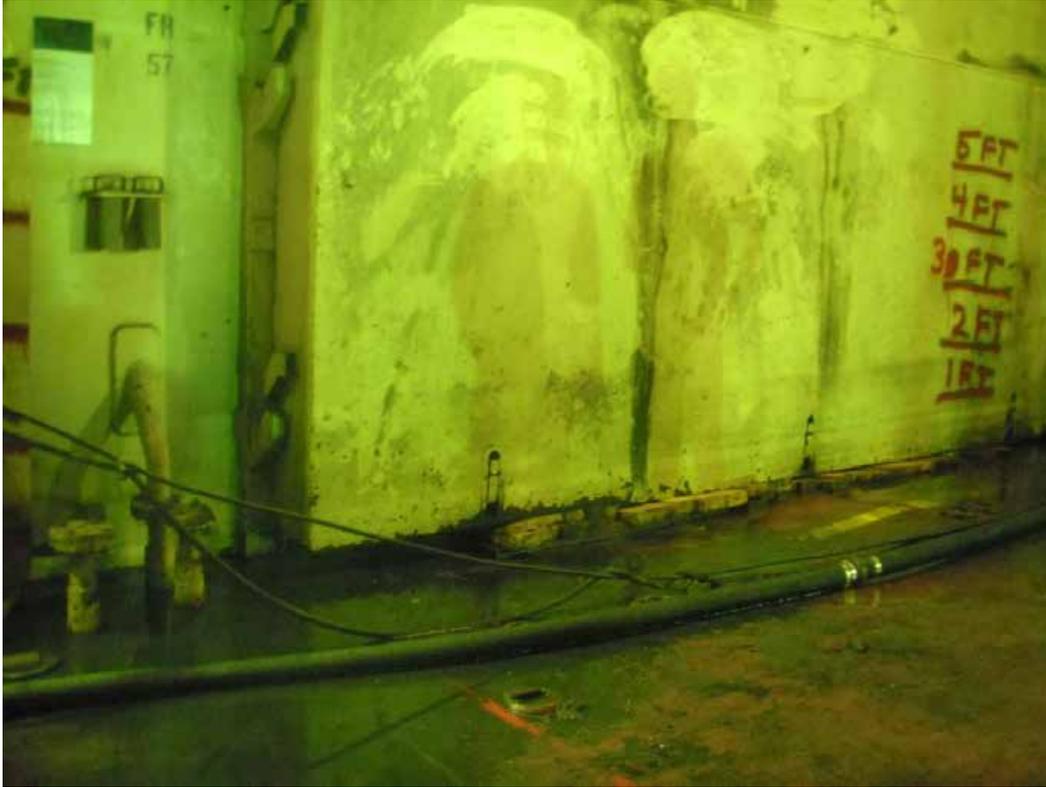
*“Internal damage consists of seawater flooding into Cargo Hold 3A. On 23 January the floodwater reached and ignited an unsecured battery in one of the cargo vehicles. The fire was extinguished and the hold secured. Over the next three days the floodwater in Cargo Hold 3A rose to approximately 6-ft which is below the waterline and indicates a slow leak rather than complete free communication. The lower deck watertight vehicle doors on the port side between Cargo Holds 3A and 4 and Cargo Holds 4 and 4A have been forced out of alignment and are no longer tight. The gaps have been plugged and communication from the flooded Cargo Hold 3A has been reduced to a manageable level. Additionally, there are minor deflections in the deck and bulkhead between Cargo Holds 4 and 4A both port and starboard.”*

**Figure 3-3. A view from Hold 4 looking aft at the water tight door.**

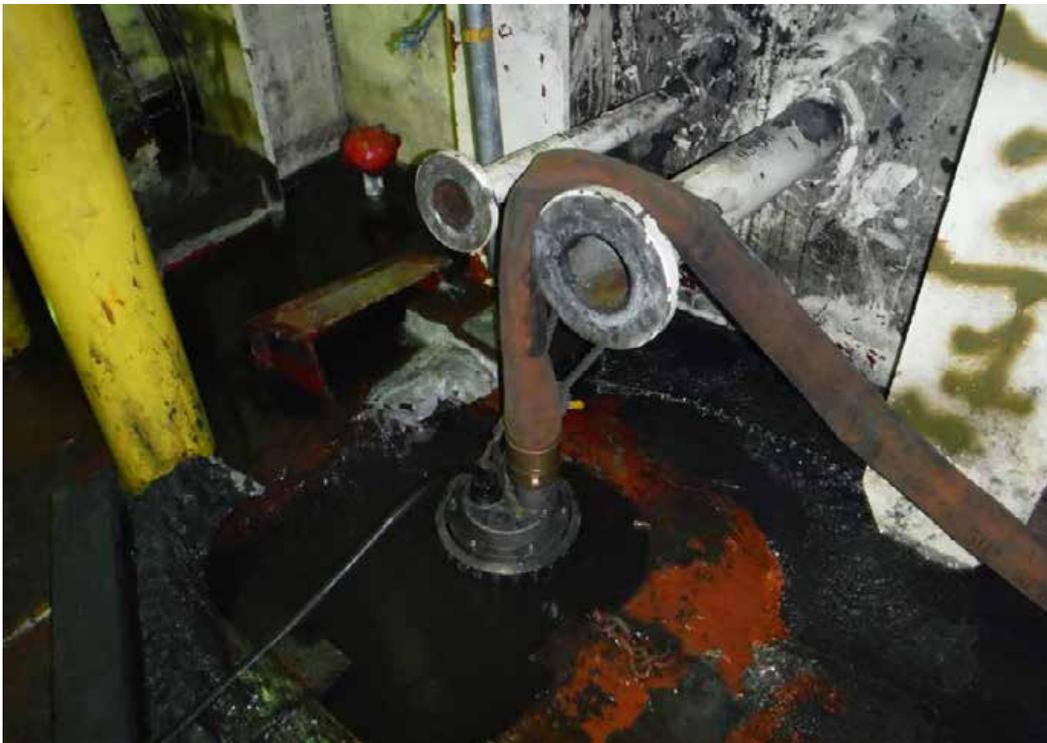
**Figure 3-7. Pump rigged in sump of Cargo Hold 3A. Evidence of oily residue on bulkhead bears witness to higher water levels.**

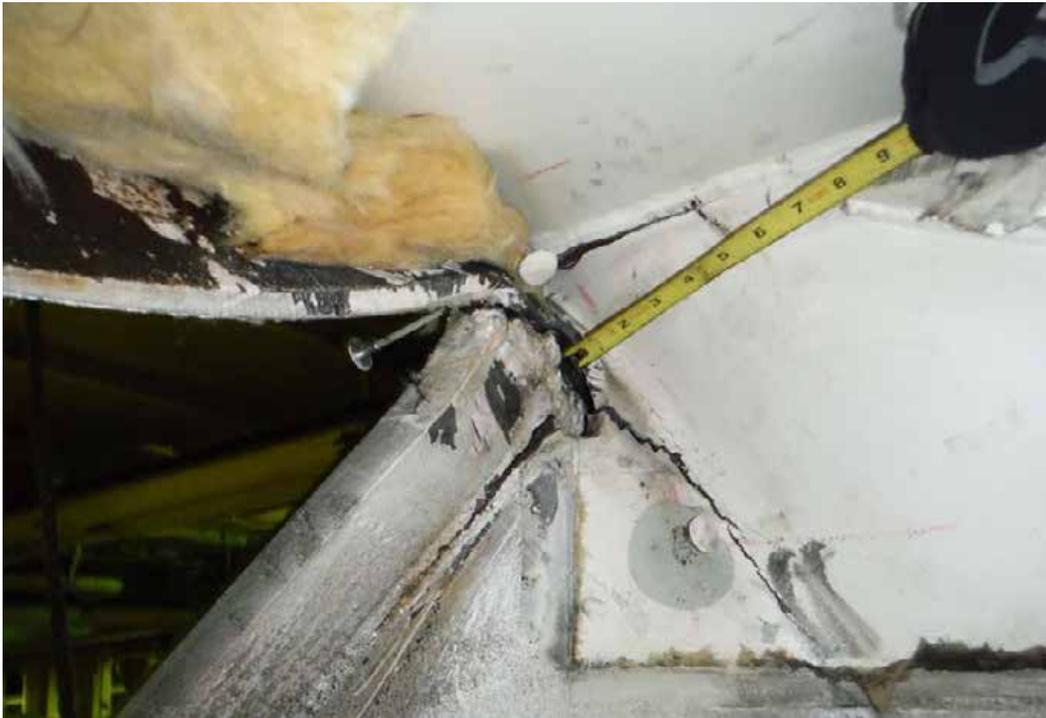
With the water levels lowered in all three previously flooded holds, the crew were better able to assess the damage. The salvors found 3 significant leaks in Hold 3A. Two areas had cracked welds between the tank top and vertical beams, and the third was a hole where a person could stick their hand through in the deck. A more detailed depiction of the internal damages is provided in Figure 3-10 and images of damage and actions to stabilize the damage are provided in the next few pages.

**Figure 3-8. Bulkhead Stiffener Cracks in Hold 3A.**

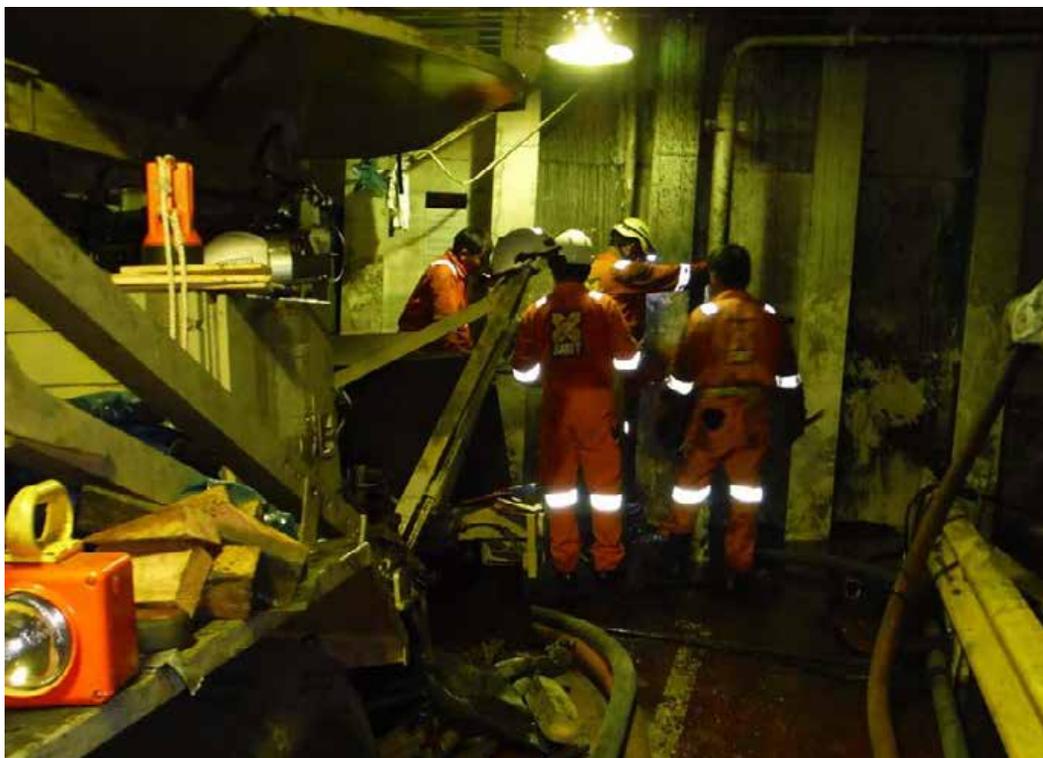
**Figure 3-9. SMIT salvors assessing leak rates in Hold 3A.**

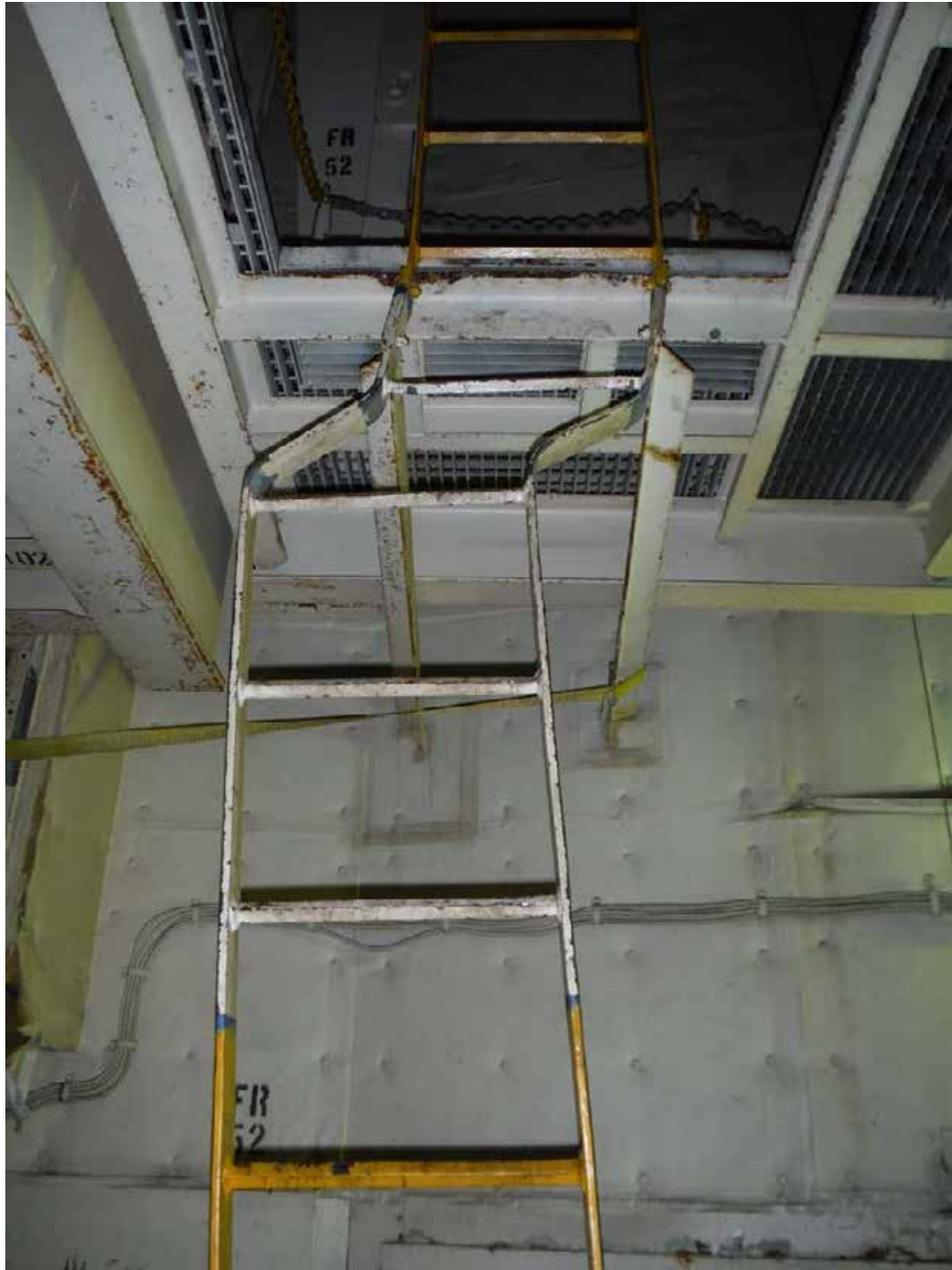
**Figure 3-10. Hold 4 port side tank top buckling resulted in stress on this ladder.**

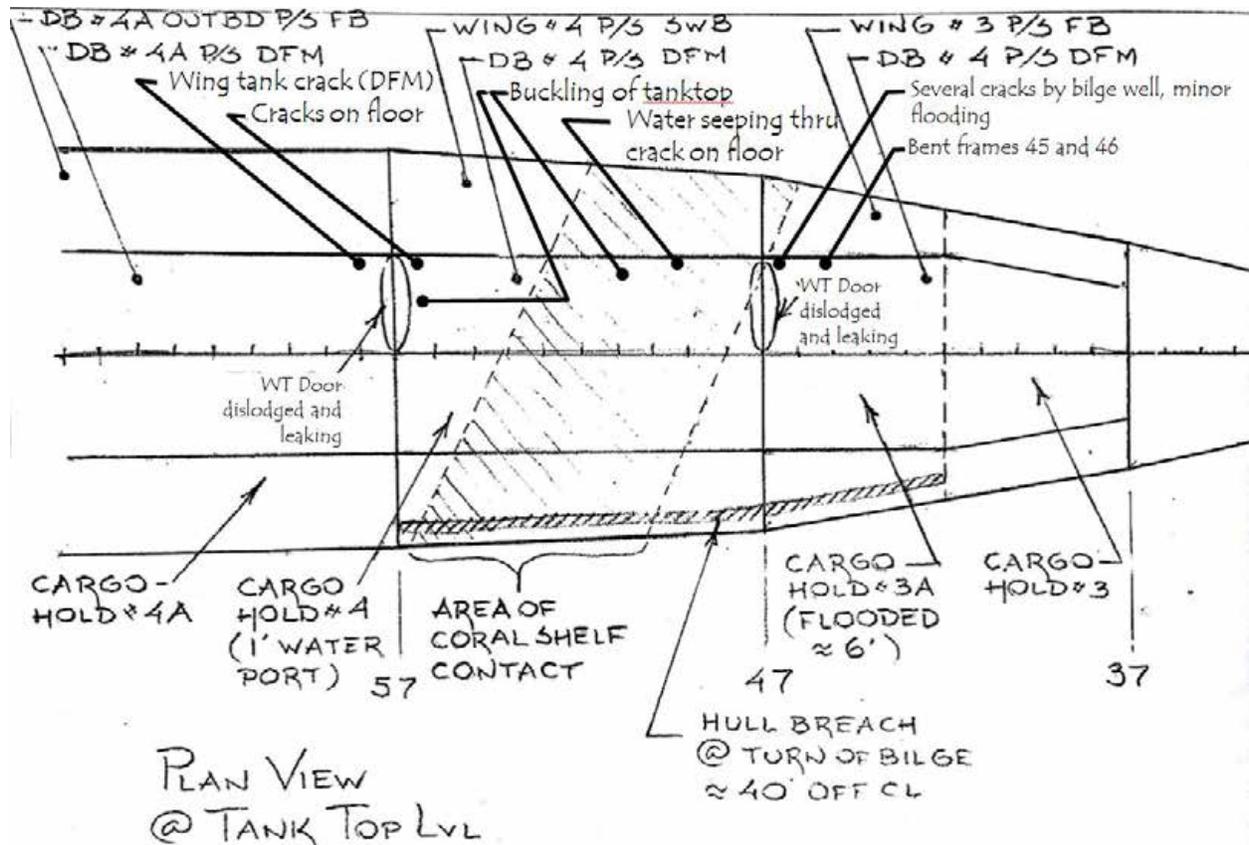
Figure 3-11. Internal damage following detailed survey.

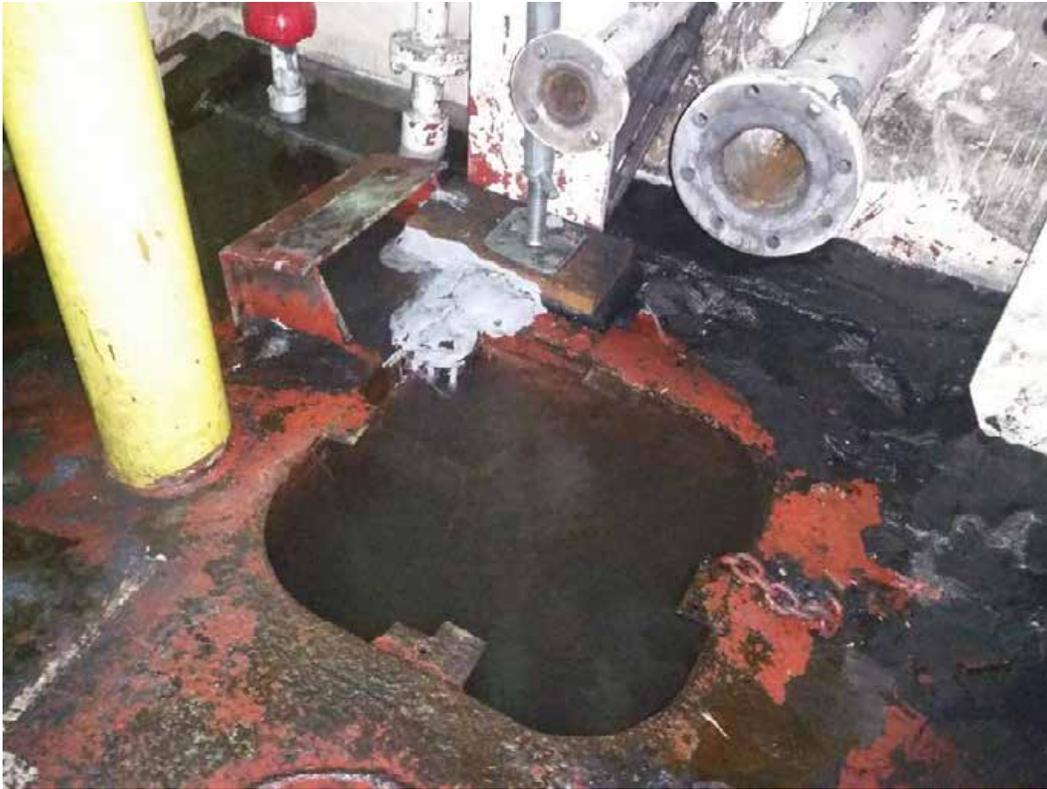
**Figure 3-12. Patched and cleaned Hold 3A sump awaiting float off.**

On the days leading up to the higher tide cycles, the team continued to work on stopping / slowing the ingress of water into holds 3A, 4 and 4A. The team made excellent progress in slowing the leakage in 3A at the port side, aft bulkhead. The leaks in that area were at the welds on the I-beams on the aft bulkhead at the intersection with the deck. They're very difficult to access and plug. But the team slowed the flooding to the point that they were not concerned about how much water the ship would take on after having to shut down pumping operations during float off.

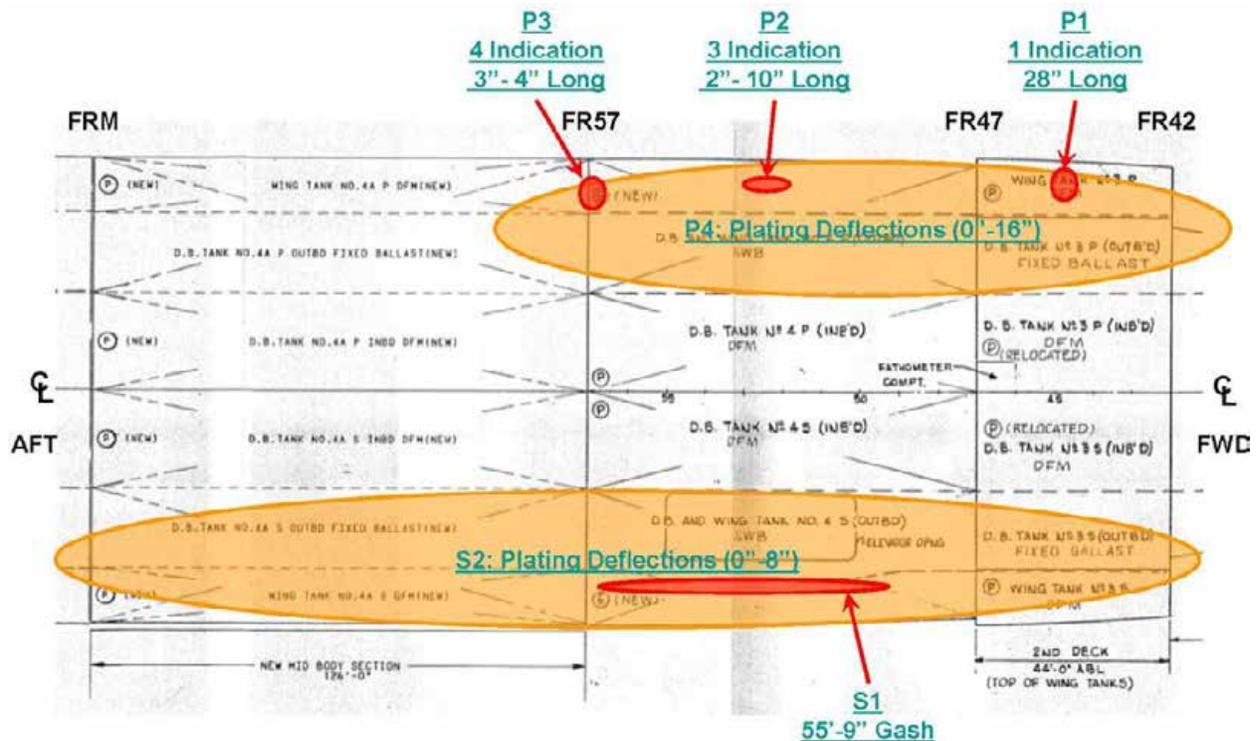
Figure 4-2. Shell damage and repair planning.

Figure 4-2 provides an overview of the shell planning damage and repair locations.

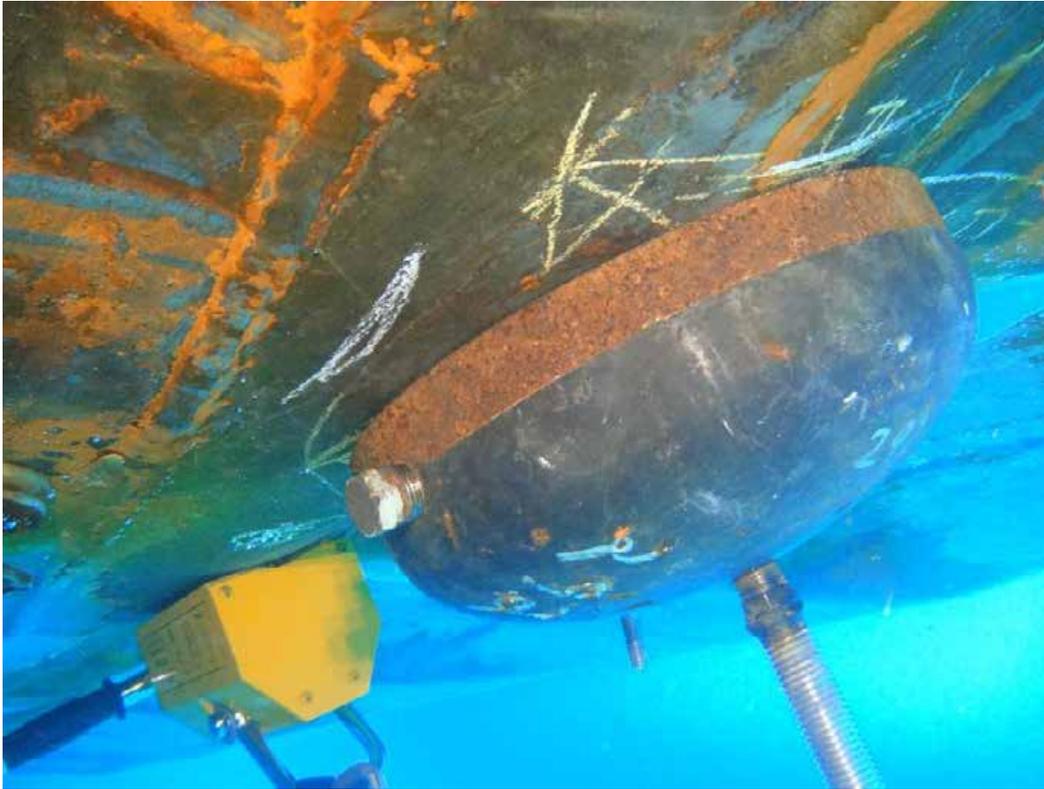
**Figure 4-4. Dome patch templating on port side of USNS KOCAK. The repair team used dome patches to compensate for the distortions the hull plating.**

Repairs to these five breaches were conducted over the period of 12 to 15 February. 225 inches of production welding was accomplished. In some cases, an elliptical patch or box patch was used in place of the planned doubler plates due to the extreme contour of the hull, the longest of which was 41" x 8". Figure 4-4 shows the templating of a dome patch on port side of the hull.

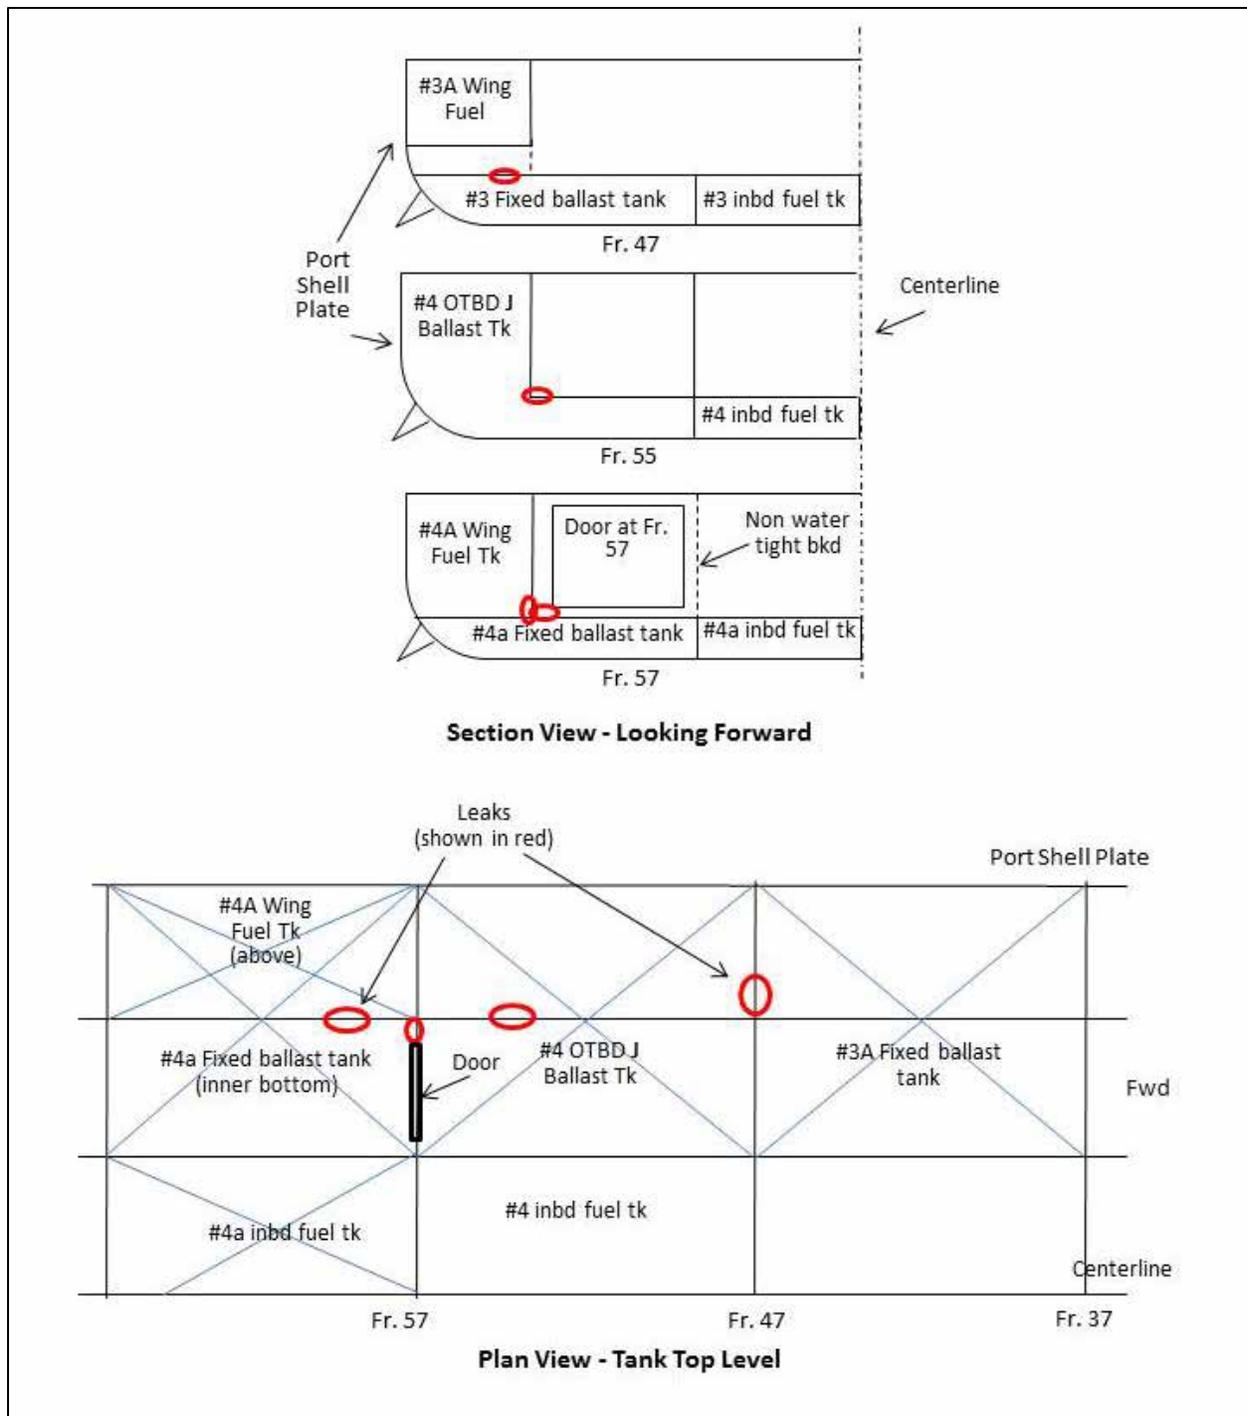
**Figure 4-5. Plan and Sectional views of tank top level leaks.**

Much of the inner bottom and tank welding depended on cleaning the space for entry and hot work. The Marine Chemist, who was hired to support the operation, arrived on 13 February and from that point on, interior welding began to move forward. Loss of tank integrity hampered production. For example, the team would clean a tank for inspection, only to find standing fuel oil in it some hours later when welding was scheduled. The team determined that the failures in some of the tanks cascaded into other tanks. Figure 4-5 shows the inner connectivity of tanks and compartments from #3A Fixed Ballast to 4A wing Fuel.

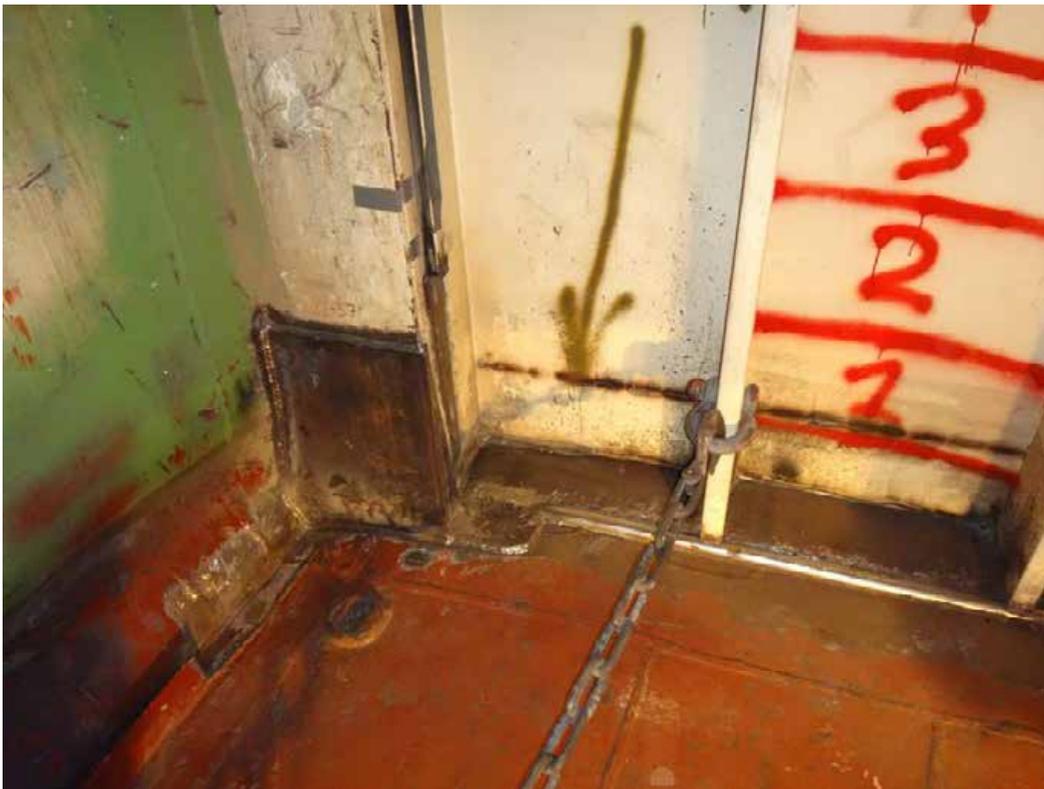
**Figure 4-6. 4-4A Watertight door repairs. Left hand corner welds were strengthening and sealing outboard bulkhead of compartment and adjacent wing fuel tank.**

- Cutting bottom of door to match tank top contour
- Replacing existing shoe plate with new ½" shoe plate
- Cut back bottom 24" of the outboard side of the door to match the contour of the bent frame and modify side seal channel to match contour.
- Weld new shoe plate to deck
- Securing closed door with turnbuckles to replace the upper and lower door locks that were removed to facilitate door opening.

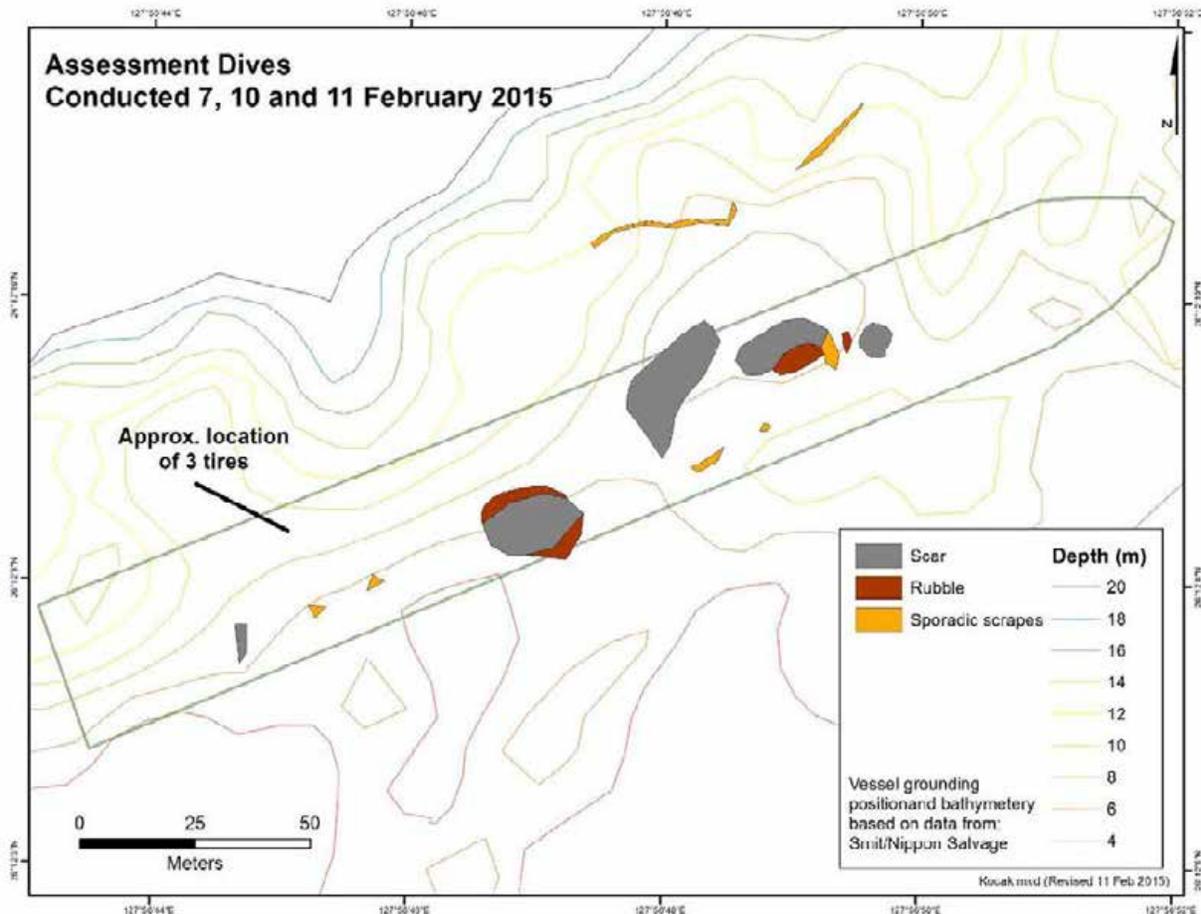
The Reef survey was conducted with dives on February 7, 10 and 11 to investigate and document the damage as a result of the grounding. During the total of 730 minutes of combined bottom time, the team evaluated damage inside the KOCAK's footprint and outside the footprint to compare scarred bottom conditions with adjacent unaffected areas. Damage to the reef was observed in four main scars where hull contact resulted in 80 – 100 percent contact damage. This damage can be seen on map provided as Figure 5-2. This map of reef damage, prepared by NAVFAC Marine Resource Assessment Diving Services' Lee Shannon, documents the main scars and the patchy scraped areas likely indicating the hull briefly impacted the coral. The full NAVFAC report is available as Attachment F.

**Figure 5-2. Post salvage dive survey map documenting coral damage following KOCAK's extraction.**

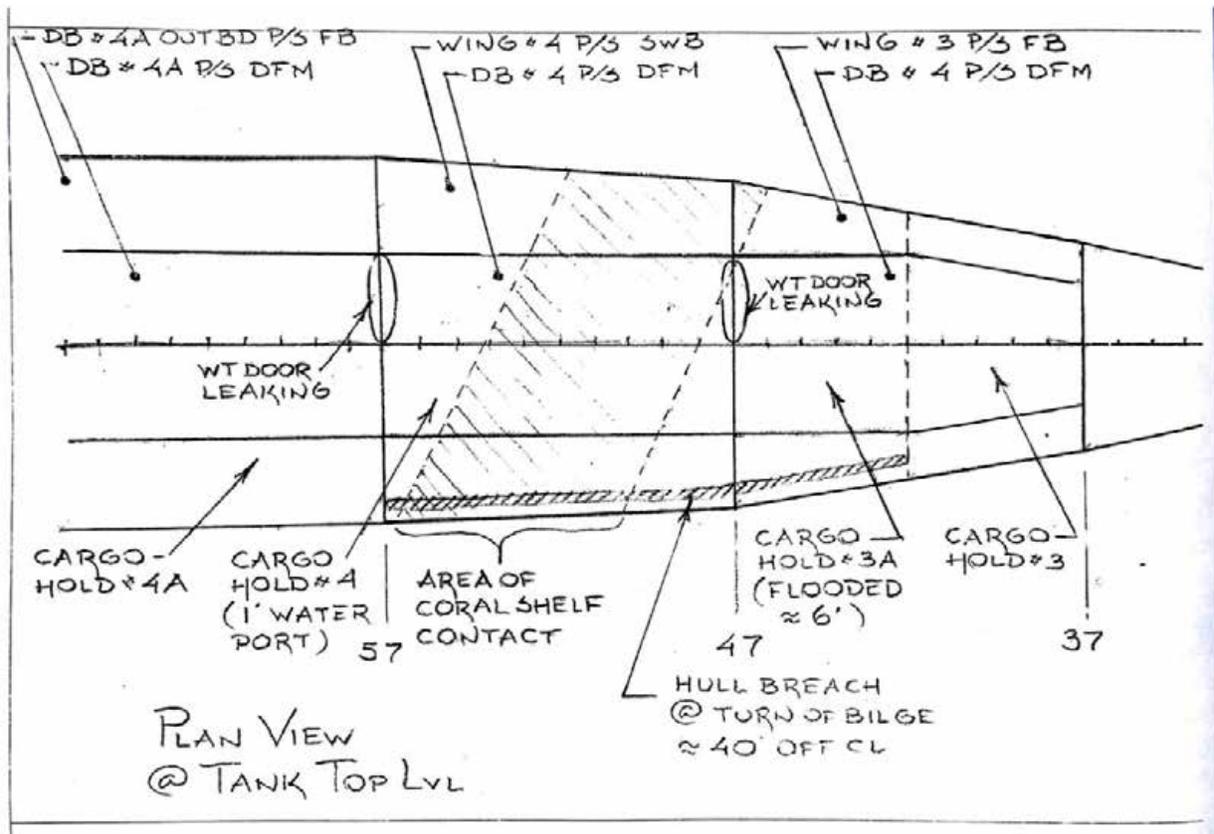
Figure 4: Damage and Grounding Location

KOCAK was hard aground throughout the tide cycle. Multiple dive surveys were performed to identify ground locations. KOCAK was aground on a coral shelf running diagonally beneath Cargo Holds 4 and 3A (Fig. 4). Additionally, a smaller coral pinnacle was beneath the starboard side forward of the house (not shown). KOCAK was afloat at the bow and stern but clearance below the rudder and propeller was only about 1m. This complicated refloat efforts as additional trim had to be limited.

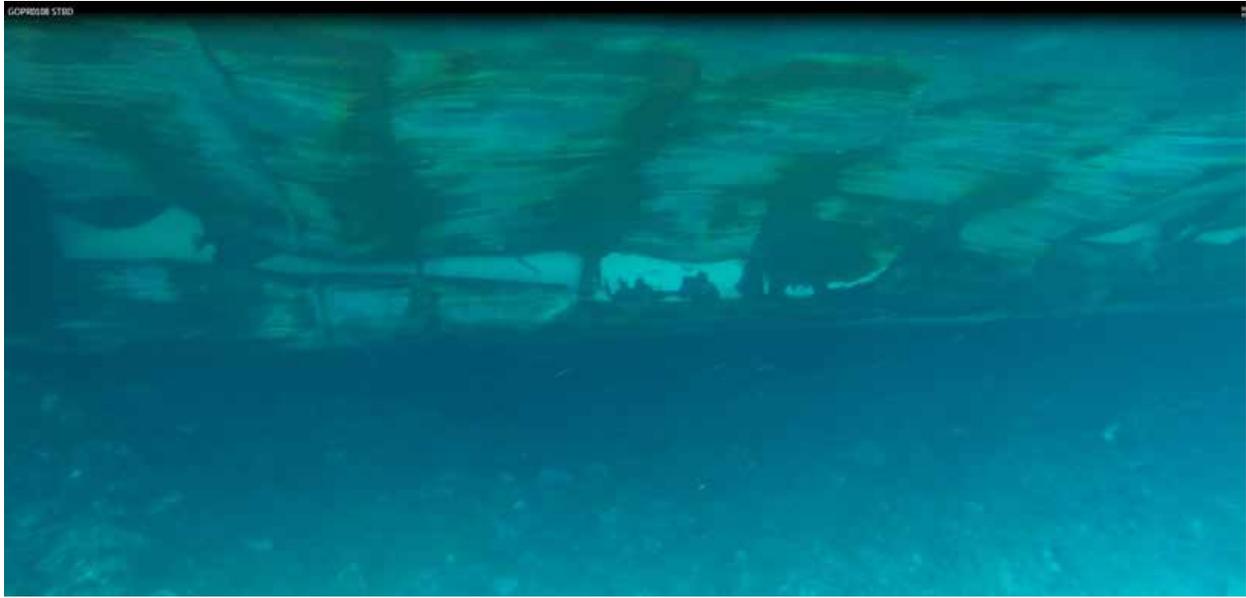
Figure 7: Hull Damage (Stbd)

External damage identified during dive surveys consisted solely of a longitudinal breach of the starboard hull plating running from the forward of Frame 57 to aft of Frame 42. Hull damage ran below the bilge keel and penetrates ballast tanks 4S Outboard and 3S Outboard. No fuel tanks were breached. No external hull damage was visible on the port side but KOCAK was heavily aground along that side hindering survey efforts.

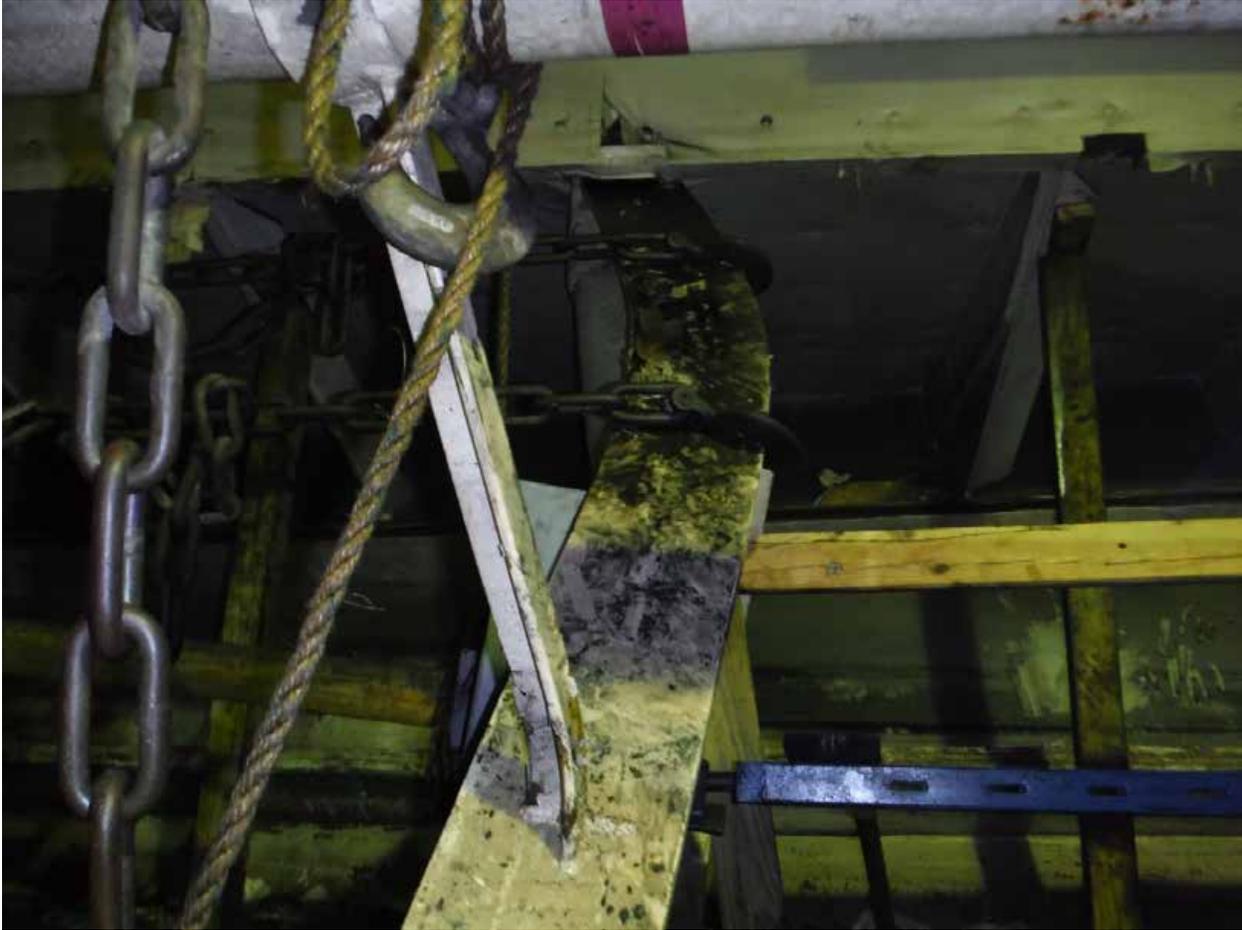
With assistance from a Damage Control team from the USS BONHOMME RICHARD (LHD-6) all three flooded holds were pumped dry to a slop barge alongside. Water ingress was identified only in hold 3A on the port side and was secured save for one leak forward of FR 47 which was manageable throughout the refloat. Floodwater was coming into Hold 3A through the #3 Outboard Port Double Bottom tank which is filled with a permanent ballast powder of primarily iron. Fuel levels in the adjoining 3P Wing and 3P Inboard DB were unchanged. Structural damage occurred to Frame 45 on the port side of the hold level of Cargo Hold 3A buckling approximately 6 inches. The web but not flange of the two frames to either side of Frame 45 also buckled approximately 3 inches. Additionally, the welds connecting Frames 44-46 to the 3 Stbd Wing Tank above cracked to varying degrees. Damage Control teams shored both sides of Frame 45 to prevent further buckling damage and the cracks were monitored for propagation.

**Figure 8: Frame 45 Damaged & Shored**

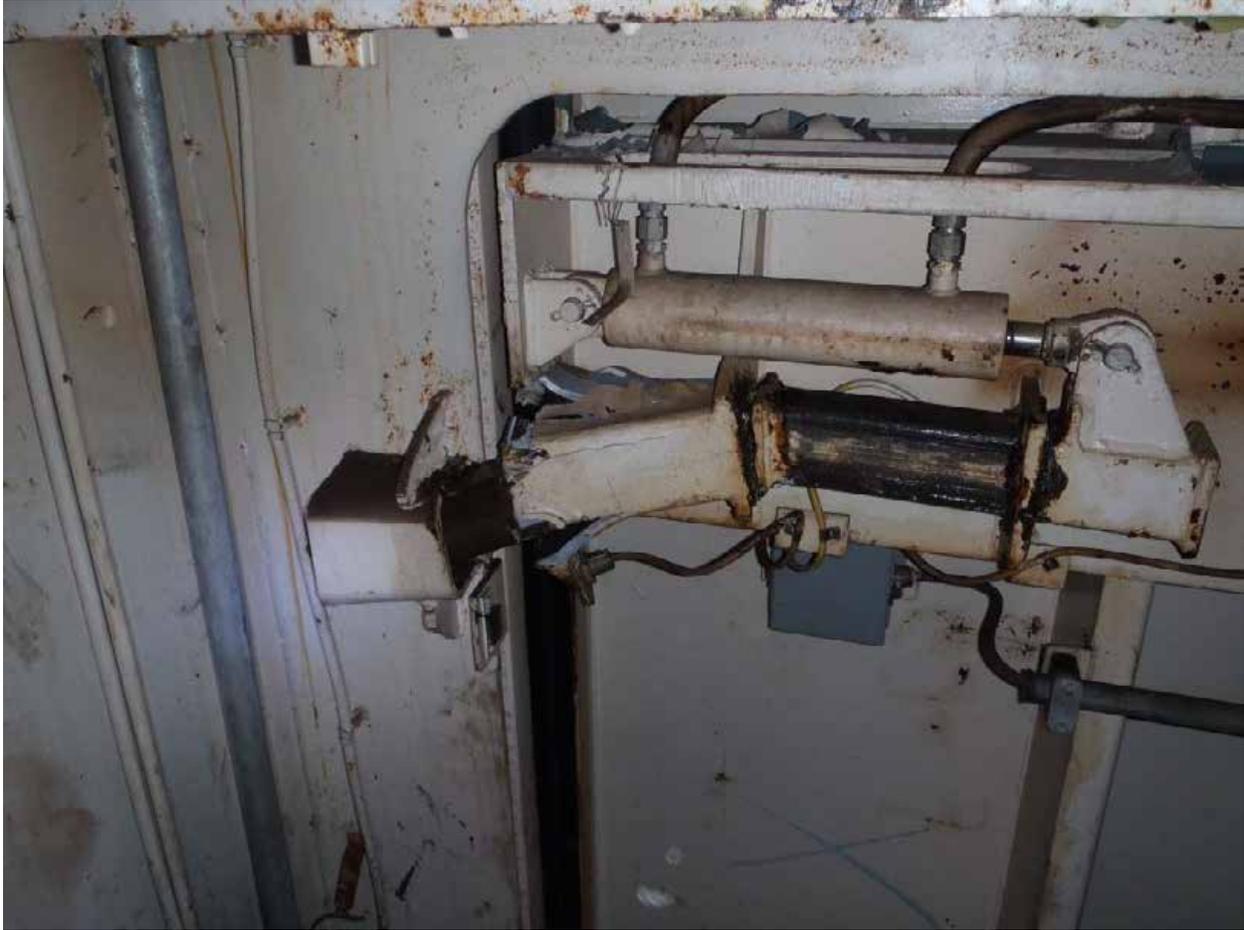
Additional structural damage was identified as cargo hold tank top decks forced upward along a longitudinal girder running through the double bottom tanks 9 ft inboard of the port bulkhead in Cargo Holds 3A and 4. The deck in this area is raised from 2-5 inches. This resulted in the misalignment of the vehicle doors and buckling of a longitudinal between FR 44 and 45 on the port side of Cargo Hold 3A. Watertight integrity was re-established in the door between Hold 3A and 4 but the door between Hold 4 and 4A continued to leak by even with DC plugs and epoxy patches applied.

**Figure 9: Dislodged Watertight Door**

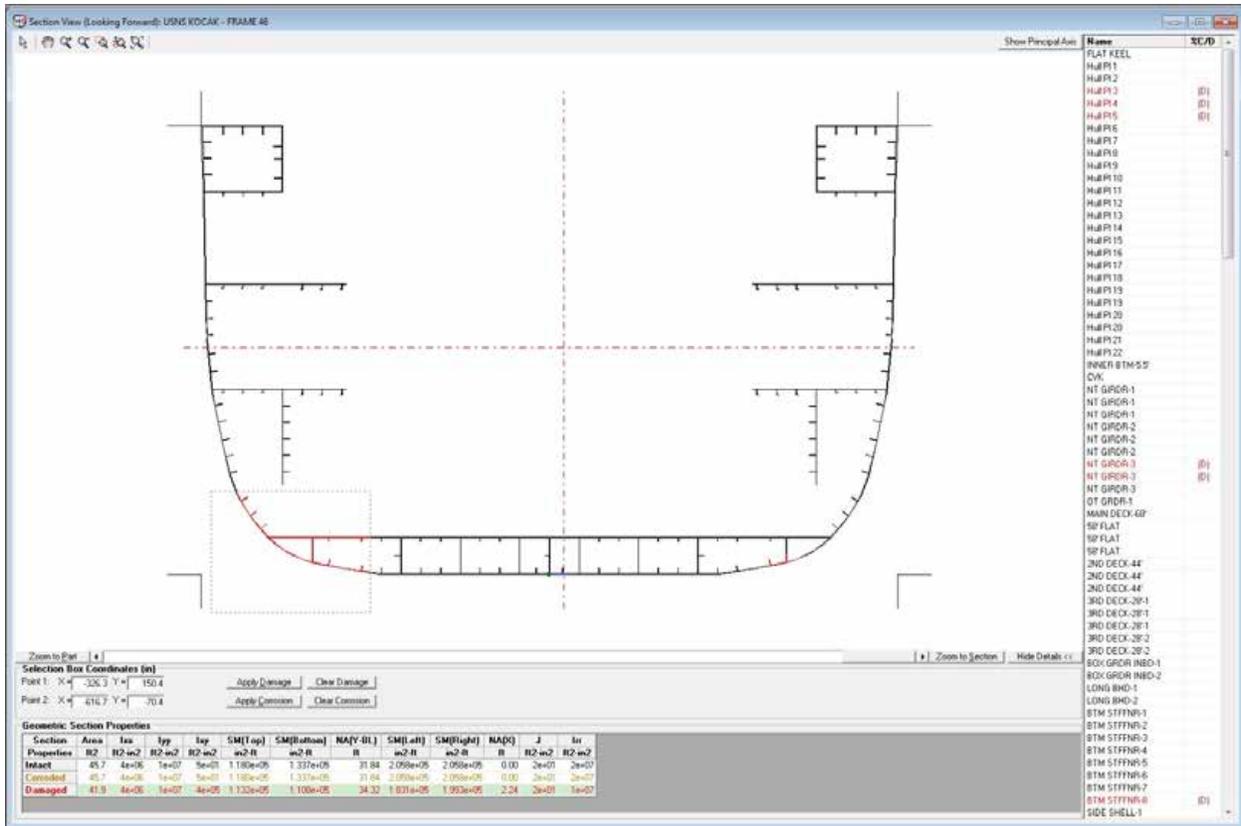
Figure 18: Assumed Structural Damage

Stresses applied to the damaged structural areas during refloating was considered a risk and required additional review. A POSSE .smd file at Frame 46 had been prepared as part of the initial POSSE model development and was considered an appropriate representation of the structure at the damaged Frame 45. For analysis, it was assumed that all structural members with proximity to the known damage were completely ineffective. This was an extremely conservative assumption as it was clear that many members had only been minimally deformed and would retain a substantial portion of their intact strength.

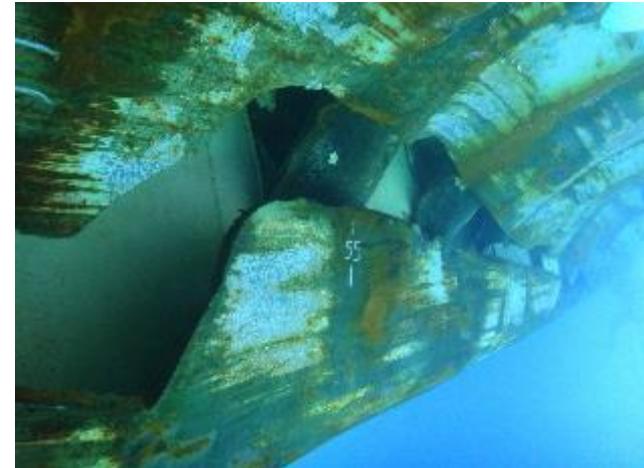
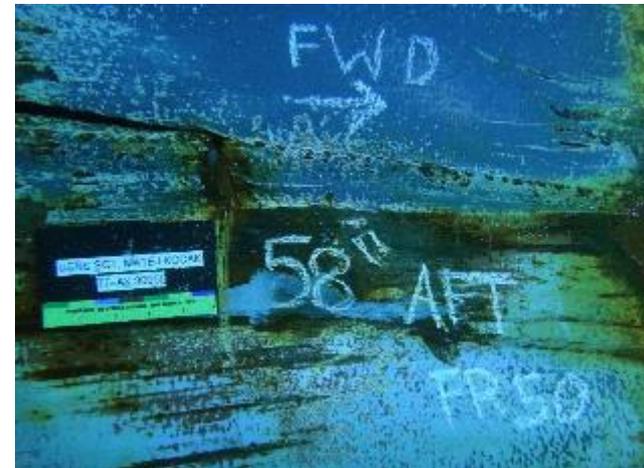
# S1

Stbd, round bilge, into #4 O/B D/B wing tank (SWB): 55'-9" gash, 58" aft of FR50 to 38" fwd of 57, average 8" opening.

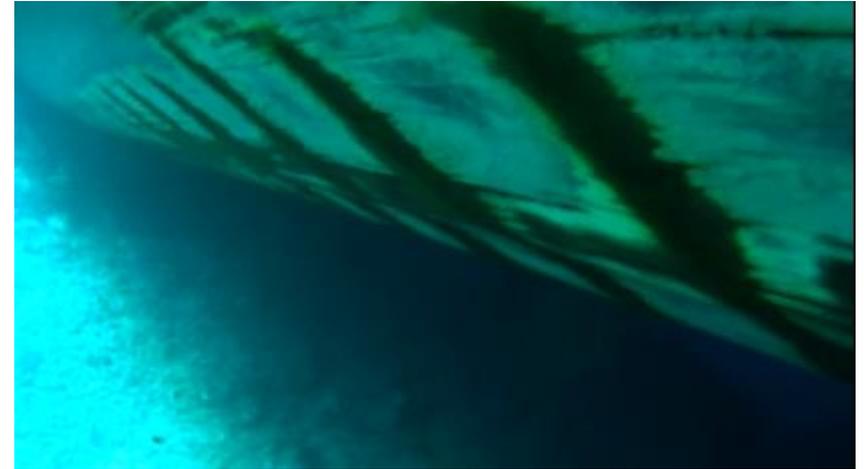
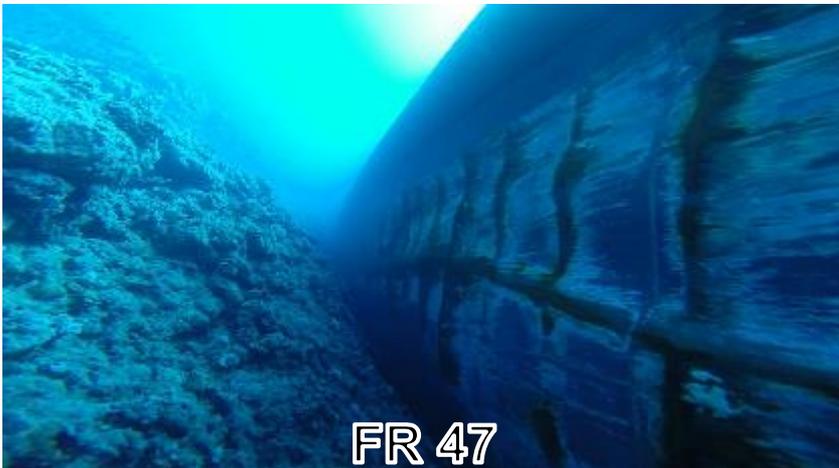
# S2

Stbd, bilge keel and round bilge, FR42-FR62: plate deflection up to 8"

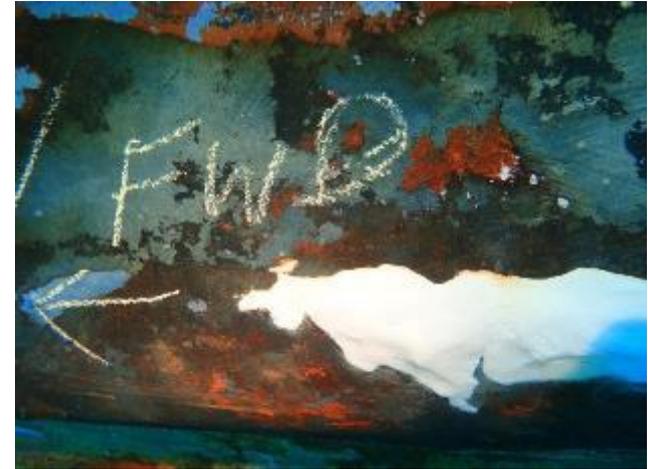
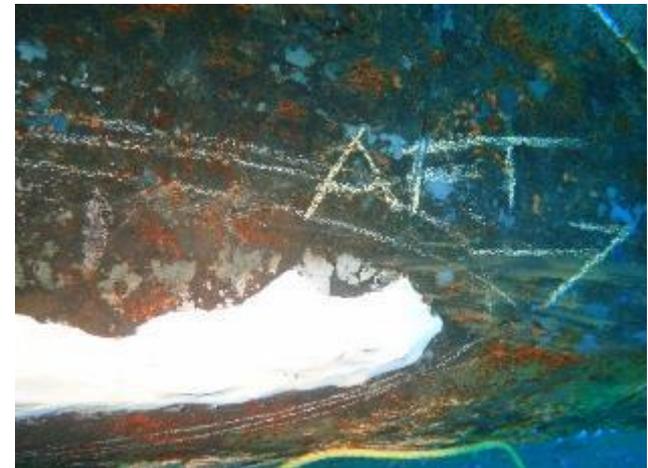
Port, round bilge, into #3 O/B D/B wing tank (FB): 28" indication, across FR 45 (PE-45)
