# U.S. NAVY SALVAGE REPORT USNS SGT MATEJ KOCAK (T-AK 3005) SALVAGE AND TEMPORARY REPAIRS

This salvage report documents the recovery and temporary repairs conducted by NAVSEA 00C, Supervisor of Salvage and Diving, for the Military Sealift Command. The operations took place off the east coast of Okinawa from 22 January 2015, the date of the grounding, to 20 February 2015, when the temporary repairs were completed. Details of the efforts and accomplishments are provided in this report.

## USNS KOCAK (T-AK 3005) Refloating and Temporary Repairs

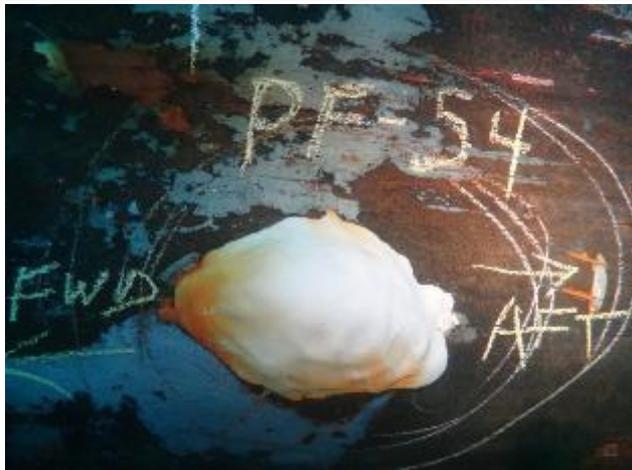
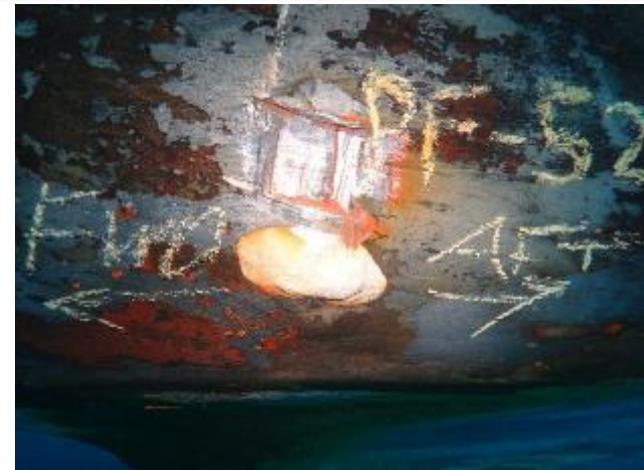
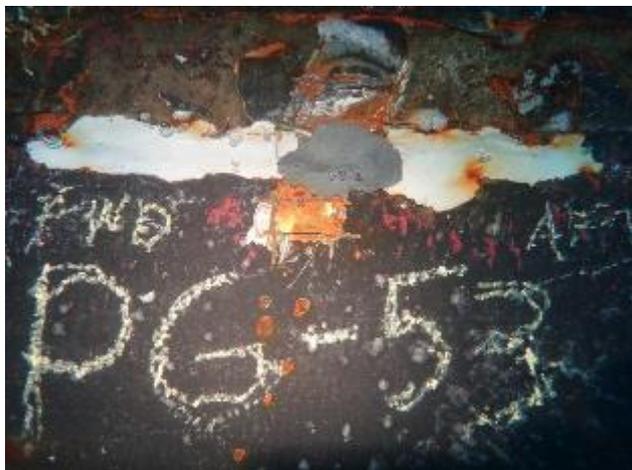
Port, round bilge, into #4 O/B D/B wing tank (SWB): 3 indications between FR52-54 (PF-54)

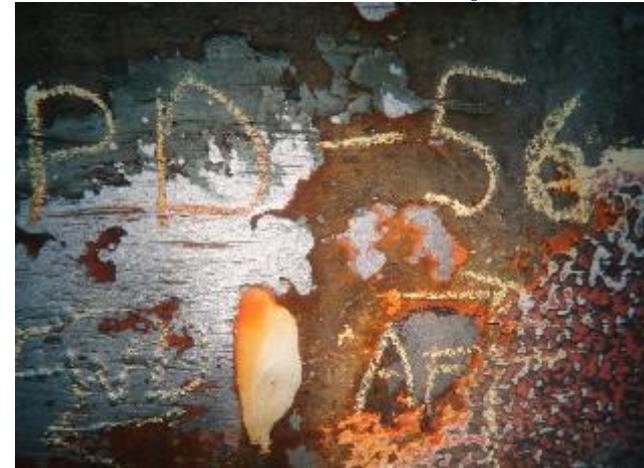
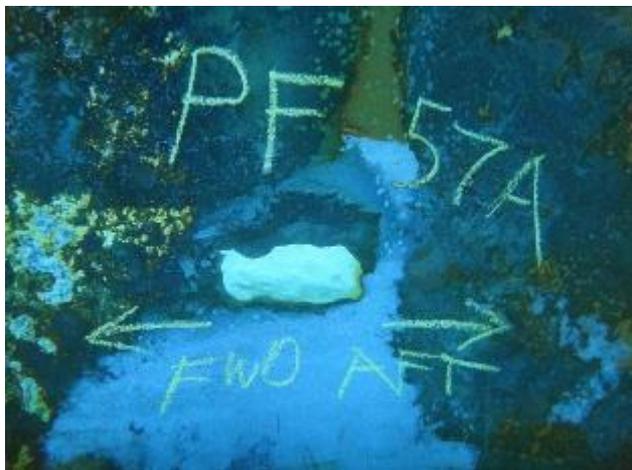
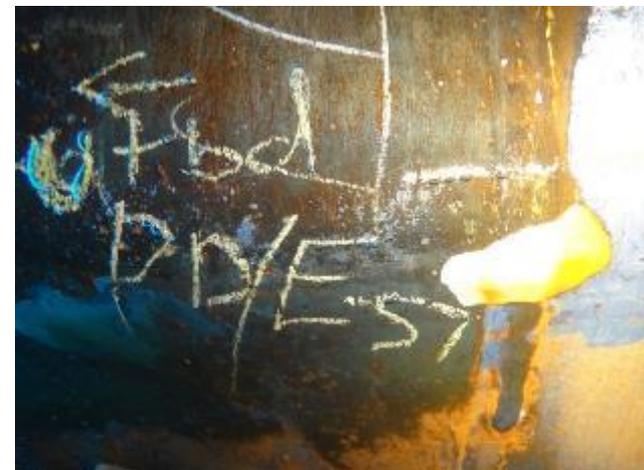
Port, flat bottom, into #4 O/B D/B wing tank (SWB): 3 indications between FR56-57, ~31' from CL, up to 3" in length. Port, round bilge, into #4A O/B D/B wing tank (FB): 1 indication on FRA, 4" in length (PD-57I, PD-57 and PD-56)

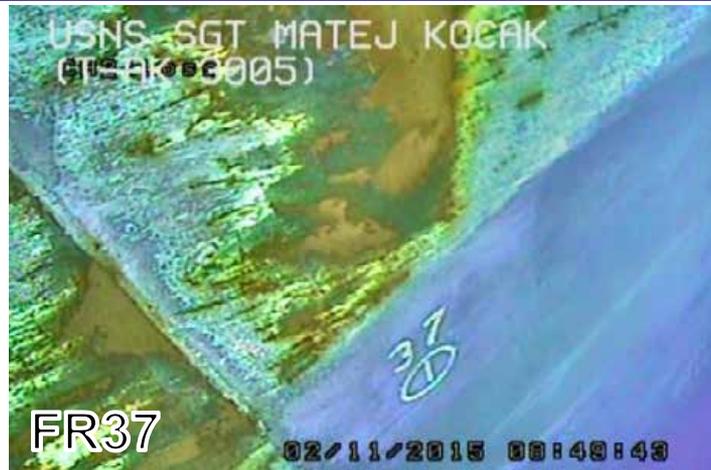
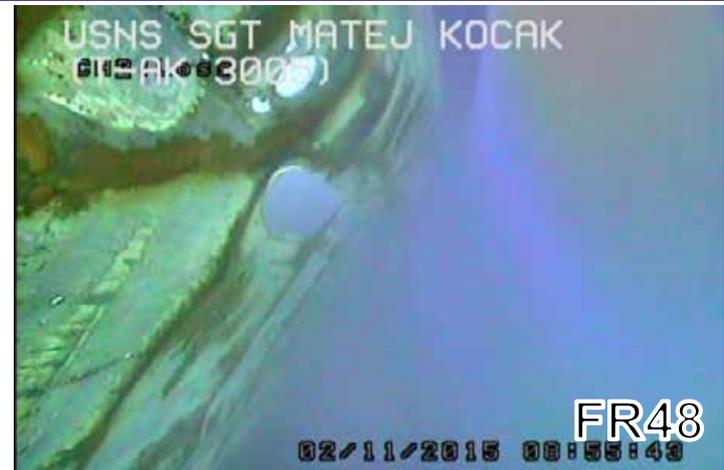
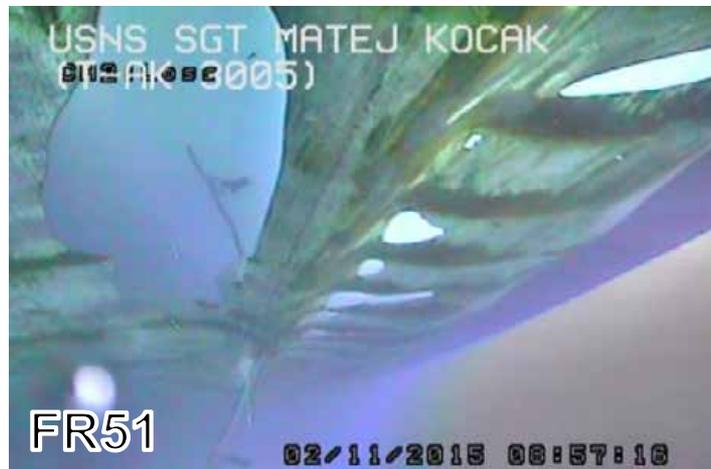
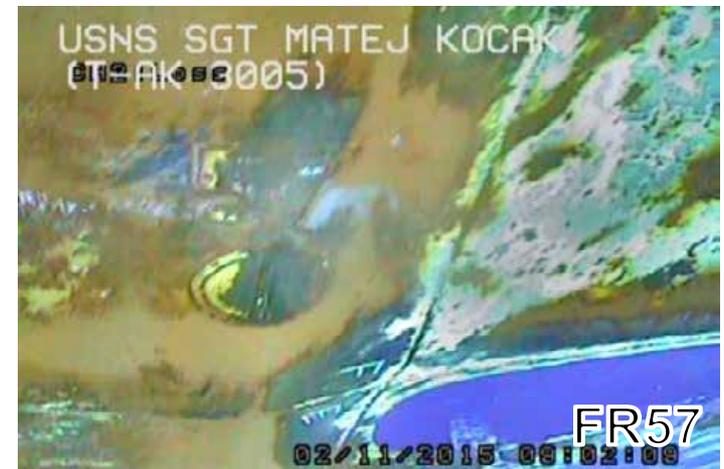
Port, bilge keel and shell plating, FR39-FRA: plate deflection up to 16"

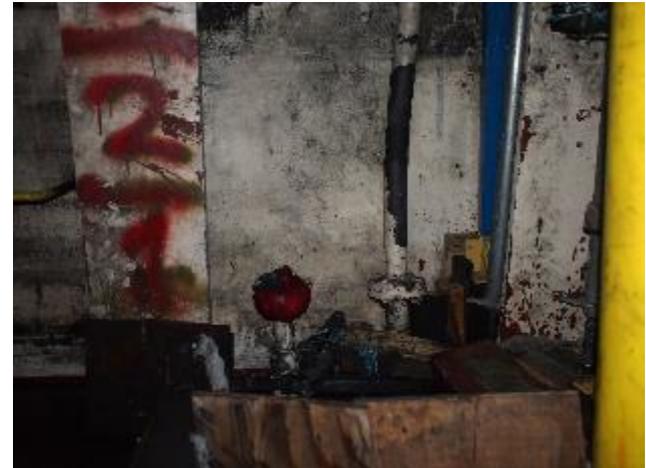
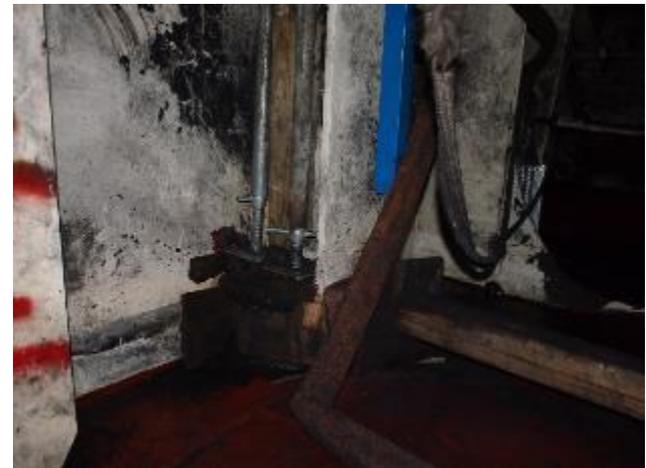
#3 O/B D/B (FB) leak into #3A tank top deck: 4 locations where the fillet welds between the decking and the WTB have failed.

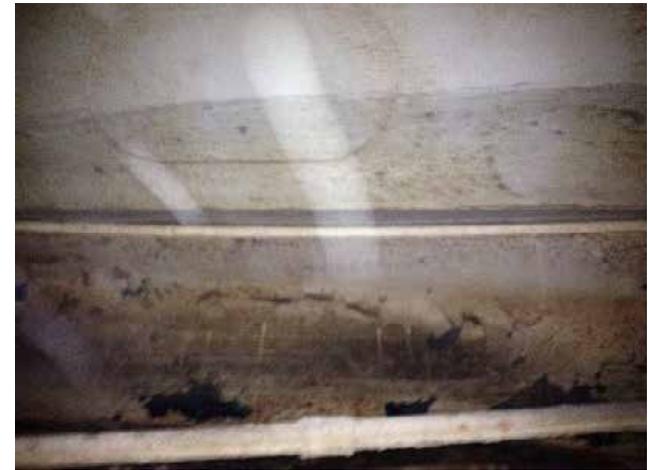
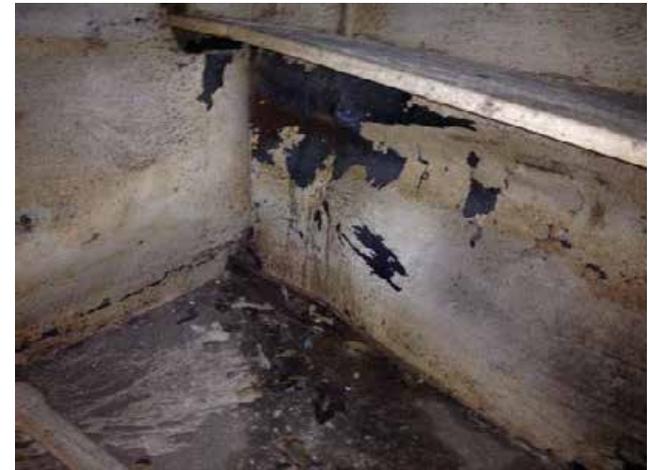
#4 O/B D/B (SWB) leak into 4 tank top deck: 48" long indication.

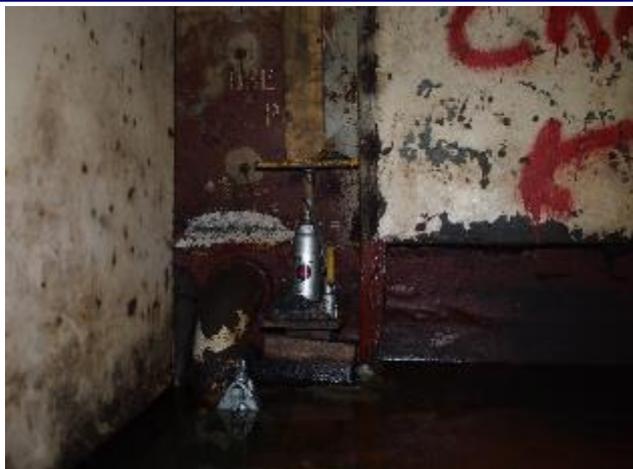
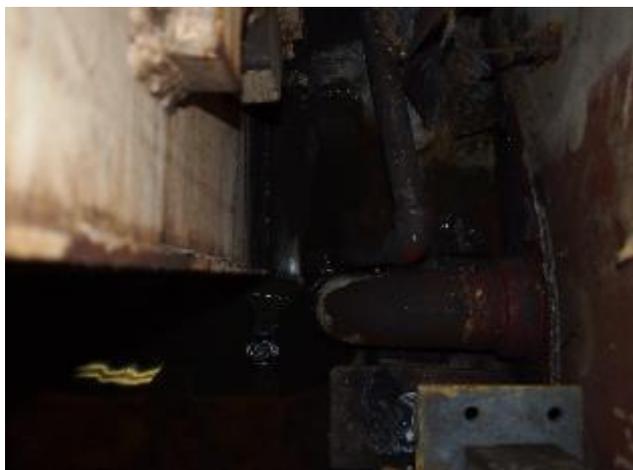
- . #4 & #4A O/B D/B (SWB/FB) leak into tank top deck: 4 indications around WTD foundation. Location is patched and shored. No leaks when #4 O/B D/B tank is below tank top (5'-6" ABL), leak rate of less than 1 GPM when full.

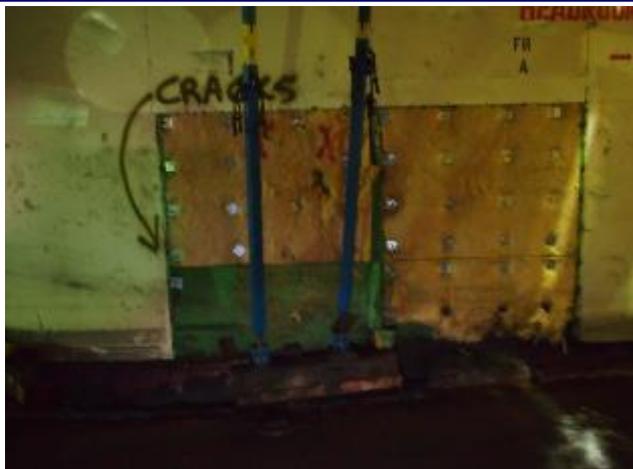
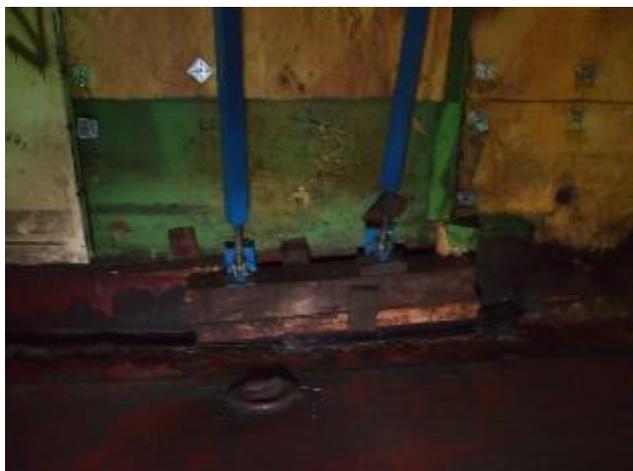
#4A O/B D/B (F/O - Empty) leak into 4 tank top deck: 48" long indication. Patch will remain in place.

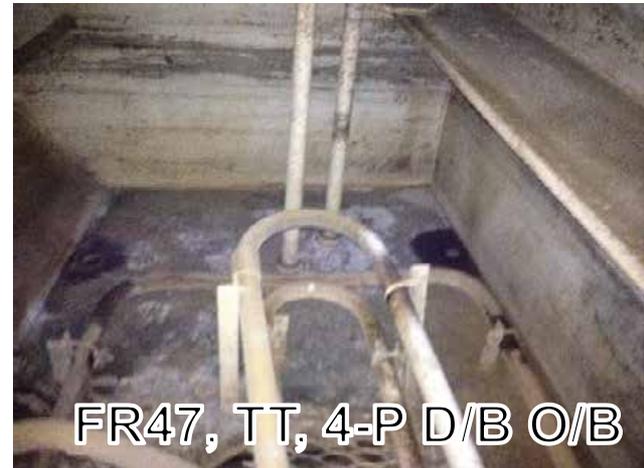
Port side. WTB between #3 O/B D/B (FB) and #4 O/B D/B (SWB). Leaks at P4 stopped when #4 O/B D/B was dewatered.

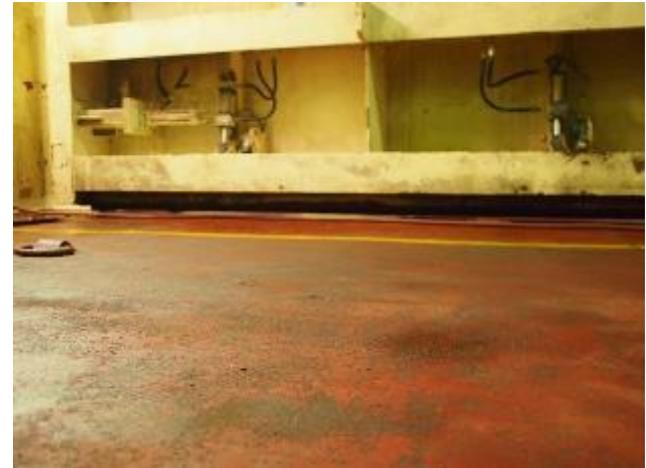
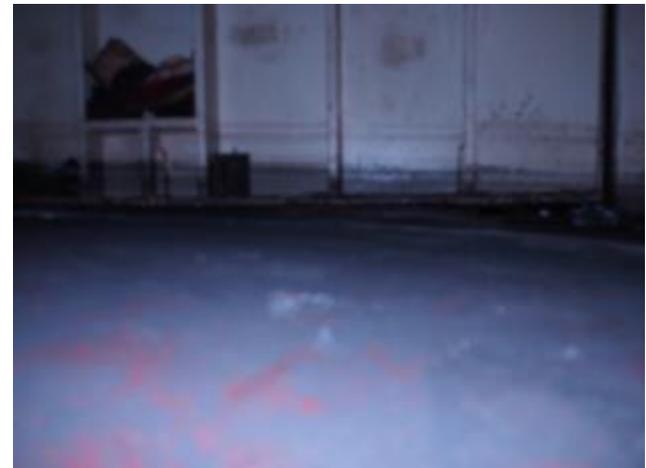
Port side WTD, floor deflections leave gap between door and floor and vertical sealing surfaces.

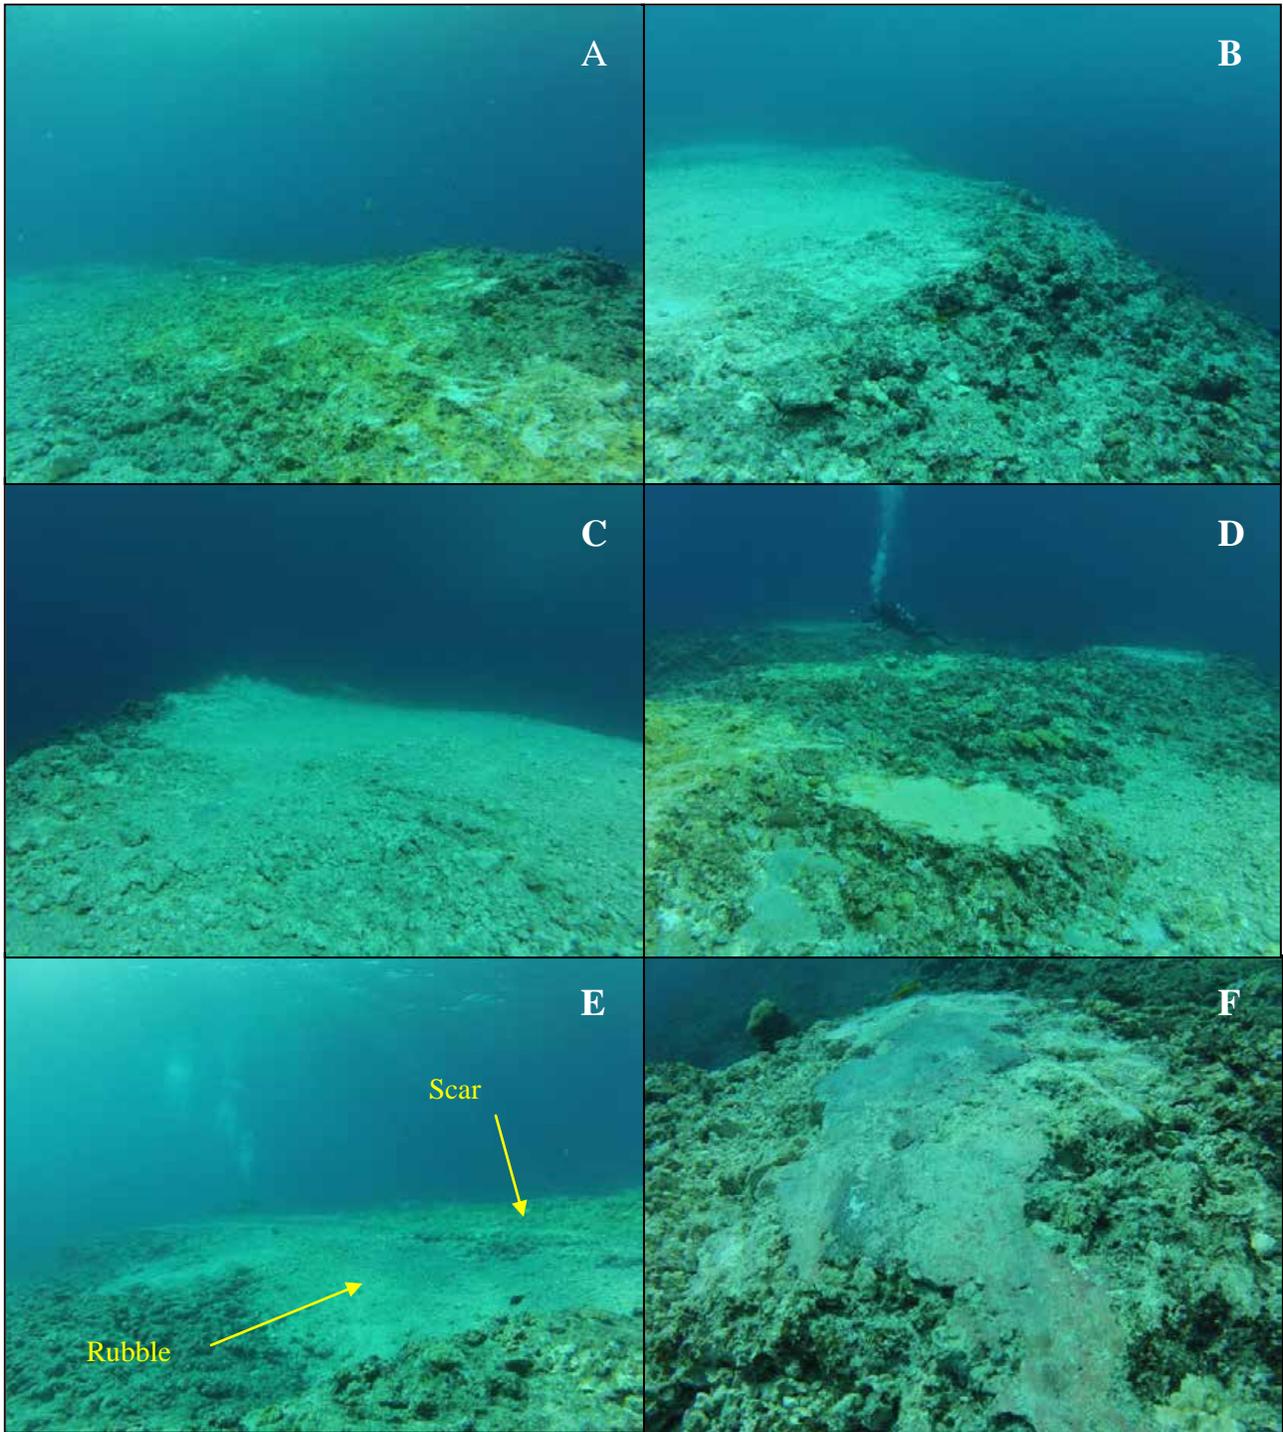
**Figure 7.** A, B and C) crushed and broken coral/limestone in main scar areas, D) patchy, partially scraped areas in between main scar areas, E) larger, defined rubble pile next to scar area, F) hull paint on reef.

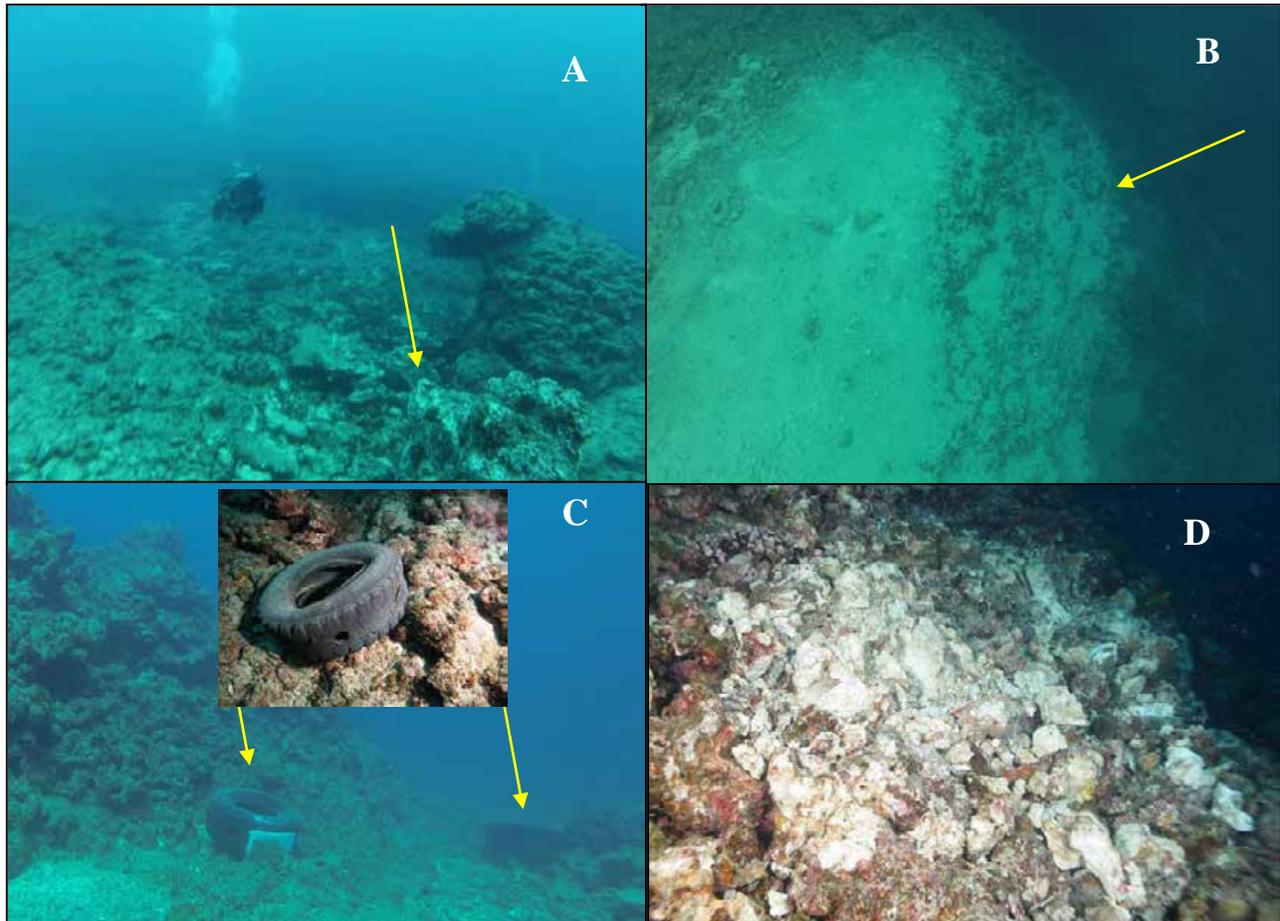
**Figure 8.** A) long, linear scrapes to the north of the grounding site, B) small, fine rubble pile covering slope off of a main scar area, C) tires on the reef, likely from a barge or tug, D) rubble pile likely originating from reef material lodged in the hull then subsequently deposited on the reef.
