# USS FRANK KNOX (DDR-742) STRANDING SALVAGE

NAVSHIPS 0994-002-6010

DEPARTMENT OF THE NAVY  
NAVAL SHIP SYSTEMS COMMAND  
WASHINGTON, D.C.

1968

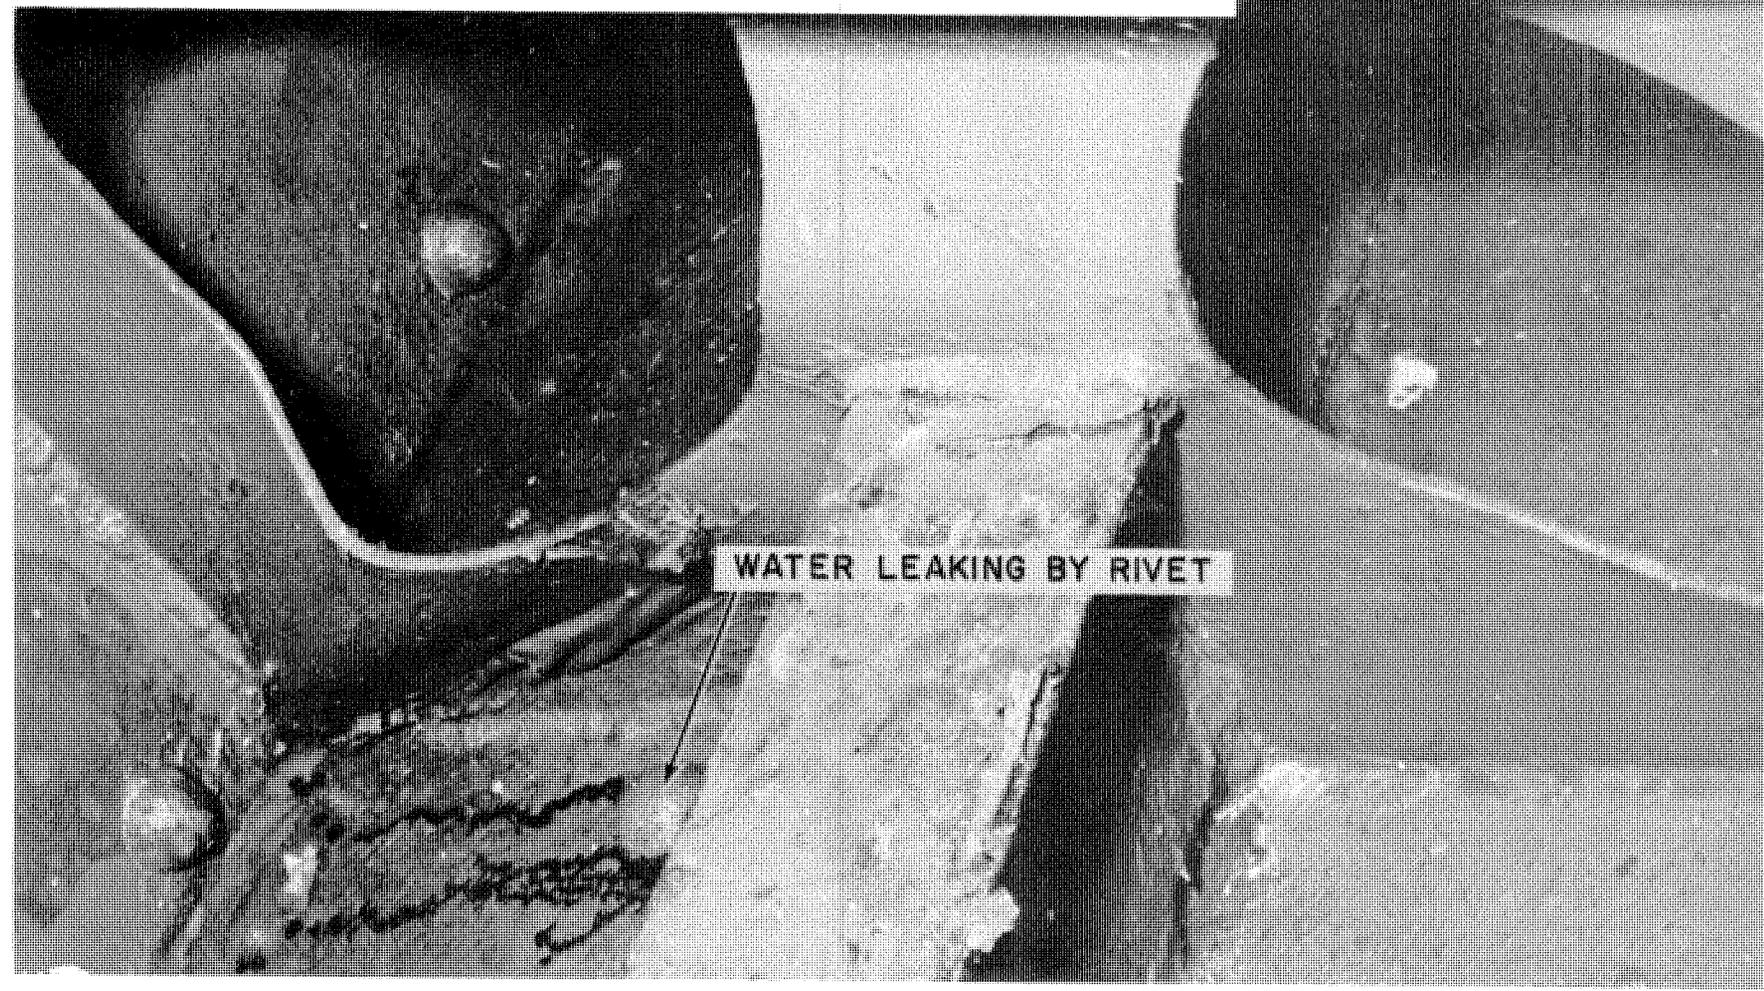
PHOTOGRAPH No. 3

BULKHEAD TRANSVERSE STIFFENER BELOW MAIN  
CONDENSER IN FORWARD ENGINE ROOM.  
NOTE LEAK BY RIVET.

During the day, winds had been from the west with much rain, and there was a 1-2 foot swell. Shortly after securing the pulling effort, the wind shifted to the southeast and began building rapidly as did the swells. By 1600, the winds, swell and surf, broad on the starboard side, caused the ship to roll and work heavily; heading began to shift to the right, that is, toward a broached position. Reballasting of the destroyer's forward tanks commenced immediately. GRAPPLE commenced heaving again to prevent broaching and FRANK KNOX backed on engines. It appeared that GRAPPLE's Eells anchor was no longer holding, so engines were used at full power with occasional heaving on beach gear. This effort managed to hold the ship's heading, but the destroyer continued to sustain a terrific beating. The bottom in the forward fireroom and forward engine room worked badly and smaller structural members began to take a permanent set; rivets began to leak. (See Photograph 3 page 10.)

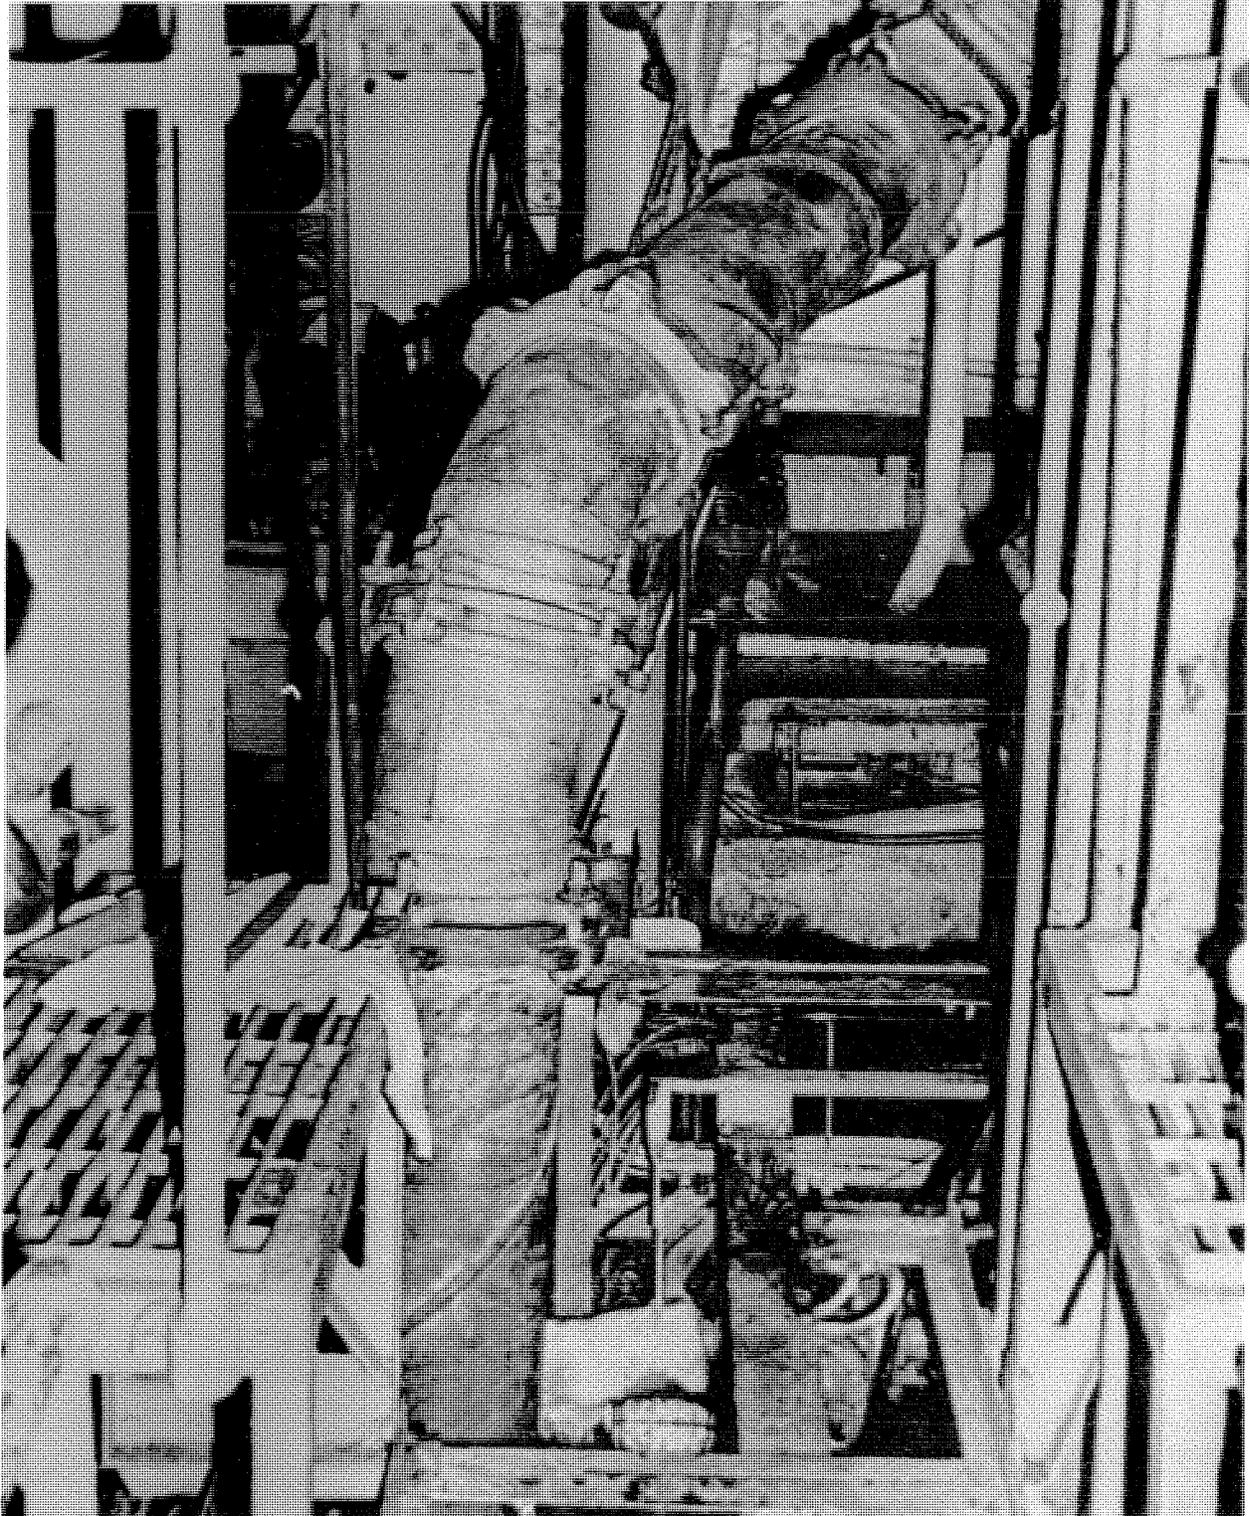
PHOTOGRAPH No. 4

SUCTION PIPING FOR 10 INCH  
PUMP IN FORWARD FIRE ROOM

Hopes for easily dewatering the forward engine room and fire-room ended on 22 July, when test pumping with the six-inch electric pumps revealed large leaks; the water level in each space could only be lowered about six inches. Plans were immediately made to use 10-inch gasoline driven salvage pumps in these spaces. The pumps weighed 2700 pounds and were, therefore, far beyond the capacity of IWO JIMA helicopters. Boating conditions were still impossible, so nothing could be immediately done about the large pumps. However, 10-inch foot valves and suction piping were transferred by helicopter, so that the time-consuming rigging of the pump suction did proceed with one suction being placed down the port side access to each forward space. (See Photograph 4, page 17.)

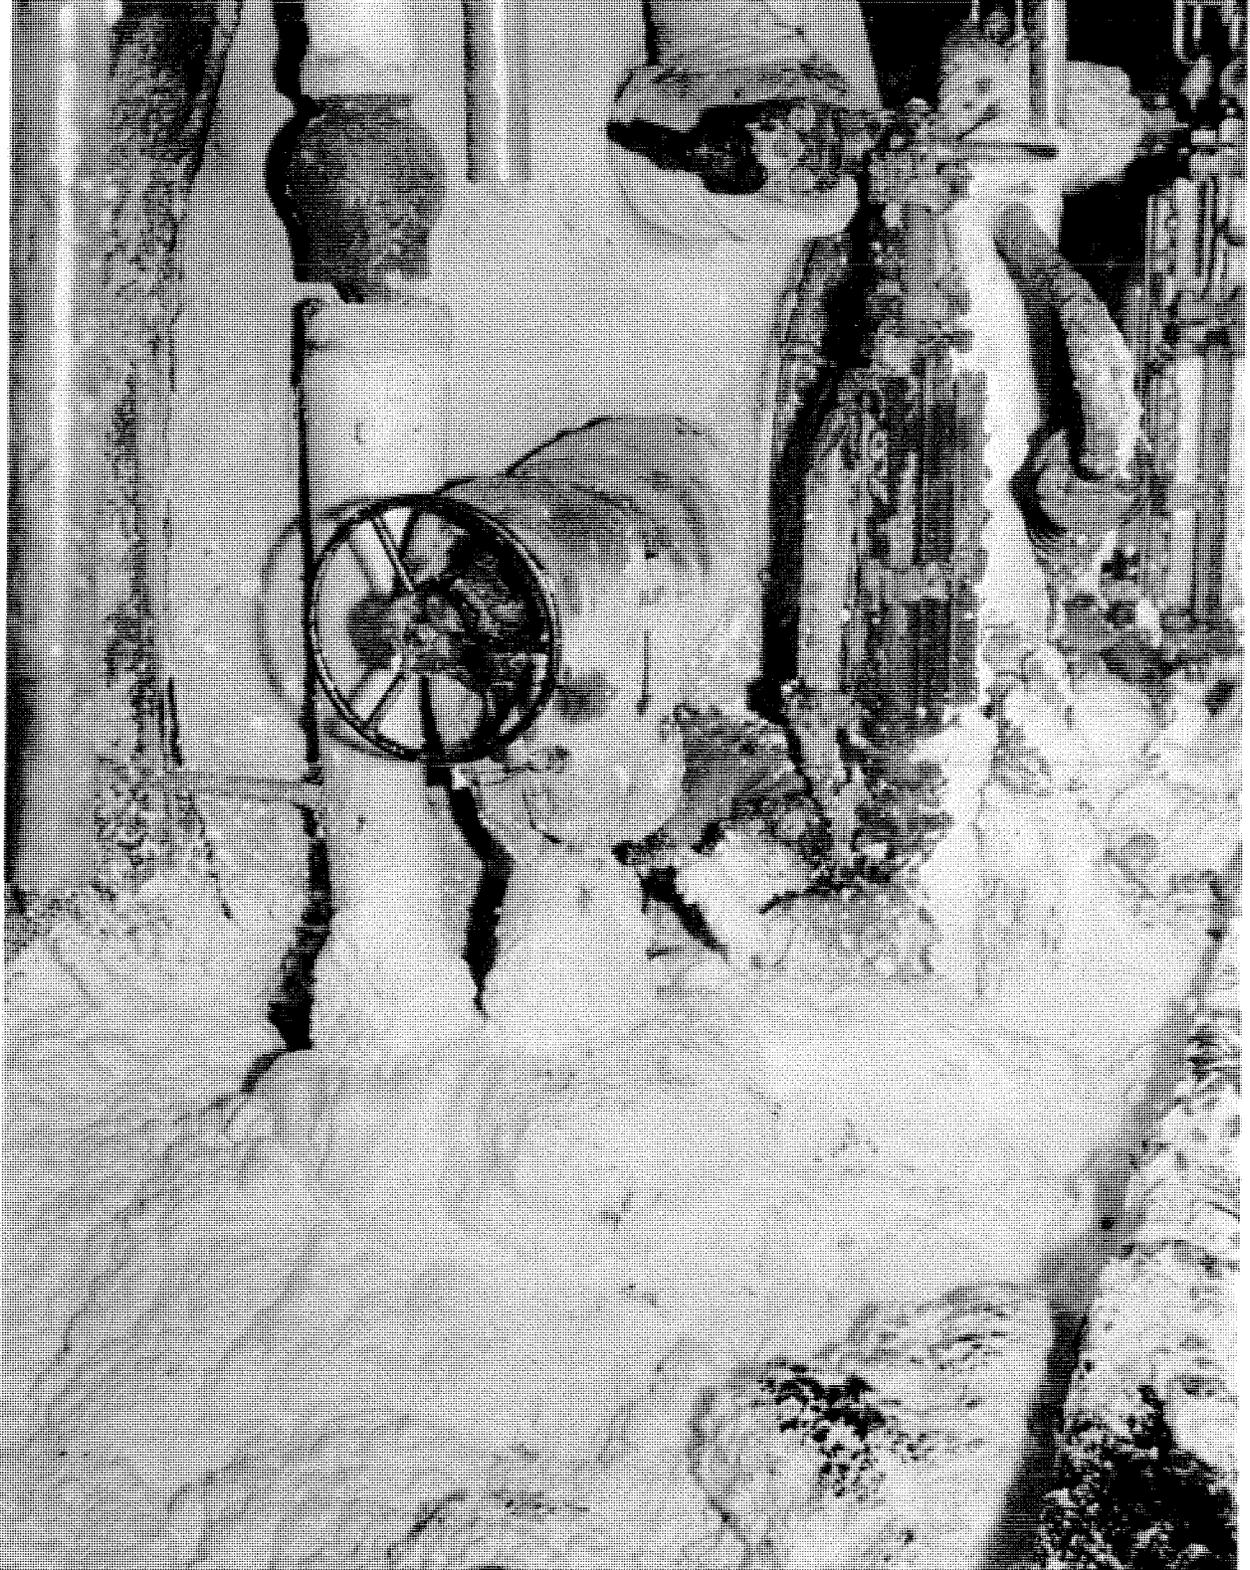
PHOTOGRAPH No. 9

HARDENED FOAM IN FWD FIREROOM

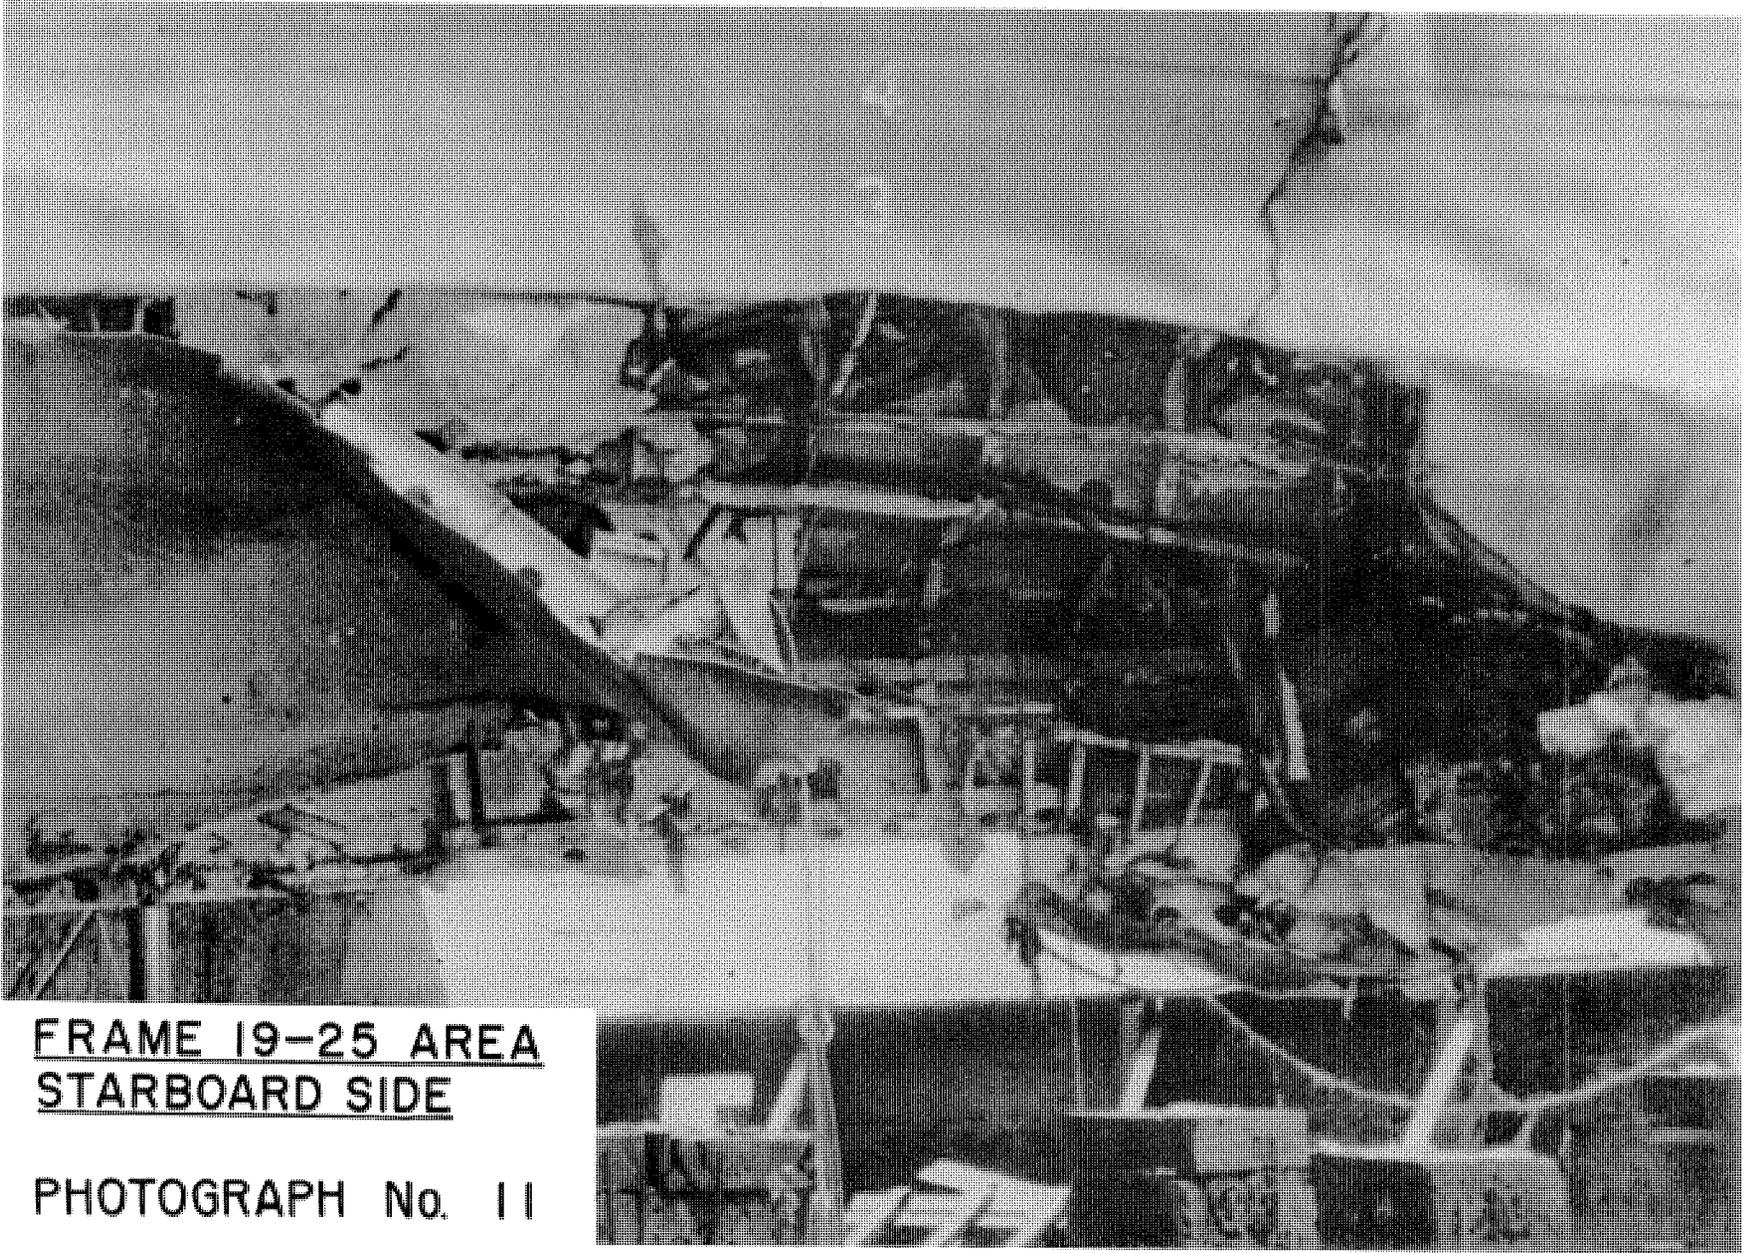
PHOTOGRAPH No. 11

FRAME 19-25 AREA  
STARBOARD SIDE

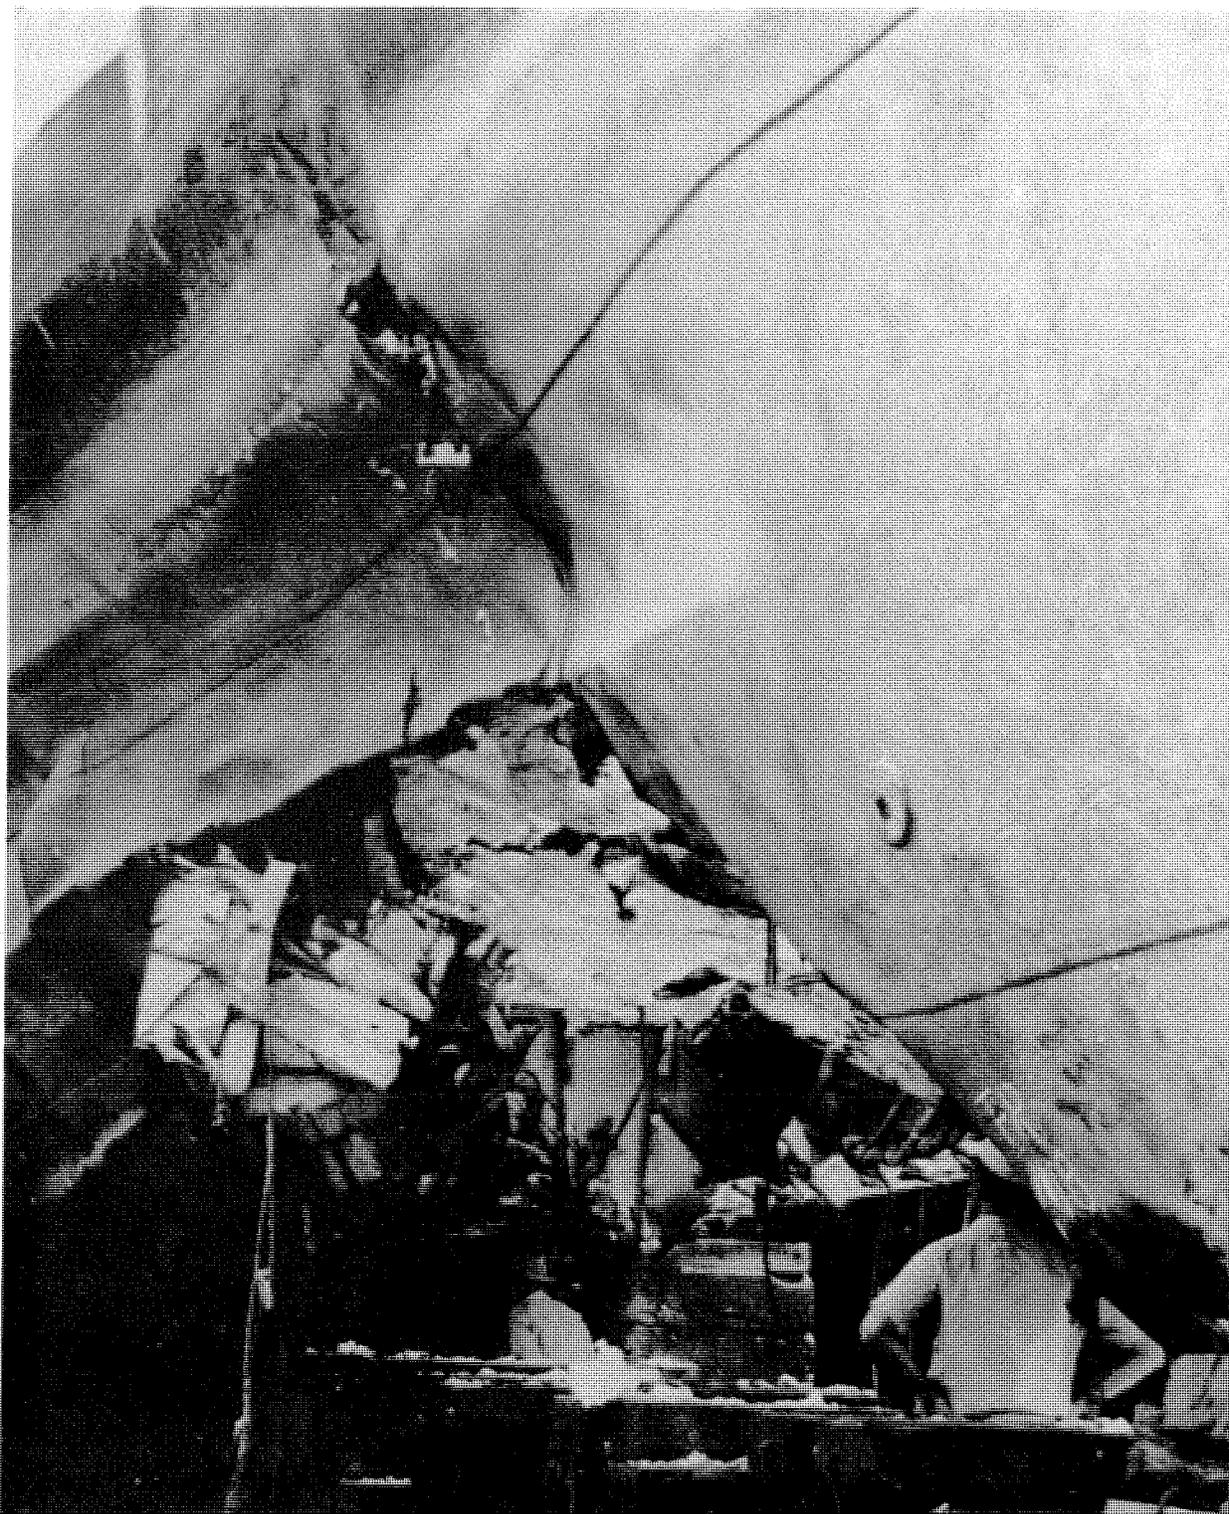
**PHOTOGRAPH No. 12**

**LOOKING AFT ON STARBOARD SIDE**  
**INTO A-503-A**

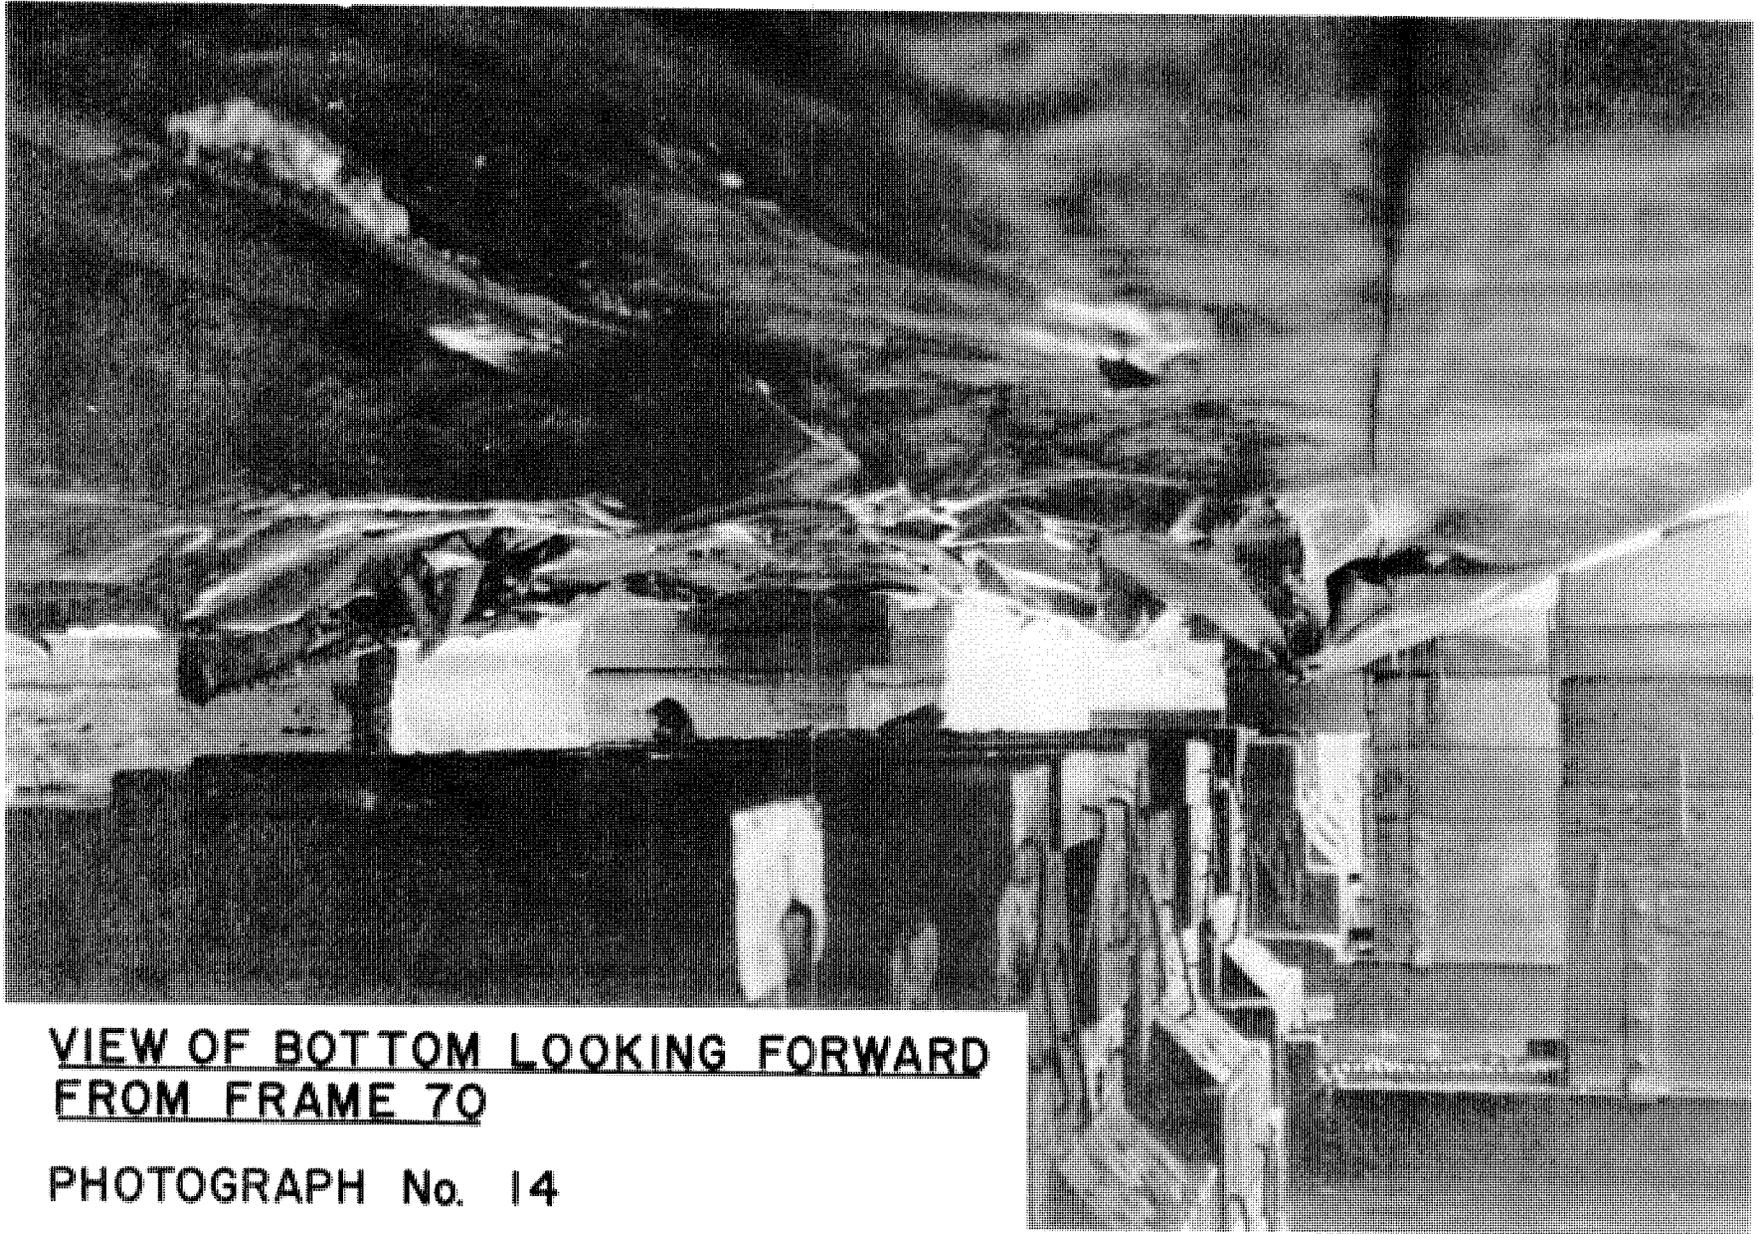
PHOTOGRAPH No. 14

VIEW OF BOTTOM LOOKING FORWARD  
FROM FRAME 70

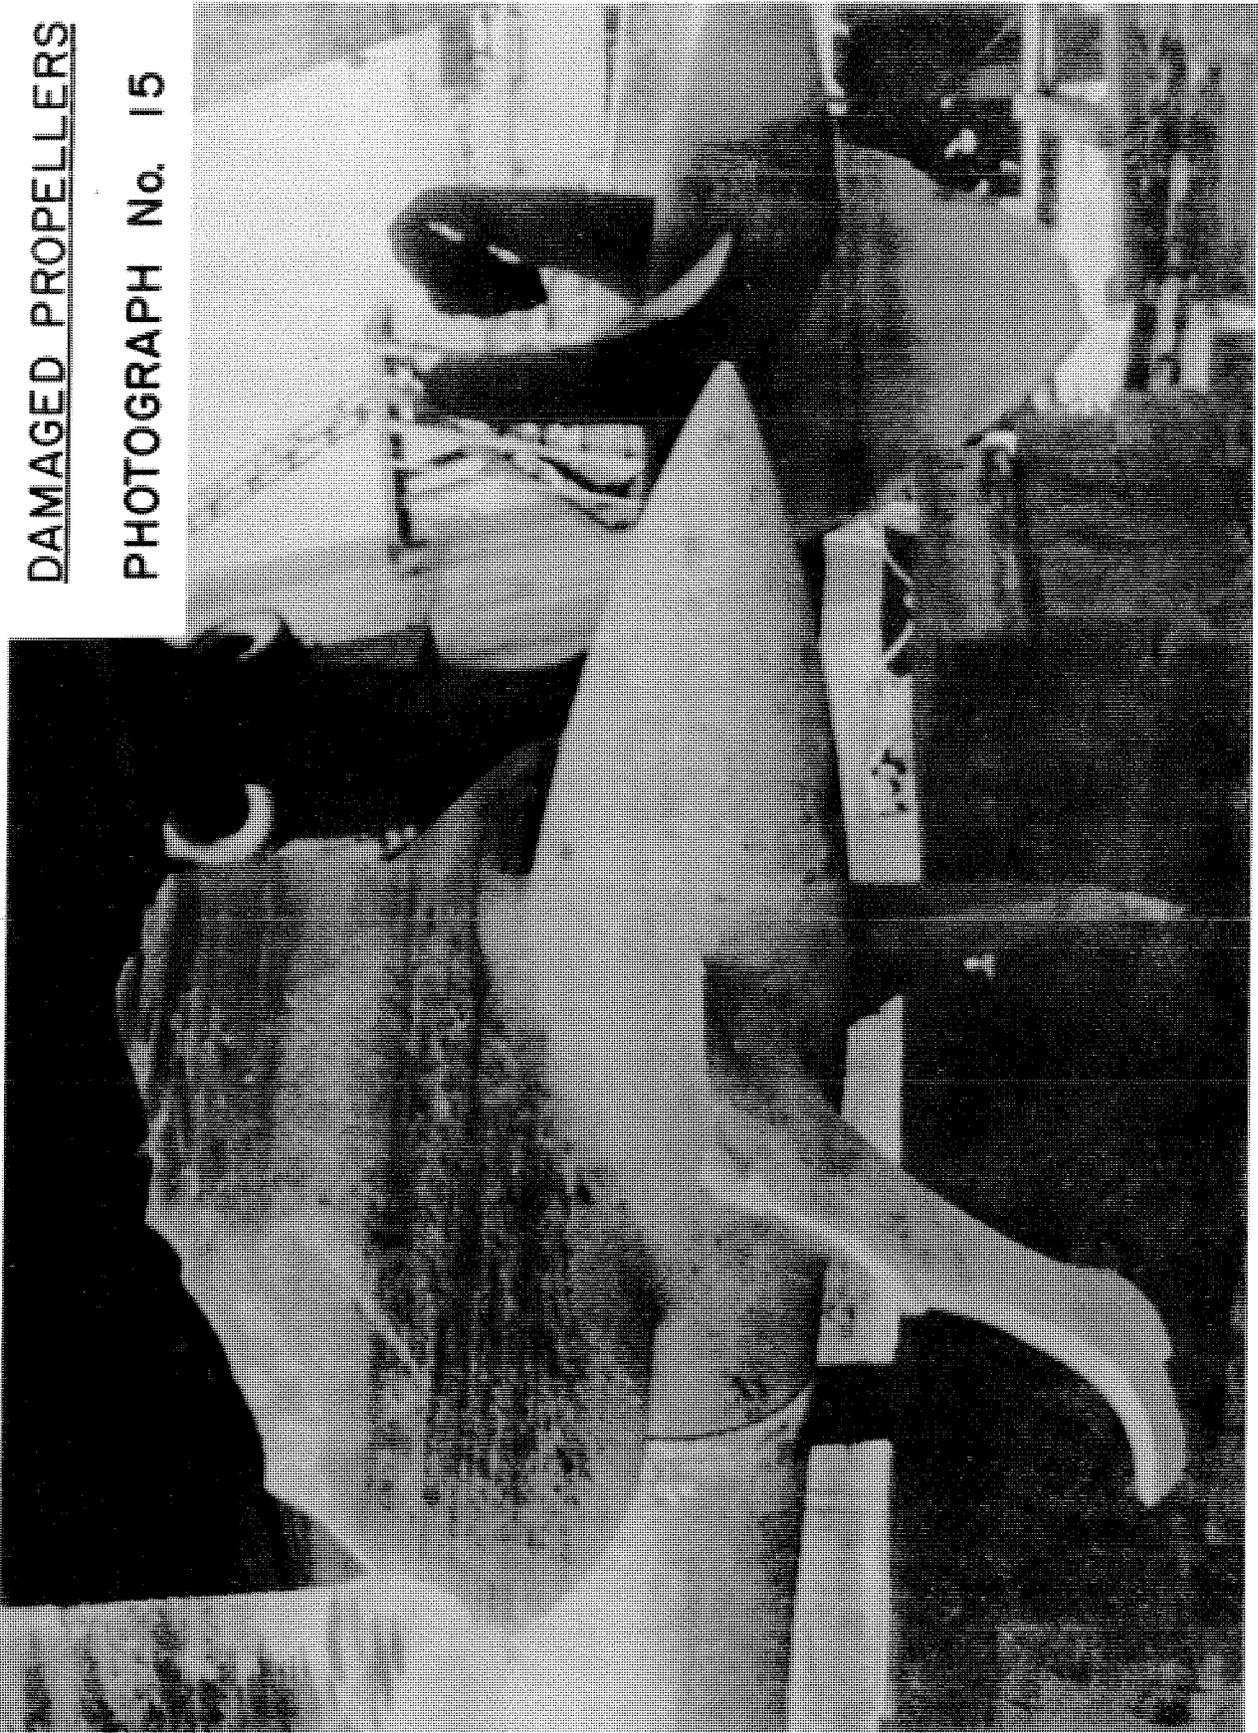
PHOTOGRAPH No. 15

FRANK KNOX's port engine was backed at maximum available RPM (112 was achieved since about two feet of each blade tip was missing). As usual, the beach gear anchor to FRANK KNOX's set held well until the 1 5/8-inch wire parted where it had chafed against a closed chock at the deck edge. Blowing of tanks was effective, but the pumps still made only 14 inches in the forward fireroom and seven inches in the forward engine room.

DAMAGED PROPELLERS

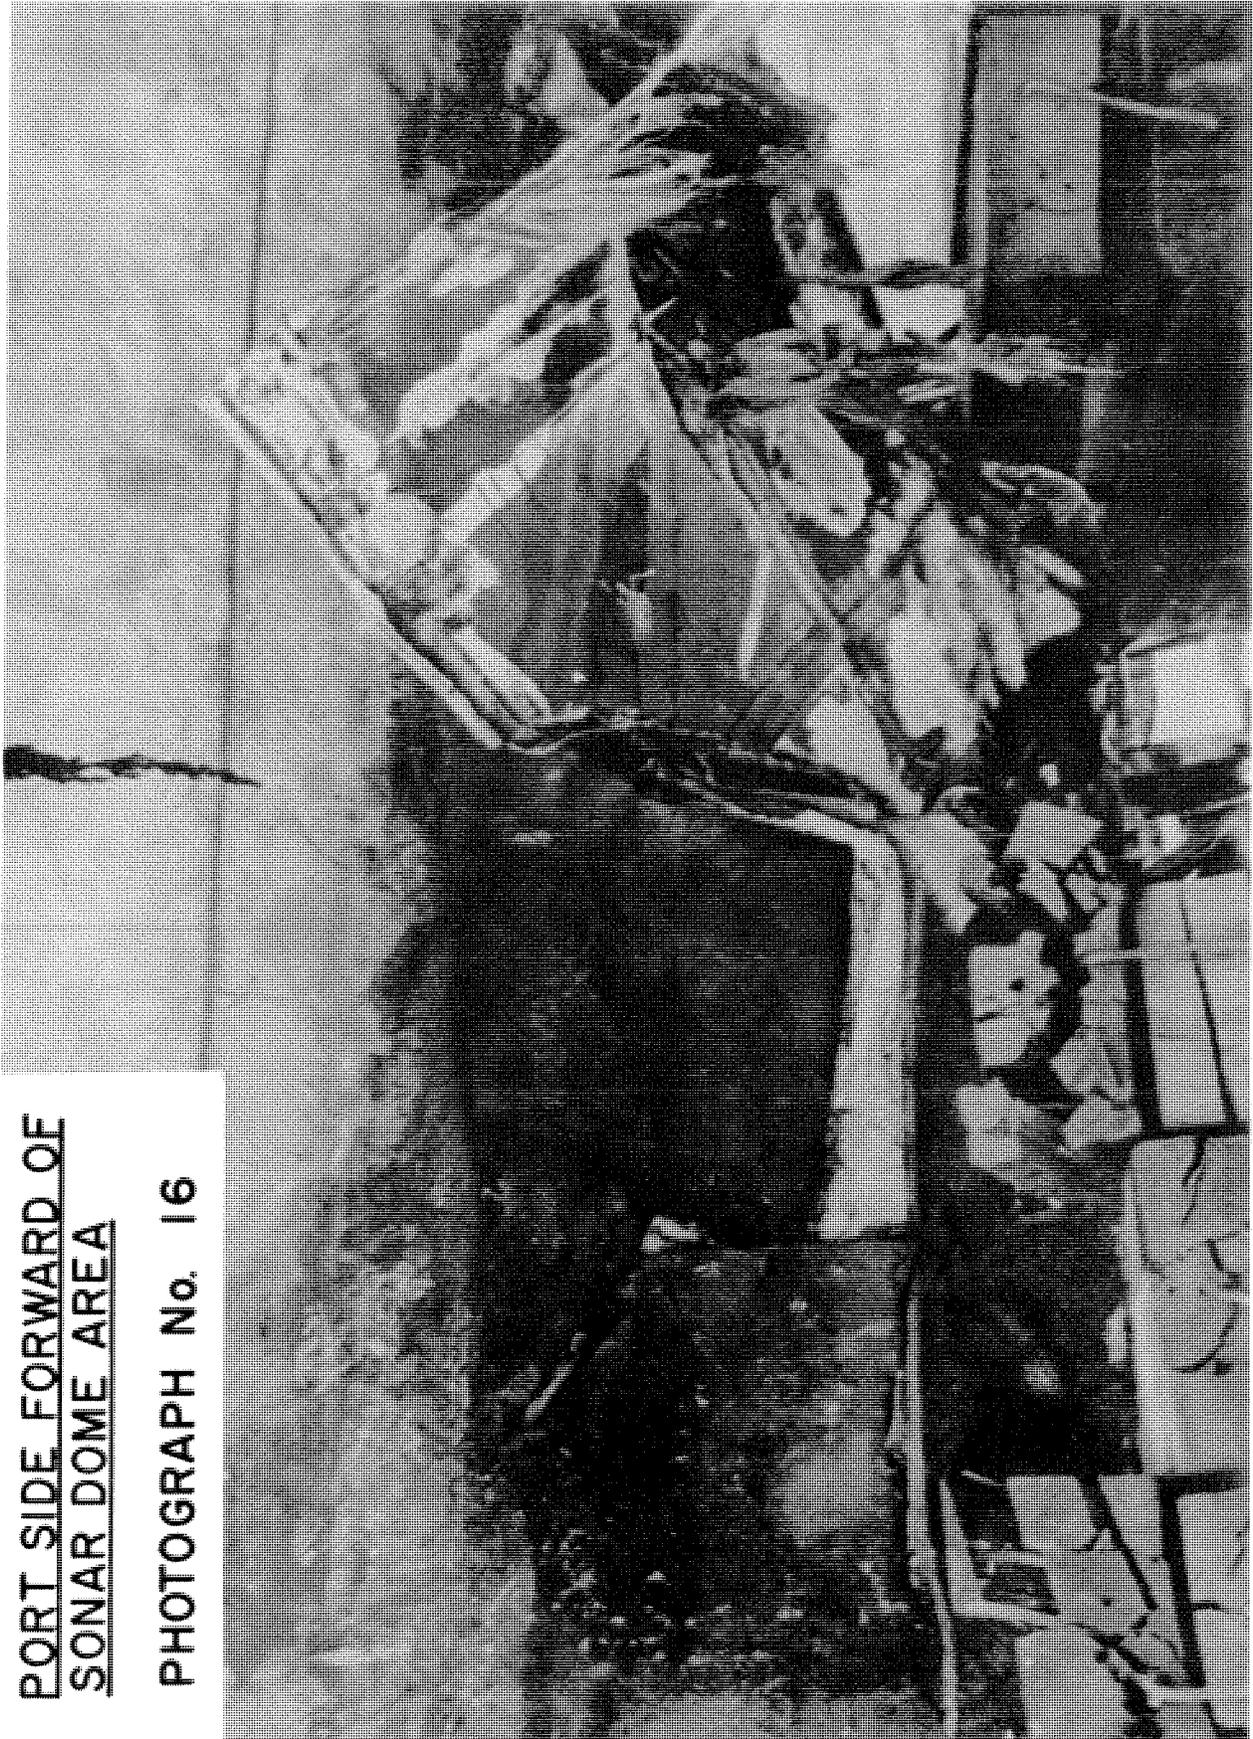
PHOTOGRAPH No. 16

PORT SIDE FORWARD OF  
SONAR DOME AREA

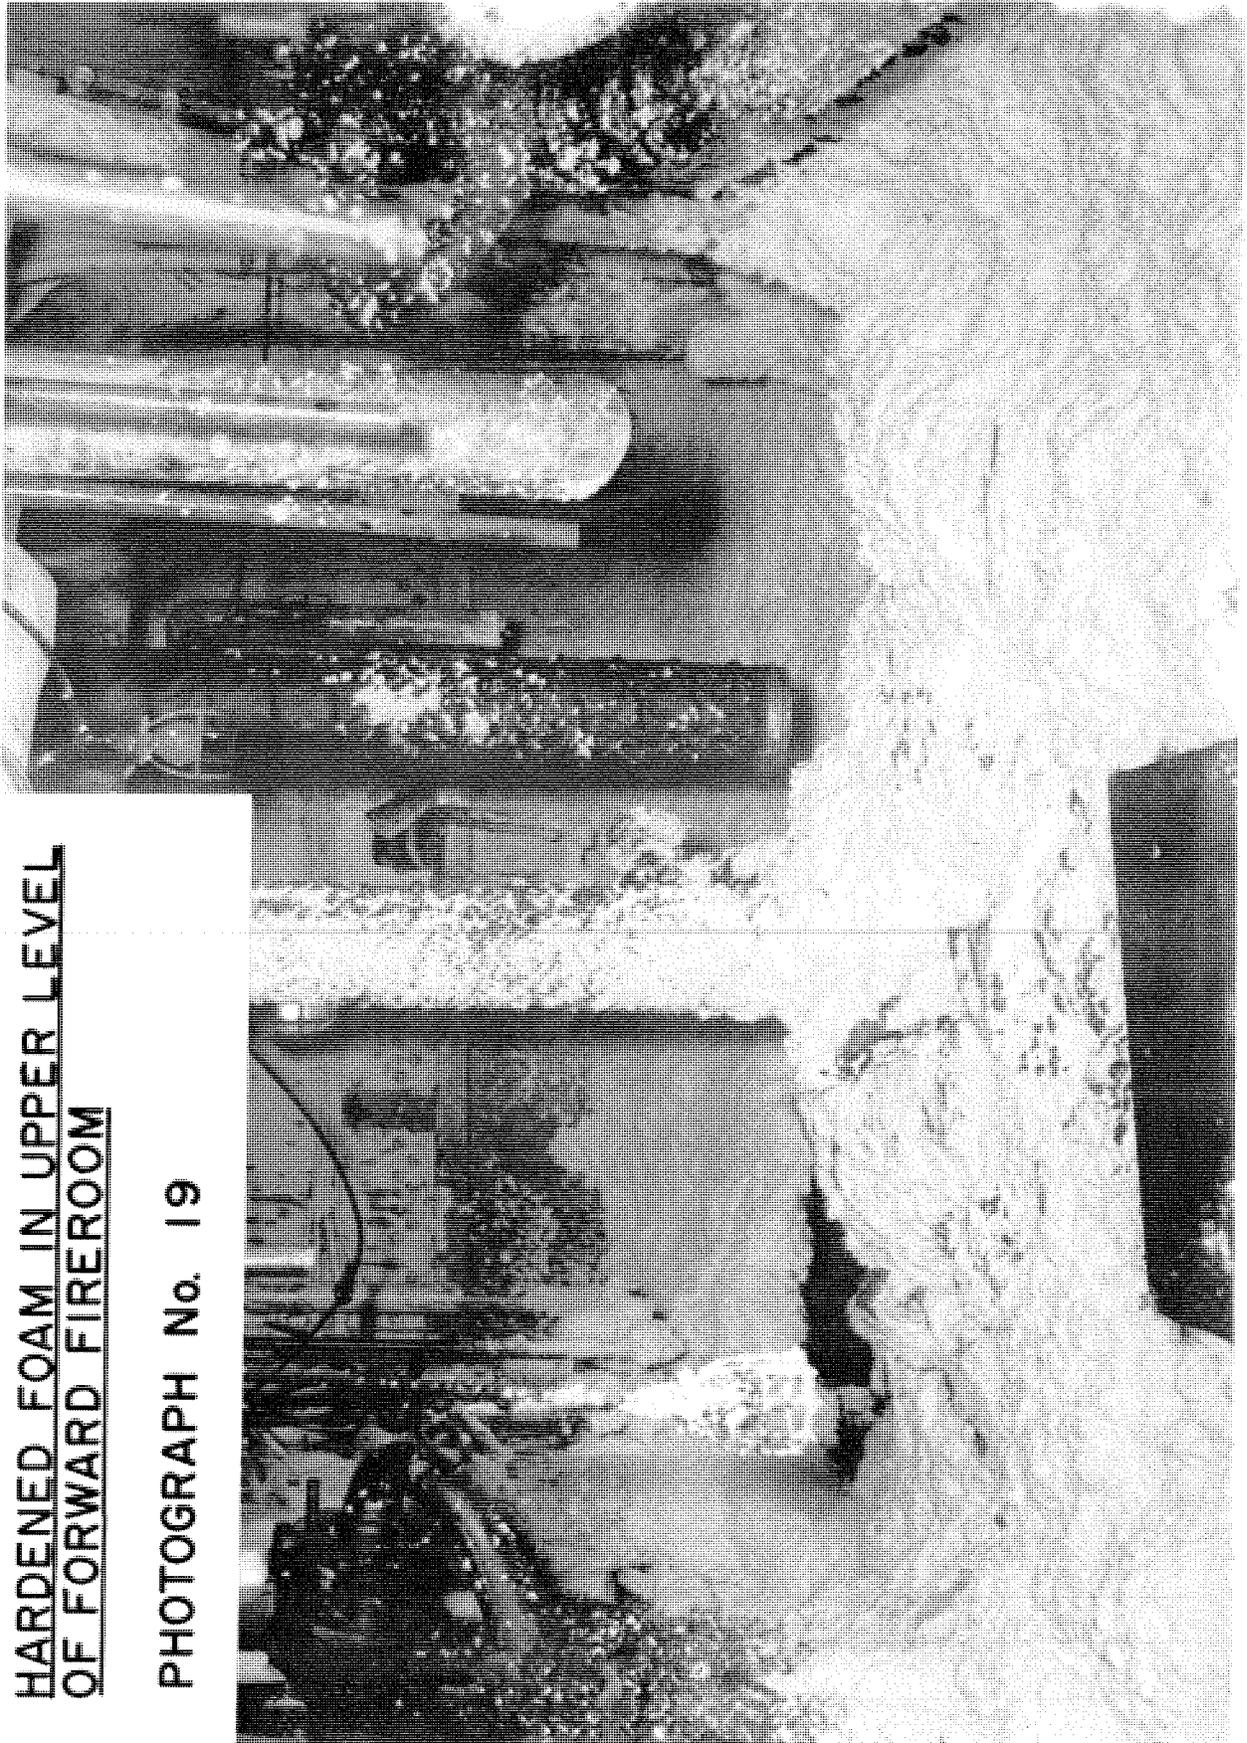
PHOTOGRAPH No. 19

HARDENED FOAM IN UPPER LEVEL  
OF FORWARD FIREROOM

Allowing for the weight of the foam, 641 tons of net buoyancy was obtained giving an overall efficiency of 51.5%. The efficiency goes up to 53.5% if the weight of foam (approximately 26 tons) unavoidably expended in air spaces is deducted. These spaces were the above-water portions of the forward engine room and fireroom and A-303-L. (See Photograph 19, page 74.)
