FACEPLATE

The Official Magazine for the Divers and Salvors of the United States Navy

Fall 1983
Volume 14, No. 3

34-Ton Propeller Changed on USS ENTERPRISE

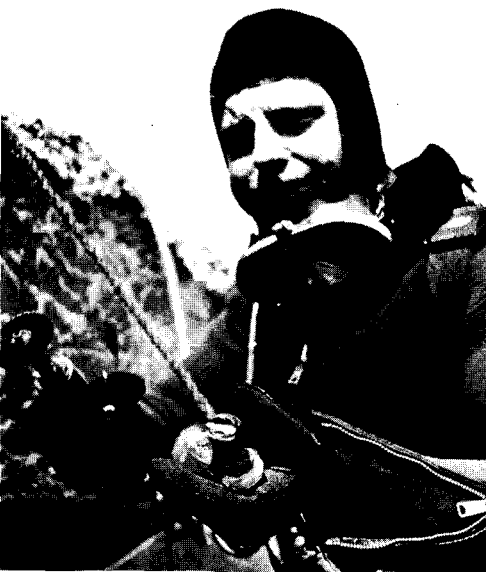
Diver shows three of the steel studs that were ground off the face of the harbor's main pier.

MDSU divers also located and removed steel studs—metal rods from 1 to 1-1/2 inches thick—which protruded dangerously from the face of the south quaywall and main pier. Damage caused by these pins to the hulls of the Mike boats had originally called attention to the hazards in the NTC harbor.

The studs were left over from portions of the pier which had been installed years earlier. As boats rubbed against wooden portions of the pier they gradually wore it down, leaving the steel pins protruding beyond the pier walls. While the spuds posed little problem to the small sport boats in the harbor, they could seriously damage the deep, straight-sided Mike boat hulls, which came into more direct contact with the pier.

During the final five days of the project, as many as four divers at a time worked underwater to remove the steel spuds. Using SCUBA gear and welding pneumatic three-inch grinding wheels, divers cut and removed the steel rods. Each diver held the wheel of the air-driven grinder, spinning at 20,000 rpm, against the stud where it entered the quaywall. After approximately half an hour of grinding, the stud was sufficiently cut through to allow the diver to place a steel pipe over the stud and wrench it off manually. The studs were made of dense, hardened steel and as such were difficult to sever. Some divers used gravity to help them pry off the studs, by standing up on the pipe and bouncing up and down on it until the stud was broken off. By the end of the project, 51 studs had been removed.

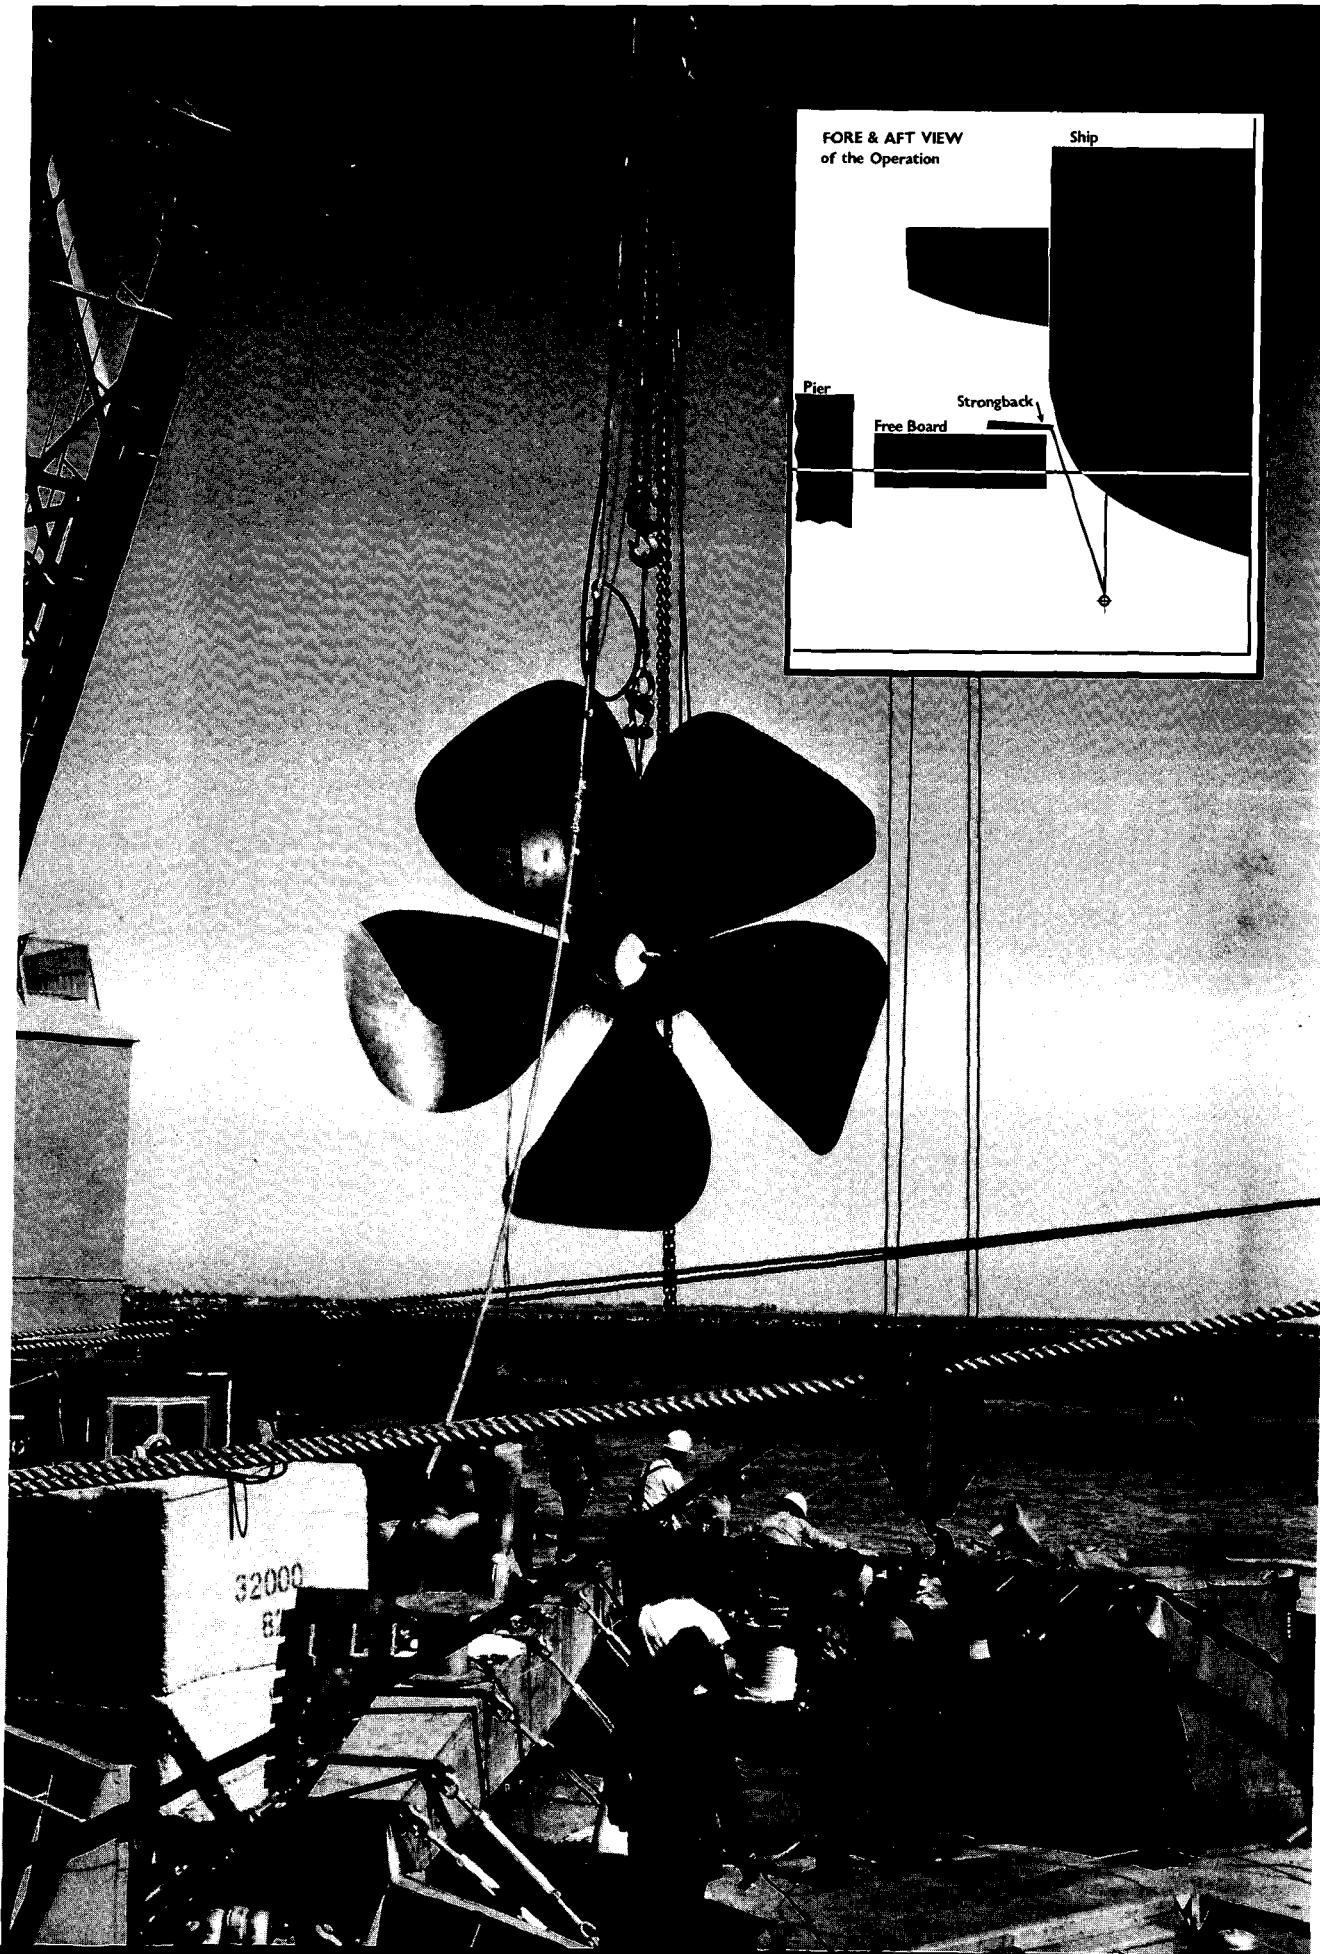
◀ The damaged propeller is lifted out of the water.

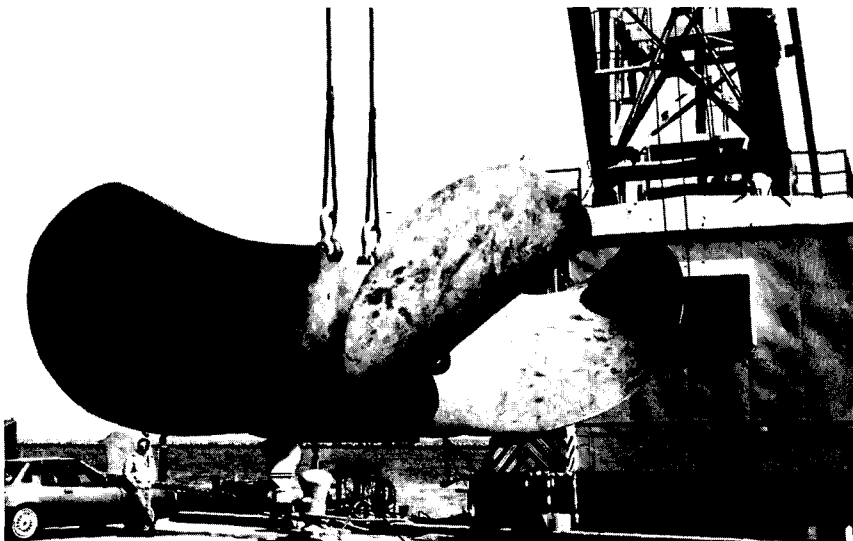
Divers lay the damaged propeller on the pier.

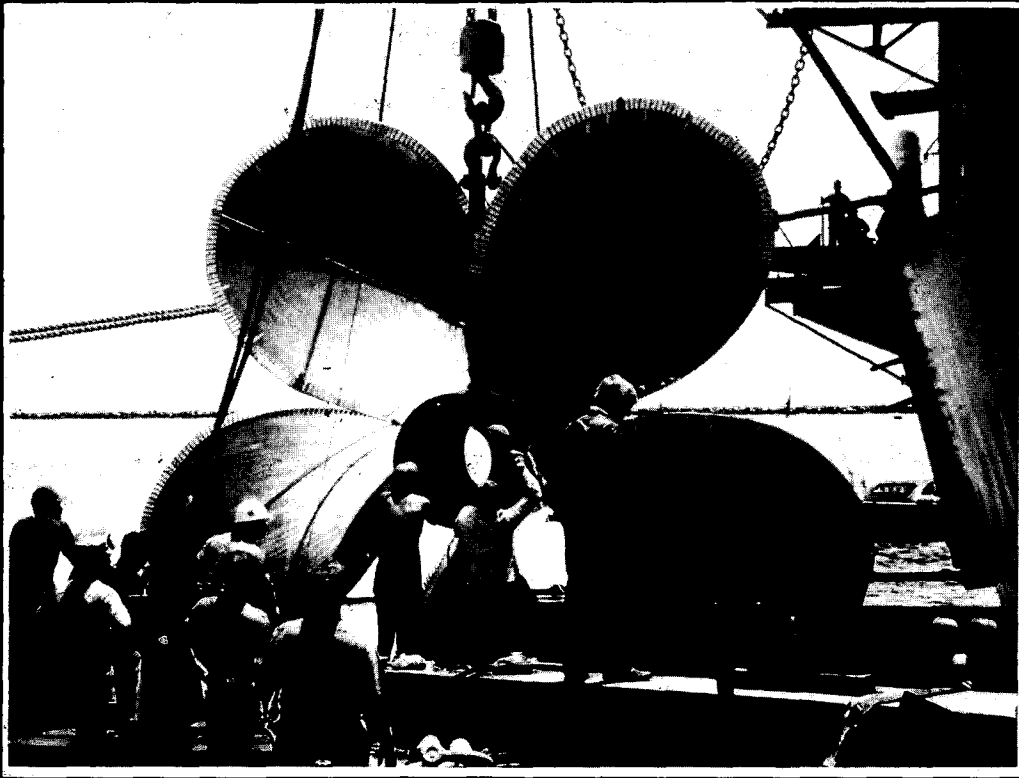
The ENTERPRISE's new propeller is positioned for installation.

The installation of the new propeller was relatively straightforward. After arrival and visual inspection, the 34-ton, 21-foot replacement propeller was lifted from the flatbed truck and placed on the pier, using the 100-ton floating crane. A lifting eye had been installed in the propeller hub. This would allow the dive team to rotate the propeller 90° on its axis before lowering it into the water alongside the barge. (This was accomplished by utilizing the 50-ton chain hoist.)
