SUPSALV Performs Strut Bearing Replacement on USS EISENHOWER (CVN 69) in Norfolk, VA.

1 March 2011

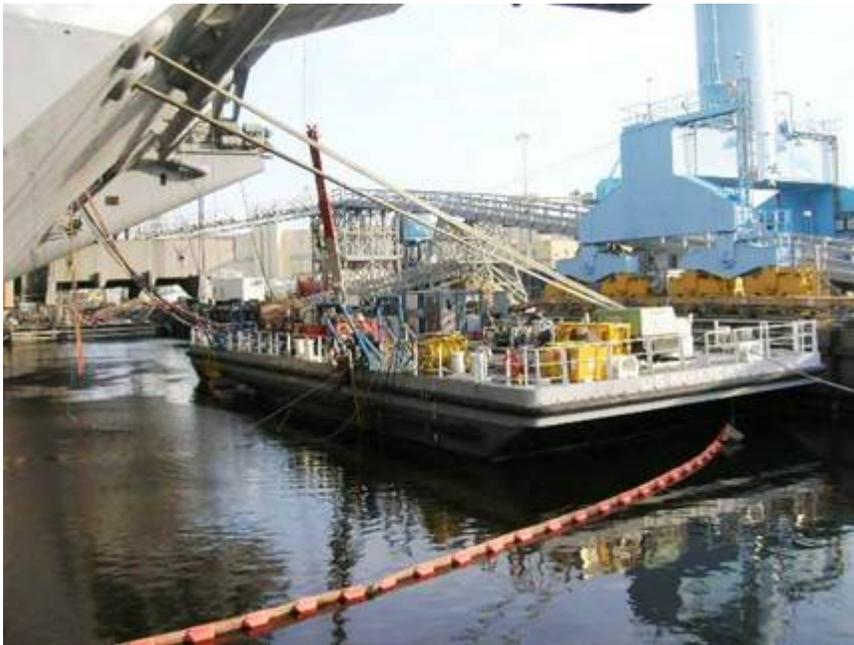
The first task was to rig work barges port and starboard off the stern of IKE to support the divers and rigging the heavy equipment and bearings from under the ship to the pier. Shown here is the starboard barge, used for rigging only. The port barge was set up the same for rigging but is also where the dive station was set up.

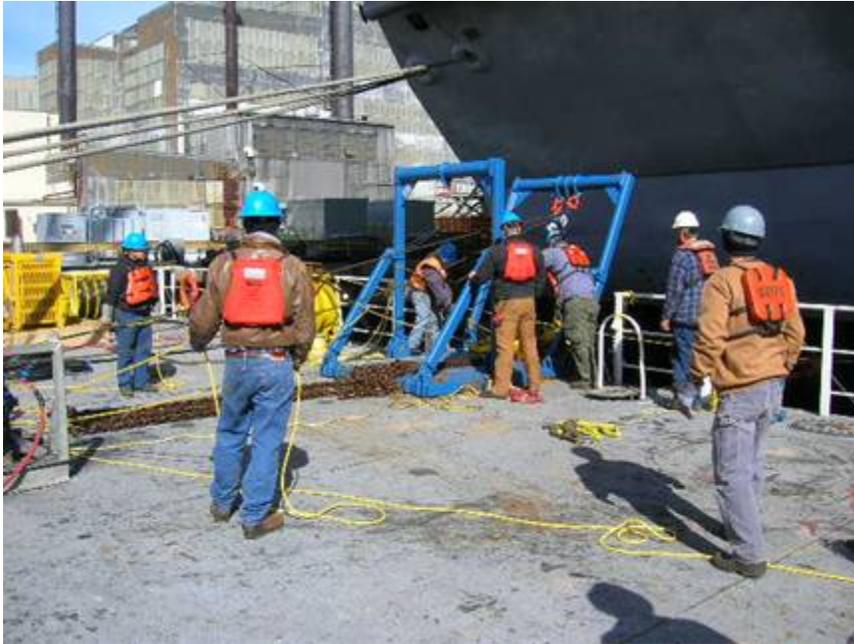
Tuggers were installed to aid the divers in handling heavy equipment in the water and under the ship. For example, 50-ton hydraulic chain hoists (weighing about 3,000 lbs) had to be rigged under the vessel for lifting the shaft and propeller (weighing about 100,000 lbs) enough to remove the lower half of each of the bearings.

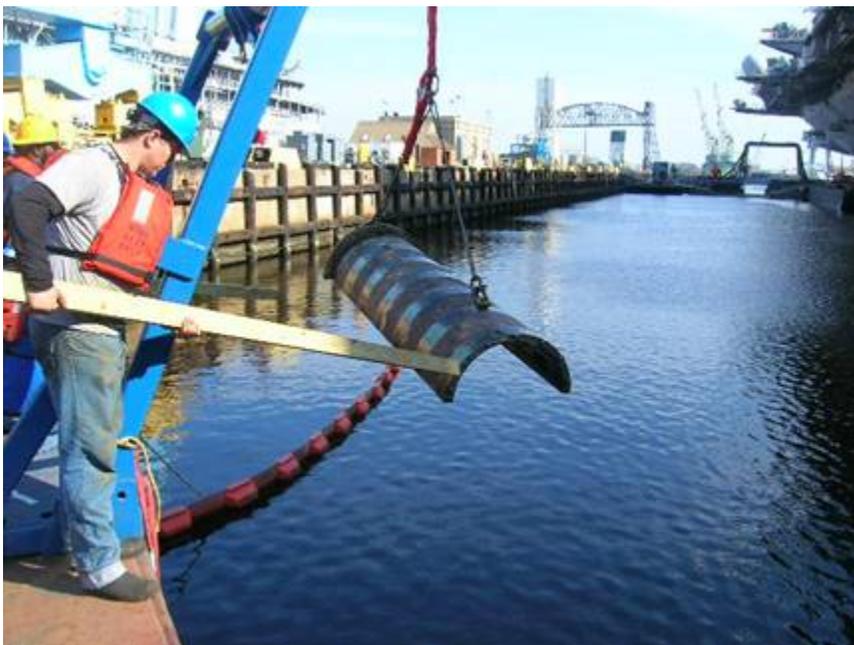
In this image, riggers can be seen guiding the newly re-staved bottom bearing half back over the barge to be hung from the A-frame and then installed on shaft number 4 (blue structure seen to the left of the bearing).

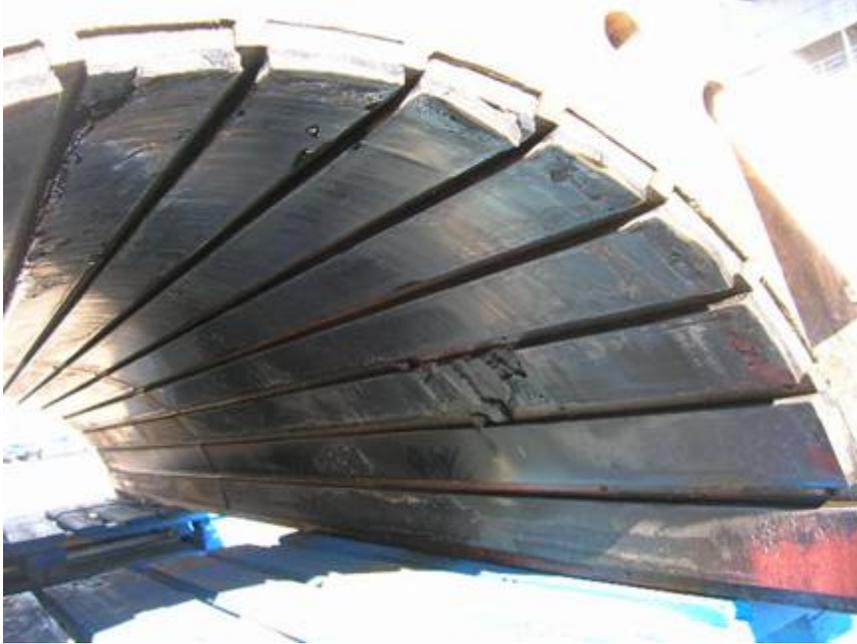
This image shows damage to the lower half of IKE's number 3 shaft bearing. After rigging the damaged bearing ashore, a Norfolk Naval Shipyard machine shop will remove all the old staves and re-install new ones. SUPSALV will then rig them back under the ship for installation. It is anticipated the entire task will take between 4 and 5 weeks to accomplish.
