A. MACKENZIE SALVAGE OPERATION

SUPERVISOR OF SALVAGE
NAVAL SEA SYSTEMS COMMAND

On 24 April 1974, the Hopper Dredge A. MACKENZIE was involved in a three ship collision while dredging in the Galveston Inner Bar Channel. Shortly thereafter, the stricken dredge sank in a position which restricted passage through the waterway.

DREDGE " A. MACKENZIE " SALVAGE OPERATIONS

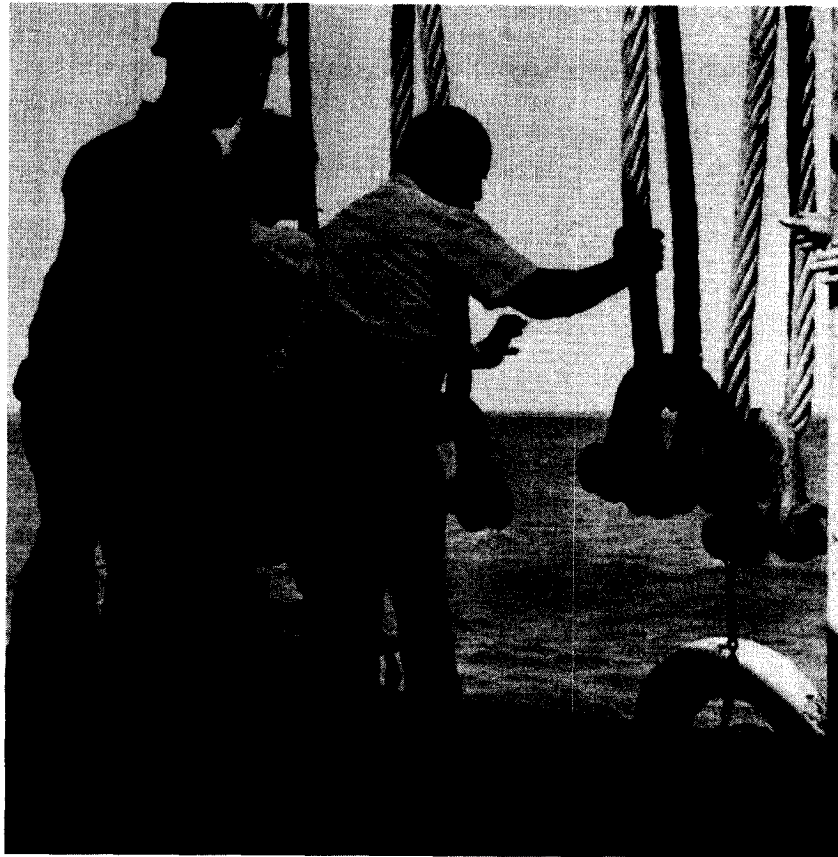
CHECKING THE TELEDYNE 2½" SLINGS AND SHACKLES
FOR THE FIRST HOOK UP IN PHASE I ON THE BOW
24 JUNE 1974

THE INITIAL LIFT ESTIMATE OF 194 SHORT TONS WAS EXCEEDED ON ACTUAL HOOK WEIGHTS BY OVER 332 TONS ON INITIAL HOIST ATTEMPTS. AS A CONSEQUENCE, THE BOW SECTION WAS RERIGGED PRIOR TO FINAL LIFT ON 25 JUNE. THE FINAL WEIGHT LOADED ON THE SCRAP BARGE WAS 332 TONS AFTER AN ESTIMATED 60 TO 70 TONS OF MATERIAL AND SILT HAD BEEN TAKEN OFF THE WRECK.

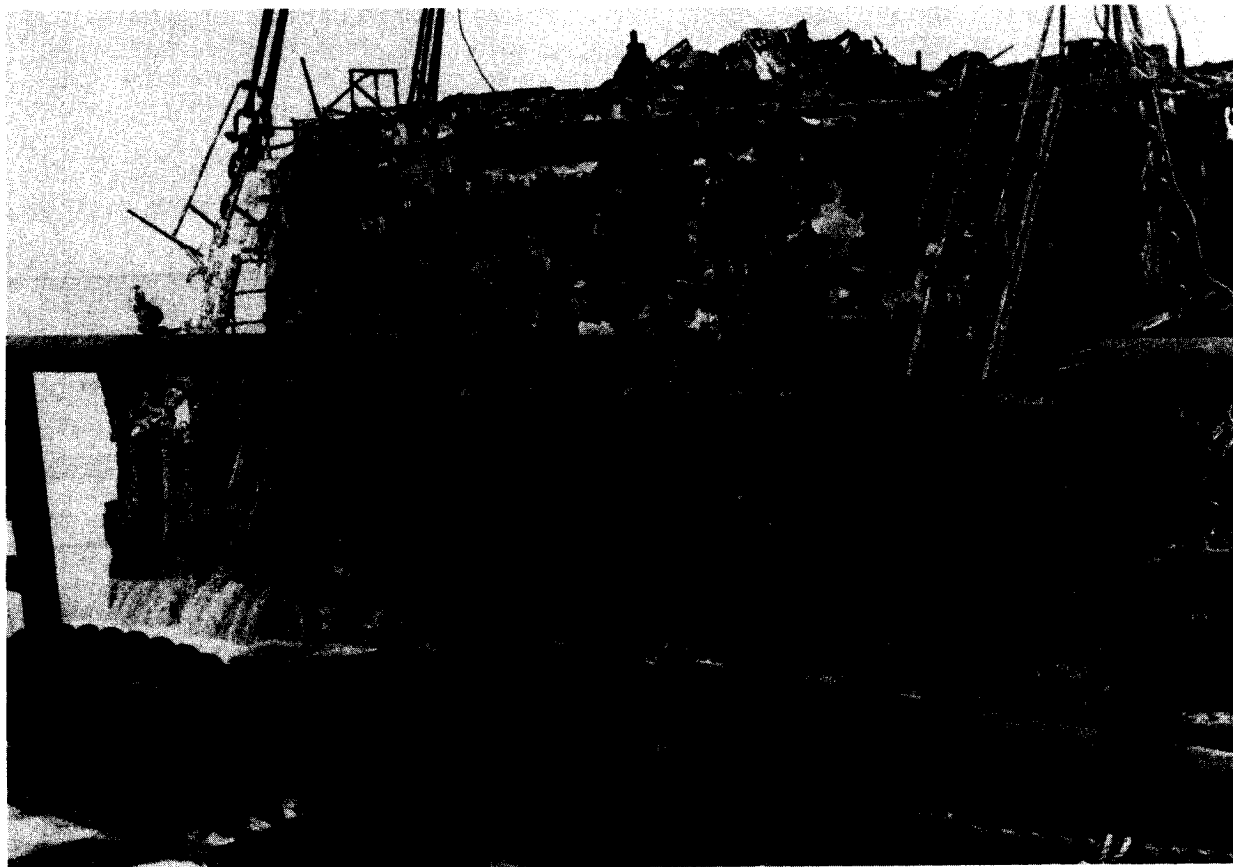
UPPER "G" COMING THROUGH THE INTERFACE
22 JULY 1974

UPPER "G" WEIGHED LIGHT AT 105 TONS. THE TOTAL TIME FROM DIVERS IN THE WATER UNTIL THE LIFT SLACKED ON THE FORWARD END OF THE SCRAP BARGE WAS 106 MINUTES.

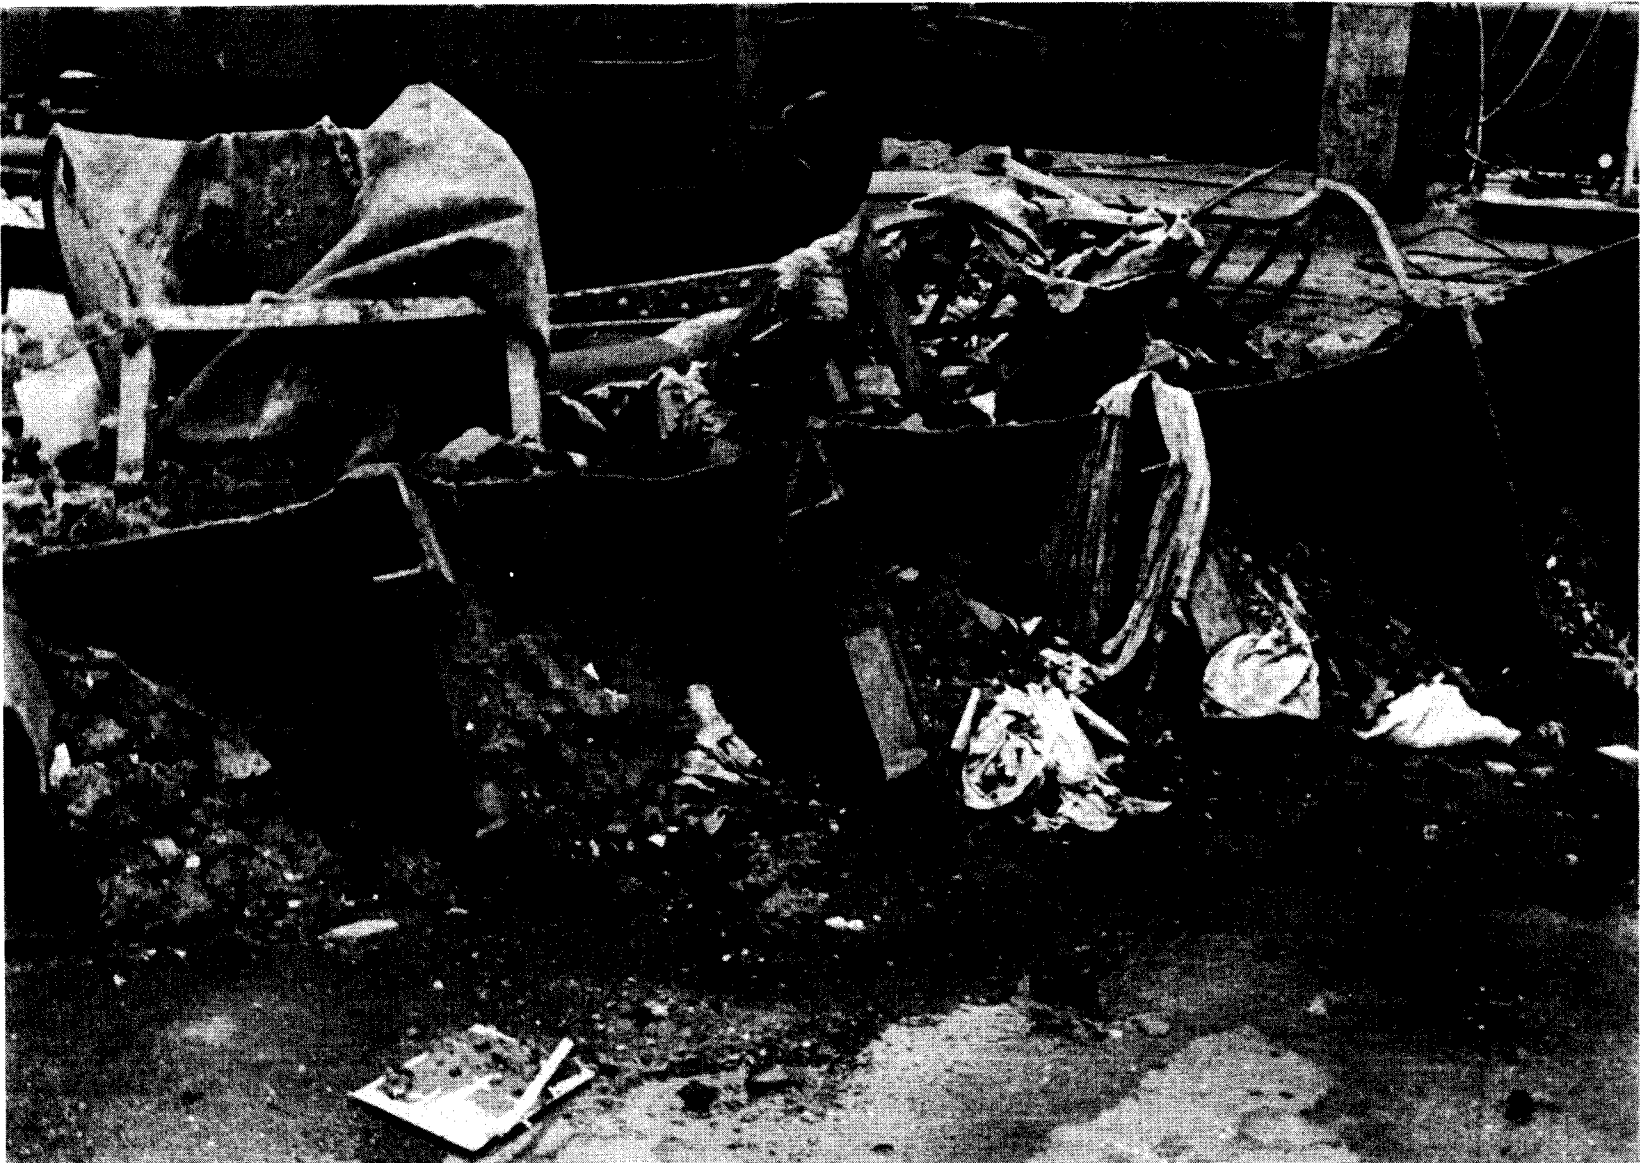
SILT TRAPPED IN BOW SECTION UNCOVERED DURING SCRAPPING OPERATIONS

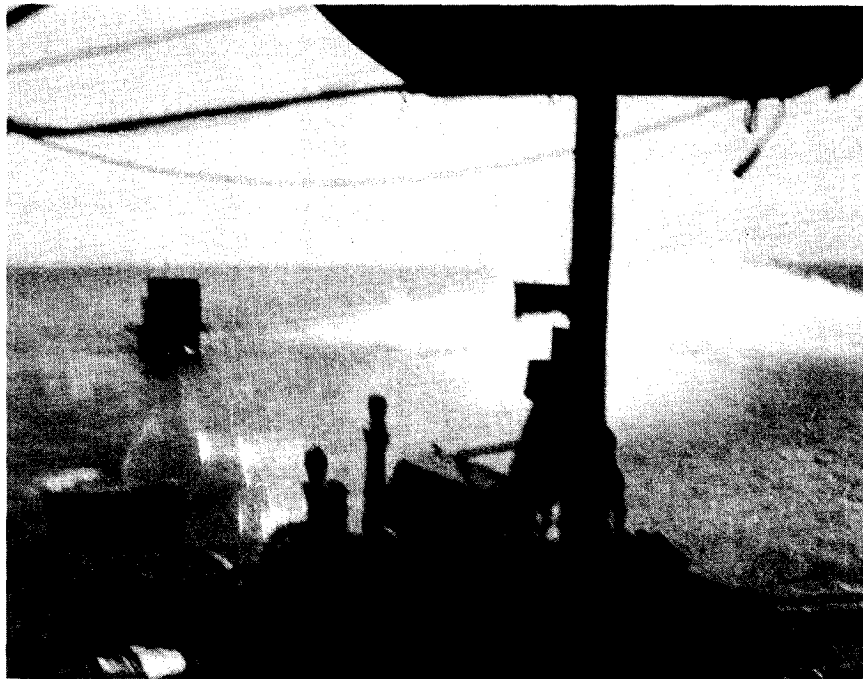
SHOCK WAVE PLUME - 155 LBS. OF C-4 IN
DISTRIBUTED CHARGES ON 31 JULY 1974
