# **EX-USS BLUEGILL (SS-242)**

## **SALVAGE OPERATIONS**

### **SUPSALV REPORT 84-06**

EX-USS BLUEGILL (SS-242)  
SALVAGE OPERATIONS

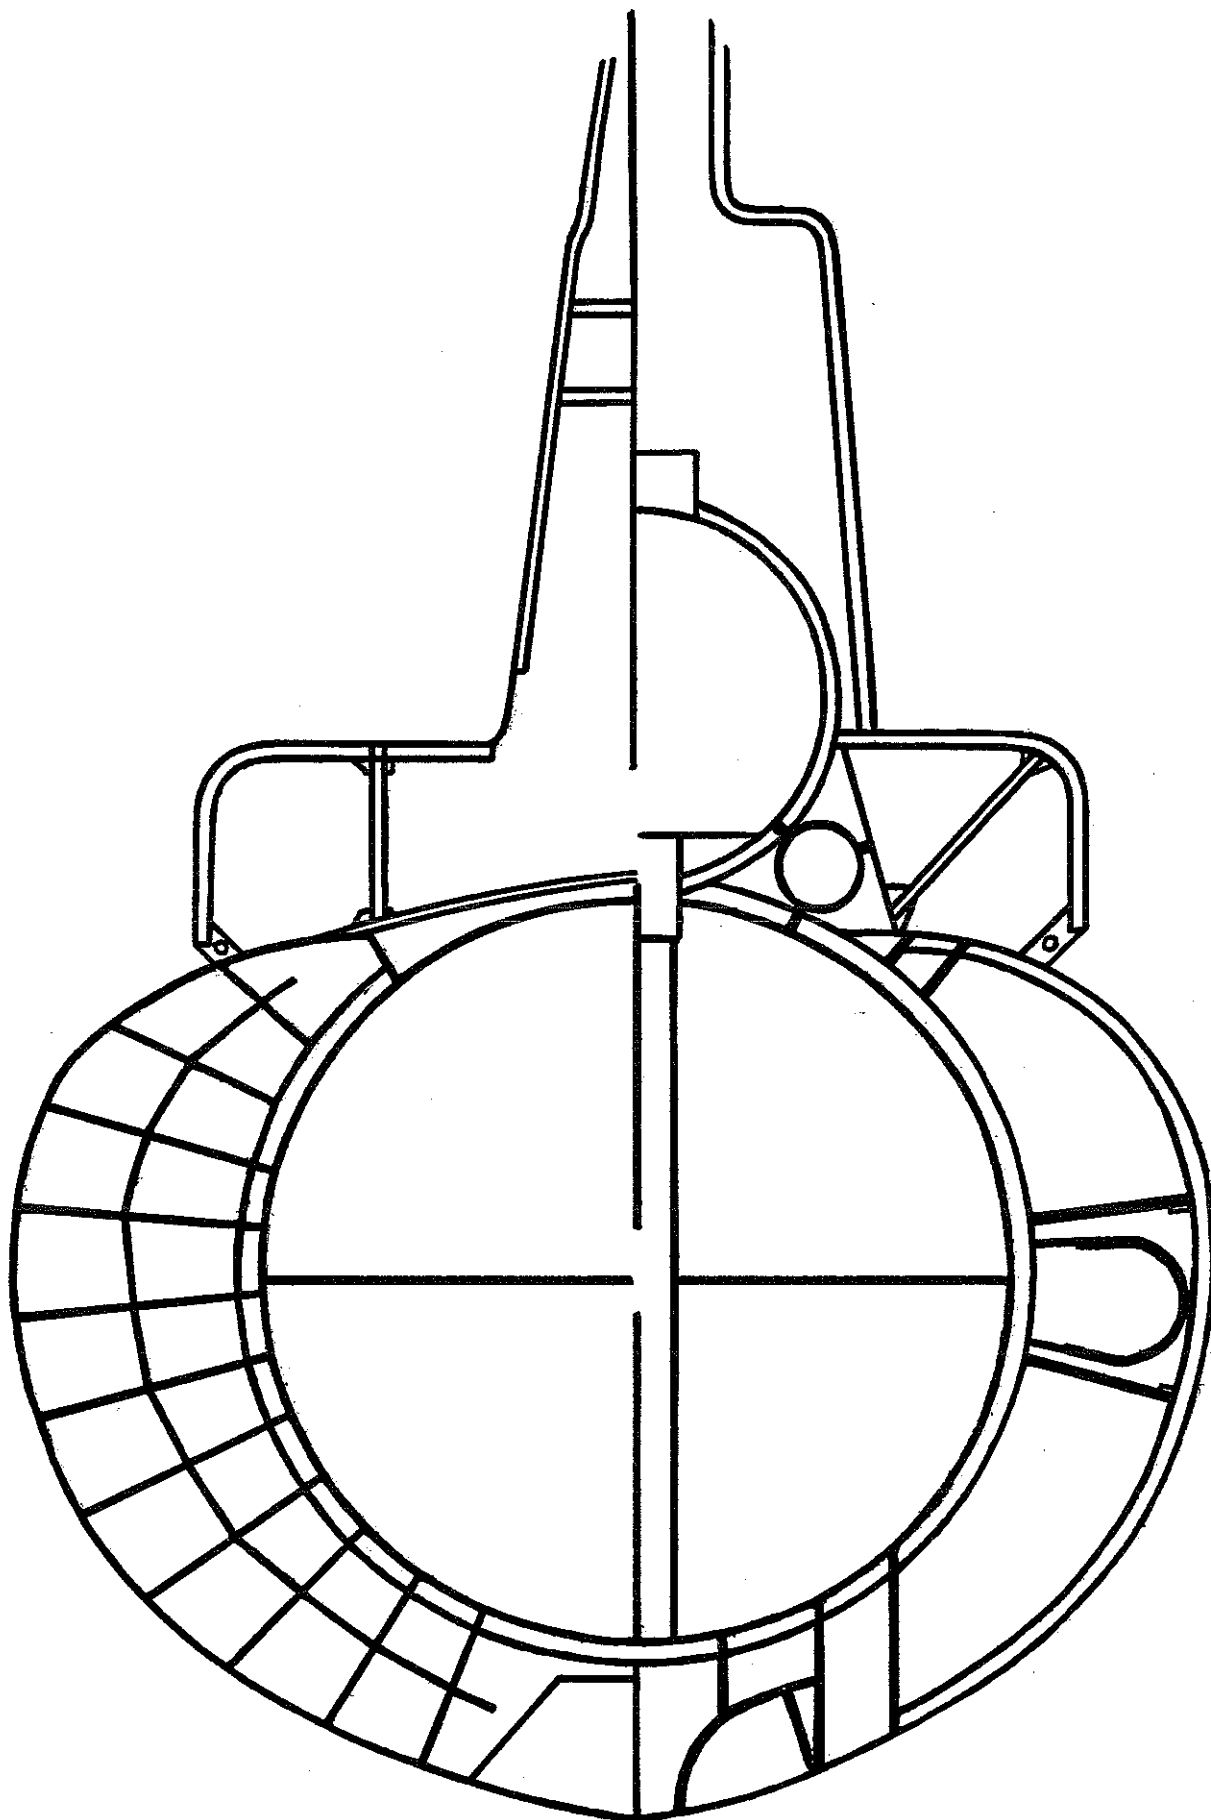
SECTION AT FR. 62  
LOOKING FWD

SECTION AT FR. 53  
LOOKING FWD

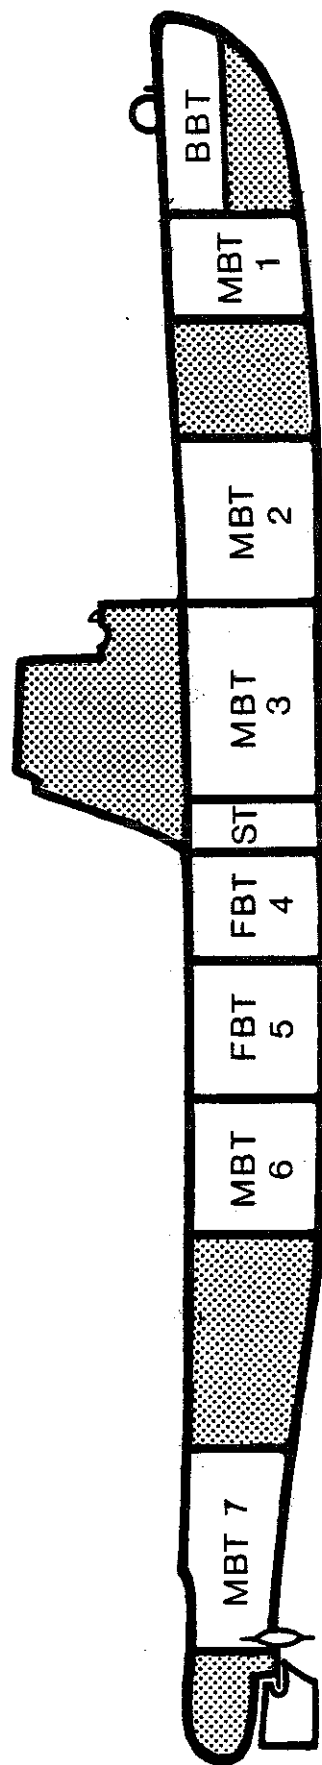
# GENERAL LONGITUDINAL DISTRIBUTION OF BALLAST TANKS FOR DEWATERING

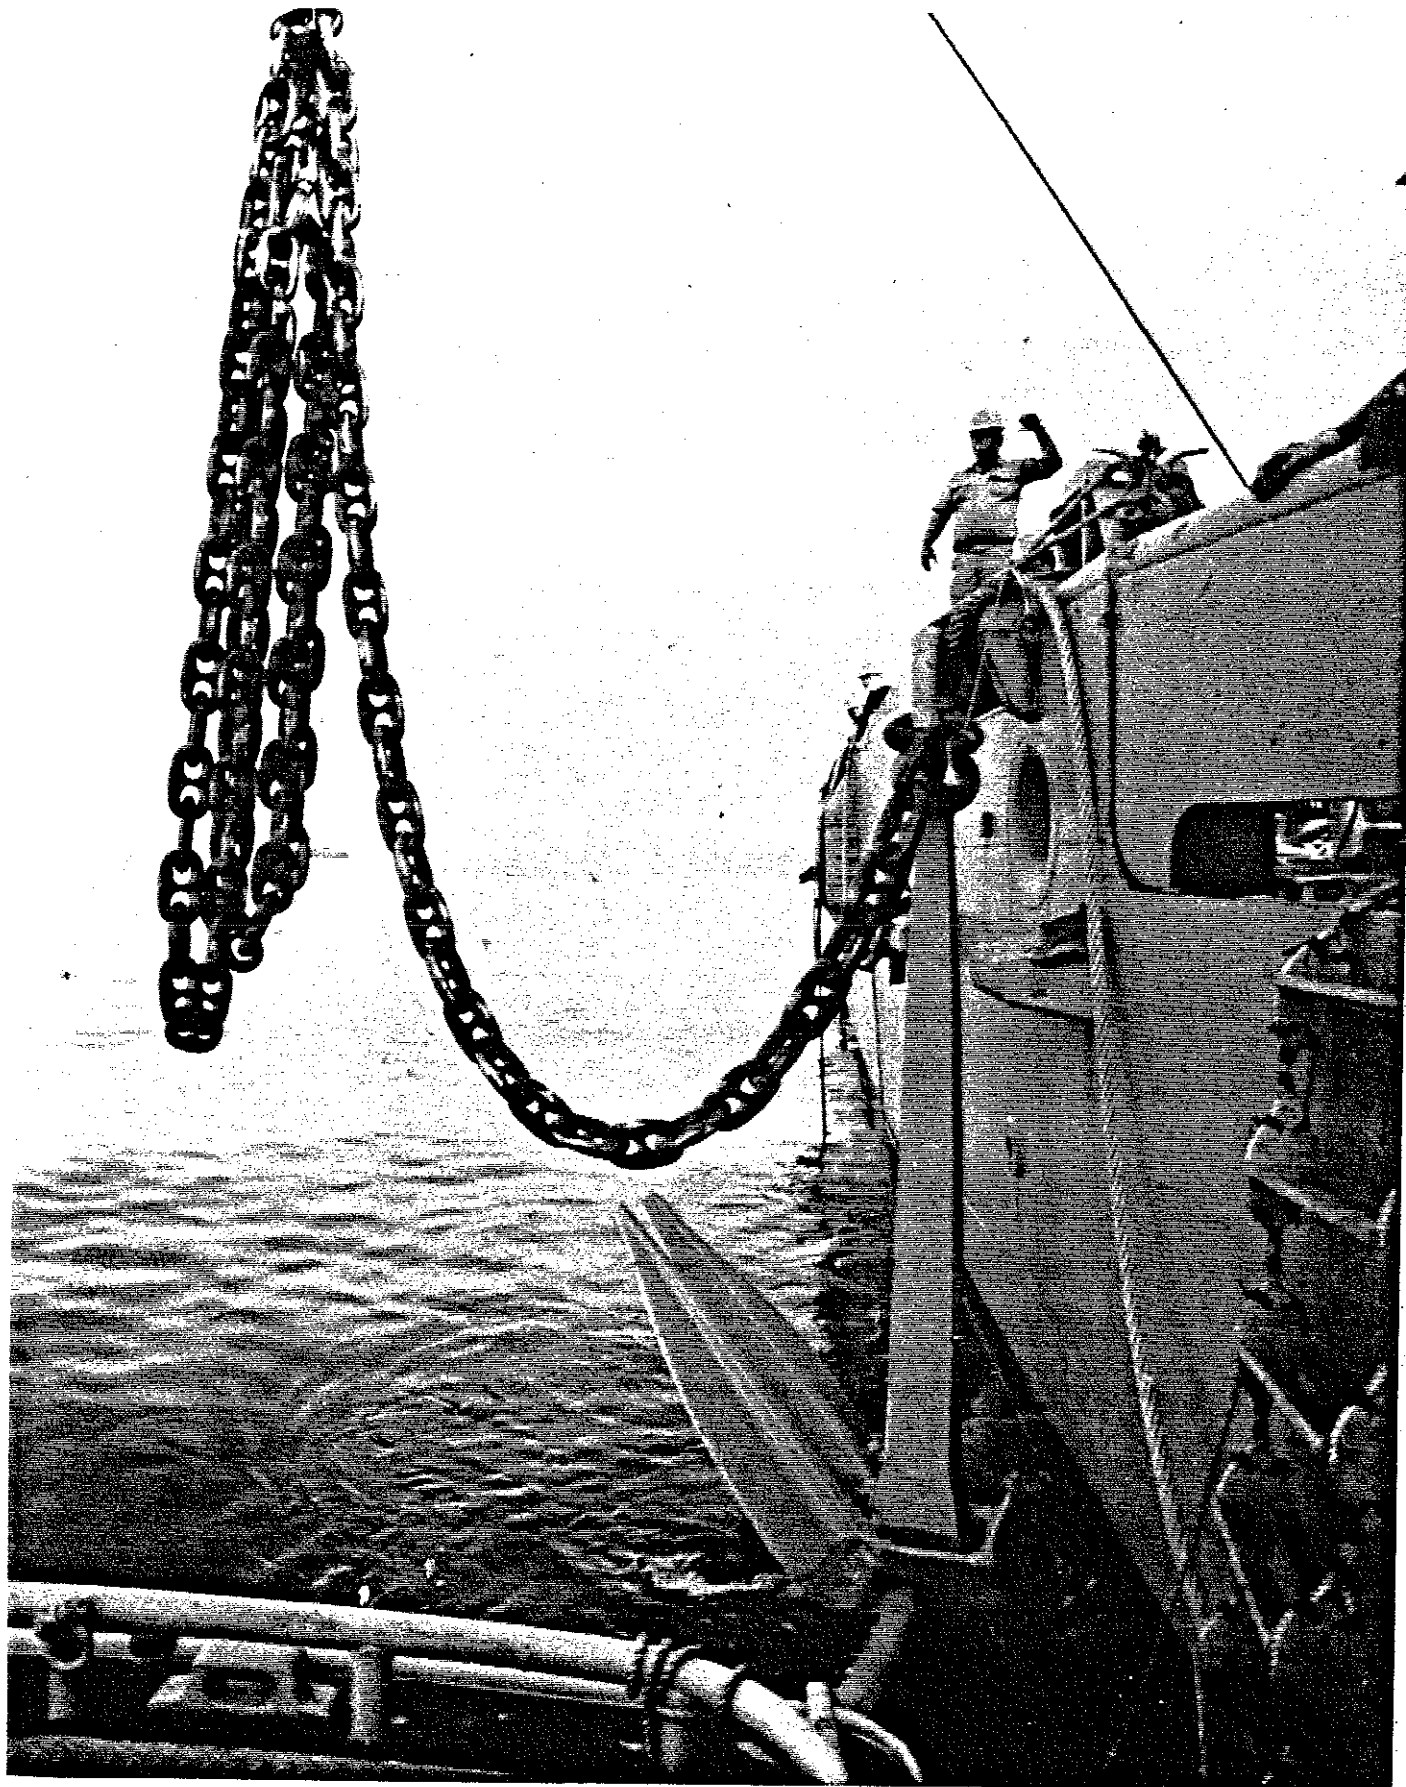
LWT ANCHOR BEING RIGGED FOR LEG OF MOOR

BRUNSWICK completed rigging of a 6,000 pound STATO anchor to the bullrope and layed this anchor while moving into a six point moor over the submarine. This provided BRUNSWICK a convenient means to move toward shallow water without use of

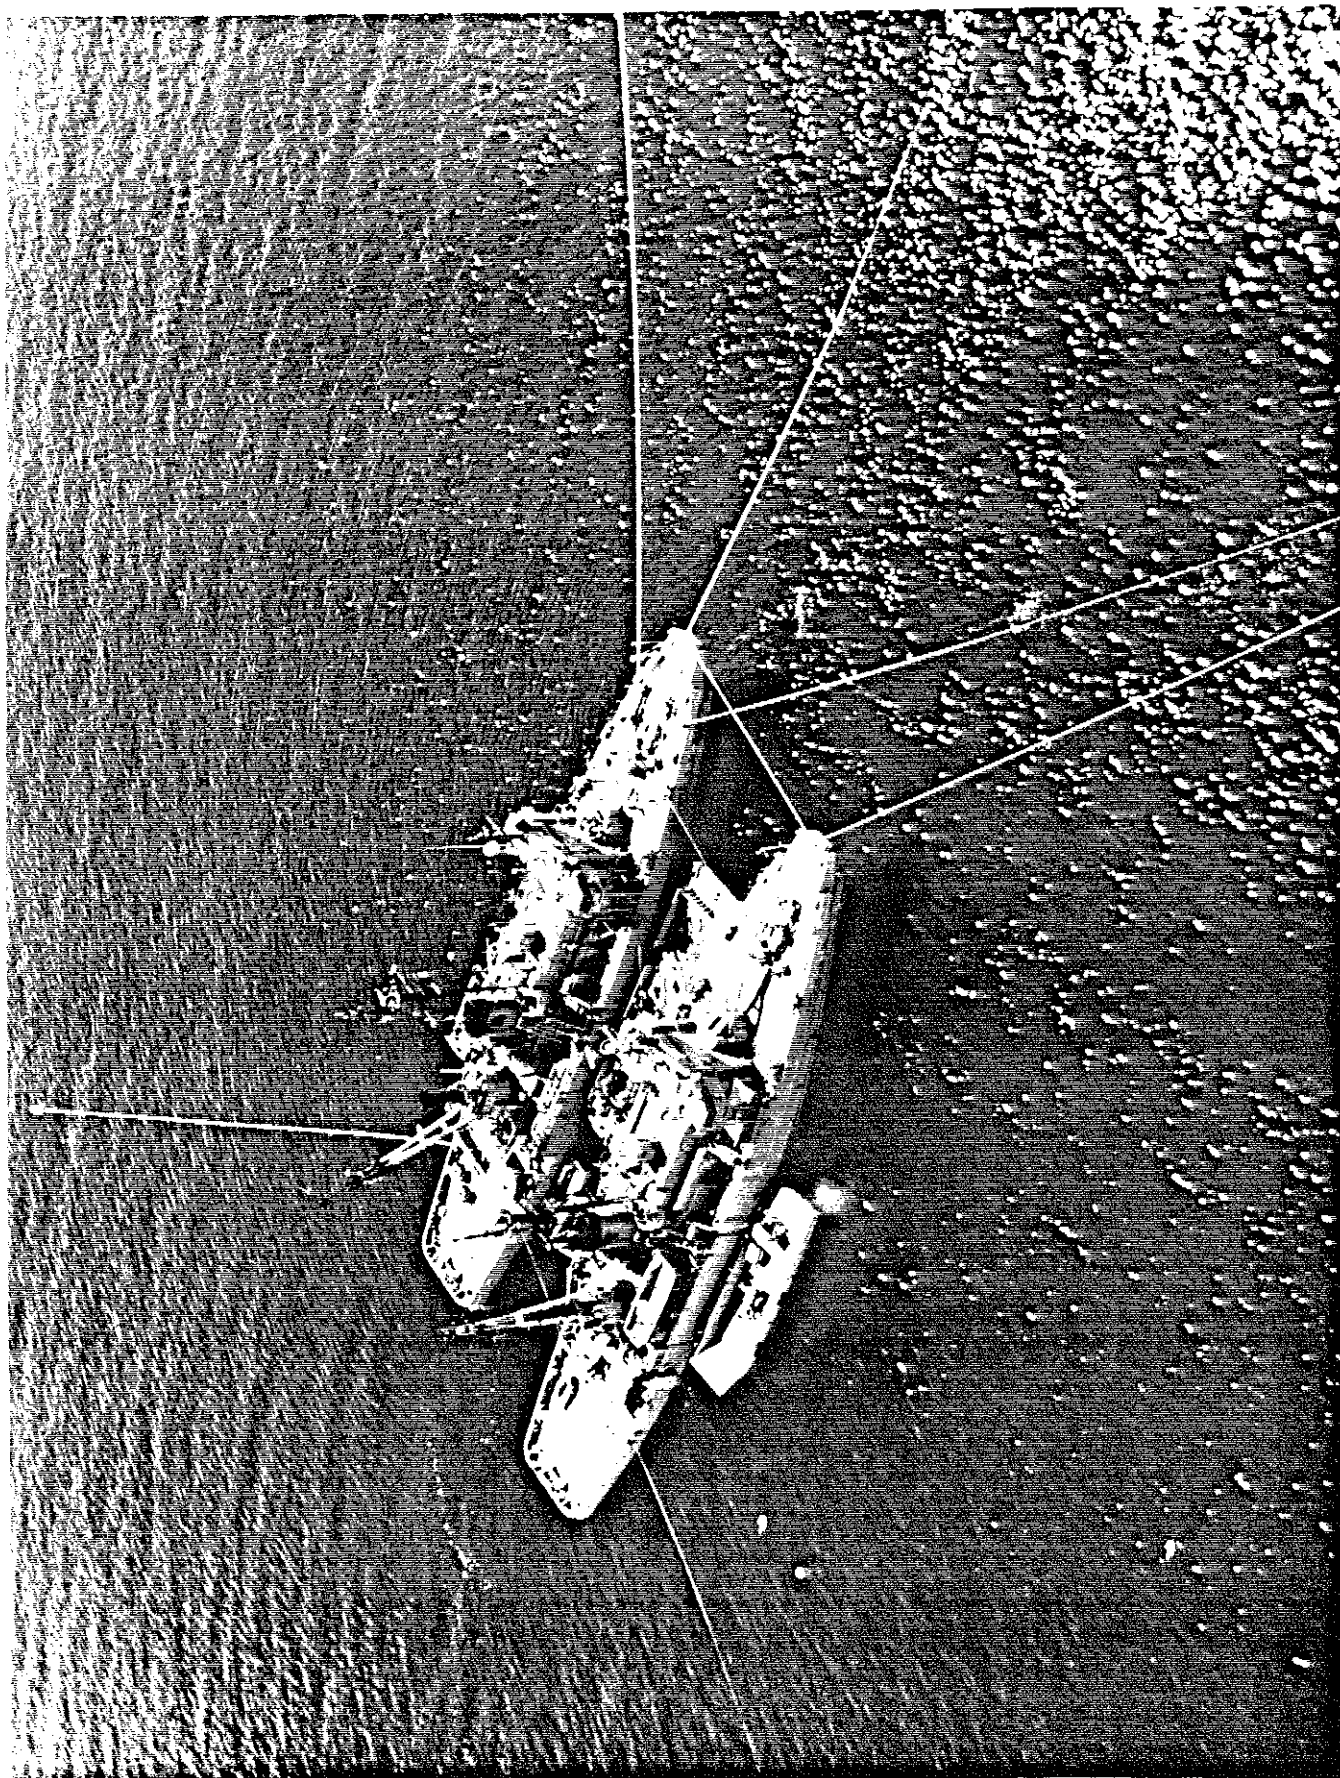
7-POINT MOOR OVER SUBMARINE

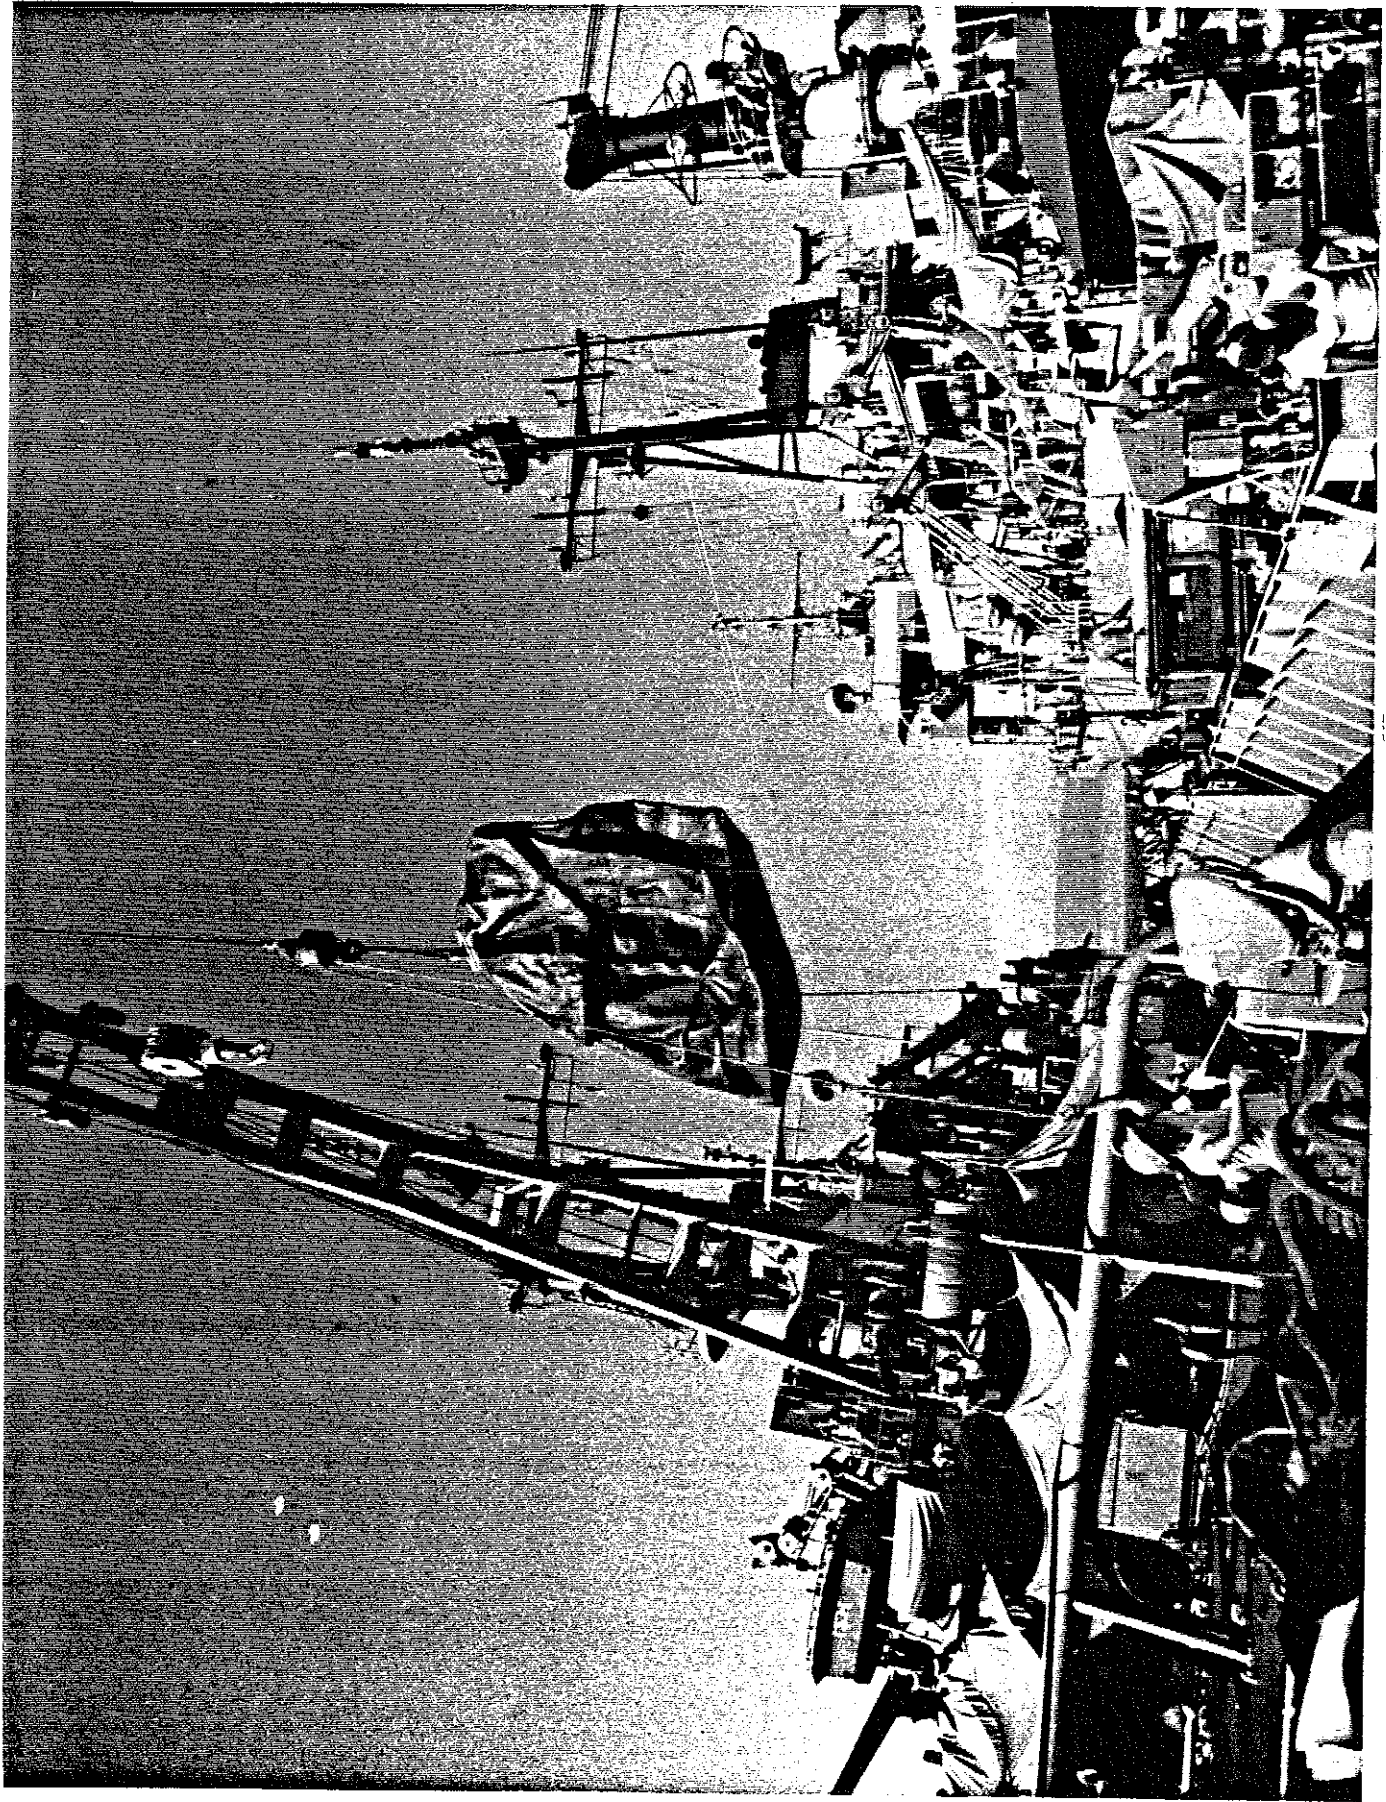
8.4 TON SALVAGE PONTOON

ballast tanks between the check valve and riser. Nine 8.4 ton salvage pontoons were uncrated and successfully pressure and leak tested. Calculations were made to reconsider the "added-buoyancy" and "added-weight" discrepancy and confirmed that the best estimate for residual weight to lift was 178 tons. A check of the possible ballast tank combinations to enhance stability (transverse and longitudinal) while raising the submarine determined an optimal combination whose buoyancy contribution was close to 178 tons (bow buoyancy, 4AB, #7). Hose was rigged to main ballast tanks 2B and 6D flood ports in order to test the tanks for leaks. Divers verified that the bow buoyancy vent was open.

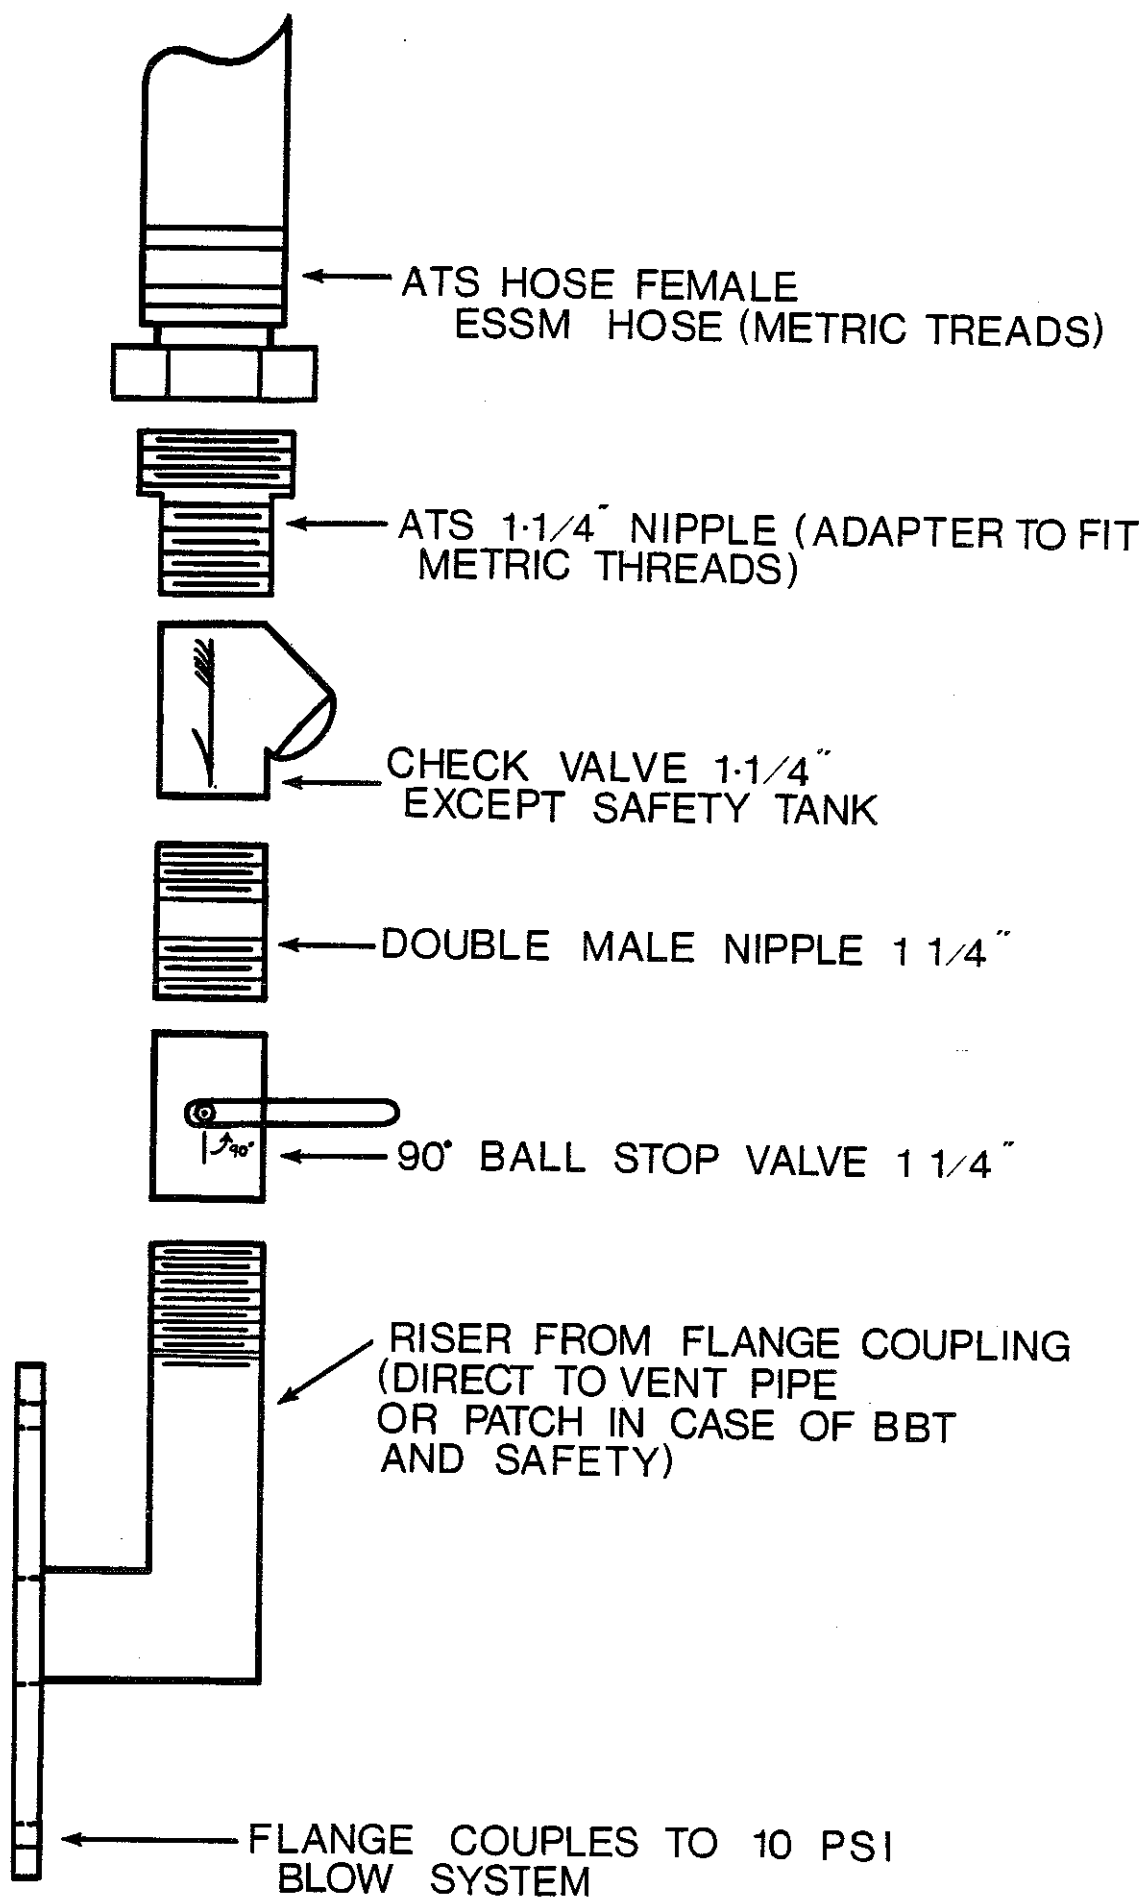
# BALLAST TANK ADAPTER SETUP

with air hose connection. The result was a better airtight fitting, greater air flow, and positive segregation of tanks.

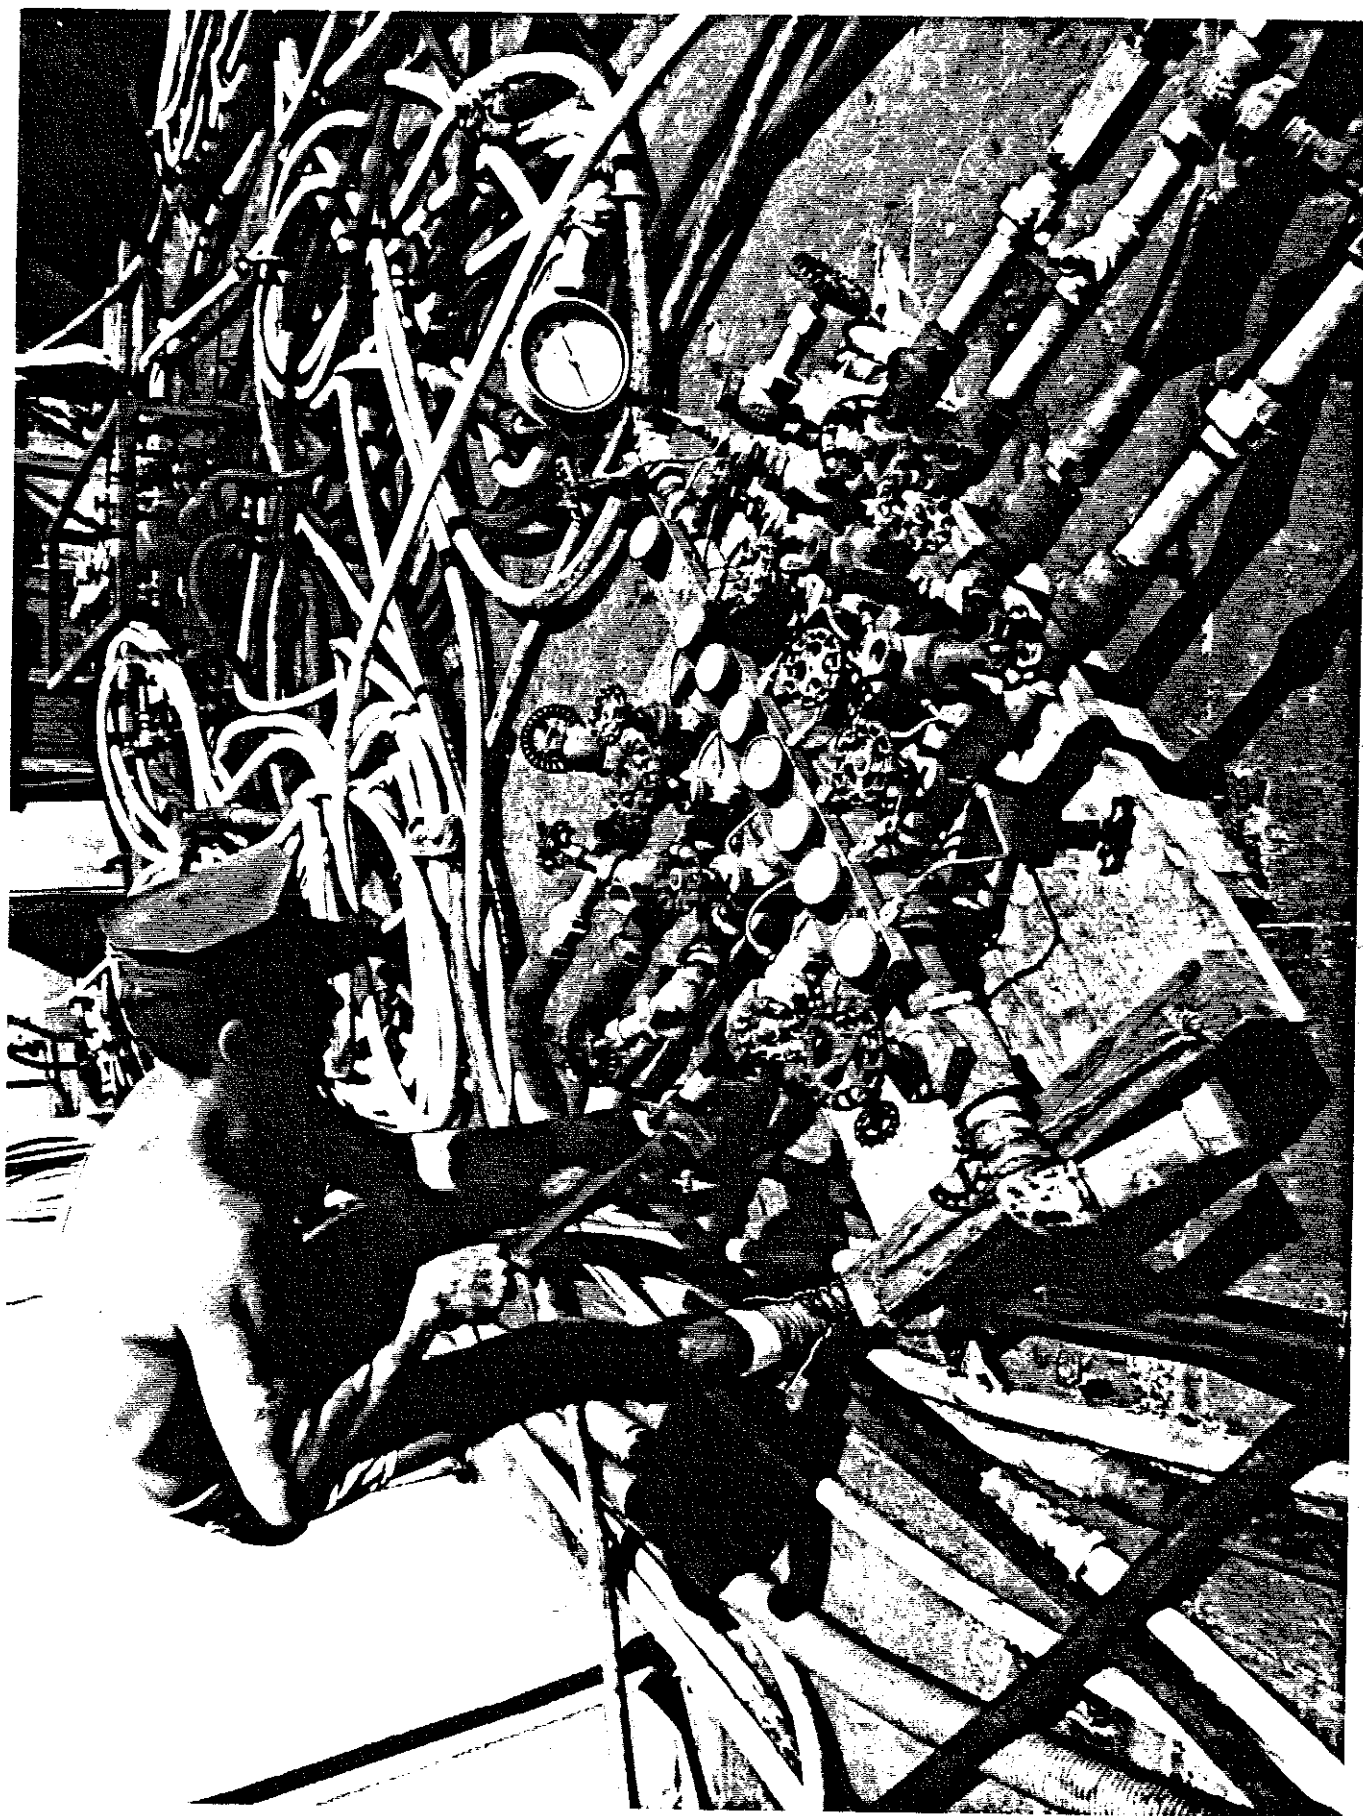
SALVAGE AIR MANIFOLD

As the dewatering continued, a manifold was made to hook the other low salvage connections to the pump. At 1830, dewatering was stopped to hook up the remaining lows to the pump but the manifold would not discharge. The manifold was disconnected to determine the problem. Each of the lows was connected to the pump to check in turn. When only the after torpedo and forward battery compartments were found to discharge water, the forward battery compartment was reconnected and dewatering continued at a rate of approximately 2.5 tons per hour.

The air manifold was modified to accept and distribute the supply from all three salvage compressors, and BRUNSWICK's salvage air in an emergency, to the 31 hoses attached to the submarine. A large air leak from the radar mast of submarine sail area was found and a patch was made and installed. All the ballast tanks were vented by removing the plugs on installed check valves. Dewatering of all compartments was restarted and continued. The safety tank, 6A, 6B, 2C, 2D and 7 MBT could not be successfully test blown. The causes of the problem could not be identified.

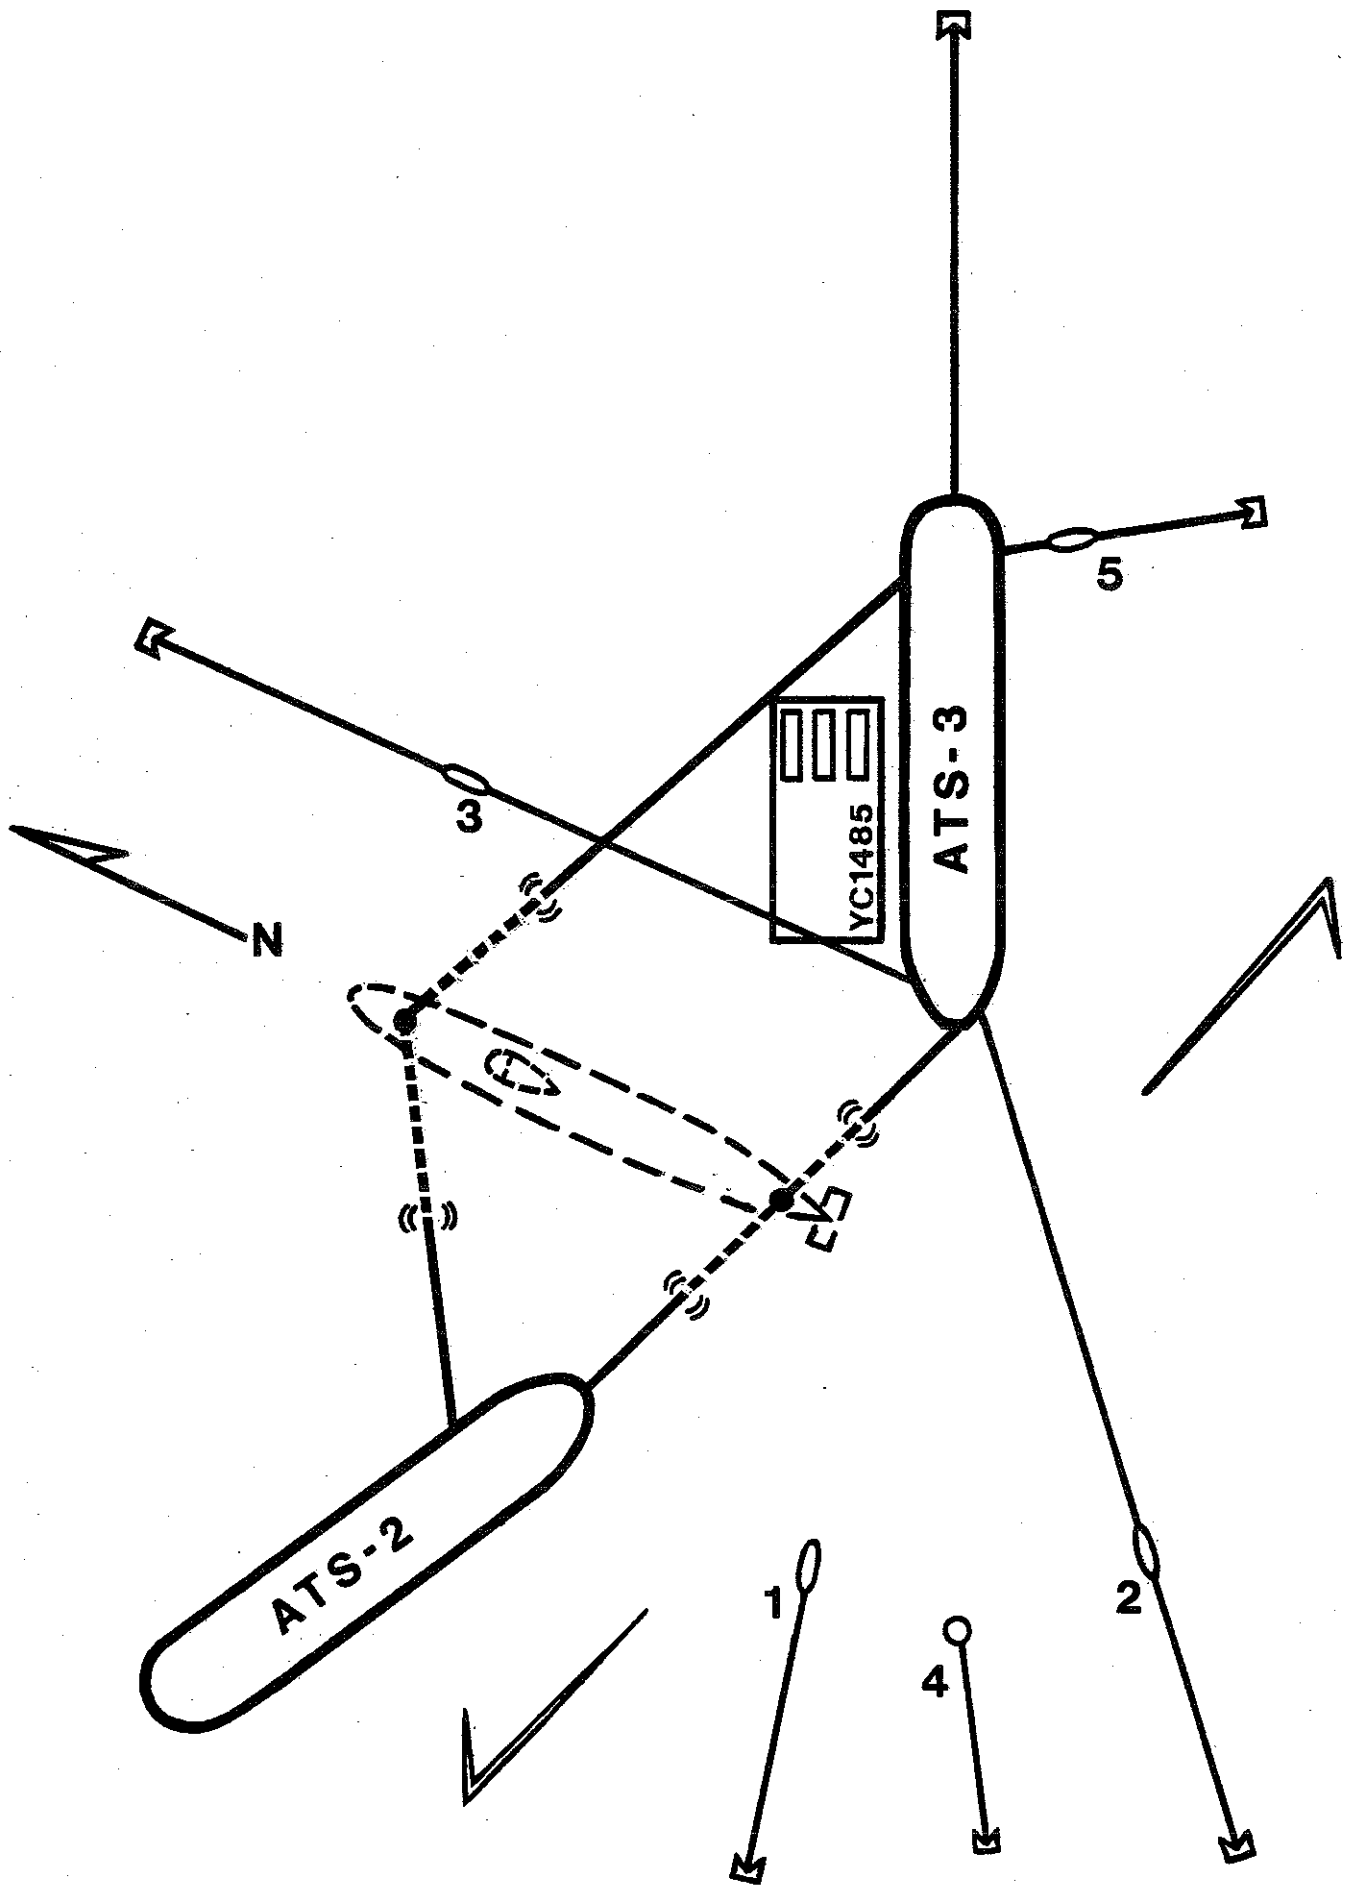
MOORING PLAN

An additional four legs were laid (legs 6-9) but were not used. In the original plan these legs were to be used to shift the operation into shallow water when using the heavy bow lift.

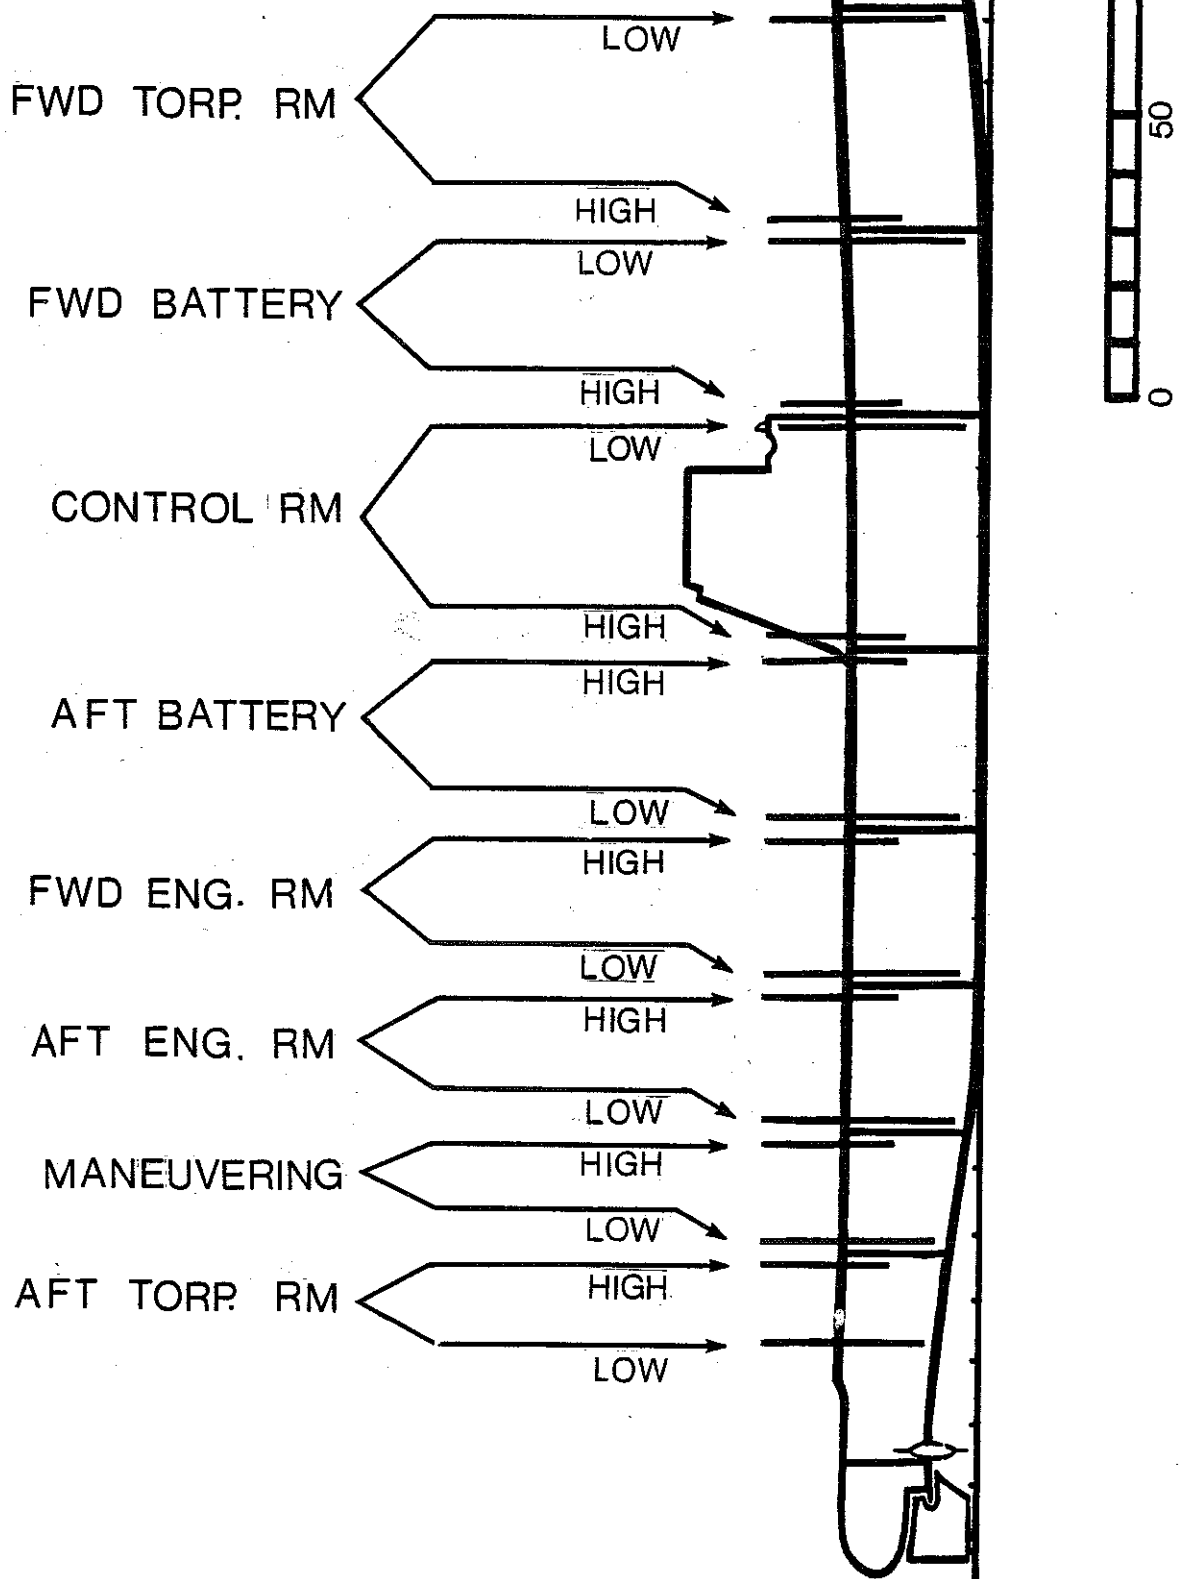
SUBMARINE SALVAGE FITTINGS

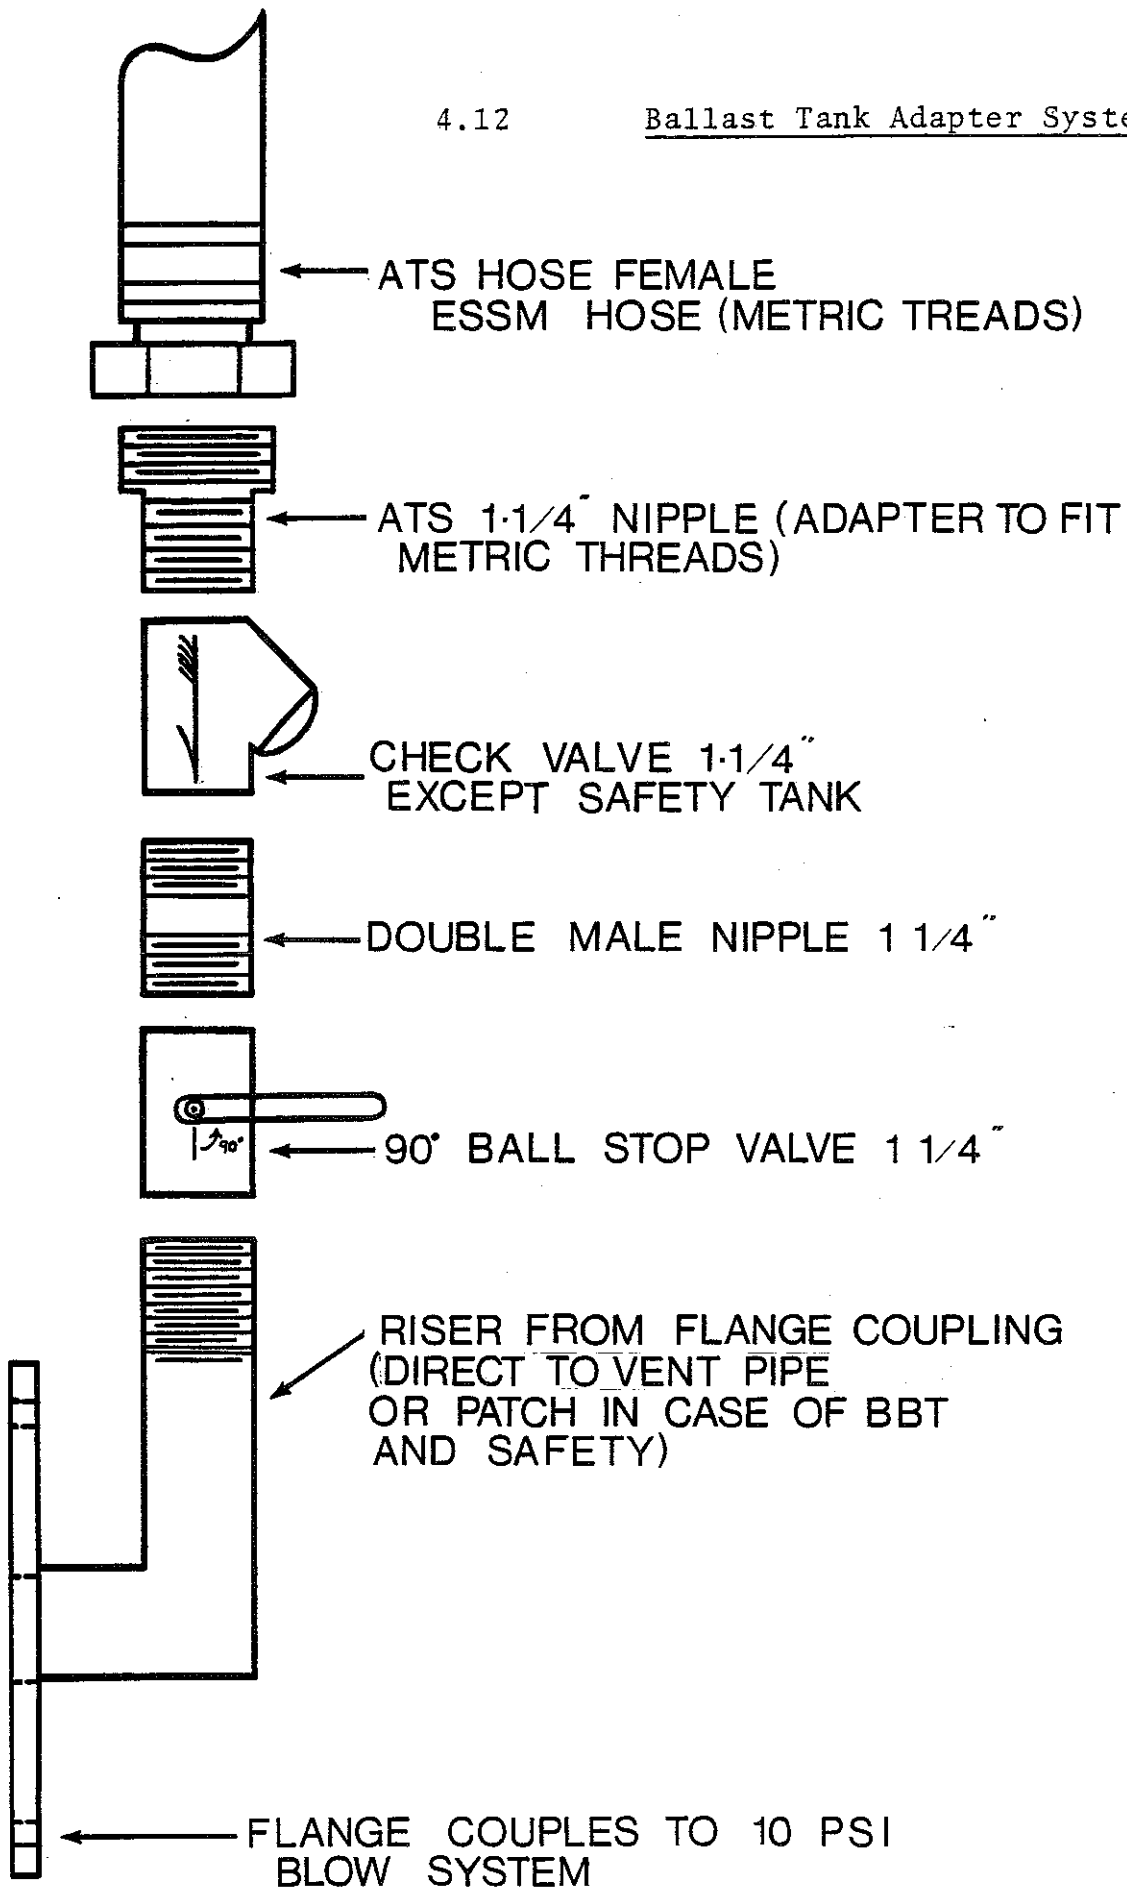
BALLAST TANK ADAPTER SETUP

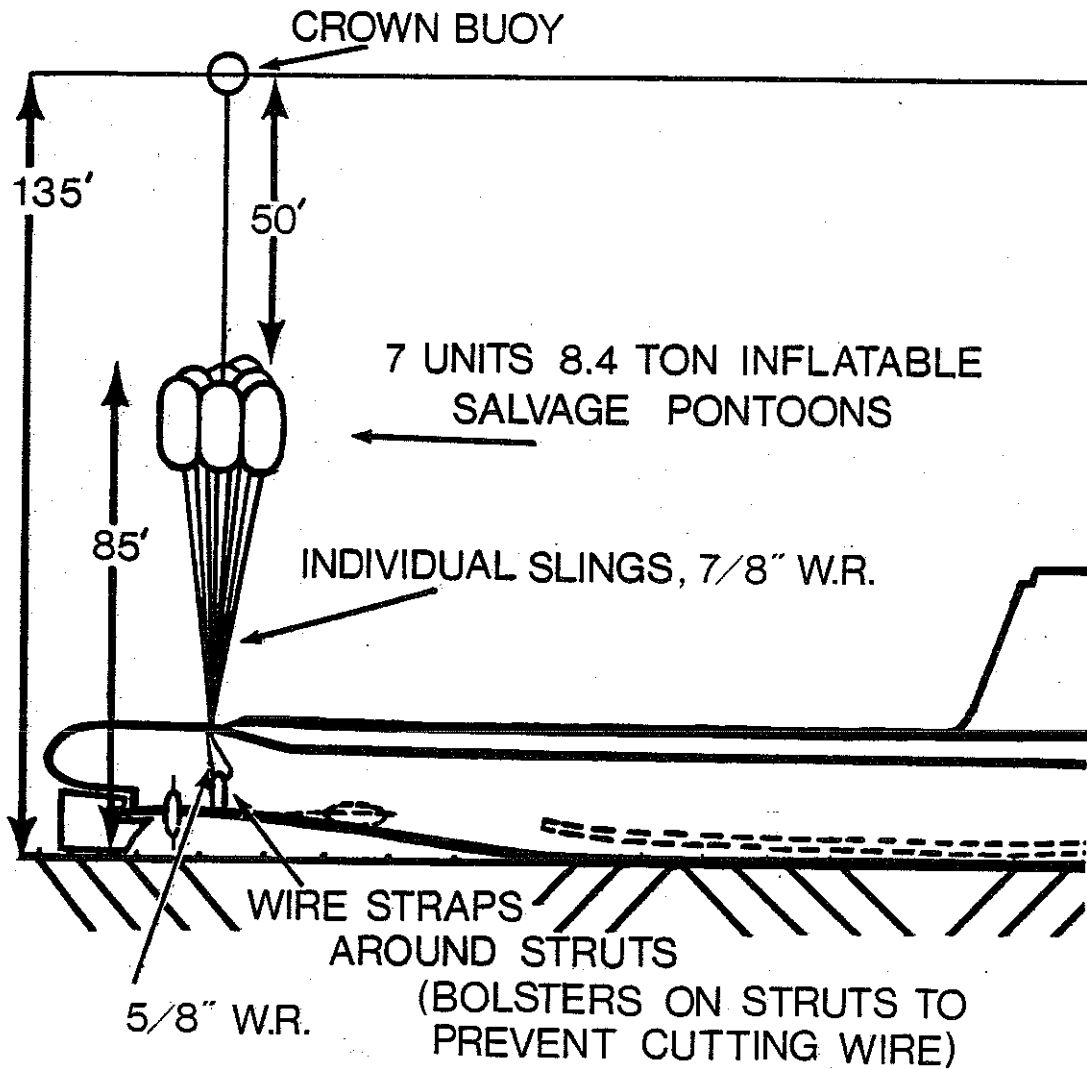
SALVAGE PONTOONS  
RIGGING DETAIL ASTERN
