# **EX-USS BLUEGILL (SS-242)**

## **SALVAGE OPERATIONS**

### **SUPSALV REPORT 84-06**

EX-USS BLUEGILL (SS-242)  
SALVAGE OPERATIONS

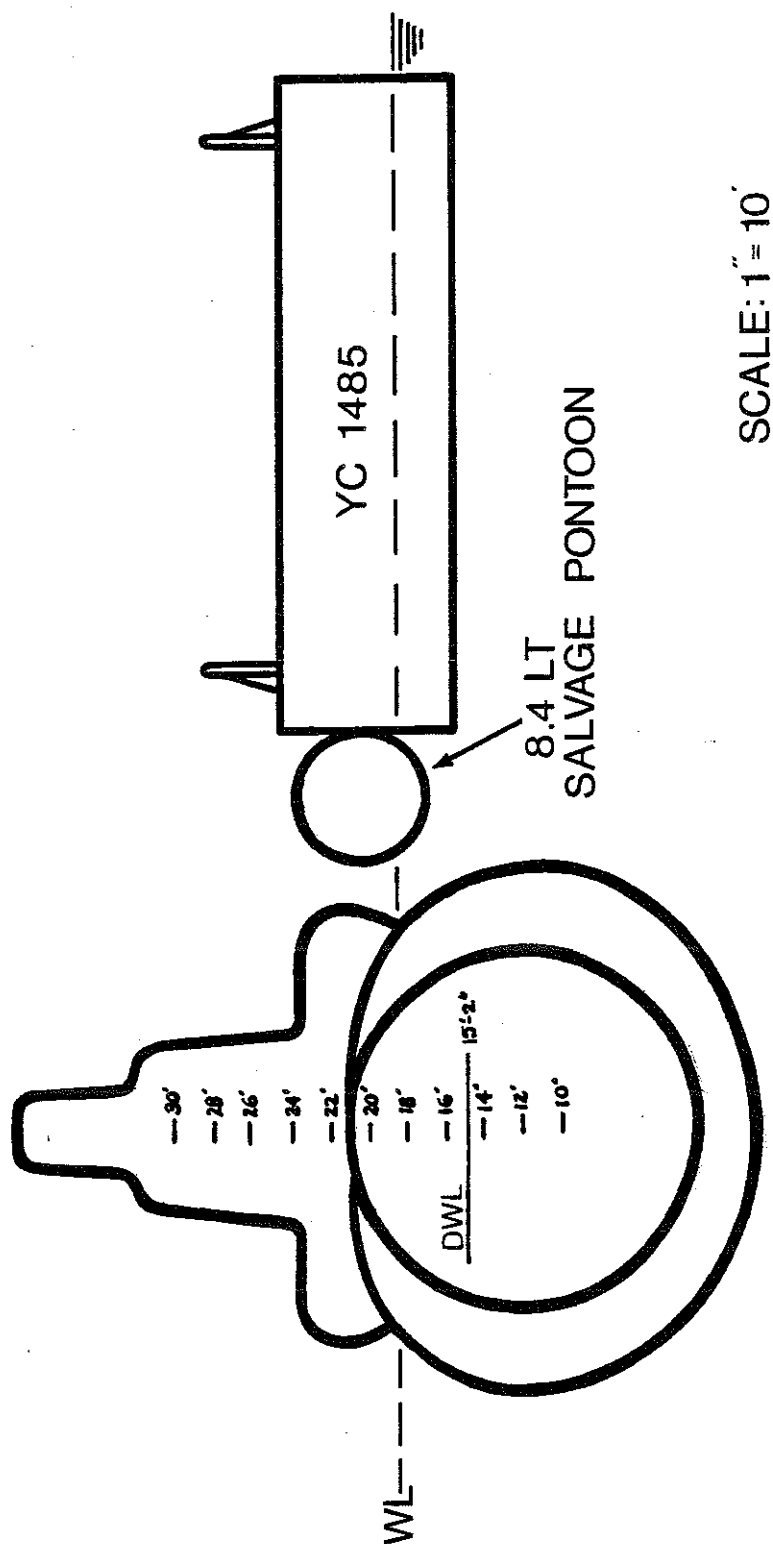
SURFACE MOORING PLAN

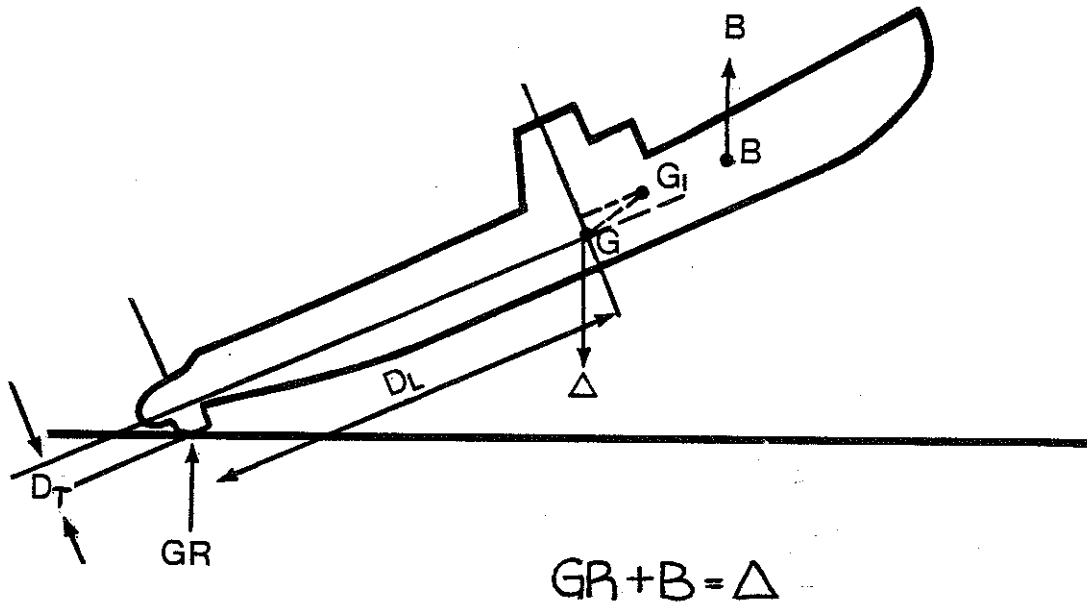
# WEIGHT SHIFT DUE TO GROUND REACTION

$$GG_1 = \frac{WD}{\Delta} \quad W = GR; GR = \Delta - B$$

$$GG_L = \frac{(GR)DL}{\Delta}$$

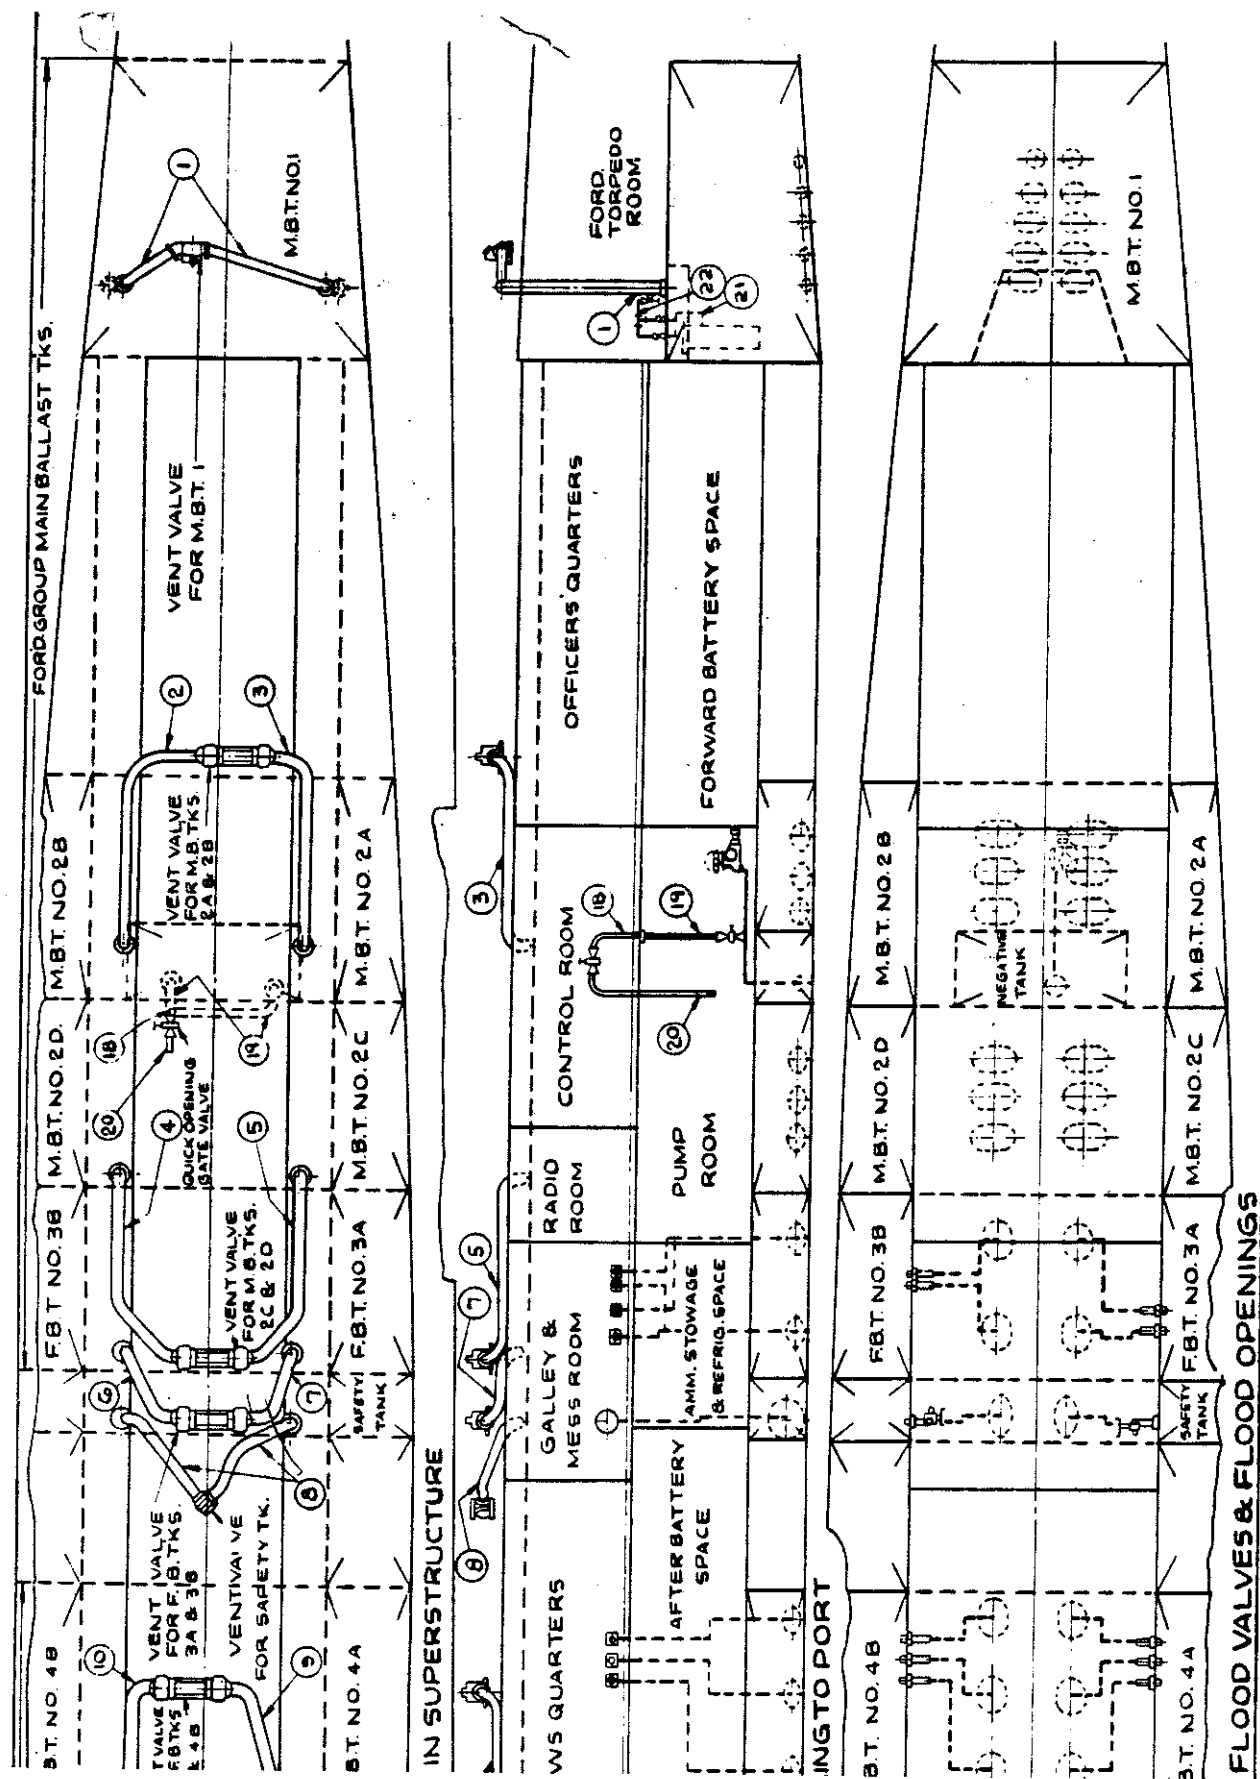
MAIN BALLAST TANK  
FLOODING & VENTING SYSTEM (2 OF 2)

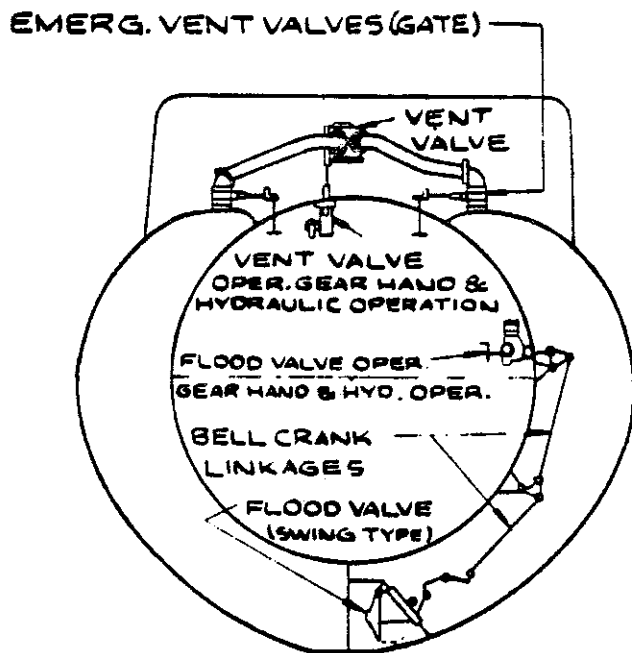
**SECTION SHOWING SAFETY TANK FLOOD & VENT VALVES**

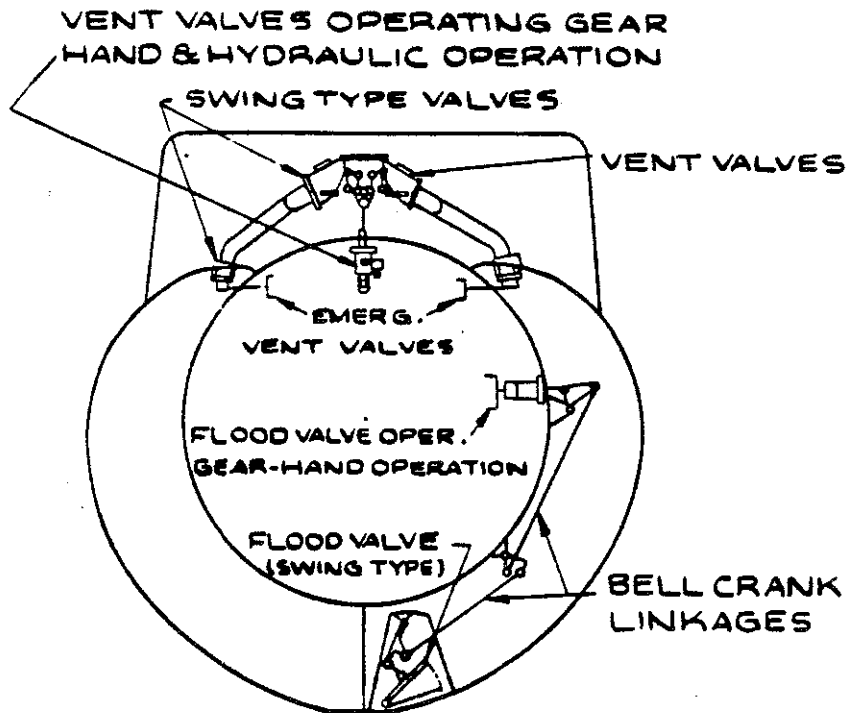
**TYPICAL SECTION SHOWING VENT VALVES OF FORD. & AFT GROUPS & FLOOD VALVES IN F.B. TANKS NOS. 3, 4, & 5.**

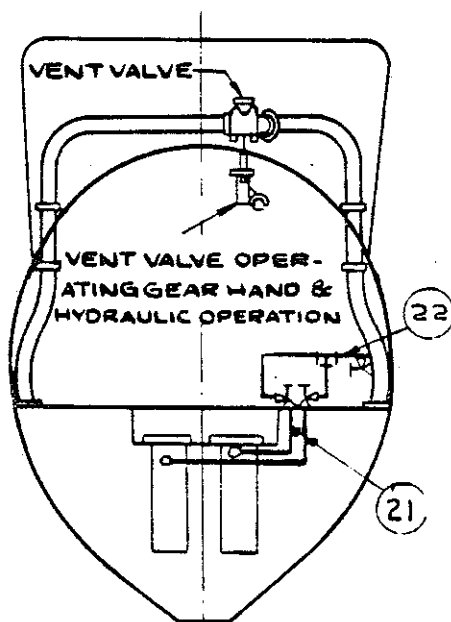
**TYPICAL SECTION SHOWING VENT VALVE FOR M.B. TANKS NO. 1 & 7**

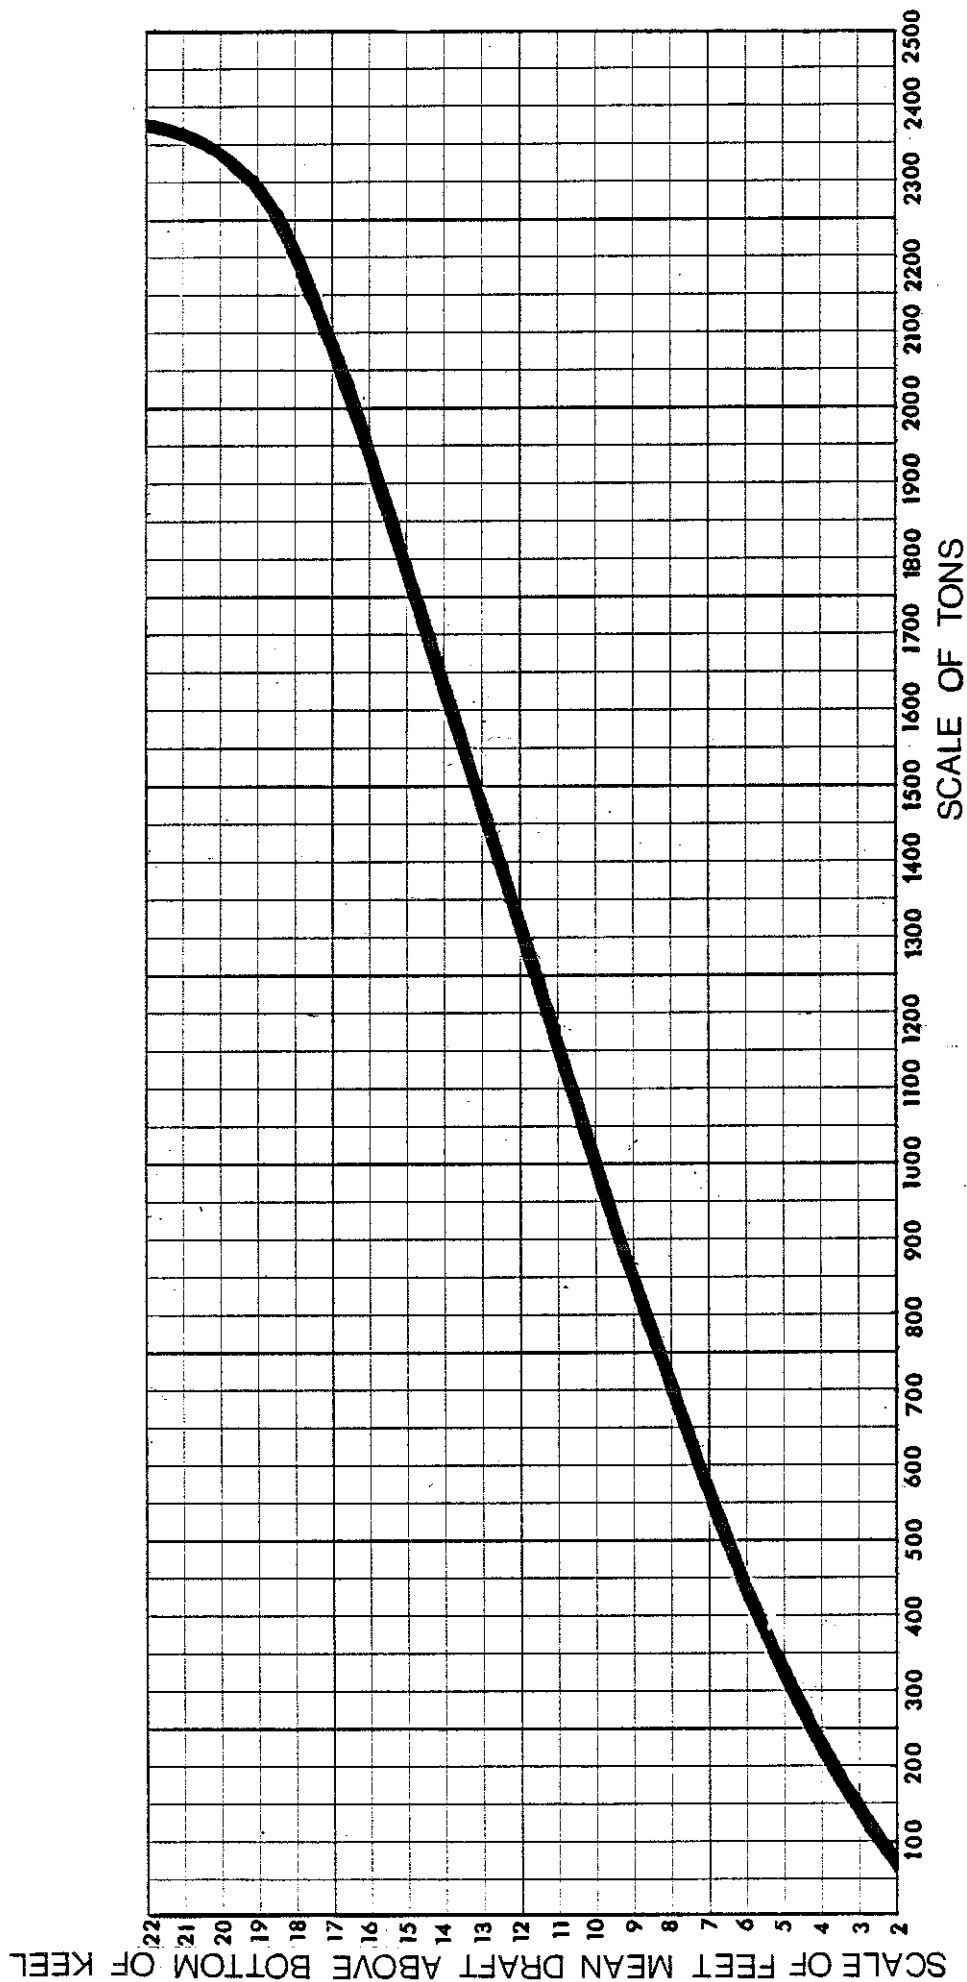
# SSK TYPE II CONVERSION DISPLACEMENT CURVE

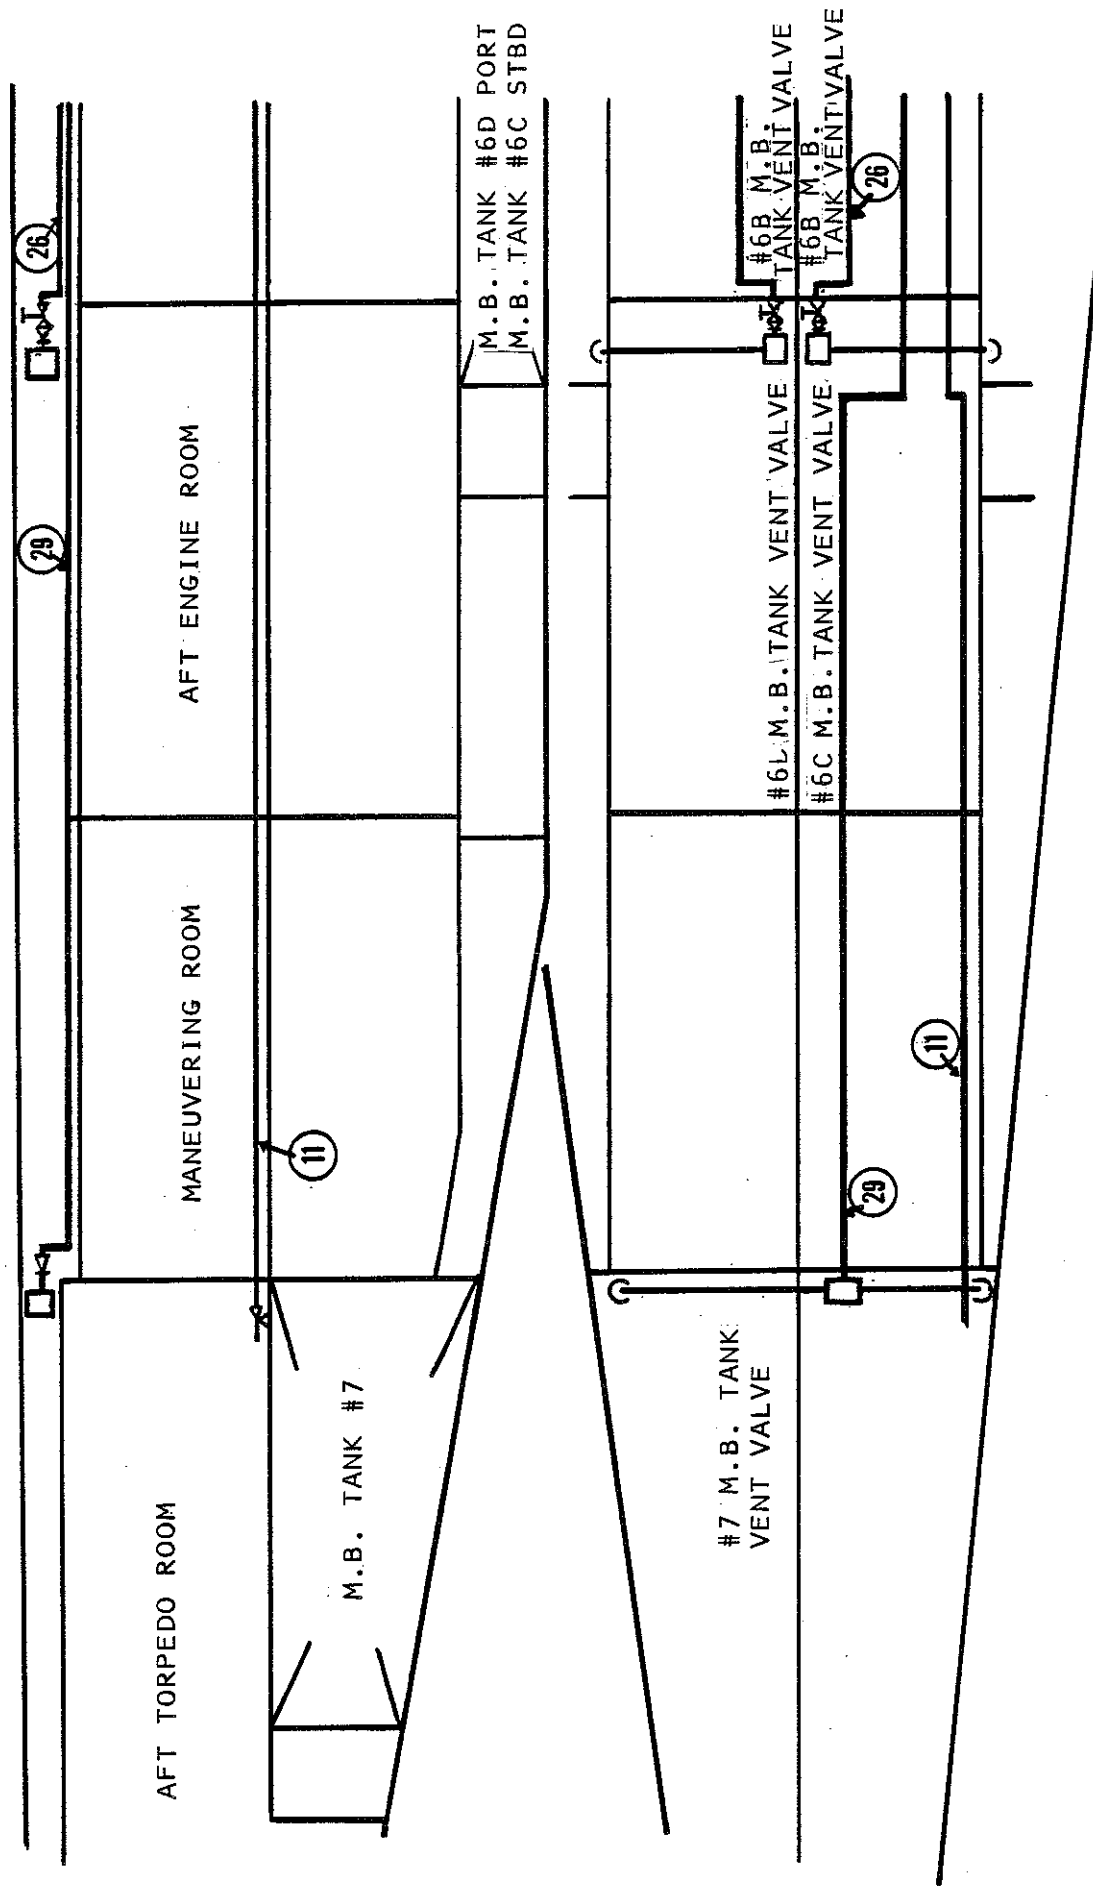
# MAIN BALLAST TANK BLOWING SYSTEM (10F3)

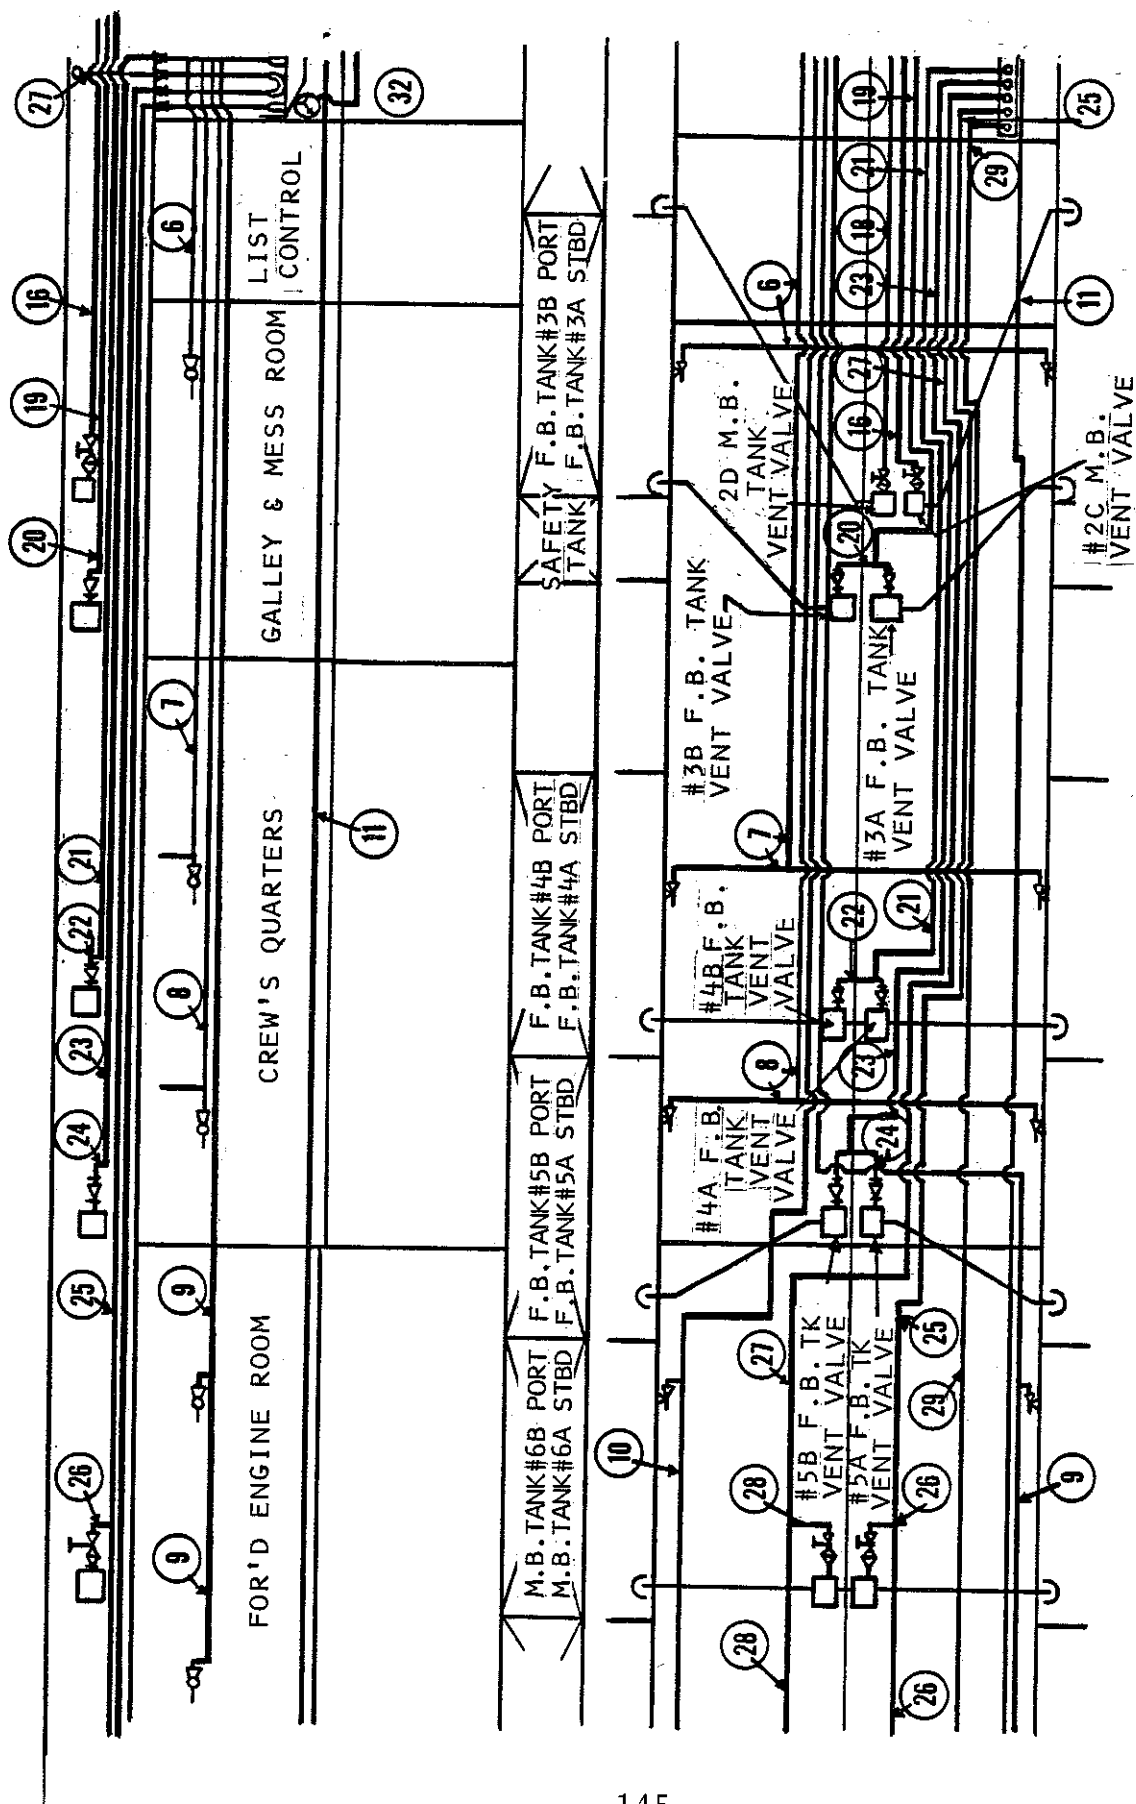
# MAIN BALLAST TANK BLOWING SYSTEM (20F3)

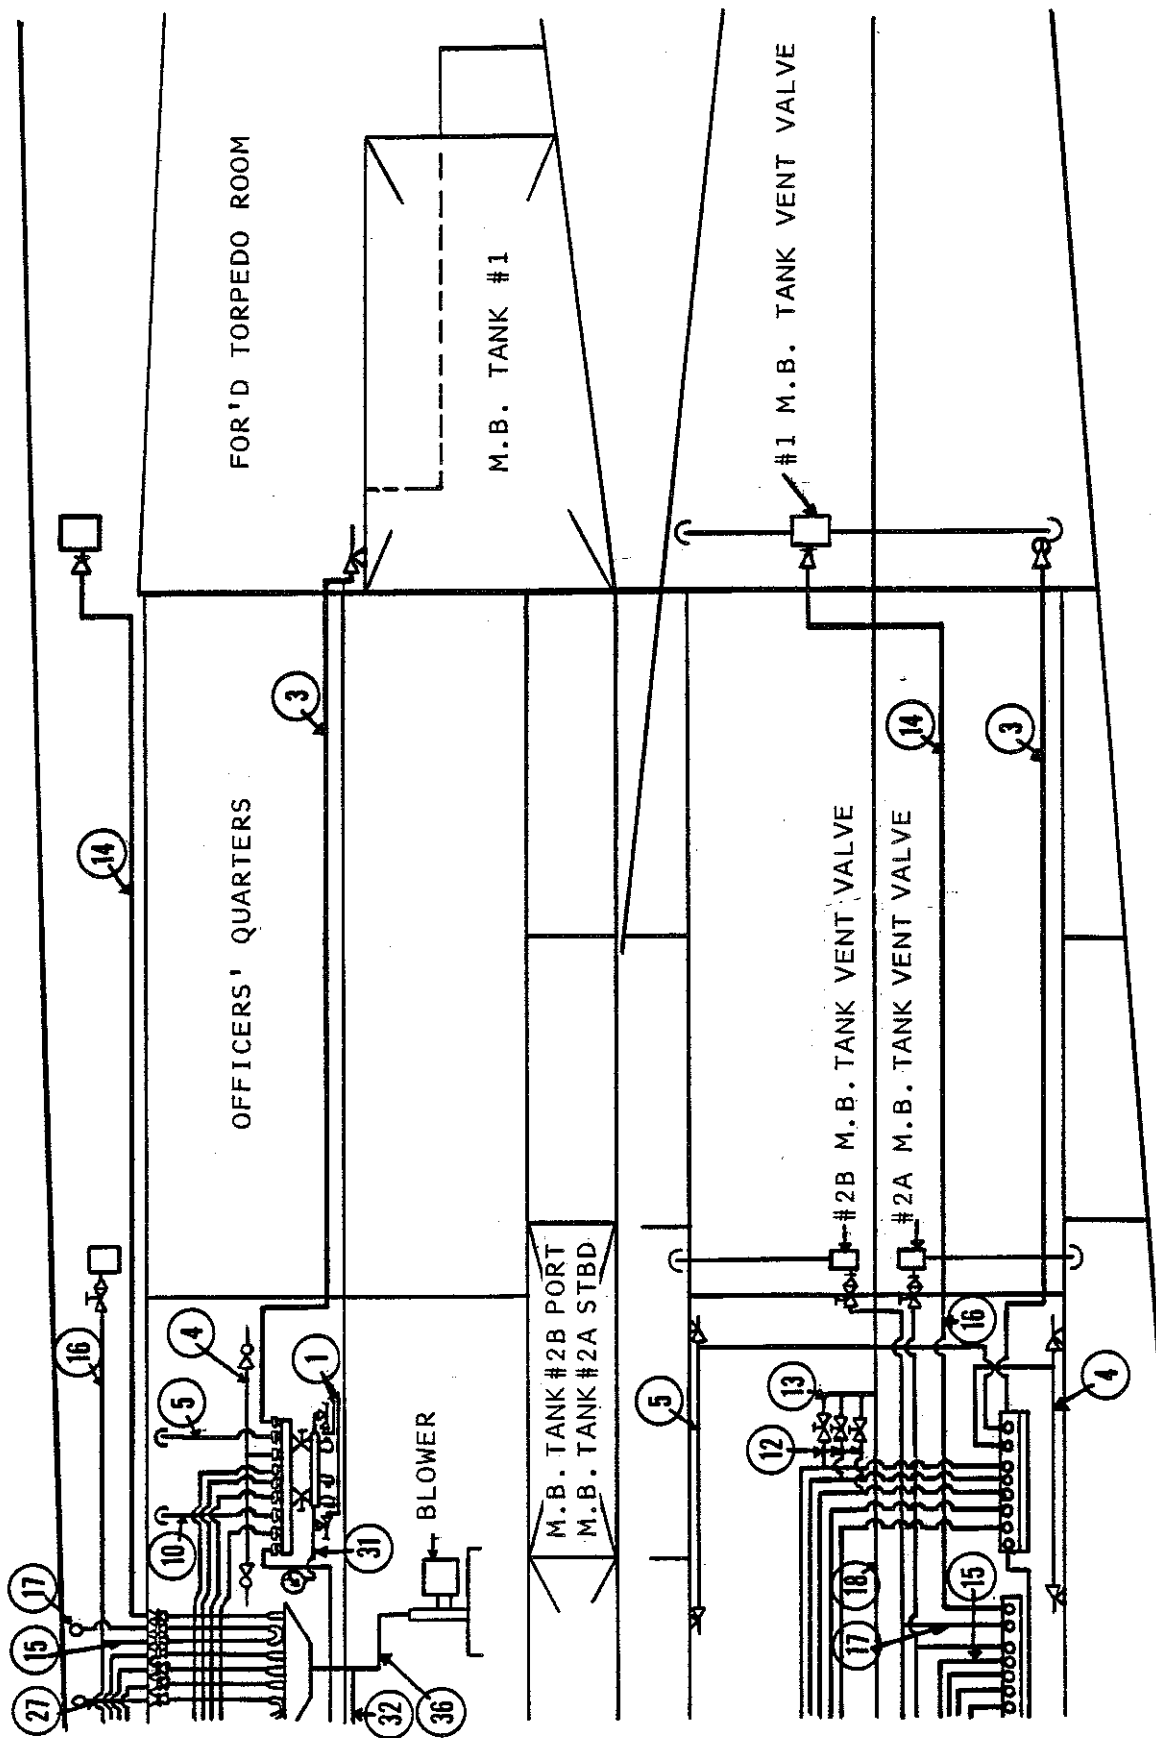
MAIN BALLAST TANK  
BLOWING SYSTEM (30F3)

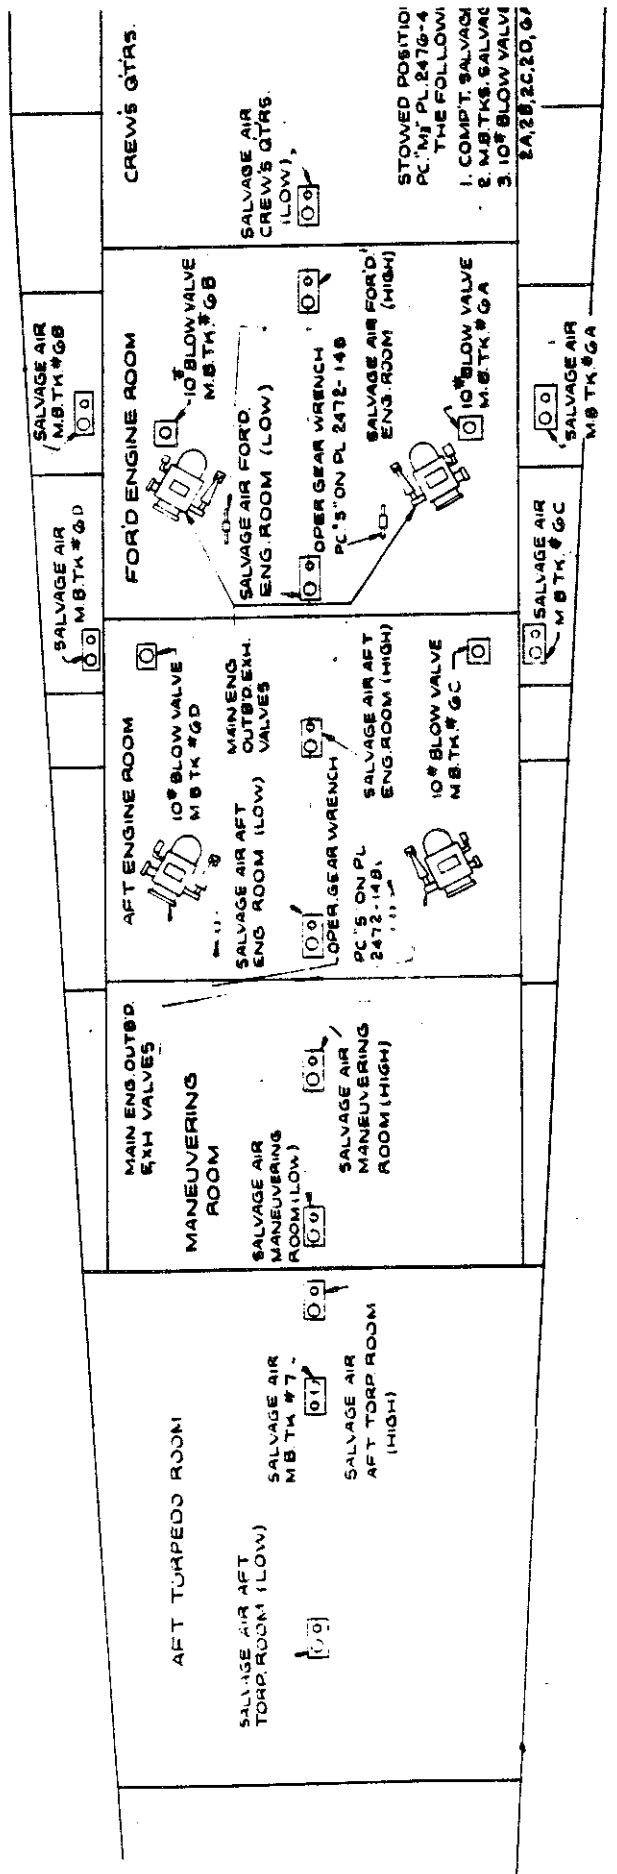
# COMPARTMENT & BALLAST TANK SALVAGE SYSTEM (1 OF 2)
