# **U.S. NAVY SALVAGE REPORT SPACE SHUTTLE COLUMBIA**

Published by Direction of Commander, Naval Sea Systems Command

**September 2003**

**Prepared by ROH Incorporated under  
contract with Naval Sea Systems Command**

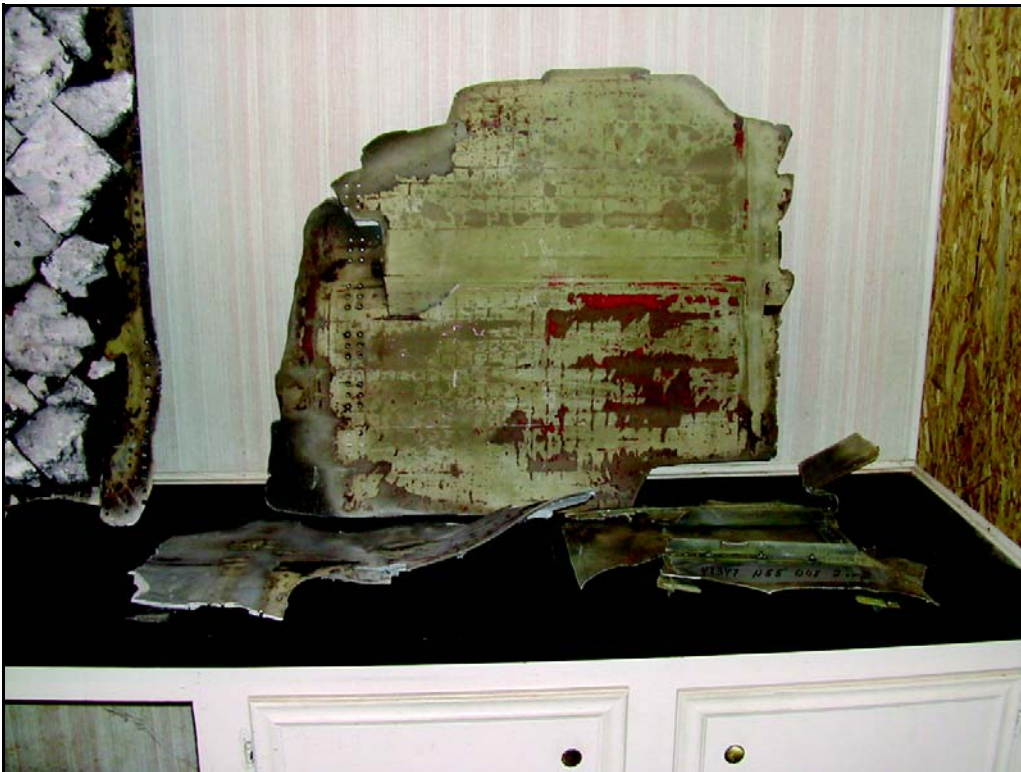
*Figure 3-14. Actual Shuttle Pieces Used as Test Targets.*

Tests were conducted over a two-week period during the operation to ensure the equipment being used was able to achieve the expected results. SUPSALV ordered the first series of tests on March 2 as the water search organization had yet to find any shuttle debris. NASA provided 4 pieces of shuttle skin material that had been recovered on land for controlled testing. The dive team tied these pieces to buoys and dropped them in approximately 20 feet of water in a relatively clear bottom in front of the Fin and Feather. These pieces ranged in size from the largest being 1 by 2 meters to the smallest measuring 0.4 by 0.5 meters. See Figure 3-14 for photos of these shuttle pieces. Search boats operating both multibeam system and a Marine Sonic side scan ran the test range. It was noted that detection of the largest target was possible, while detection of the smaller targets was uncertain.

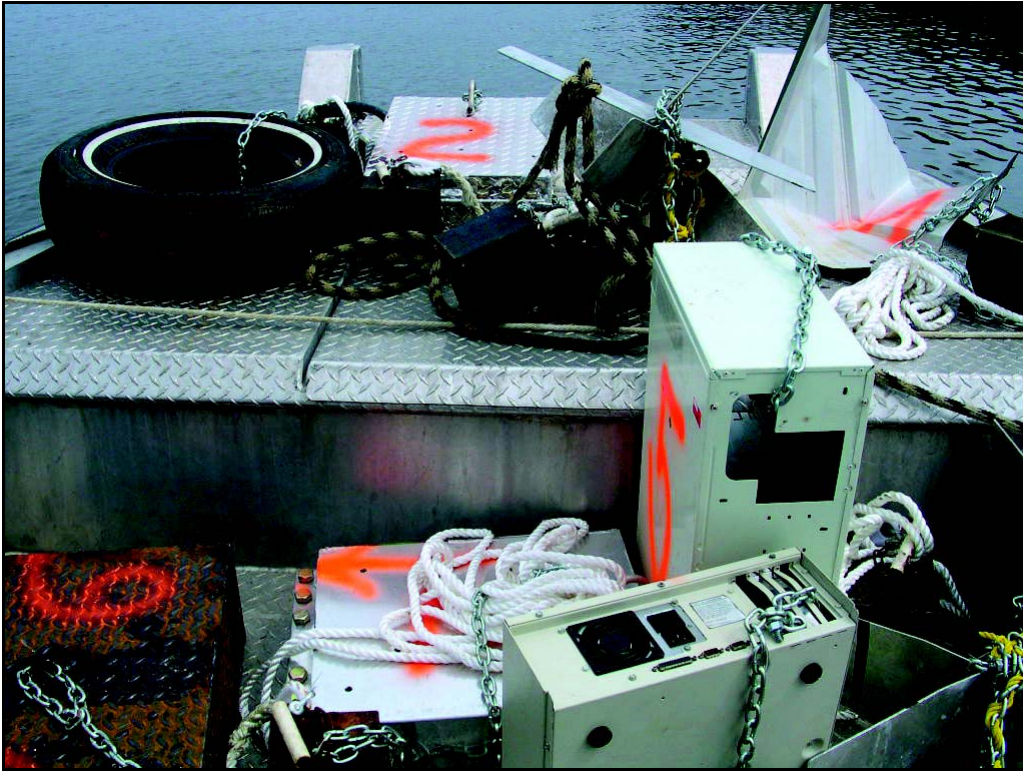
Figure 3-15. Sample Targets used for Controlled Test.

On March 11 the experts met with CAPT Wilkins, CAPT Murray, Ridge Albaugh, Lee Wolford, and NASA's Steve Bowen to discuss the situation. CAPT Wilkins set up two "Tiger" teams to try to solve the problem of target discrimination. The first team focused on software and data analysis in an attempt to manipulate the incoming information to improve target identification. The second team focused on hardware testing. Doug Lockhart was tasked as the Testing Director. Mr. Lockhart planned a series of tests on the 8101, 8125, Klein 3000, EdgeTech MPX, Marine Sonic (standard configuration), and the Marine Sonic (custom 10-degree down angle). Testing required the location of two suitable control areas 100 x 200 meters in 20 feet of water and in 75 feet of water. An area was selected and thoroughly scanned with both side scan and multibeam to map the existing bottom conditions. Upon completion of the initial scan, 10 targets were placed 10 meters apart on a 100-meter long track. Included in these targets were three OEX Data

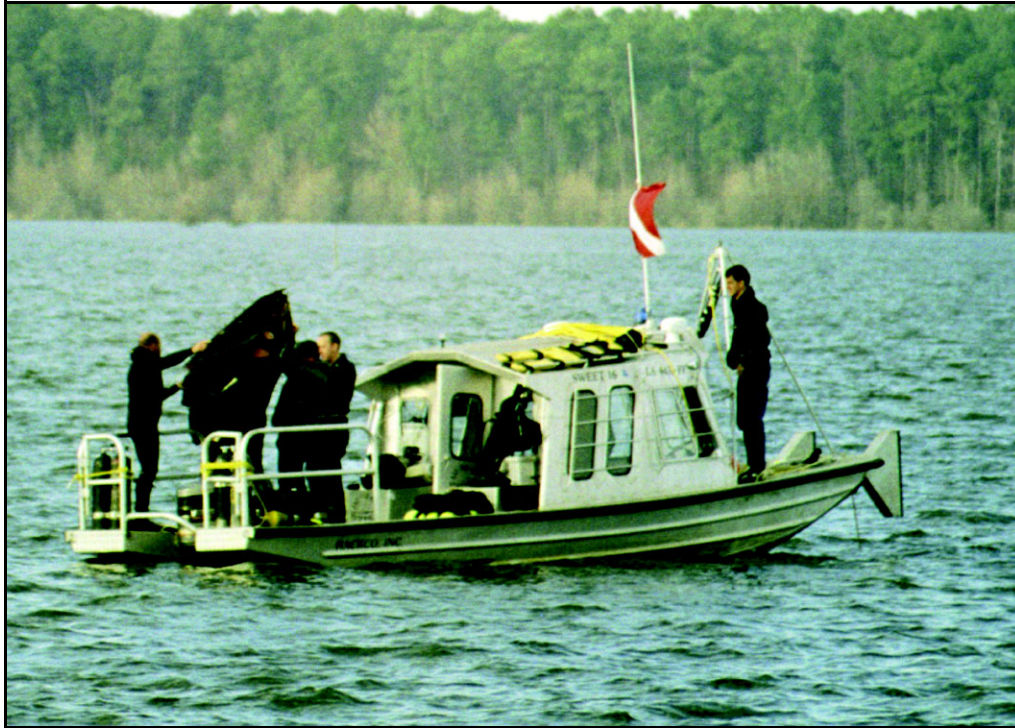
*Figure 4-6. Actual Shuttle Debris Being Placed in the Water for Testing.*

After about three weeks of searching and not finding any shuttle debris, the water search team asked NASA for some actual shuttle debris to place on the lake floor to test their search processes. Tests were conducted on March 3 and 4 on four pieces of actual shuttle debris, irregular aluminum pieces ranging in size from the largest at 2 x 3 meters to the smallest at 0.3 x 0.7 meters. Figure 4-6 provides an image of this debris being placed in the test area by one of the Navy dive teams.

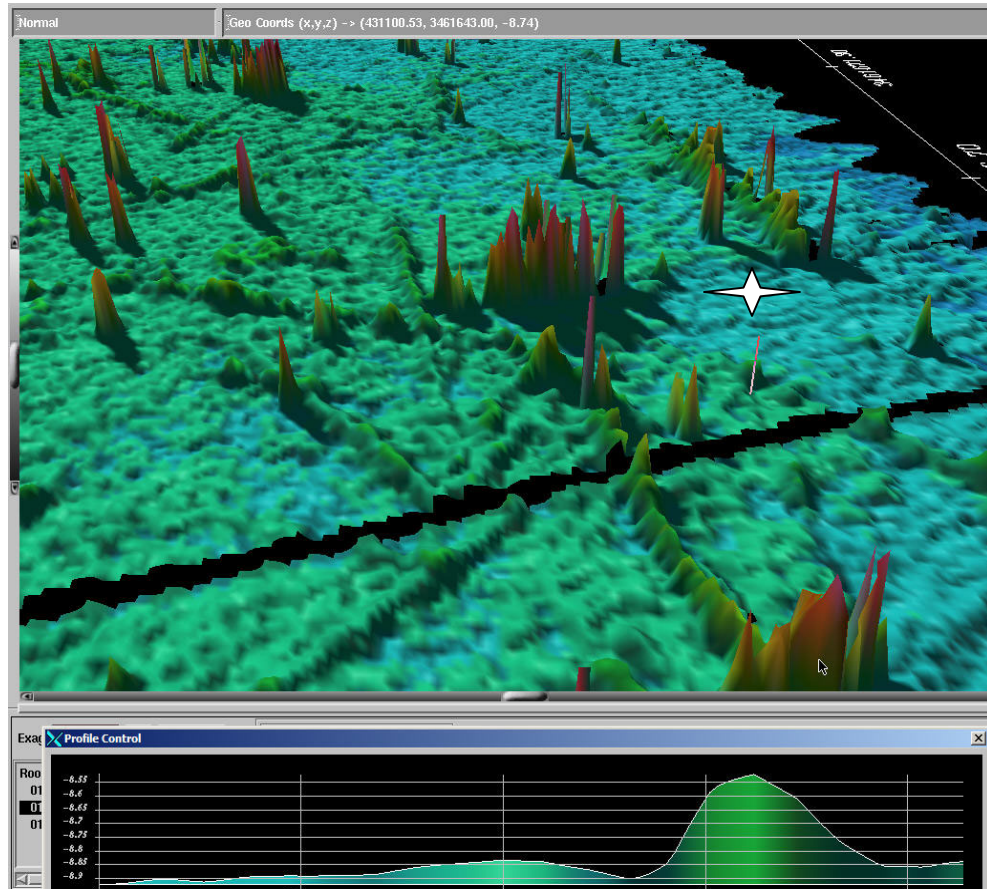
Figure 2. Same scene as above with color mapped stretch to accentuate smaller targets. Profile across 40 cm high target in Fig 1 is at bottom of Figure 2

As is clear in Fig. 1 there are a number of large features in the bathymetry some of which may be real features (trees) and others which may be system noise or other midwater targets (fish). These targets dominate the view. Most of the targets that we are interested in would not reach high into the water column so one quick approach to focusing on smaller targets is to cut the data at some height above the seafloor and stretch the color map to accentuate those features that are in the depth range of interest (Fig 2).

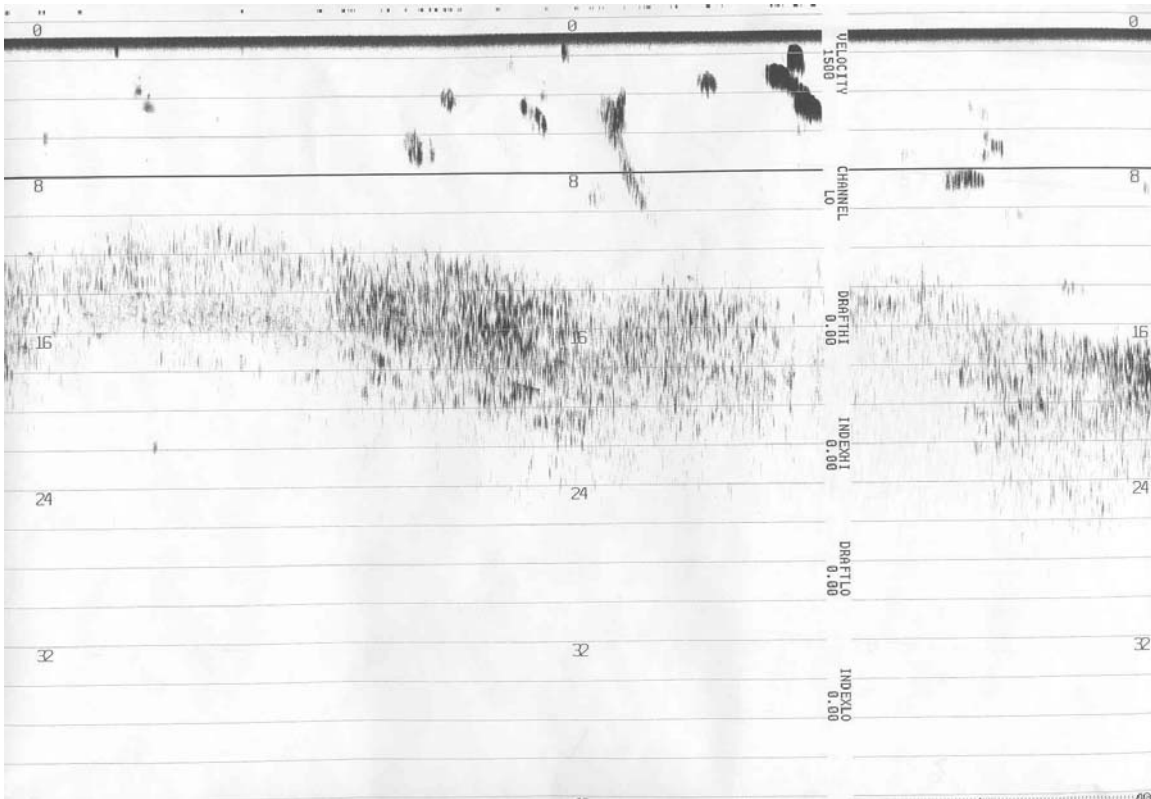
Figure 12: 12kHz echosounder in wooded terrain
