TF-05-013 FY05 HAST EVALUATION REPORT

Prepared by: Naval Surface Warfare Center, Crane Division
Component Engineering Branch, Code 6056

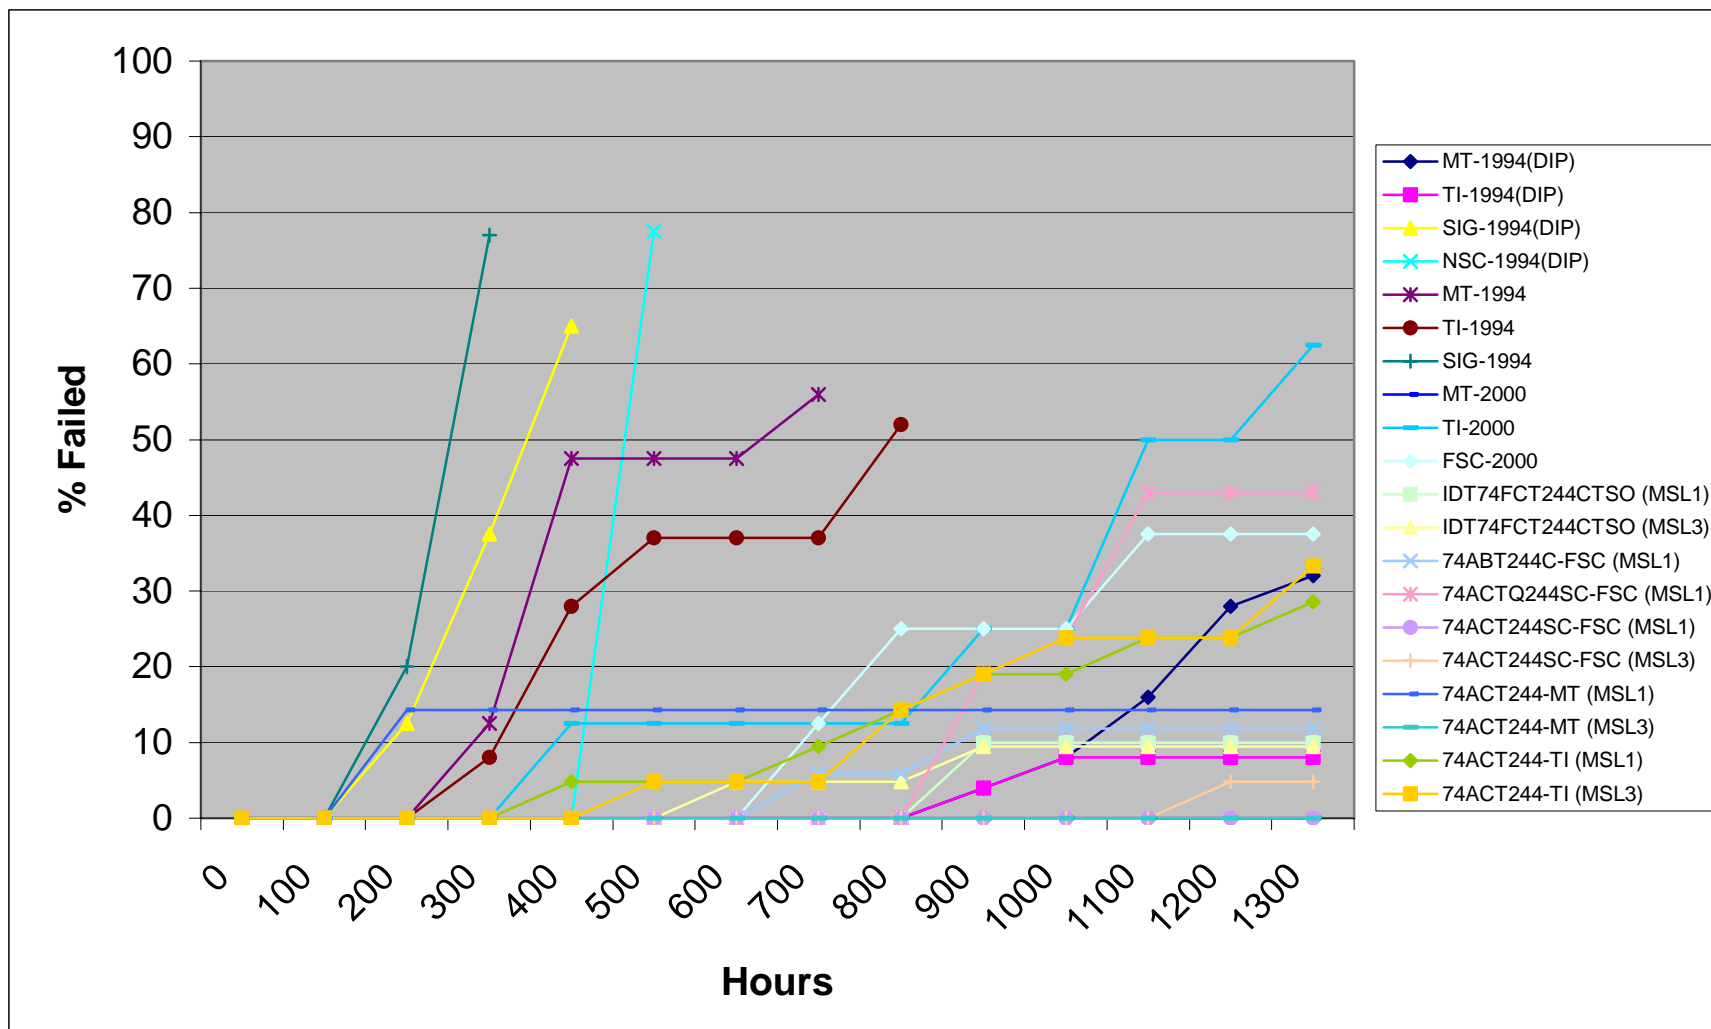
Figure 4 Current/Historical HAST Evaluation Results

The HAST evaluation was initially scheduled to proceed until there was a 50% failure rate for each device type. The 50% failure rate could not be achieved. Only 1300 hours of HAST could be completed because of electrical continuity problems due to the integrity of the device leads. Test results for this evaluation are illustrated in Figure 3. Figure 4 incorporates the results from this evaluation with historical results. The HAST
