ARKANSAS RIVER SALVAGE OPERATIONS AT DAM NO. 2

**SUPERVISOR OF SALVAGE
NAVAL SEA SYSTEMS COMMAND
DEPARTMENT OF THE NAVY
WASHINGTON, D.C. 20362
1983**

The purpose of this report is to set forth a factual reconstruction of the events that took place on the Arkansas River at Dam No. 2 between the period 4 December 1982, when 38 unattended barges broke loose from the fleeting area upstream of the dam, and 8 February 1983, when salvage operations at the dam were completed.

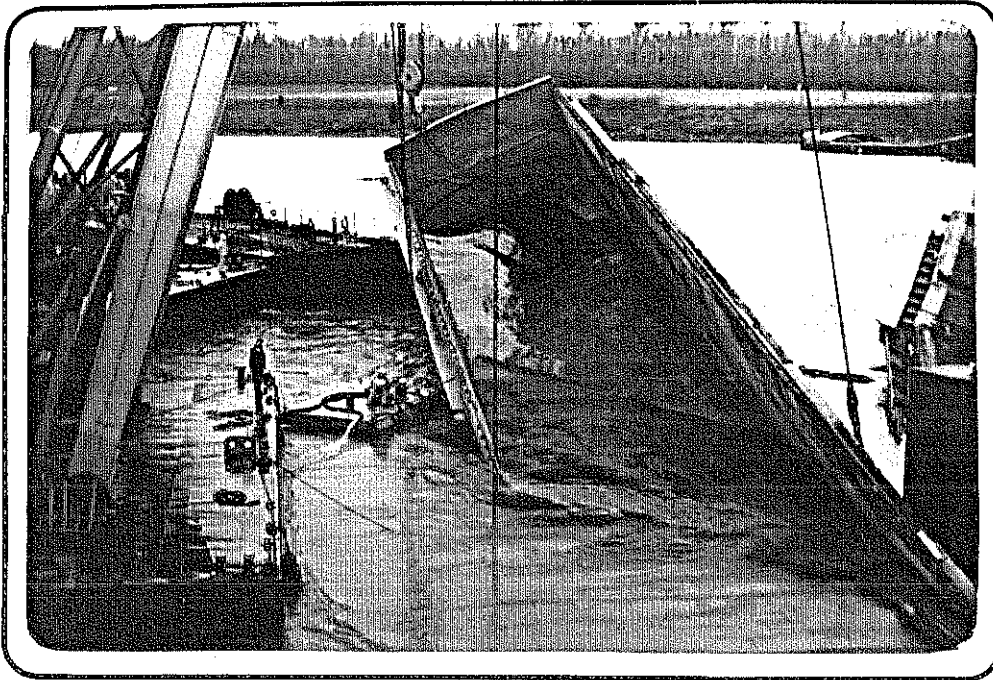
Figure 7.6.2: Pumping Starboard Tank of CGB 172

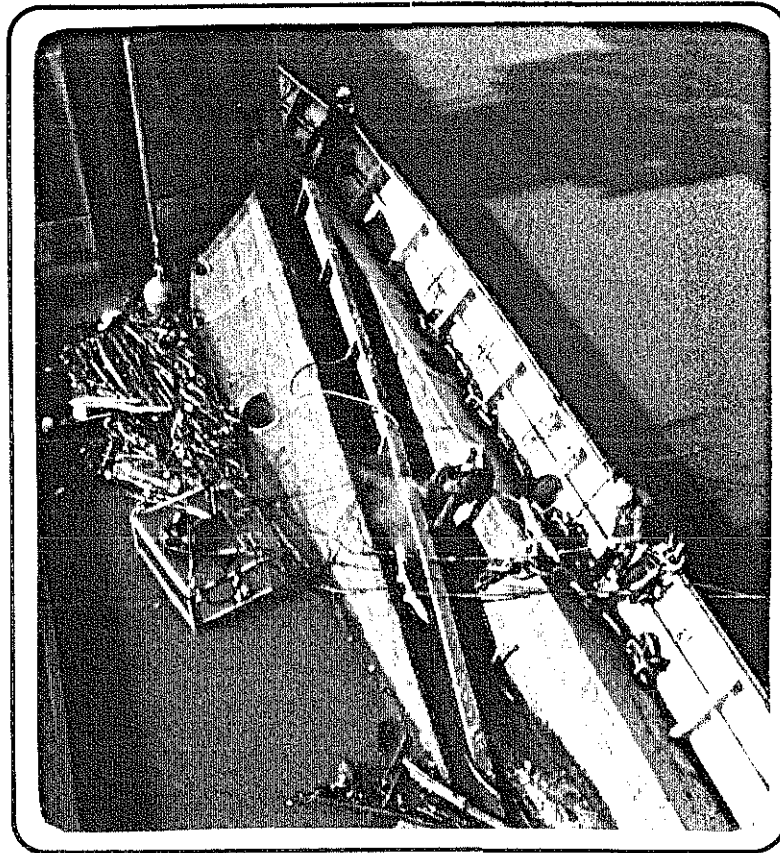
Figure 7.13.1: Diver Deployed in Man Basket to Burn Chain Holes in MST 351
