NAVSHIPS 0994-008-1010

The recovery of Bunker "C" fuel oil from the sunken tanker, SS ARROW and concurrent measures used to control oil pollution in Chedabucto Bay, Nova Scotia, during the winter of 1970.

Department of the Navy
Naval Ship Systems Command
Washington, D.C.

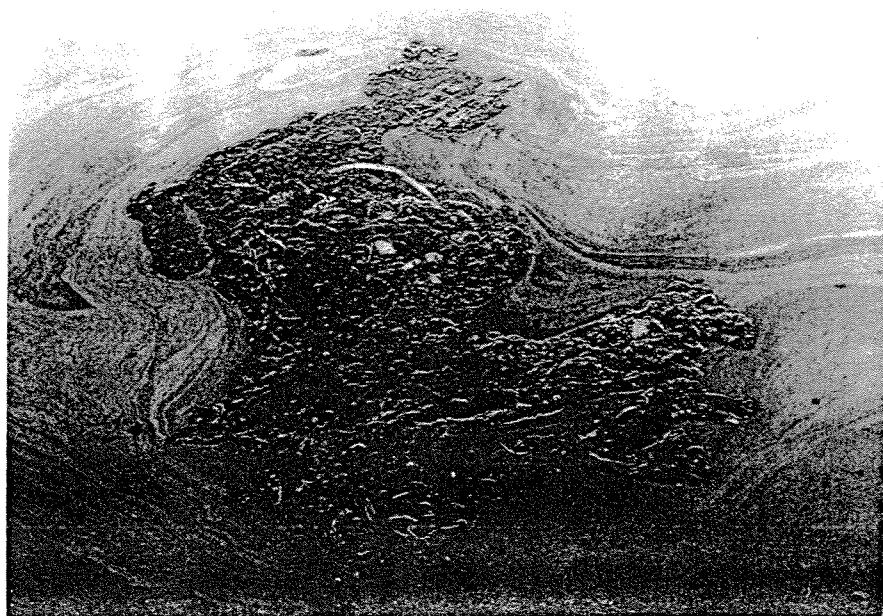
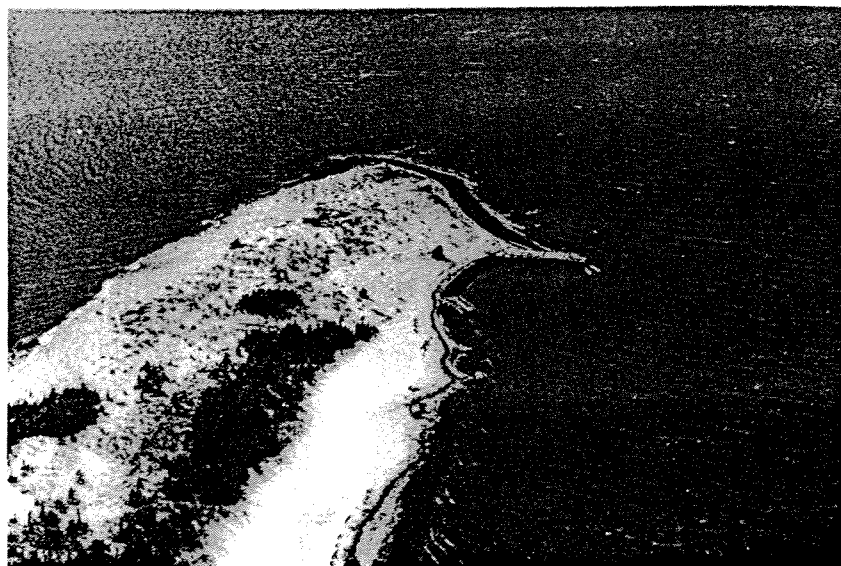
Figure 5. Bunker "C" Invading the Waters and Beaches of Chedabucto Bay.

the area by the Canadian Government. The oil was described by various observers as "globular masses," "goop," "tooth paste," and "sludge." The oil that was still in the water caused even greater concern than that which had already washed ashore. Both scientists and laymen feared that the polluted waters would threaten the livelihood of the people engaged in the fishing business, largest industry in the area. The start of the spring fishing season was little more than a month away.

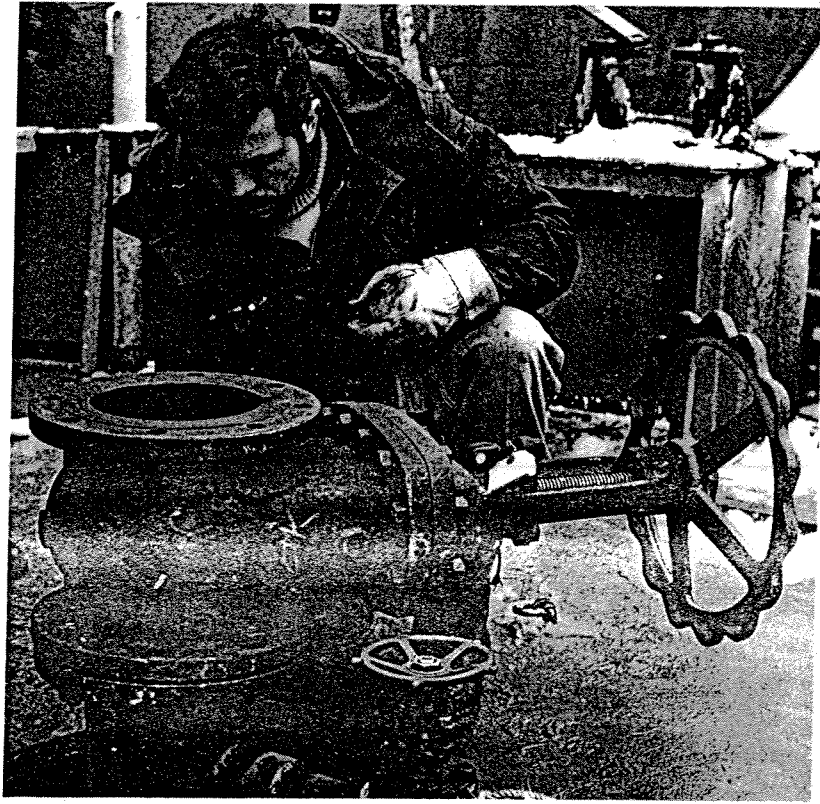
Figure 23. Gate Valve Mounted on Spool Piece.

The gate valve (figure 23), 8 inches in internal diameter, is a disc type valve that withdraws fully from the valve opening when the "gate" is opened, allowing passage for the cutting head and shaft of the hot tap machine. The gate valve played a crucial role both during the hot tap procedure and throughout the pumping operations since it enabled the divers to control the flow of oil at its source. The first gate valves used were obtained from the Imperial Oil Company Refinery in Halifax; others were purchased locally in Port Hastings through a retail outlet of the Gulf Oil Company.

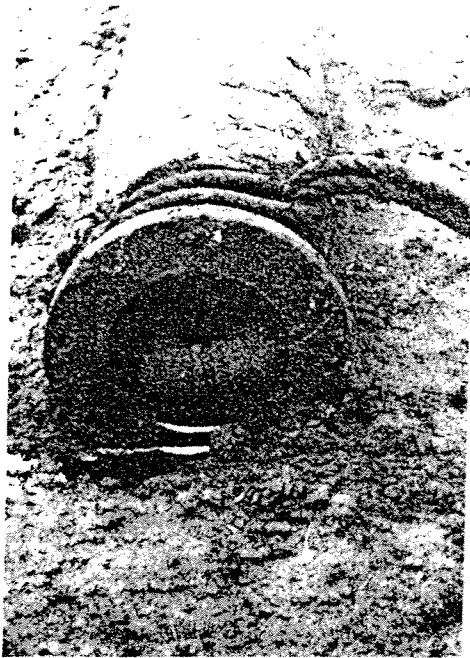
Fitting at bottom of suction hose.

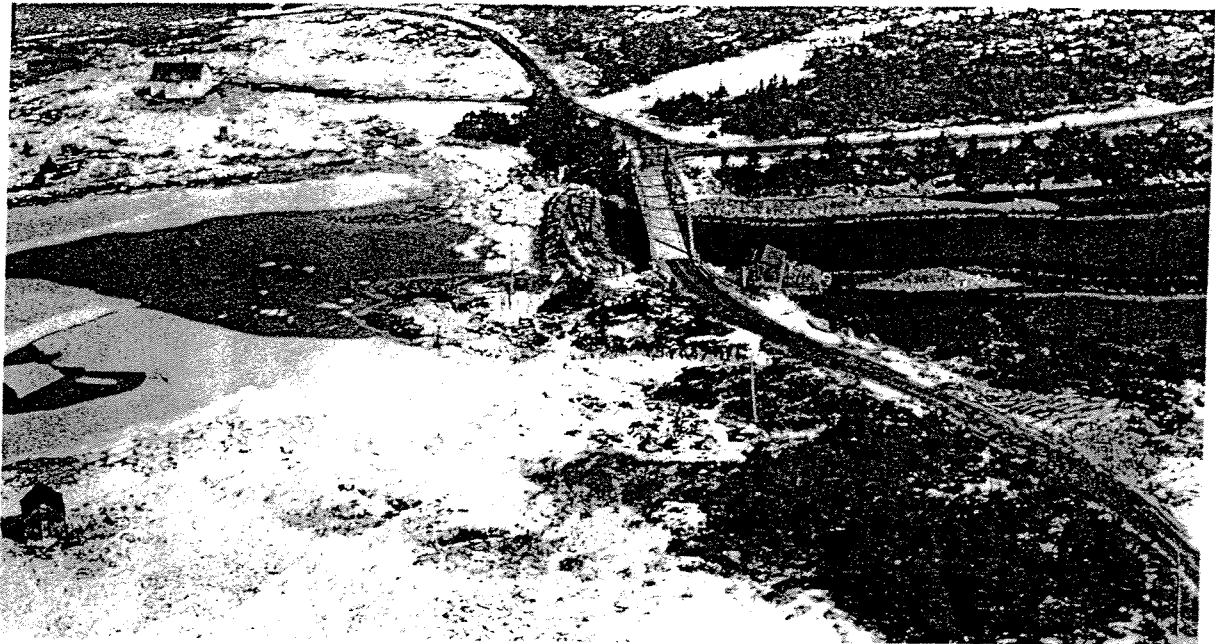
Causeway protecting Canso area against infiltration of Bunker "C" through coastal waterway.
