EX-USS BROOKINGS WRECK REMOVAL OPERATIONS

PUBLISHED BY DIRECTION OF COMMANDER, NAVAL SEA SYSTEMS COMMAND

1 JULY 1992

EXECUTIVE SUMMARY

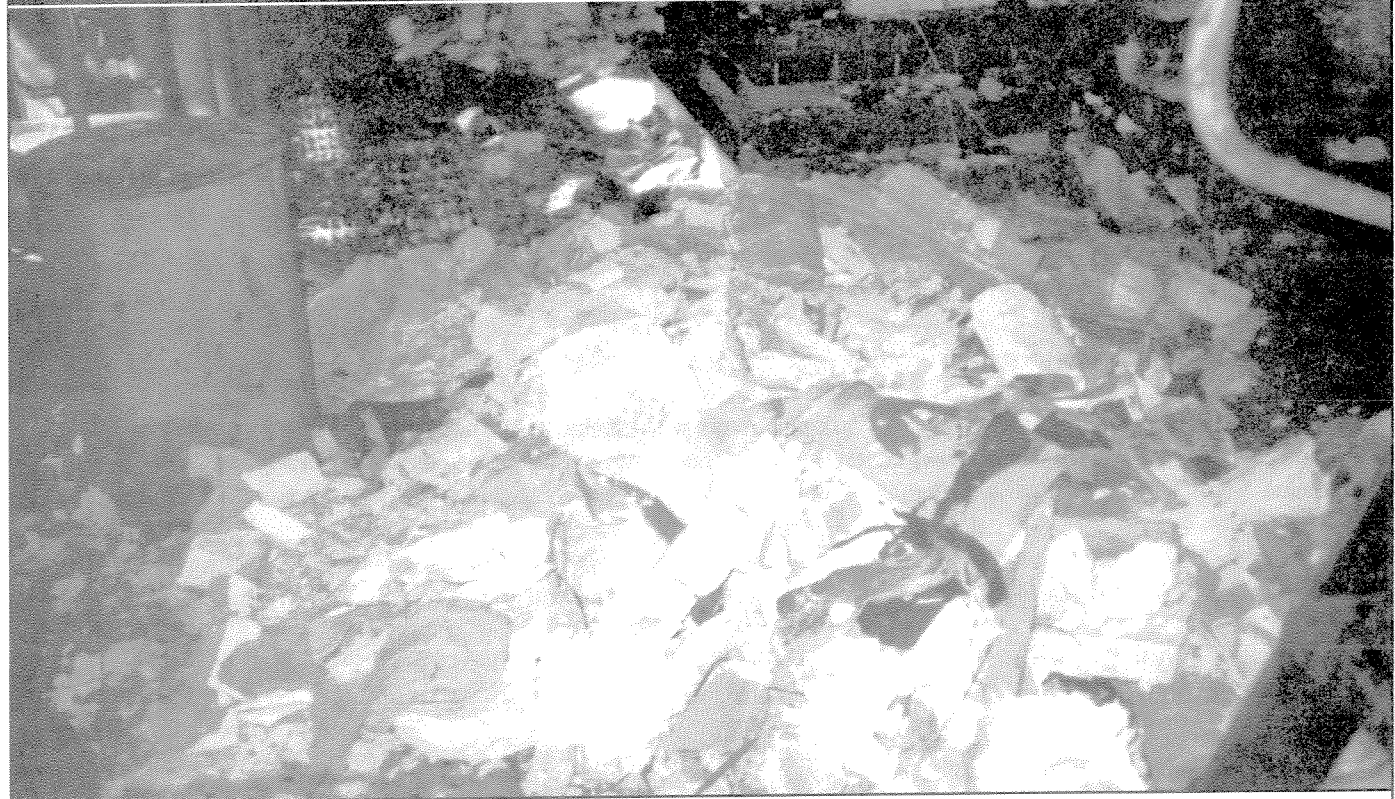
Figure 5-1A. Asbestos Removal.

5-2.1 Asbestos and PCB Removal. Asbestos removal was slated to begin 19 days after mobilization. After arriving in Puerto Rico, the SUPSALV representative approached a San Juan environmental services firm about the job; on 13 January, this firm advised that it could not take the job, and DONJON Marine contracted its subsidiary, Clean Ventures Incorporated, who dispatched an eight-man asbestos removal team that arrived 16 January. Materials containing asbestos were completely removed from all structure and machinery designated for removal to ensure that all scrap sold was asbestos-free. After removal, asbestos lagging and insulation were sealed in plastic bags and stowed in the ship's refrigeration storage spaces for disposal by sinking with the hulk. Areas where asbestos removal was in progress were cordoned off and placarded to prevent entry of unprotected workers or observers. Exposed asbestos was kept wet to limit the release of fibers into the air. Licensed asbestos removal workers were provided protective clothing consisting of full face mask respirators with combination filter cartridges for protection against dust, asbestos, and metal fumes, disposable (Tyvek) coveralls, hoods, boot covers, and gloves, as shown in Figures 5-1A and 5-1B (Pages 5-2 and 5-3). A change room was established on board, so that contaminated clothing was not worn off the vessel.

PCB-containing gaskets in ventilation ducting were removed without disturbing the gaskets by cutting the ducting on either side of the gasketed joint. The disposal of the entire joint lessened the danger of contamination.

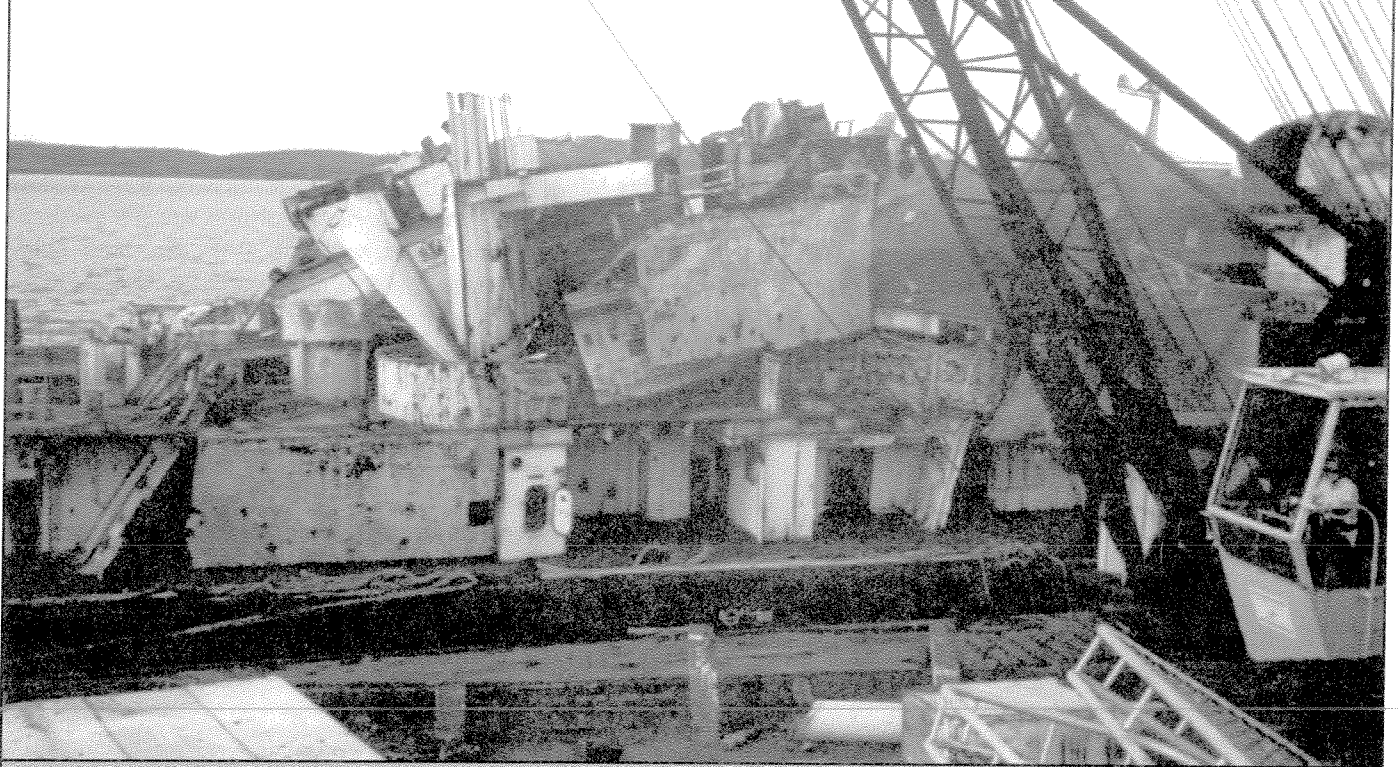
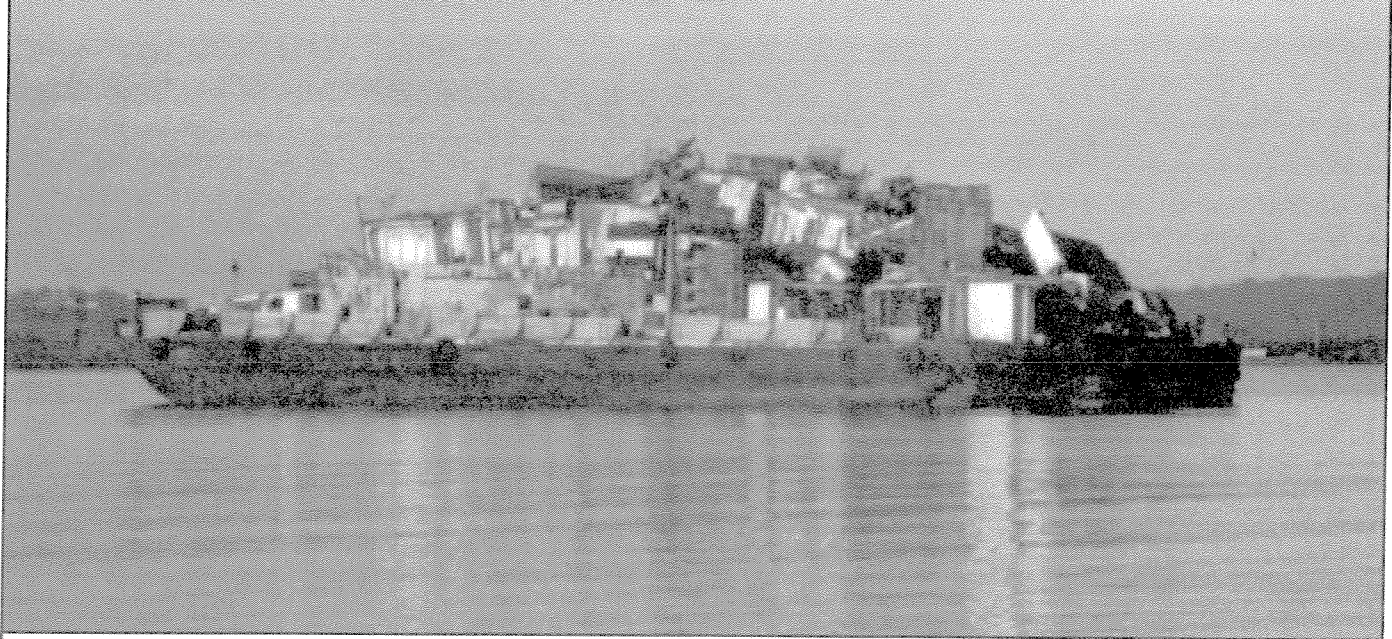
Figure 5-4. Scrap Barges.

5-5.3.2 Scrap Barges. The first scrap barge, PS-201, was a simple 210-foot, flat-topped, steel-decked, rake-bowed barge. The 250-foot SANTO DOMINGO, hired later in the operation, was better suited to hauling scrap. In addition to her larger size, SANTO DOMINGO's deck was sheathed with heavy timber, an important feature when hauling heavy scrap loads. The timber decking protected the barge deck from chafing and gouging by the scrap, but more importantly, helped prevent shifting as the heavy and sharp edged pieces of scrap bite into the wood. This is important as scrap is a high-volume cargo and must be piled high to even approach the barge's deadweight capacity. This is shown clearly in Figure 5-4. The 40-foot pile of scrap on the 5,000-ton (DWT) SANTO DOMINGO weighs approximately 1,325 long tons. SANTO DOMINGO was also fitted with 5-foot timber side and end bulwarks to help contain the scrap.

210-FT CROWLEY BARGE
LOADED BY OBS-2250

SANTO DOMINGO WITH
1,326 TONS OF SCRAP

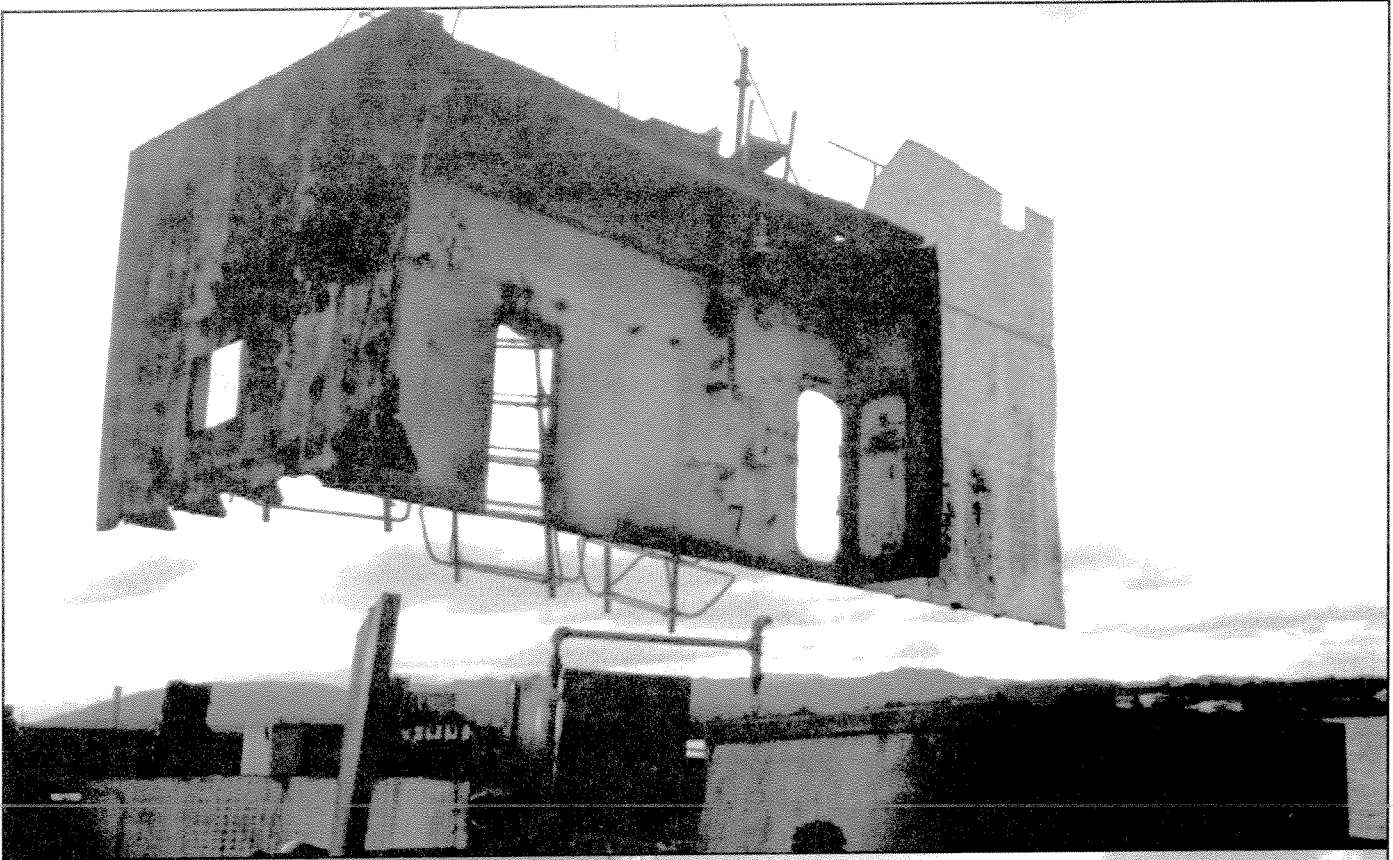
Figure 5-7A. Scrap Sections.

5-5.4.2 Scrap Lifts. For lifting, holes were cut in the top of each scrap section, often in the corners, to receive the hooks of a multi-leg sling. The slung sections were lifted, swung out, and placed directly on the scrap barge. Skill and experience of the crane operator had a direct bearing on the speed of the operation, and the amount of scrap that could be placed on the barge safely.
