SUPERVISOR OF SALVAGE U.S. NAVY

EXXON VALDEZ OIL SPILL RESPONSE

T0800-AD-RPT-010/SUPSALV
0910-LP-352-3100

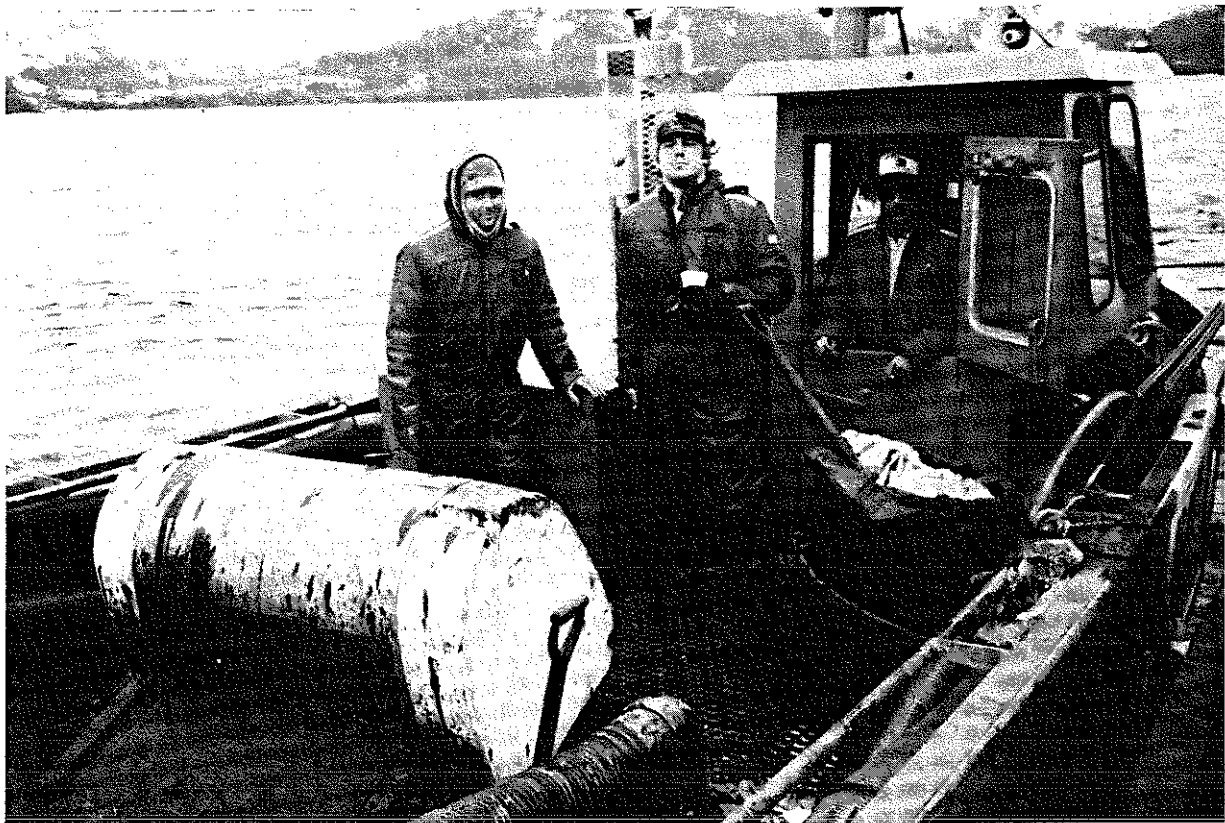
Figure 3-12. A Third Crew Member was added to the Class V Skimmer's Normal Crew.

Oil adhered to kelp and the forest debris typical of Alaskan waters so that the skimmers gathered a significant amount of this material along with oil. As the oil became more viscous, the quantity of debris recovered increased. A third crew member was added to the Class V skimmer's normal crew of two to keep the skimmer belt free from debris and to assist in placing recovered debris in bags. The third person was essential to keep the skimmer in operation (see Figure 3-12). As skimmers were deployed progressively farther apart during this response, large quantities of bagged debris accumulated on skimmer decks where it sometimes interfered with skimmer operations. Workers recovered thousands of bags containing a mixture of oil, and debris. Trash barges circulated among skimmers collecting bagged debris.
