U.S. NAVY SALVAGE REPORT

M/V WENDY

FEBRUARY 1994

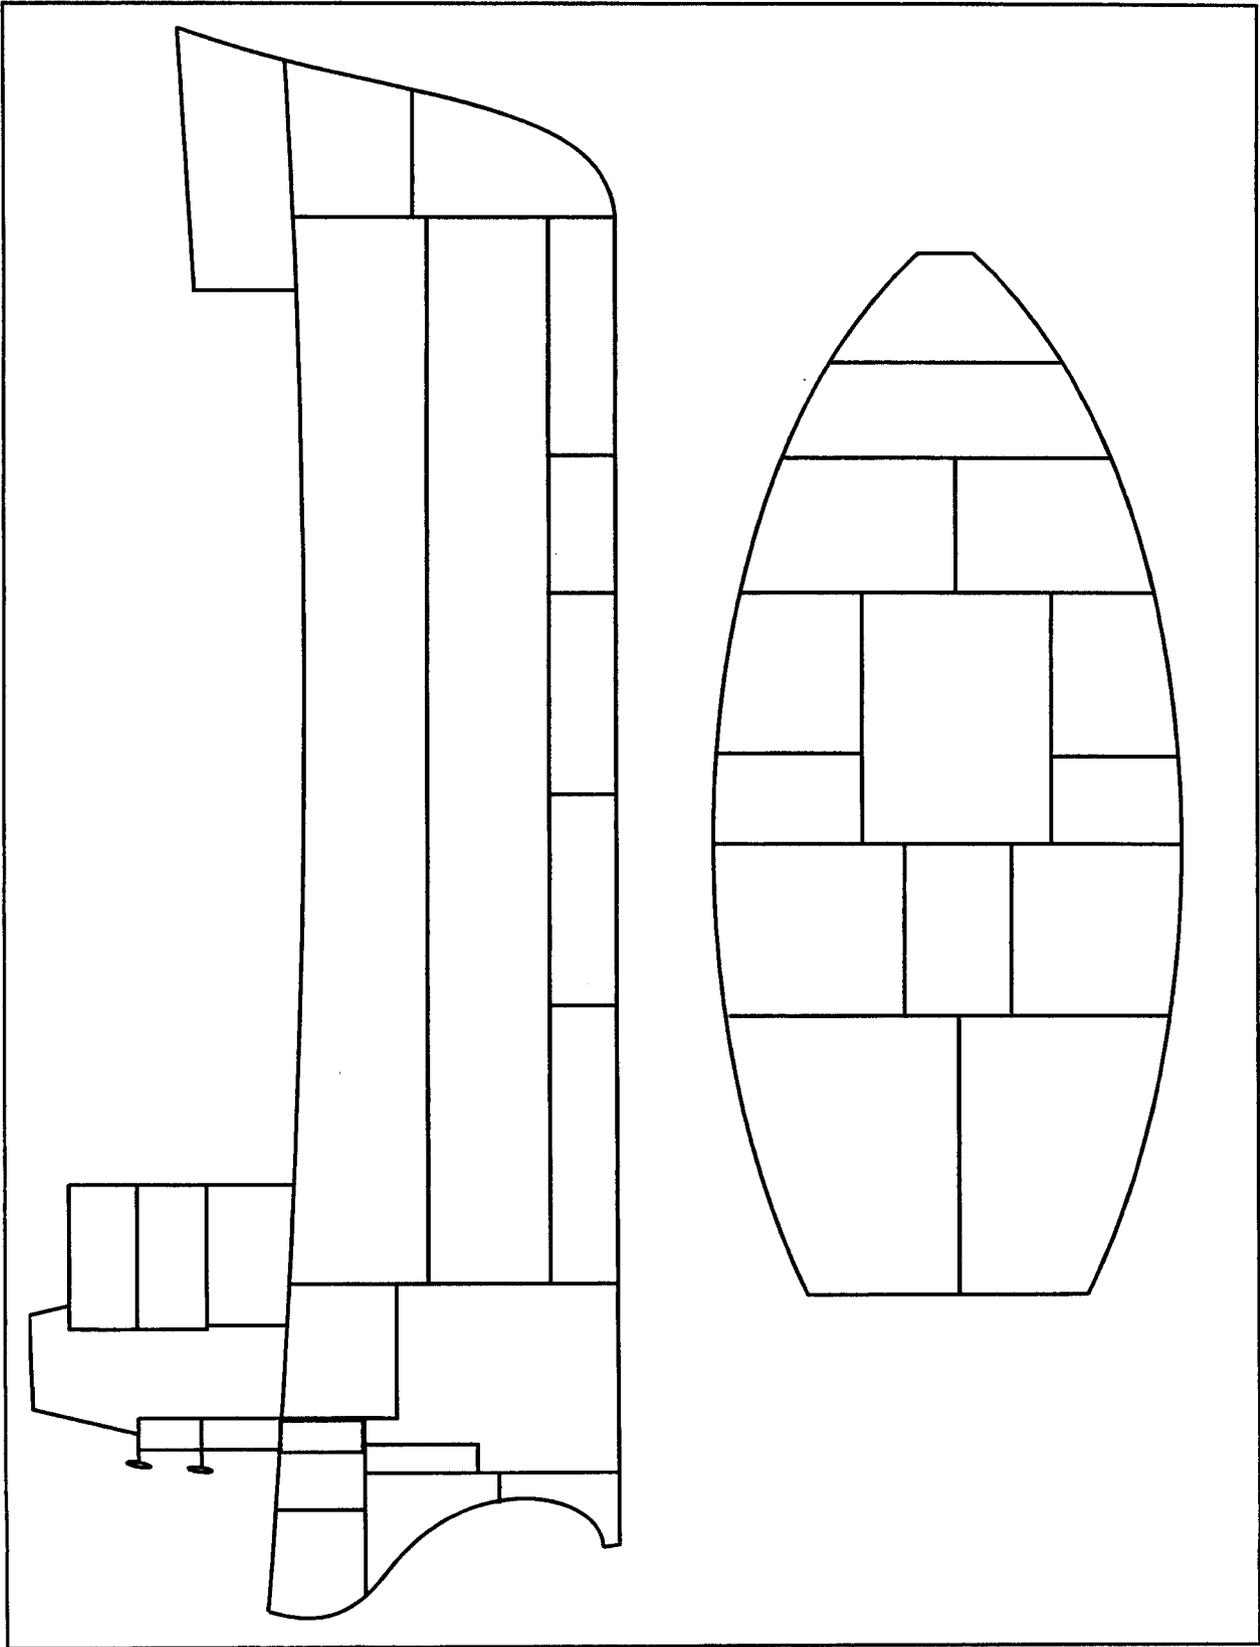
Figure 3-1. Layout of the WENDY'S Compartments.

The damage control plans obtained during the February 1993 trip (Appendix Q), provided the first real indication of how the ship's compartments were laid out. The resulting compartment model was relatively accurate and was modified only after divers completed the initial survey of the engine room compartment during the salvage of WENDY itself.

The major concerns for the salvage of WENDY were the free surface contributions from the engine room and especially the cargo compartment. The cargo compartment had a 155 foot length and a 35 foot beam. The concern for the free surface affect resulting from this compartment drove the initial salvage plan to consider only two alternatives. First, heavy lift WENDY in the submerged condition to a disposal site or second, drag WENDY up the beach to maintain stability due to ground reaction until the cargo compartment could be de-watered.

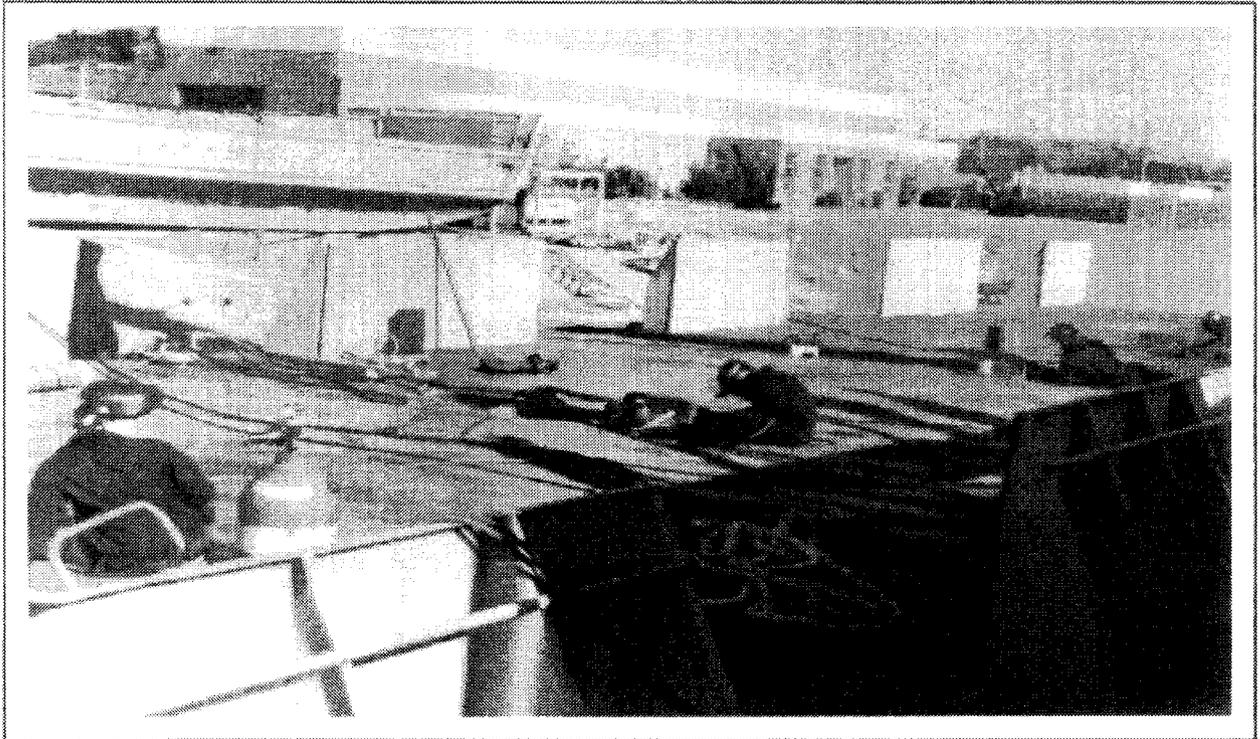
Figure 3-6. Installation of Padeyes by SUPPRON EIGHT Personnel.

3-2.3.2.1 Padeyes. Both barges were modified for use in a heavy lift configuration by installing five padeyes on the centerline of the deck. Each padeye was centered over a tank compartment bulkhead to take

Manufacture of the padeyes was accomplished with the assistance of NAVSEA 00C and Cheatham Annex ESSM personnel who supplied the steel plate material and cut the plate to the required dimensions. Welders from SIMA, Norfolk and COMSUPPRON EIGHT ships constructed and attached the padeyes to the barges. Figure 3-6 shows the installation of the padeyes by SUPPRON EIGHT personnel.

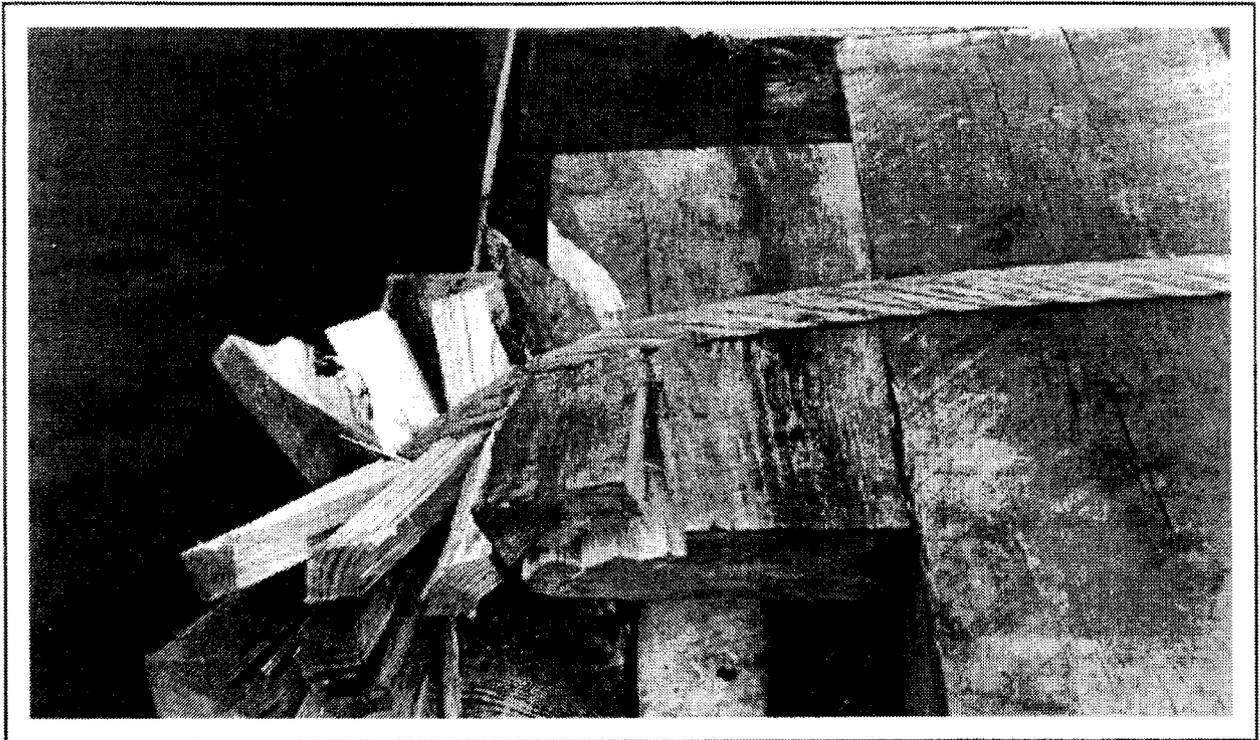
Figure 3-8. Barge Deck Edges Showing Structural Reinforcement.

3-2.3.2.2 Deck Edges. To handle the stress of the cables as they passed over the deck edges of the barges, 5-foot sections of 6-inch angle iron were welded in place. 10x14-inch oak docking blocks (Figure 3-8) were also obtained to provide an 8-inch minimum radius for the cable as it passed over the deck edge. This radius and the additional structural angle iron ensured that failure by cable slicing and shear would not occur. Appendix B discusses cable slicing as it pertains here and to WENDY.

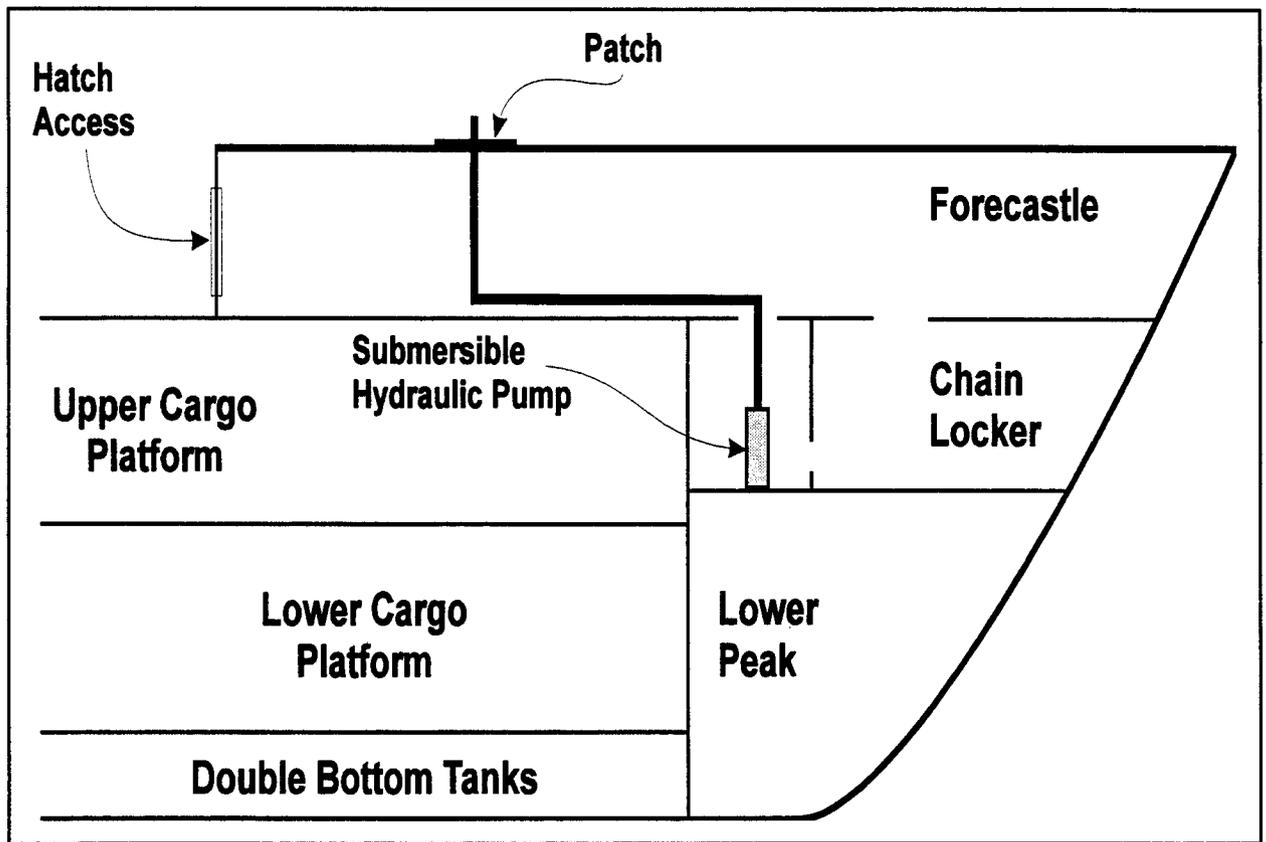
Figure 3-9. Placement of Submersible Hydraulic Pump in Forward Compartments. The Lower Peak was not Accessible to Divers.

3-4.1.1 Forward Compartments. Patches were installed on all holes that could be identified by the divers. An access was cut into the forecastle deck over the bosun locker. A patch was then manufactured and installed with fittings for a six-inch hydraulic pump. The pump was then installed into the upper peak tank through deck openings in the bosun locker. Figure 3-9 illustrates the positioning of the pump within the compartments. This configuration would ensure that both the bosun locker and upper peak tank would be de-watered completely. A pneuemo hose was attached to the deck in the upper peak tank to monitor the de-watering progress.

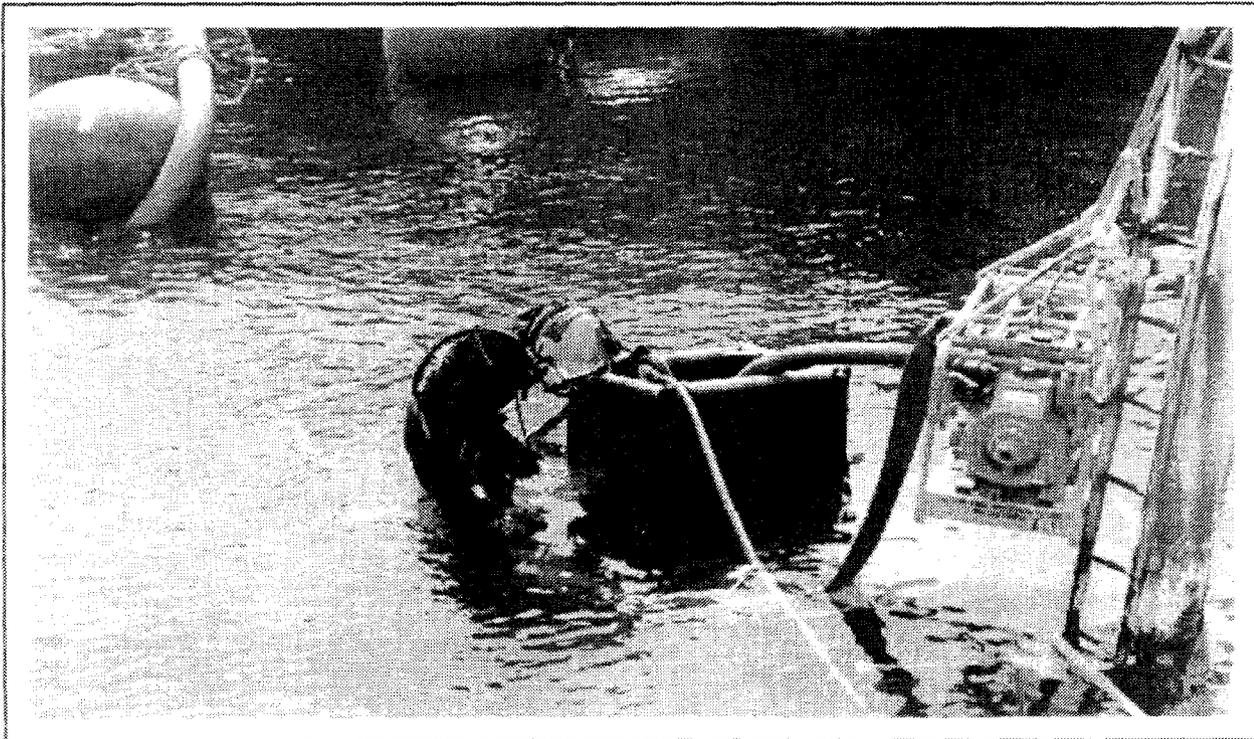
Figure 3-10. View of Cofferdam Attached to the WENDY Stack.

The top of the stack was roughly two feet below the surface and therefore required a cofferdam to be constructed and installed to provide water tight access directly to the surface. It was through this access (Figures 3-10 and 3-11) that the de-watering pumps were installed. Numerous attempts at de-watering the engine room space with a six-inch and two three-inch diesel pumps succeeded in achieving only a couple of feet. Significant de-watering occurred only after an additional 4-inch hydraulic and a 4-inch electric pump were installed. As the engine room was de-watered, additional leaks were identified by salvors looking down the stack. Once the location of the leaks were determined, divers were able to locate them and install various damage control plugs to secure them. Using all four pumps, the test de-watering of the engine room was successful.

3-4.1.2.2 Engine Room Stack. During the engine room de-watering, there was considerable concern over the ability of the stack plating to withstand the hydrostatic loading once the internal water level was reduced below the main deck. Calculations (Appendix E) indicated that failure of the engine room stack would occur if de-watering of the engine room was undertaken. Therefore, de-watering of the engine room was considered a last resort if de-watering of all other compartments failed to achieve a sufficient reduction in the ground reaction. As the plating did not fail as was predicted, it can only be assumed that the frame spacing and/or material was heavier than reported by the divers.

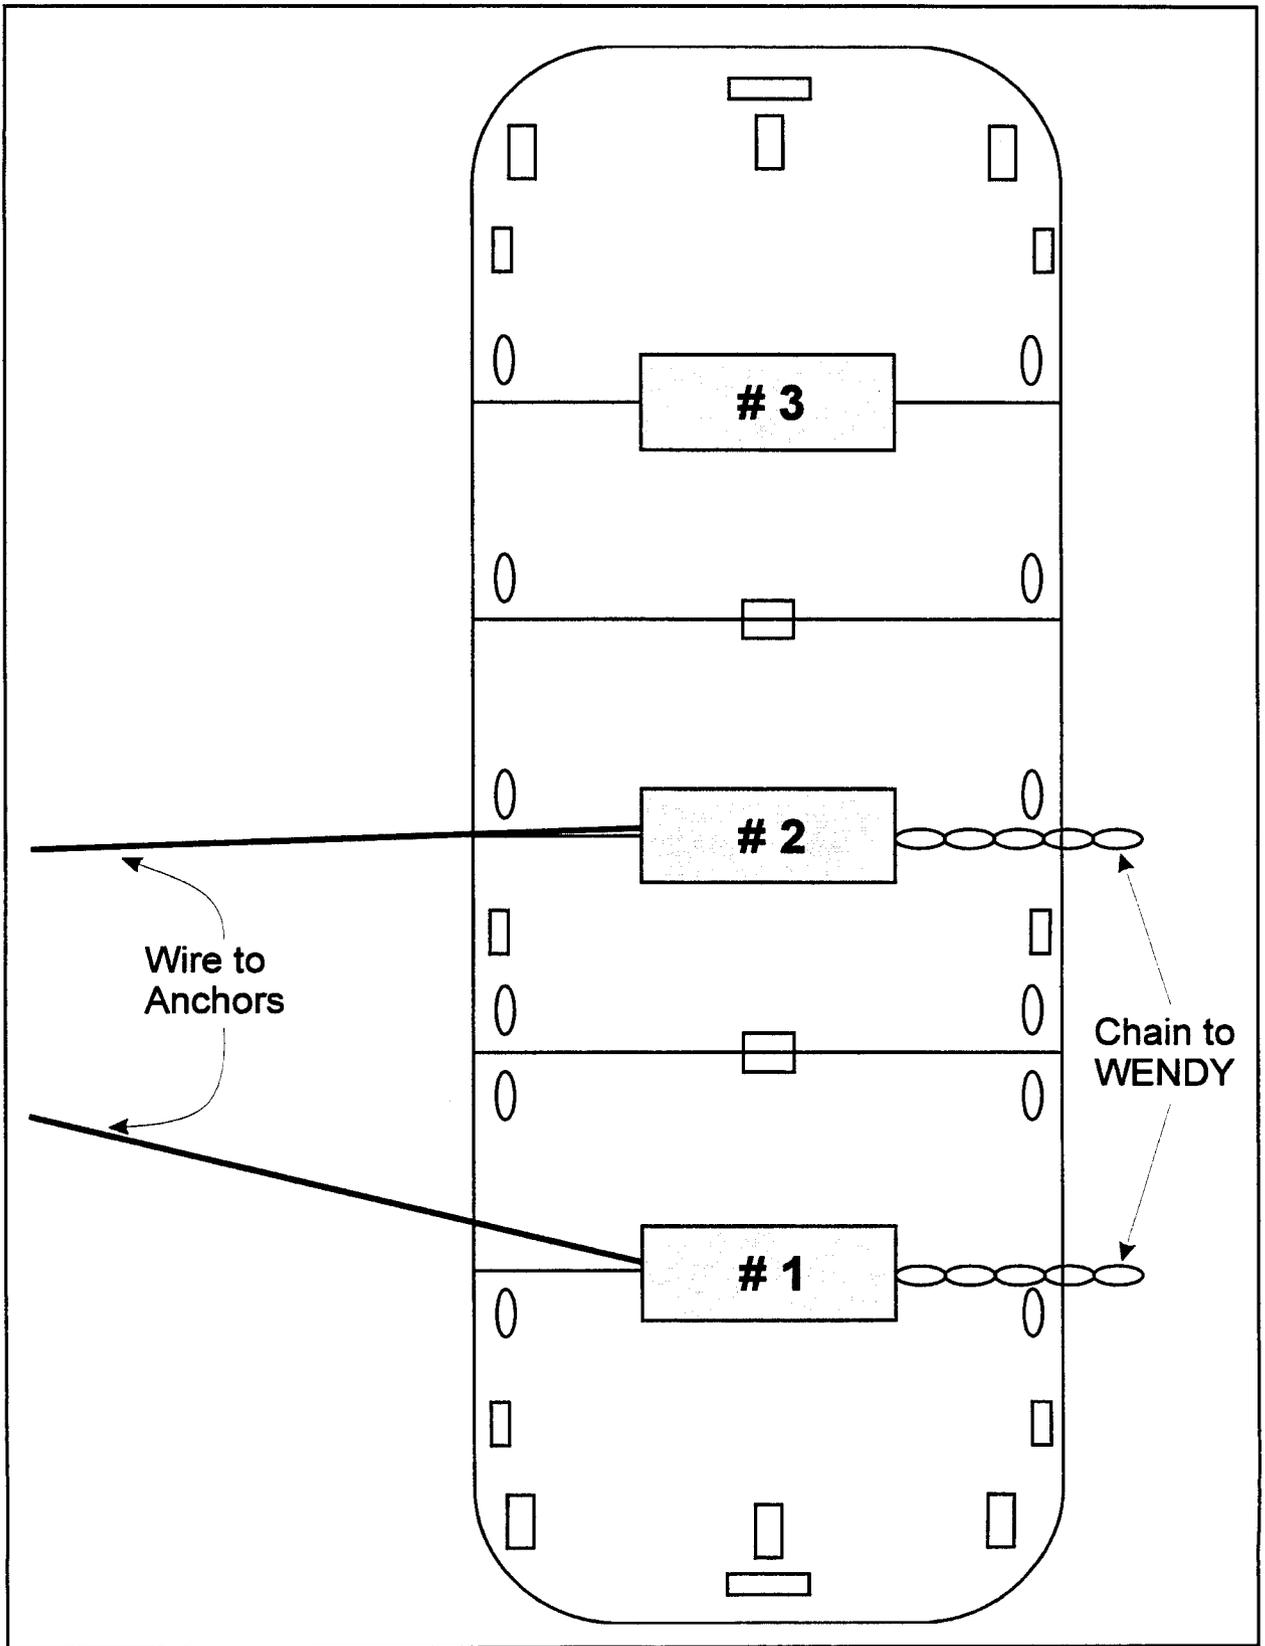
Figure 3-20. YC Puller Configuration for Second Pull of WENDY. Hydraulic Puller #3 is Idle.

3-4-3.2. Second Pull YC Configuration. For the second pull, only positions 1 and 2 were used to pull directly on WENDY as shown in Figure 3-20. The third stato anchor was reconnected to a sheeve through which GRASP's tow wire would pass. The Port 2-1/4-inch chain on the stern of WENDY was fastened to GRASP's tow wire which passed through the sheave as shown in Figure 3-21. The YFN was configured for heavy lift as shown in Figure 3-22 to provide a reduction in forward ground reaction.

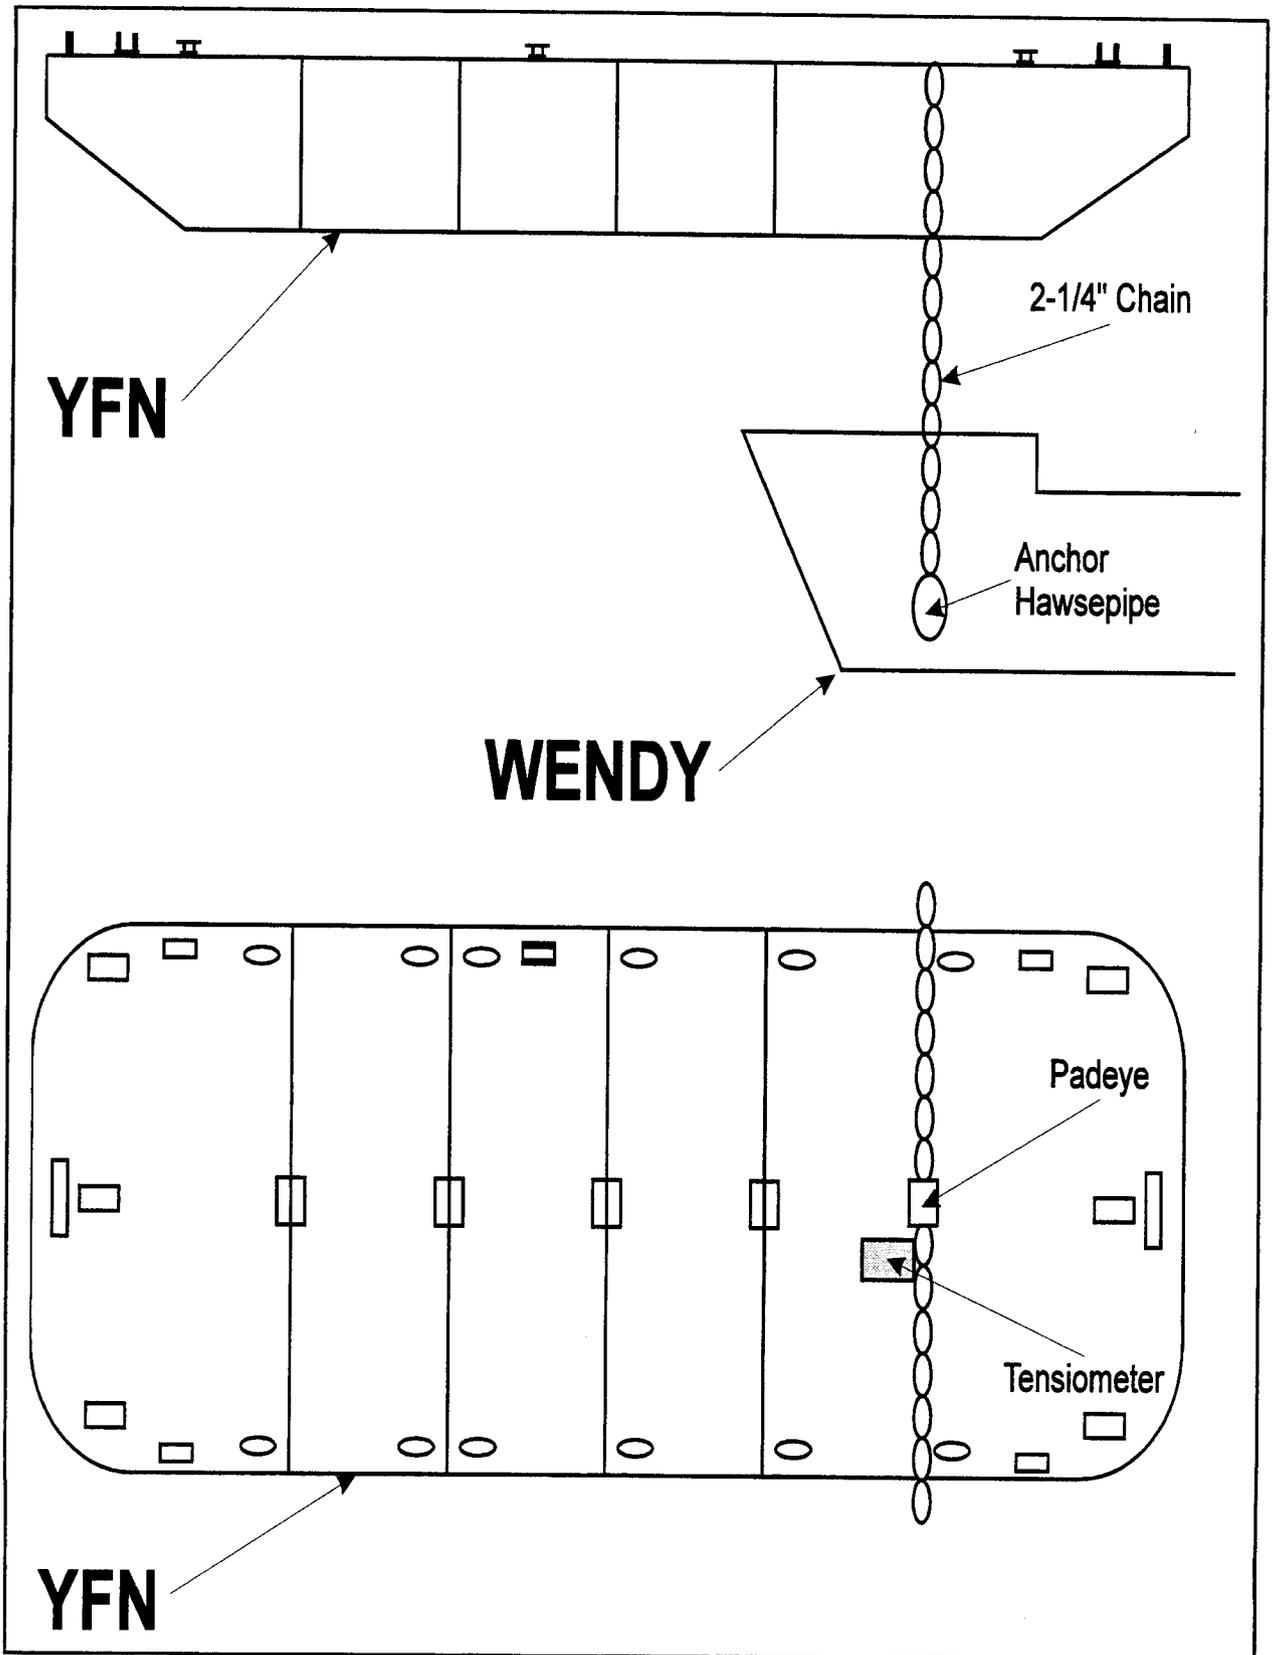
Figure 3-22. YFN Configuration for Heavy Bow Lift of WENDY for Second Pull into Shallow Water.

3-4.3.3 YC Ballasting. To achieve additional lift and further reduce the required freeing force, the YC was used as a lift barge at the same time it was being used as a pulling barge. The YC tanks were fully flooded using 3-inch de-watering pumps and fire hoses. The ballast obtained was about 140 tons for each tank. The slack in the 2 1/4-inch chain from WENDY to the hydraulic pullers was then taken in. After the maximum strain (50,000 lbs. each) was taken on the hydraulic pullers, the two tanks were de-watered. This added lift and the resultant additional freeing force combined to initiate the retraction of WENDY. Appendix F presents an in-depth analysis of this configuration.

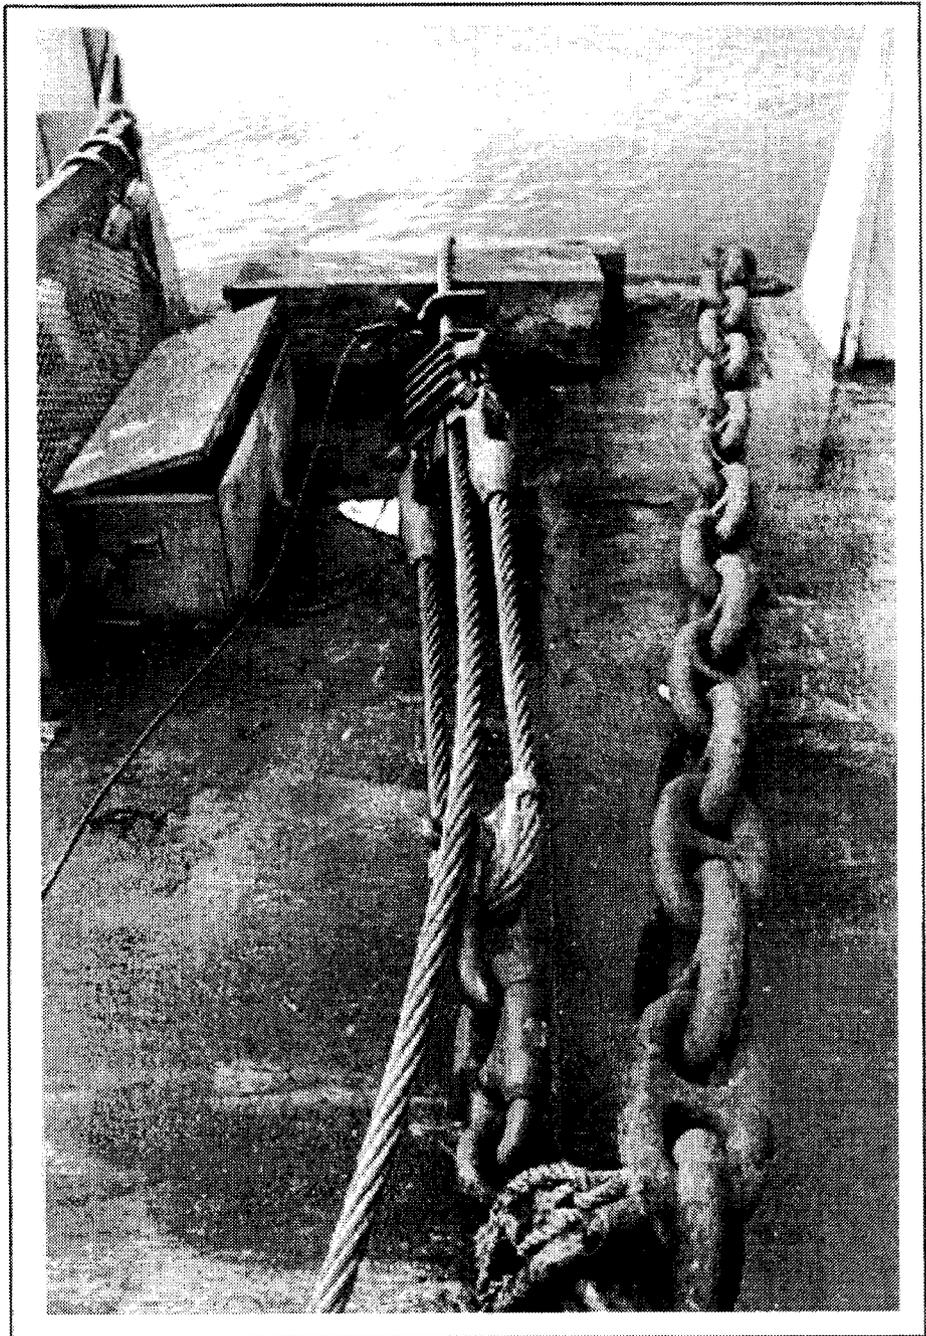
Figure 3-34. Topside View of YC Rigged with Wire and Chain to Support the WENDY.

Figures 3-34 through 3-36 show the placement of charges on the YC. Charges were placed after the YC had been fully pumped and all equipment removed from the barge. Only the demolition crew remained on board the YC during the tow.

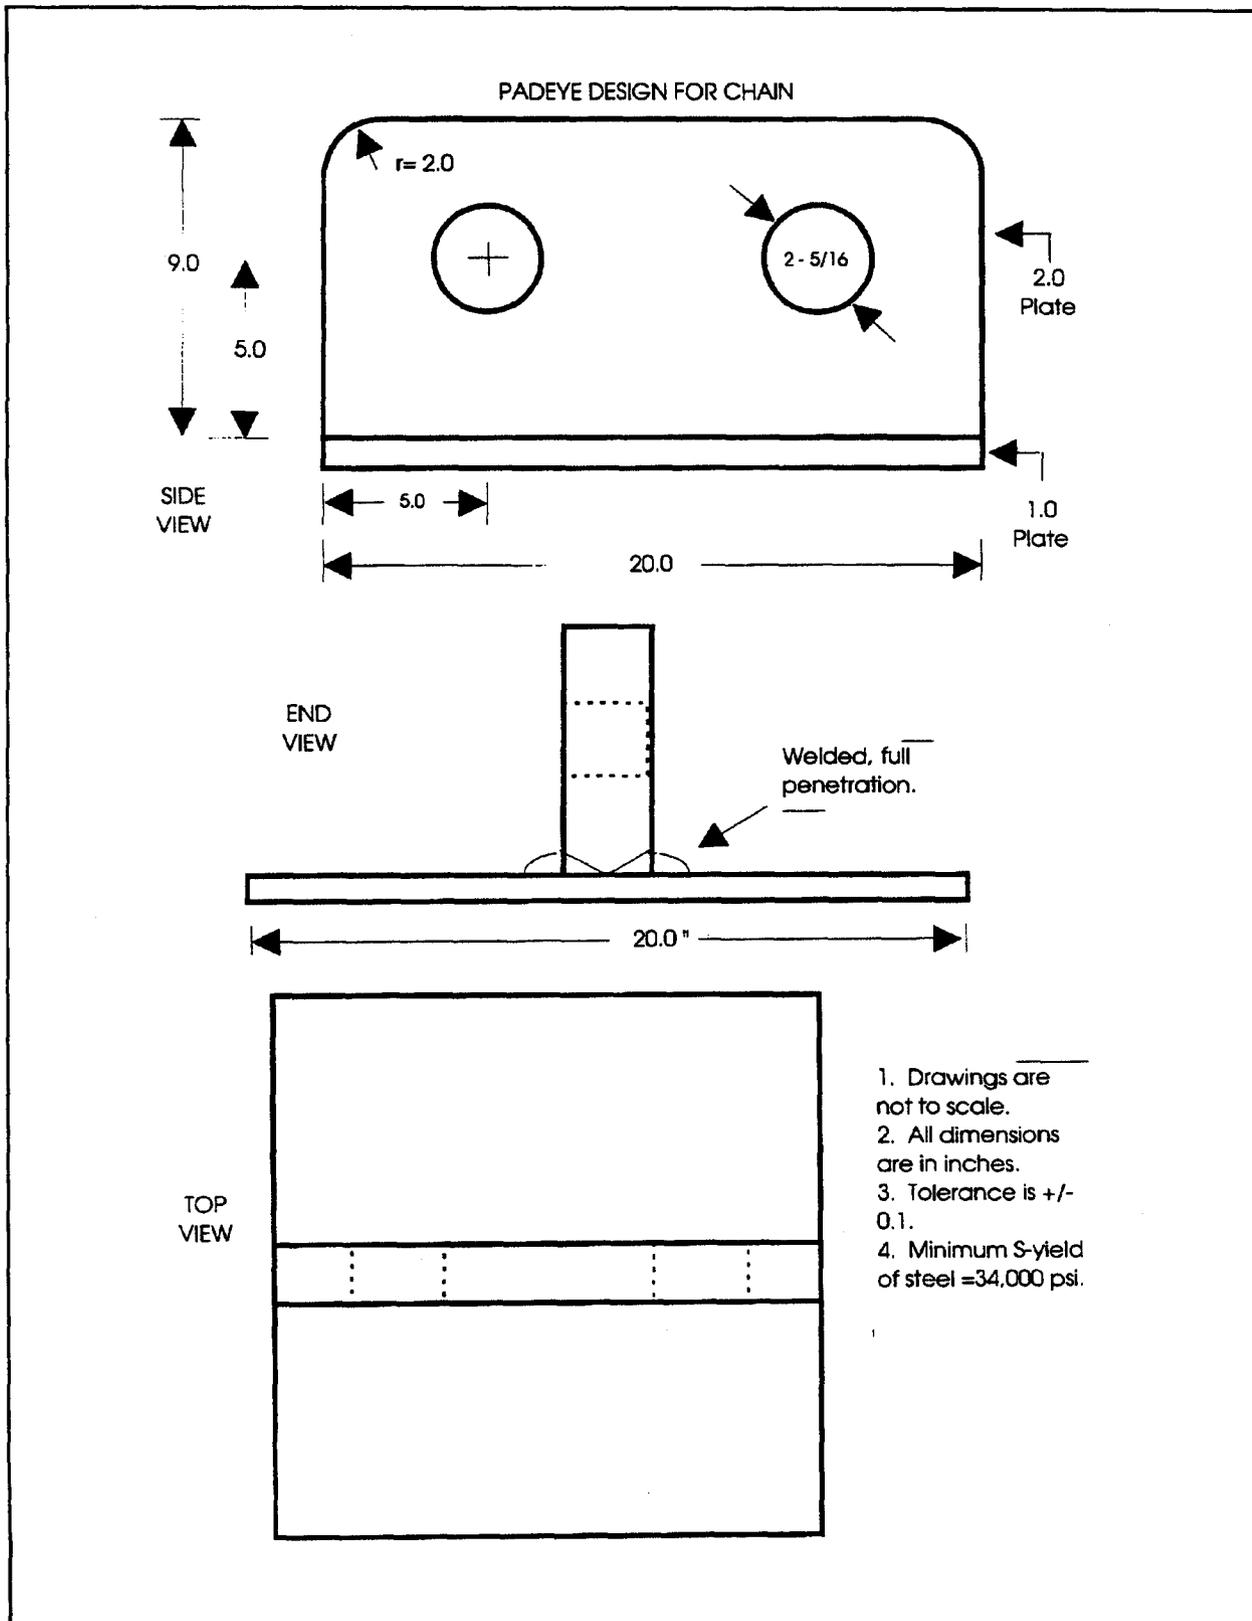
Figure A-1. Completed Padeye Installation.

Failure due to rupture of the padeye plate itself will occur if $\sigma > S_y$.

The only remaining failure mode is pure shear of the pin connecting the padeye to the plate shackle which is rated at 65 tons.

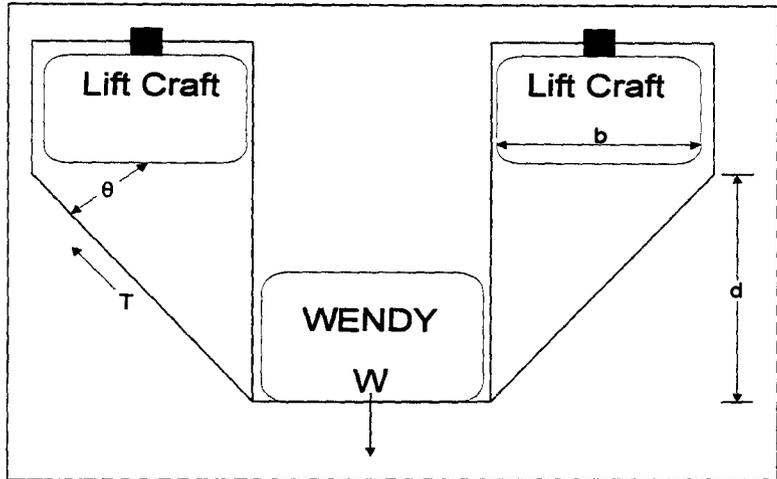
Fig. B-1. Tandem Lift Configuration.

- W = Wreck weight in water
- T = Lift wire tension
- b = Lift craft beam
- d = Distance from lift craft bottom to WENDY bottom
- θ = Angle between bottom of lift craft and outboard wire
- N = Number of lift wire sets used

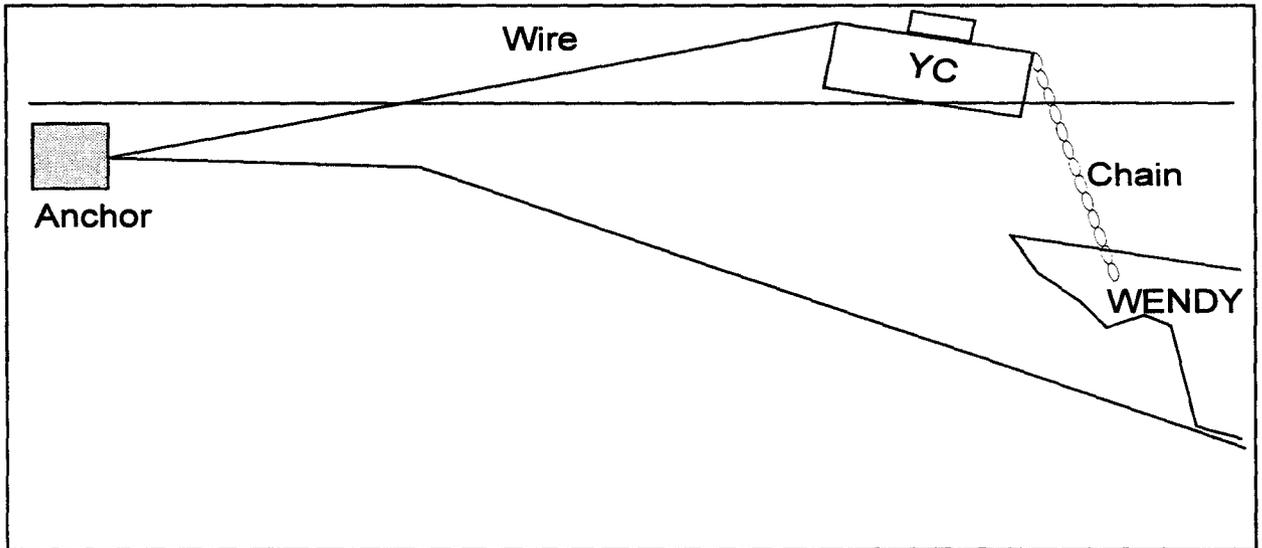
Fig. F-1. Beach Gear Configuration.

Figure F-1 shows the general configuration used to pull WENDY into shallower water. Three hydraulic pullers were positioned on the barge as shown in figure F-2. The wire rope from each puller was taken to a shot of 2 1/4-inch chain which was then attached to a stato anchor. The water depth of each anchor was roughly 10-12 feet.

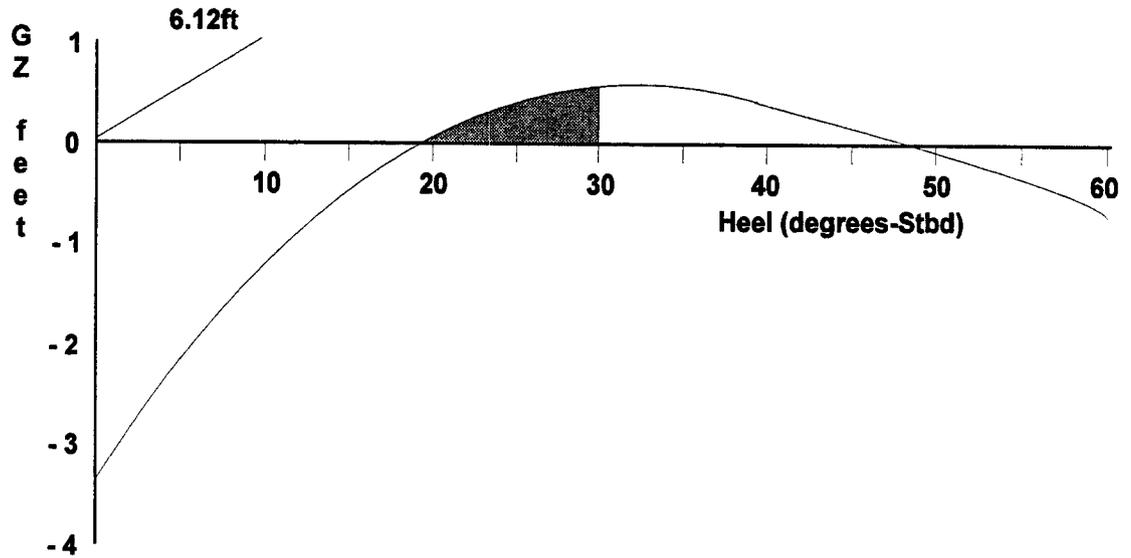
Angle of Heel	19.5 deg-S
Angle at Maximum GZ	30.8 deg
Area to 30.8 degrees	4.11 ft-deg
Maximum GZ	0.54 ft

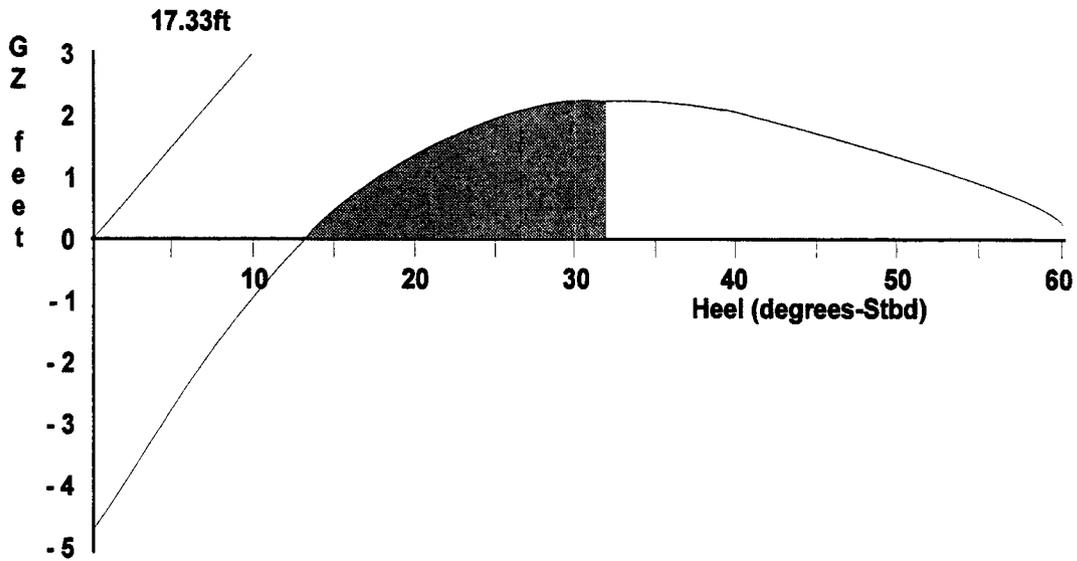
Angle of Heel	13.2 deg-S
Angle at Maximum GZ	32.3 deg
Area to 32.3 degrees	29.31 ft-deg
Maximum GZ	2.20 ft
