SALVOPS 70

A review of significant salvage operations
conducted by U.S. Navy salvage forces
and other salvage activities during 1970

Department of the Navy
Naval Ship Systems Command
Washington, D.C.

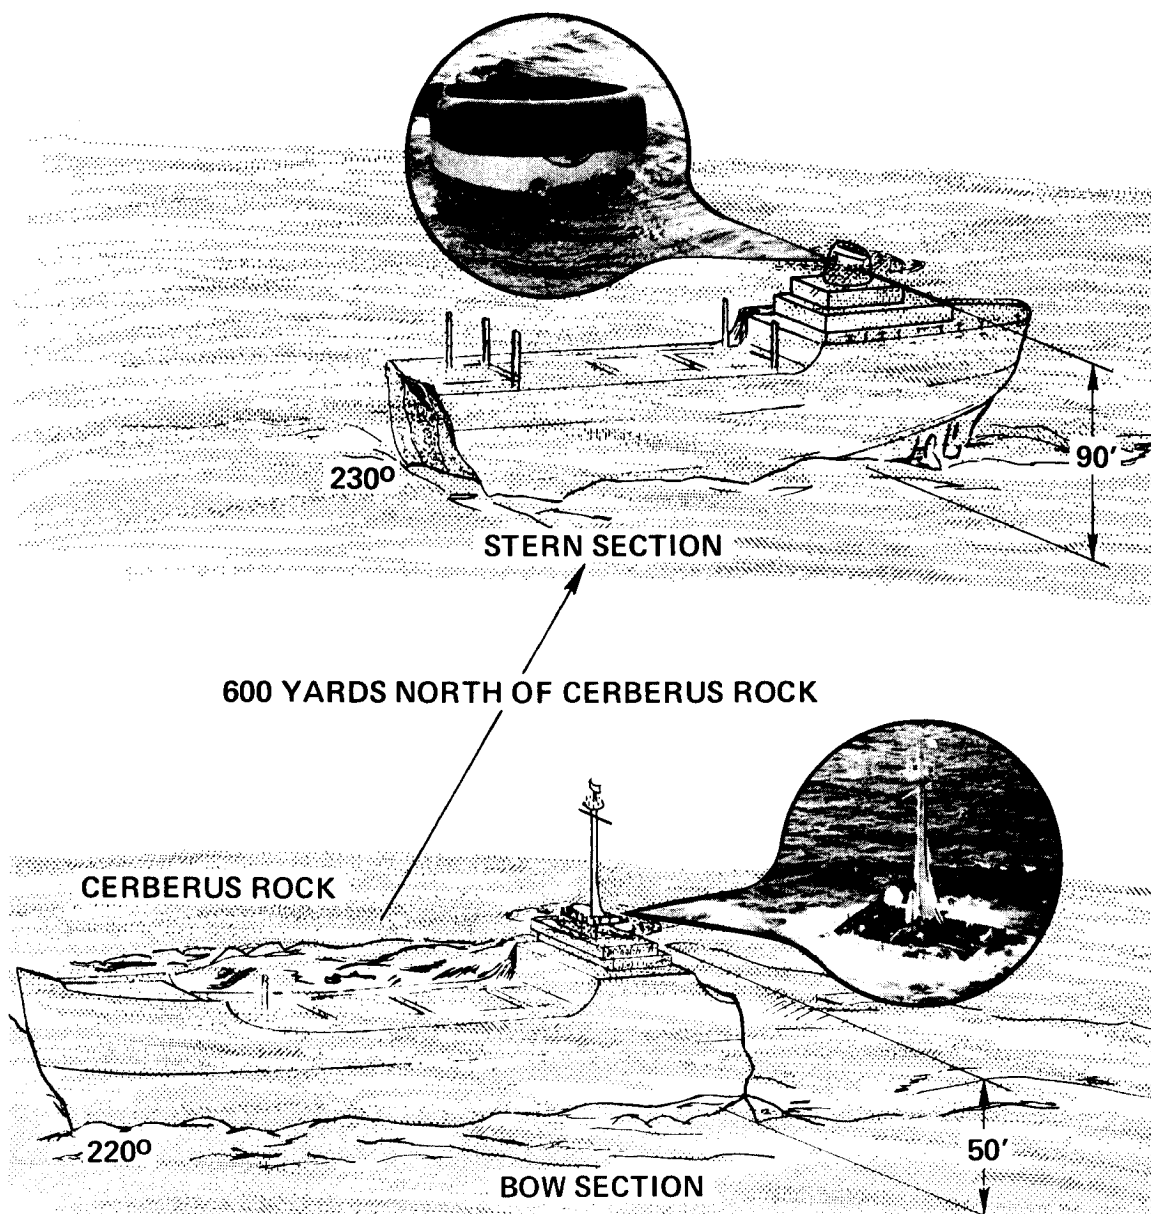
Divers reported the bow section badly smashed and stern section relatively intact. Over 6,000 tons of high viscosity fuel oil remained in the ARROW's cargo tanks. Canadian Government initiated salvage operations to debunker the wreck.

THE ARROW, BROKEN IN TWO SECTIONS, ON THE BOTTOM OF CHEDABUCTO BAY, NOVA SCOTIA

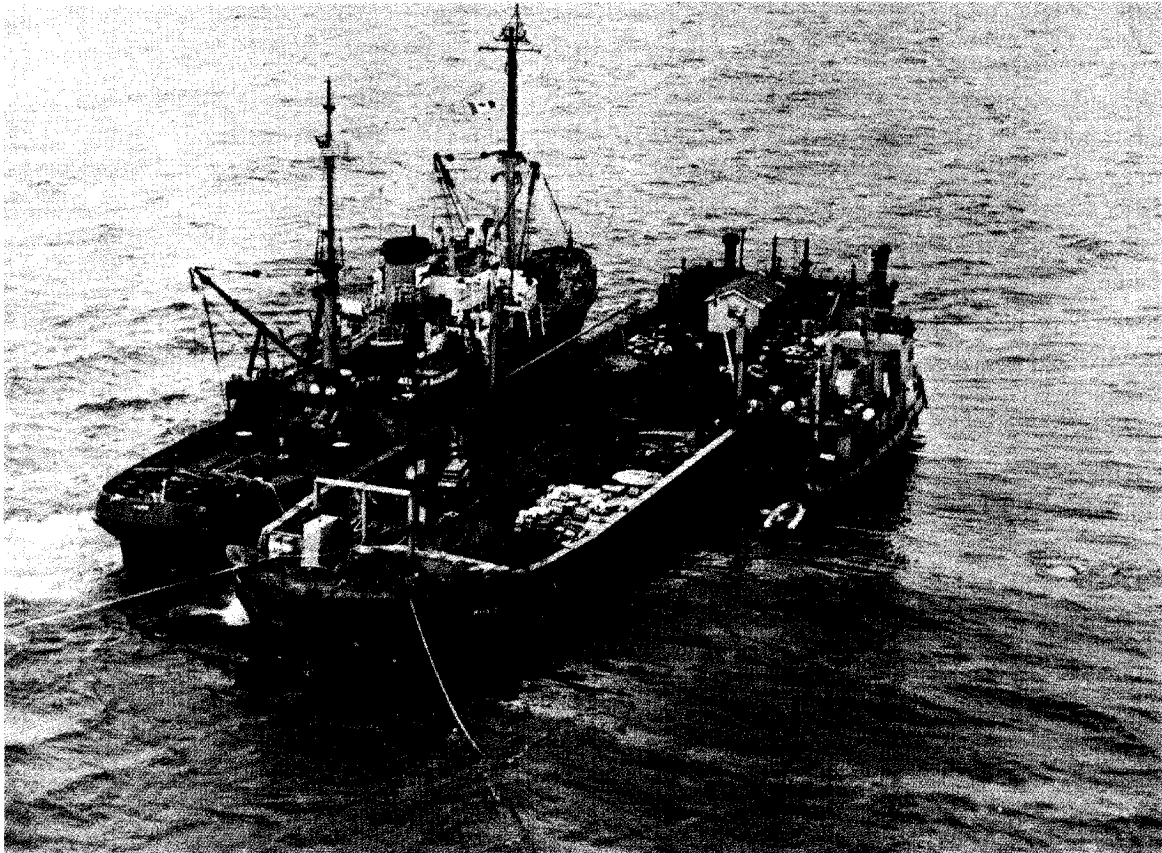
The oil transfer barge, IRVING WHALE, with the U.S. Navy salvage ship, CURB, and the Royal Canadian Navy diving tender, YMT-12, alongside.

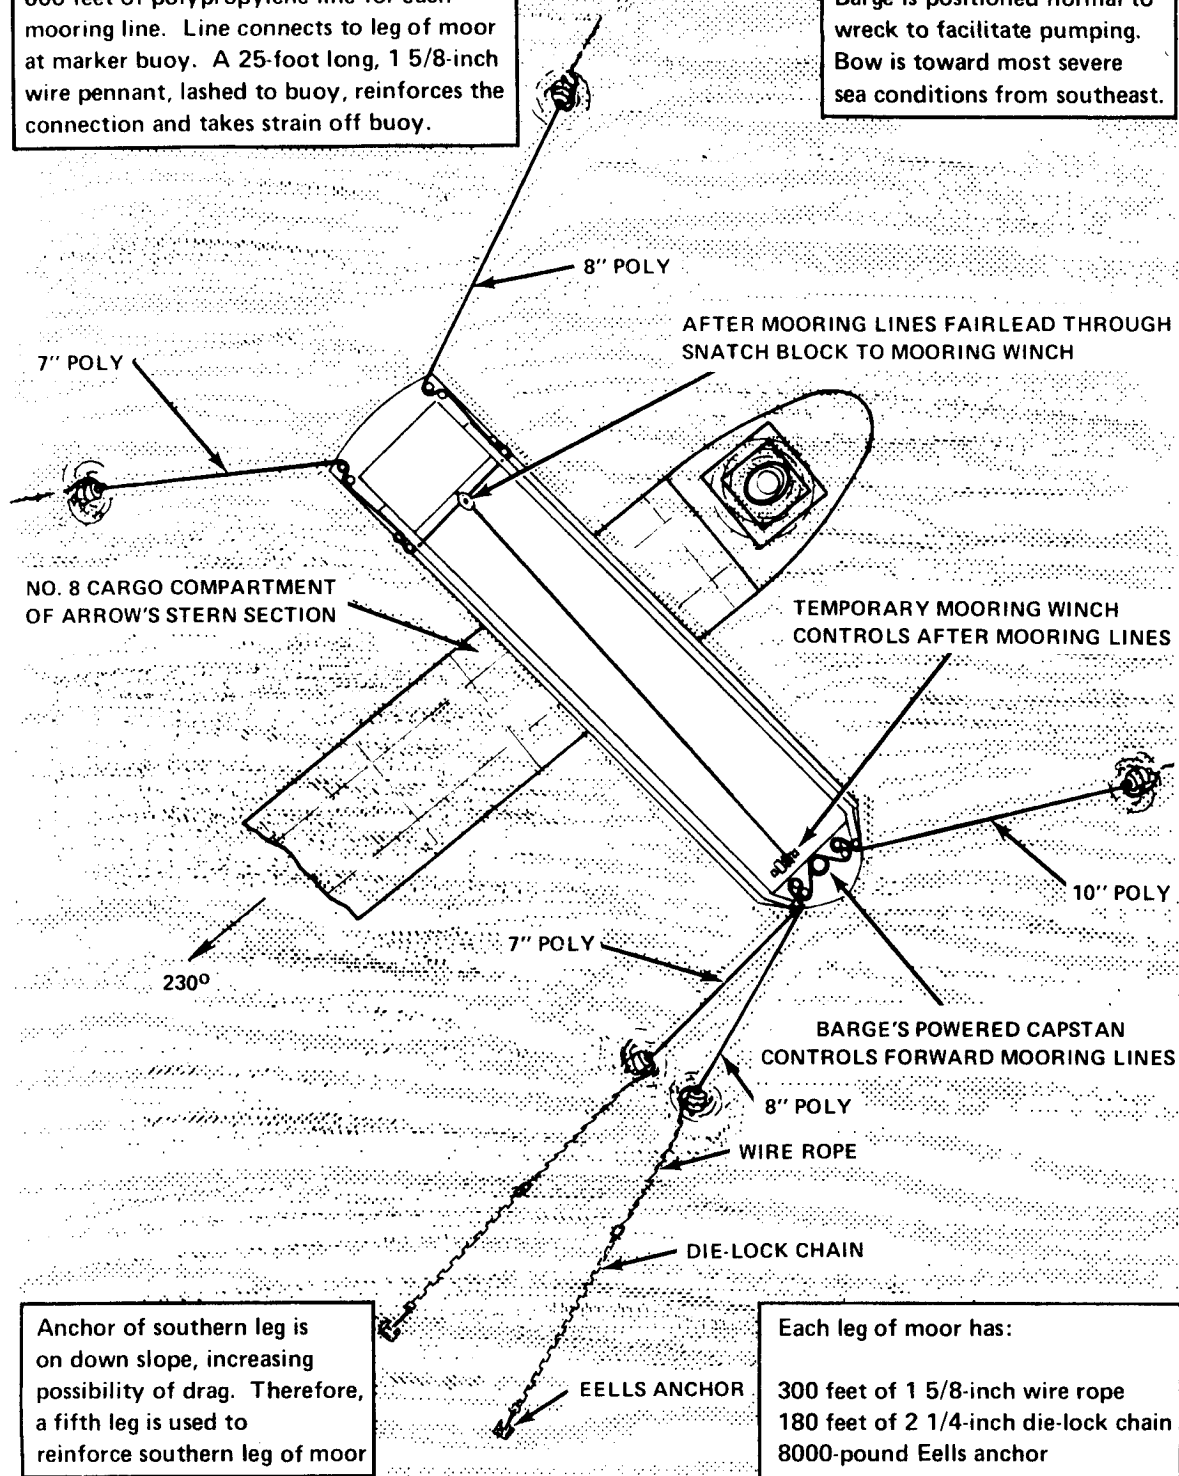
Barge is positioned normal to wreck to facilitate pumping. Bow is toward most severe sea conditions from southeast.

The barge was positioned directly over the center of the stern section and perpendicular to it in order to equalize the distances between the barge's pumping stations and the ARROW's cargo tanks.

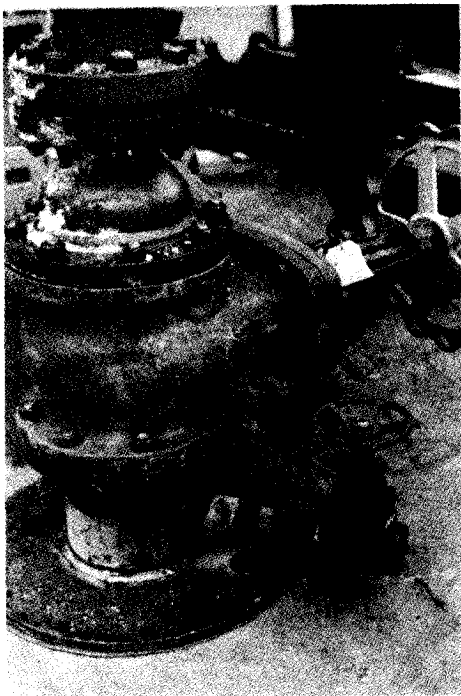
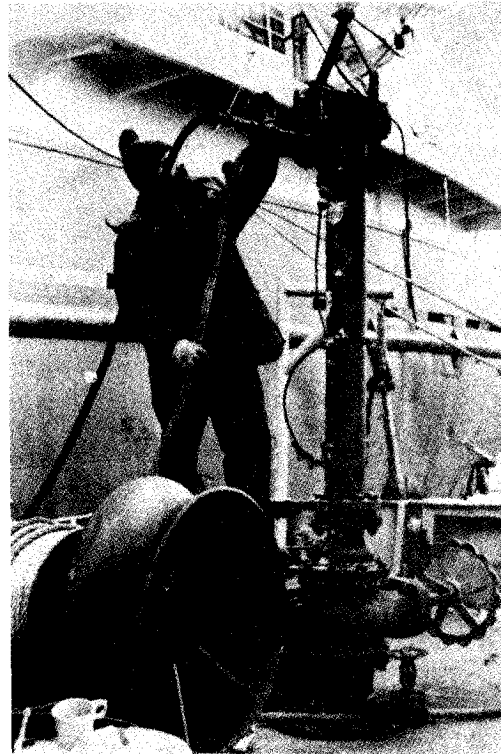
Hot tap machine is flange mounted on gate valve which, in turn, is secured to spool piece bolted to ship's deck. Rotary cutter is lowered through gate valve and spool piece and then withdrawn after cutting through deck. Complete rig is shown in right photo. Details of gate valve and spool piece are shown in left photo.

The technique, as applied to the salvage operation, required that the cutting operation be conducted through a gate valve attached to the deck above the cargo tank. The gate valve arrangement provided positive control over the opening in the deck to prevent upward discharge of oil caused by the pressure differential between the Bunker "C" and the sea

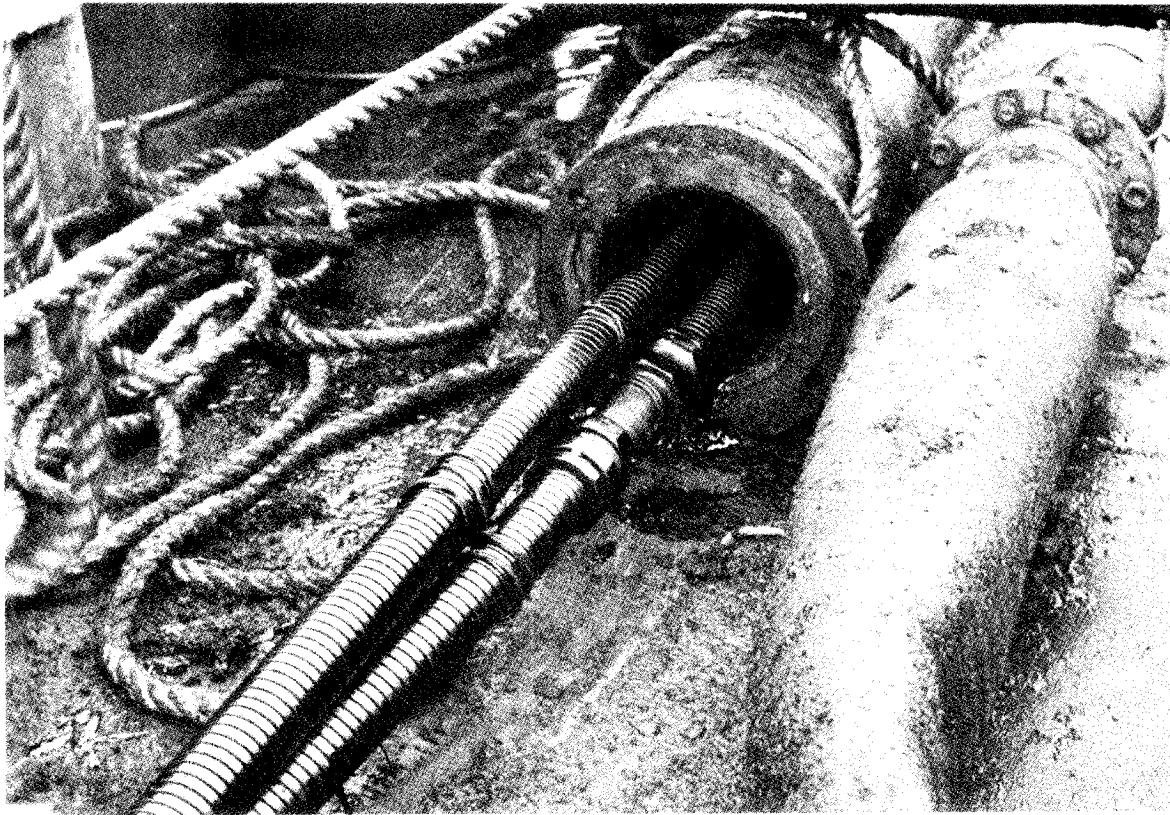
The surface of the metal steam hose was convoluted to add to its heat transfer capabilities. Trace shown is the closed-loop configuration.

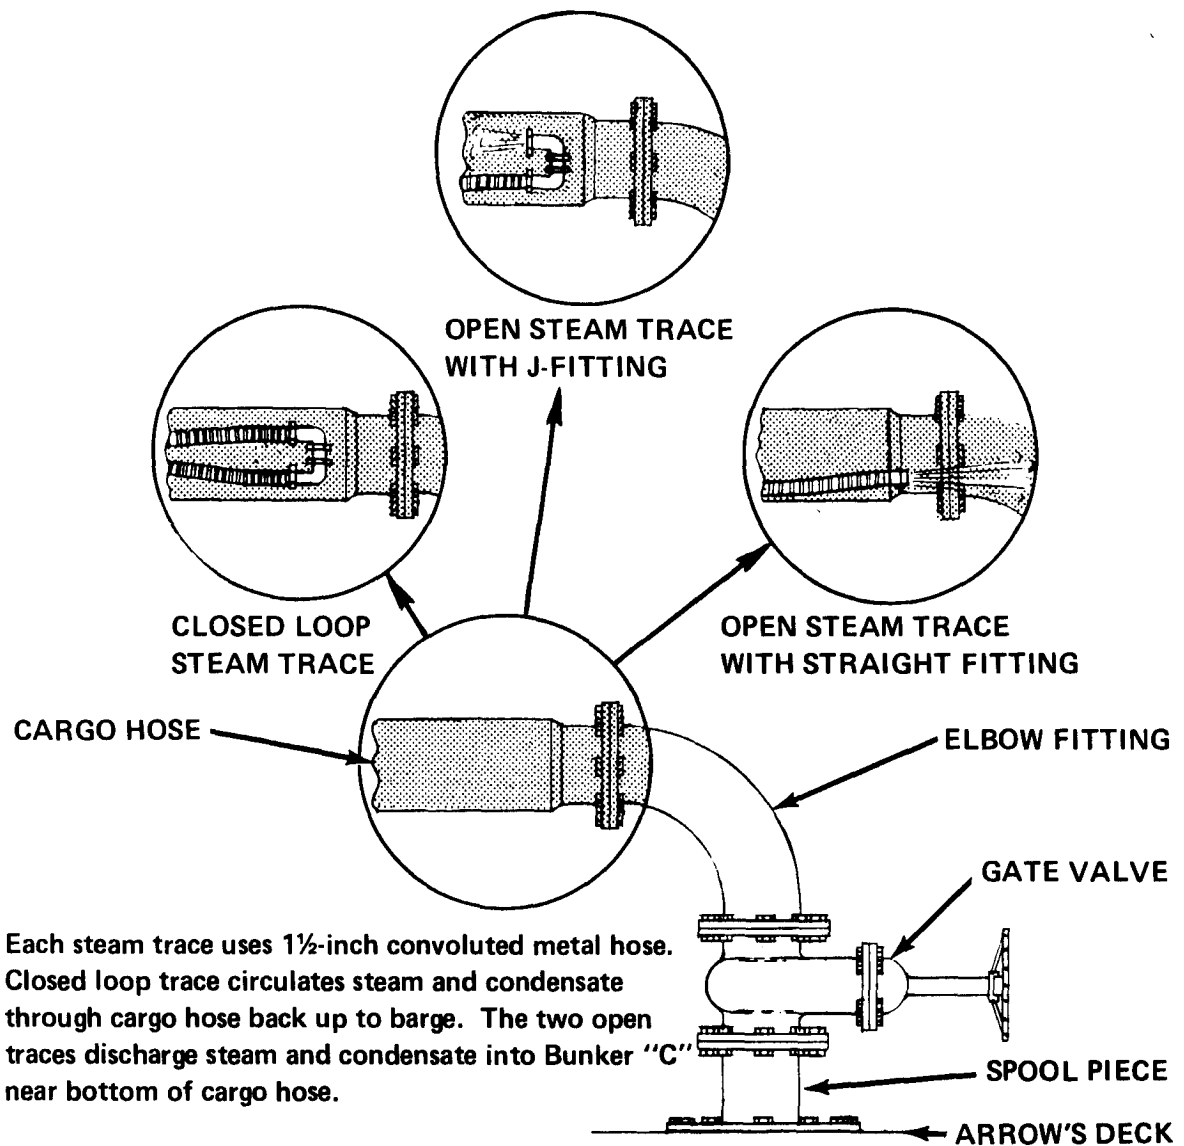
The salvage force steam traced all cargo hoses. Each configuration produced heat transfer within the hose. Temperatures of the recovered oil were consistently above 100°F.

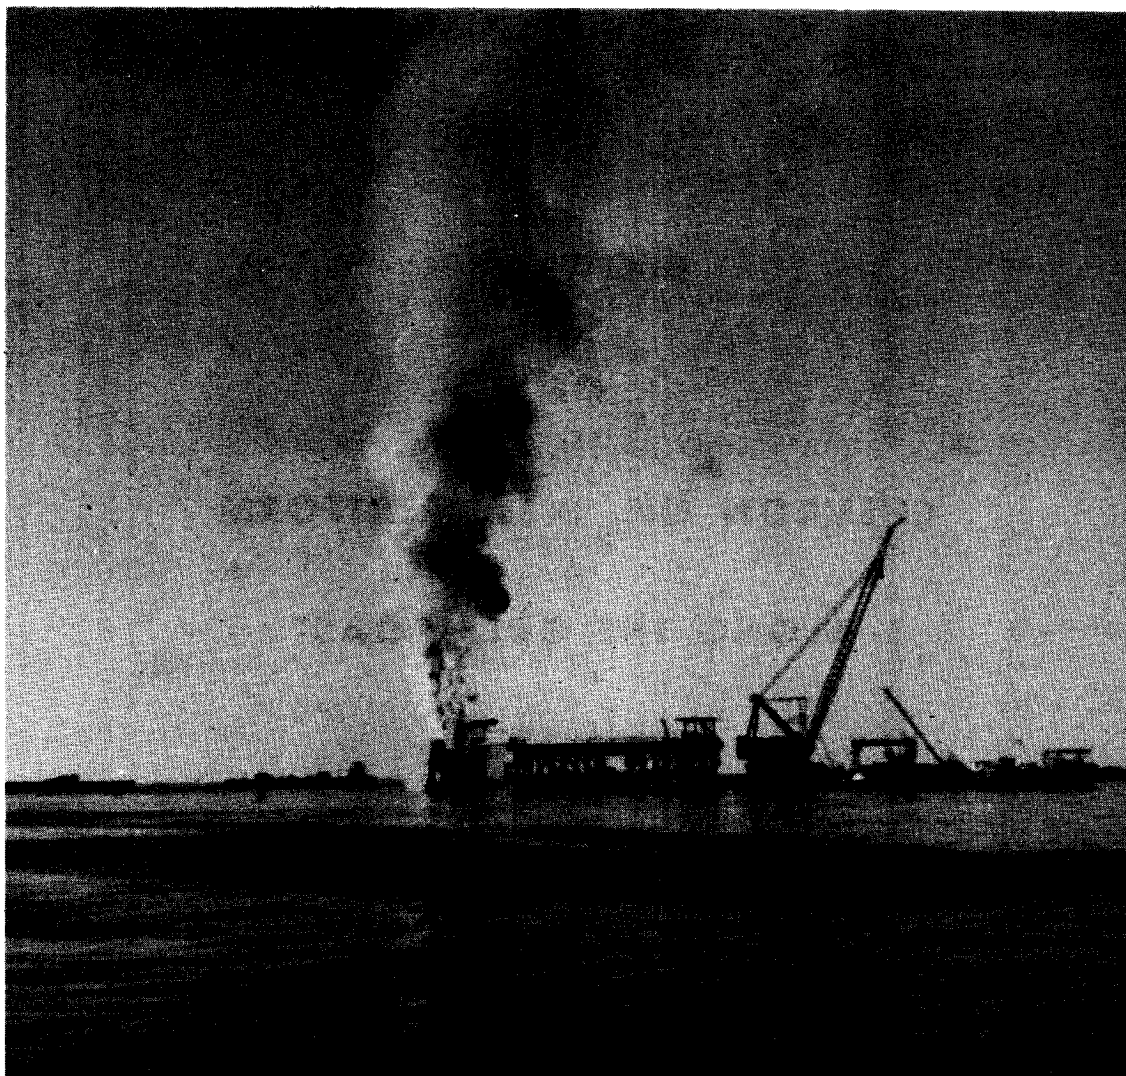
Chevron forces constructed a huge work platform to gain access to the blowout. Barges in the background formed a boom/barge barrier to contain the oil spill from the wild wells.

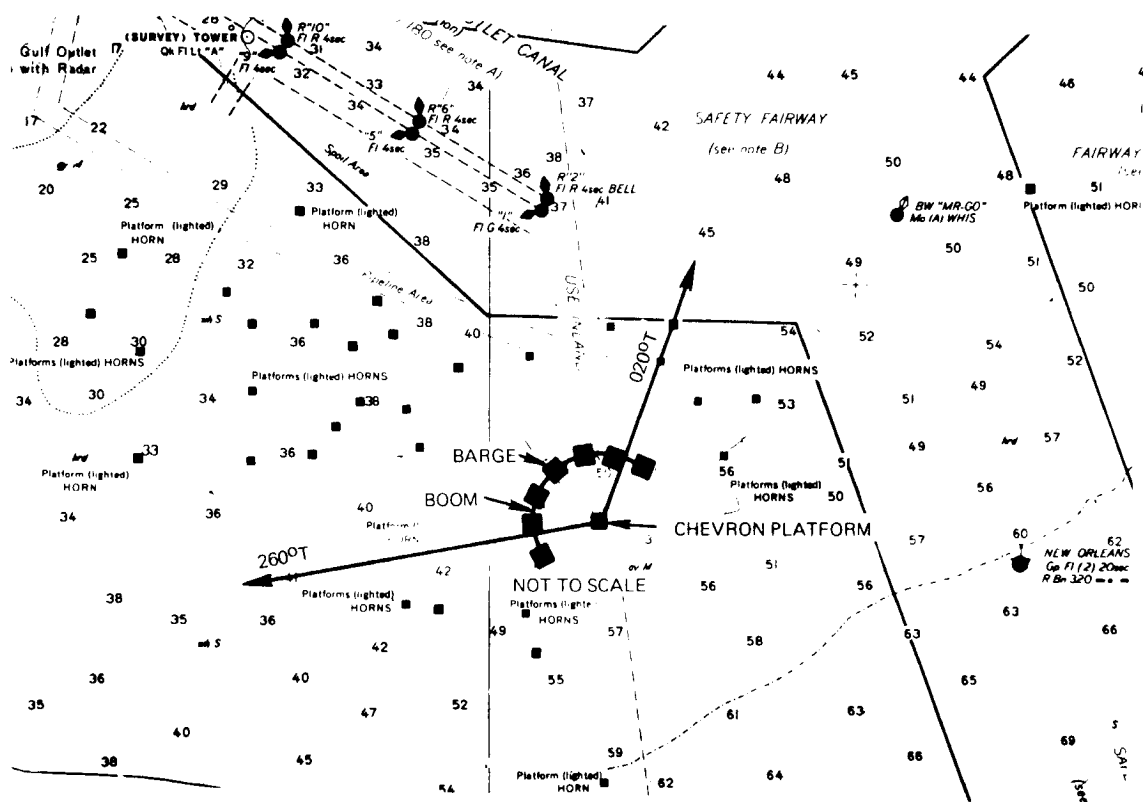
The crescent-shaped barrier, 3,300 feet long, was deployed to block the oil erupting from the wild wells from penetrating to the vulnerable area northwest of the platform.

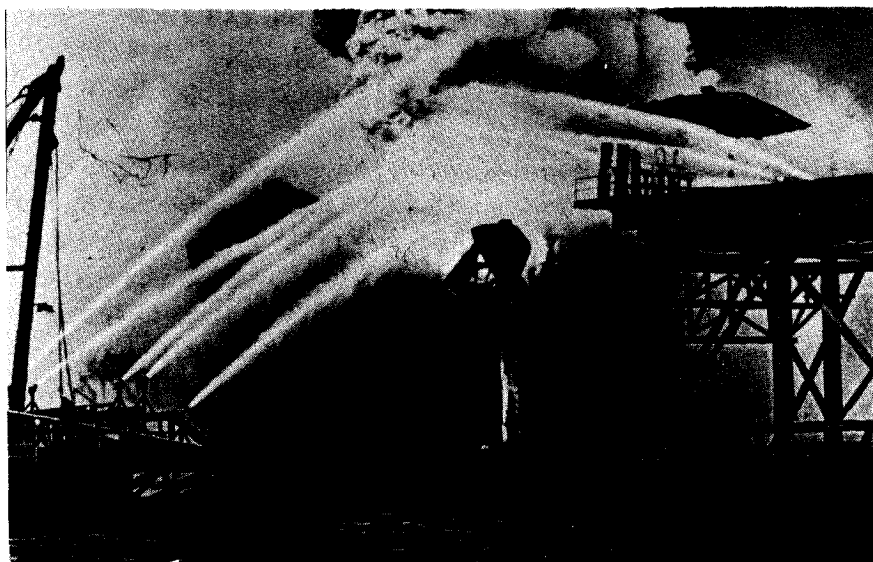
Fire fighters detonated TNT in the heart of the fire and engulfed the site with massive sprays of water from the work platform and a trenching dredge. Their second attempt on 10 March succeeded in putting out the fire.

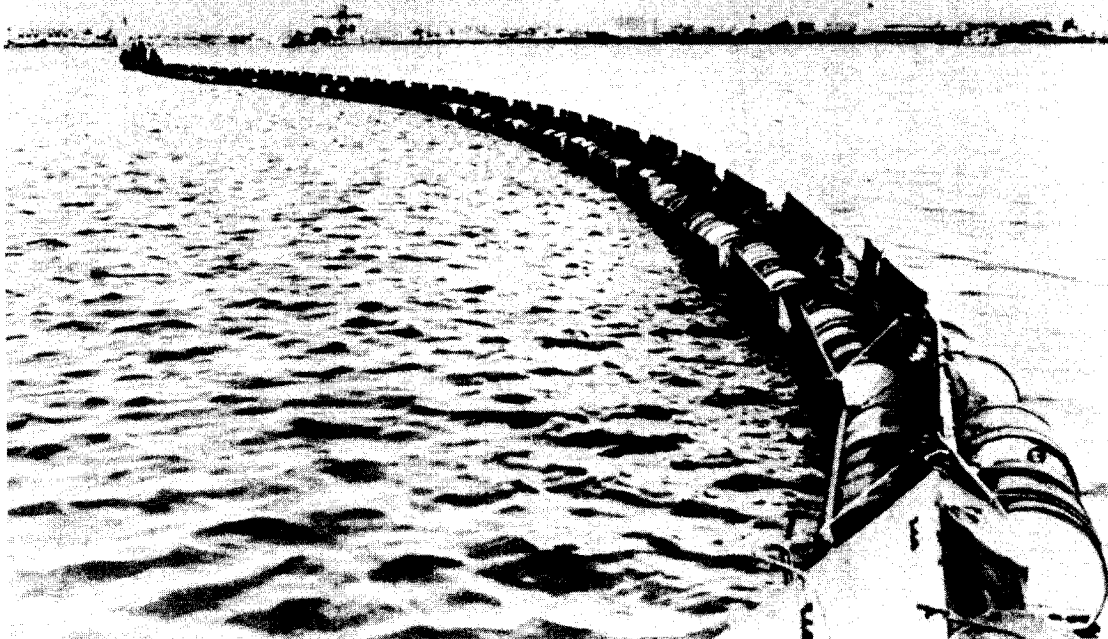
Designed primarily for heavy duty use in the open sea, the line is a series of 10-foot segments. A plywood sheet, oil drums, and a skirt and joint of plasticized canvas form each segment.

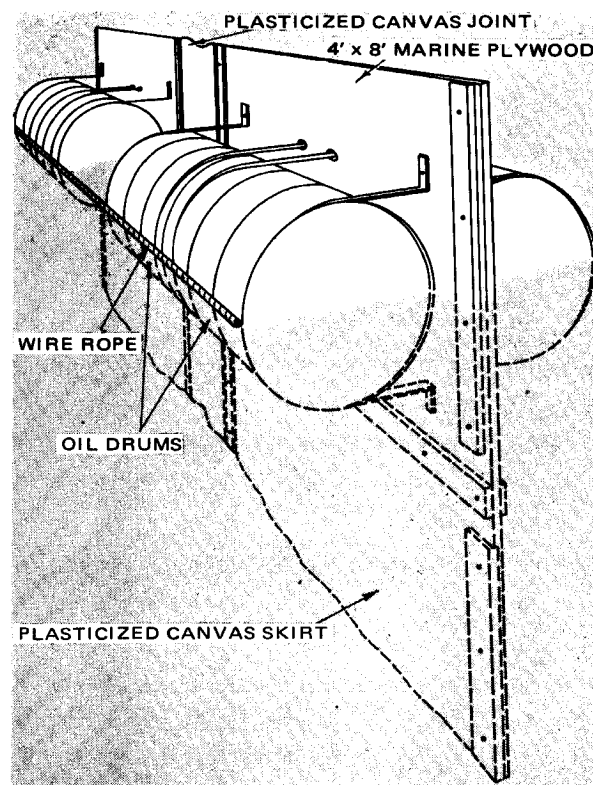
Segments are tied together by wire rope secured along the outboard edges of the oil drums. Canvas joints provide flexibility between segments. Segments can also be connected with chains if necessary.

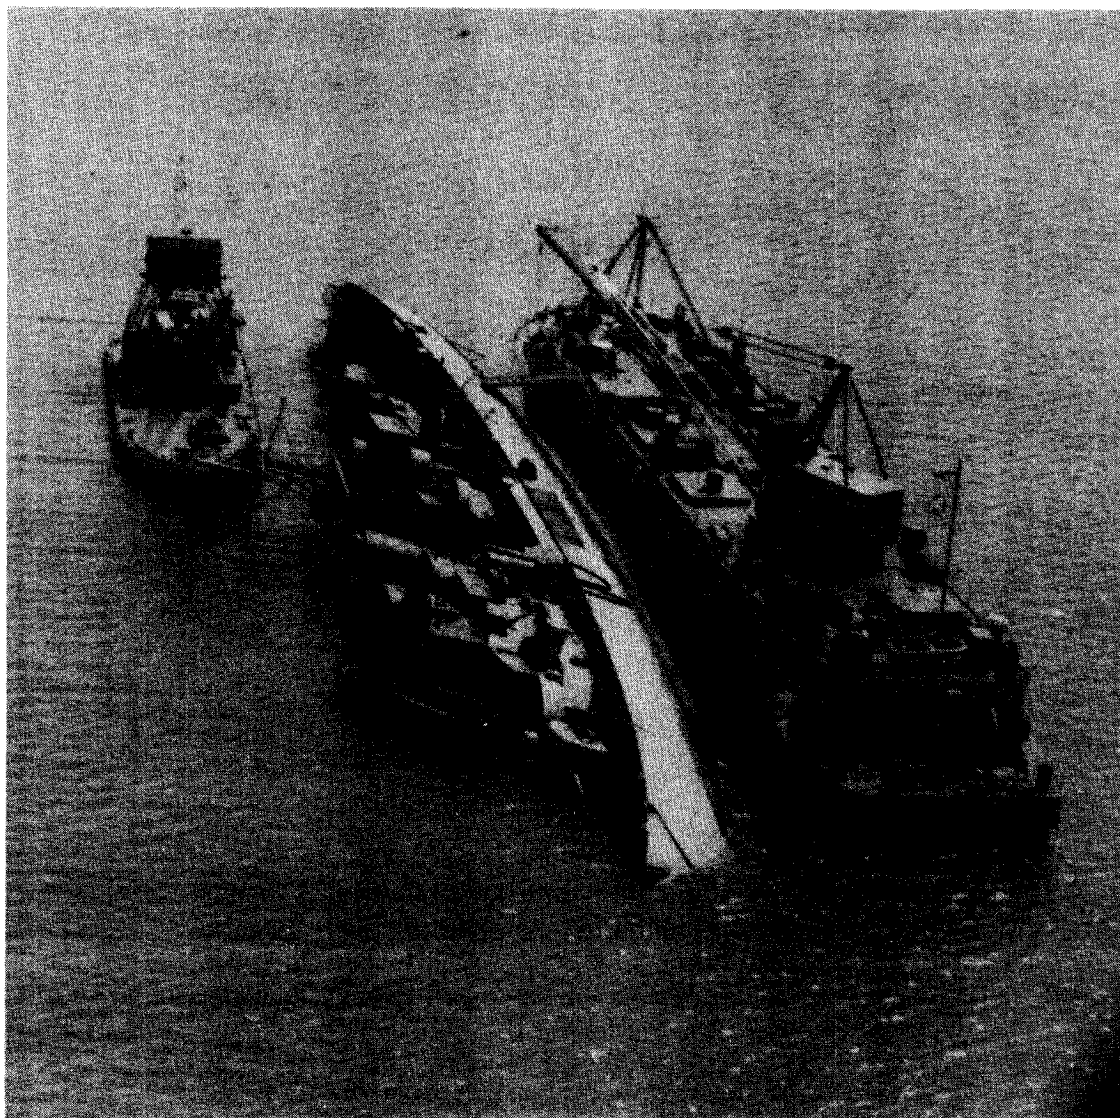
HCU-2 salvors moored YRST-2 (on right) and YSD-53 (on left) alongside REUBEN JAMES to prepare it for the big pull. Both craft were also used later in the operation to help control the hulk during the lift.

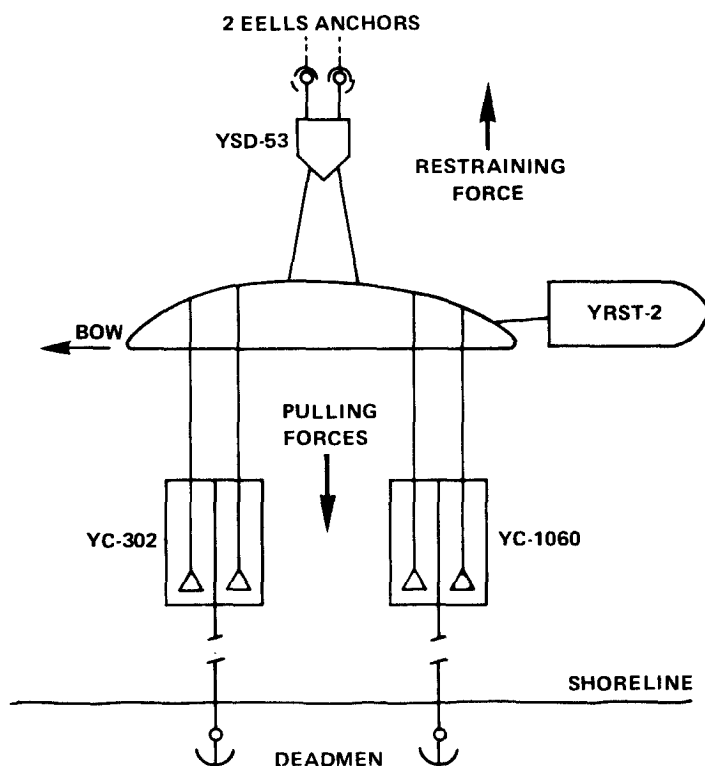
The two YC's, backed by deadmen ashore, apply the pulling forces. YSD-53 to seaward applies restraining force and YRST-2, astern, maintains the hulk in line.

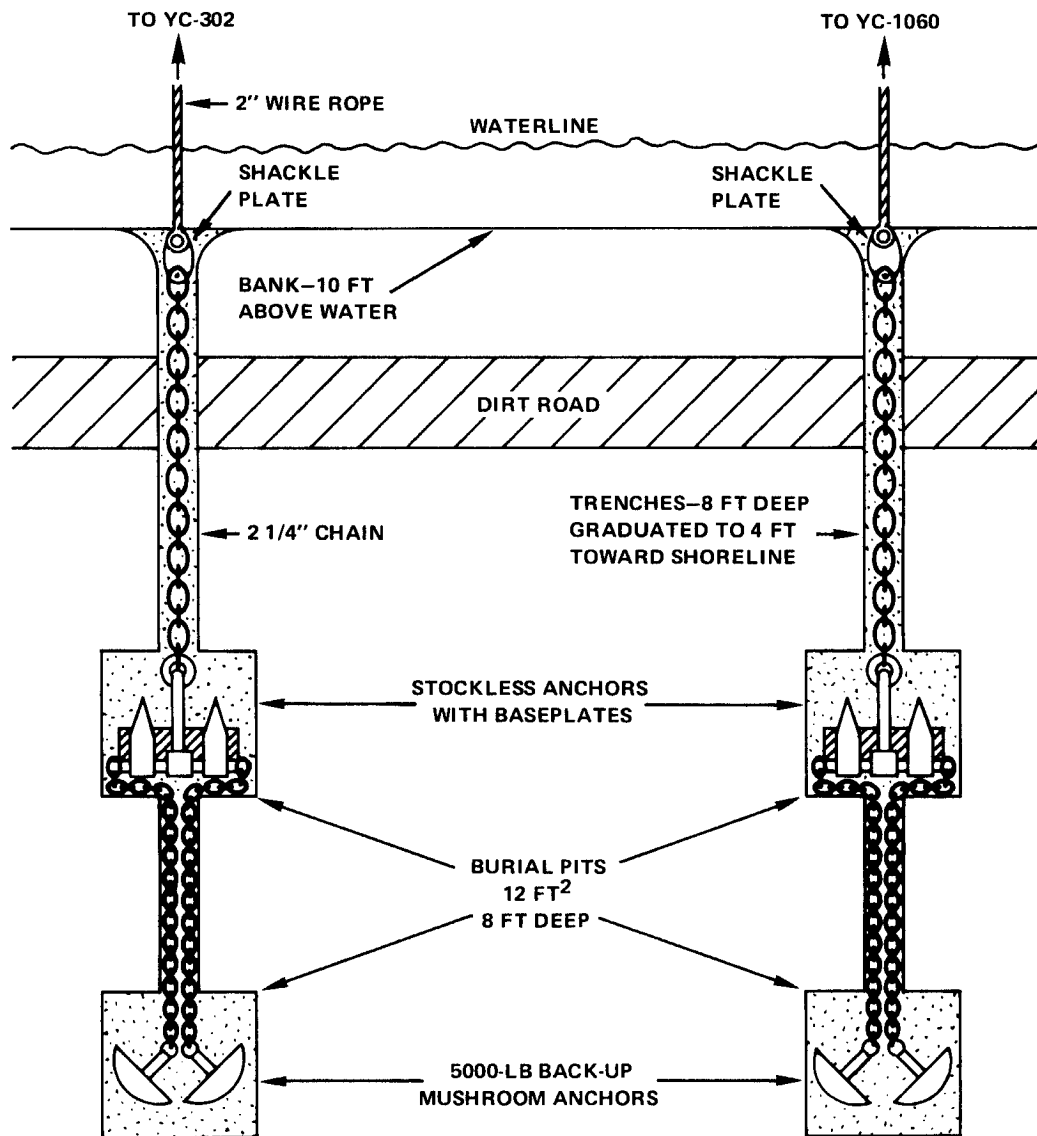
Deadmen for each YC were a stockless anchor and two back-up mushroom anchors. Burial sites were located 120 feet inland, 140 feet apart.

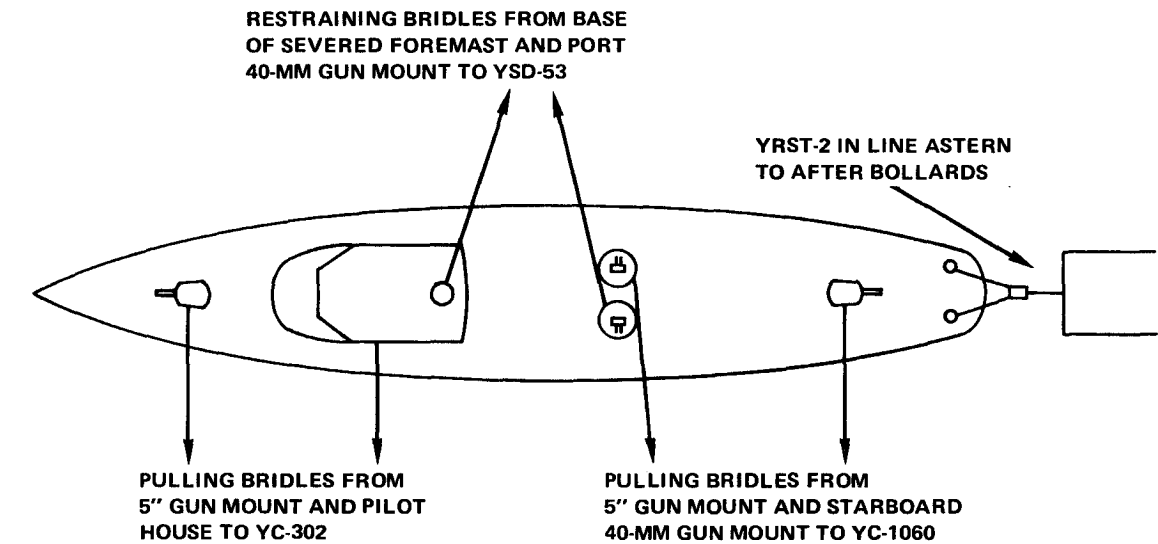
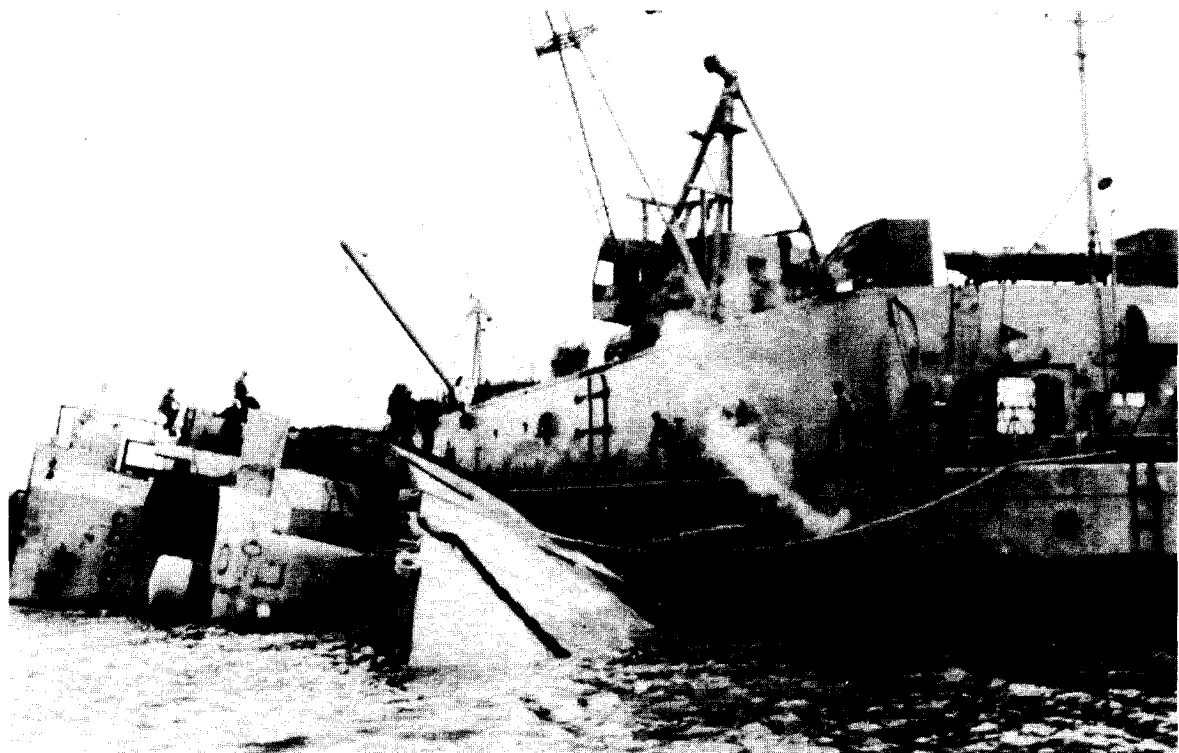
HCU-2 salvors rigged four pulling bridles and two restraining bridles. In the photograph, they are rigging a pulling bridle around the pilothouse.

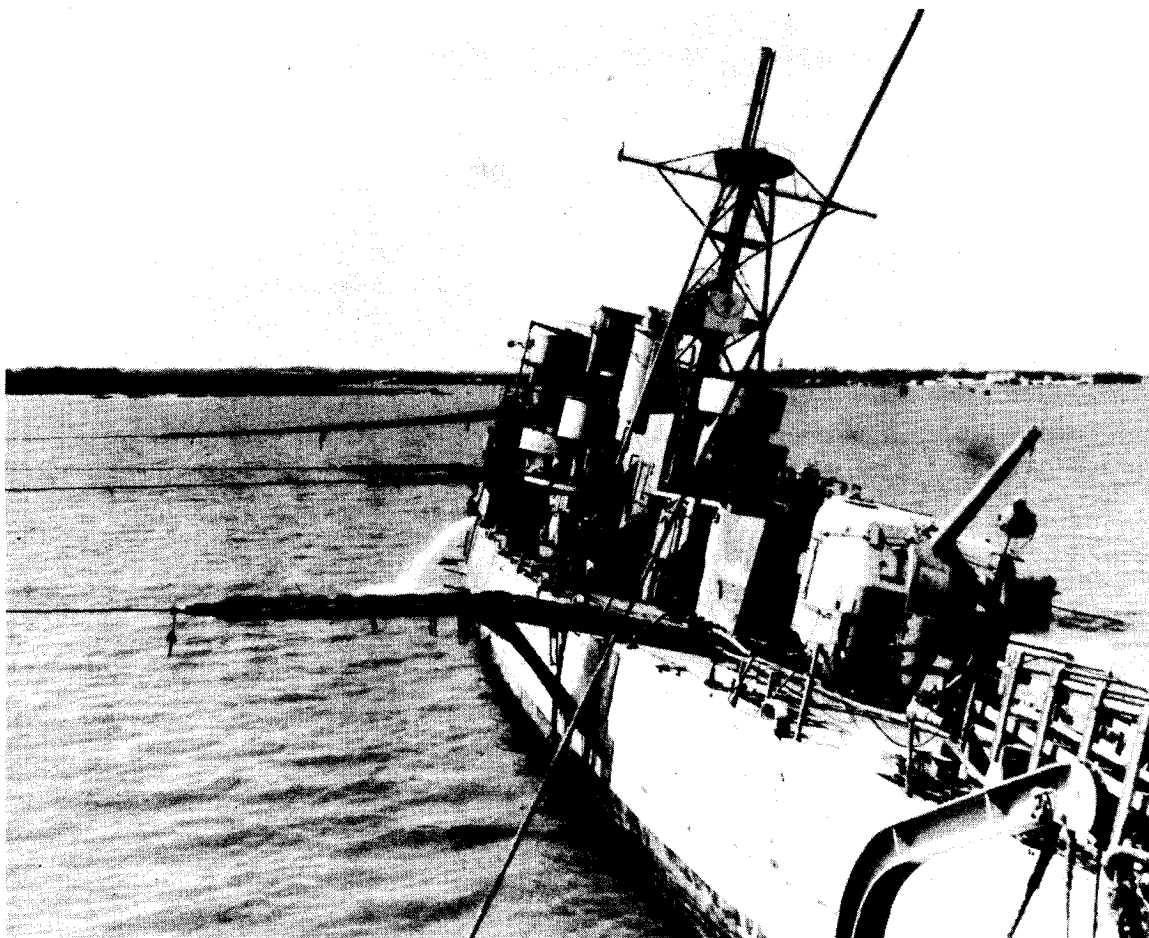
Chain bridles stretch taut as the pulling force is applied from port side. Stand-offs, fore and aft, improve pulling leverage for bridles around 5-inch gun mounts. Diesel pump is suspended from gun barrel.

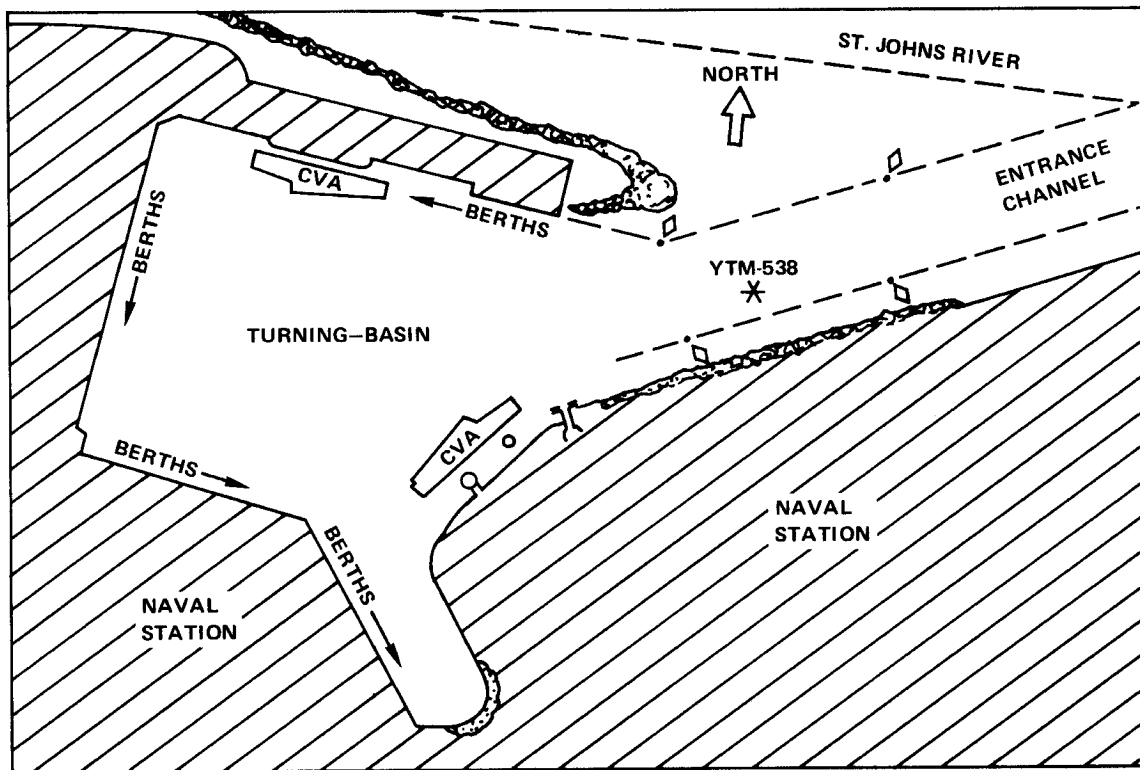
YTM-538 sunk in entrance channel while assisting USS PAWCATUK. Hazardous to navigation, it was essential to raise and refloat the tug at the earliest opportunity.

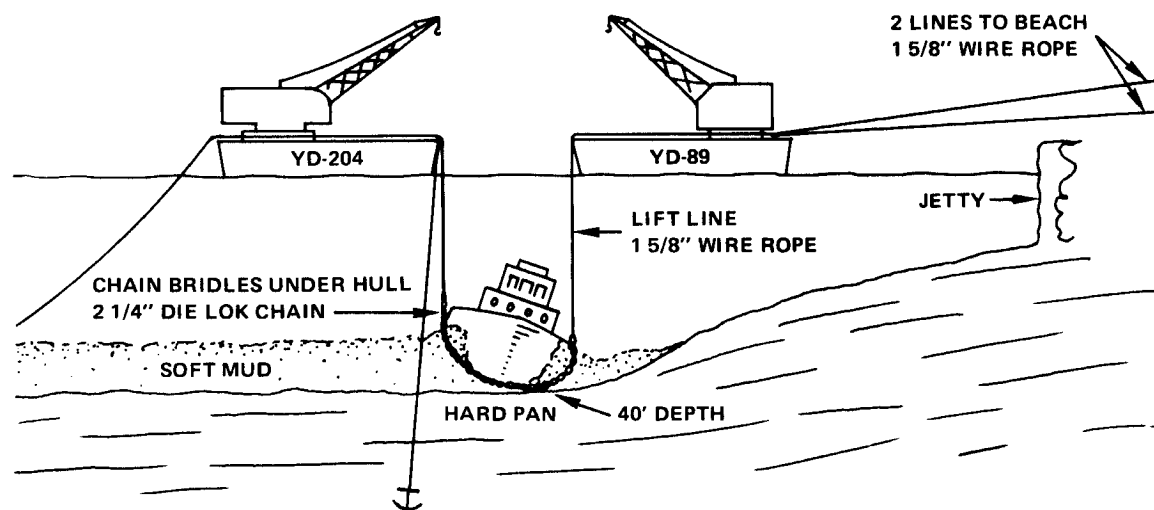
The salvage plan featured the use of two YD's, each rigged with beach gear, as lifting platforms. Bulldozers on the beach backed YD-89. The YC barge was employed as a diving platform to prepare the hull for the lift.

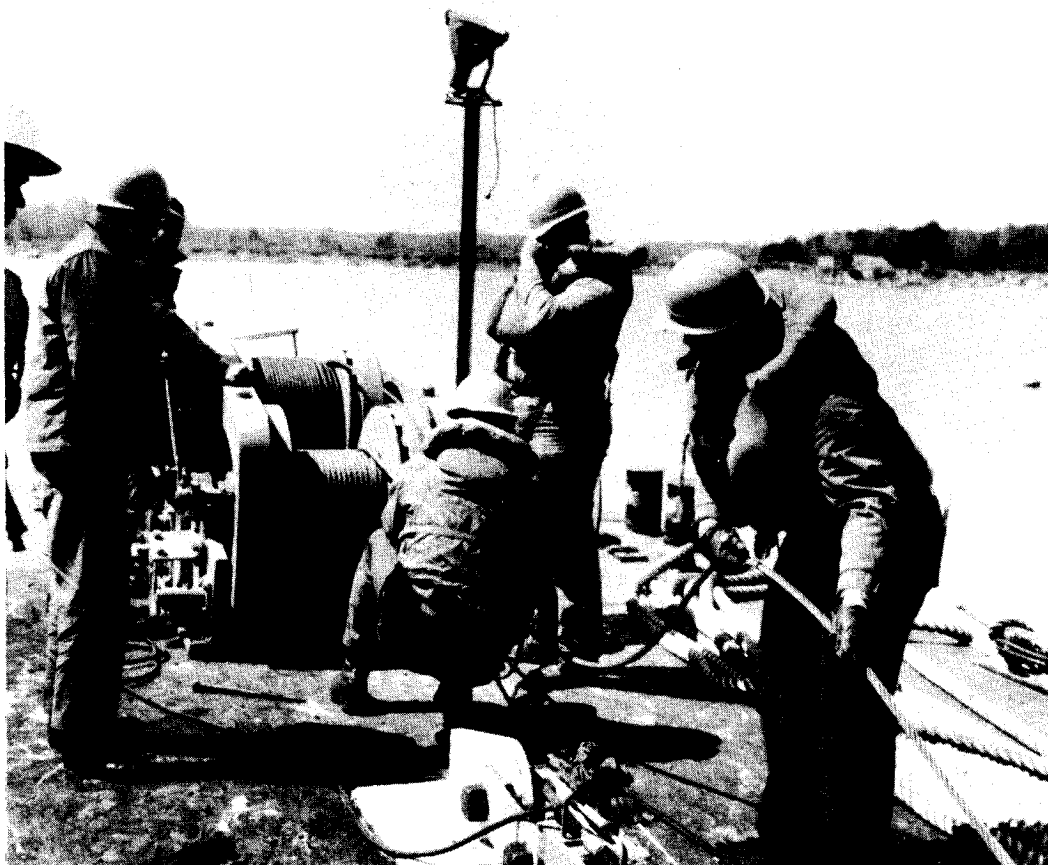
Clyde winches became critical items in planning as local craft were not rigged for heavy lifting. The salvage force obtained two winches and installed them on YD-89.

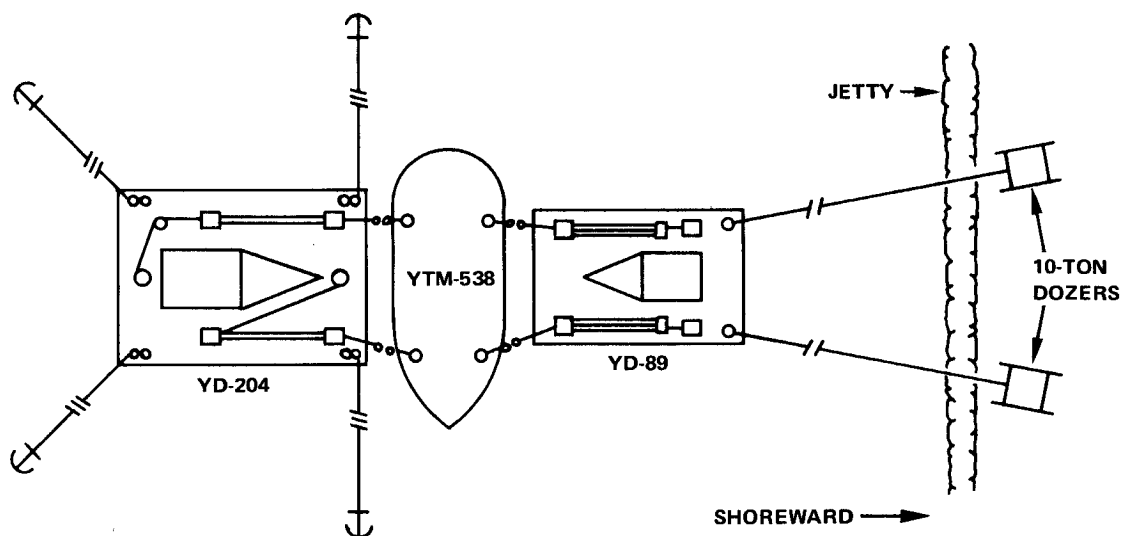
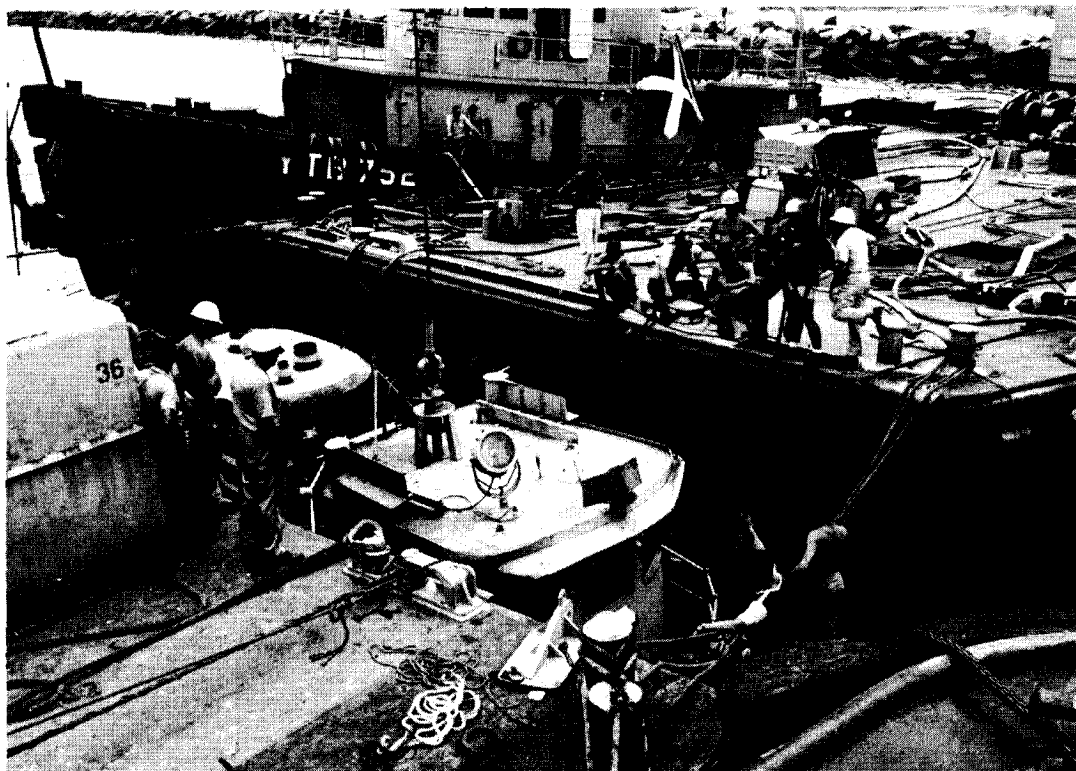
Schematic indicates position of beach gear aboard the two platforms. Doubler plate, heavy duty padeye had to be welded in place aboard each YD. Photo shows YD-89.

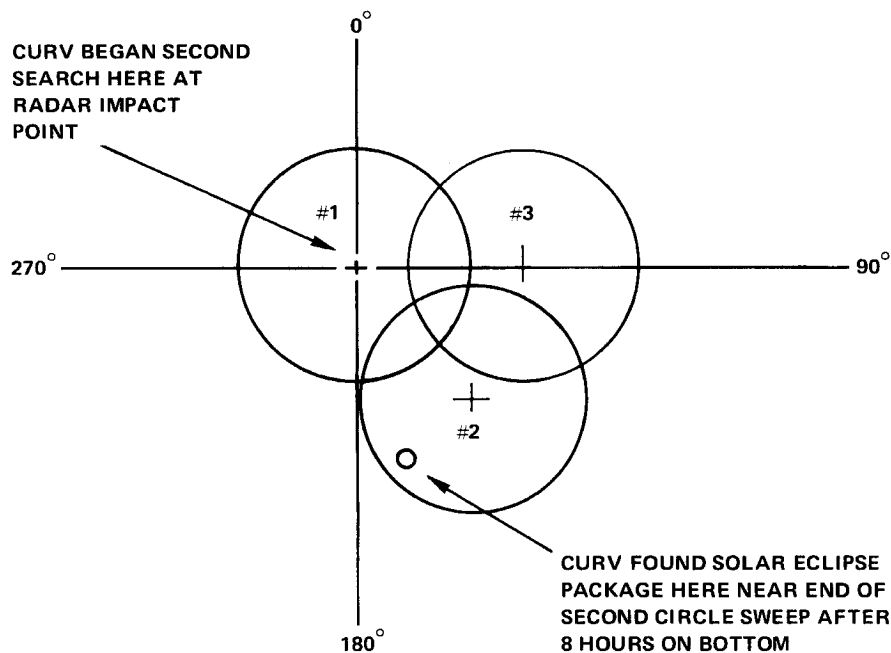
CURV uses sonar to locate potential targets within each circle and then investigates each target at close range with its television system.

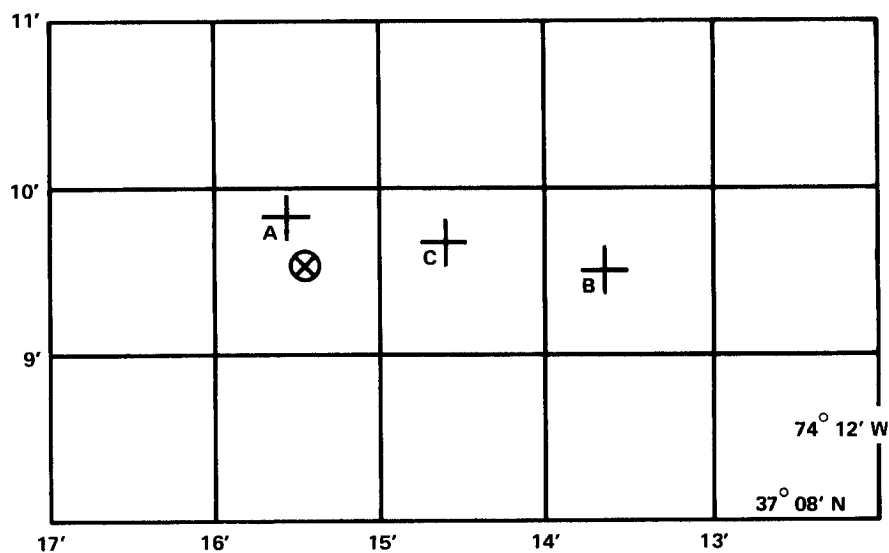
- A - RADAR-EXTRAPOLATED FREE-FALL IMPACT POINT.
- B - PINGER LOCATION AS CALCULATED FROM SIGNAL RECEIVED BY NASA RECOVERY VESSEL.
- C - MID-DATUM POINT SELECTED FOR FIRST RECOVERY ATTEMPT.
- ⊗ - LOCATION OF PACKAGE WHEN FOUND BY CURV OPERATING FROM POINT A.
