SALVOPS 70

A review of significant salvage operations
conducted by U.S. Navy salvage forces
and other salvage activities during 1970

Department of the Navy
Naval Ship Systems Command
Washington, D.C.

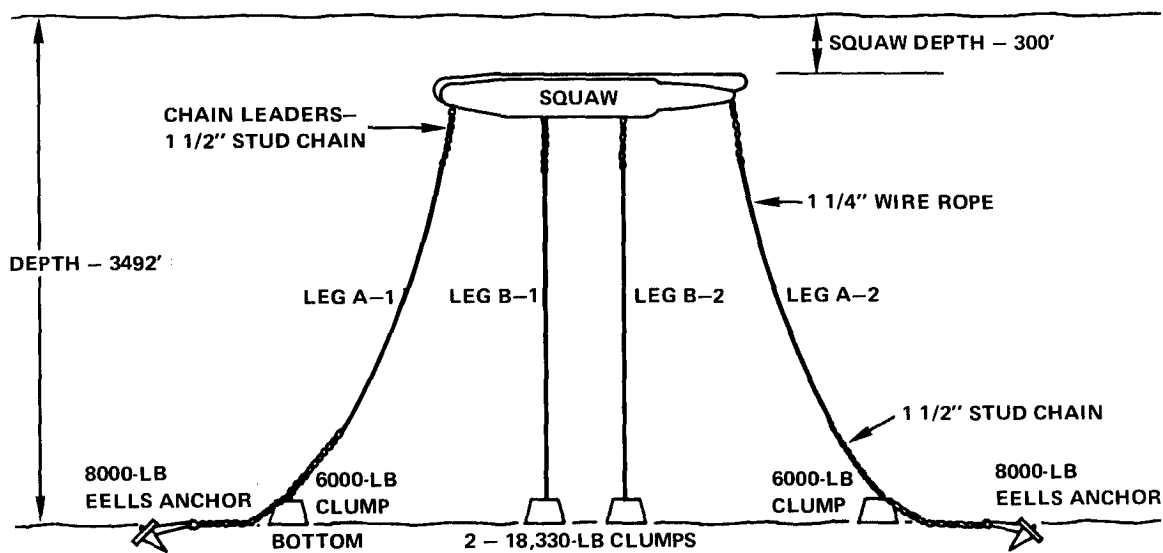
Heavy clumps anchoring the vertical inner legs restrain the hull from surfacing. Outer legs, forming an underwater catenary, are also anchored securely, restraining horizontal movement of the hull.

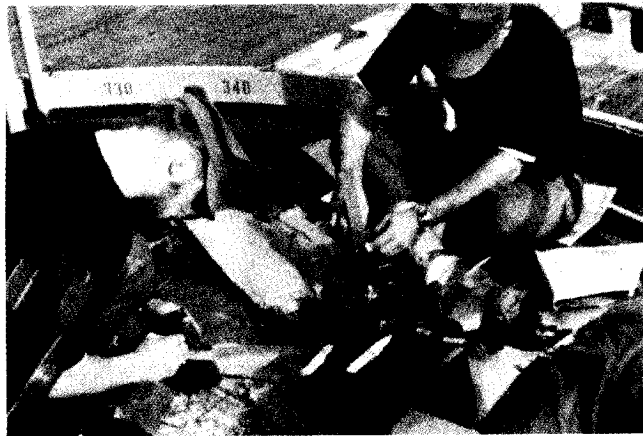
CHOWANOC and KALMIA pay out wire rope for mooring leg and crown line as UDT personnel prepare explosive wire cutters for severing the pendants connecting surge buoys with suspended anchor and clump.

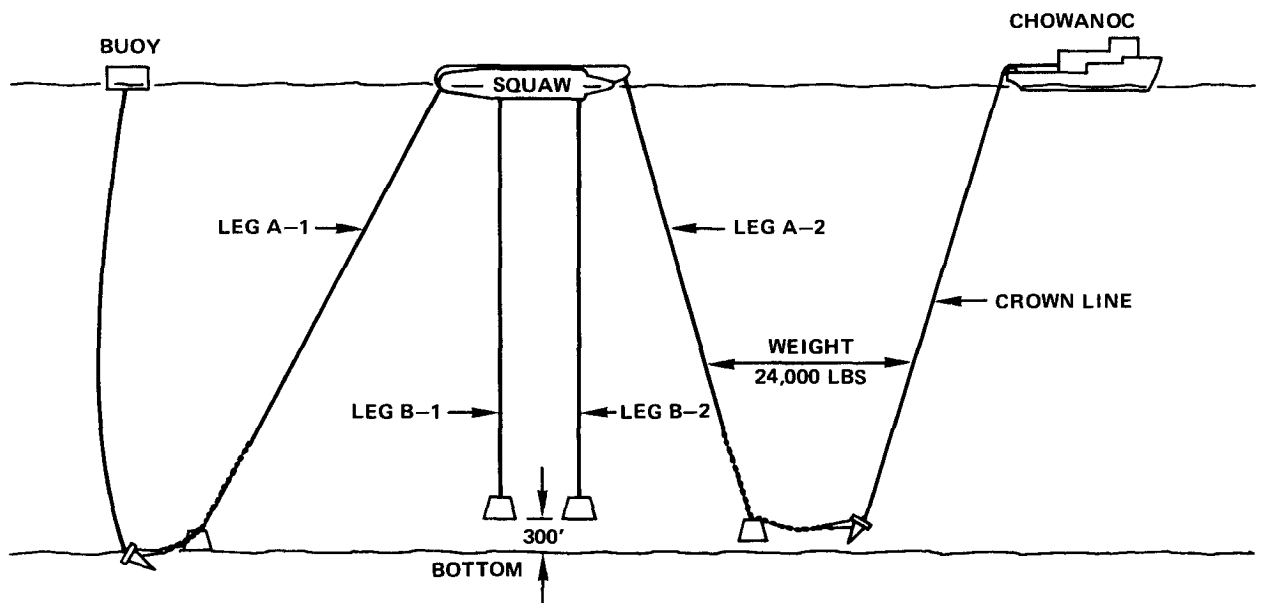
CHOWANOC takes strain to predetermined mooring tension. Flood valves are then opened and SQUAW submerges. CHOWANOC moves northeast until SQUAW reaches 300-foot depth, stops and lowers anchor and clump back to bottom.

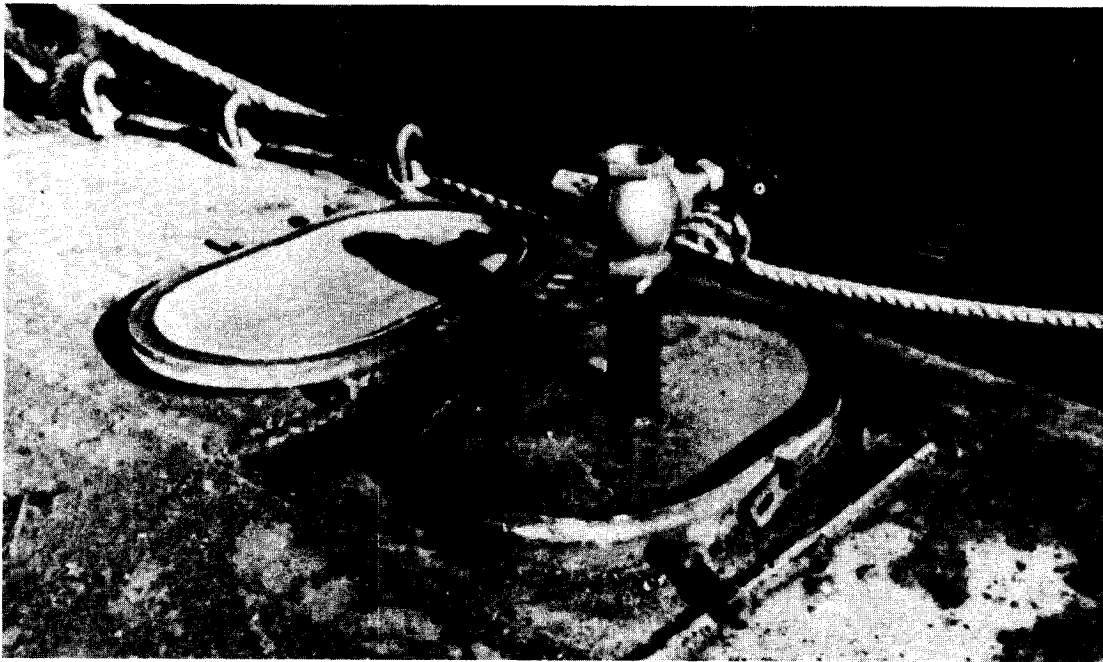
Vent valves were installed on the sealed hatches to the barge's compartments. The task force opened valves, allowing air to escape and permitting controlled flooding of selected compartments during sinking of the barge.

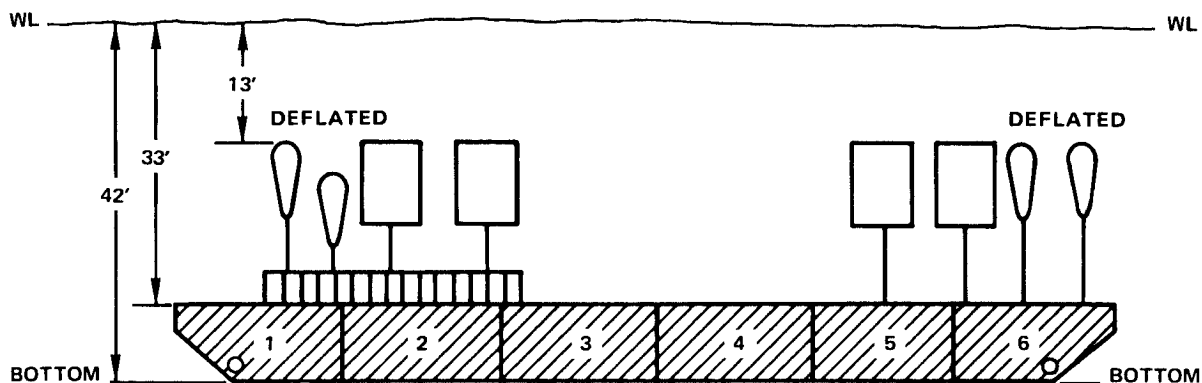
Barge has 15 pontoons here, all lower tier. Sketch shows 8 pontoons in section view. Seven pontoons are deflated.

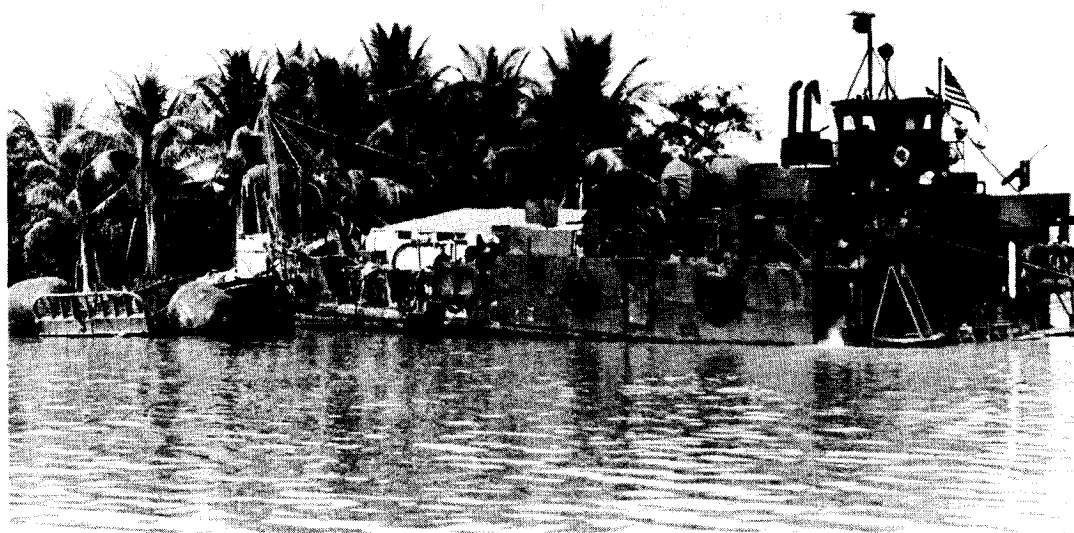
YLLC-1 lifts wrecked LCM-6 up onto the shore of the Song Vam Co Dong near Ben Keo during one of its many SALVOPS in 1970. Note 8-ton salvage balloons to keep bow afloat.

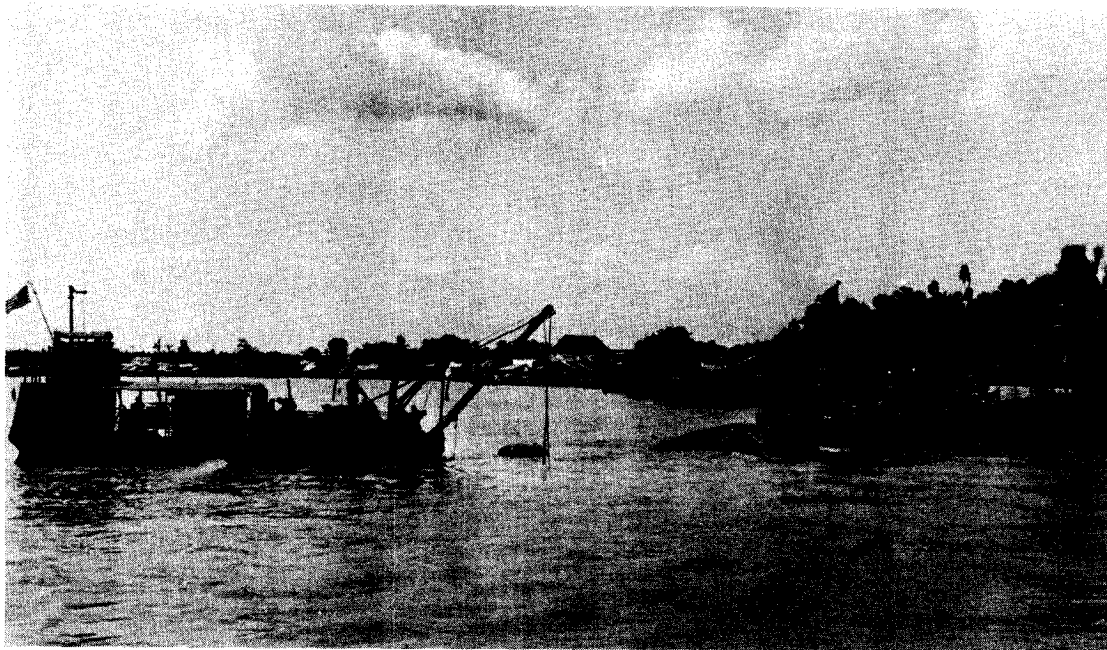
Combat Salvage Boat (CSB) lifts sunken craft with aid of LCM. Salvors often moved sunken craft such as this one close to shore for patching, dewatering and refloating.

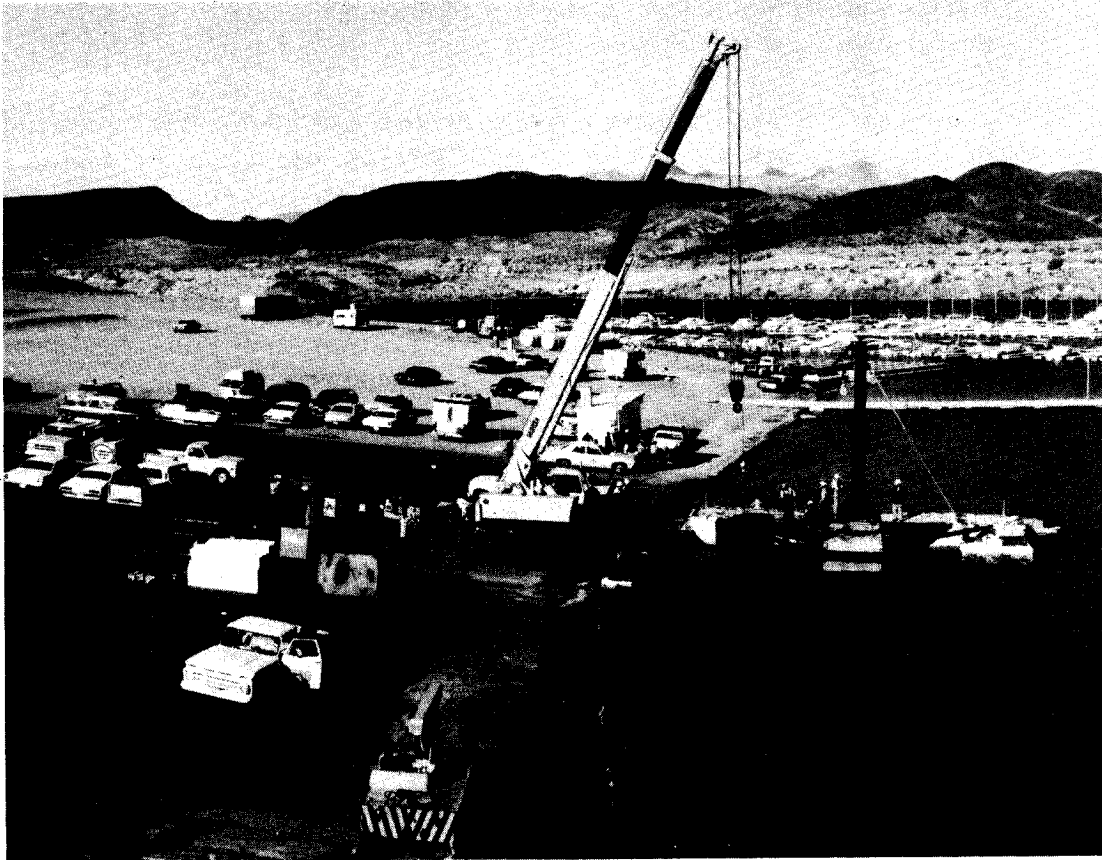
Crane swings cube-shaped flotation cell into position. Platform was assembled by marrying a lifting davit to a 35-foot barge and rigging them with flotation devices.

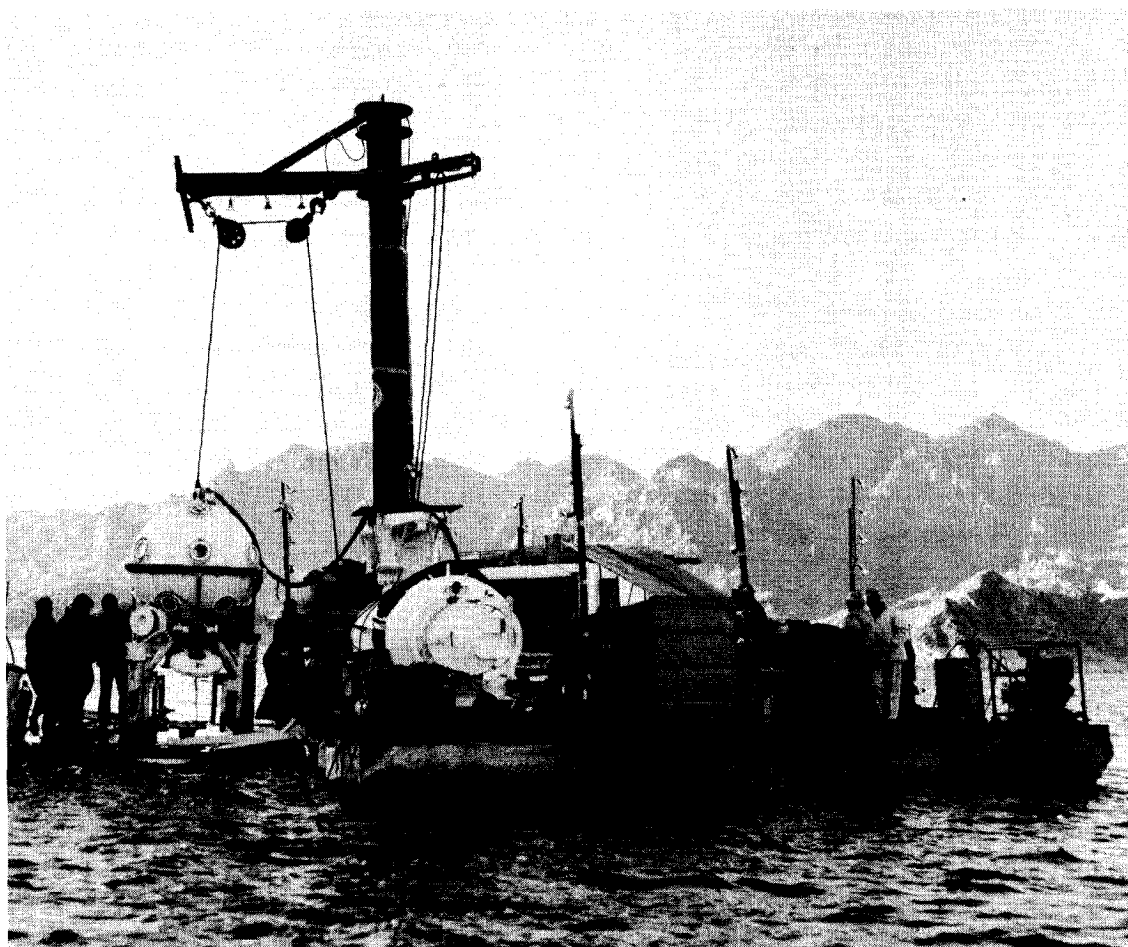
After initial observation dives failed to locate the plane, the recovery force attached two sonar transducers to the ADS-IV diving bell and used sonar to home the bell in on the target.

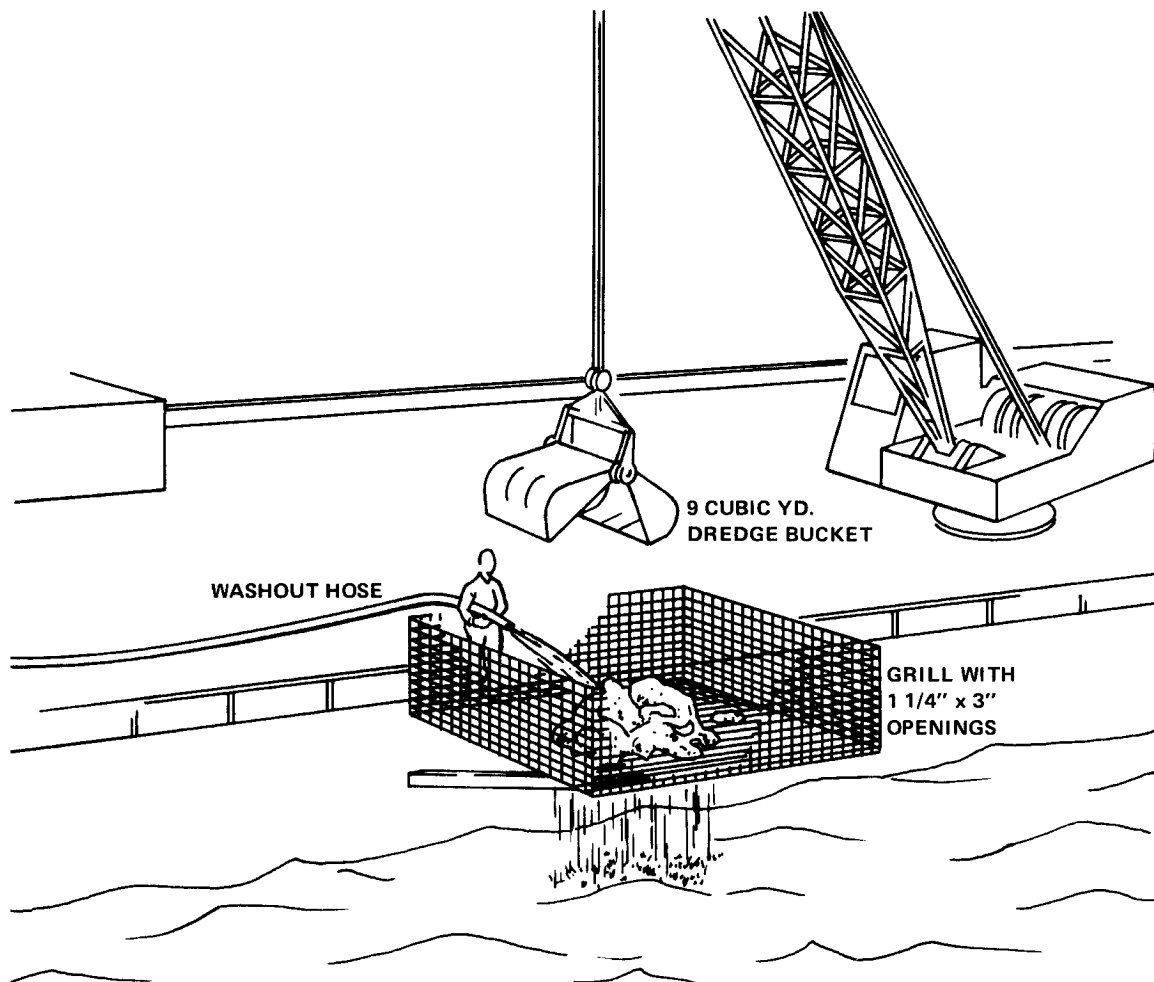
The task force used this method to recover aircraft debris after divers had recovered bodies of the plane's occupants. Debris was needed for accident investigation purposes.

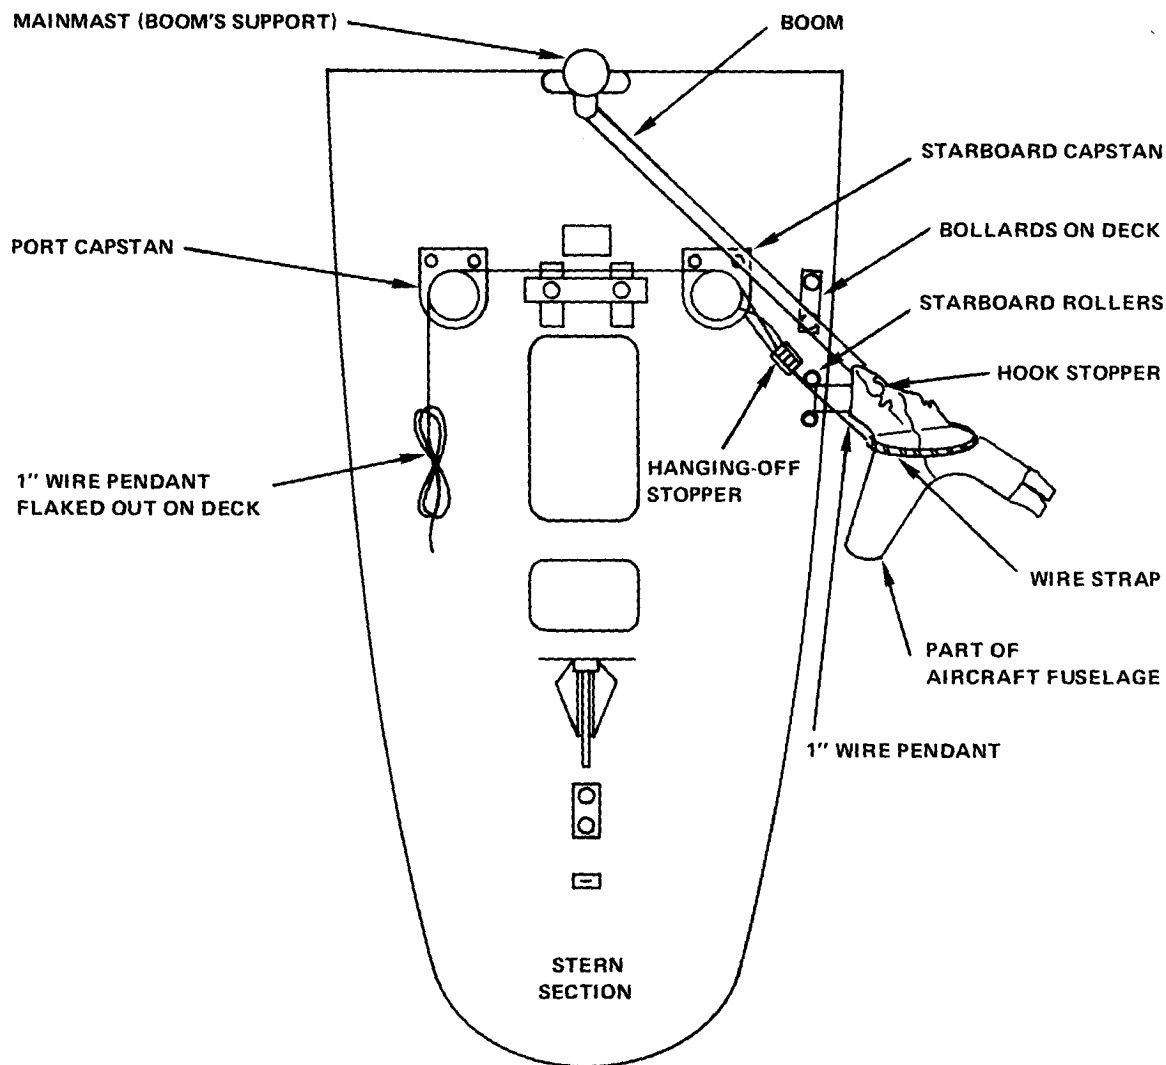
Wire holding the fuselage is secured first by the hanging-off stopper, placing the load on the capstans. The boom with another Carpenter stopper on the hook is then swung out to receive the load. The load is transferred when the hook stopper is passed and the wire is cut below the starboard capstan.

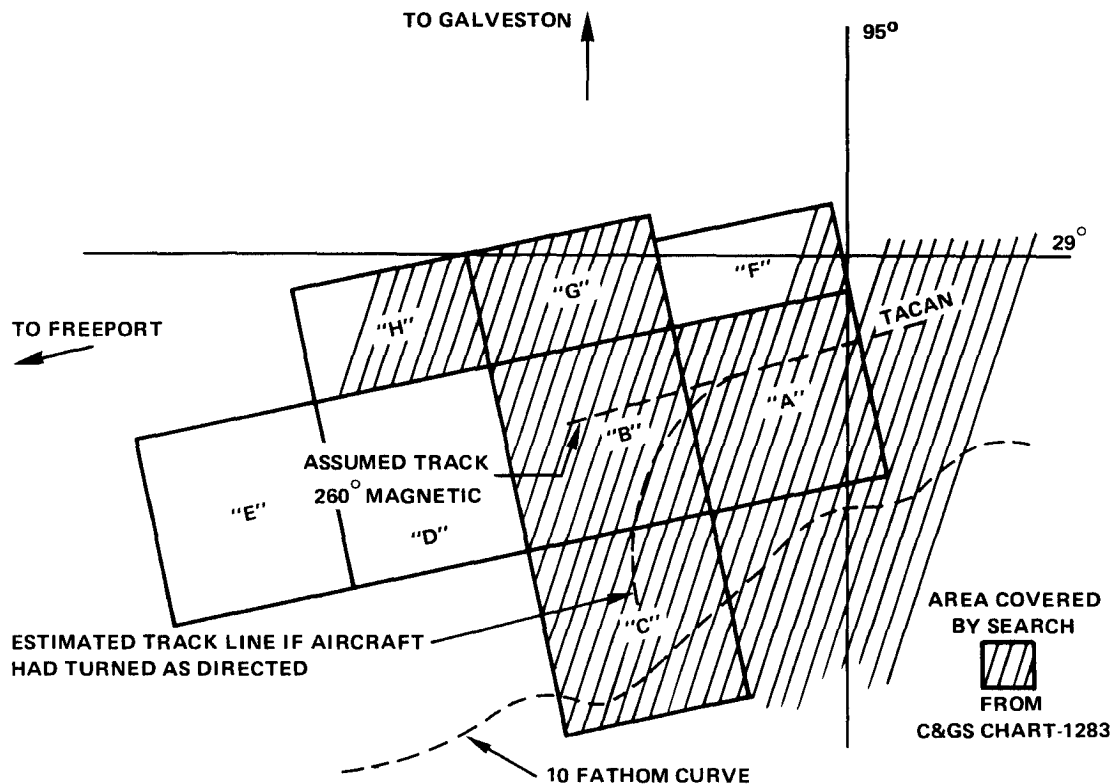
The sonar search covered almost 25 square miles. A TACAN line of bearing provided the only basis for identifying the impact area. The search did not locate the aircraft.
