Ex-SHADWELL / Ex-State of Maine Salvage Report

August 2007

Ex-SHADWELL / Ex-State of Maine Salvage Report Table of Contents

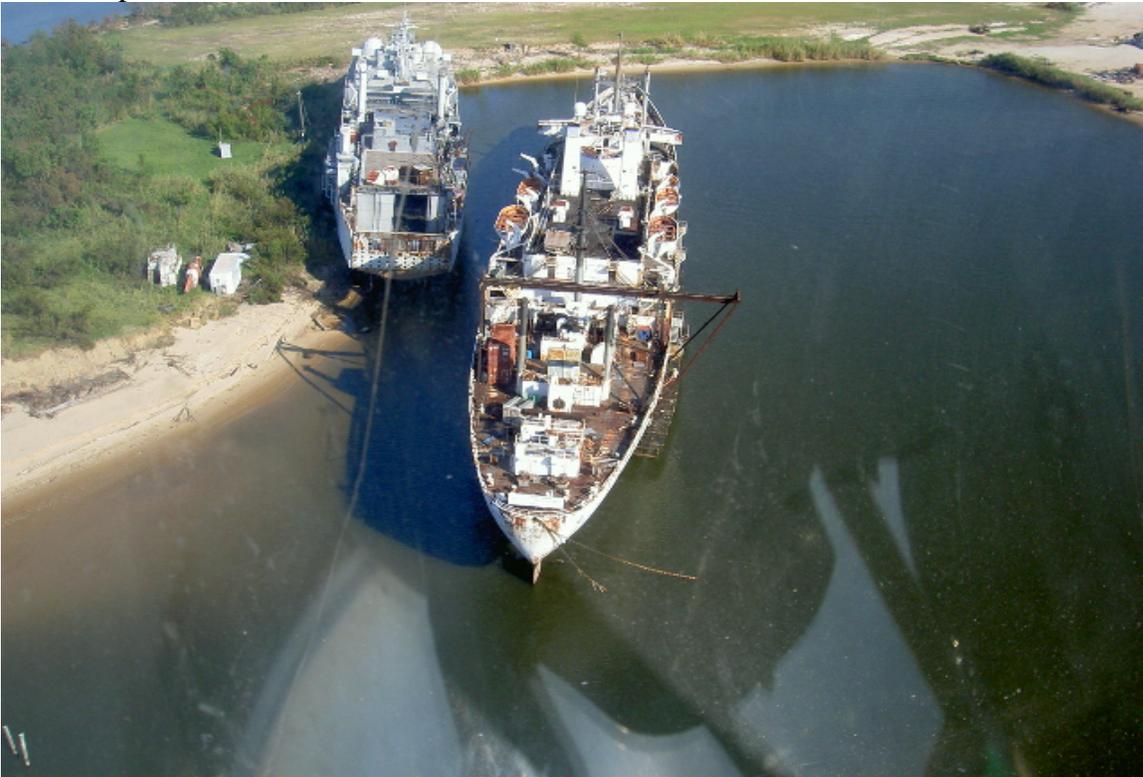
Figure 1. Ex-SO MAINE (on the right) grounded aft and to port of her original moor. Ex-SHADWELL pushed onto the beach in this overflight following Hurricane Katrina.

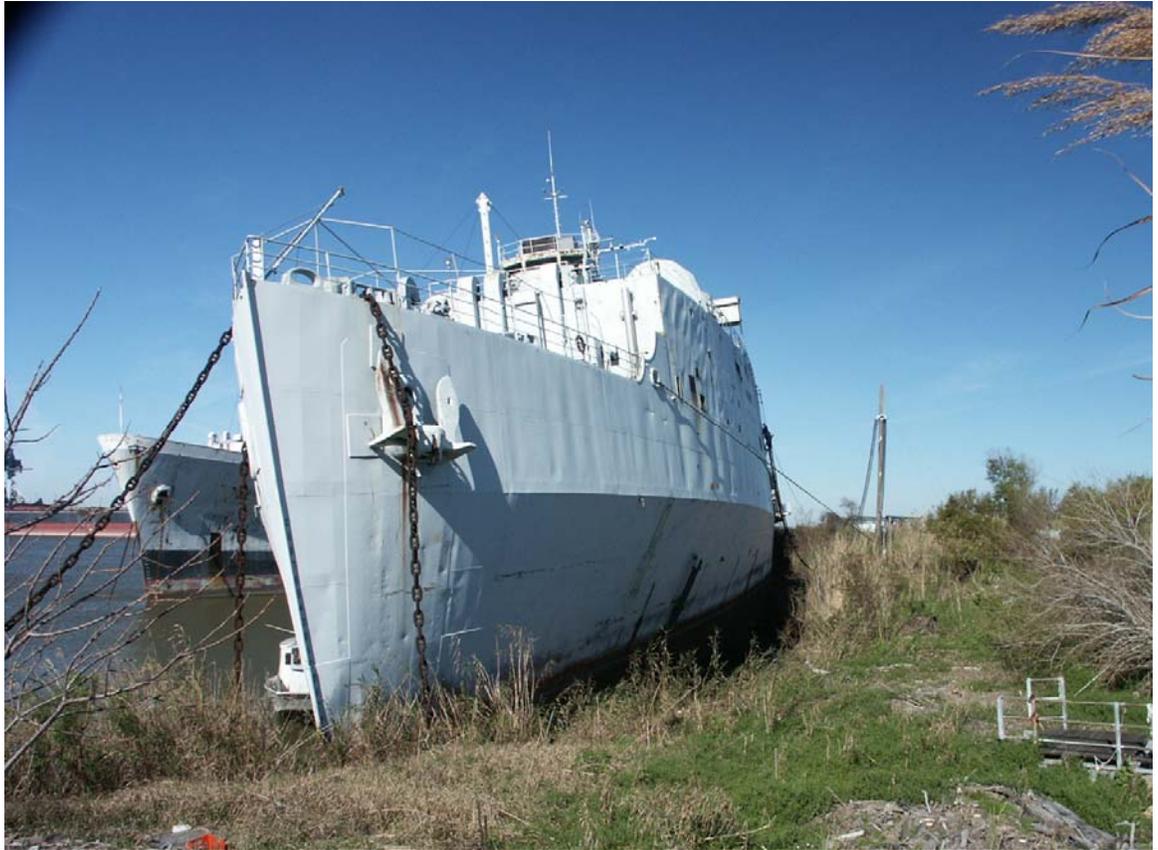
Ex-USS SHADWELL (LSD-15)

Authorized Lend-Lease Act As British Mechanized Artillery Transport Tomahawk (BAPM-7)	Originally, WWII USN Landing Ship Dock
Commissioned:	07/24/1944
Decommissioned:	03/09/70
LOA:	458 Ft
Beam:	72 Ft
Max Draft:	18 Ft
Light Displacement:	4960 LT
Custodian:	NRL, Fire Research Det., Little Sands Island, Mobile Bay, Mobile, AL

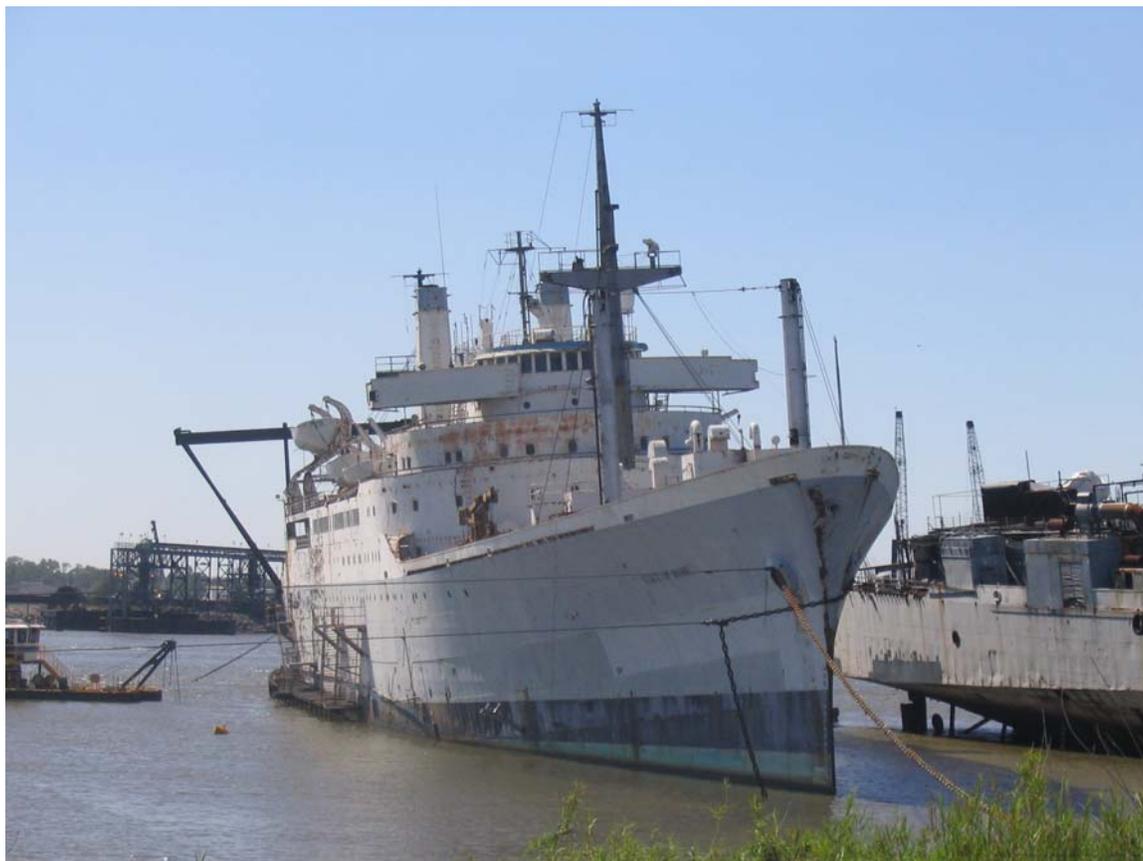
T/V STATE OF MAINE (T-AP-198)

EX-USNS UPSHUR, EX-PRESIDENT HAYES	Built by New York Shipbuilding Co. in 1951. Taken over by US Navy renamed USS Upshur and used as Troop Transport Ship during Korean Conflict. From 1973 – 1997 loaned to Maine Maritime Academy renamed State of Maine. Currently, on loan from MARAD to US Coast Guard's Fire & Safety Test Detachment on Little Sand Island, Mobile AL, for fire-fighting research
Commissioned:	12/01/52
Decommissioned:	1973 (end of USN troopship era)
LOA:	533 Ft
Beam:	73 Ft
Max Draft:	27 Ft
Light Displacement:	6720 Lt
Custodian:	U.S. Coast Guard, Fire & Safety Test Detachment, Mobile, Al

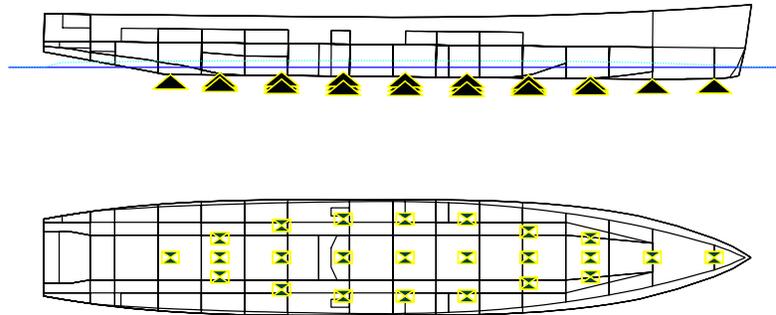
Draft/Displacement Summary Refloat

Stranded Draft / Displacement Data				
		Intact Direct	After Outflow	As Stranded
Draft at FP	ft	12.47		8.11
Draft at AP	ft	11.44		3.82
Trim	ft	1.03F		4.29F
Draft at Fwd Marks	ft	12.47		8.11
Draft at Aft Marks	ft	11.44		3.82
Static Heel Angle	deg	4P		7S
Total Weight	LT	5,482	5,482	5,482
VCG	ft	28.65	28.65	28.65
LCG	ft-FP	220.79A	220.79A	220.79A
TCG	ft-CL	0.20P	0.20P	0.20P
Buoyancy	LT	5,482		2,502
KB	ft	6.42		3.47
LCB	ft-FP	220.72A		205.17A
TCB	ft-CL	1.72P		4.66S
KMt	ft	31.53		69.00
FSc	ft	0.00		0.00
GMt	ft	2.88		32.23

Figure 2. *Ex-SHADWELL*'s initial condition as modeled by PCCI using Program of Ship Salvage Engineering (POSSE).

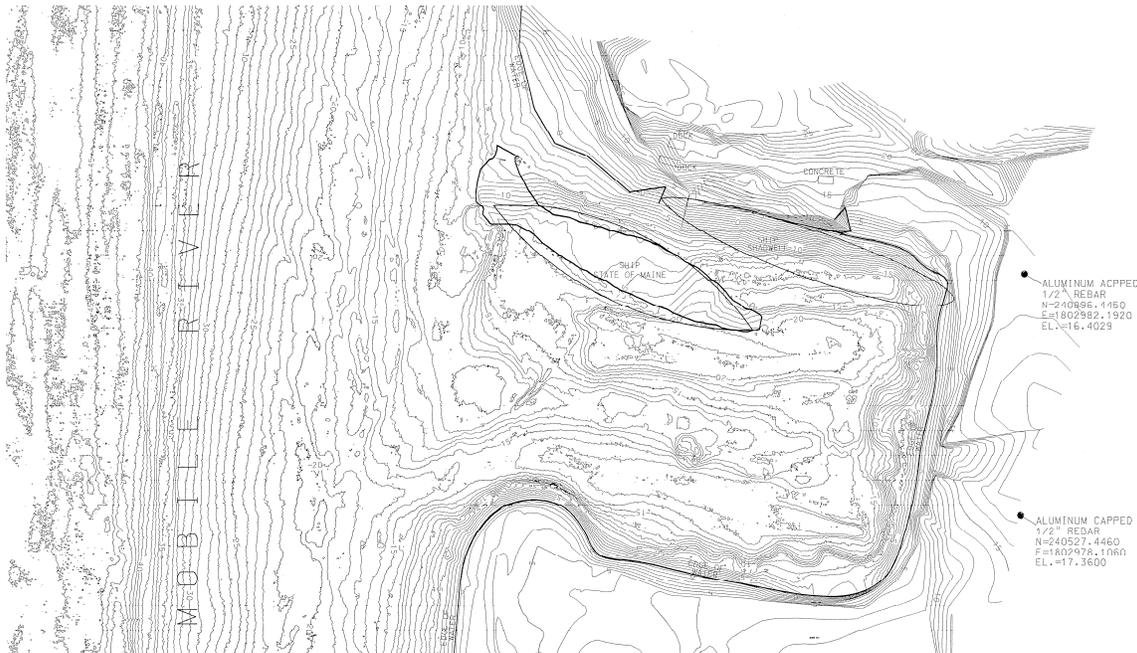
Figure 3. Chart compiled from surveys depicting the cove in Little Sand Island after the storm.

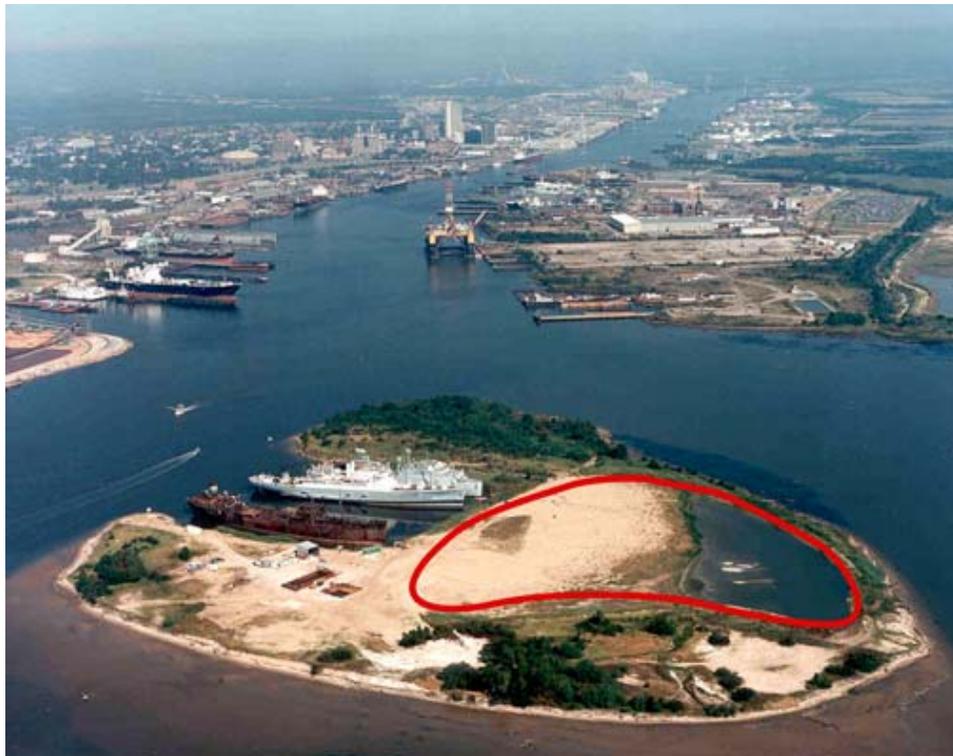
Figure 4. Little Sand Island. Cove containing Ex-SO MAINE and Ex-SHADWELL to the left. Dredge spoil area and berm location drawn in red to right. This picture was taken well before Hurricane Katrina and the third vessel shown in the image to starboard of Ex-SO MAINE was not present at the time of the storm.

created by the wall's 11 foot height. The berm wall was sloped both on the inside and outside of the berm. The outside wall was sloped at a ratio of one foot high to three feet wide while the inside wall was built with a one to two foot slope.

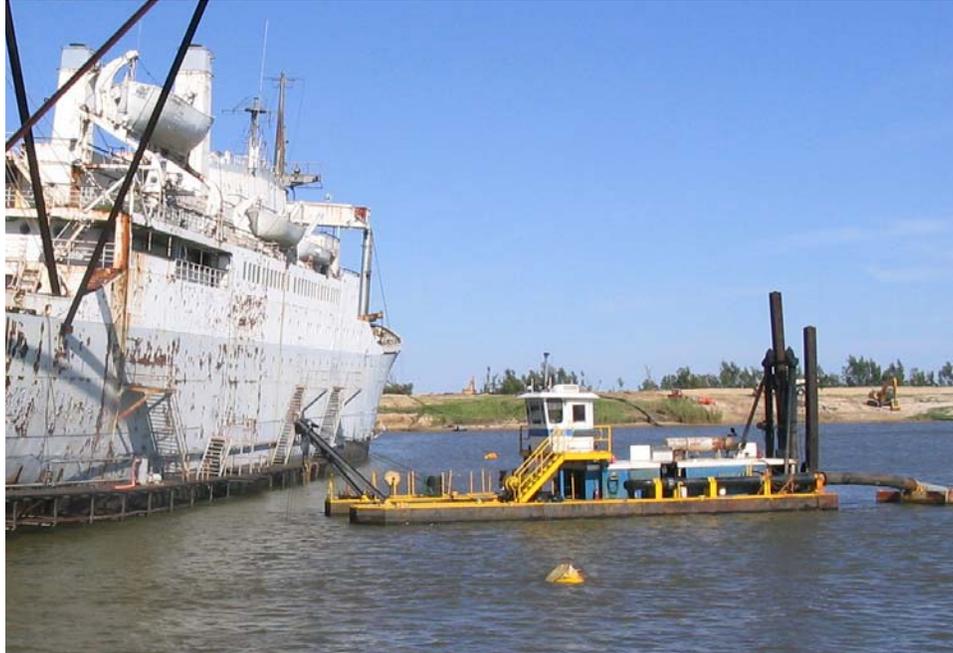
Figure 6. Large Dredge working the starboard side of State of Maine

The large dredge arrived on site on 10 April 2006 and worked through 26 June. This machine pumped through a 15” diameter pipe to the spoil site. The dredge was staffed to work 24-hour operations. As the dredge began work in the cove, metallic debris was often encountered. This included old mooring chain, wire rope, pilings, and other miscellaneous debris. Encountering this material with a dredge cutter head resulted in down time while the equipment operators, often in conjunction with MDSU divers, cleared the dredge pumps, cutter head or suction pipes. Occasionally, damage resulted from the entanglement and supplies were required to return the equipment to operation. Figure 6 is an image of the dredge working on the starboard side of the *Ex-SO MAINE*. Figure 7 is an image of the cutter head of the dredge being cleared of debris by its crew.

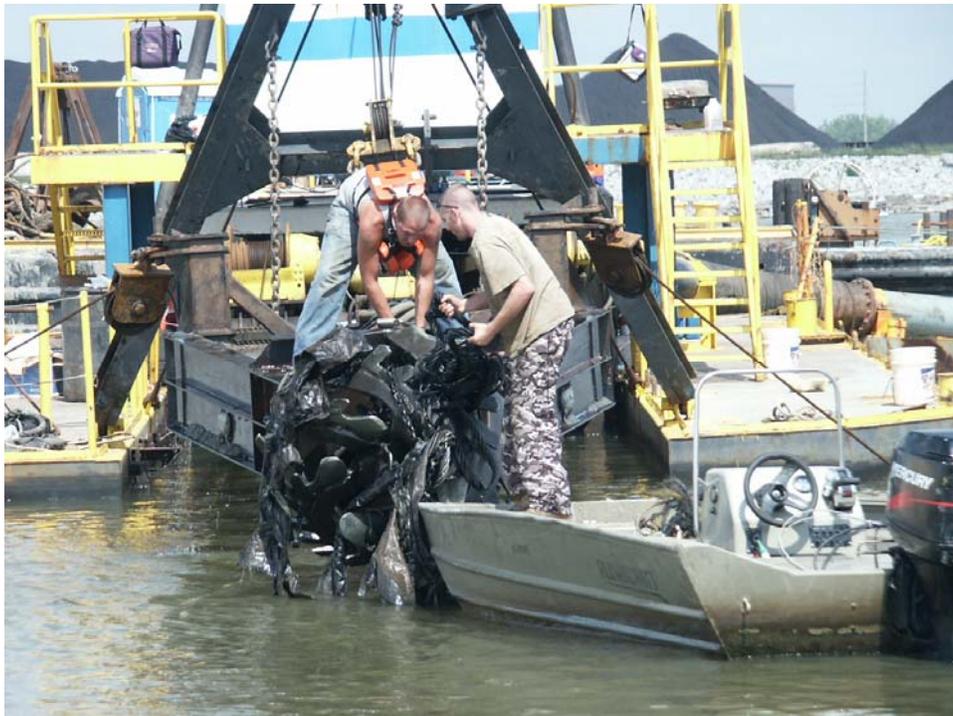
Figure 7. MDSU and dredge operators work to clear large dredge cutter head of debris encountered during dredging operations

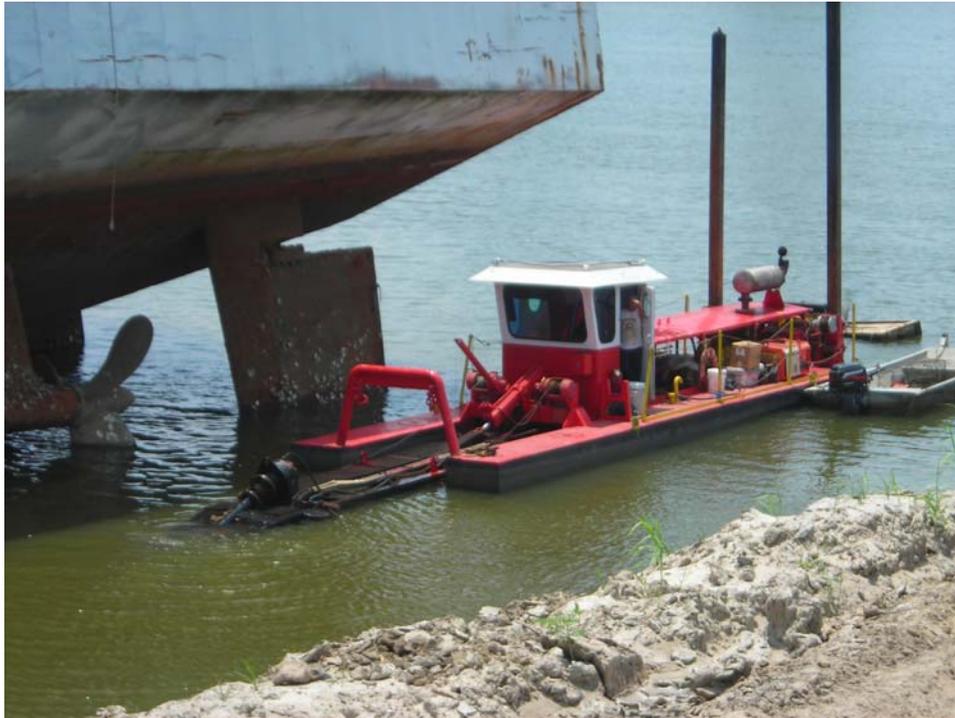
Figure 8. Small Dredge clearing a channel on the port quarter of *Ex-SHADWELL*

In order to complete the dredging, Donjon eventually ordered a second dredge to the site. The second dredge worked from 3 May through 15 June and was instrumental in combating the high concentration of clay that occupied the cove under *Ex-SHADWELL* and *Ex-SO MAINE*. Figure 8 is a picture of the smaller dredge working under the port quarter of *Ex-SHADWELL* on the 1 June 2006.

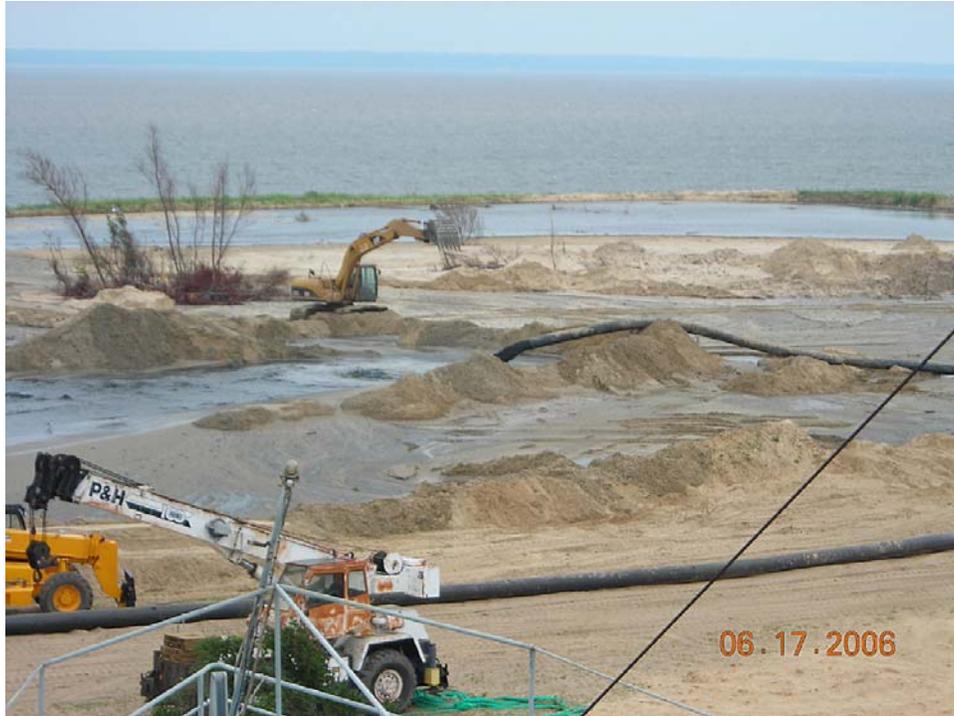
Figure 9 Little Sand Island spoil site. Earth moving equipment arranging sand during a dredging break.

The second dredging operation undertaken by the earth moving equipment was to help prepare the new moor for *Ex-SHADWELL*. During the week of 8 May, 2006 an excavator began pulling sand out of the shallows on the south west side of the cove. This portion of the cove had been filled in by Katrina and required clearing to allow *Ex-SHADWELL* into its prescribed moor. As the excavator dug, the shoreline shifted south. The sand that was removed was pushed and graded by a bulldozer and evolved into a substantial dune which would help shield *Ex-SHADWELL* from potential southerly blows. Figure 10 is an image of the sand piles being excavated and pushed up into dunes.

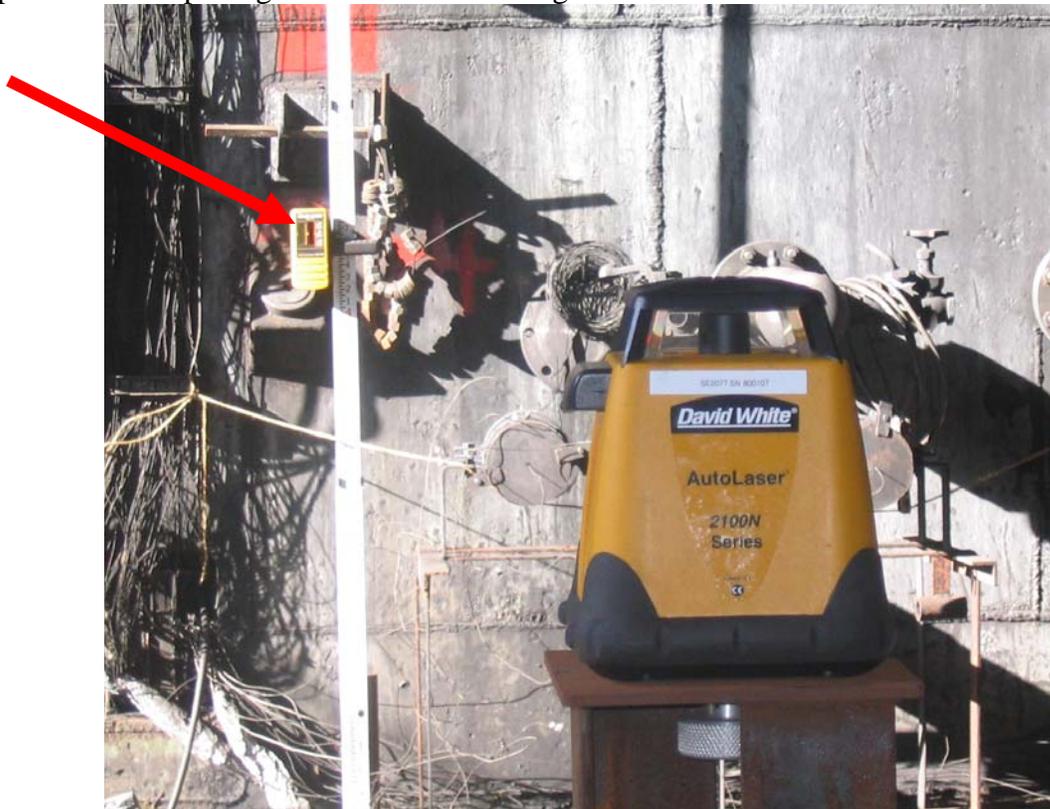
Figure 11. Davis White rotating laser level (to the right) and receiver/measurement point to the left (highlighted by arrow) in well deck of *Ex-SHADWELL*

Concern for the potential of local failure through plate buckling resulted in the development of a system to monitor very small deflections of *Ex-SHADWELL*'s hull. This system, the Hull Girder Laser Monitoring System, used a surveyor's laser level and

a laser sensing target to measure changes in the hull at multiple pre-defined points, which were then be used to calculate stress in the hull. *Ex-SHADWELL*'s well deck was open and large enough to set the system up. The rotating laser was fixed in the center of the well deck and sixteen measurement points were established. The measurement points established hull deflection conditions at frames 22, 36, 74, 88, 101 and 111. Measurements could be collected in less than 30 minutes and the system proved accurate to within 1/16-inch over the length of the well deck. Figure 11 contains a photo of the rotating laser level and one of the measurement points. Appendix F. contains several spreadsheets depicting hull deflection readings from *Ex-SHADWELL*.

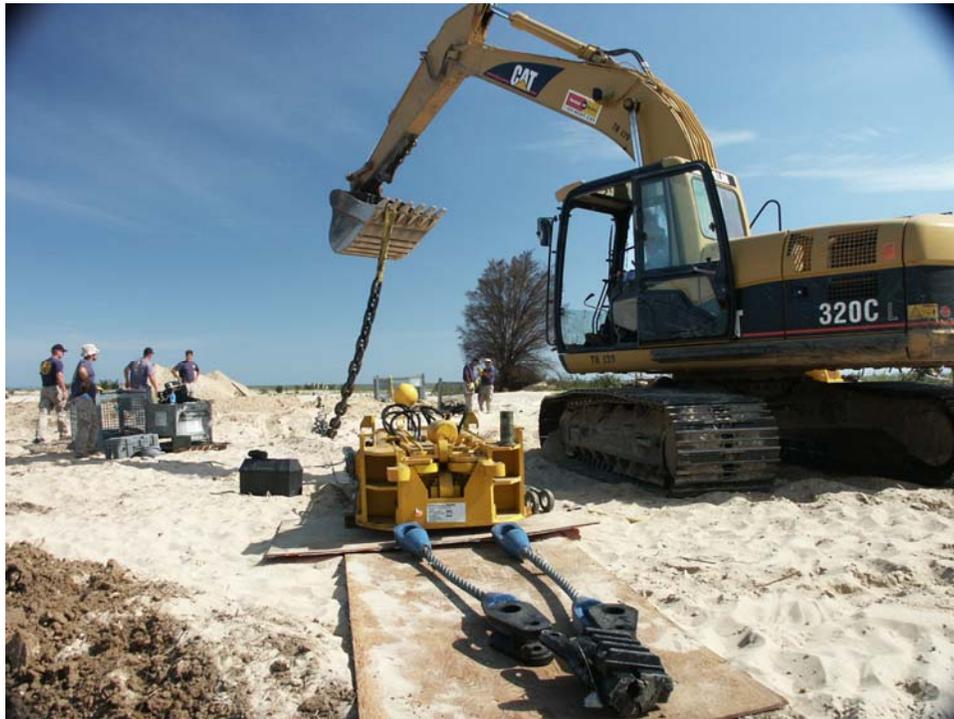
Figure 12. Excavator assisting MDSU ONE team in setting the anchor in a deadman. In foreground is the bridle assembly and 50-ton hydraulic cable puller and to the left is the control panel and new electronic tension measuring device.

dredge down time) an attempt was made to pull *Ex-SO MAINE* free of her stand. Nearly 100,000 lbs of pull was achieved with the starboard bow hydraulic puller but no movement was detected. On 10 May, a strong southerly was blowing water to the north end of Mobile Bay raising the water level above the normal high tide and two Crescent Tugs were engaged try to shift *Ex-SO MAINE*'s stern to starboard. The tugs effort in conjunction with the single leg of beach gear failed to shift *Ex-SO MAINE* that day so further dredging was employed.

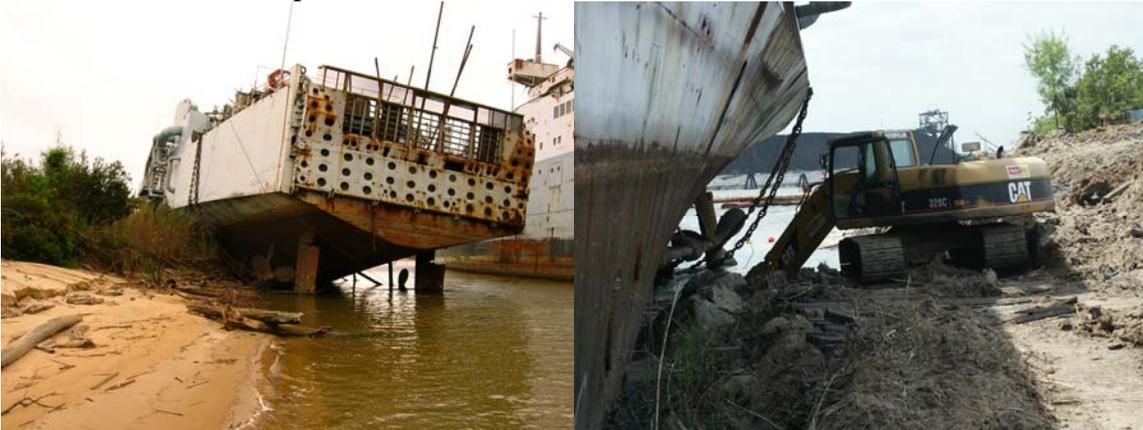
Hurricane Katrina pushed *Ex-SHADWELL* on the beach. Her port side was sitting over dry sand and her bow was firmly pined on the beach. Figure 14 shows *Ex-SHADWELL* after the storm and at the beginning of the land-based excavation. *Ex-SHADWELL*'S extraction began on 7 April with excavators and bulldozers beginning to remove earth from the port side of the hull.

Figure 14. Ex-SHADWELL hard aground and at the beginning of land based excavation.

Because of *Ex-SHADWELL*'s degraded longitudinal stringers and the potential for the hull plates to buckle under additional stress, the salvors carefully planned her extraction to maintain tension on her hull girder system. Flooding alarms were installed (components from the ESSM Towing System) on 10 April and the Laser Hull Girder Monitoring System was set up on 12 April to track changes in hull stress.

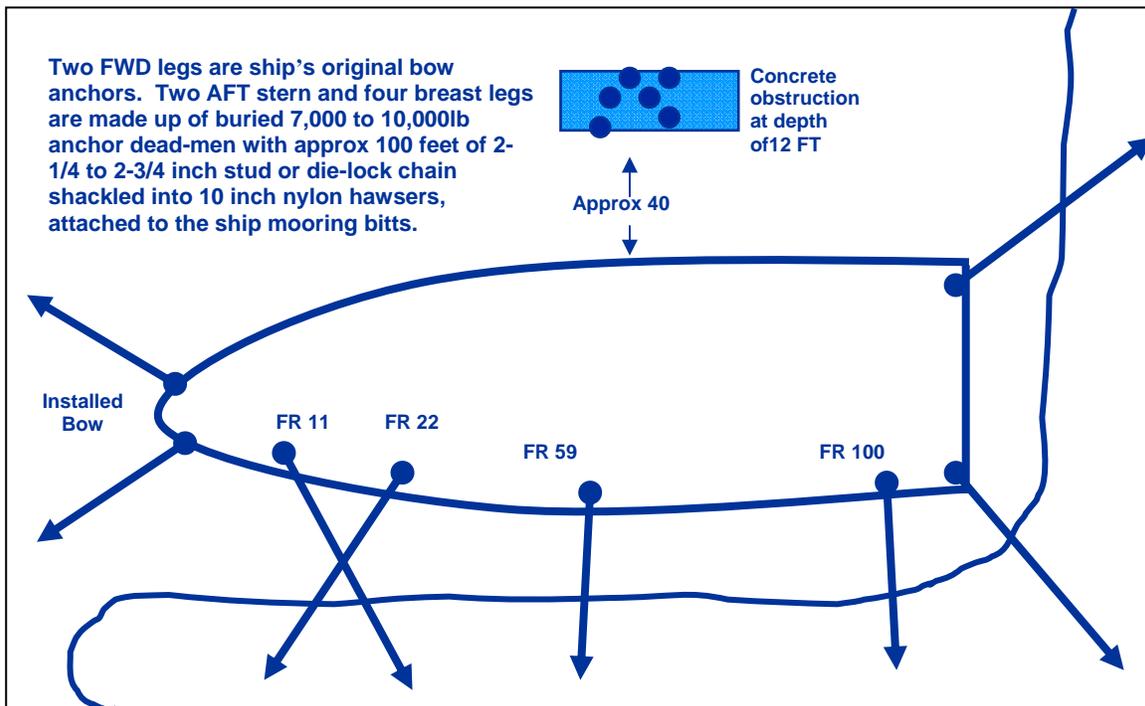
Figure 15. *Ex-SHADWELL* permanent mooring plan

Following the setting of the permanent moor, PCCI was tasked with performing a mooring analysis for the final *Ex-SHADWELL* moor. That analysis concluded that it was possible that the ship would shift in its moor with strong northerly or southerly winds. Furthermore, they noted that if a significant storm surge did not accompany the wind, it was likely that the sides of the dredged channel would assist in keeping the ship in its moor. That Mooring Analysis report is included in Appendix H.

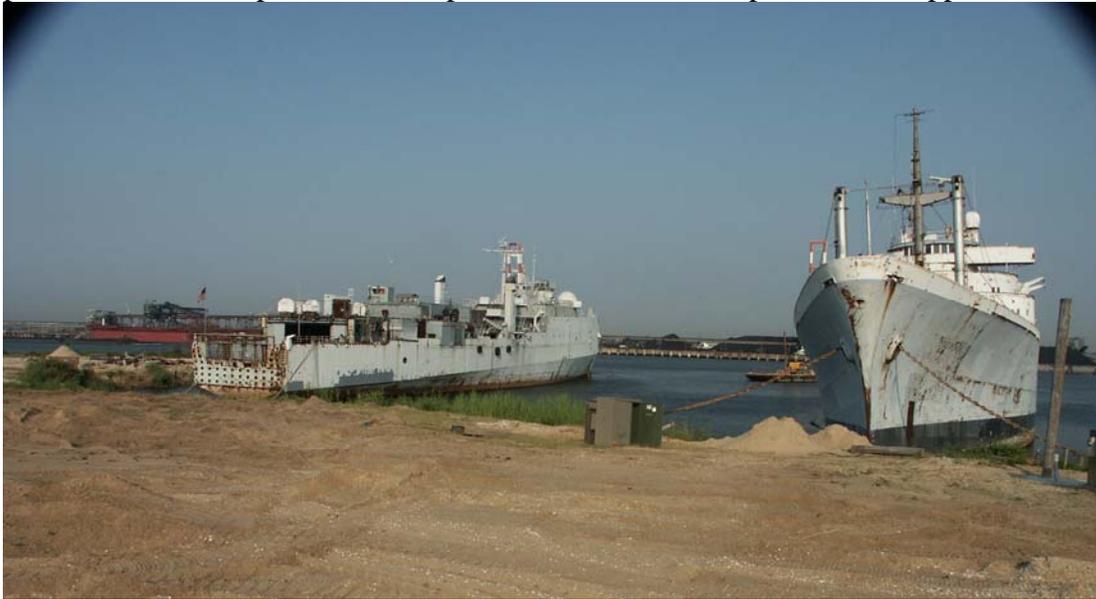
Figure 18. Ex SHADWELL and Ex-SO MAINE moored in their final positions.

Ex-SHADWELL and *Ex-SO MAINE* were extracted from their strand and positioned in their final mooring locations and all mooring equipment has been positioned to meet the customer's requirements. Little Sand Island's cove has been dredged to support the permanent moors. All salvage equipment has been removed from the island, loaded on to trucks, and is being transported back to the ESSM warehouse. Certification of Delivery letters were provided to customer reps for both ships and are included as Appendix J. A copy of the timeline for this operation is included in Appendix K. Text from the Situation Report Messages, issued three times a week, are included as Appendix L. This Timeline and the Situation Reports document the determination and perseverance of the project team who steadfastly resolved the many obstacles encountered in order to complete the successful salvage operation. GPC's final report for Operational Delivery Order #0856/S116 is provided as Appendix M. A briefing conducted after the operation highlights many of the challenges of the tasks and provides additional photos of the operations. This brief is provided as Appendix N.

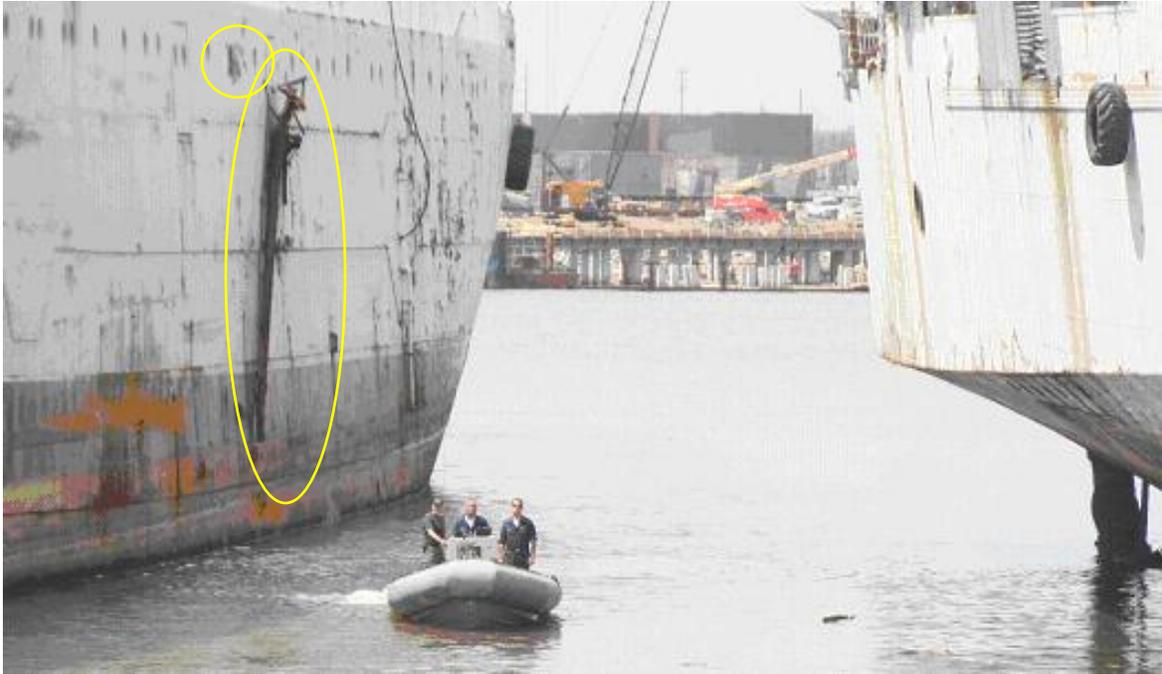
Figure 3: Structural damage to ex-STATE OF MAINE

Items to note, the crushed added-on ladder and ruptured porthole from an apparent collision with ex-SHADWELL.

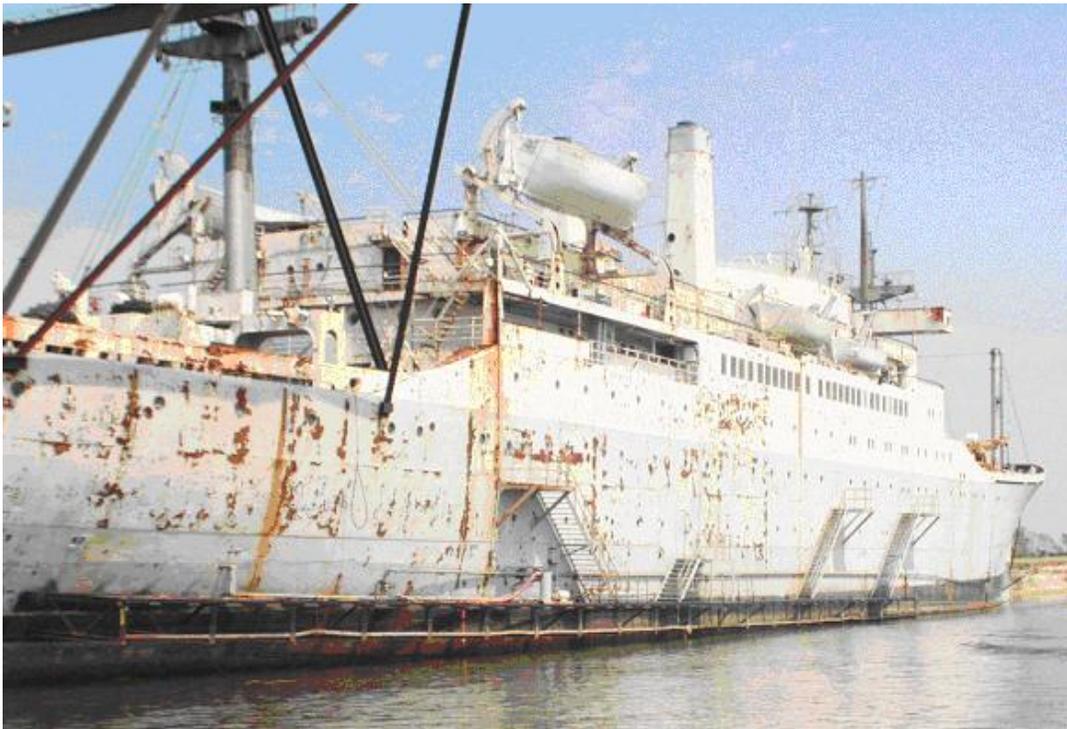
Figure 4: Starboard Side of ex-STATE OF MAINE

No apparent damage to the starboard side of ex-STATE OF MAINE as a result of Hurricane Katrina or the stranding.

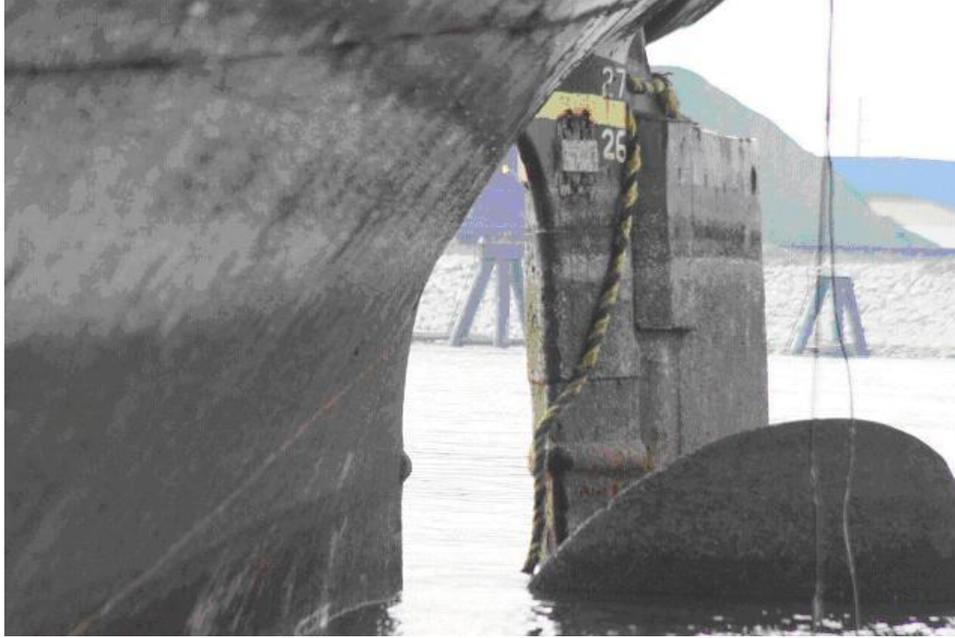
Figure 5: ex-STATE OF MAINE rudder from port side

From view of port and starboard side, with no discernable draft marks available near the waterline, scaled measurement of the above and below photographs estimates the aft draft to be approximately 18' 6". It can also be seen that the rudder is amidships after stranding.

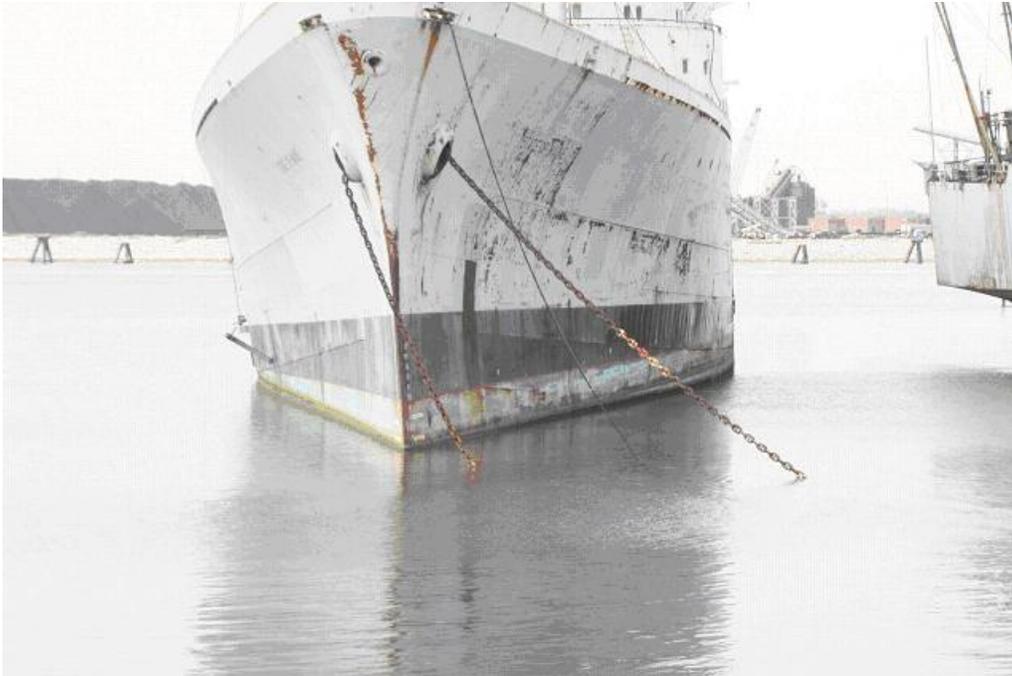
Figure 7: ex-STATE OF MAINE Bow View

Two things of importance can be seen in the above photograph. One, the obvious list to starboard of the ex-STATE OF MAINE. Two, both bow anchor chains tending out of the hawse pipe toward the ship's port side. Below (though hard to tell from the picture), port stern anchor chain now tends aft and to starboard since Katrina. From these two observations it seems the ex-STATE OF MAINE may have twisted to starboard, possibly colliding with ex-SHADWELL.

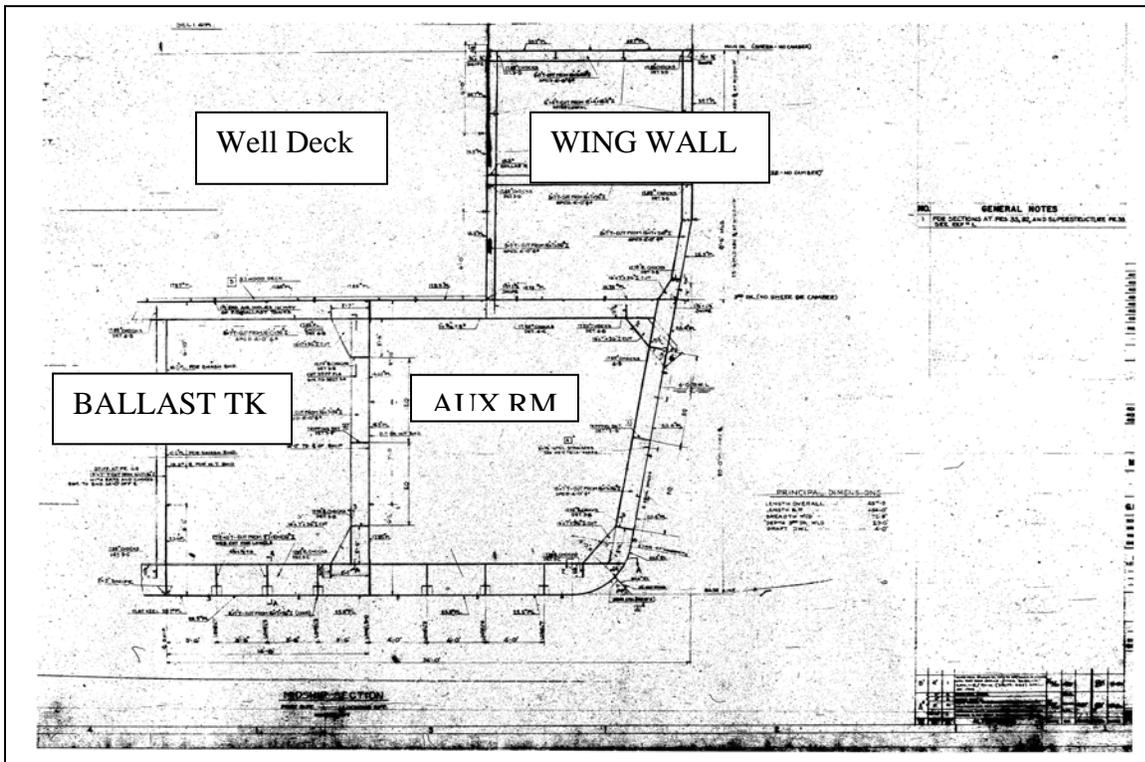
- Horizontal Axis Inertia (Ixx) 3,153 Ft⁴.
- Top Extreme Fiber Distance (yt) 18.57 Ft
- Section Modulus – Top 170 Ft³
- Bottom Extreme Fiber Distance (yb) 18.59 Ft
- Section Modulus – Bottom 170 Ft³
- Shear Area 8.0 Ft²

Figure 1
MIDSHIP SECTION

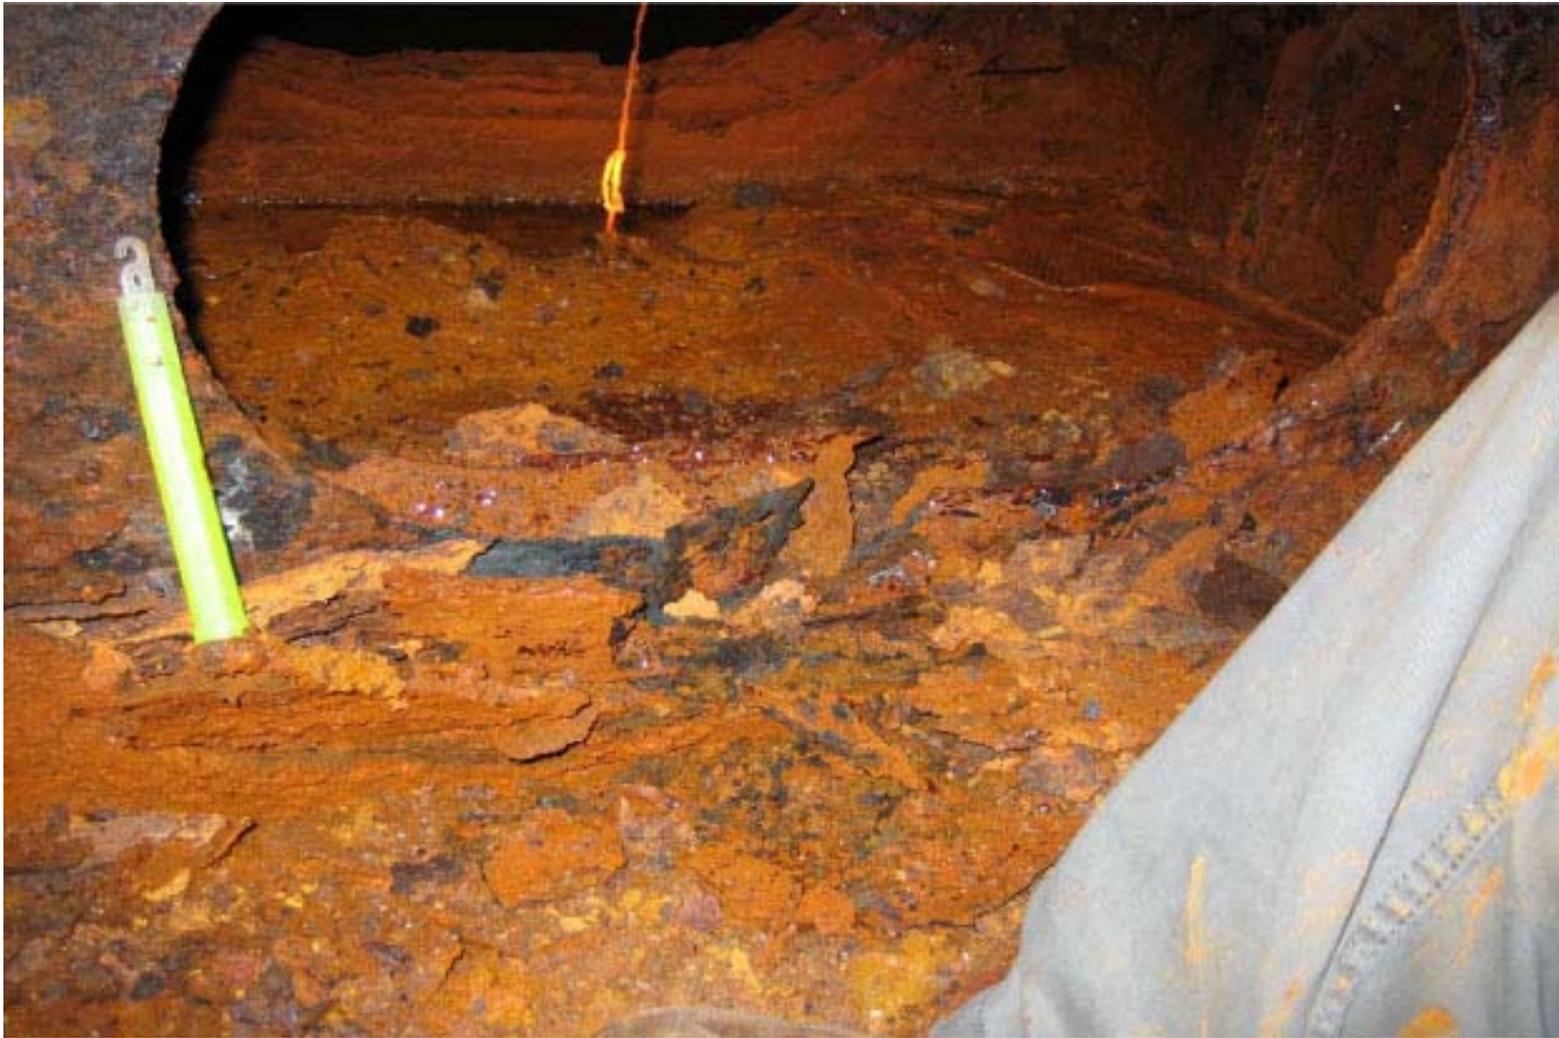
Figure 1. Longitudinal structural support frame in port engine space bilge shows rust and scale deterioration with heaviest deterioration along shell plate interface. Typical of most frames (transverse frames, longitudinal frames and many intercostals in the engine room spaces.

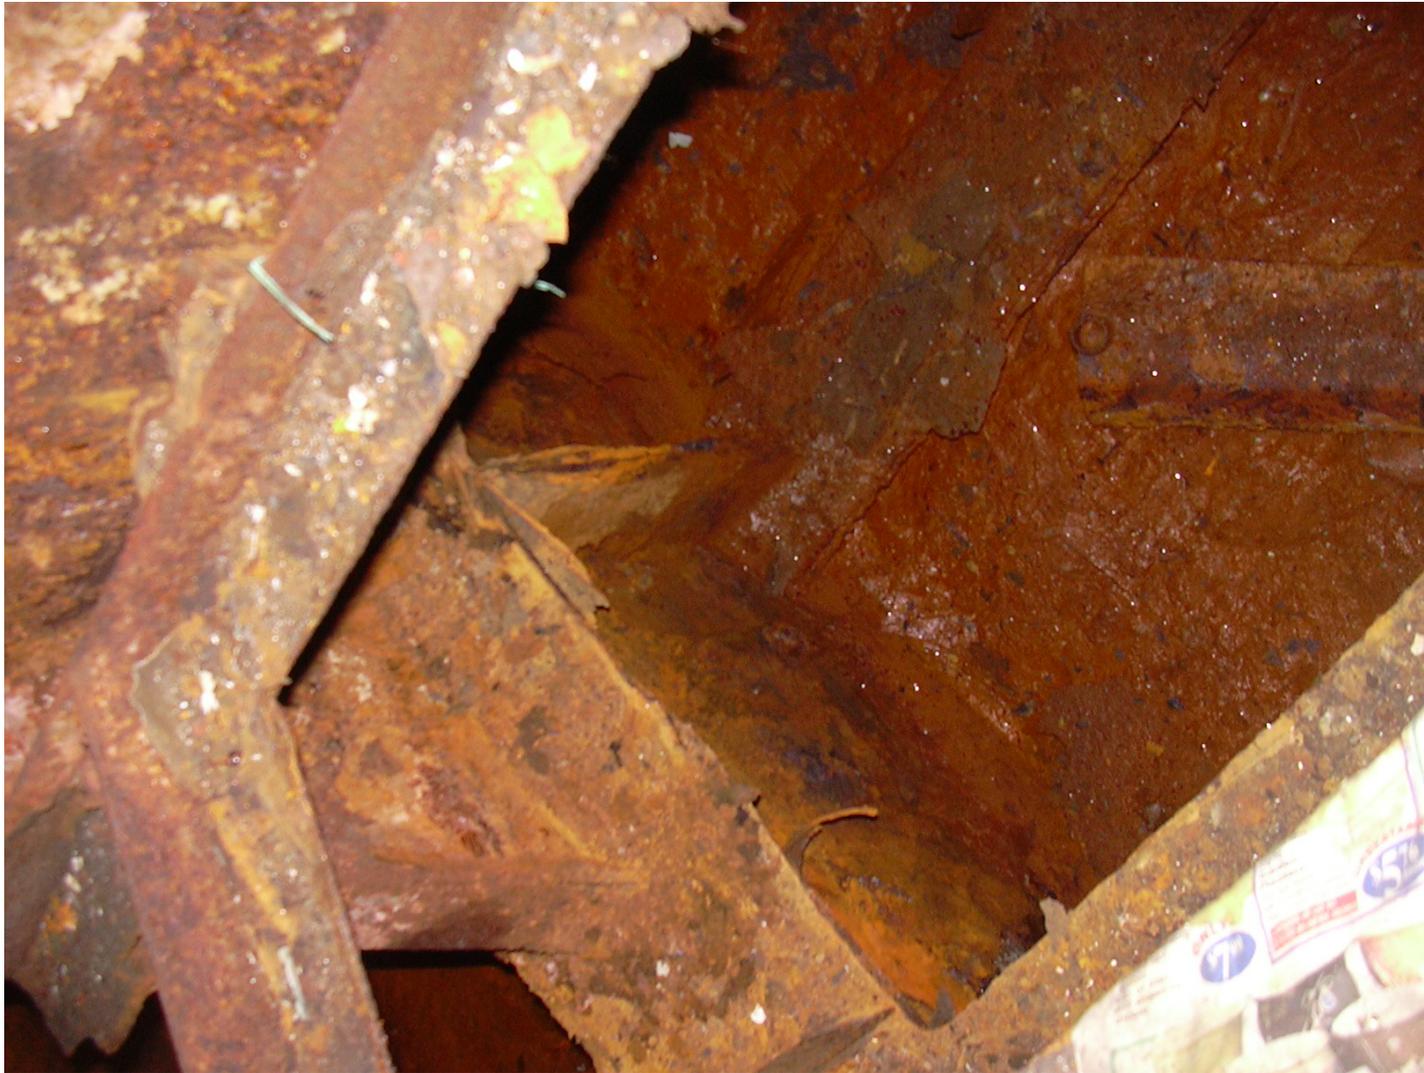
Figure 2. Transverse beam intersecting longitudinal L-7 in port engine room.

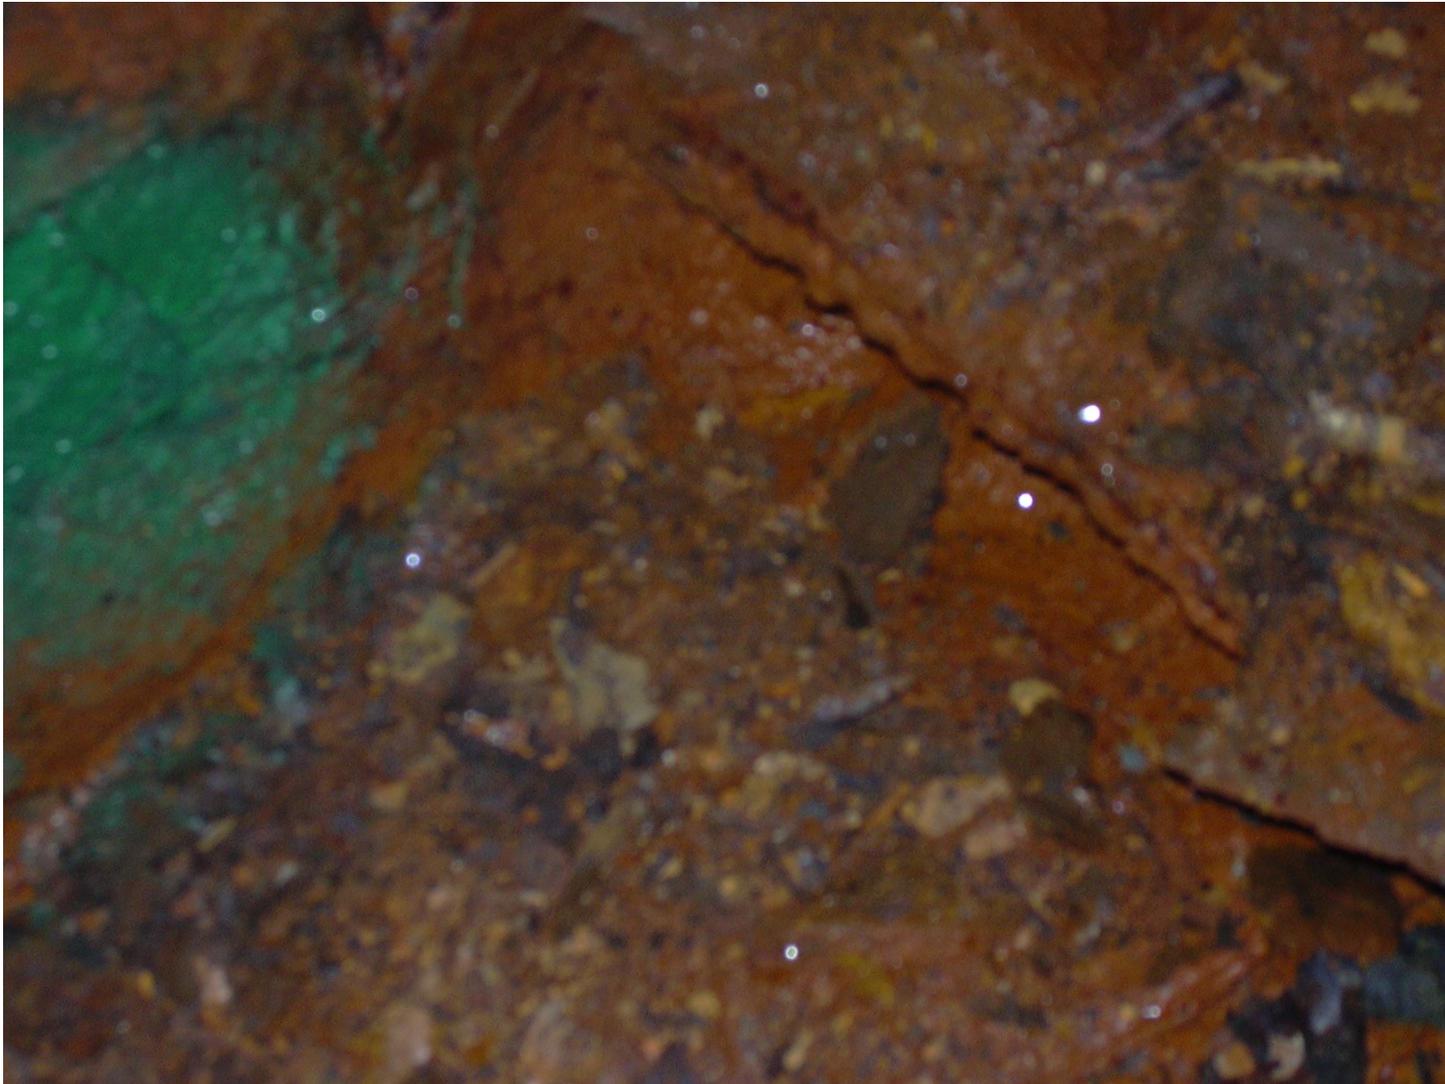
Figure 3. Typical wasted shell plating in way of turn of bilge – port engine room.
